UCRL-AR-143121-09

**Compliance Monitoring Program for the**  
**Closed Building 829 Facility**

**Annual Report**  
**2009**

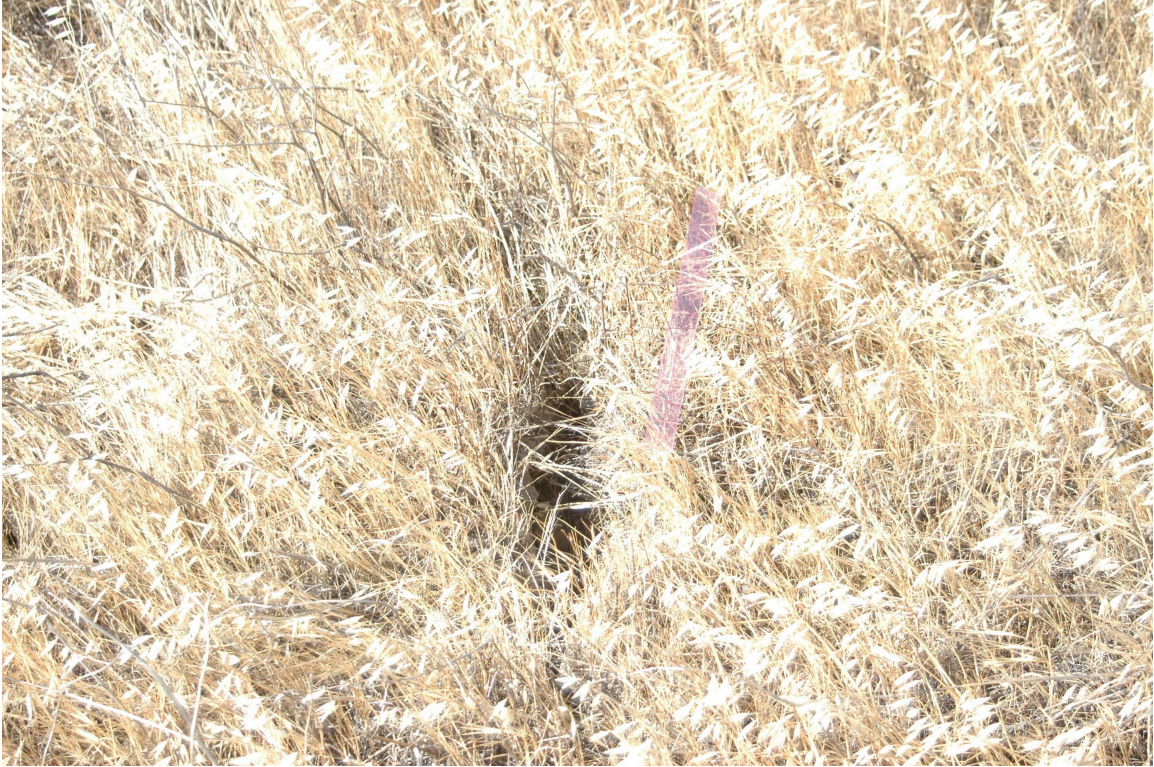
**Figure 5** Crack On the Cap

There was a crack approximately 2 feet in length visible on the west side of the cap, see Figure 5. No other cracking or other desiccation of the cover was visible during the site visit.

- Repair the crack on the west side of the cap.
- Remove vegetative debris from the drainage ditch.
- Remove vegetative growth from the drainage ditch and repair cracks as necessary.

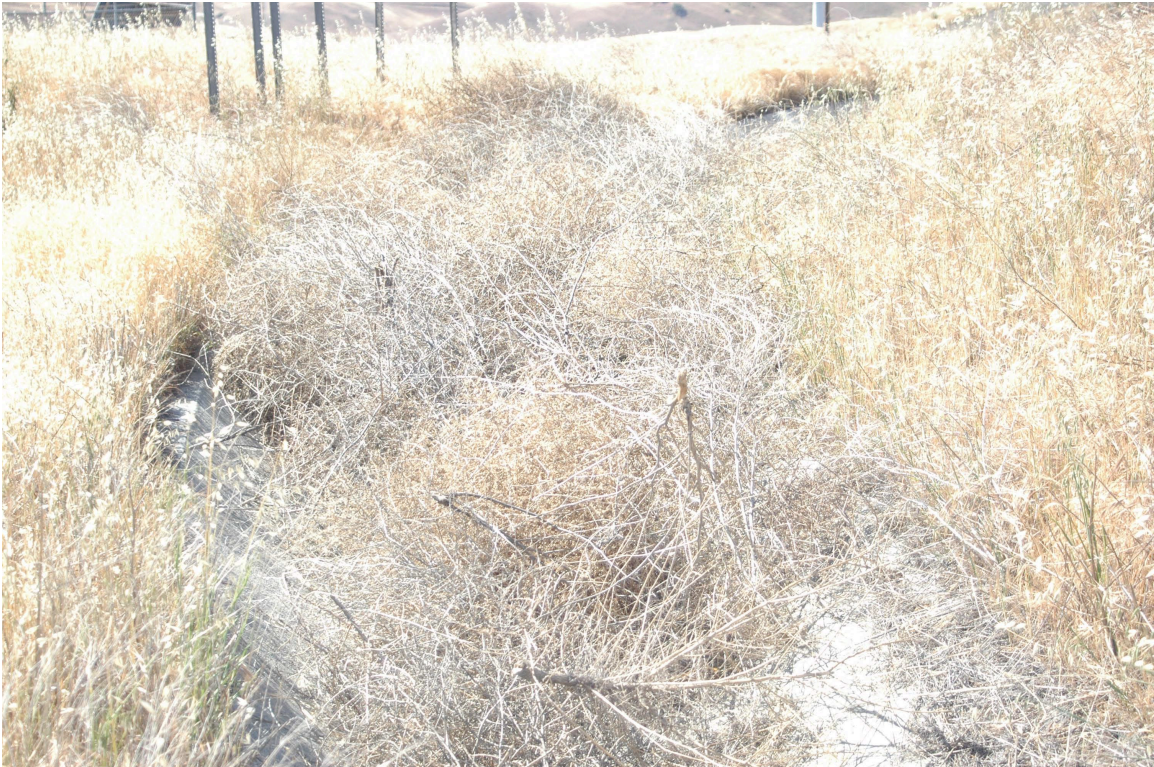
**Figure 6** Building 829 Vegetative Debris in Concrete Drainage Ditch

Surface runoff diversion structures consist of a perimeter drainage V-ditch. The V-ditch has expansion joints every 12 ft and every other one is caulked. The remaining expansion joints appear to be saw cuts partially onto the surface of the concrete. The structure also collects water from the "drainage layer" of the cap through a series of drainage pipes. Concrete lining appears to be in good condition. Evidence of vegetation debris accumulation, see Figure 6, and vegetative growth, see Figure 7, in the drainage ditch were observed. It is recommended that vegetative debris and growth be removed and cracks in the concrete ditch sealed as necessary.
