Lawrence Livermore National Laboratory
Site 300

Compliance Monitoring Program for the
Closed Building 829 Facility

Annual Report 2004

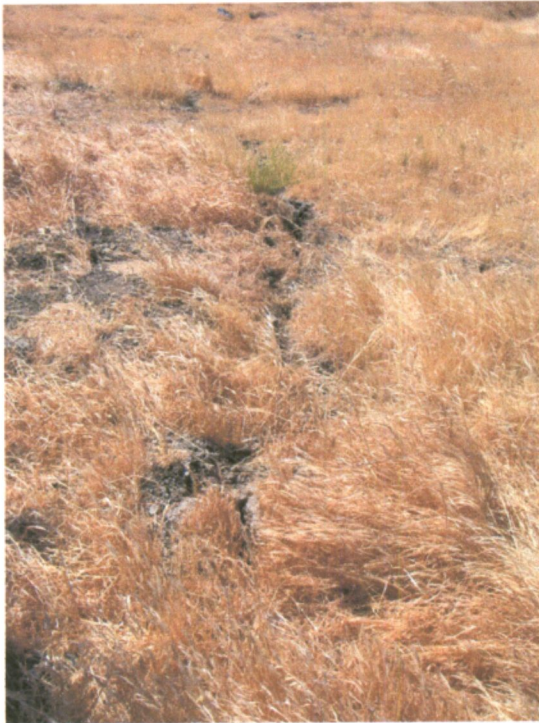
Photo 1: 829 Cap

1. Dried vegetation (e.g. tumbleweeds) was observed in the east channel and should be removed. Stress cracks in the concrete channel sections and separation of 1 inch were observed in the south and southwest sides of the channel. Settlement in the soils areas adjacent to the pit were observed including cracks 2 inches wide and 10 inches deep and more than 10 feet long.

Cracks observed beyond
the concrete channel

Soils areas adjacent to the concrete channel in the south and southeast area should be compacted to protect the pit and channel. Joints that have separated over ½ inch should be patched and sealed. Stress cracks in the channels should be monitored.

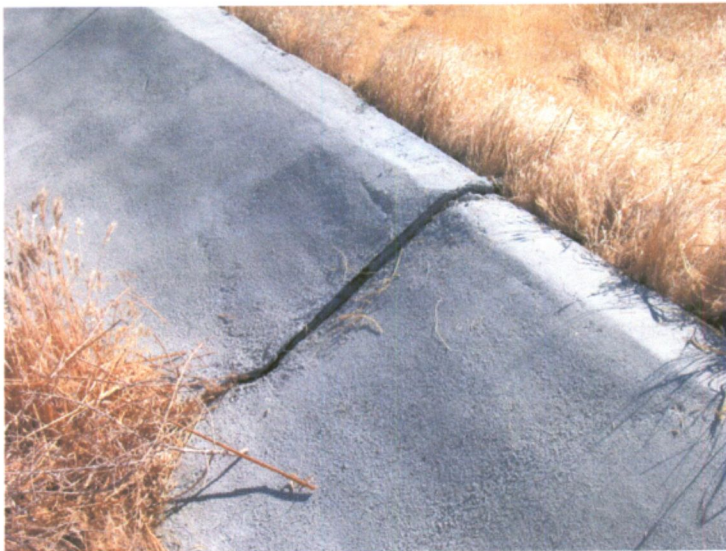
Photo 2: 829 Cap

Drainage Facilities: Some dried vegetation (e.g., tumbleweeds) has accumulated on the east side in the concrete channel and should be removed. The drainage facilities appear to be in fair condition, except for an emerging problem area. Several cracks more than 10 feet long were observed in the soil beyond the concrete channel and at the edge of the bluff (see Photo 1). These cracks were on the order of magnitude of 2 inches wide and more than 10 inches deep. The settlement here is uneven and greater than in 2003. The concrete channel adjacent to the soil area with the cracks and increased settlement has developed some cracks several feet long in random directions. The concrete channel is also developing cracks at the joints, with the vertical shift of the adjacent sections approximately 1 inch (see Photo 2). The integrity of the cap has not been compromised at this time by this settlement. Compaction of the soils in this area and monitoring of the concrete drainage channel cracks are recommended.

Cracks at the drainage
channel joints
