NIST Technical Note 1545

**Attenuation of Radio Wave Signals
Coupled Into Twelve Large Building
Structures**

C.L. Holloway
W.F. Young
G. Koepke
K.A. Remley
D. Camell
Y. Becquet

August 2008

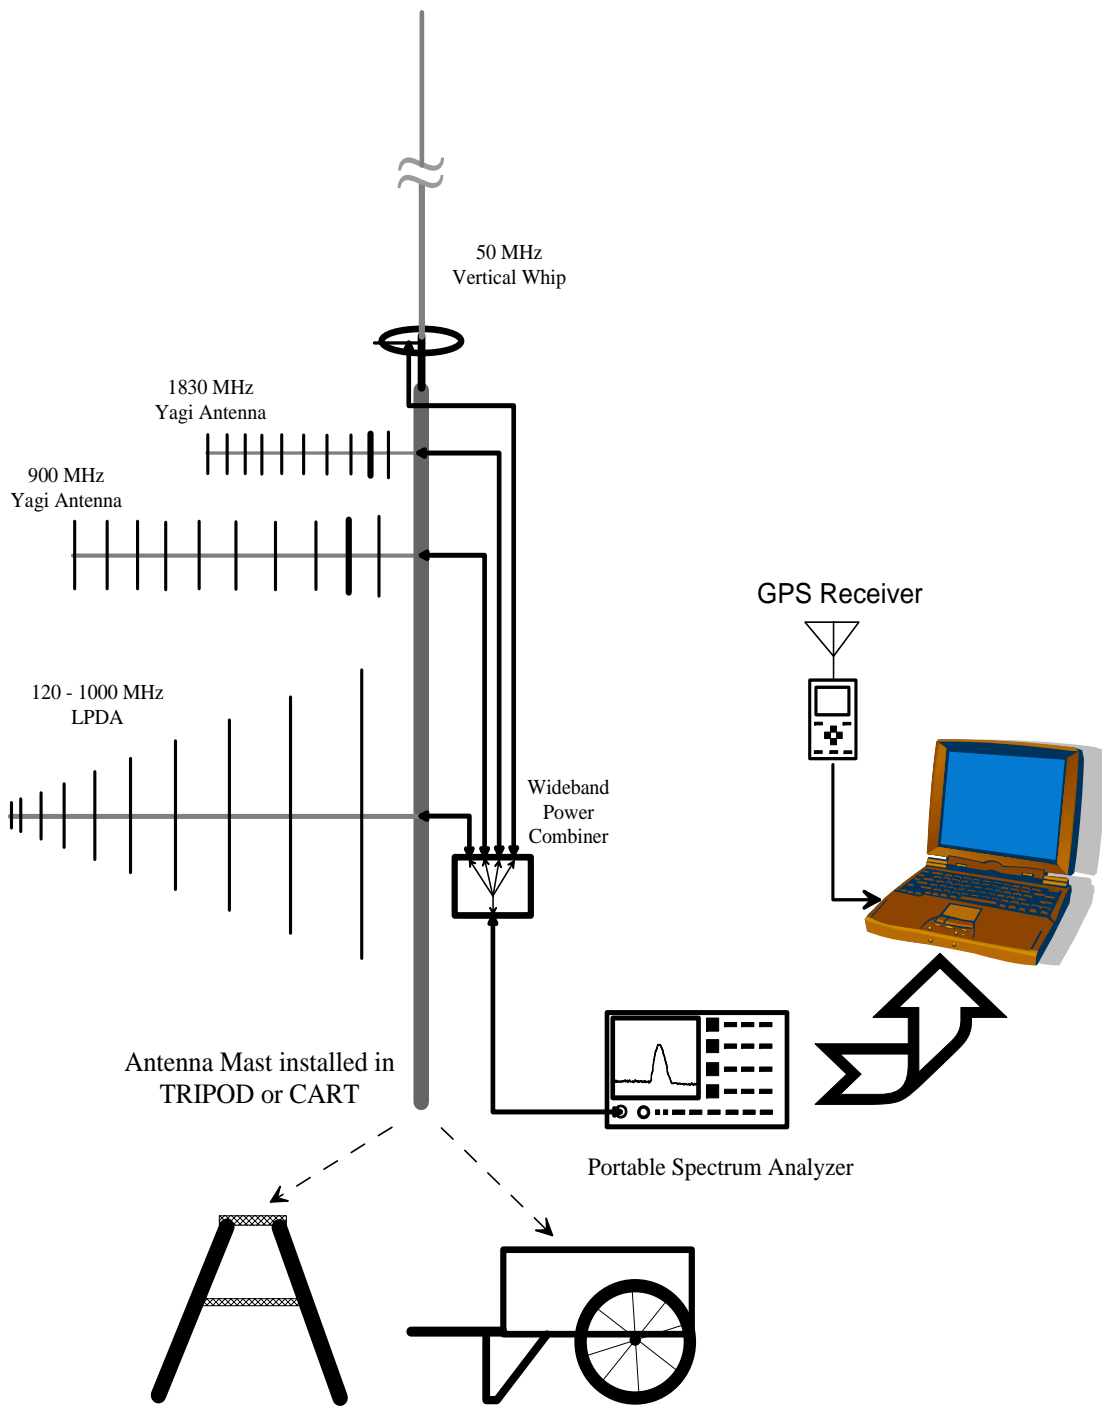
Figure 3. Schematic of the receiving system for the building penetration and field-mapping experiments.

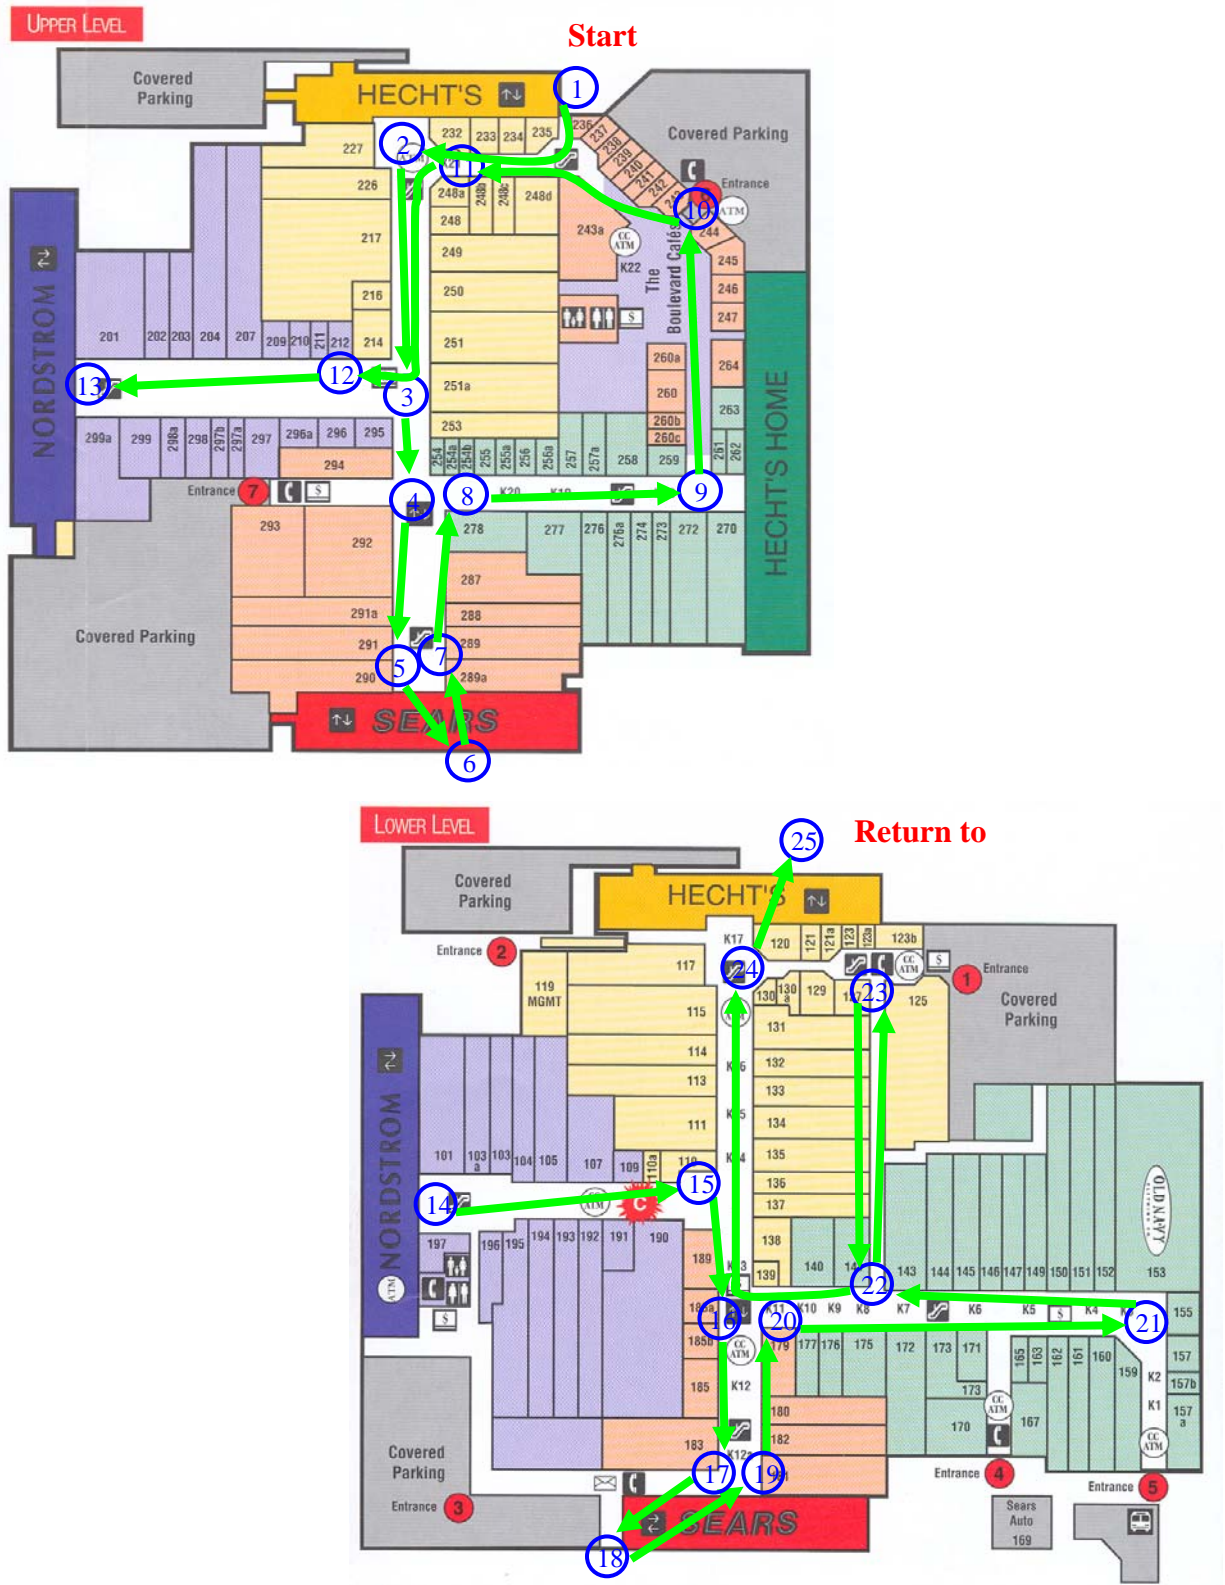
Figure 26. Upper and lower level floor plan with the predetermined locations on both levels of the shopping mall. The green arrows in the figure represent the actual paths that were walked.

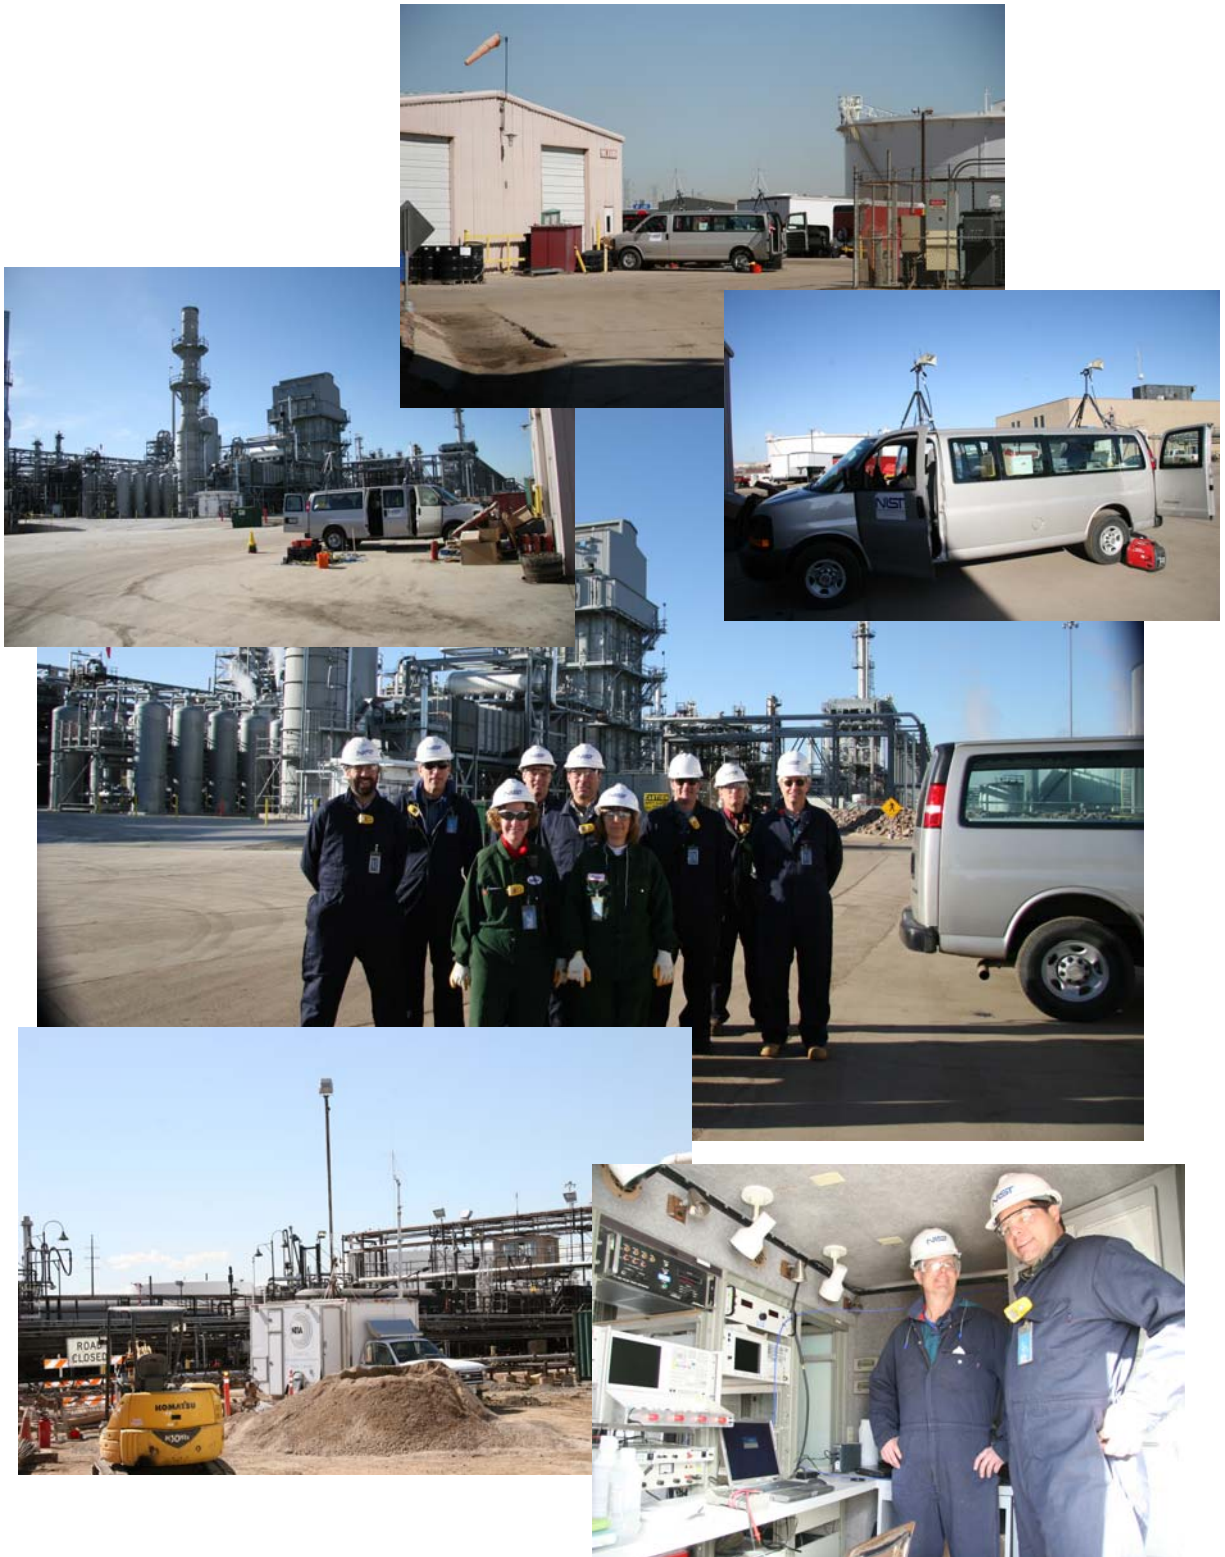
Figure 39. The receiver locations at the SUNCOR oil refinery in Commerce City, CO.

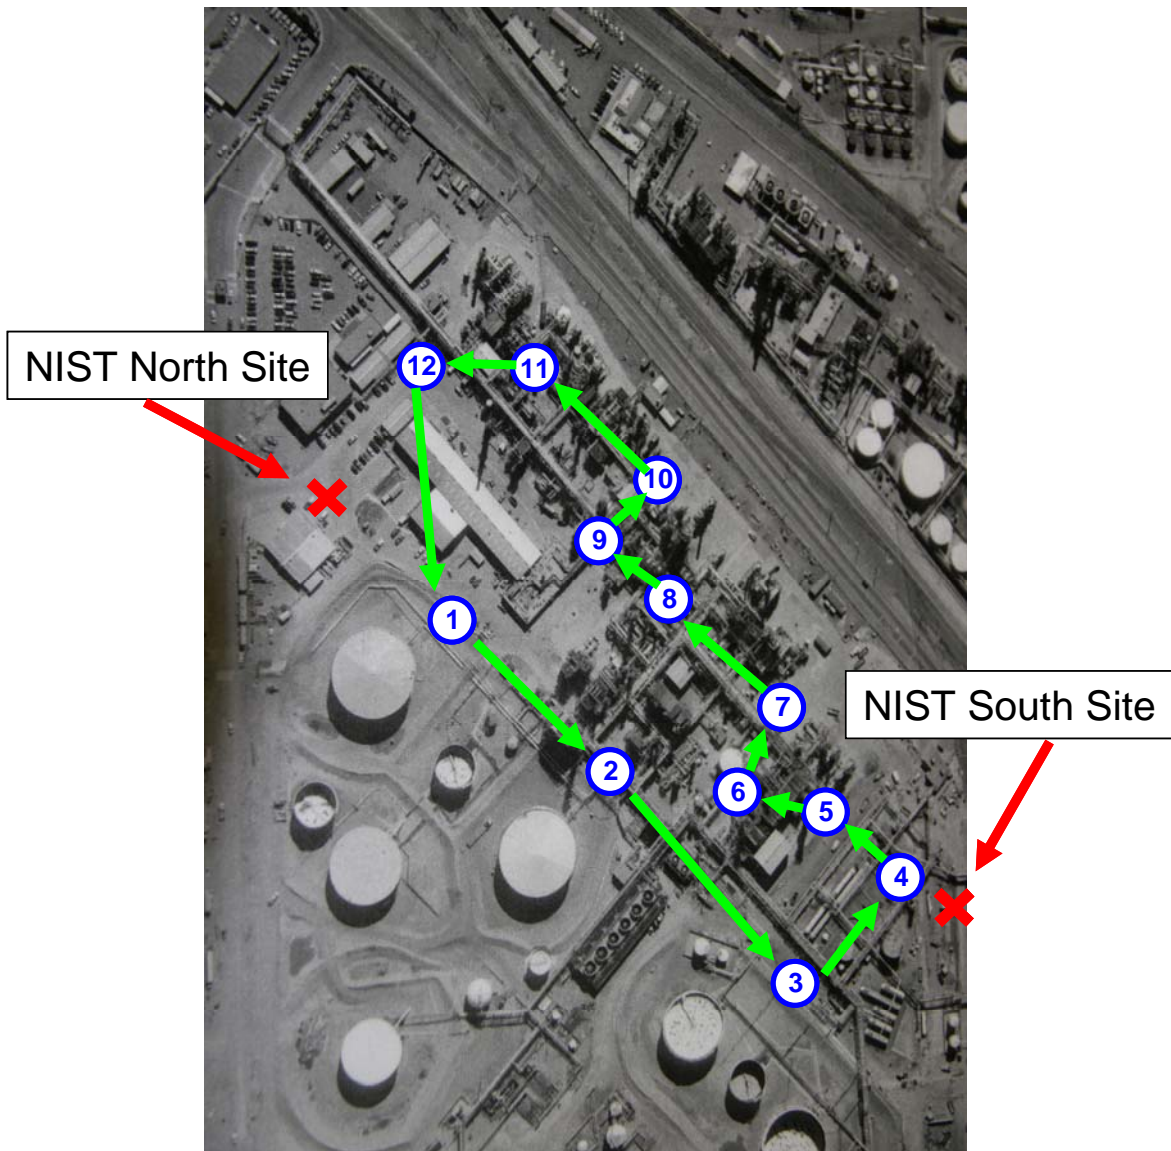
Figure 42. Receiver location and layout for the Commerce City, CO oil refinery.

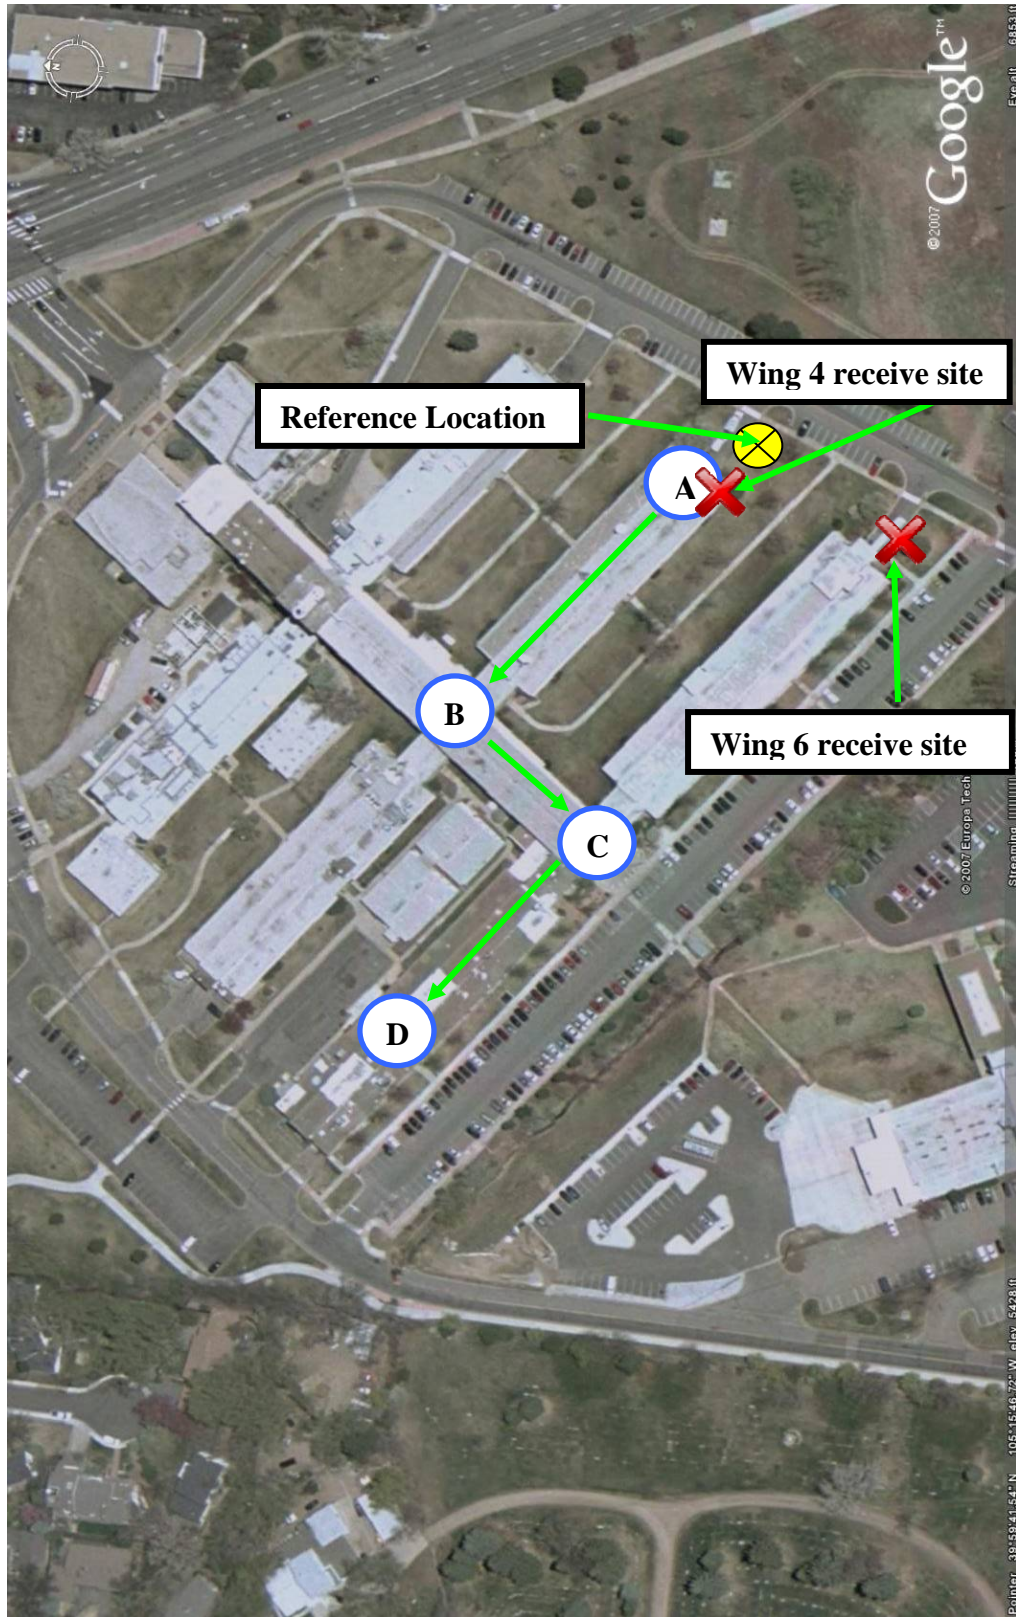
Figure 45. Receiver location and layout for the Boulder, CO laboratories.

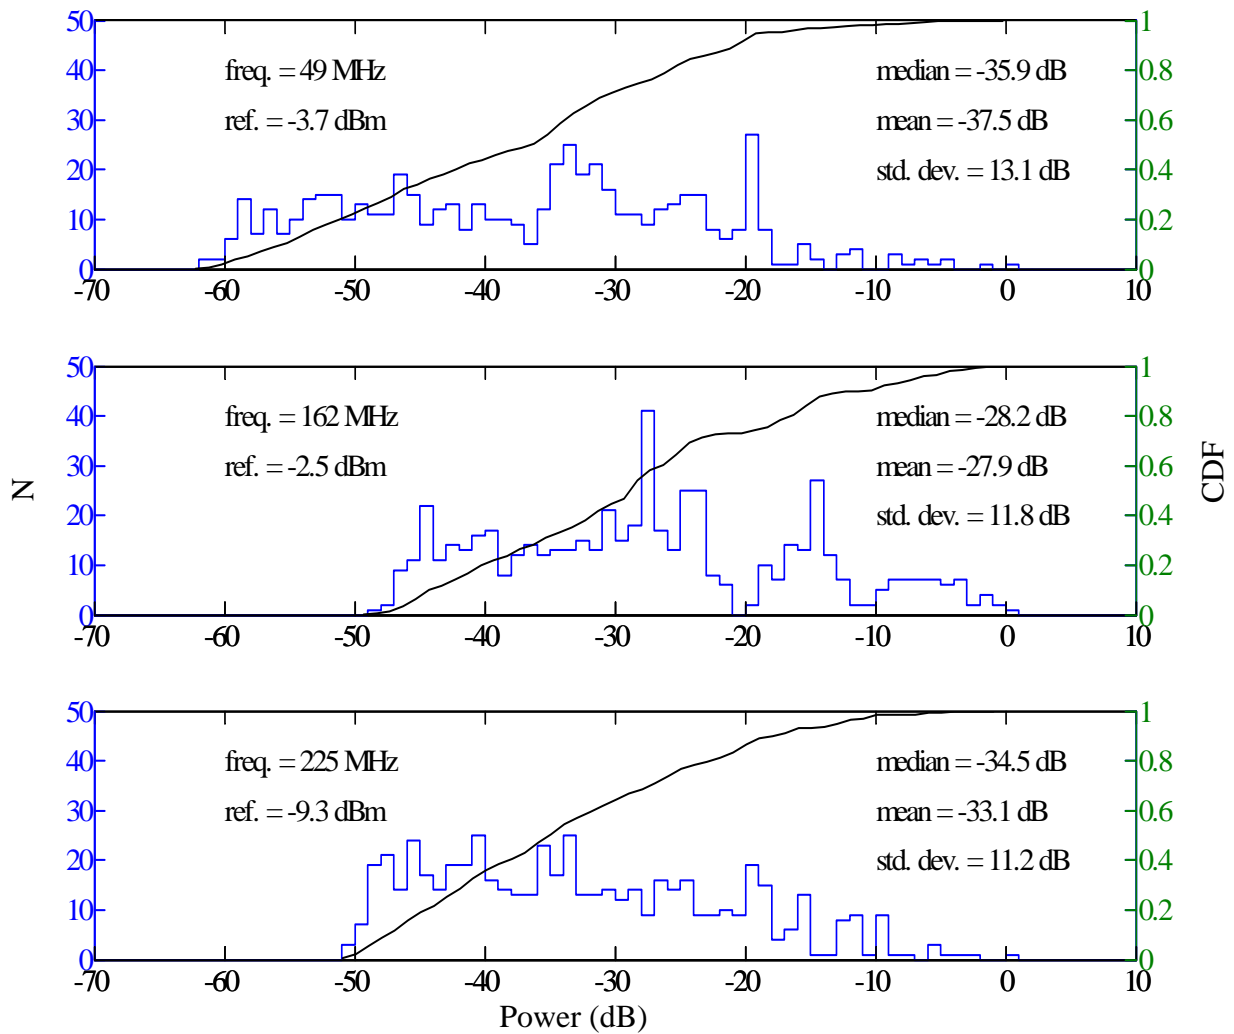
Figure 52. New Orleans, LA apartment building statistics, histograms, and empirical CDF for walk-through data at 49.60, 162.00, and 225.375 MHz.

The apartment building in New Orleans, LA provided the first set of data collected (in chronological order). Plots of the signal power versus sample number are provided for the six lower-frequency bands in Figure 46 to Figure 51. Corresponding histograms and empirical cumulative density functions (CDFs) are found in Figure 52 and Figure 53. In these experiments, approximately 500 samples were collected for each frequency over the complete building walk-through, and the time between samples was approximately 6 s. The reference level for the six frequencies is much higher than that used in most subsequent experiments, which suggests a starting location quite close to the receiver site. As we will see, the standard deviation results are quite similar to results from the other buildings. Also, this particular building had been prepared for demolition, and thus did not contain material such as window glass. This removal of substantial portions of building material, as well as internal content, may have impacted the data. We also performed measurements before, during, and after the implosion of this structure and details of these implosion measurements are reported in Reference [5].

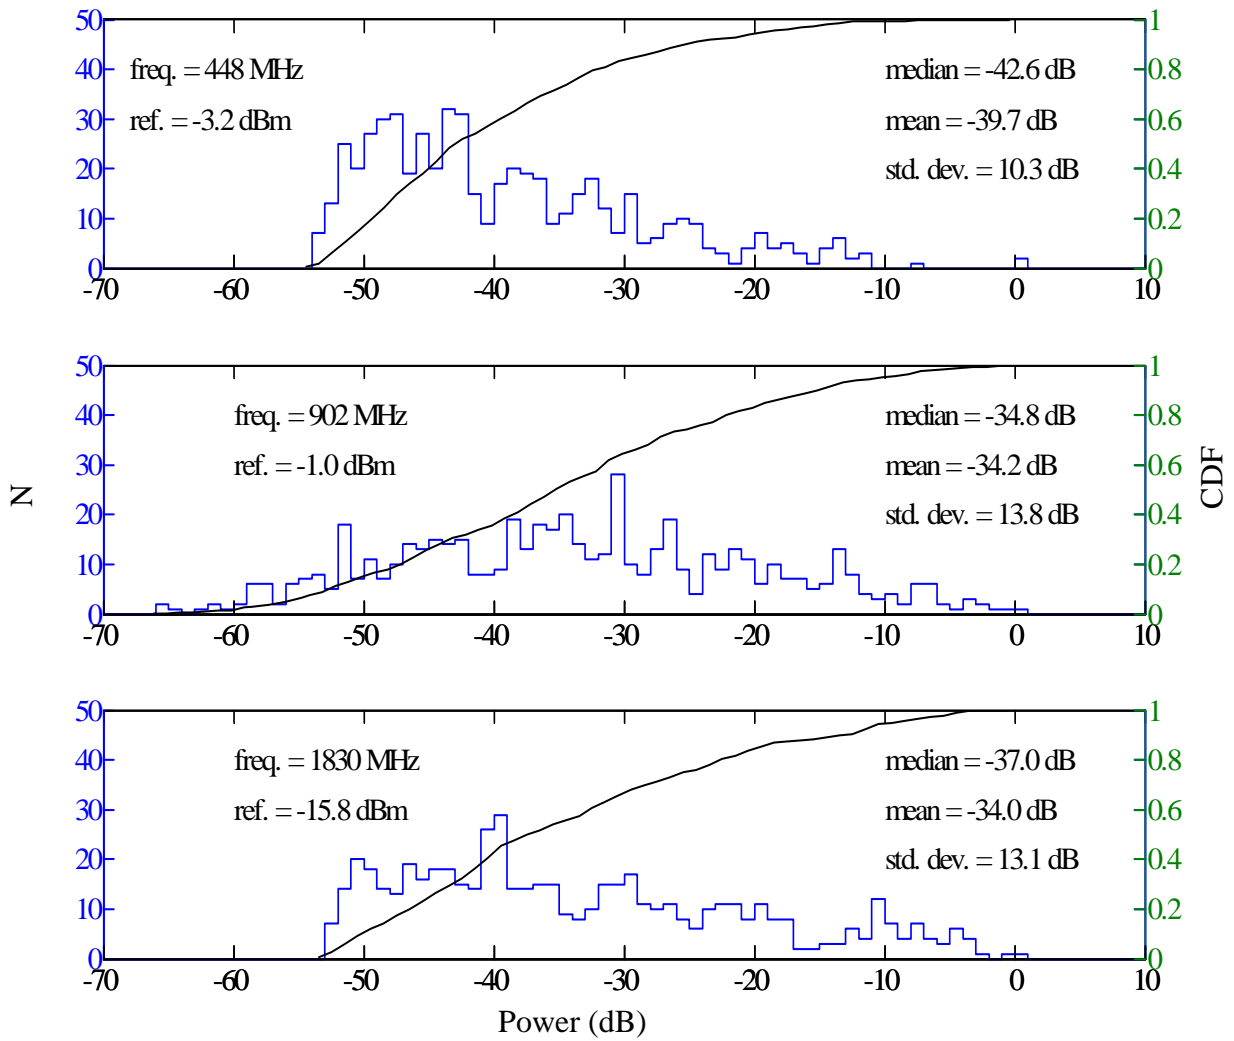
Figure 53. New Orleans, LA apartment building statistics, histograms, and empirical CDF for walk-through data at 448.60, 902.60, and 1832.50 MHz.

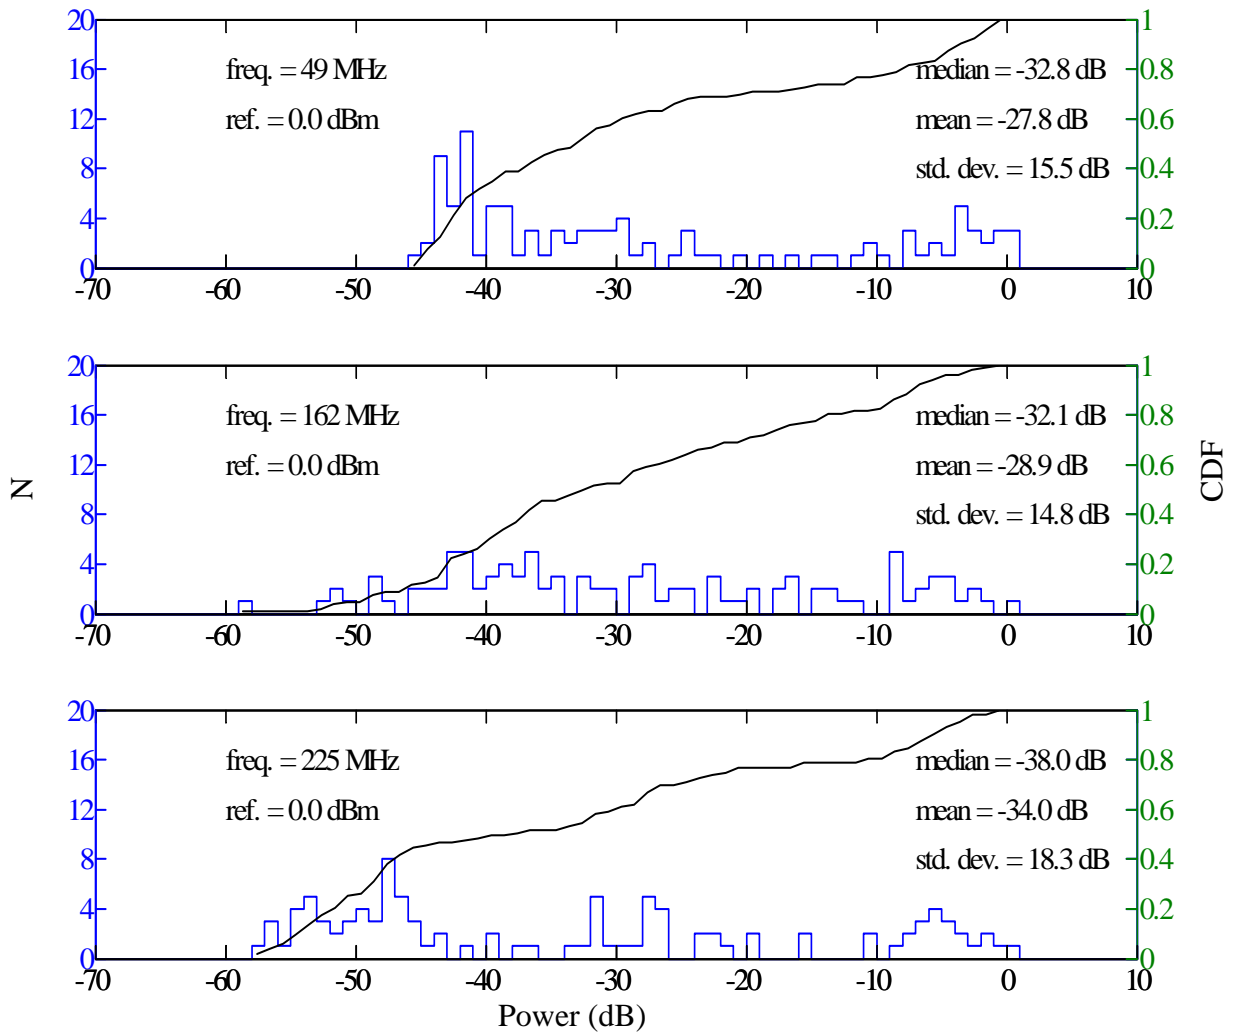
Figure 84. Philadelphia, PA sports stadium statistics, histograms, and empirical CDF for outside walk data at 49.60, 162.09, and 225.30 MHz; horizontal polarization.

Stadium exterior walk-through plots are found in Figure 78 to Figure 83 (horizontal polarization), and Figure 86 to Figure 91 (vertical polarization). The corresponding statistical plots are shown in Figure 84 and Figure 85 and Figure 92 and 93, respectively.

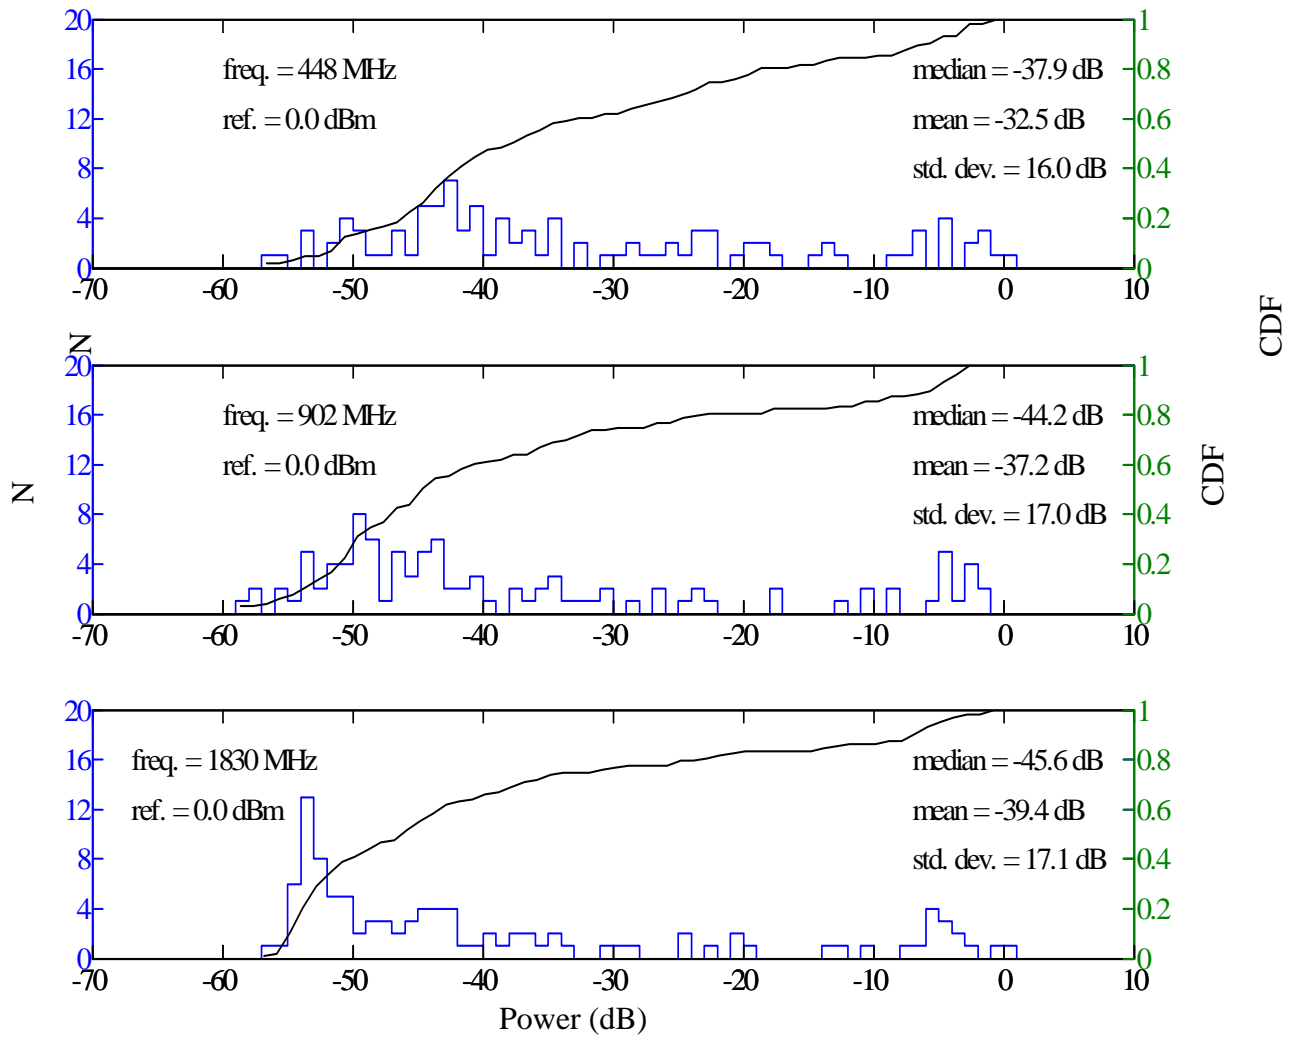
Figure 85. Philadelphia, PA sports stadium statistics, histograms, and empirical CDF for outside walk data at 448.50, 902.45, and 1832.00 MHz; horizontal polarization

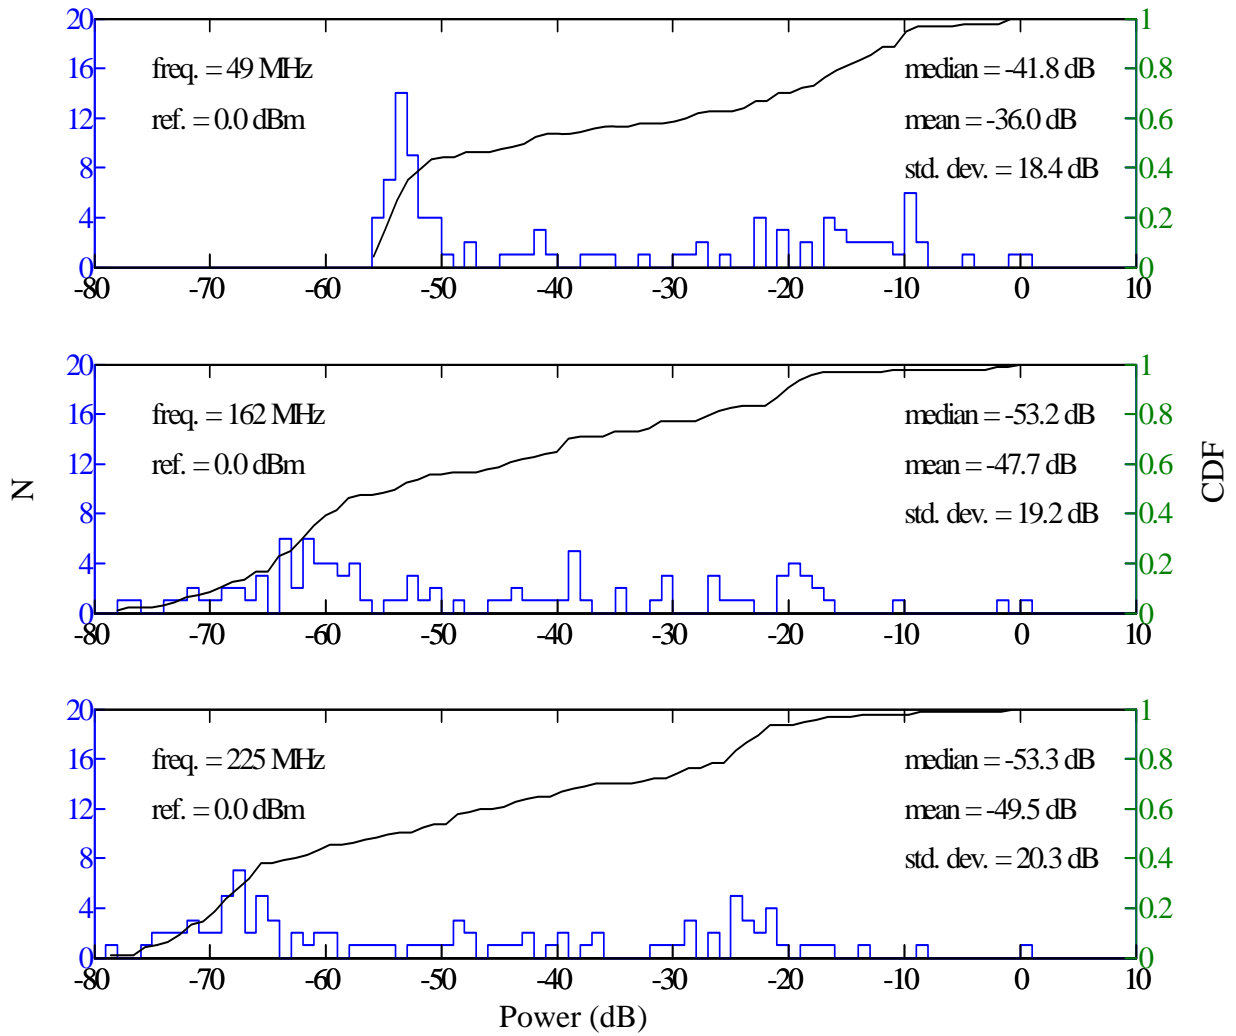
Figure 92. Philadelphia, PA sports stadium statistics, histograms, and empirical CDF for outside walk data at 49.60, 162.09, and 225.30 MHz; vertical polarization.

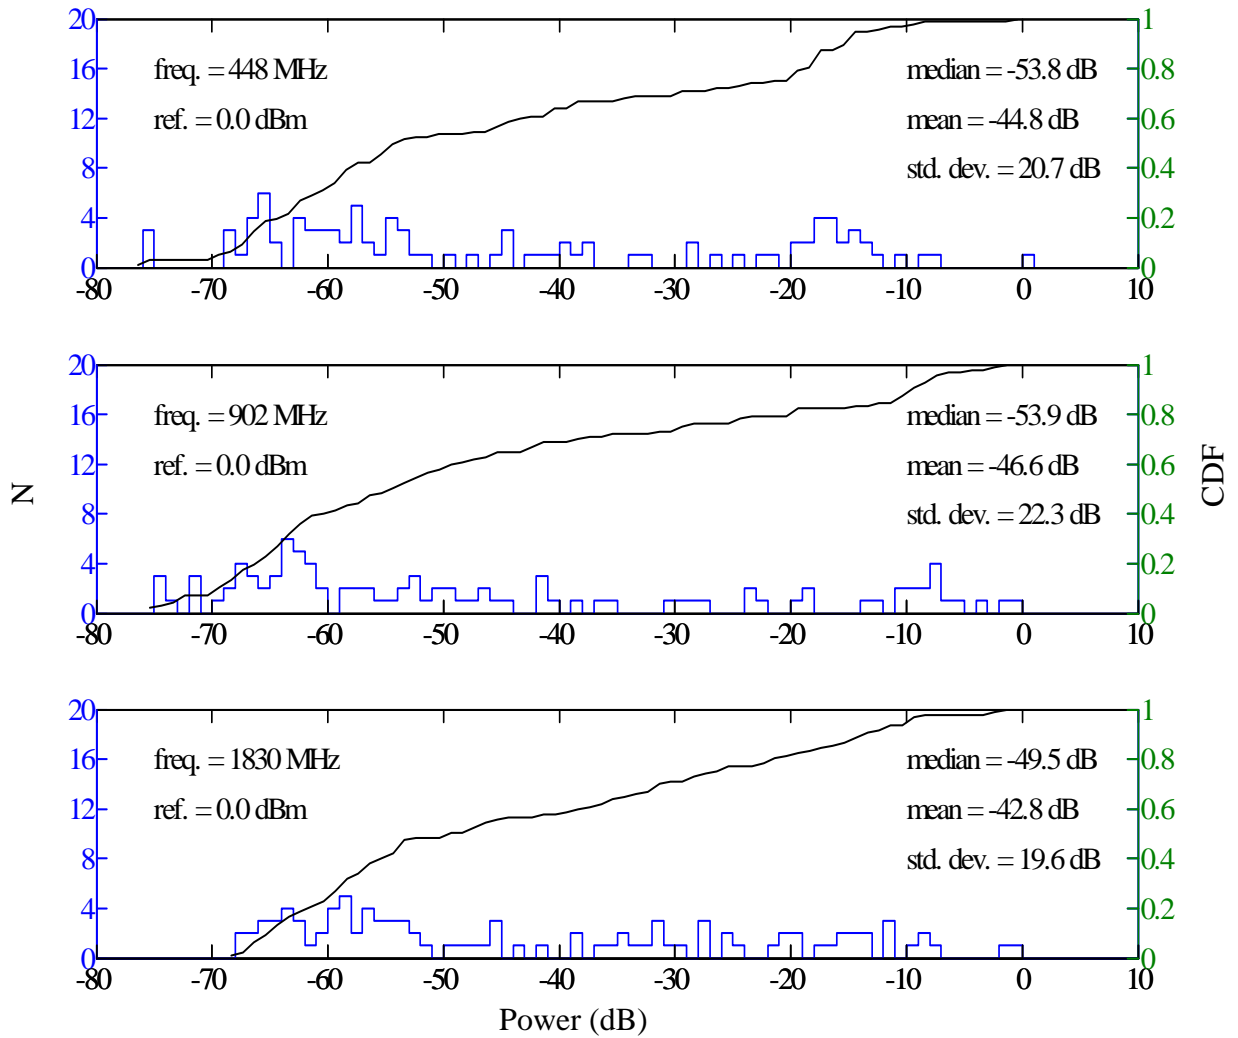
Figure 93. Philadelphia, PA sports stadium statistics, histograms, and empirical CDF for outside walk data at 448.50, 902.45, and 1832.00 MHz; vertical polarization

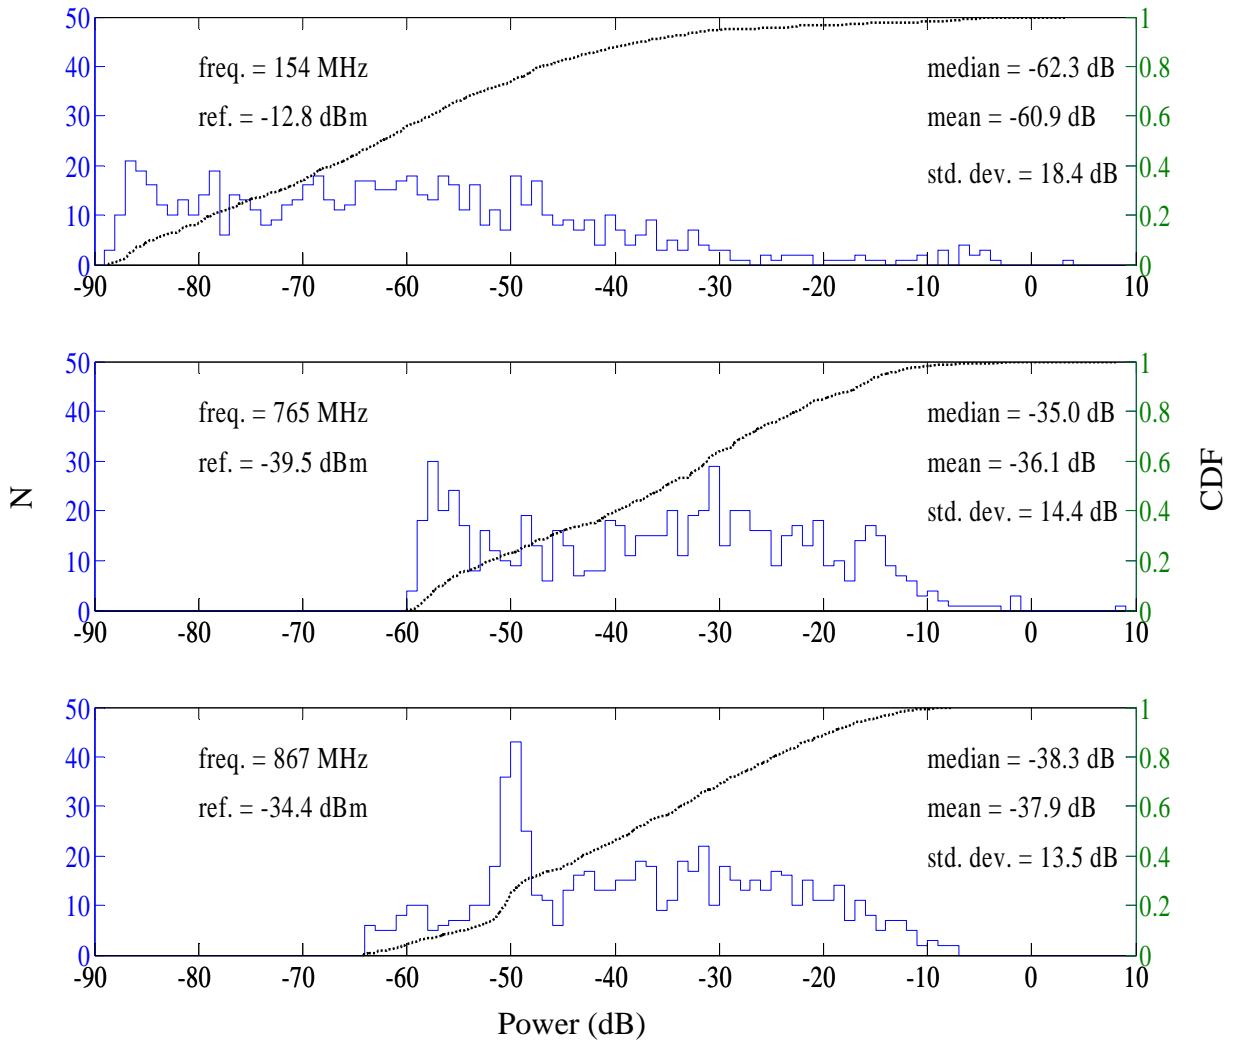
Figure 97. Phoenix, AZ office building statistics, histograms, and empirical CDF for walk-through data at 154, 765, and 867 MHz.

Three frequencies were measured at the Phoenix office building experiments described in Section 5.3. Walk-through plots are provided in Figure 94 through Figure 96, and the corresponding statistical plots are shown in Figure 97. As noted on the walk-through plots, a line-of-sight to the receiver location was possible only for the 154 MHz case. However, this did not appear to significantly alter the overall statistics in Figure 97, which depicts both a higher reference value and a larger standard deviation for the 154 MHz case, as compared to either the 765 or 867 MHz cases.

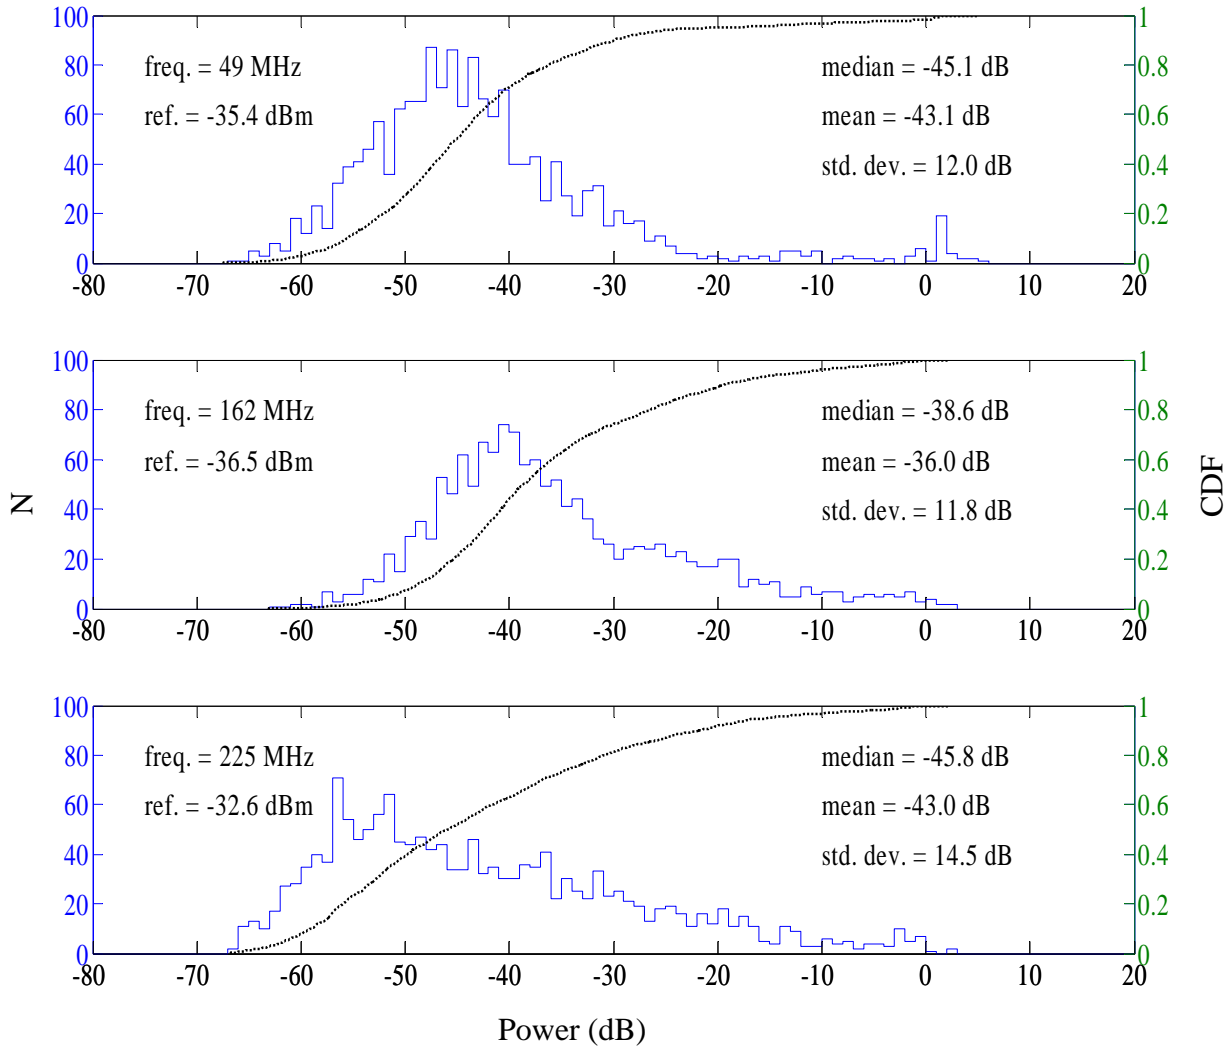
Figure 136. Boulder, CO grocery store statistics, histograms, and empirical CDF for walk-through data; 49.60, 162.09, and 225.30 MHz.

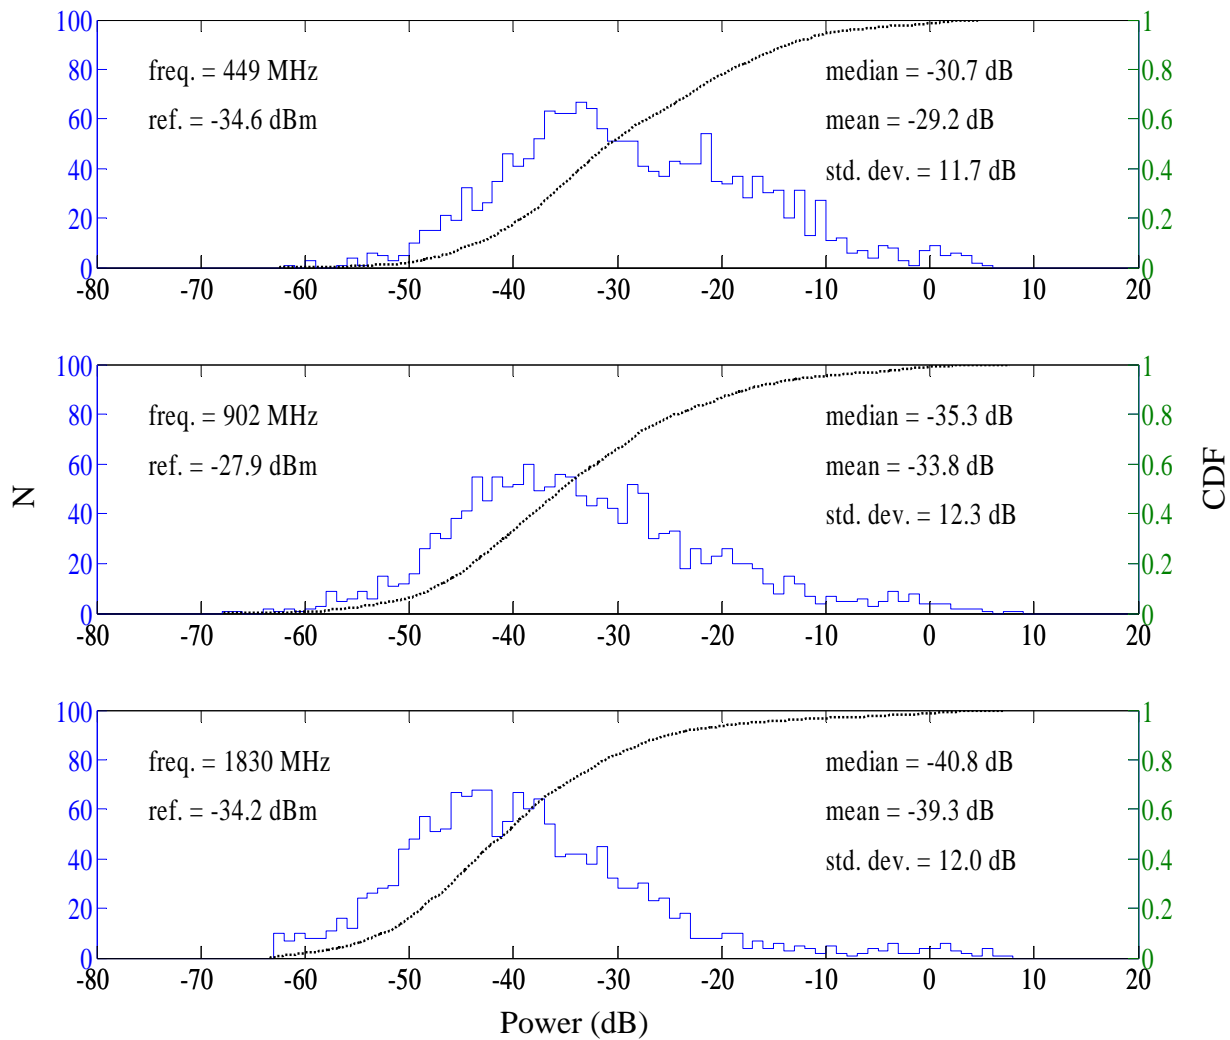
Figure 137. Boulder, CO grocery store statistics, histograms, and empirical CDF for walk-through data; 448.50, 902.75, and 1830.00 MHz.

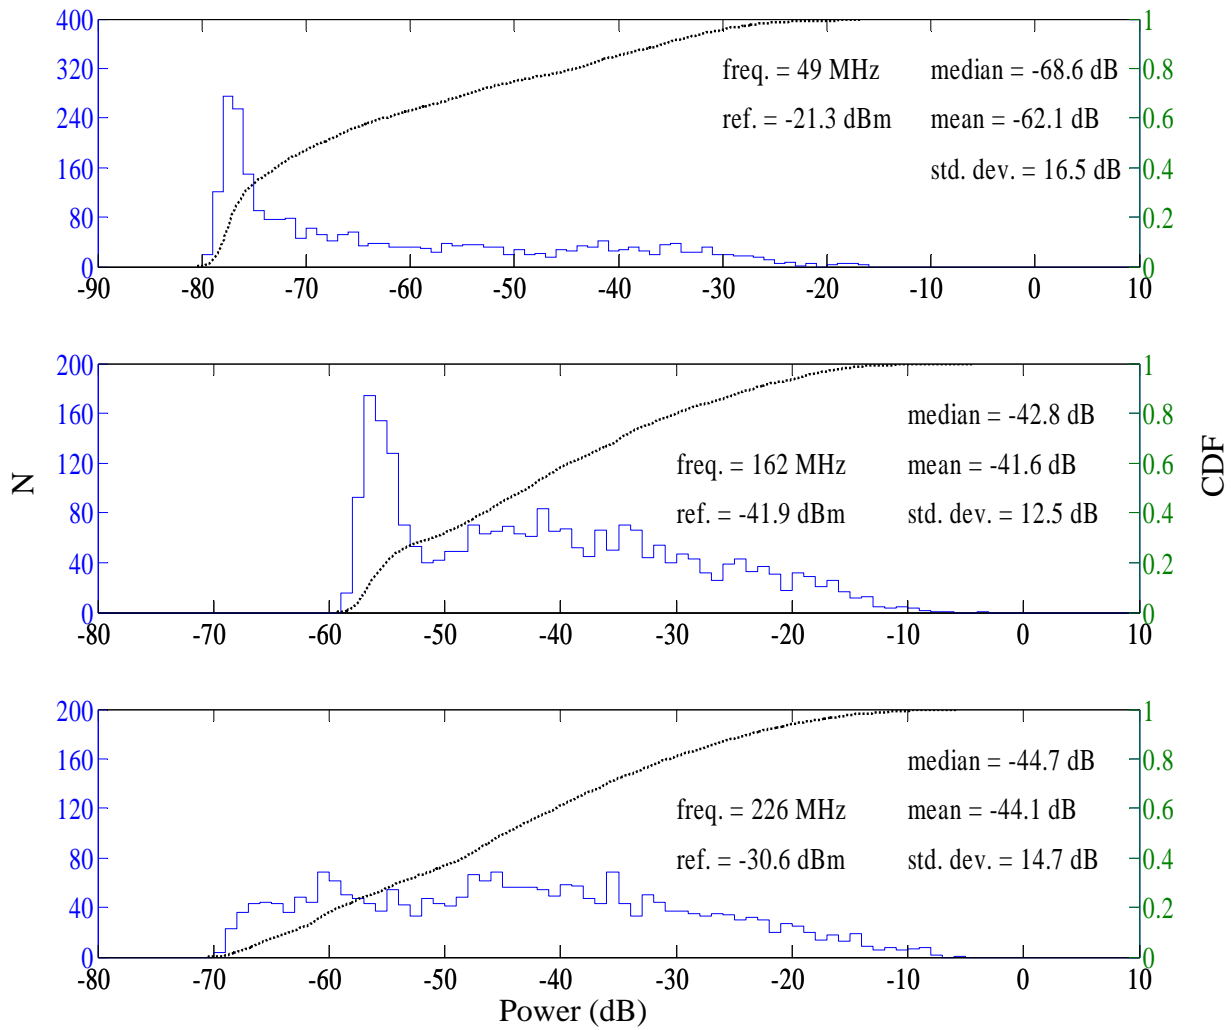
Figure 144. Gaithersburg, MD office building statistics, histograms, and empirical CDF for walk-through data; 49.60, 162.09, and 226.40 MHz.
