NIST Technical Note 1545

**Attenuation of Radio Wave Signals
Coupled Into Twelve Large Building
Structures**

C.L. Holloway
W.F. Young
G. Koepke
K.A. Remley
D. Camell
Y. Becquet

August 2008

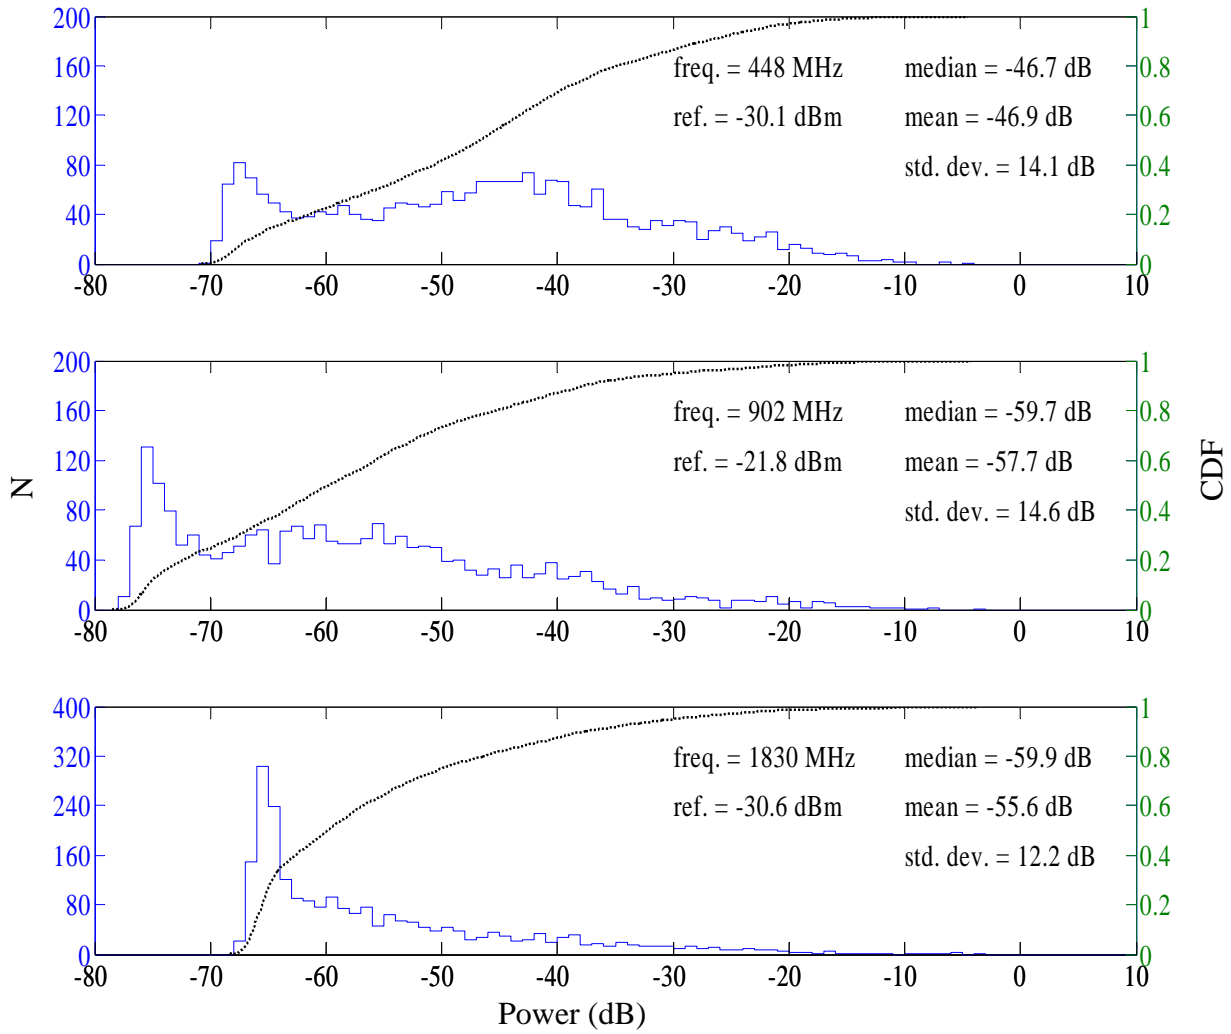
Figure 145. Gaithersburg, MD office building statistics, histograms, and empirical CDF for walk-through data; 448.30, 902.45, and 1830.00 MHz.

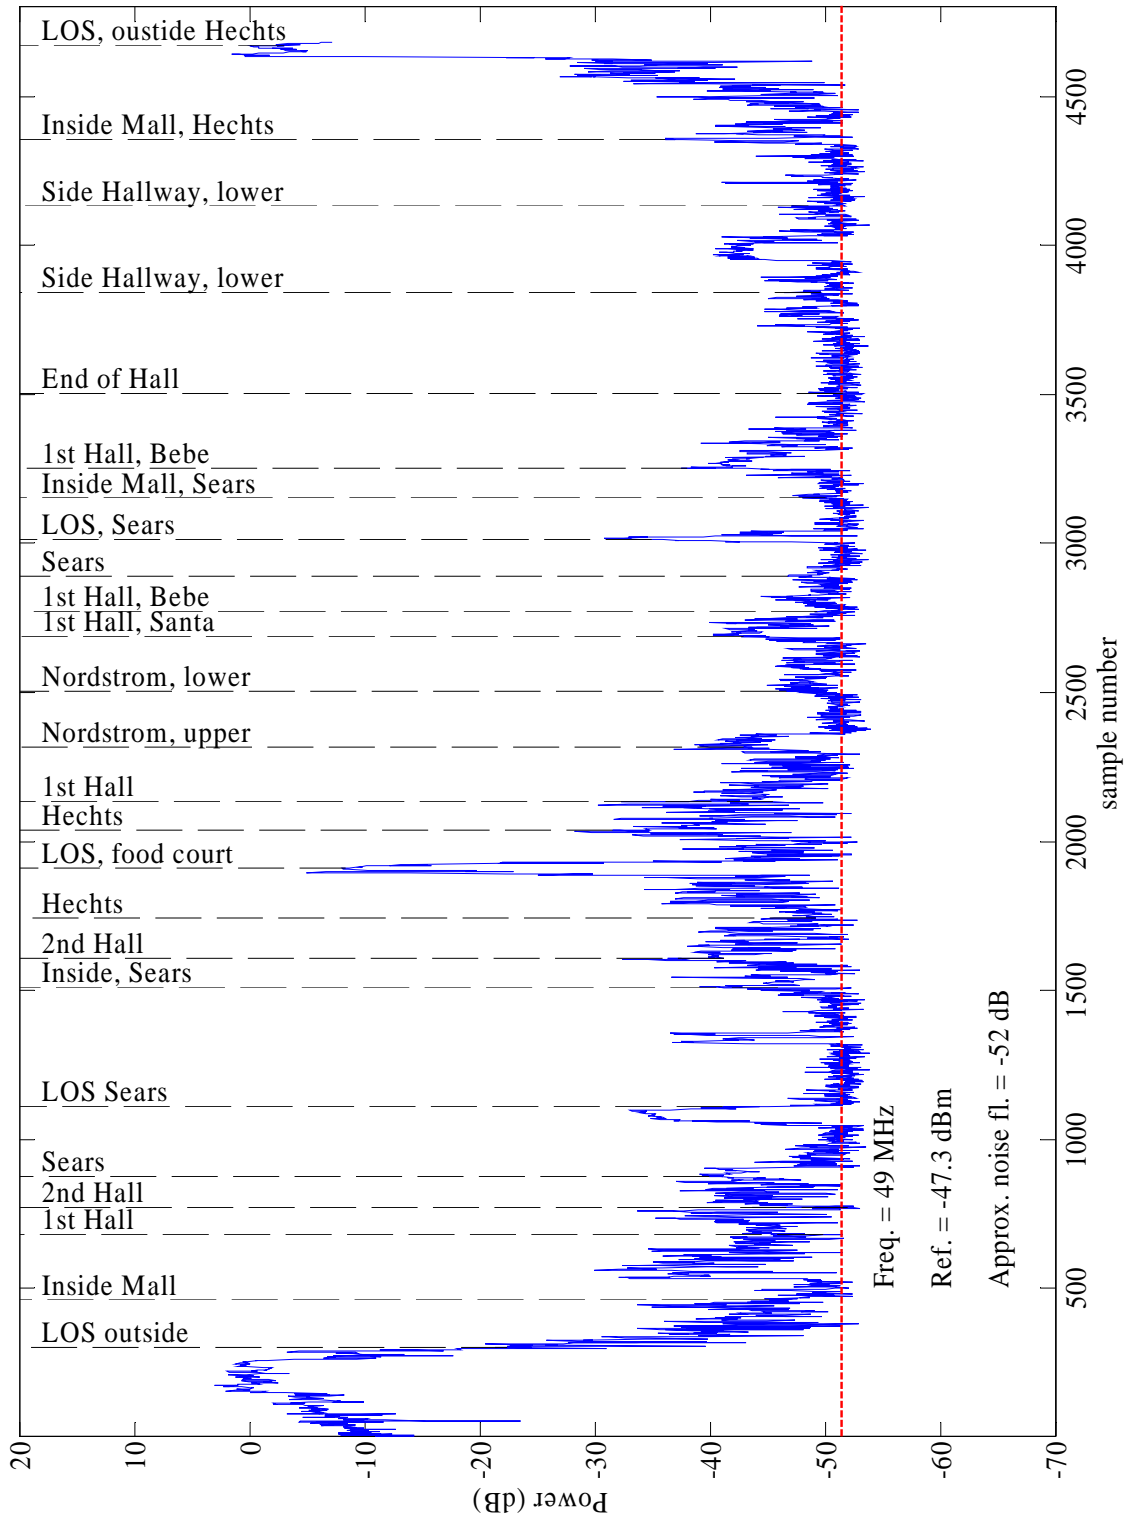
Figure 146. Bethesda, MD shopping mall walk-through at 49.60 MHz; receiver at site 1.

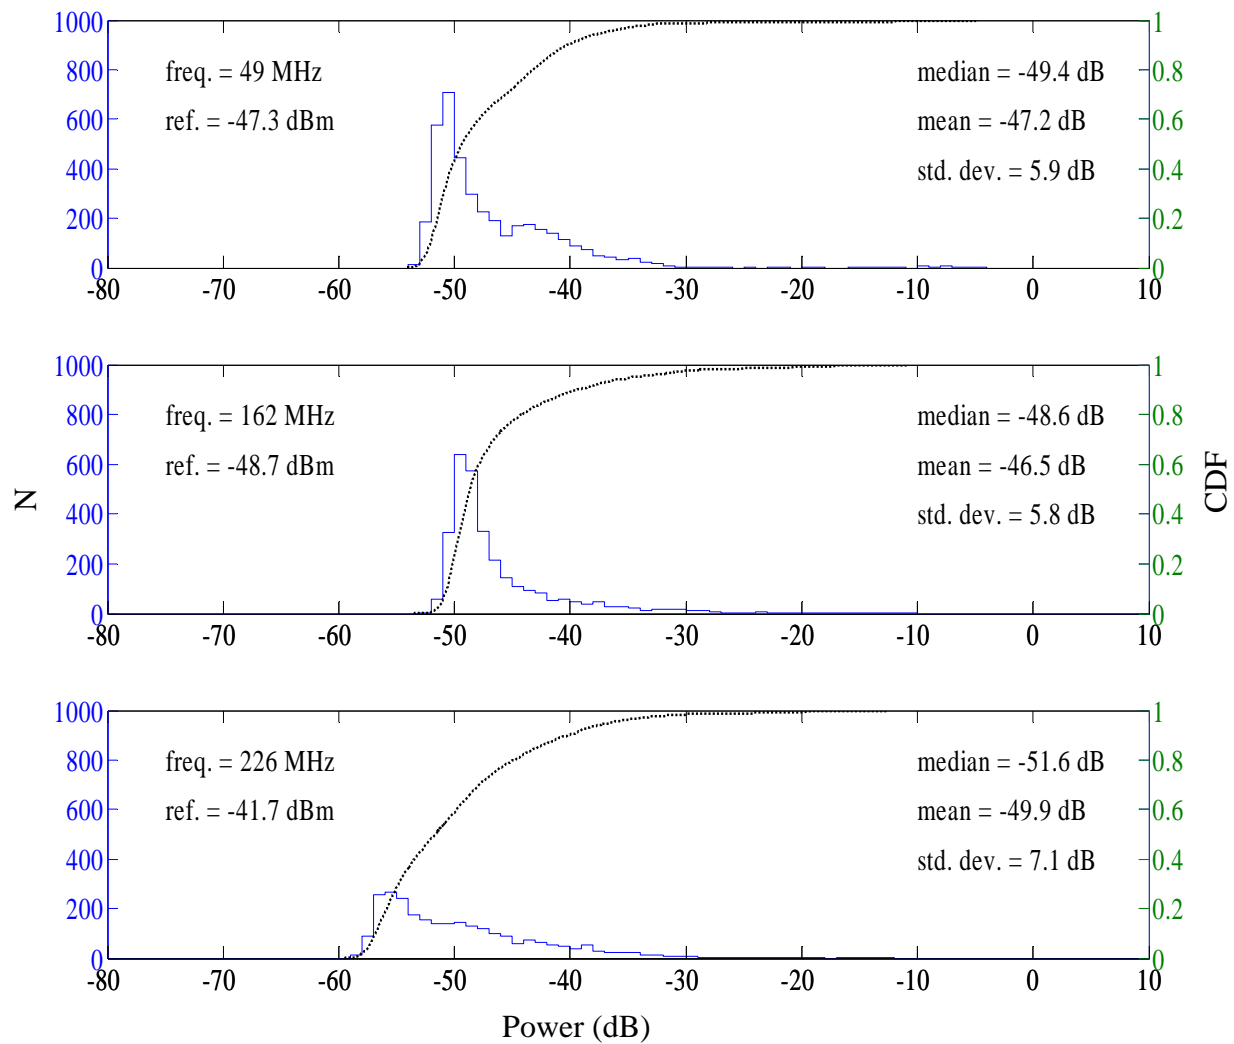
Figure 152. Bethesda, MD shopping mall statistics, histograms, and empirical CDF for walk-through data with the receiver at site 1; 49.60, 162.09, and 226.40 MHz.

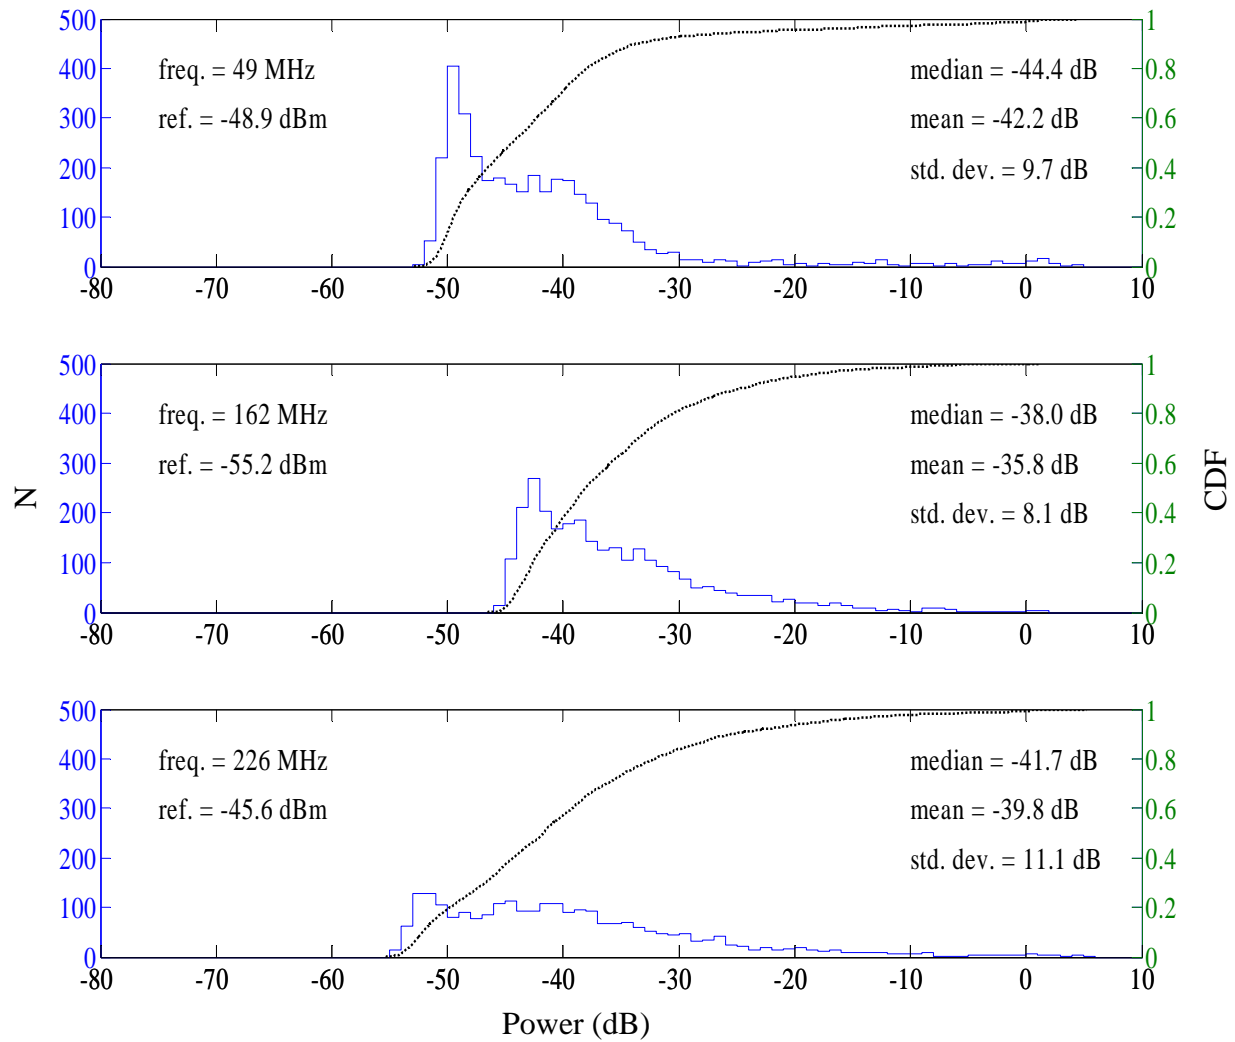
Figure 160. Bethesda, MD shopping mall statistics, histograms, and empirical CDF for walk-through data with the receiver at site 2; 49.60, 162.09, and 226.40 MHz.

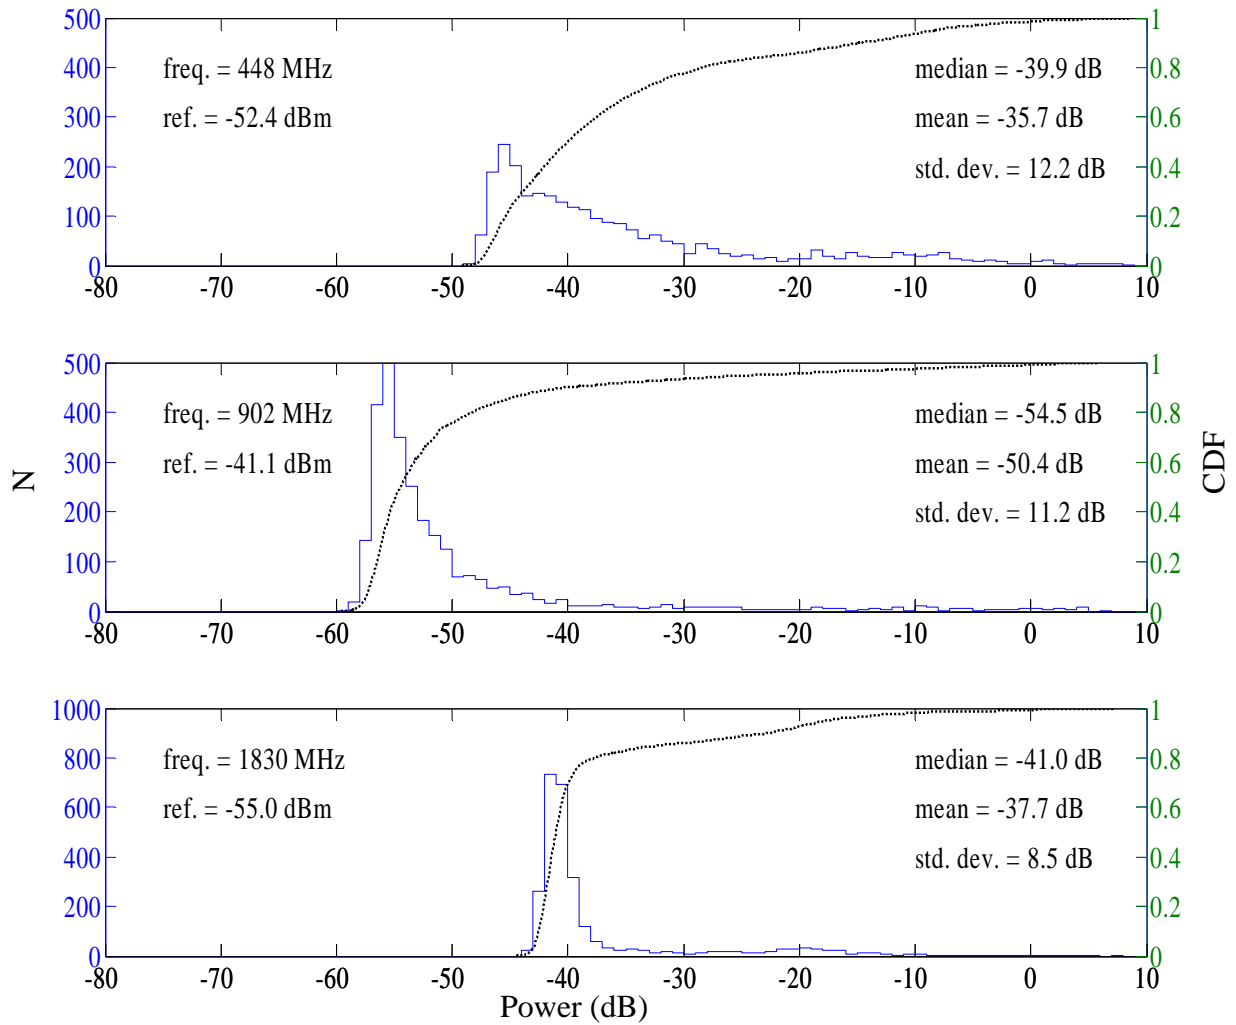
Figure 161. Bethesda, MD shopping mall statistics, histograms, and empirical CDF for walk-through data with the receiver at site 2; 448.30, 902.45, and 1830.00 MHz.

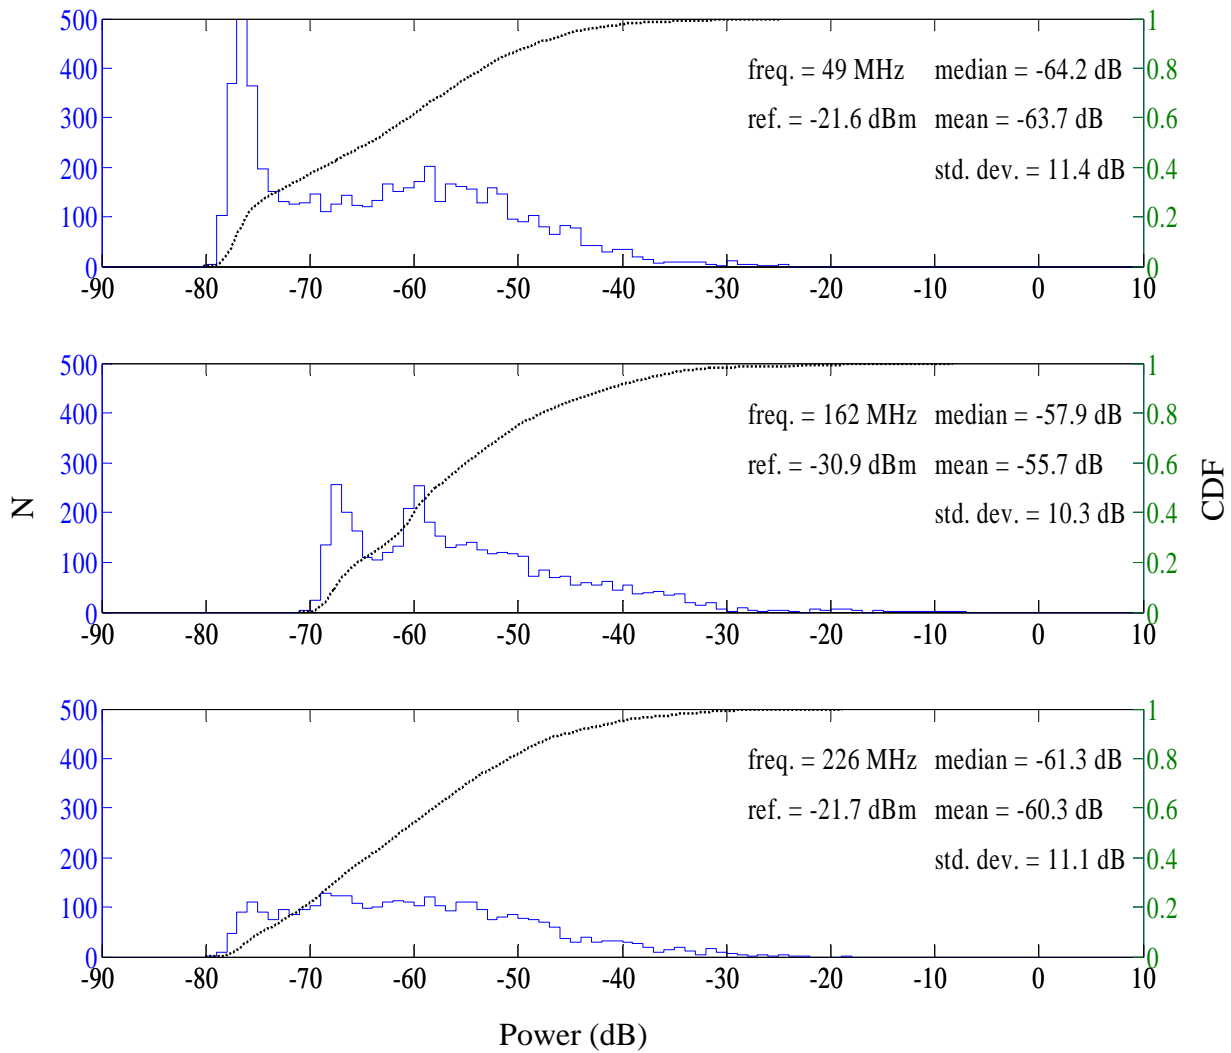
Figure 168. Silver Spring, MD office building statistics, histograms, and empirical CDF for walk-through data; 49.60, 162.09, and 226.40 MHz.

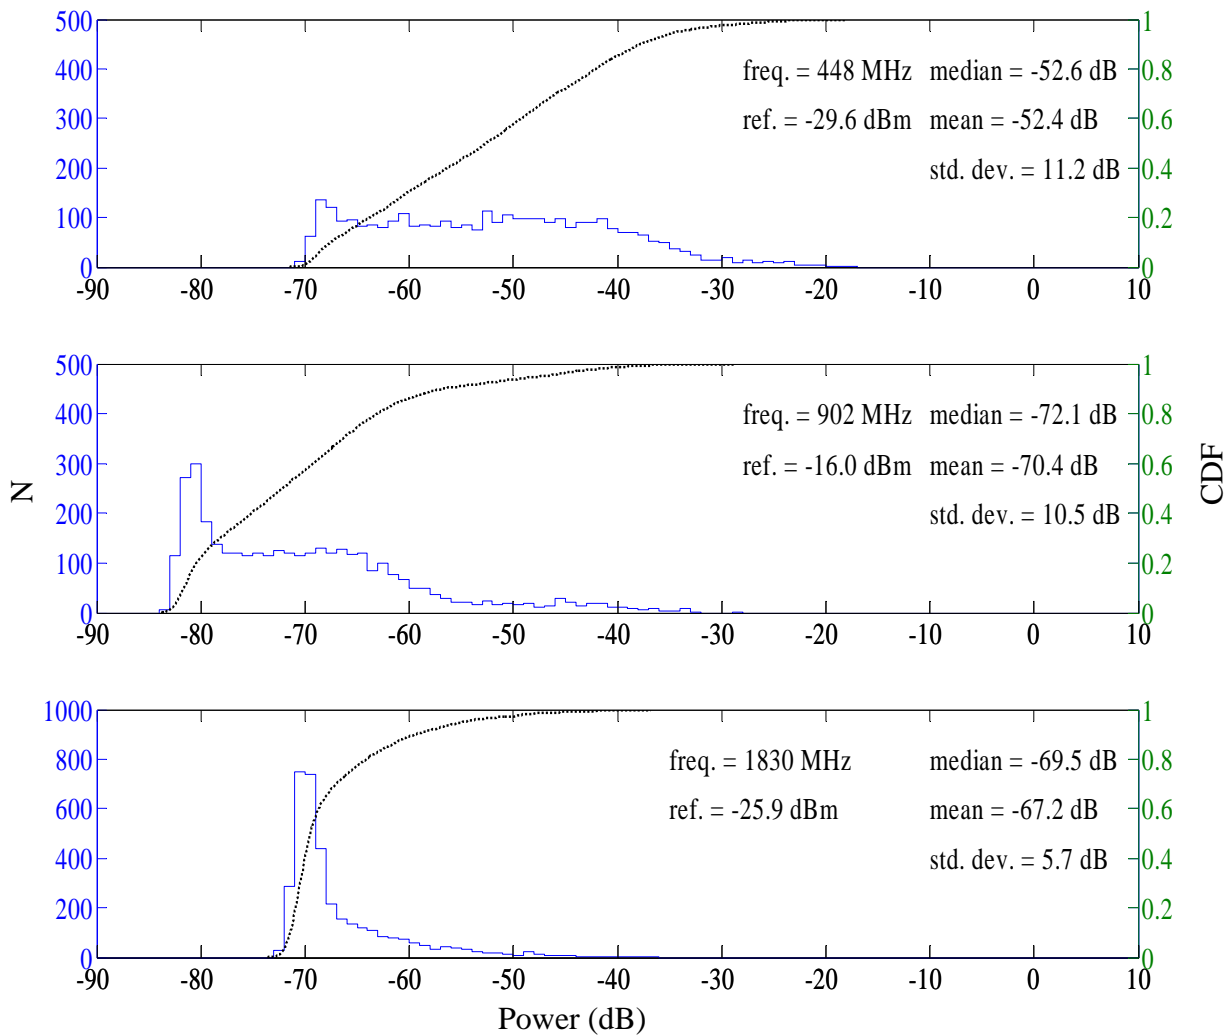
Figure 169. Silver Spring, MD office building statistics, histograms, and empirical CDF for walk-through data; 448.30, 902.45, and 1830.00 MHz.

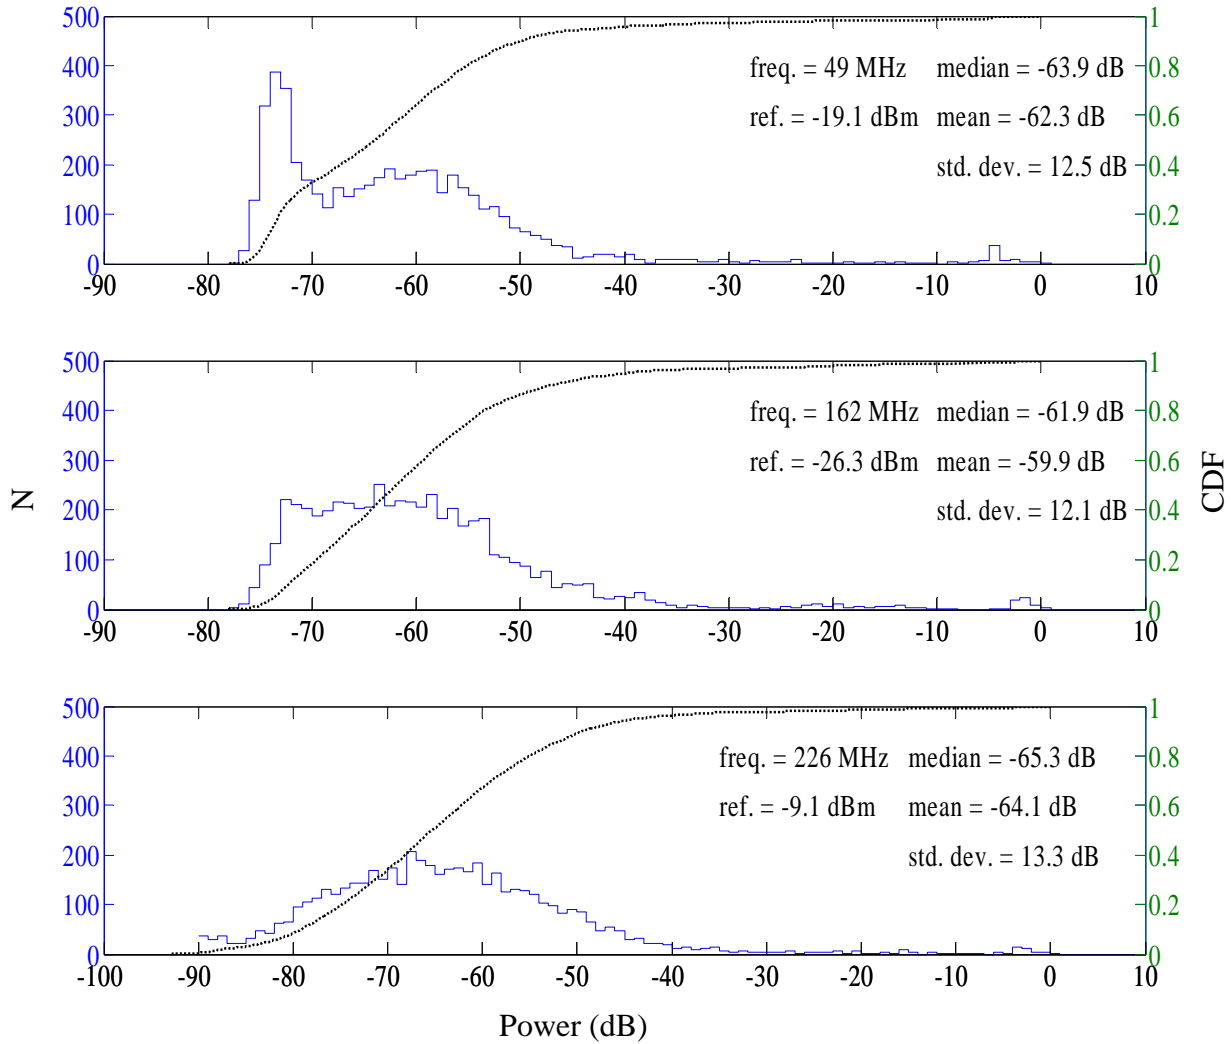
Figure 176. Washington, DC convention center statistics, histograms, and empirical CDF for walk-through data with the receiver at site 1; 49.60, 162.09, and 226.40 MHz.

Three receiver sites collected data at the Washington, DC convention center. The both the walk-through data and the statistics data for all three sites are presented in Figures 170 through 193. The corresponding walk-through data results for receiver sites labeled 1, 2, and 3 are provided in Figure 170 through Figure 175, Figure 178 through Figure 183, and Figure 186 through Figure 191, respectively. The statistics plots for receiver sites 1, 2, and 3 are found in Figure 176 and Figure 177, Figure 184 and Figure 185, and Figure 192 and Figure 193, respectively.

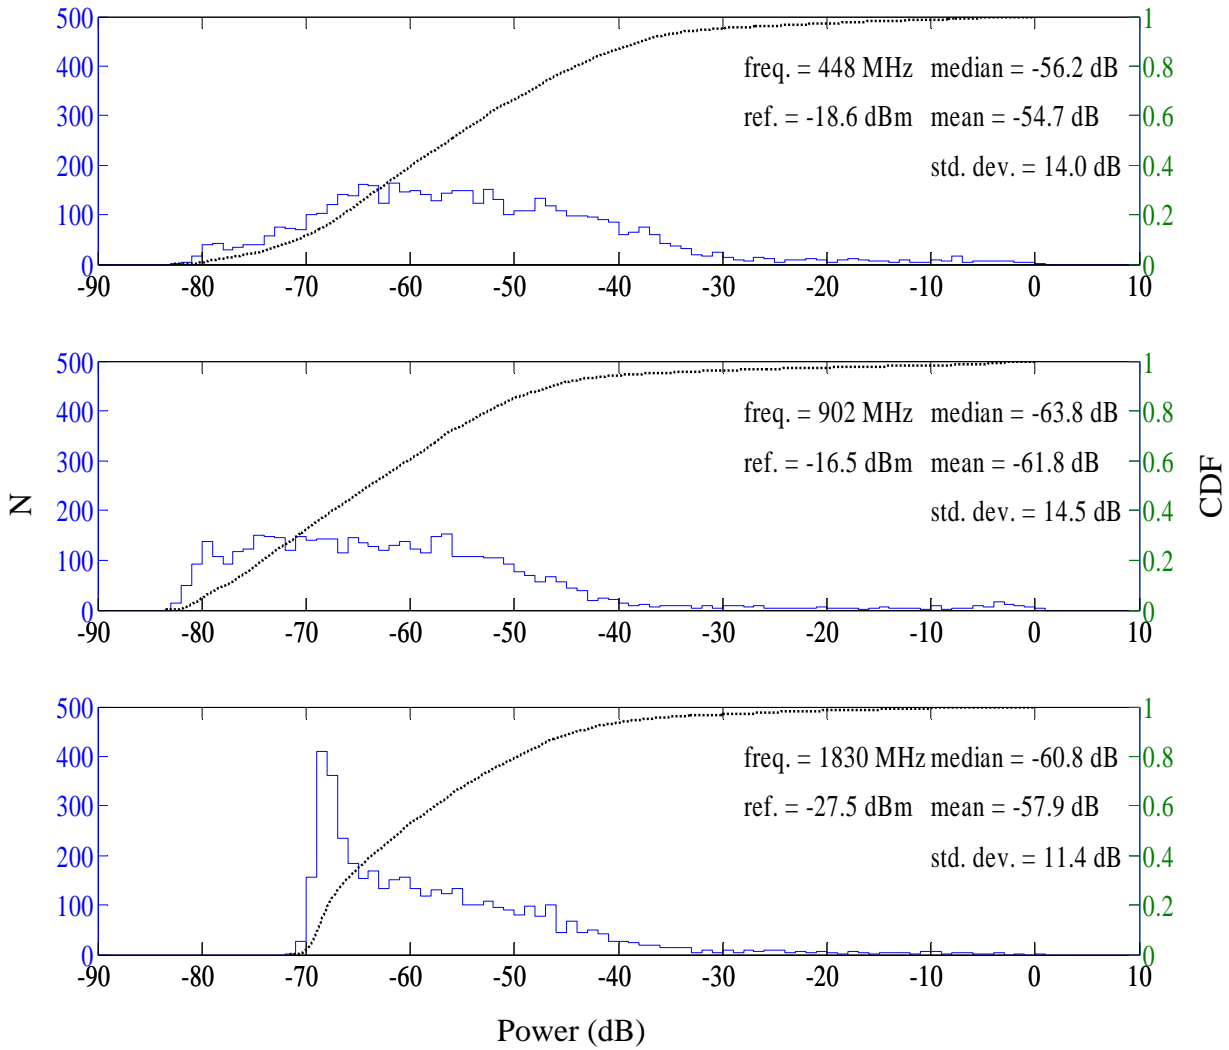
Figure 177. Washington, DC convention center statistics, histograms, and empirical CDF for walk-through data with the receiver at site 1; 448.30, 902.45, and 1830.00 MHz.

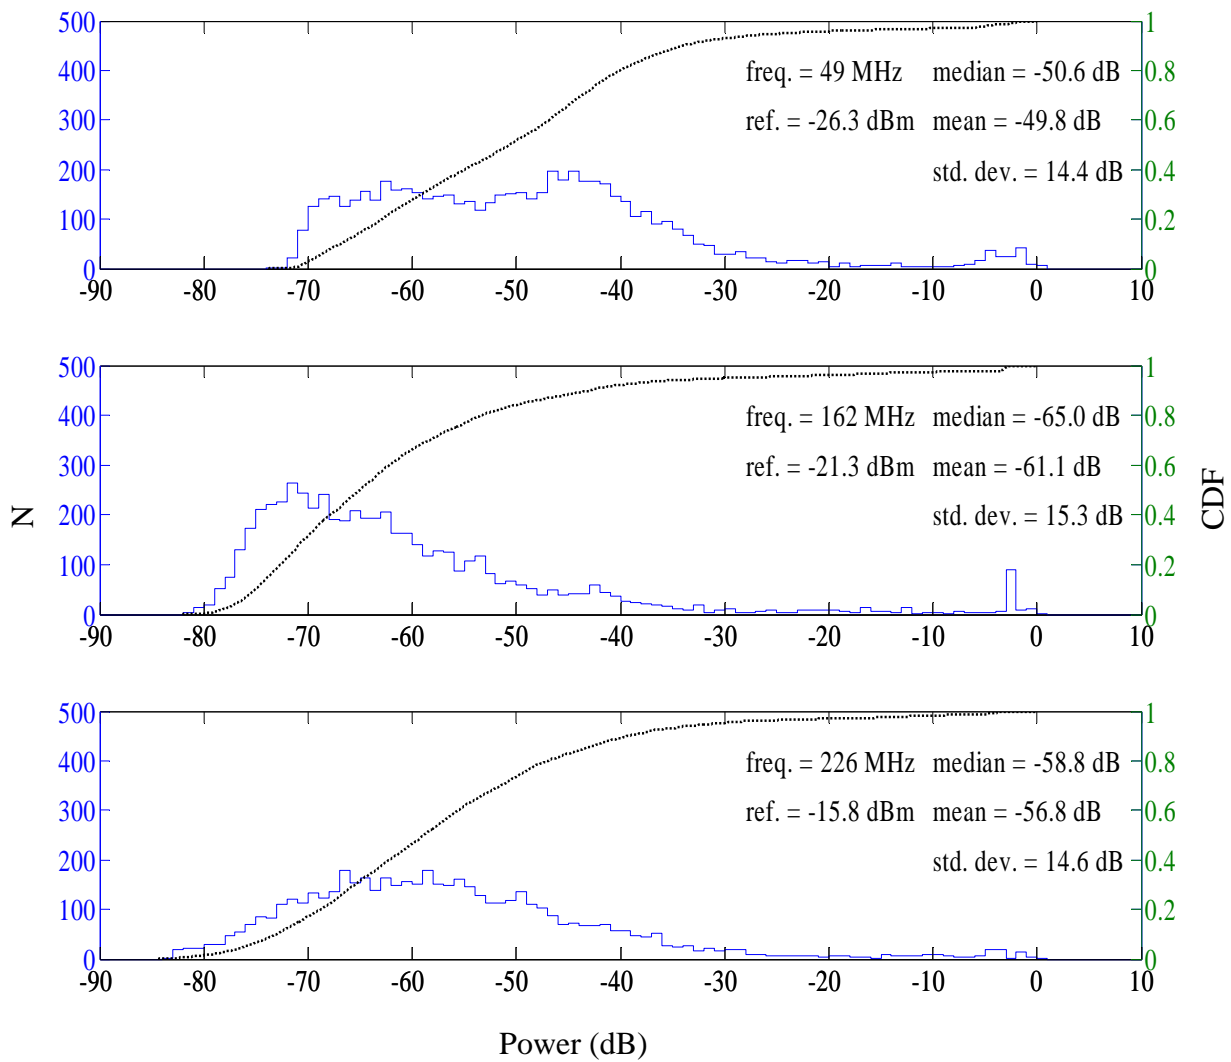
Figure 184. Washington, DC convention center statistics, histograms, and empirical CDF for walk-through data with the receiver at site 2; 49.60, 162.09, and 226.40 MHz.

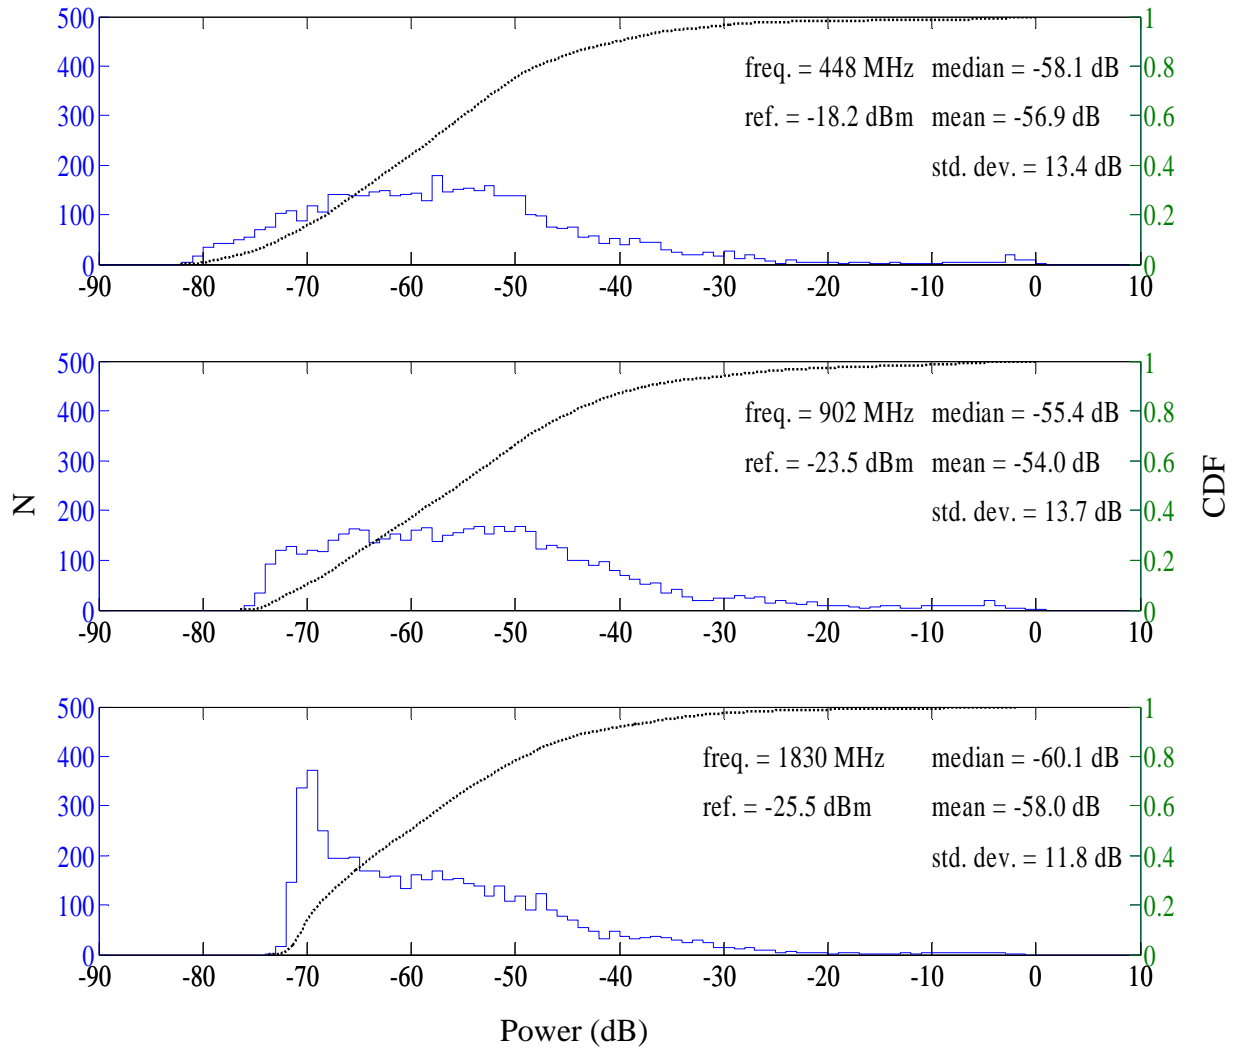
Figure 185. Washington, DC convention center statistics, histograms, and empirical CDF for walk-through data with the receiver at site 2; 448.30, 902.45, and 1830.00 MHz.

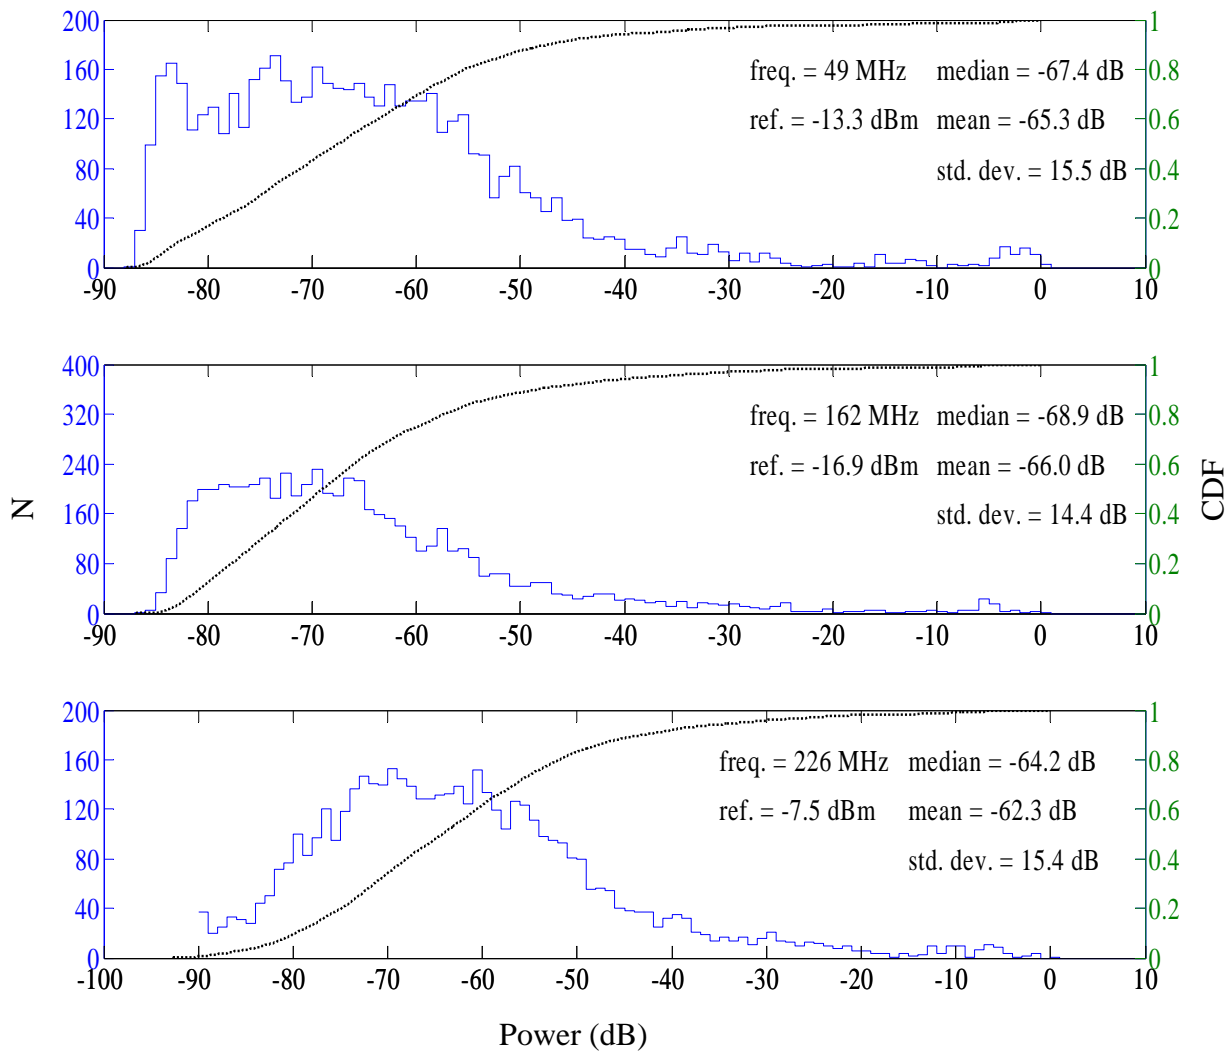
Figure 192. Washington, DC convention center statistics, histograms, and empirical CDF for walk-through data with the receiver at site 3; 49.60, 162.09, and 226.40 MHz.

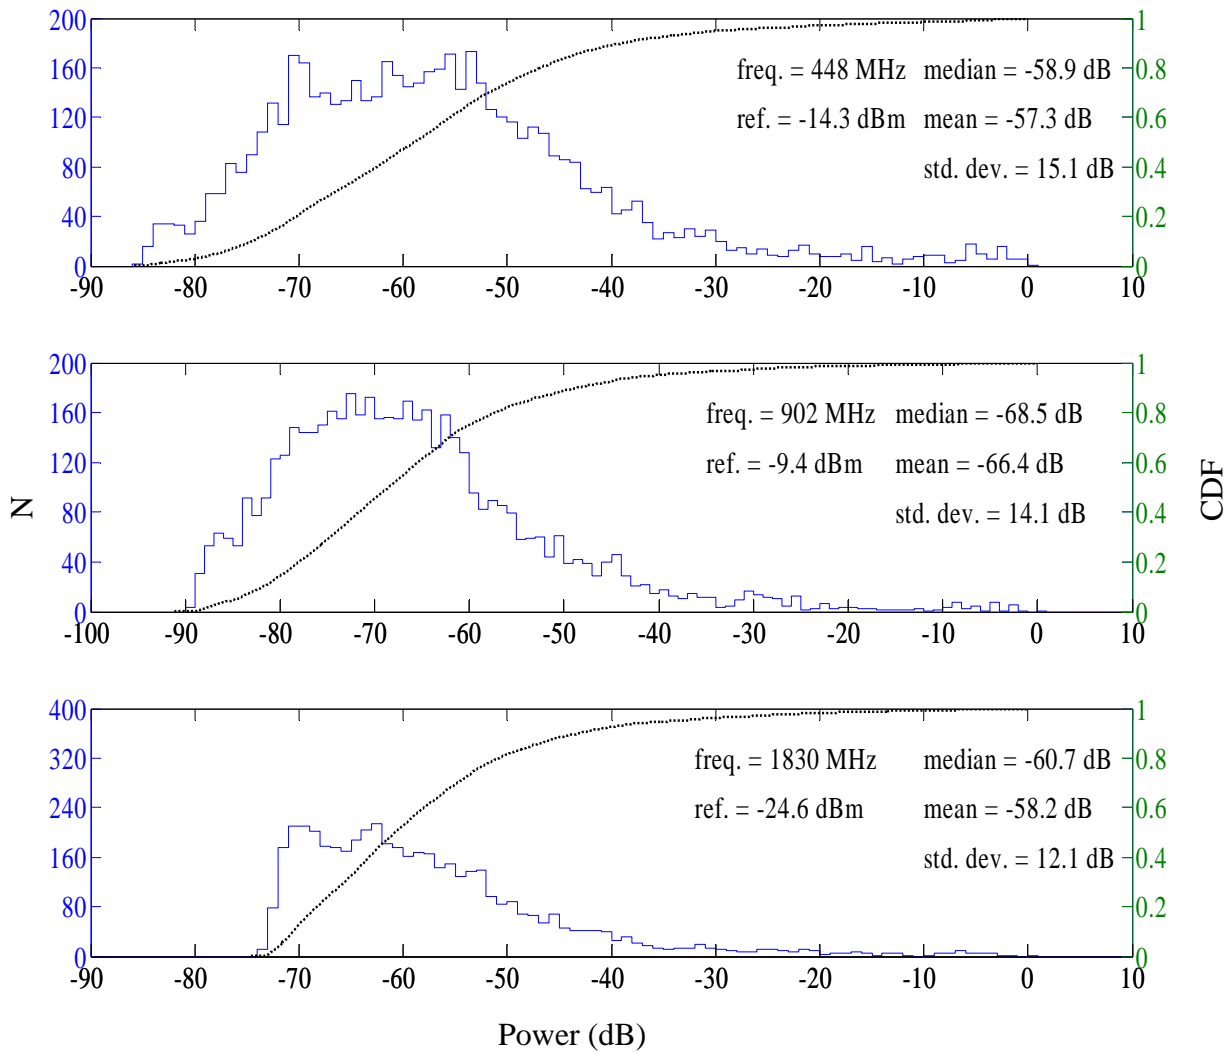
Figure 193. Washington, DC convention center statistics, histograms, and empirical CDF for walk-through data with the receiver at site 3; 448.30, 902.45, and 1830.00 MHz.

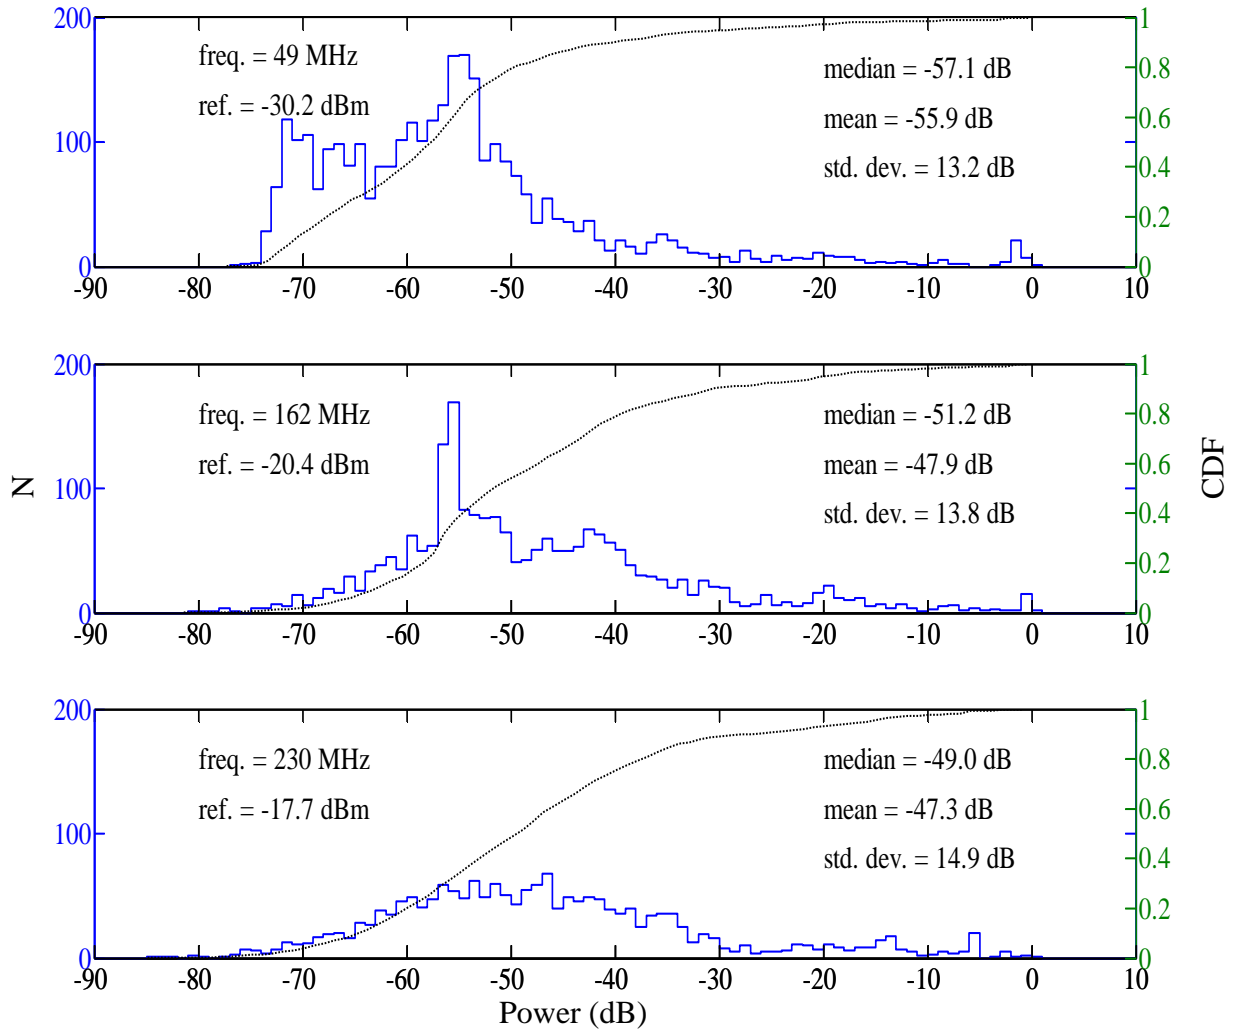
Figure 222. SUNCOR oil refinery statistics, histograms, and empirical CDF for walk-through data at 49.85, 162.075, and 230.0 MHz; receiver at south site.

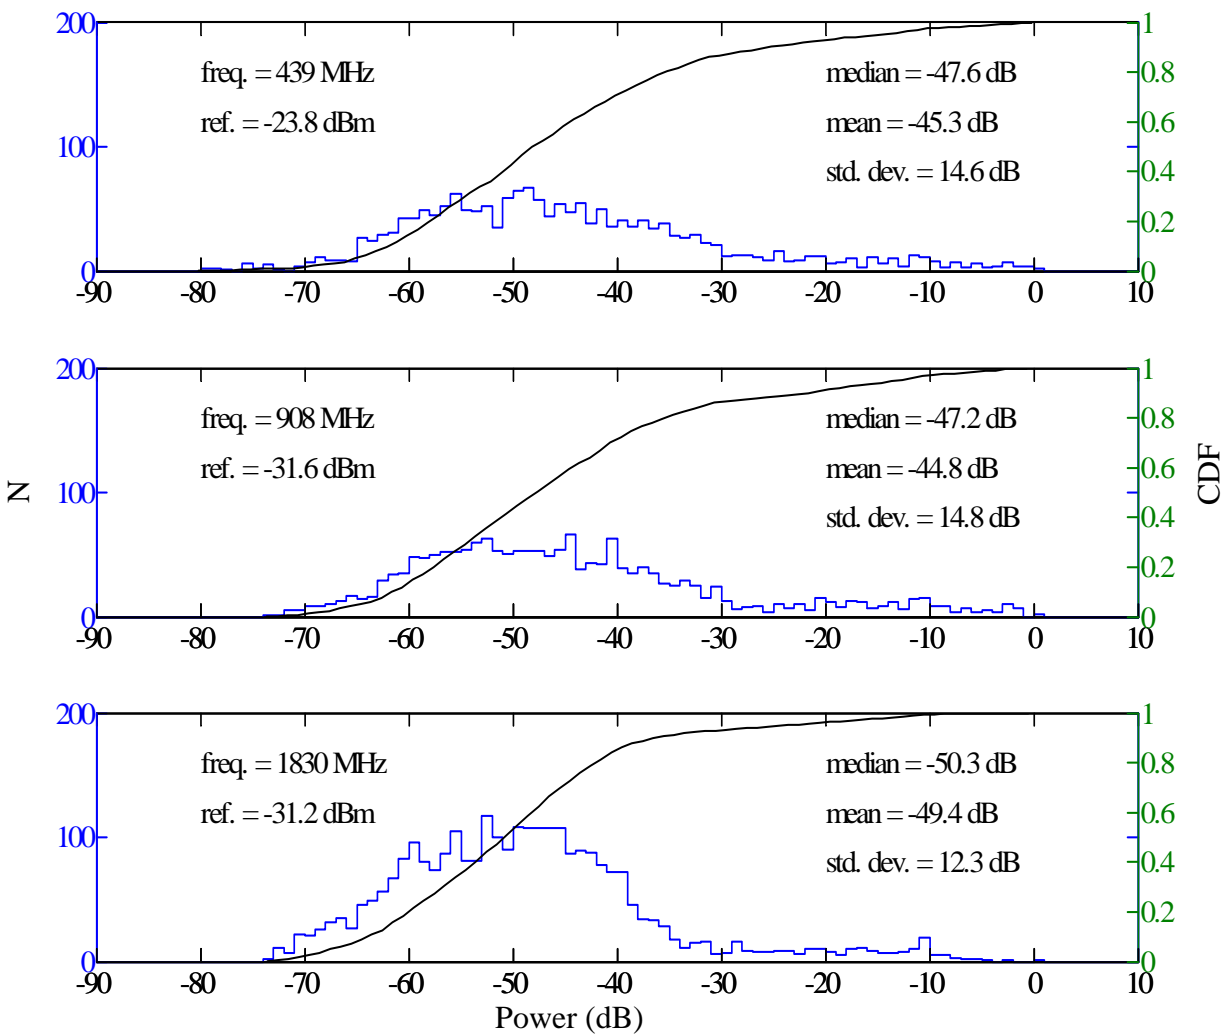
Figure 223. SUNCOR oil refinery statistics, histograms, and empirical CDF for walk-through data at 439.25, 908.0, and 1830.1 MHz; receiver at south site.

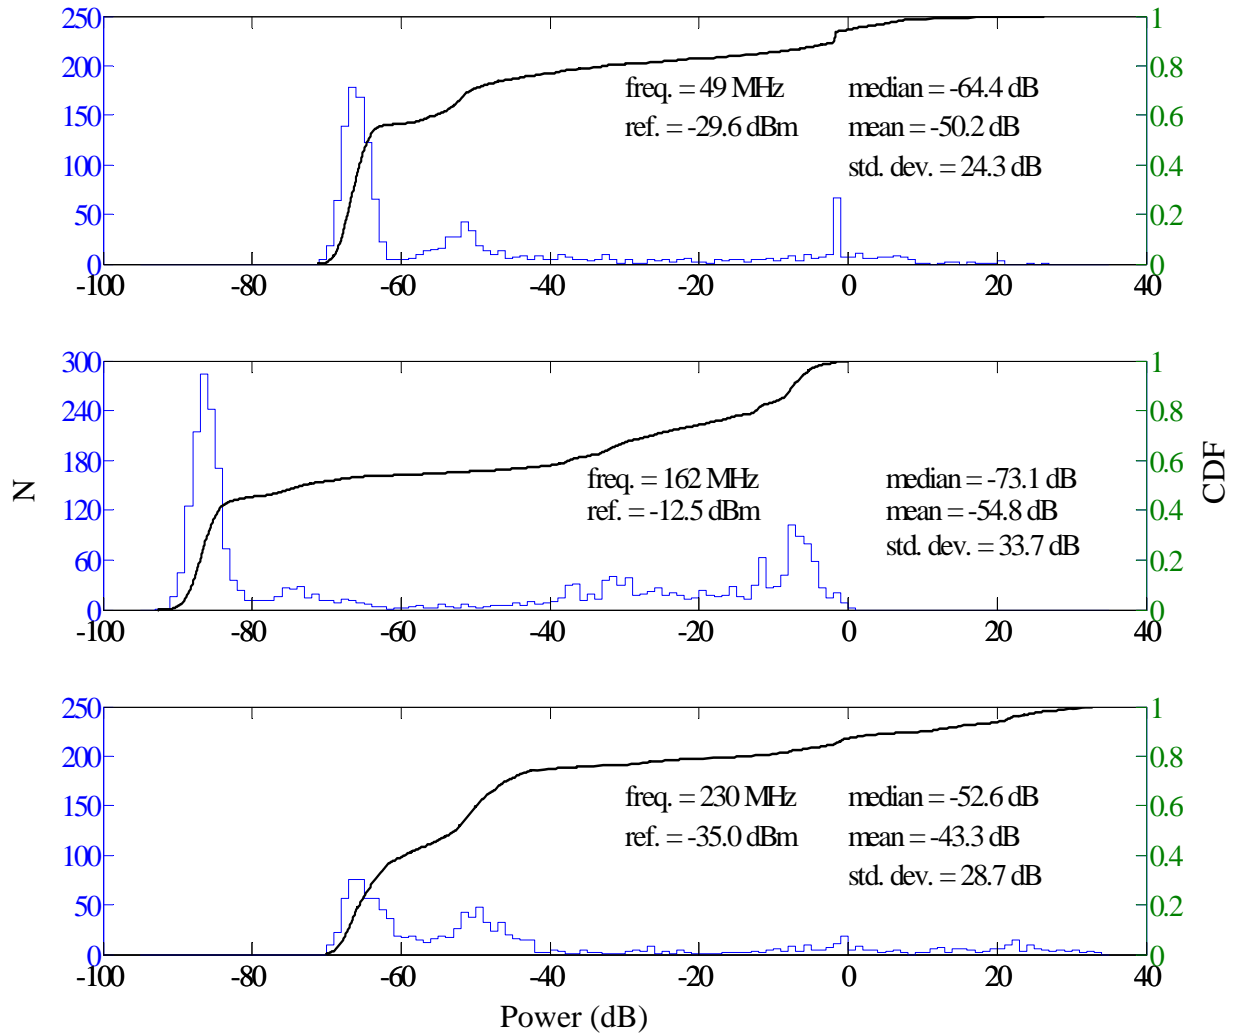
Figure 255. NIST Boulder laboratory statistics, histograms, and empirical CDF for walk-through data at 49.8, 162.075, and 230.0 MHz; receiver at wing 4 site.

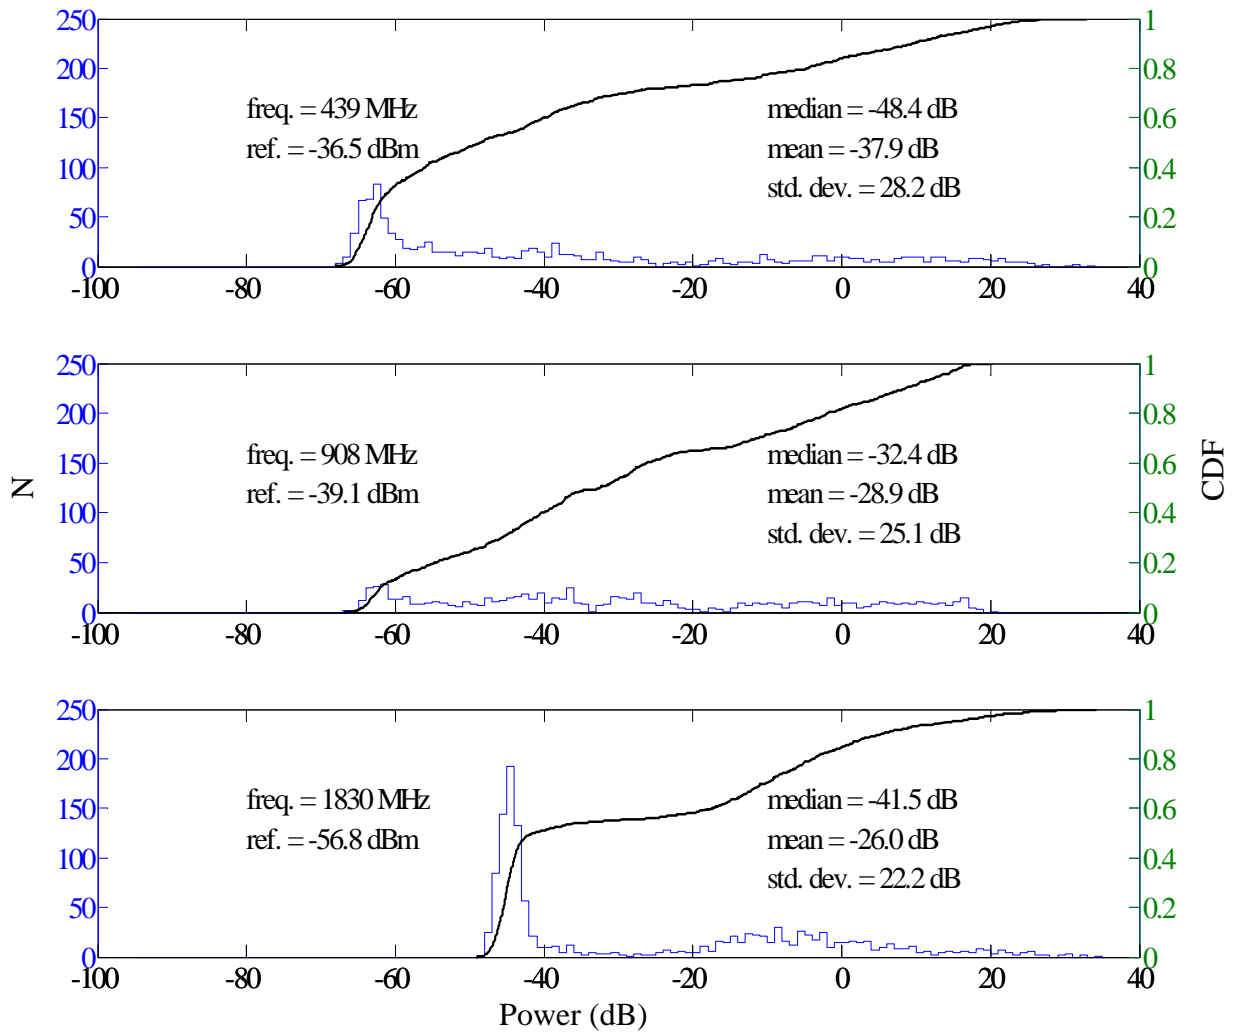
Figure 256. NIST Boulder laboratory statistics, histograms, and empirical CDF for walk-through data at 439.25, 908.0, and 1830.0 MHz; receiver at wing 4 site.
