**ARCHITECTURAL SURVEY
OF PROPOSED AREA OF POTENTIAL EFFECTS
ROUTE 1 IMPROVEMENTS AT FORT BELVOIR
(TELEGRAPH ROAD TO MOUNT VERNON MEMORIAL
HIGHWAY), FAIRFAX COUNTY, VIRGINIA**

VDHR File # 2001-007

DRAFT January 2012

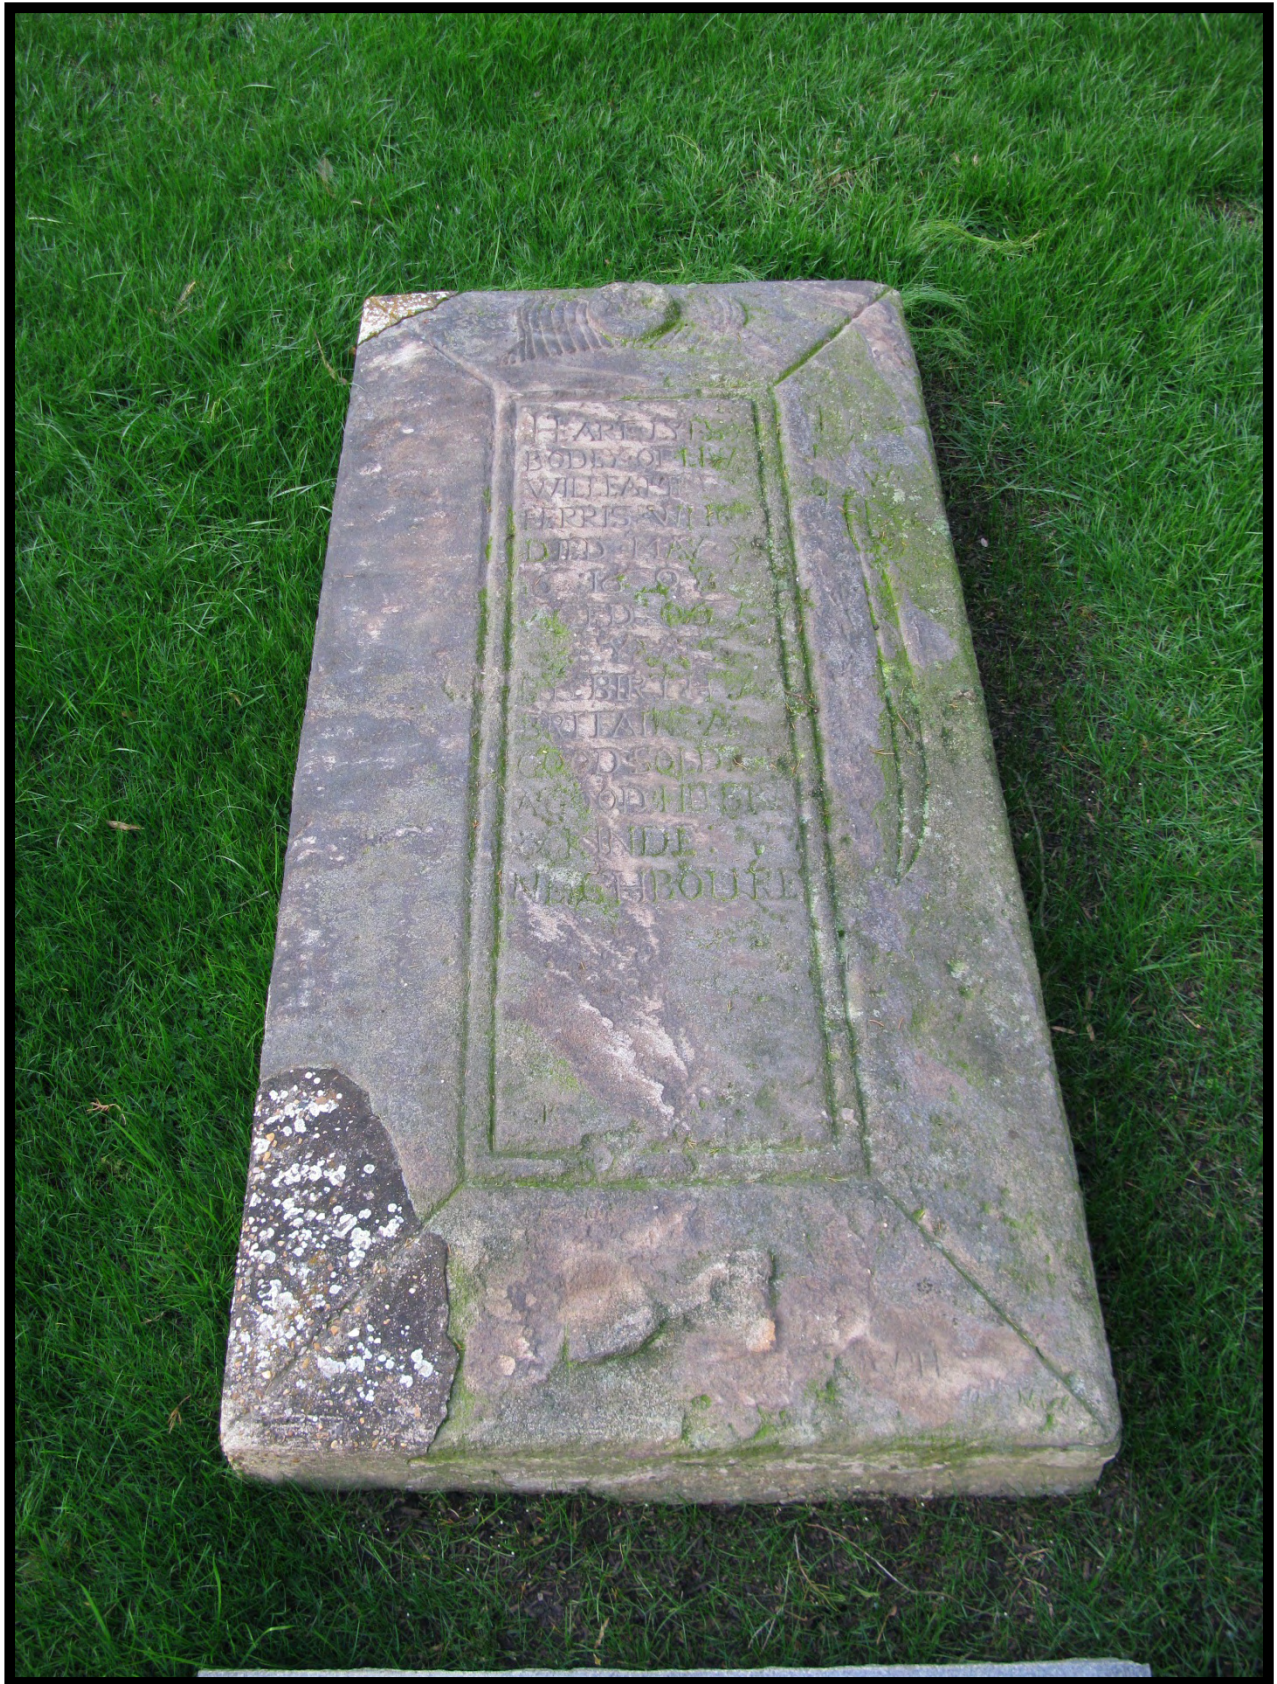
Figure 2.4-1: View of William HERRIS's Gravemarker (VDHR # 029-0562).

RECOMMENDATIONS: The William Herris gravemarker is a rare surviving example of a late seventeenth-century gravestone. The marker is similar to the Brent Tombs (VDHR # 089-0069) located near Aquia in Stafford County, Virginia, although William Herris’s marker is less eroded. Despite it being moved, William Herris’ gravemarker retains a high level of integrity. Although it has been moved, it is recommended as potentially eligible for the NRHP on an individual basis as it may meet Criterion C for its high artistic value as well as Criterion Consideration B for a moved resource placed in a churchyard environment that is compatible with its potential significance as an important example of a gravemarker. The gravemarker could also be evaluated under Criterion Consideration C for its association with William Herris, whose historical significance and remaining associations have not been fully documented, as well as Criterion Consideration D as a surviving example of a cemetery component of great age.

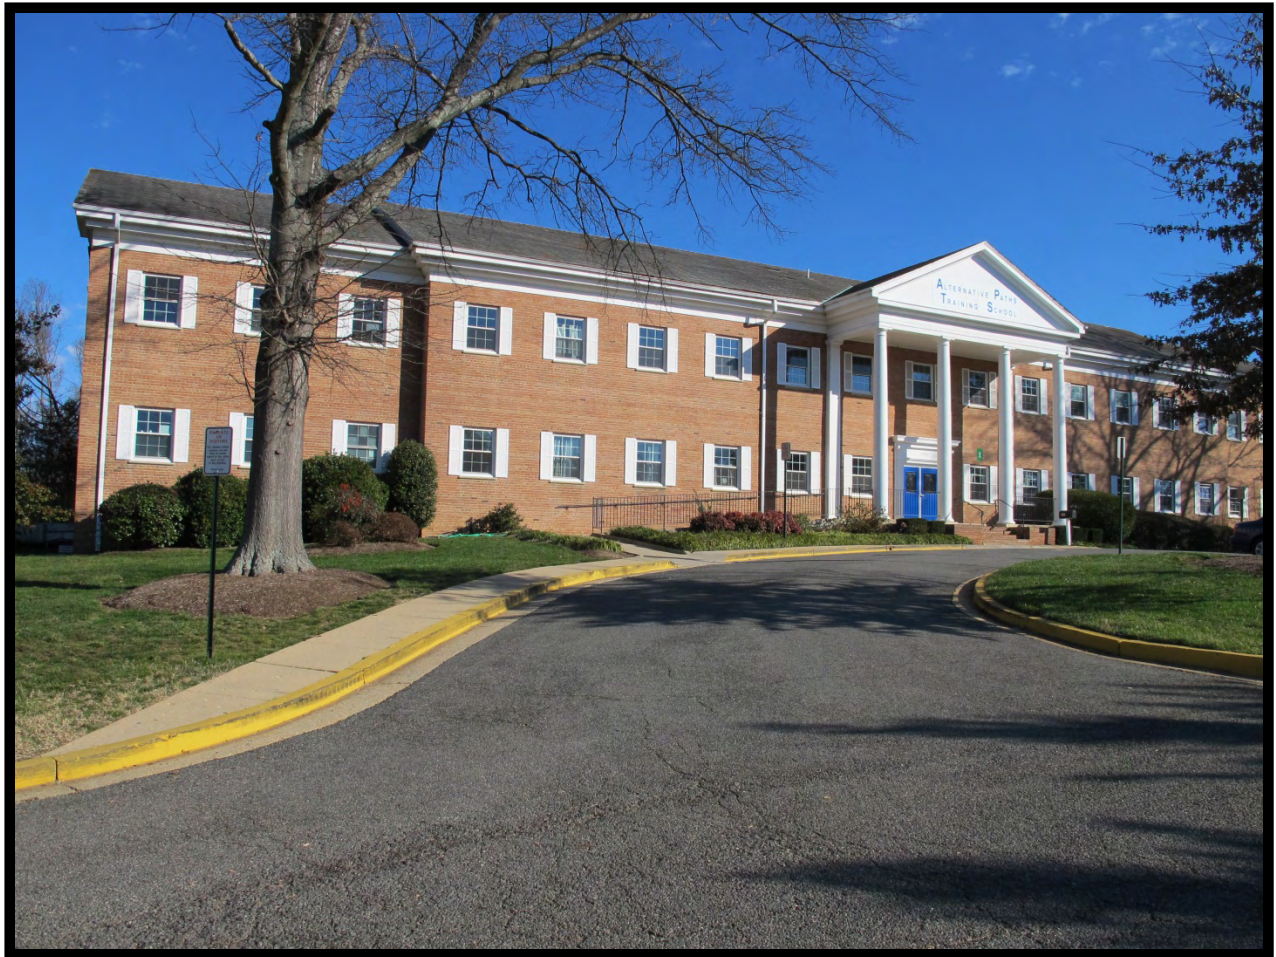
DESCRIPTION: Originally built as the National Headquarters for the Future Farmers of America, the oldest section of the building dates to 1958 (Figure 2.4-2). A second section was added in 1962, and a third around 1975, giving the building its current U-shaped footprint. The oldest section is a two-story, thirteen-bay, side-gabled brick building, with slightly lower two-story, three-bay wings off the northwest and southeast gable ends of the main block, and is typical of the Colonial Revival style used for institutional buildings throughout the twentieth century. A tetrastyle portico with four colossal Tuscan columns and a plain classical pediment shelters the three central bays on the southwest (front) elevation of the building. A door surround with a simple classical entablature frames the double entry doors on the front elevation, the walls are laid in six-over-one common bond, and non-functional shutters flank the six-over-six replacement sash windows. A two-story, flat-roofed brick wing, built in 1962, extends off the northeast (rear) elevation of the southeast wing of the main block. The addition is open on the first floor to the southeast side, which provides for covered parking. Six bays divide the second floor with doors flanking four large plate-glass windows. A cantilevered balcony runs between the doors on the second floor. A large rectangular, three-story, flat-roofed brick section was added against the northeast side of the addition around 1975, finishing the U-shaped footprint of the school. Because of the sloping terrain the last addition has only two stories exposed closest to the 1962 section, but three stories along the northeast (rear) elevation. A loading dock and garage door are located against the southeast gable end, and thirteen window

Figure 2.4-2: View of the Alternative Paths Training School (VDHR # 029-5608), Facing Southeast.

RECOMMENDATIONS: Overall, this resource retains a low level of integrity. Despite its importance as the first National Headquarters of the Future Farmers of America, the resource has lost its original pastoral setting. The replacement of all of the original windows, as well as alterations on the interior, have affected its architectural integrity. Furthermore, the building does not appear to have the ability to yield important information and is therefore recommended as not eligible for the NRHP under Criteria A, B, C, or D.

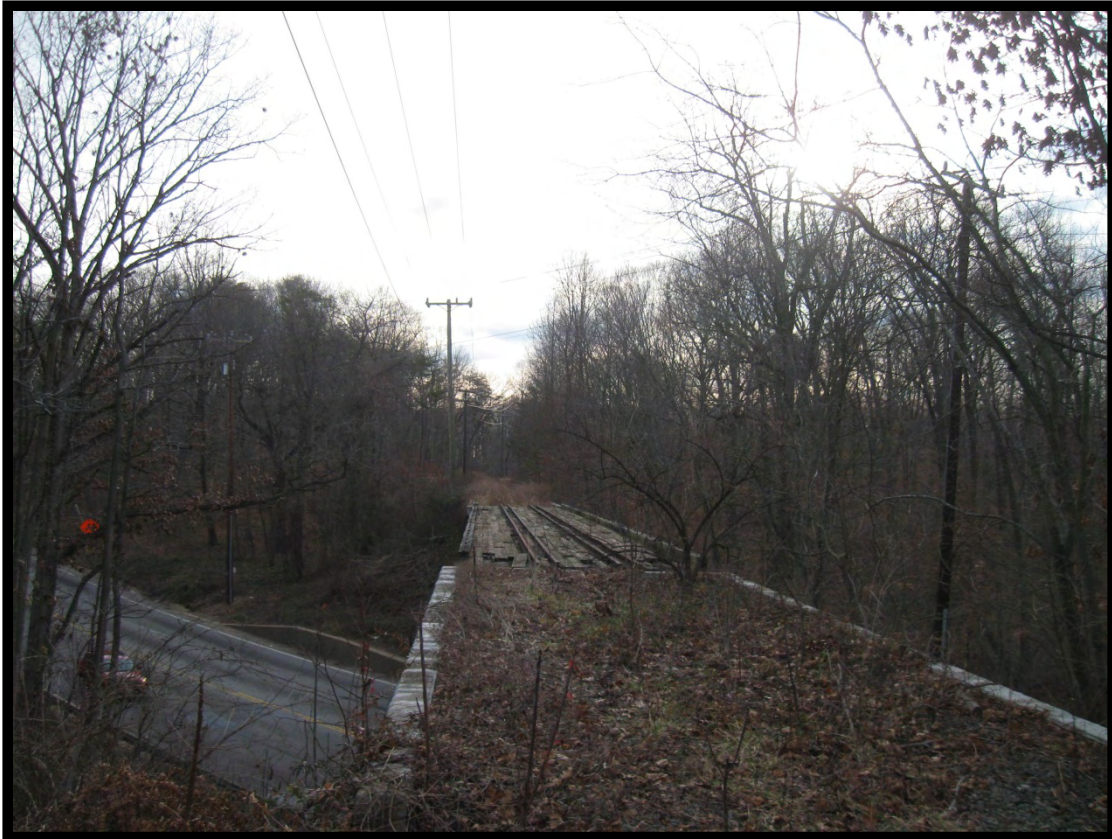
DESCRIPTION: The section of the Fort Belvoir Military Railroad (FBMRR) in the current APE for direct effects is part of the approximately five miles of the FBMRR began in 1918, which extends across U.S. Army Garrison Fort Belvoir (Figure 2.4-3 and 2.4-4). The section is part of the main track, which branched off from the Richmond-Fredericksburg & Potomac Railroad (RF&P) at the original site of Accotink Station and connected the North Post to the South Post. The section of track in the current APE runs along the level grade of two low ridges, without any significant cuts or fills, and is divided by a small drainage and the current Route 1.

Figure 2.4-3: View of the Fort Belvoir Military Railroad Track Bed at Route 1 Crossing (VDHR # 029-5648), Facing Southeast.

RECOMMENDATIONS: Despite the fact that the original railroad corridor still exists, it has lost one of its most significant element, the actual tracks. Rail service was discontinued in 1990, and the steel rails and wooden ties were eventually removed (John Milner Associates, Inc. 2006). The remaining ballast and the original right-of-way along the section within the current APE are overgrown. Despite its loss of integrity the section does maintain its significance as a contributing element to the entire track bed of the FBMRR, which Fort Belvoir cultural resources staff has recommended eligible for the NRHP under Criterion A as part of a multiple property listing as part of the FBMRR Historic District (see current DSS form).

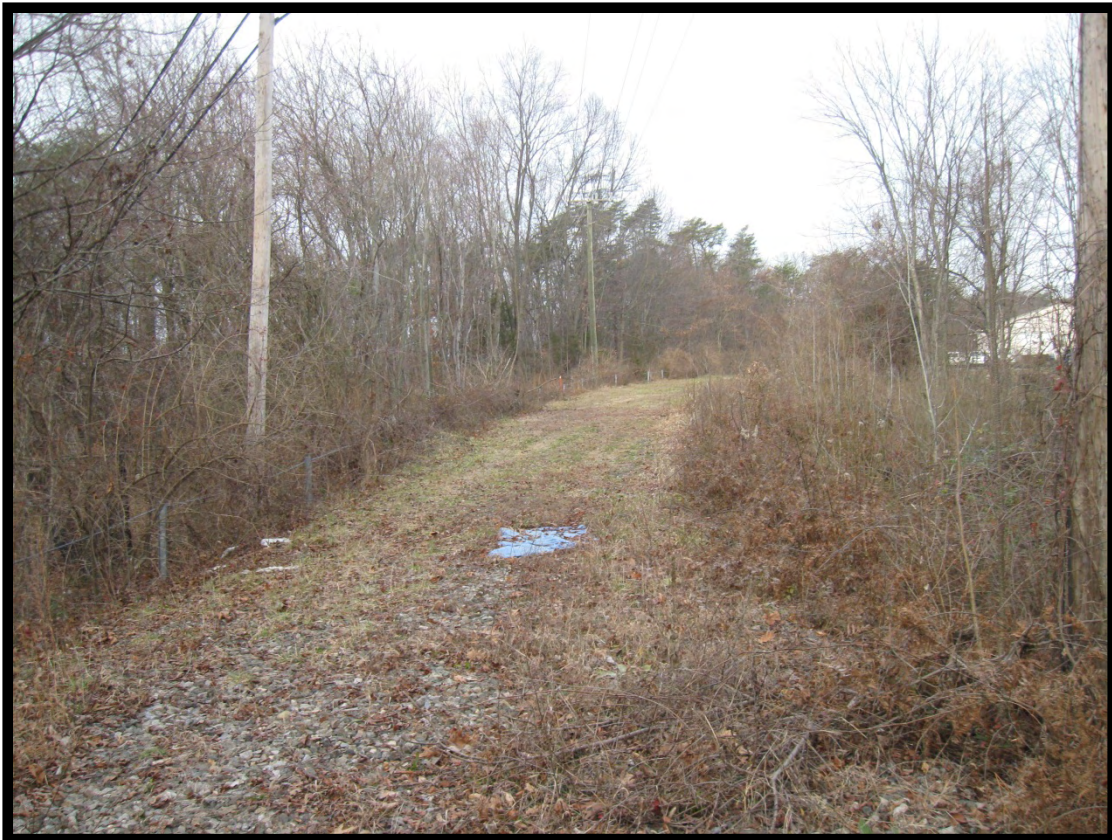
Figure 2.4-4: View of the Fort Belvoir Military Railroad Track Bed to North of Route 1 (VDHR # 029-5648), Facing Northwest.

Railroads consist of three elements: the right-of-way, the so-called permanent way, and the roadbed. The right-of-way is established as 100 feet of land on either side of the railroad line by the 1875 General Railroad Right of Way Act and was designated for the operation and maintenance of the railroad (Anonymous 2011). The permanent way is the actual track itself and consists of the pairs of steel rails, wooden railroad ties or sleepers, and the ballast in which the ties are embedded. The last section, the roadbed, consists of the earthwork on which the ballast rests (Raymond 1917). The section of track, or permanent way, in the current APE has no noticeable embankment with the exception of the parts closest to abutments of the railroad bridge, Facility No. 1433 (VDHR # 029-5424), where the terrain slopes down to Route 1 and the original drainage.

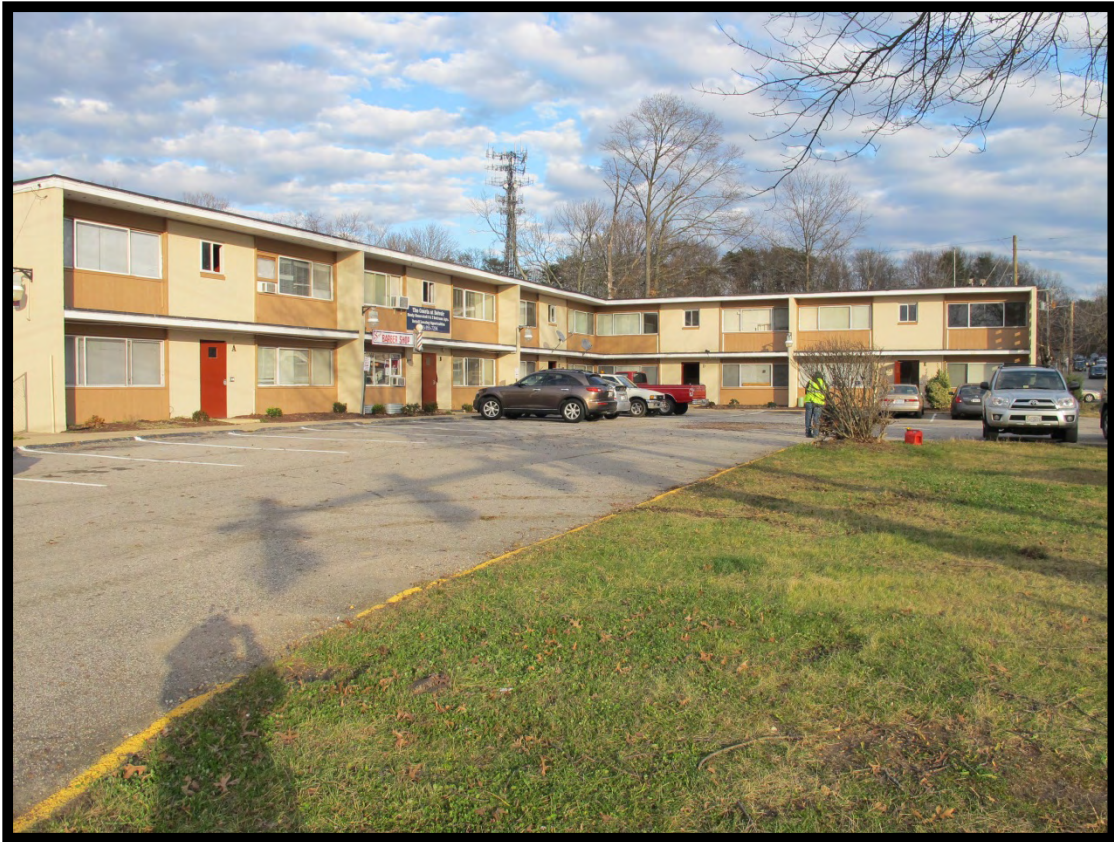
Figure 3.2-1: View of The Courts at Belvoir (VDHR # 029-5682 – South Block), Facing Northeast.

RECOMMENDATIONS: Overall, this resource retains a low level of integrity. The replacement of the original windows, and presumably the doors, has affected its integrity, and the apartment complex design lacks architectural significance. Furthermore, the complex has no significant association with any event or person important to our nation's history and does not

appear to have the ability to yield important information. This architectural resource is recommended as not eligible for the NRHP under Criteria A, B, C, or D.

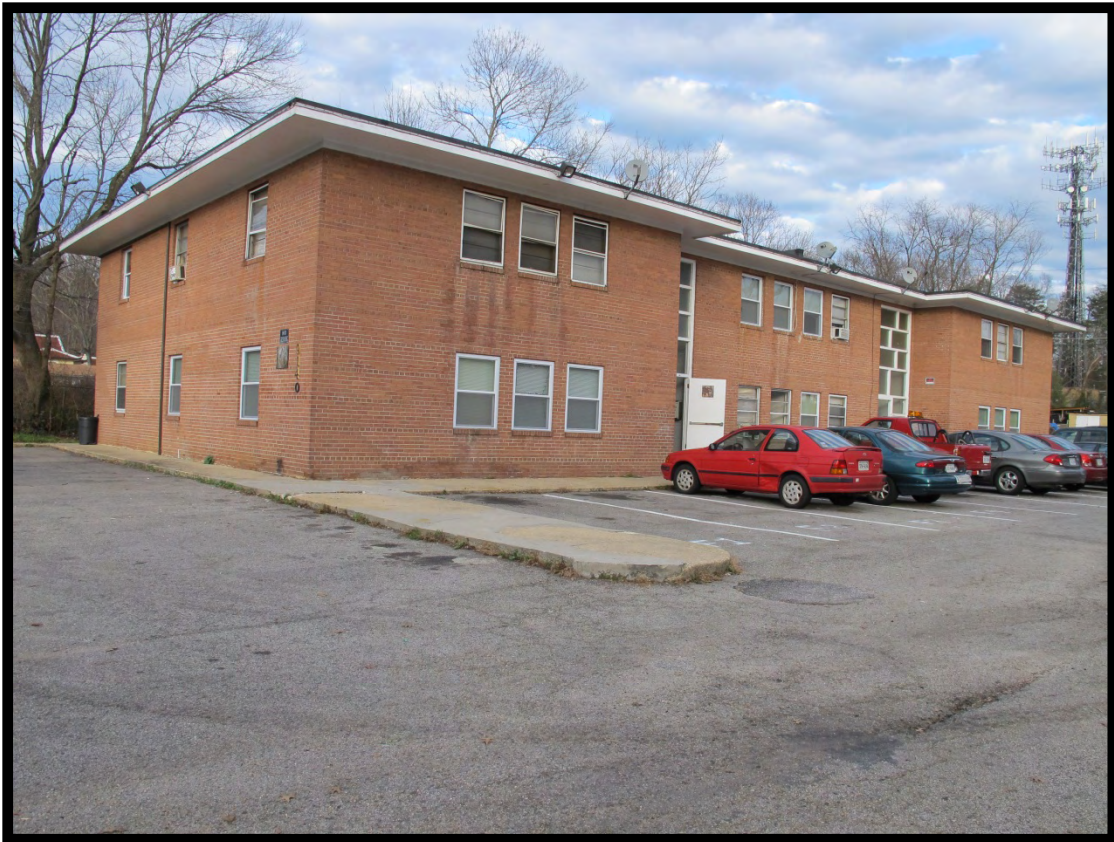
Figure 3.2-2: View of The Courts at Belvoir (VDHR # 029-5682 – North Block), Facing Northeast.

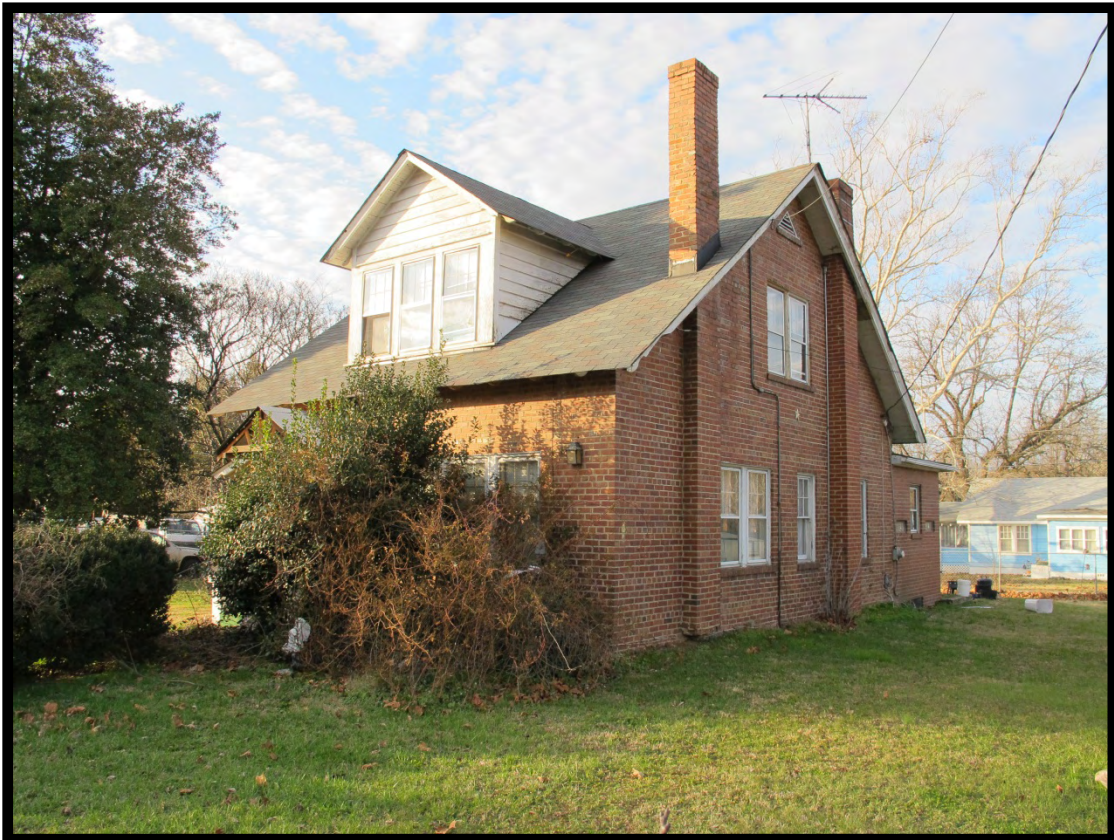
Figure 3.2-4: View of 9170 Richmond Highway (VDHR # 029-5684), Facing Northwest.

DESCRIPTION: Built around 1930, according to research done by Laurie Turkawski and Laura Gumkowski, this one-and-a-half-story, two-bay, side-gabled brick dwelling is an almost typical example of a modest Craftsman bungalow (Turkawski and Gumkowski 2011) (Figure 3.2-4).

The only missing distinctive feature is an integral porch across the south (front) elevation of the building. A triple six-over-one sash window flanks the entrance door with a small projecting door hood on the front elevation. Typical of the Craftsman style is the large gable-roofed dormer with the triple six-over-one window, which dominates the south (front) slope of the roof. The brick walls are laid in seven-over-one common bond, and two exterior brick flues are located against the east gable end. The roof is covered with asphalt shingles, which has decorative exposed rafter tails. An enclosed shed-roofed, frame porch is located against the west gable end and an enclosed, hip-roofed brick porch spans the entire north (rear) elevation of the dwelling. A shed-roofed carport and a smaller enclosed brick entrance extend off the rear porch. The rear porch and the entrance section are both laid in seven-over-one common bond, but there are clear seams between each of the sections. Whereas the rear porch has six-over-one sash windows, the entrance section has a door in the west elevation and a twenty-four glass-block opening in the north elevation.

RECOMMENDATIONS: Overall, this resource retains a fair level of integrity. However, the alterations of the rear porch and the addition of the side porch have affected its integrity, and the dwelling lacks significance as it represents a common design for the period of construction and place. Furthermore, the dwelling has no significant association with any event or person important to our nation's history and does not appear to have the ability to yield important information. This architectural resource is recommended as not eligible for the NRHP under Criteria A, B, C, or D.

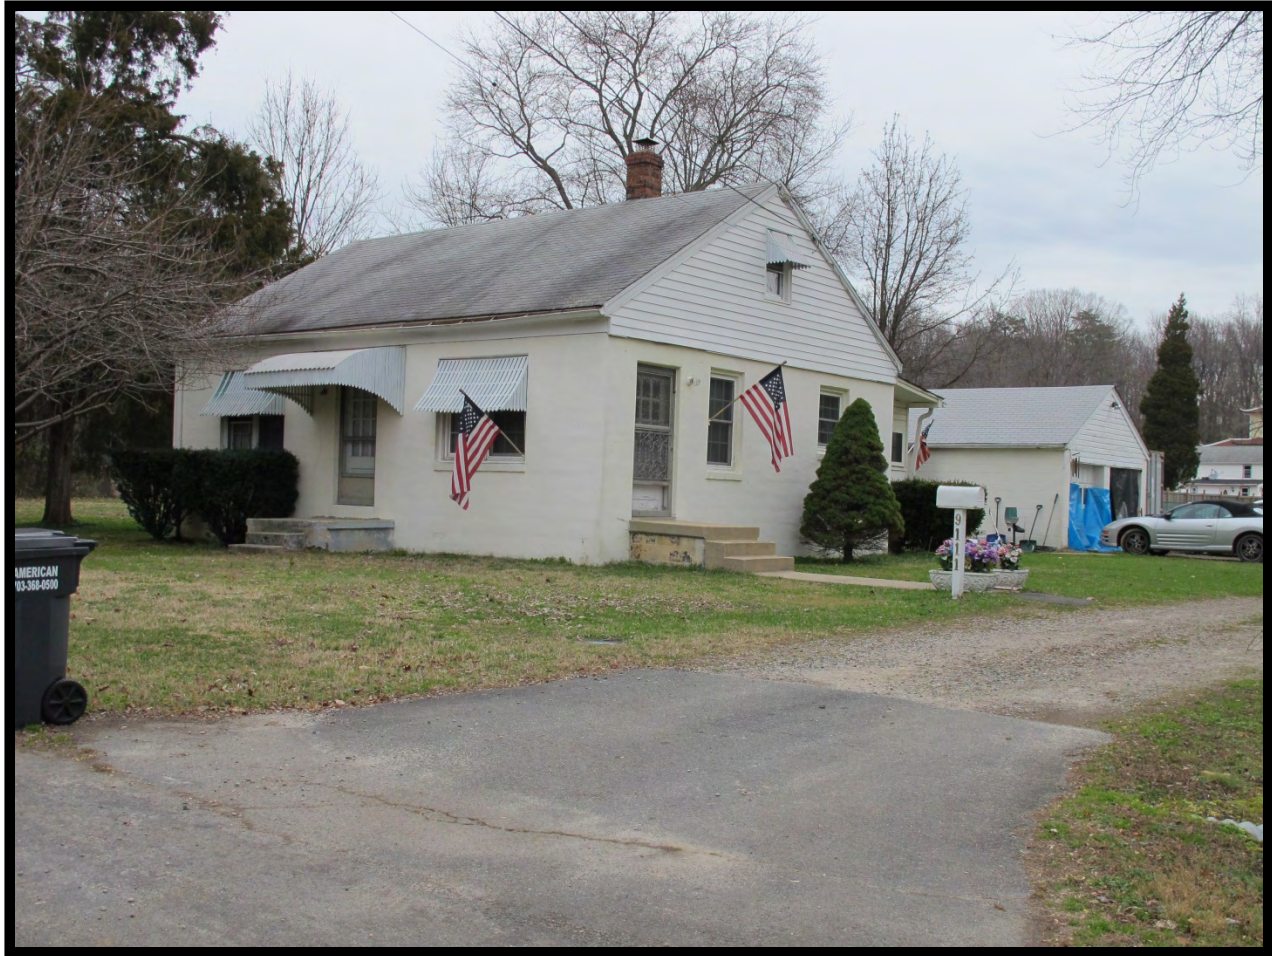
Figure 3.2-5: View of 9111 Anderson Lane (VDHR # 029-5685), Facing Northeast.

DESCRIPTION: Built around 1940, according to research done by Laurie Turkawski and Laura Gumkowski, this one-story, three-bay, side-gabled building is typical of the Minimal-Traditional style (Turkawski and Gumkowski 2011) (Figure 3.2-5). Paired, or double, six-over-six sash windows flank the central entrance door on the west (front) elevation of the dwelling. Metal awnings shelter the door and window openings, and a concrete stoop with two steps leads up to the front door. A second stoop and entrance door are located on the south gable end. The building is stuccoed and has plain weatherboard in the gable peaks and an asphalt shingle roof.

A brick flue pierces the east (rear) slope of the roof, just below the ridge, and a small frame shed-roofed section was built against the east (rear) elevation of the building.

RECOMMENDATIONS: Overall, this resource retains a fair level of integrity. However, the dwelling lacks significance and represents a common design for the period of construction and place. Furthermore, the dwelling has no significant association with any event or person important to our nation's history and does not appear to have the ability to yield important information. This architectural resource is recommended as not eligible for the NRHP under Criteria A, B, C, or D.

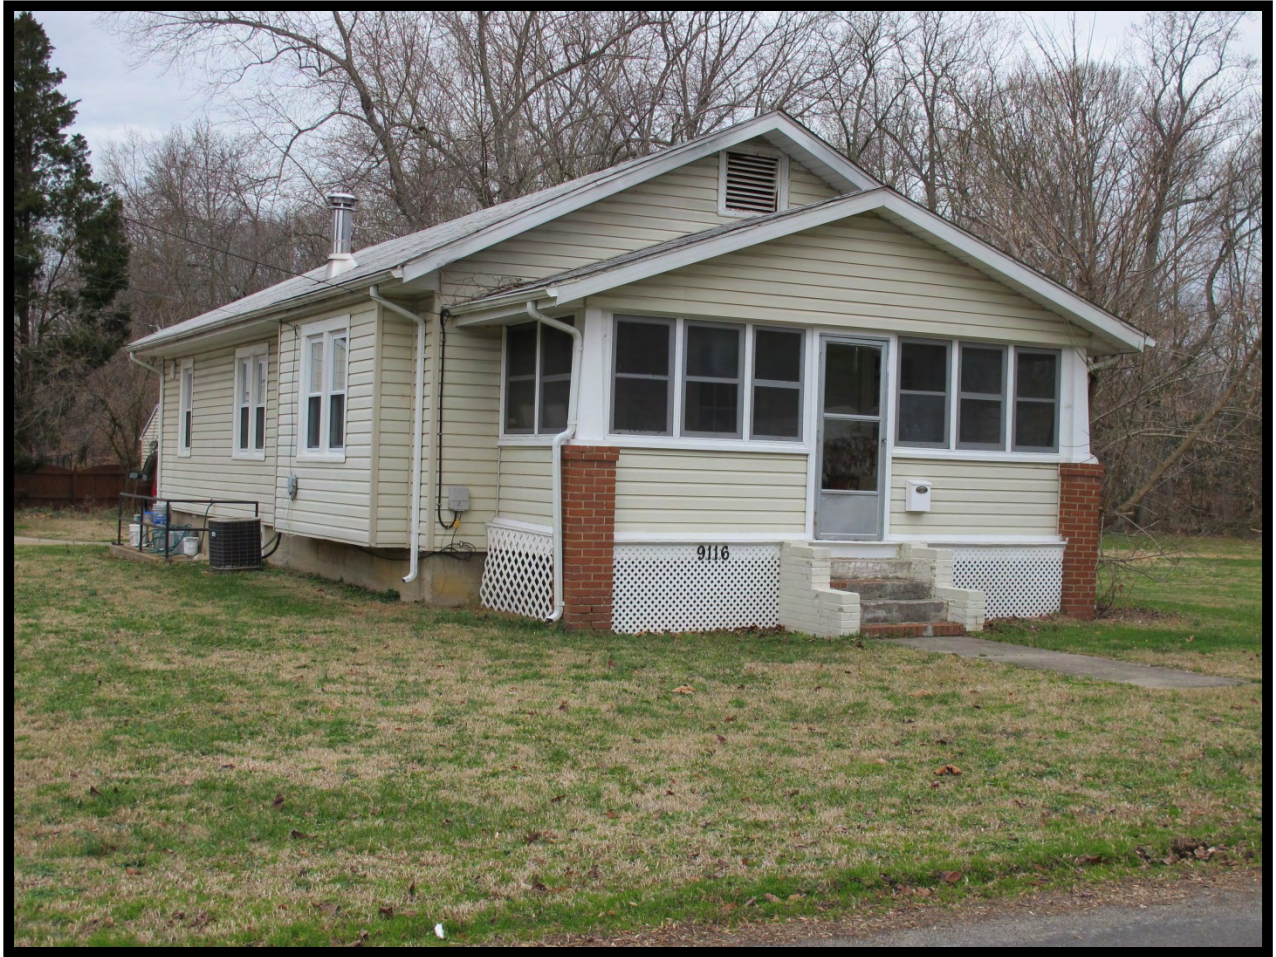
DESCRIPTION: Built around 1930, according to research done by Laurie Turkawski and Laura Gumkowski, this house is one of at least four almost identical dwellings on Anderson Lane, which may have been mail-order houses – the other four houses are VDHR #s 029-5687, 029-5688, 029-5689, 029-5690 (Raymond T. Hicks, personal communication 2011) (Turkawski and Gumkowski 2011) (Figure 3.2-6). The house is typical of the more modest front-gabled box-style Craftsman bungalows. A front-gabled porch supported by battered box columns on brick pedestals shelters the three bays on the east (front) gable end of the dwelling – the porch at 9116 is enclosed obscuring the actual bays. The windows on the north and south elevations are either single or double one-over-one sash vinyl replacement windows. Typical of the Craftsman style is the projecting square bay on the south elevation, which has a double window. The building sits on a slightly raised poured concrete foundation, and is currently clad in vinyl drop siding with an asphalt shingle roof.

Figure 3.2-6: View of 9116 Anderson Lane (VDHR # 029-5686), Facing Northwest.

RECOMMENDATIONS: Overall, this resource retains a low level of integrity. The replacement of the original siding and windows and the enclosure of the front porch have affected its integrity, and the dwelling lacks significance as it represents a common design for the period of construction and place. Furthermore, the dwelling has no significant association with any event or person important to our nation's history and does not appear to have the ability to yield important information. This architectural resource is recommended as not eligible for the NRHP under Criteria A, B, C, or D.

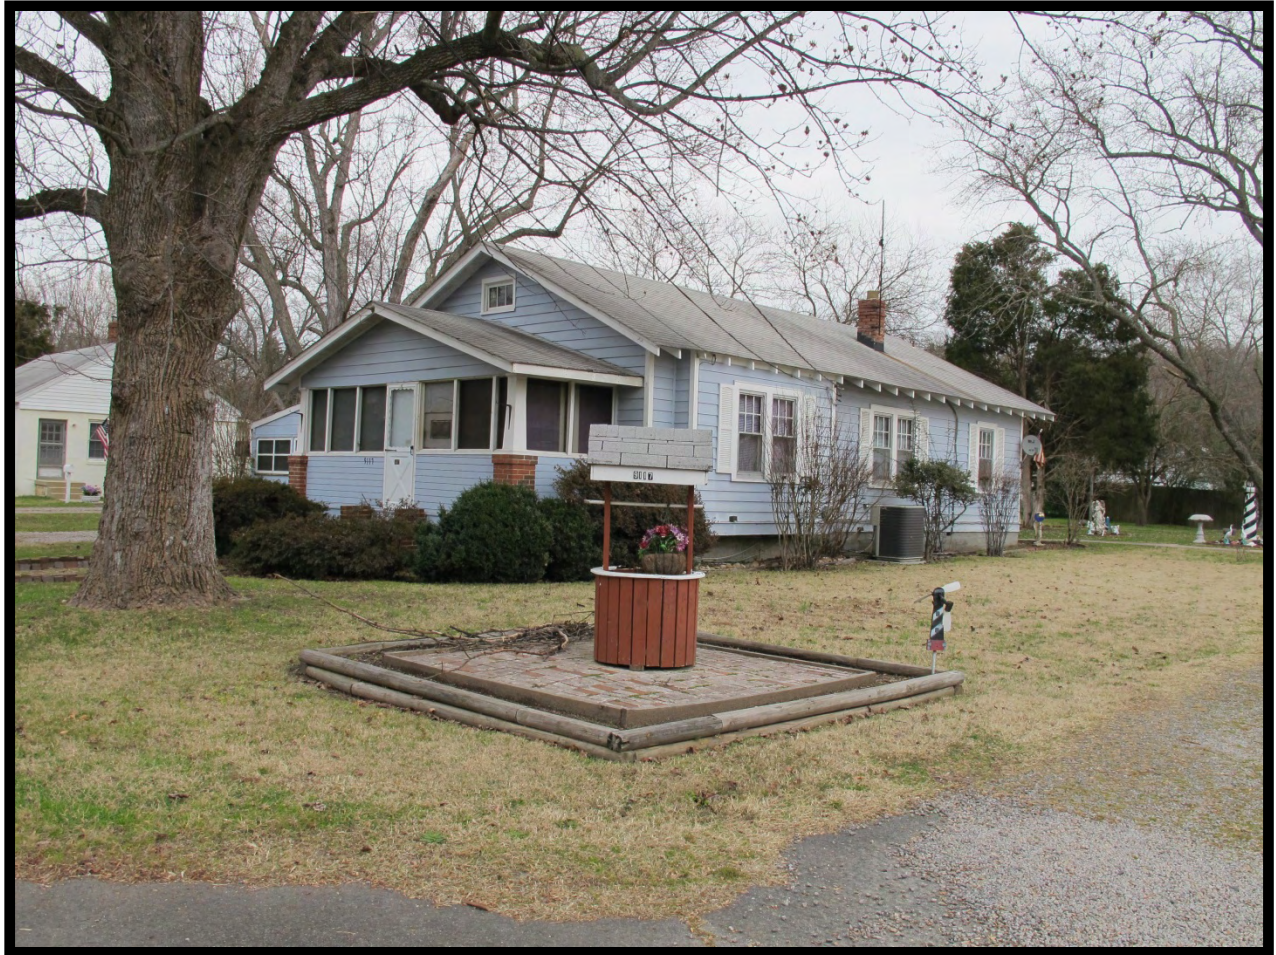
DESCRIPTION: Built around 1930, according to research done by Laurie Turkawski and Laura Gumkowski, this house is one of at least four almost identical dwellings on Anderson Lane, which may have been mail-order houses – the other four houses are VDHR #s 029-5686, 029-5688, 029-5689, and 029-5690 (Raymond T. Hicks, personal communication 2011) (Turkawski and Gumkowski 2011) (Figure 3.2-7). The house is typical of the more modest front-gabled box-style Craftsman bungalows. A front-gabled porch supported by battered box columns on brick pedestals shelters the three bays on the west (front) gable end of the dwelling – the porch at 9117 is enclosed obscuring the actual bays. The windows on the south elevation are either single or double six-over-one sash windows. Typical of the Craftsman style are the projecting square bay on the south elevation, which has a double window, and the exposed rafter tails. A brick flue pierces the south slope of the roof towards the east (rear) gable end. The building sits on a slightly raised poured concrete foundation and is clad in plain weatherboard siding with an asphalt shingle roof. A large shed-roofed addition, enclosed with composition board and horizontal four-light fixed windows, covers much north elevation, and a smaller shed-roofed addition extends off the rear gable end.

Figure 3.2-7: View of 9117 Anderson Lane (VDHR # 029-5687), Facing Northeast.

RECOMMENDATIONS: Overall, this resource retains a fair level of integrity. However, the large addition along the north elevation and the enclosure of the front porch have affected its integrity, and the dwelling lacks significance as it represents a common design for the period of construction and place. Furthermore, the dwelling has no significant association with any event or person important to our nation's history and does not appear to have the ability to yield important information. This architectural resource is recommended as not eligible for the NRHP under Criteria A, B, C, or D.

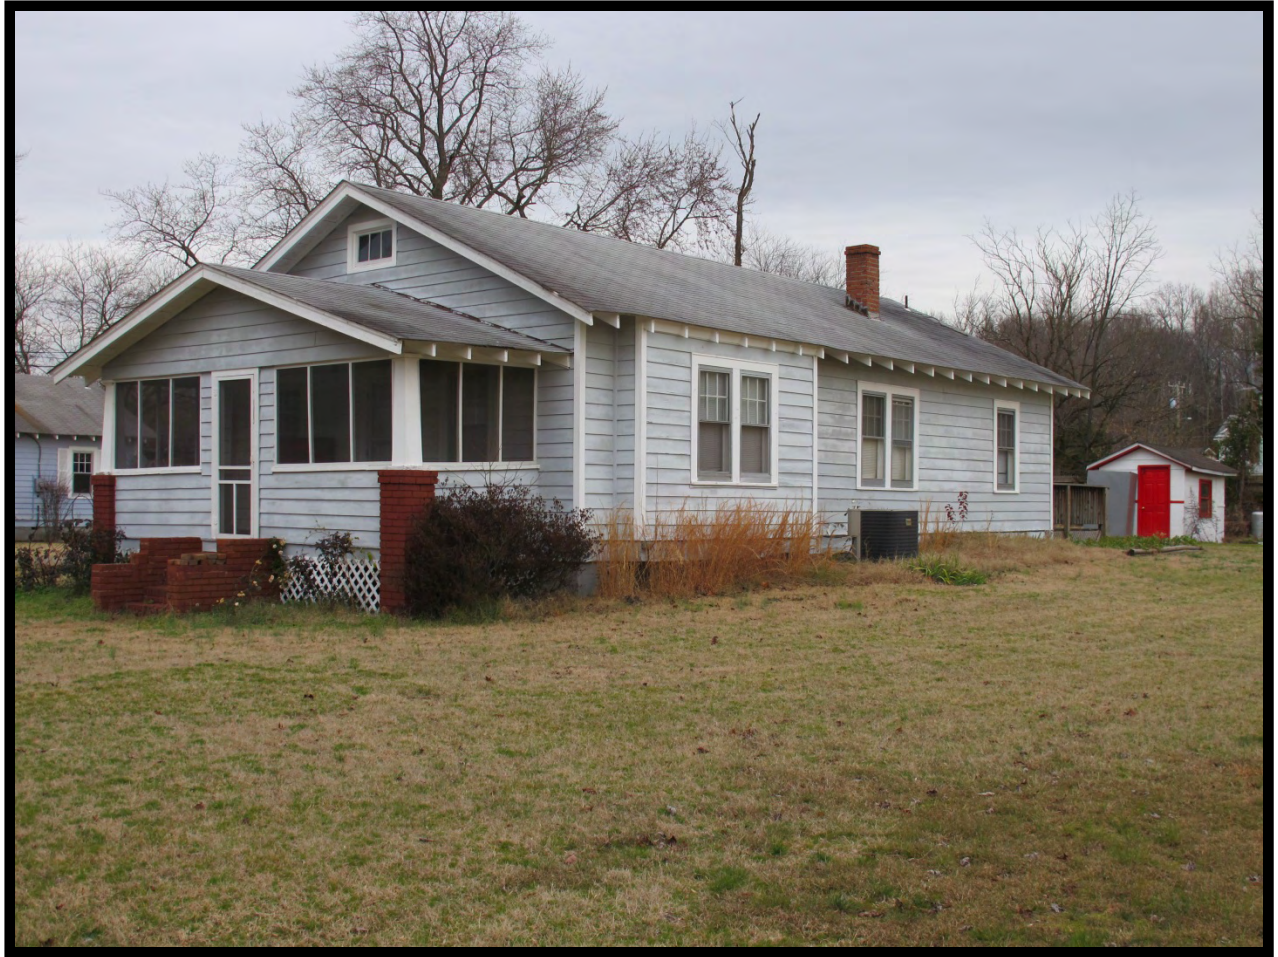
Located behind to the dwelling to the east stand a row of four small outbuildings, including two sheds, and what appear to be two one-car garages. Located farthest to the south stands a small, front-gabled garden shed. Next to it to the north stands a front-gabled one-car, frame garage, clad in plain weatherboard with exposed rafter tails. A short picket fence connects the garage to a front-gabled, three-bay shed clad in vertical composition board. A second short picket fence continues on the north side of the shed connecting it to a second front-gabled one-car frame garage, which is clad in plain weatherboard siding with exposed rafter tails.

Figure 3.2-8: View of 9119 Anderson Lane (VDHR # 029-5688), Facing Northeast.

RECOMMENDATIONS: Overall, this resource retains a fair level of integrity. However, the dwelling lacks significance and represents a common design for the period of construction and place. Furthermore, the dwelling has no significant association with any event or person important to our nation's history and does not appear to have the ability to yield important information. This architectural resource is recommended as not eligible for the NRHP under Criteria A, B, C, or D.

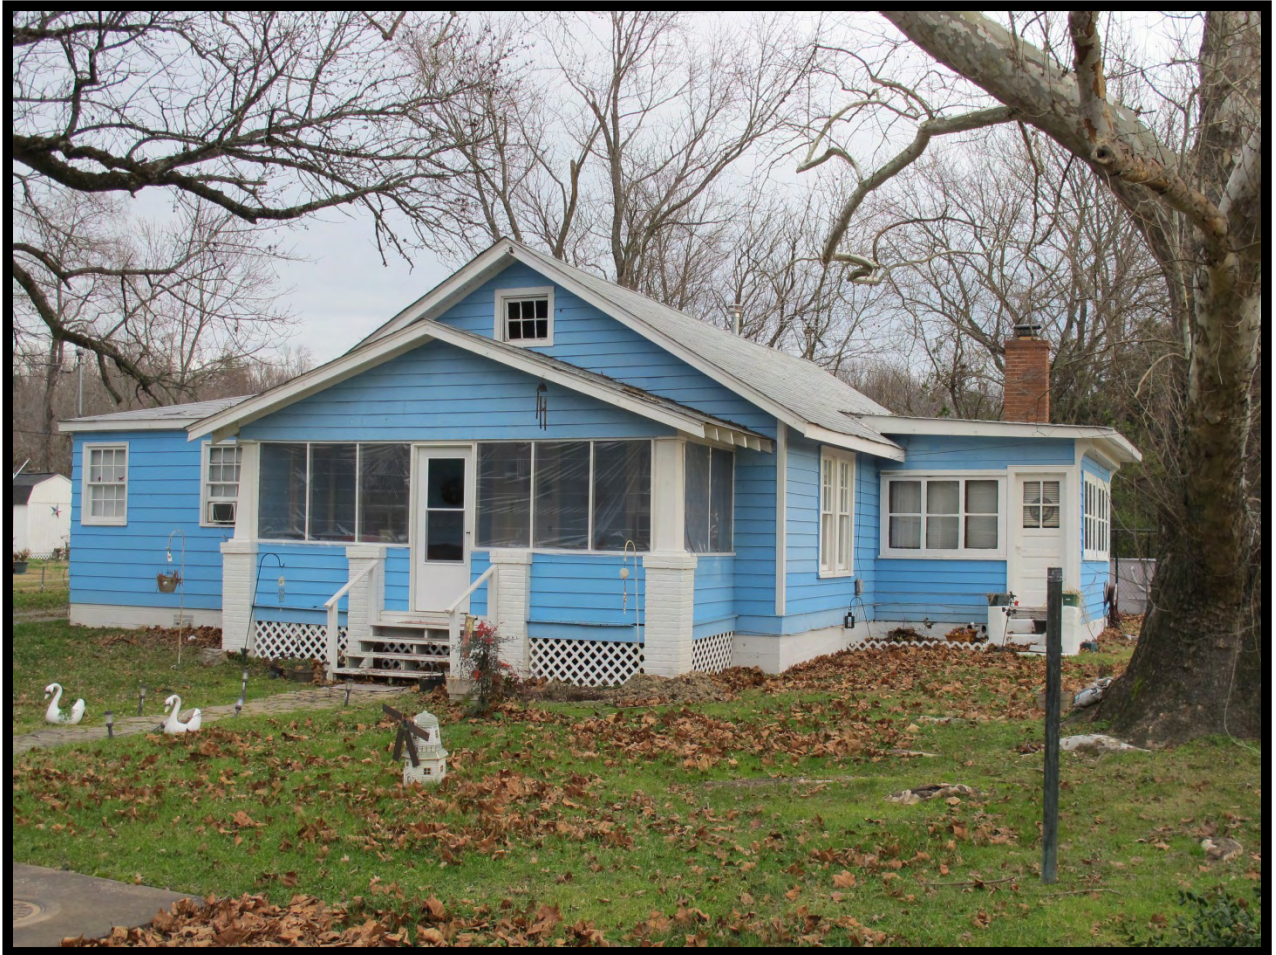
Located behind to the dwelling to the northeast stands a one-car frame garage clad in vertical composition board, with a modified front-gabled roof, giving the appearance of a gambrel roof.

Figure 3.2-10: View of 9135 Anderson Lane (VDHR # 029-5690), Facing Northeast.

RECOMMENDATIONS: Overall, this resource retains a low level of integrity. The two additions have affected its integrity, and the dwelling lacks architectural significance. Furthermore, the dwelling has no significant association with any event or person important to our nation's history and does not appear to have the ability to yield important information. This architectural resource is recommended as not eligible for the NRHP under Criteria A, B, C, or D.

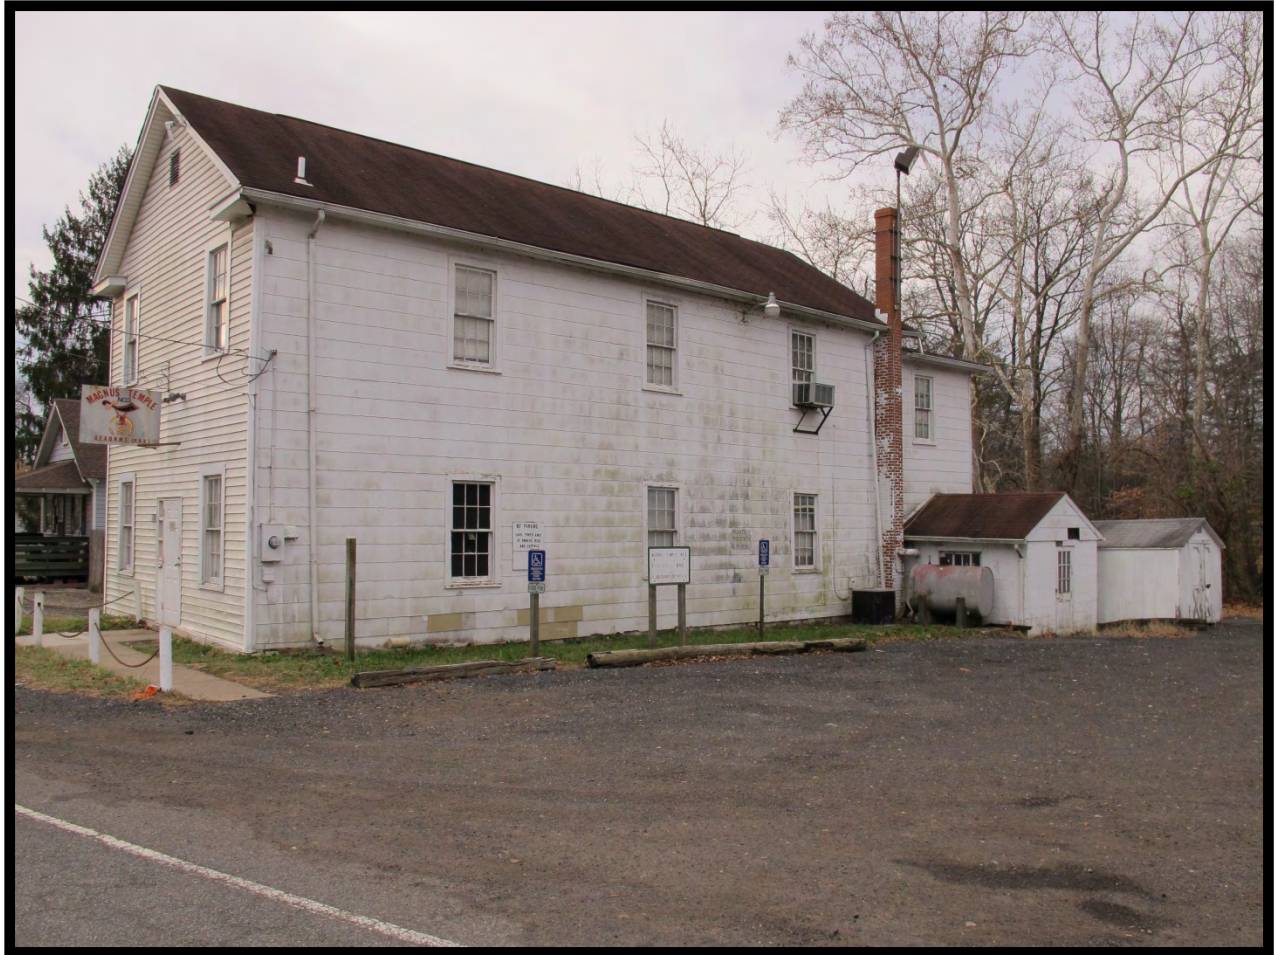
DESCRIPTION: Built around 1916, according to research done by Laurie Turkawski and Laura Gumkowski, this two-story, three-bay, front-gabled frame building currently functions as the Magnus Temple No. 3 of the Ancient Egyptian Arabic Order Nobles Mystic Shrine Prince Hall Affiliated (A.E.A.O.N.M.S.P.H.A.) (Turkawski and Gumkowski 2011) (Figure 3.2-11). Six-over-six wooden-sash windows flank the replacement entry door on the east (front) gable end. The front elevation is clad in vinyl siding, whereas the other elevations are clad in asbestos shingles, and the building sits on a poured concrete foundation. The main block is three bays deep on the first and second floor. An exterior brick flue is located against the north elevation of the main block near the west (rear) gable end. A slightly lower two-story, hip-roofed section is built against the rear gable end of the main block. It is clad in asbestos shingles and has six-over-six wooden-sash windows in the north and south elevations, and three doors on the west elevation – two on the first floor and one on the second floor – with an exterior stair giving access to two of the three doors. A small one-story, front-gabled, concrete-block boiler/heater room is built against the north wall of the rear addition.

Figure 3.2-11: View of Odd Fellows Hall (VDHR # 029-5691), 9012 Backlick Road, Facing Southwest.

RECOMMENDATIONS: Overall, this resource retains a fair level of integrity. However, the addition of the vinyl siding on the front gable end, the replacement of the original door, and the stairs against the rear elevation have affected its integrity. The building also lacks significance and represents a common design for the period of construction and place. Furthermore, the building has no significant association with any event or person important to our nation's history

and does not appear to have the ability to yield important information. This architectural resource is recommended as not eligible for the NRHP under Criteria A, B, C, or D.

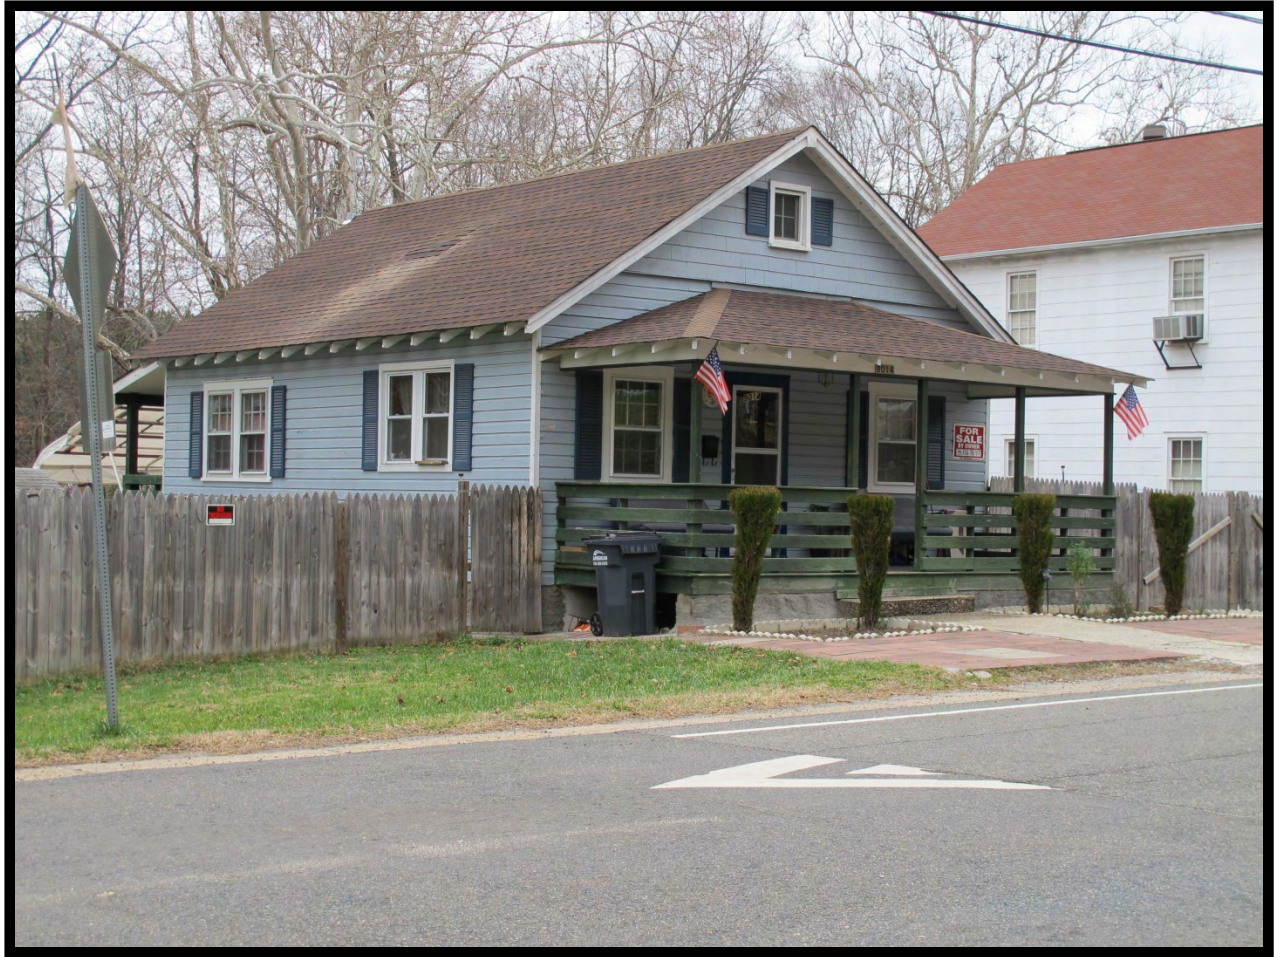
DESCRIPTION: Originally built around 1925, according to research done by Laurie Turkawski and Laura Gumkowski, the dwelling was substantially remodeled in the late 1970s and 1980s,

Figure 3.2-12: View of 9014 Backlick Road (VDHR # 029-5692), Facing Southwest.
