**ARCHITECTURAL SURVEY
OF PROPOSED AREA OF POTENTIAL EFFECTS
ROUTE 1 IMPROVEMENTS AT FORT BELVOIR
(TELEGRAPH ROAD TO MOUNT VERNON MEMORIAL
HIGHWAY), FAIRFAX COUNTY, VIRGINIA**

VDHR File # 2001-007

DRAFT January 2012

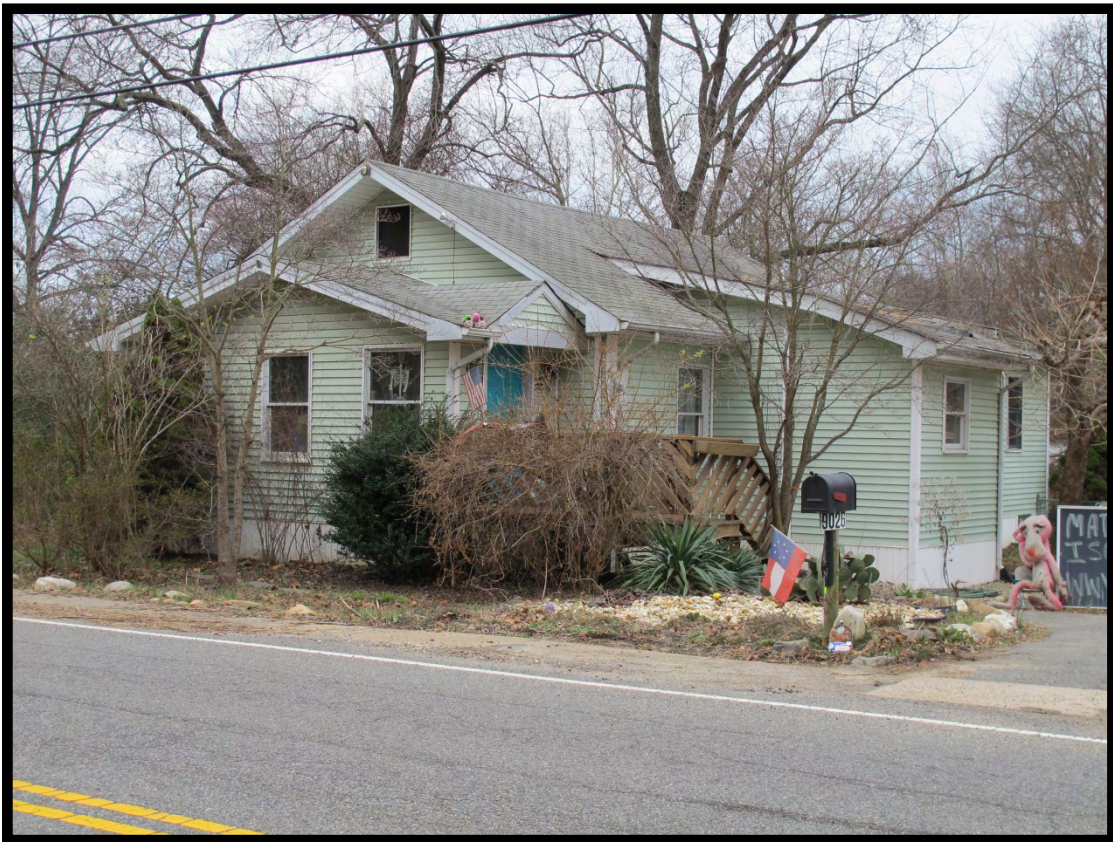
Figure 3.2-14: View of 9026 Backlick Road (VDHR # 029-5694), Facing Southwest.

DESCRIPTION: Originally built around 1925, according to research done by Laurie Turkawski and Laura Gumkowski, the dwelling has since been substantially remodeled (Turkawski and Gumkowski 2011) (Figure 3.2-14). Its original form was probably that of a one-story front-gabled box-style Craftsman bungalow, similar to VDHR # 029-5692 and the original #029-5693. At some point the owners enclosed the original front-gabled porch – the brick pedestals, which

supported the porch posts are still visible. They also added a gable-roofed wall dormer to the south slope of the roof with a bay window below on the south elevation. An irregular shed-roofed section was added to the north elevation of the original block, and at some point a rectangular flat-roofed section was built to the west (rear) gable end of the original dwelling. The flat-roofed addition is flush with the north elevation of the shed addition, but extends several feet beyond the south elevation of the main block. The entire building is clad in vinyl siding with one-over-one vinyl replacement windows and asphalt shingle roofs.

RECOMMENDATIONS: Overall, this resource retains no integrity. The numerous additions, the vinyl siding, and the replacement windows have destroyed its integrity, and the building lacks significance and no longer represents a common design for the period of construction and place. Furthermore, the dwelling has no significant association with any event or person important to our nation's history and does not appear to have the ability to yield important information. This architectural resource is recommended as not eligible for the NRHP under Criteria A, B, C, or D.

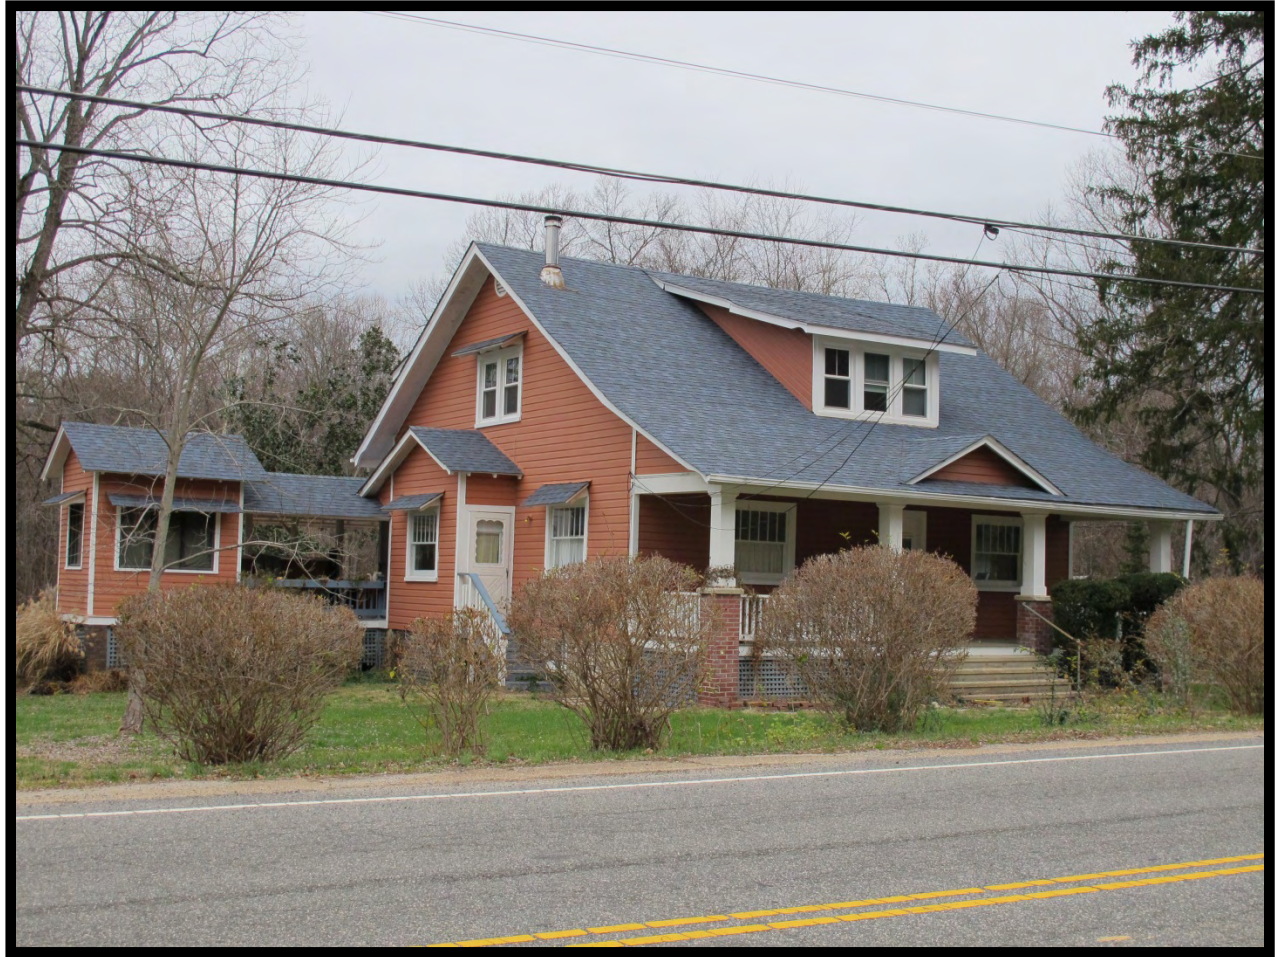
DESCRIPTION: Built around 1920, according to research done by Laurie Turkawski and Laura Gumkowski, this one-and-a-half-story, three-bay, side-gabled frame dwelling is a typical example of a more elaborate Craftsman bungalow (Turkawski and Gumkowski 2011) (Figure 3.2-15). Two large rectangular six-over-one wooden-sash windows, with vertical lights in the top sash, flank the central entry door on the east (front) elevation. A deep integral porch, supported by box pillars on brick pedestals, shelters the front elevation. A shed-roofed dormer with a triple two-over-one wooden sash window, and a small decorative cross gable at the porch level, dominate the front slope of the roof, and a large shed-roofed dormer with three two-over-one sash windows covers most of the west (rear) slope of the roof. A small rectangular gable-roofed projecting bay, with a door in the short east elevation, is located against the south gable

Figure 3.2-15: View of 9034 Backlick Road (VDHR # 029-5695), Facing Northwest.

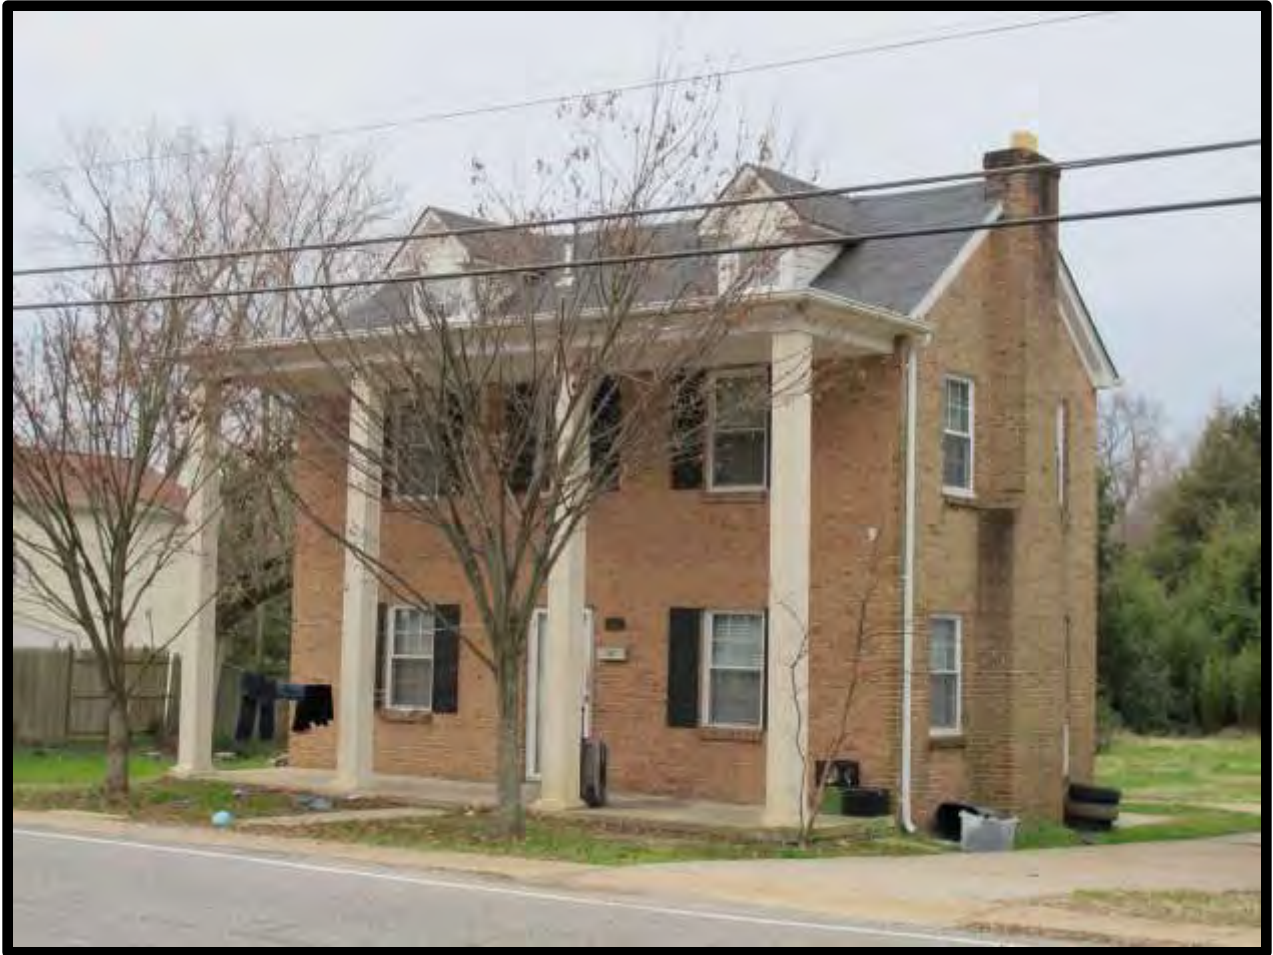
Figure 3.2-16: View of 9042 Backlick Road (VDHR # 029-5696), Facing Southwest.

DESCRIPTION: Built around 1920, according to research done by Laurie Turkawski and Laura Gumkowski, this two-and-a-half-story, three-bay, side-gabled frame dwelling is a modest example of the so-called I-houses popular across the United States during the nineteenth and early twentieth century (Turkawski and Gumkowski 2011) (Figure 3.2-16). A two-story wing extends off the west (rear) elevation of the main block giving the building a T-shaped footprint. At some point the main block and the wing were clad in stretcher-bond brick. A full-height shed-roofed porch, supported by colossal square posts, shelters the entire east (front) elevation, and two gable dormers with small four-light casement windows sit on the front slope of the roof. Six-over-six vinyl replacement windows flank the central entry door, which is also not original. Located against the north gable end is a single-shouldered brick chimney, with paved shoulders, and an exterior brick flue is located against the west gable end of the wing. A one-story frame shed section is built against the south elevation of the rear wing.

Located behind the house to the northwest stands a modern gambrel-roof garden shed clad in vertical composition board. Located to the southwest stands a second small outbuilding. It is a rectangular frame structure with a pyramidal roof; it is clad in vertical composition board and has a door in the north elevation and a four-over-four sash window in the east elevation.

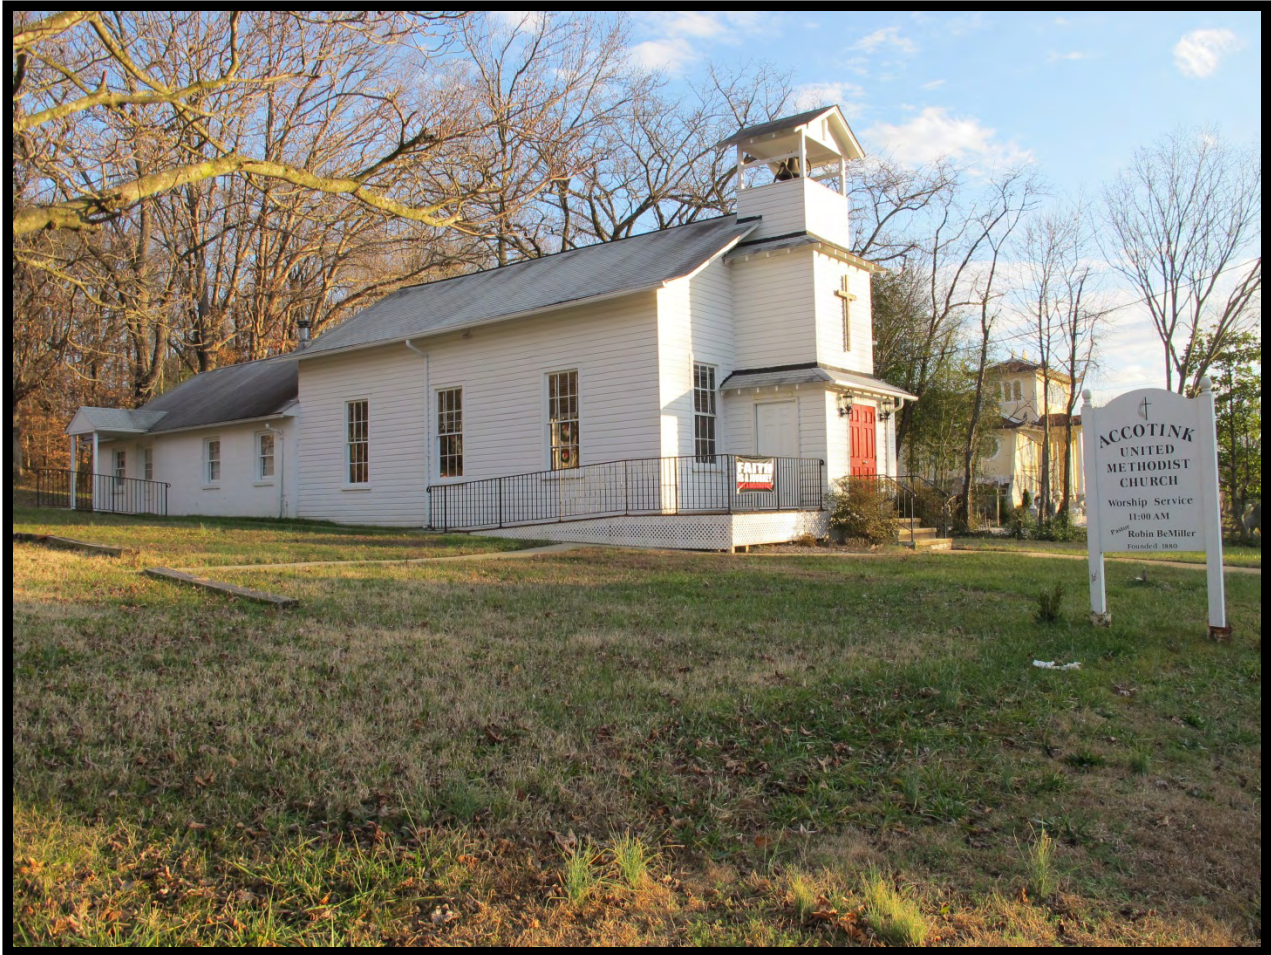
DESCRIPTION: Built around 1880, according to church records, as a Methodist Episcopal church, the current Accotink United Methodist Church is a typical example of a modest nineteenth-century rural church (Figure 3.2-17). Large six-over-six wooden-sash windows flank the three-tiered square entrance tower on the west (front) gable end of the church. The tower was not added until 1966 and rests on a concrete-block foundation (Pastor Robin BeMiller, personal communication 2012). Small pent roofs, with exposed rafter tails, separate each of the tiers. The top tier has a front-gabled roof and an exposed bell – the bell came from a schoolhouse that originally stood next to the church (Pastor Robin BeMiller, personal communication 2012). The tall, one-story, front-gabled church is clad in drop siding and sits on a continuous brick foundation. Three large six-over-six wooden-sash windows pierce the north and south elevations of the original section of the church and light the interior. In 1958, a lower, one-story, gable-roofed concrete block fellowship hall was built against the east (rear) gable end of the original church (Pastor Robin BeMiller, personal communication 2012). Doors in the north and south elevations give access to the addition, and a small gable-roofed portico supported by plain studs shelters the door on the north elevation. Seven of the windows are six-over-six wooden-sash windows, and two are vinyl replacement windows. A handicapped-

Figure 3.2-17: View of Accotink Methodist Church (VDHR # 029-5697), 9043 Backlick Road, Facing Southeast.

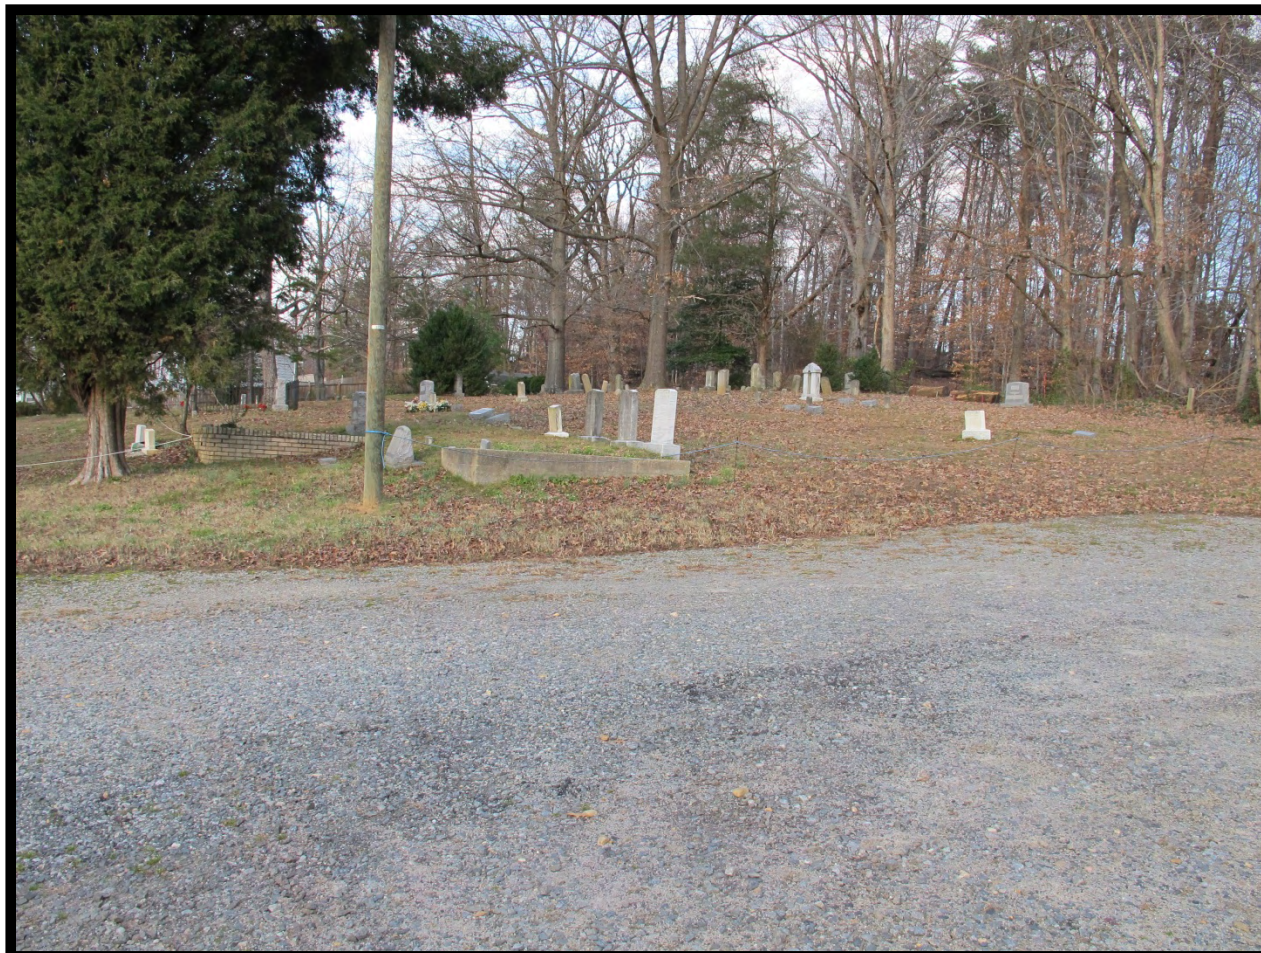
Figure 3.2-18: View of Cemetery at Accotink Methodist Church (VDHR # 029-5697), 9043 Backlick Road, Facing Northeast.

Despite the presence of such family names as Mason and Troth in the Accotink Methodist Church Cemetery there does not appear to be a clear connection between the burial population and the Mason and Troth families associated with Woodlawn Plantation (VDHR # 029-0056), Woodlawn Baptist Church (VDHR # 029-0070), or Woodlawn Friends Meeting House (VDHR # 029-0172). Paul Hillman Troth was buried in the Woodlawn Friends Meeting House Cemetery and John Mason, the owner of Woodlawn between 1853 and 1889, was buried at Woodlawn Baptist Church Cemetery, which he helped found. The cemetery is neither eligible because of its age nor for any distinctive design features and is therefore recommended as not eligible for the NRHP under Criteria Consideration D.

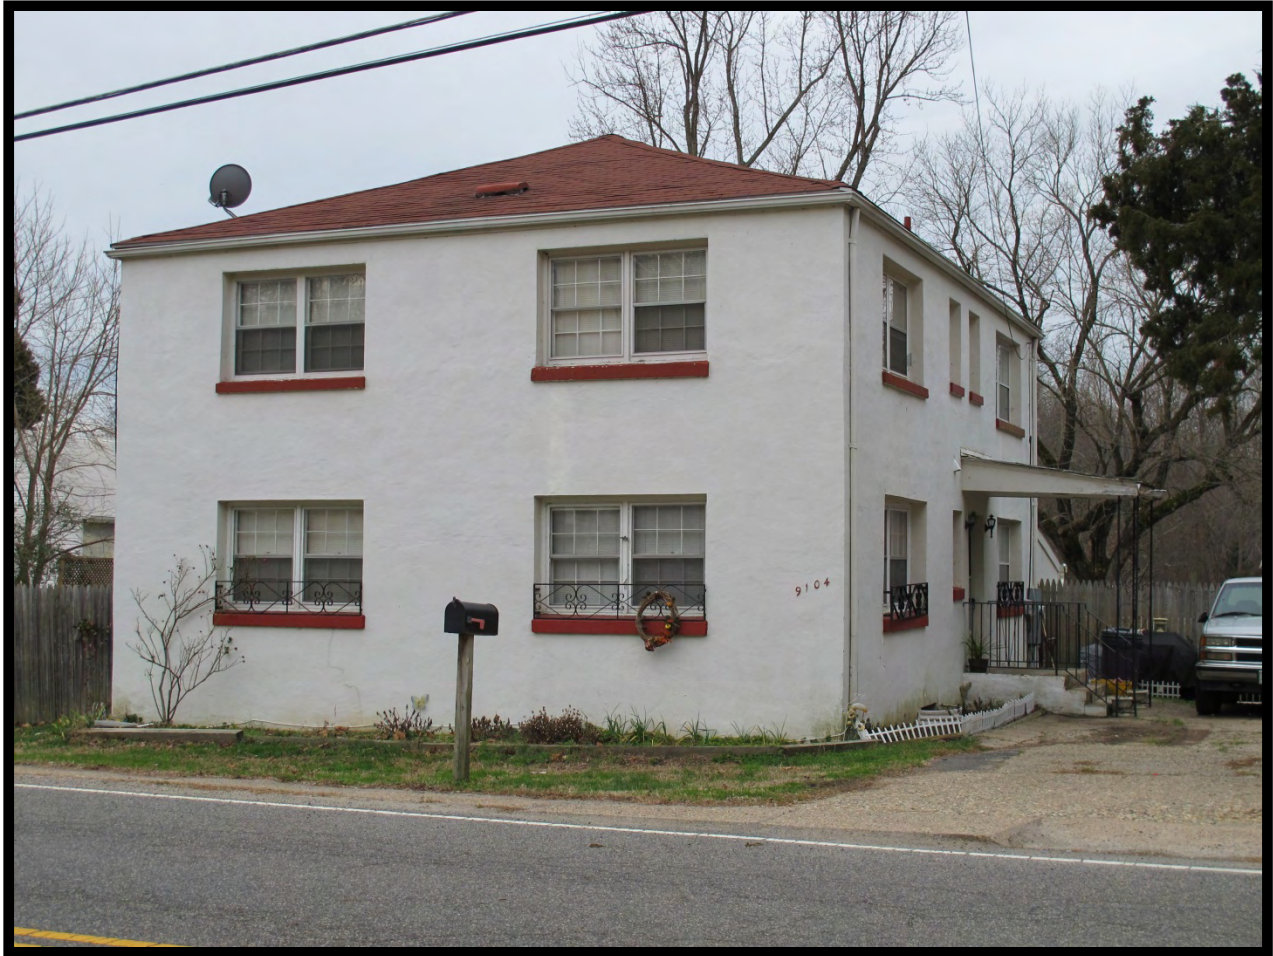
Figure 3.2-19: View of 9104 Backlick Road (VDHR # 029-5698), Facing Southwest.

DESCRIPTION: Built around 1930, according to research done by Laurie Turkawski and Laura Gumkowski, this two-story, three-bay, hip-roofed stucco dwelling sits perpendicular to Backlick Road and appears to have been built as a small apartment block (Turkawski and Gumkowski 2011) (Figure 3.2-19). Recessed double six-over-six sash windows flank the central entrance door on the north (front) elevation of the building. A simple shed roof supported by iron posts with decorative infill shelters the entrance, and concrete steps with a metal railing on either side lead up to a small stoop in front of the door. A small recessed rectangular window opening flanks the door directly to the left. The fenestration pattern on the second floor of the front elevation consists of recessed double windows flanking two small recessed rectangular window openings. Two bays of recessed double six-over-six sash windows also divide the first and second floor on the east and south elevations. A recessed leaded-glass window is located between the two windows on the second floor of the south elevation, and a door was added between the two windows on the first floor. Until recently a one-story, shed-roofed section extended off the west elevation of the building. The current owners raised two-thirds of this section to the full height of this main block and extended it west to incorporate a one-car garage. The addition is clad in aluminum siding.

Located behind the dwelling to the northwest stands a front-gabled frame outbuilding.

RECOMMENDATIONS: Overall, this resource retains a fair level of integrity. However, the addition of the door in the south elevation and the section off the west elevation have affected its integrity, and the dwelling lacks significance and represents a common design for the period of construction and place. Furthermore, the dwelling has no significant association with any event or person important to our nation's history and does not appear to have the ability to yield important information. This architectural resource is recommended as not eligible for the NRHP under Criteria A, B, C, or D.

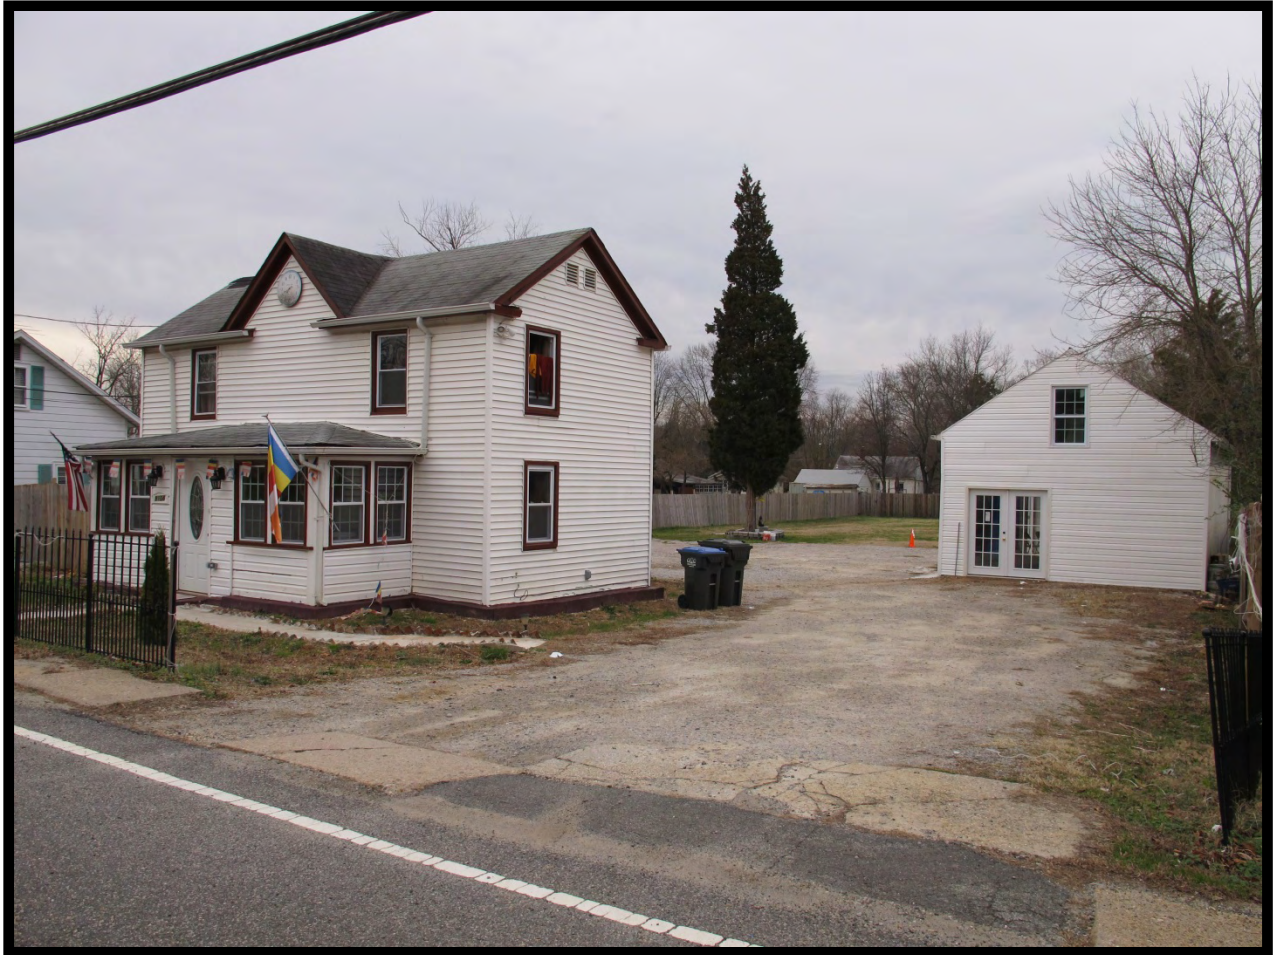
Figure 3.2-20: View of 9108 Backlick Road (VDHR # 029-5699), Facing Southwest.

RECOMMENDATIONS: Overall, this resource retains a low level of integrity. The addition of the vinyl siding and the replacement of the original windows have affected its integrity, and the dwelling lacks significance and represents a common design for the period of construction and place. Furthermore, the dwelling has no significant association with any event or person important to our nation's history and does not appear to have the ability to yield important information. This architectural resource is recommended as not eligible for the NRHP under Criteria A, B, C, or D.

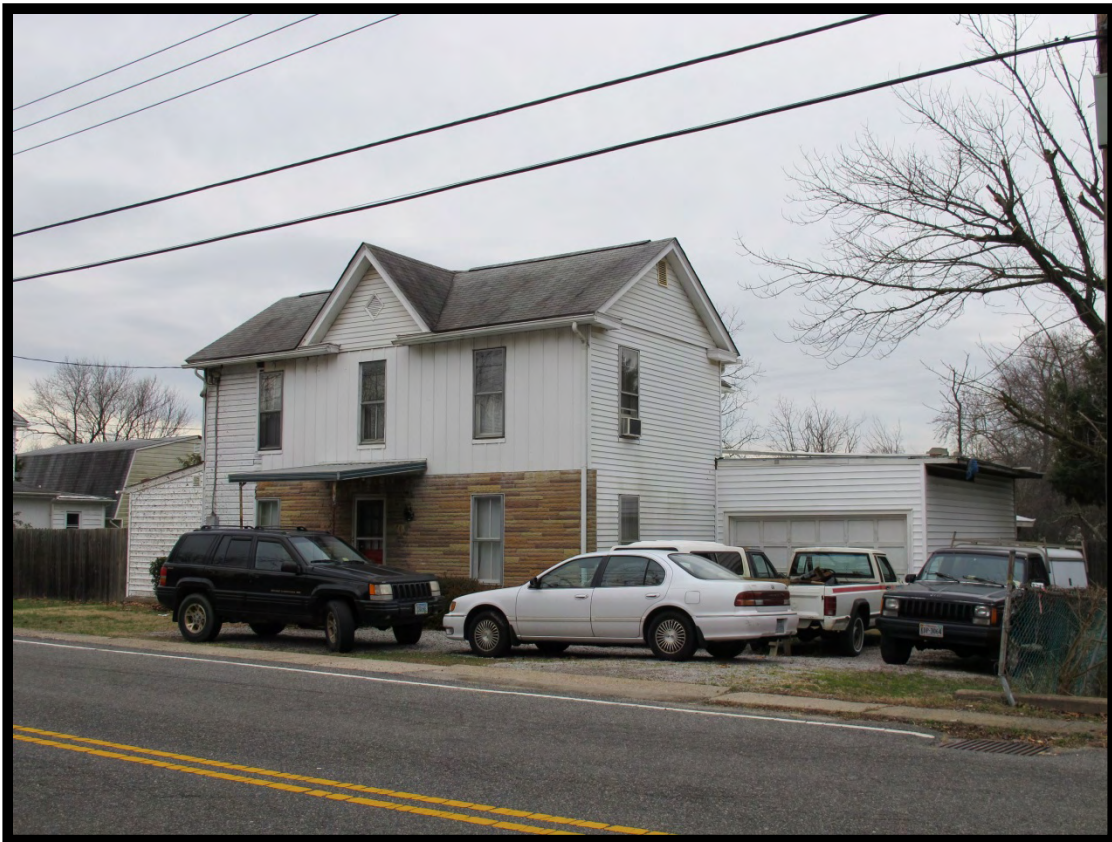
Figure 3.2-22: View of 9120 Backlick Road (VDHR # 029-5701), Facing Southwest.

DESCRIPTION: Built around 1904, according to research done by Laurie Turkawski and Laura Gumkowski, this two-story, three-bay, side-gabled frame dwelling is a typical example of the so-called I-house (Turkawski and Gumkowski 2011) (Figure 3.2-22). Elongated two-over-two sash windows flank the central entrance door on the east (front) elevation of the building. A modern shed-roofed porch supported by metal poles shelters the door, and a decorative cross gable with a

small diamond-set louvered opening terminates the front elevation. A two-story wing extends off the west (rear) elevation of the main block giving the building a T-shaped footprint. A brick flue is located against the west gable end of the wing. A two-story shed addition was constructed against the south elevation of the rear wing. A one-story shed addition extends off the west gable end of the wing, and one was built against the south elevation of the two-story shed addition. The latter extends across the south gable end of the main block. At some point the owners built a large shed-roofed two-car garage against the north elevation of the rear wing, which extends well beyond the north gable end of the main block and is accessed from the east side. The building was originally covered in drop siding, which was subsequently covered with three other materials on different sections of the building: Perma-Stone on the first floor of the front elevation; aluminum board-and-batten siding on the second floor of the front elevation; and regular vinyl siding in the gable peak on the front elevation and on the remaining elevations of the building. The original siding is visible on a section of the front elevation, where the later siding materials have been removed.

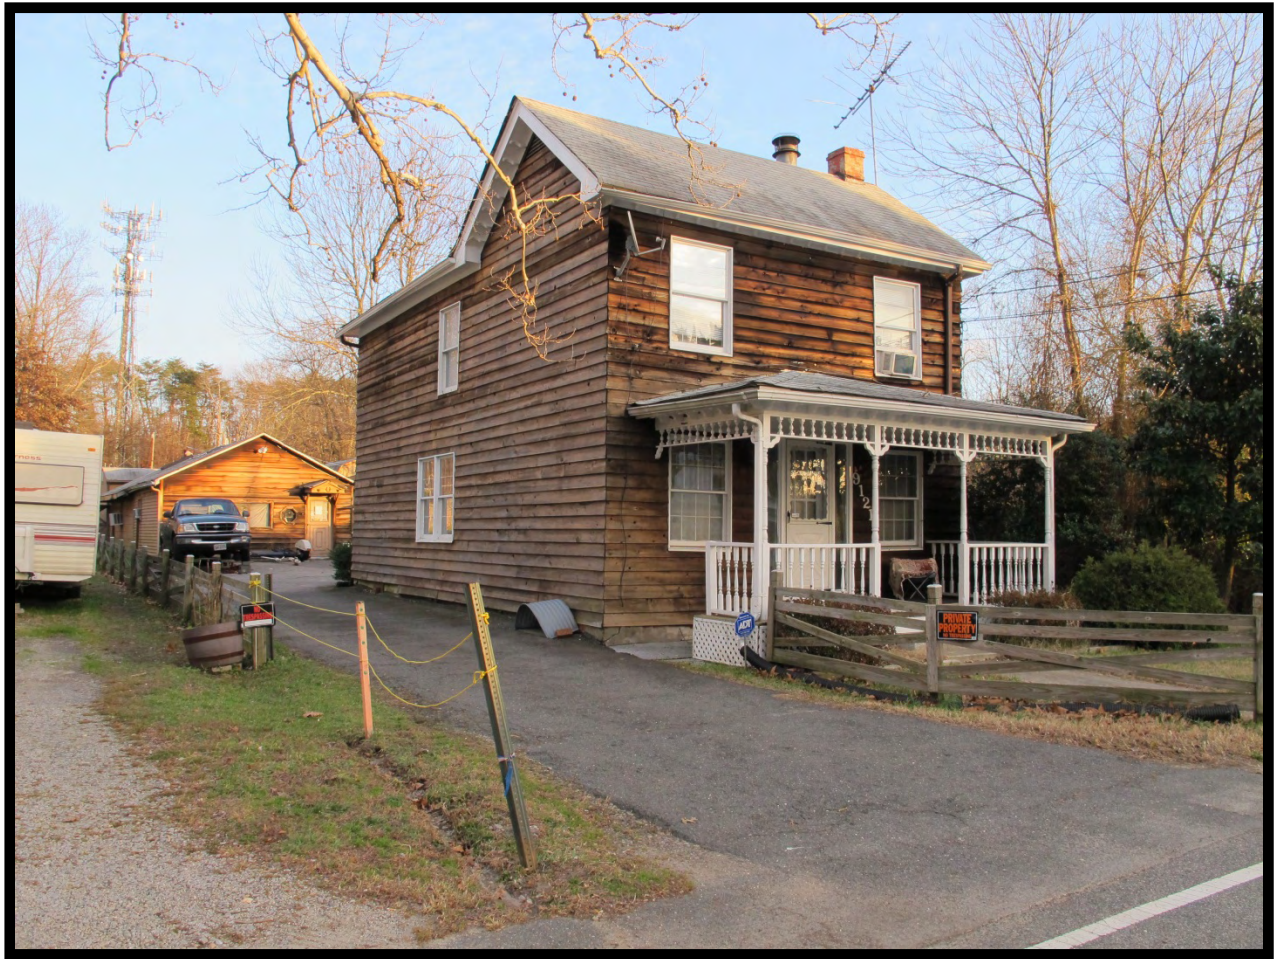
DESCRIPTION: Built around 1878, according to research done by Laurie Turkawski and Laura Gumkowski, this two-story, three-bay, side-gabled frame dwelling appears to be the oldest surviving structure in the village of Accotink (Turkawski and Gumkowski 2011) (Figure 3.2-23). Large, eight-over-eight sash replacement windows flank the central entry door on the west

Figure 3.2-23: View of 9121 Backlick Road (VDHR # 029-5702), Facing Southeast.

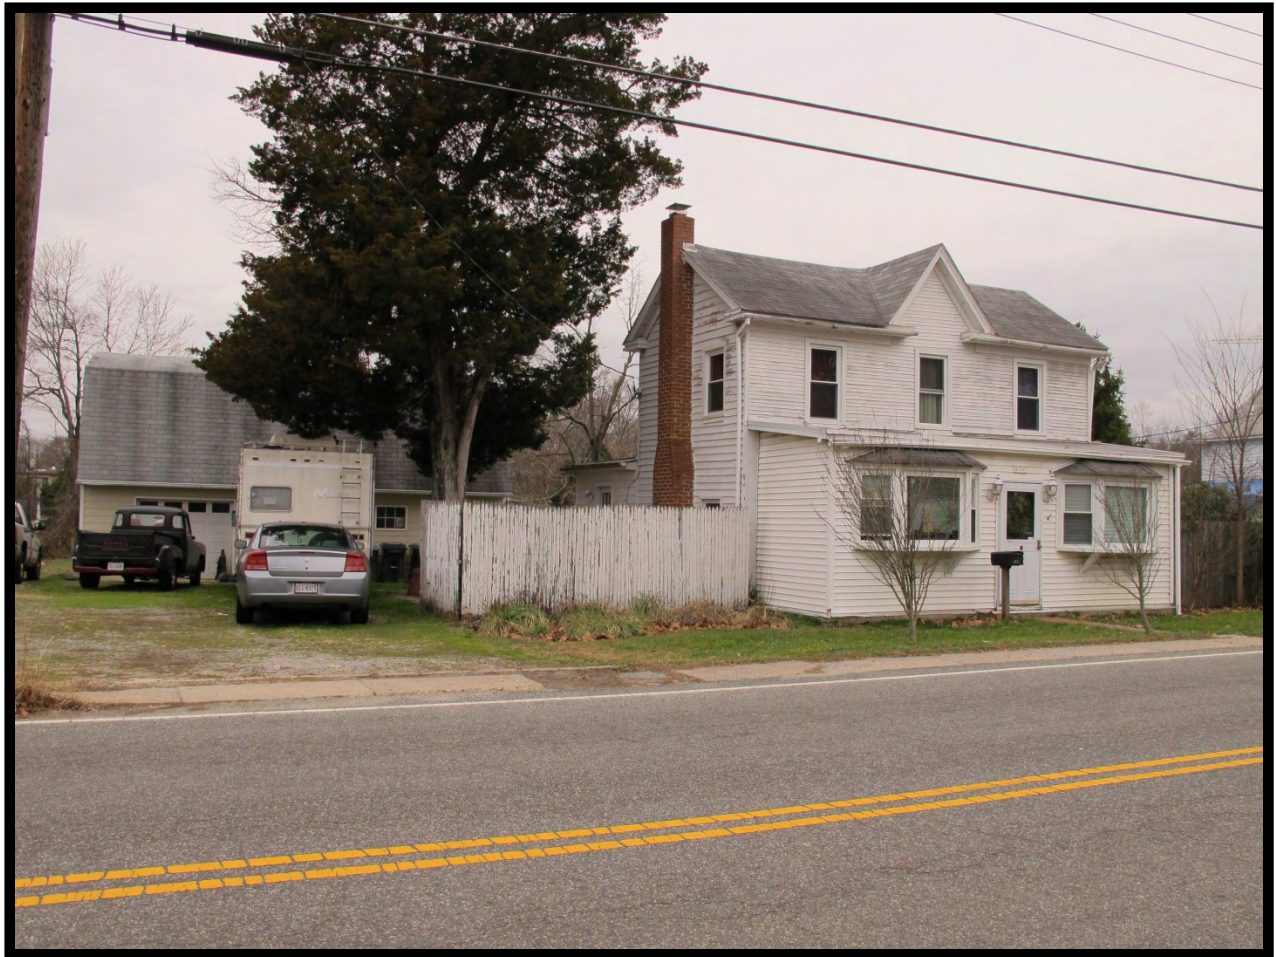
DESCRIPTION: Built around 1902, according to research done by Laurie Turkawski and Laura Gumkowski, this two-story, side-gabled frame dwelling was originally a typical example of the so-called I-house, similar to the nearby VDHR # 029-5701 (Turkawski and Gumkowski 2011) (Figure 3.2-24). However, the house was remodeled in 1925 and again in 1990, affecting its original appearance and integrity (Turkawski and Gumkowski 2011). An enclosed shed-roofed porch covers much of the first floor on the east (front) elevation of the dwelling, and the elevation terminates in a decorative cross gable. The enclosed porch is clad in vinyl siding with bay windows flanking the central entrance door. A one-story, hip-roofed section runs along the west (rear) elevation of the main block, and a one-story, shed-roofed addition extends off the north gable end. A single-shouldered brick chimney/flue is located against the south gable end

Figure 3.2-24: View of 9124 Backlick Road (VDHR # 029-5703), Facing Northwest.

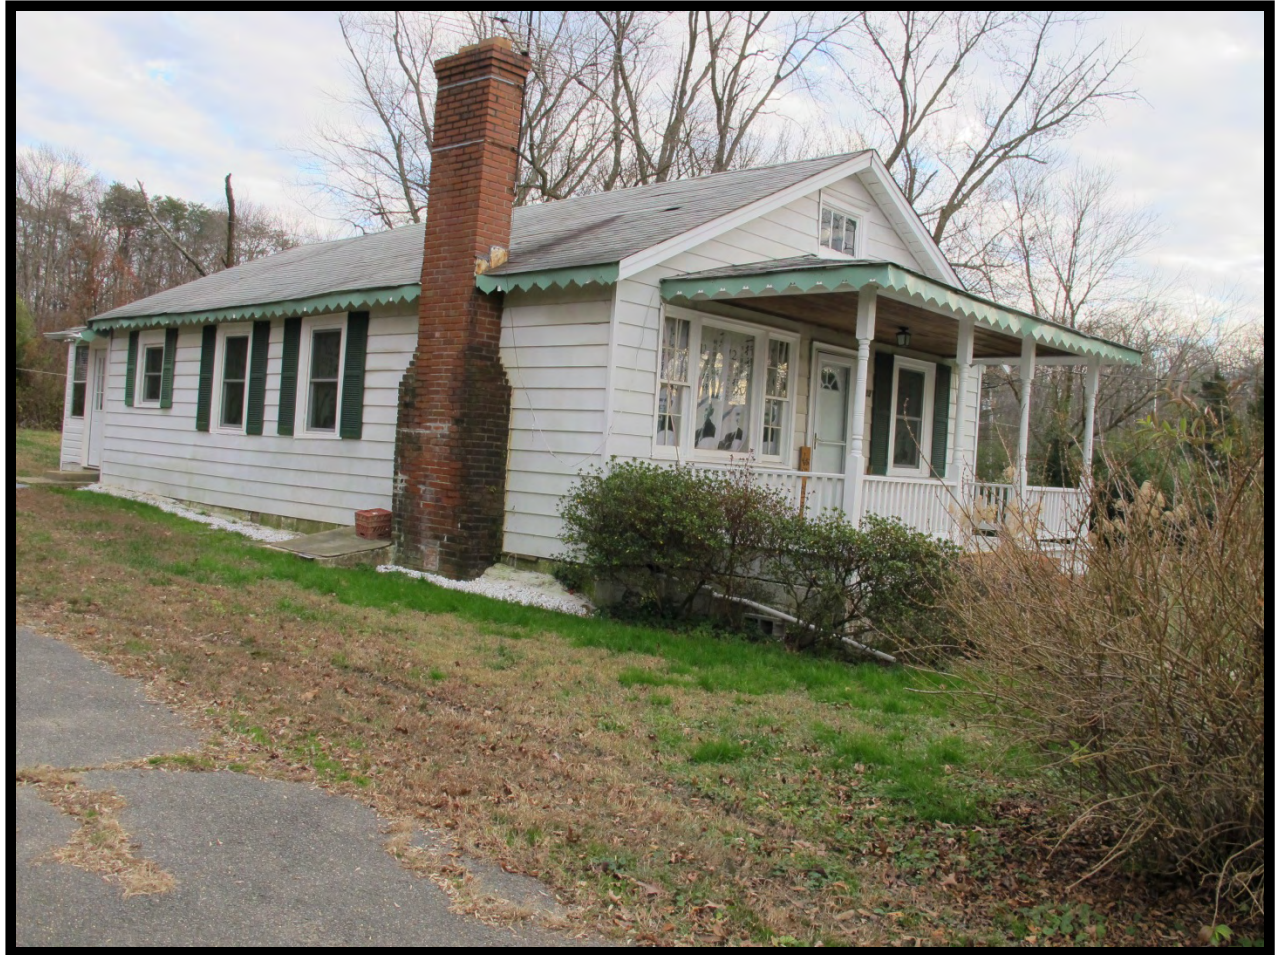
DESCRIPTION: Built around 1930, according to research done by Laurie Turkawski and Laura Gumkowski, this one-story, three-bay, front-gabled frame dwelling shares similarities with the modest Craftsman bungalows on Anderson Lane (VDHR #s 029-5686 through 029-5689) (Turkawski and Gumkowski 2011) (Figure 3.2-25). A Chicago-style picture window, with narrow four-over-four sash windows flanking a large rectangular fixed window, flanks the central entry door on the west (front) gable end of the dwelling to the left, and a one-over-one vinyl-sash replacement window flanks it to the right. A hip-roofed porch supported by turned posts shelters the three bays on the front gable end. The north and south elevations are four bays wide, and an exterior single-shouldered chimney is located on the north elevation in the bay closest to the front gable end. The main block is clad in vinyl siding and sits on a concrete block foundation, and all of the windows, with the exception of the picture window, are vinyl replacement windows with non-functional shutters. A small enclosed, hip-roofed porch is located against the east (rear) gable end. The porch is clad in wooden drop siding.

Figure 3.2-25: View of 9123 Shepherd Lane (VDHR # 029-5704), Facing Southeast.

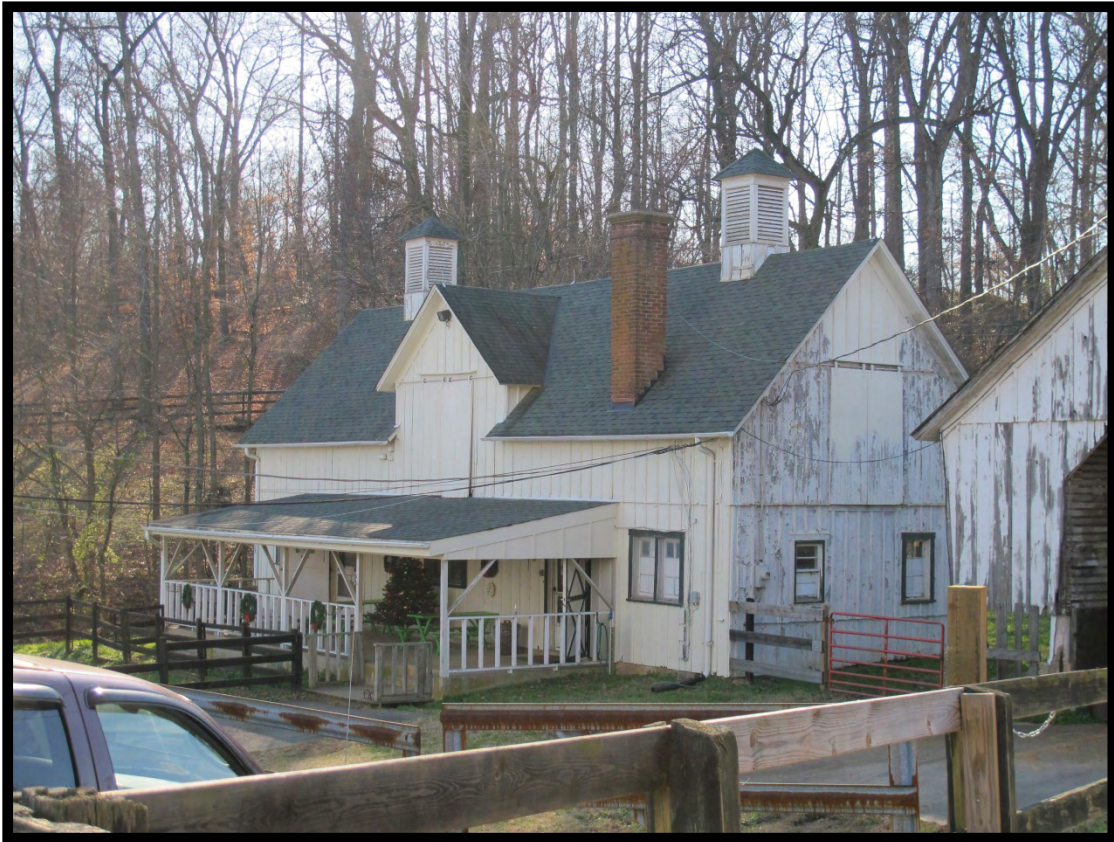
Figure 4.2-1: View of Dairy at the Sharpe Stable Complex (VDHR # 029-5181-0005), Facing Southwest.

sliding double door is located at the attic level in the north gable end, giving access to the former hayloft. Two small square cupolas with louvered openings sit on the ridge of the roof and flank the dormer on either side, and a square brick chimney pierces the front slope of the roof to the right of the dormer. The windows on the front elevation are paired, or double six-light casement windows with simple surrounds and flank the two entry doors. Some of the other windows are single six-light casement windows, some of which have been replaced with horizontal two-over-two sash windows. At some point the lower floor of the dairy was converted into office spaces.

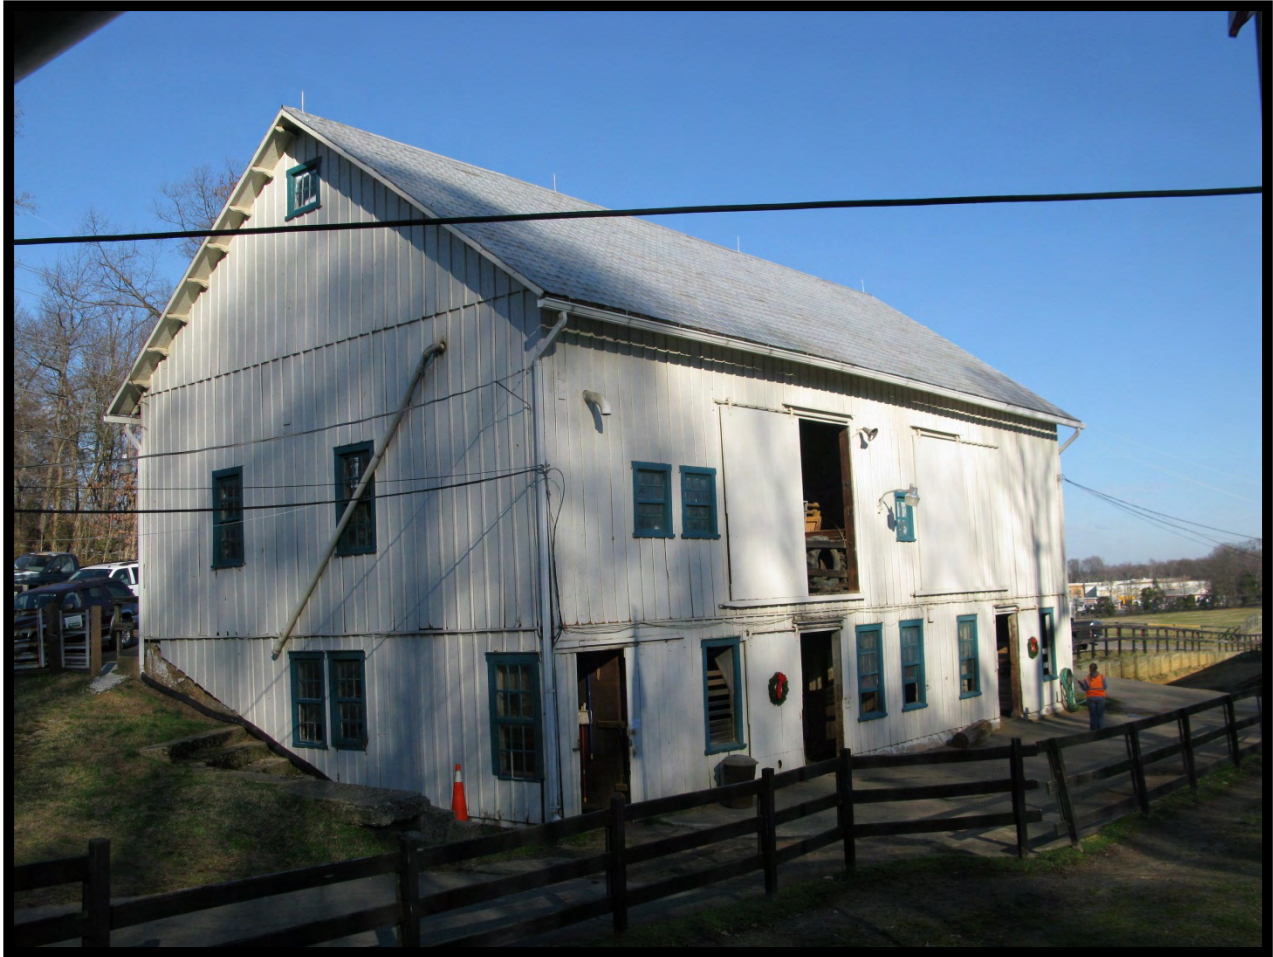
Figure 4.2-3: View of Bank Barn at the Sharpe Stable Complex (VDHR # 029-5181-0005), Facing Northeast.

Located east of the corncrib stands a large bank barn (see Figure 4.2-3). Similar to the dairy and the corncrib, it is clad in board-and-batten siding. The barn has a poured-concrete foundation, which rises up to the upper floor on the north side and is partially exposed near the northeast corner. A ramp on the north side gives access to the upper floor of the bank barn. Three large bents with angled posts divide the upper floor into four bays. The two central bays could have been used for threshing, or to store large farm equipment, and have sliding doors at either end. The far eastern bay is used as a haymow and the far western bay held a granary (Figure 4.2-4). Eight bays divide the lower floor on the south side of the bank barn. Three sliding doors give access to the different stable areas on the lower floor. The windows are six-over-six sash windows with plain surrounds similar to those on the dairy.

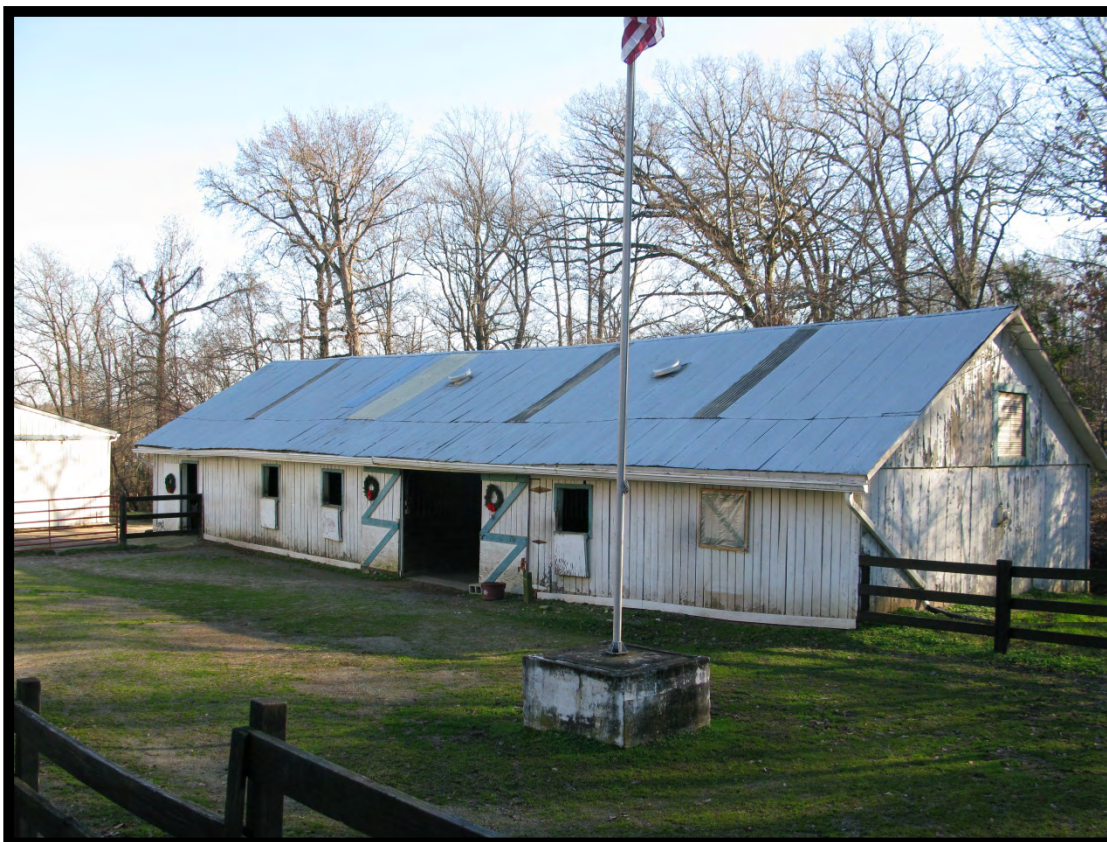
Figure 4.2-5: View of Stable at the Sharpe Stable Complex (VDHR # 029-5181-0005), Facing Southeast.

Located to the south of the bank barn is one of two stables (Figure 4.2-5). The first is a one-story, side-gabled, frame stable built around 1970 and is clad in simple vertical boards with

board-and-batten siding on the east gable end and a corrugated metal roof. Two doors and a double sliding door on the north (front) elevation give access to the interior, and four square window openings, with shutters hinged at the bottom, allow for light and air to enter. The second, larger, one-story, side-gabled frame stable is located to the east of the first stable and was built around 1955 (Figure 4.2-6). It is clad in board-and-batten siding with a corrugated metal roof. A shed-roofed porch with a 5V crimp-metal roof, and supported by plain posts shelters the entire north (front) elevation of the stable. Attached to the east gable end of the stable is a one-story, gable-roofed indoor riding ring, which was built in 1997 and replaces an earlier indoor riding ring (see figure 4.2-6).

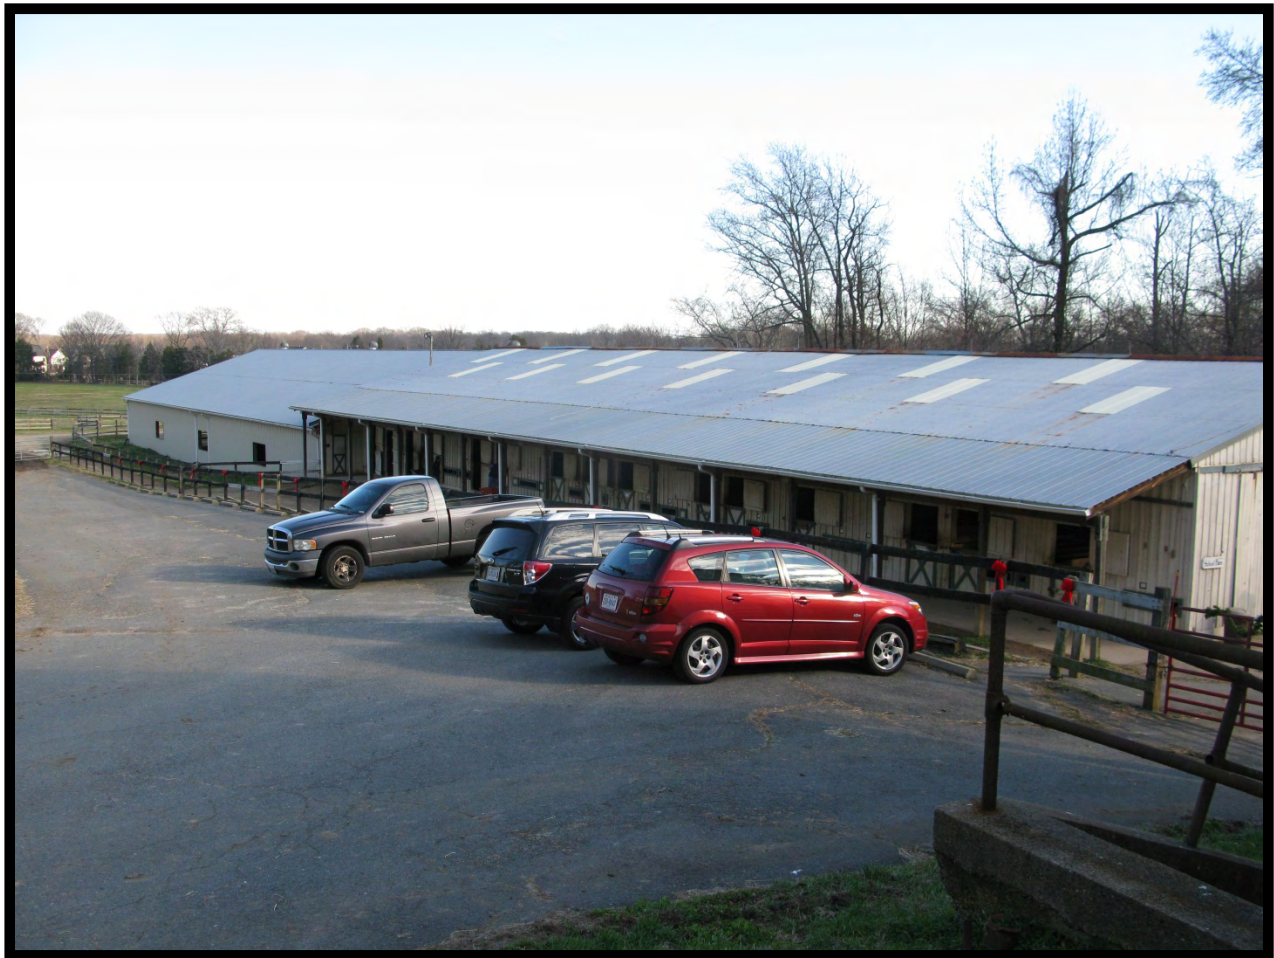
Figure 4.2-6: View of Stable and Indoor Riding Ring at the Sharpe Stable Complex (VDHR # 029-5181-0005), Facing Southeast.

RECOMMENDATIONS: Only four of the six structures are historic. The three oldest structures retain a fair to high level of integrity. Of the three, the dairy has been most extensively altered, but still retains most of its overall exterior appearance. The dairy is therefore not recommended as individually eligible for the NRHP under Criteria A, B, C, or D, but is recommended as a contributing resource to the Woodlawn Historic District (VDHR # 029-5181). The corncrib retains a higher level of integrity, but also has been slightly altered and is therefore also not recommended as individually eligible for the NRHP under Criteria A, B, C, or D, but is recommended as a contributing resource to the Woodlawn Historic District. The bank barn retains the highest level of integrity and is a rare example of a bank barn in Fairfax County. Out of the 48 properties recorded in DSS in Fairfax County that mention a barn, only two list a bank barn (VDHR # 029-5262 and 029-5518) both of which postdate the bank barn at the Sharpe Stable Complex. The bank barn is recommended as potentially eligible for individual listing in the NRHP under Criterion C as an excellent example of an early twentieth-century agricultural building that retains a high level of architectural integrity, and is also recommended as a contributing resource to the Woodlawn Historic District. The ca. 1955 stable lacks significance and represents a common design for the period of construction and place; it furthermore has no significant association with any event or person important to our nation's history and does not appear to have the ability to yield important information. This architectural resource is recommended as not eligible for the NRHP under Criteria A, B, C, or D, but is recommended as a contributing resource to the Woodlawn Historic District. The other stable and indoor riding ring are less than fifty years old, represent a common design, and do not warrant Criteria
