**ARCHITECTURAL SURVEY
OF PROPOSED AREA OF POTENTIAL EFFECTS
ROUTE 1 IMPROVEMENTS AT FORT BELVOIR
(TELEGRAPH ROAD TO MOUNT VERNON MEMORIAL
HIGHWAY), FAIRFAX COUNTY, VIRGINIA**

VDHR File # 2001-007

DRAFT January 2012

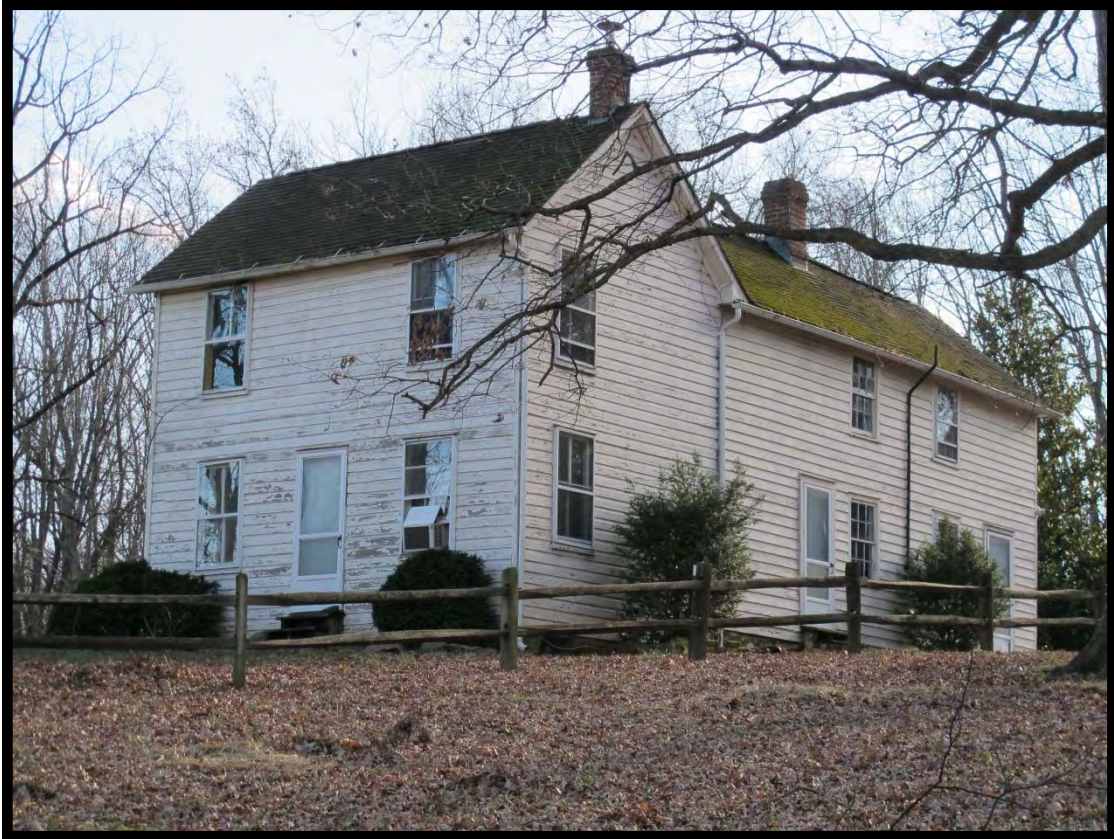
Figure 4.2-7: View of the Otis T. Mason House (VDHR # 029-5181-0006), Facing Southeast.

DESCRIPTION: The Otis T. Mason House is a two-story, three-bay, side-gabled frame dwelling with a two-story wing off the southwest (rear) elevation, giving the building an L-shaped footprint (Figure 4.2-7). Building evidence suggests the house was built in two stages, the oldest of which dates back to ca. 1865. The house currently faces northeast, and two-over-two sash windows flank the central paneled door on the northeast (front) elevation of the newer front section. The front section is clad in drop siding and rests on brick piers and a continuous brick foundation wall along the front elevation. An interior brick chimney with a corbelled top is located against the northwest gable end, and the roof is covered with cedar shingles. The rear wing is clad in plain weatherboard and rests on a fieldstone foundation. A central brick chimney, with a corbeled top, pierces the ridge of the cedar shingle clad roof of the wing, and the windows are six-over-six sash. Four bays divide the northwest elevation of the wing with two paneled doors giving access to the two rooms on the first floor of the wing. Five bays divide the southeast elevation of the wing, having a door-window-window-door-window configuration. A one-story, shed-roofed porch supported by chamfered posts shelters the length of the southeast elevation of the wing.

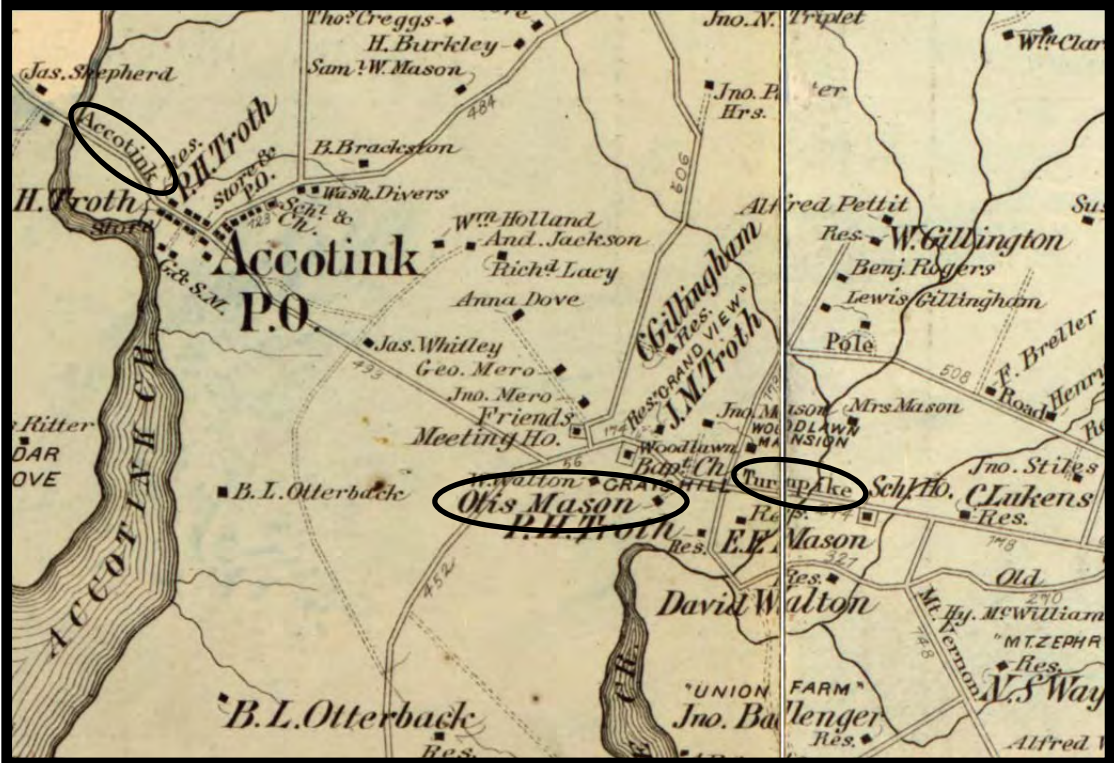
Figure 4.2-8: Detail of 1879 "Mt. Vernon Dist. No. 3" Map from *Atlas of fifteen miles around Washington, including the county of Montgomery, Maryland* (Hopkins 1879), Showing Location of the Otis T. Mason House and the Accotink Turnpike.

An 1879 map of the “Mt. Vernon Dist. No. 3” from G. M. Hopkins’ *Atlas of fifteen miles around Washington, including the county of Montgomery, Maryland*, includes the area around Woodlawn and identifies the property as that of Otis Mason (Hopkins 1879) (Figure 4.2-8). Otis Tufton Mason was born in Eastlake, Maine in 1838. His family moved to Virginia in 1849 and purchased Woodlawn in 1853 from Jacob Troth (Tuminaro 1998; Trinkley 2000). The Mason family was significant in the history of Woodlawn, along with the Quakers, for contributing to the intellectual and religious character of the surrounding community through philanthropic acts and service, and leadership in the community (Tuminaro 1998:22-23). Otis Mason moved to the property shortly thereafter to join his family. He attended Columbian College, which later became George Washington University, from 1856 to 1861. After graduating he became the

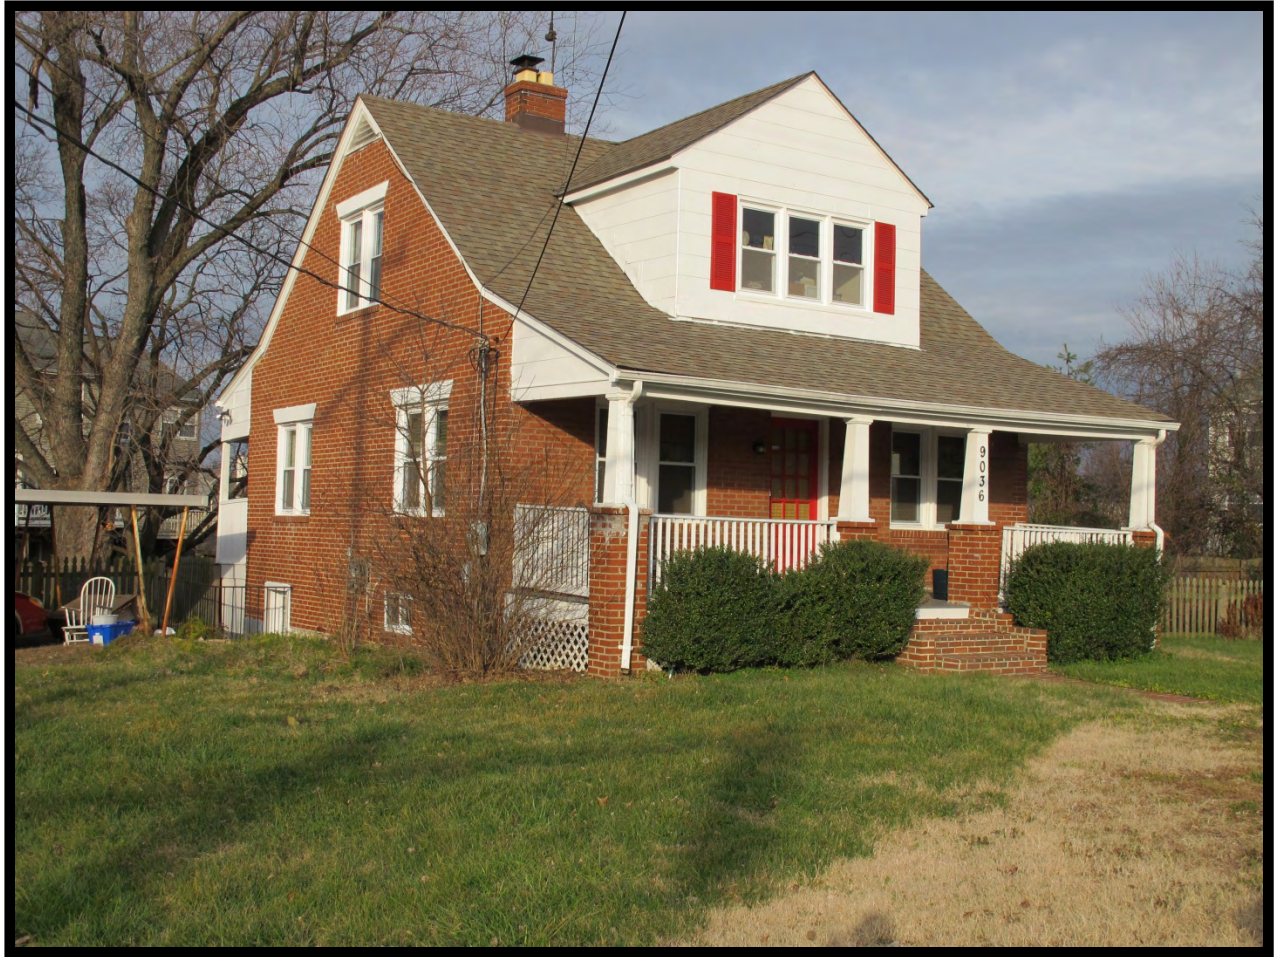
Figure 4.2-9: View of 9036 Telegraph Road (VDHR # 029-5680), Facing Northwest.

DESCRIPTION: Built around 1935, this one-and-a-half-story, three-bay, side-gabled brick dwelling is a typical example of a modest Craftsman bungalow (Figure 4.2-9). Paired, or double, one-over-one sash replacement windows flank the glazed central entry door on the east (front) elevation of the dwelling. An integral porch, supported by battered box pillars on brick pedestals shelters, the front elevation, and a large gable dormer with a triple window dominates the front

slope of the roof, all elements typical of the Craftsman style. The brick is laid in a stretcher bond suggesting it is only a veneer, and an unusual detail are the plain flat arches over the windows in the gable ends. A small integral porch runs along the west (rear) elevation of the dwelling, and terminates in pantry or bathroom at the north end. A smaller gable dormer with a paired, or double window sits on the west (rear) slope of the roof and is flanked to the right by a brick chimney that pierces the roof behind the ridge.

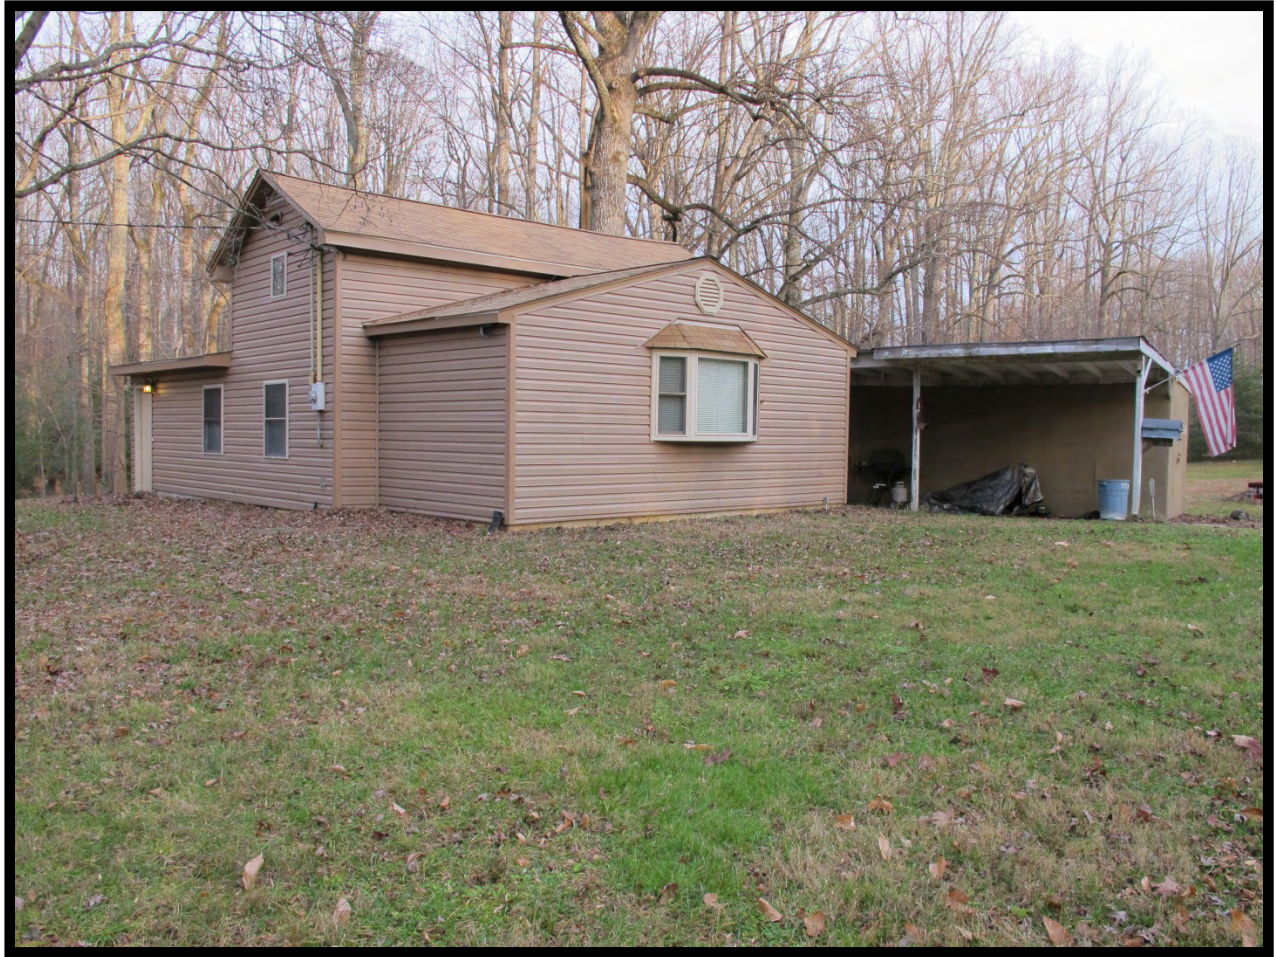
Figure 4.2-10: View of 9300 Old Colchester Road (VDHR # 029-5681), Facing Northwest.

DESCRIPTION: Originally built around 1900, according to local tax records, this dwelling has been substantially altered (Figure 4.2-10). Originally, it was probably a small one-story, or one-and-a-half story, side-gabled frame dwelling with a one-story wing off the west (rear) elevation. At some point the owners added a one-story front-gabled section to the east (front) elevation of the house covering most of the elevation, or they enclosed and enlarged an existing porch. They also expanded the rear wing, adding a shed section to the south elevation of the wing, making it as wide as the original front of the dwelling. Perhaps at the same time they also extended the wing to the rear with a slightly lower gable-roofed section. The rear section sits on a full concrete block basement, which was stuccoed. The entire dwelling is clad in vinyl drop siding and has vinyl sash replacement windows and an asphalt shingle roof.

Located to the southwest of the dwelling stands a small gable-roofed concrete block well or pump house, with an asphalt shingle roof, and to the northeast stands a modern carport/garage with a flat roof.

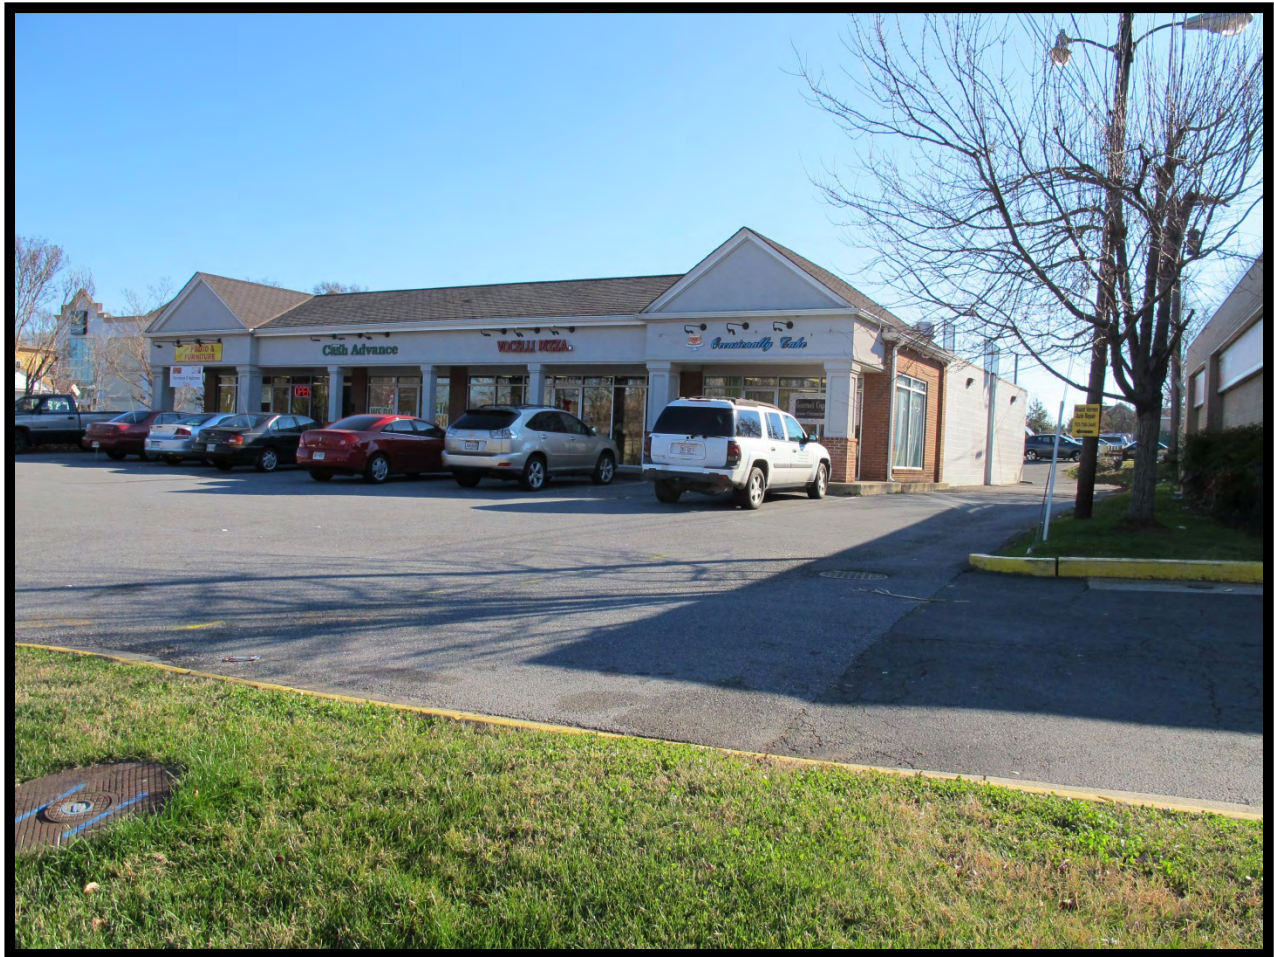
Figure 4.2-11: View of 8853-59 Richmond Highway (VDHR # 029-5705), Facing Southeast.

DESCRIPTION: Built around 1960, according to tax records, this one-story, concrete block commercial building with brick veneer on the northwest (front) elevation contains four stores (Figure 4.2-11). A covered sidewalk runs in front of the stores and terminates in projecting front-gabled bays. Square pillars on brick pedestals support the overhang. The stores have floor to ceiling shop windows. The front third of the building is clad in brick veneer and has a hipped roof, whereas the remaining part of the building consists of whitewashed concrete block and has a flat roof. The unit for the store at # 8853 projects several feet farther than the other three stores giving the rear section of the building an L-shaped footprint.

RECOMMENDATIONS: Overall, this resource retains a fair level of integrity. However, the building also lacks significance and represents a common design for the period of construction and place. Furthermore, the building has no significant association with any event or person important to our nation's history and does not appear to have the ability to yield important information. This architectural resource is recommended as not eligible for the NRHP under Criteria A, B, C, or D.

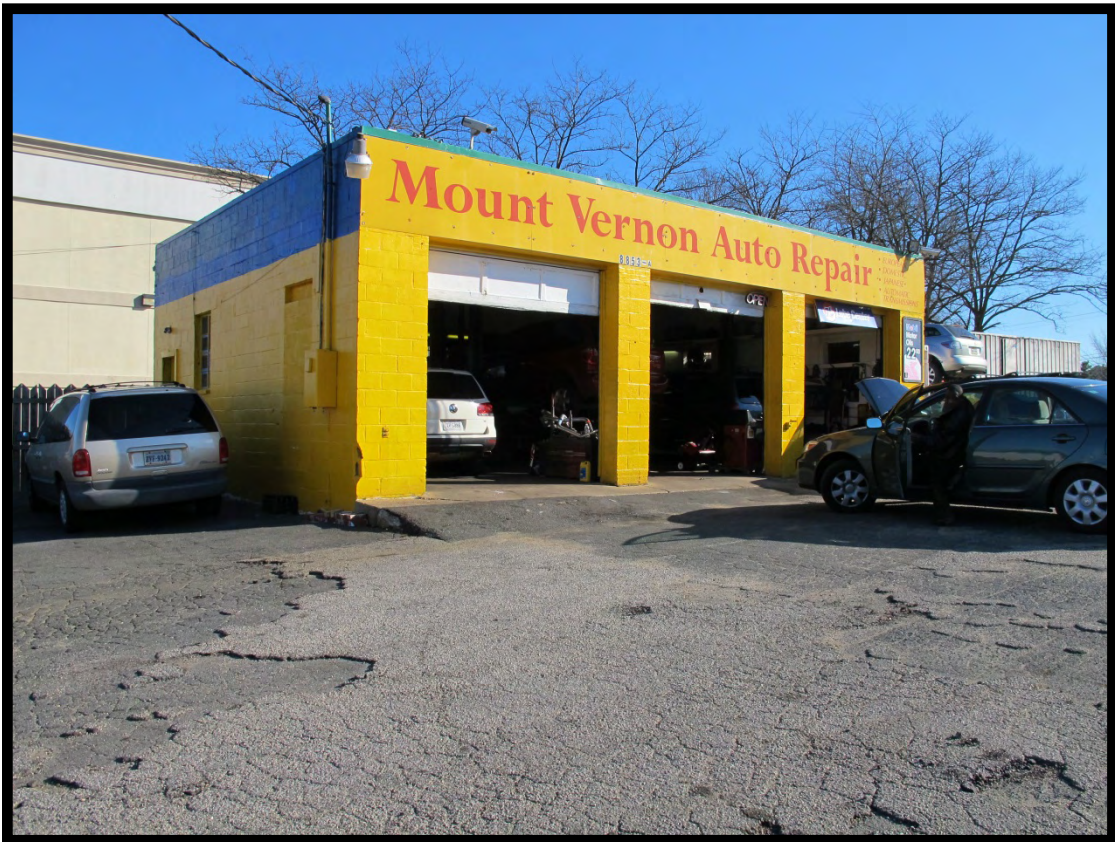
Figure 4.2-12: View of 8853 A Richmond Highway (VDHR # 029-5706), Facing East.

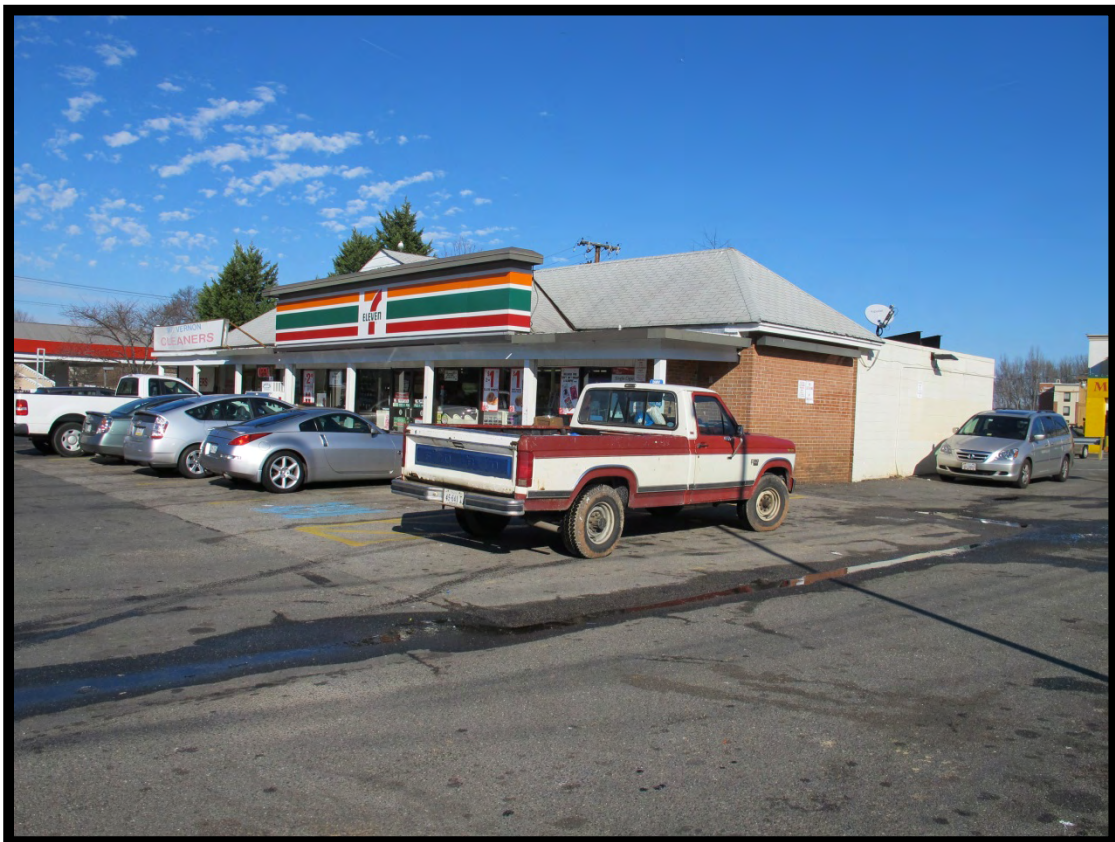
DESCRIPTION: Built around 1961, according to tax records, this one-story, concrete block commercial building with brick veneer on the southwest (front) elevation contains a drycleaner and a 7-Eleven (Figure 4.2-13). A covered sidewalk, sheltered by a flat roof supported on plain square posts, runs in front of the stores. The front third of the building is clad in brick veneer and has a hipped-roof, whereas the remaining part of the building consists of whitewashed concrete block and has a flat roof. The 7-Eleven takes up approximately two-thirds of the building and projects slightly farther forward than the drycleaner and has a large decorative cross-gable on the front slope of the roof, which is currently obscured by the store sign. The drycleaner projects farther backwards and partially wraps around the 7-Eleven store at the back.

Figure 4.2-13: View of 5638-40 Mount Vernon Memorial Highway (VDHR # 029-5707), Facing Northeast.

RECOMMENDATIONS: Overall, this resource retains a fair level of integrity. However, the building also lacks significance and represents a common design for the period of construction and place. Furthermore, the building has no significant association with any event or person important to our nation's history and does not appear to have the ability to yield important information. This architectural resource is recommended as not eligible for the NRHP under Criteria A, B, C, or D.

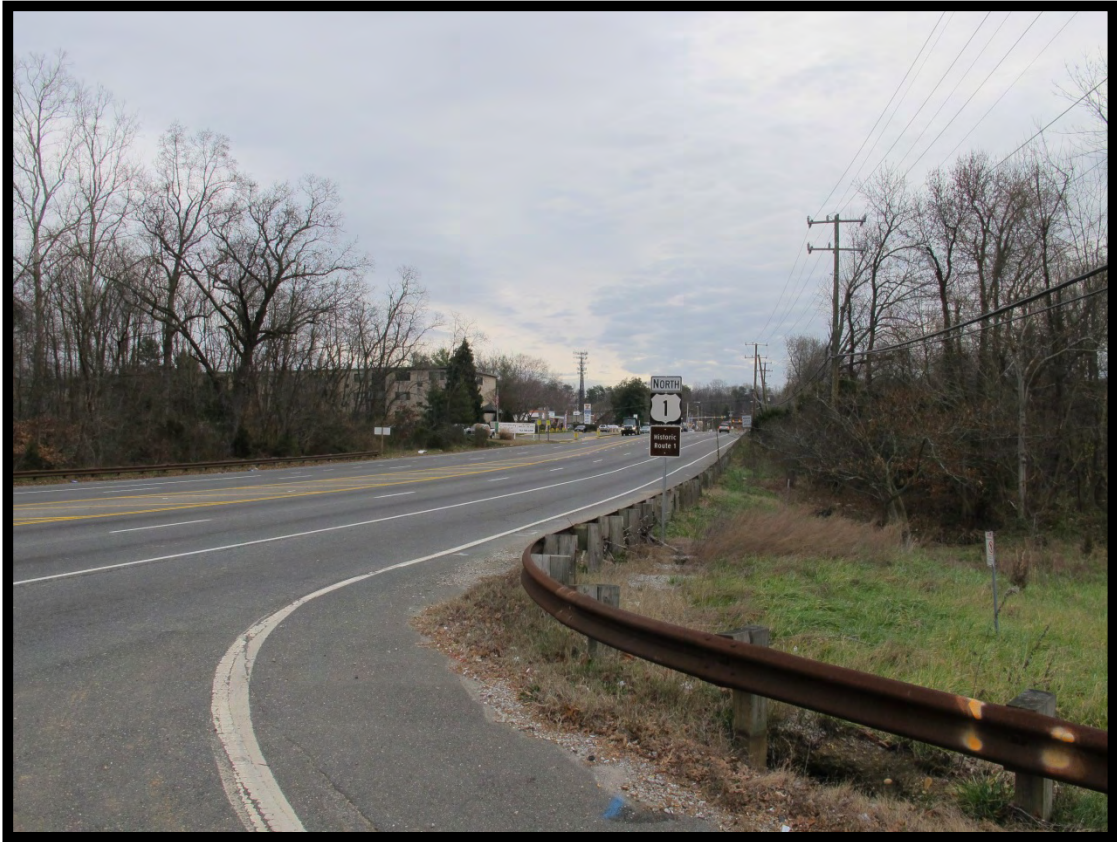
DESCRIPTION: The approximately 2.0-mile, four-lane, undivided stretch of Route 1 between the bridge over Dogue Creek in the east and the Fairfax County Parkway (SR 7100) in the west follows part of the original route between Colchester and Alexandria, parts of which were known at times as the Potomac Path, the King's Highway, Old Colchester Road, and Telegraph Road. Following the corridor of earlier Indian trails, the Potomac Path crossed the Occoquan at Colchester and followed the current Old Colchester Road (SR 611) towards Pohick Creek and Pohick Church (Figures 4.2-14 through 4.2-19). Just south of Pohick Church, less than a mile after it crossed Pohick Creek, there was a fork in the road and it split into "back road" and "river road" or "county road" (Mitchell and Sweig 1987:81-82). The "back road" followed a more inland route north – part of what later became known as Telegraph Road (SR 611). The "river road" headed east towards Accotink Creek and Accotink Village, and meandered across land now part of Fort Belvoir. Just west of Accotink Village (near the current Fairfax County Parkway (SR7100)) the "river road" straightened out heading towards Woodlawn (VDHR # 029-0056). On September 12, 1781, George Washington and the French General Jean-Baptiste Donatien de Vimeur, comte de Rochambeau, left Mount Vernon on their way south to face the British troops at Yorktown. They proceeded towards the northwest towards Washington's gristmill (VDHR # 029-0330), after which they followed the "river road" towards Colchester (Virginia Washington - Rochambeau Route (September 1781) 2011). On G. M. Hopkins' 1879 map of the "Mt. Vernon Dist. No. 3" the section of road between Accotink and Woodlawn is identified as the Accotink Turnpike, and continues towards Gum Springs and Great Hunting

Figure 4.2-14: View of Route 1, (Old) River Road (VDHR # 029-5708), Towards Accotink, Facing East.

RECOMMENDATIONS: This section of the “river road,” or Accotink Turnpike in the current architectural APE, is a historically important roadway, and the old corridor can be identified with the help of historic maps. However, the various changes to the road during the twentieth century have affected its integrity. The road was sparsely developed until well into the first quarter of the twentieth century and certain stretches still retain a wooded and rural appearance; however, increasing development of the surrounding areas and improvements to the road itself have diminished its design, feeling, materials, and setting. Despite its significance with respect to the association with Washington and Rochambeau’s march, it lacks sufficient integrity to convey that significance. This section of the historic roadway would therefore not contribute to any NRHP eligibility that may be found for parts of the (Old) River Road outside the current APE.

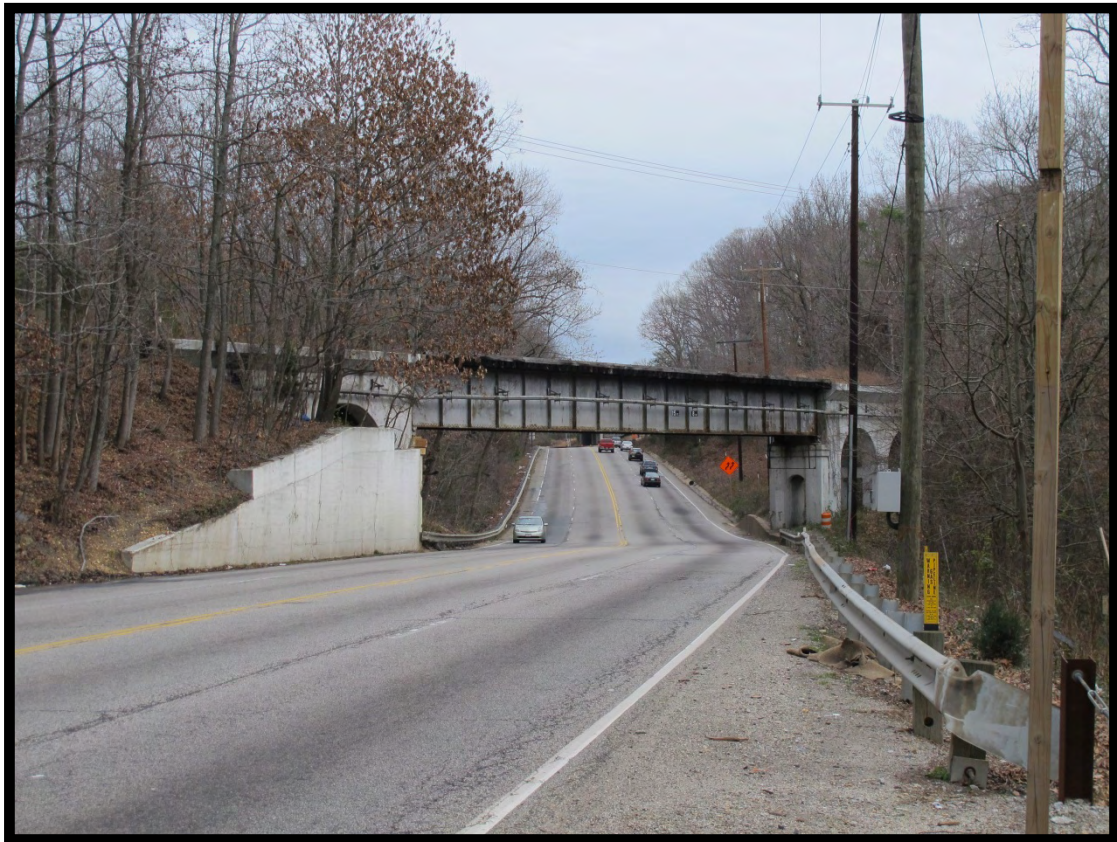
Figure 4.2-15: View of Route 1, (Old) River Road (VDHR # 029-5708), Towards Railroad Bridge (Facility No. 1433, VDHR # 029-5424), Facing East.

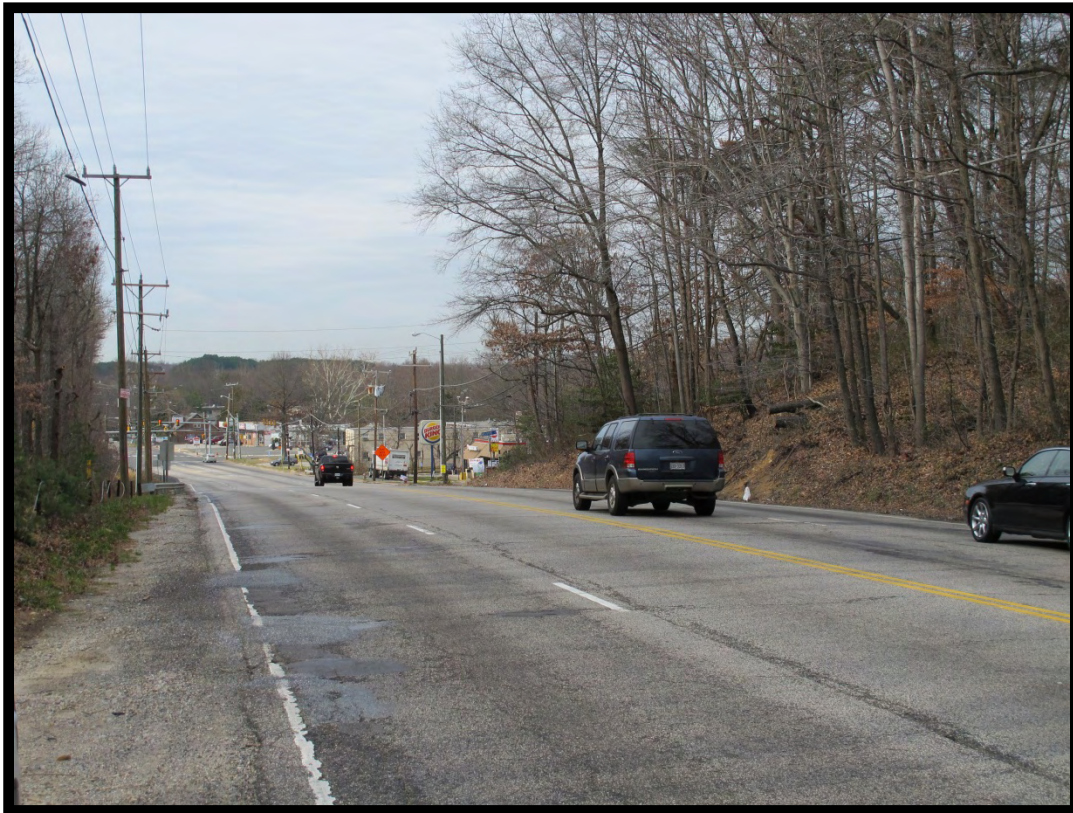
Figure 4.2-16: View of Route 1, (Old) River Road (VDHR # 029-5708), Towards Accotink, Facing West.

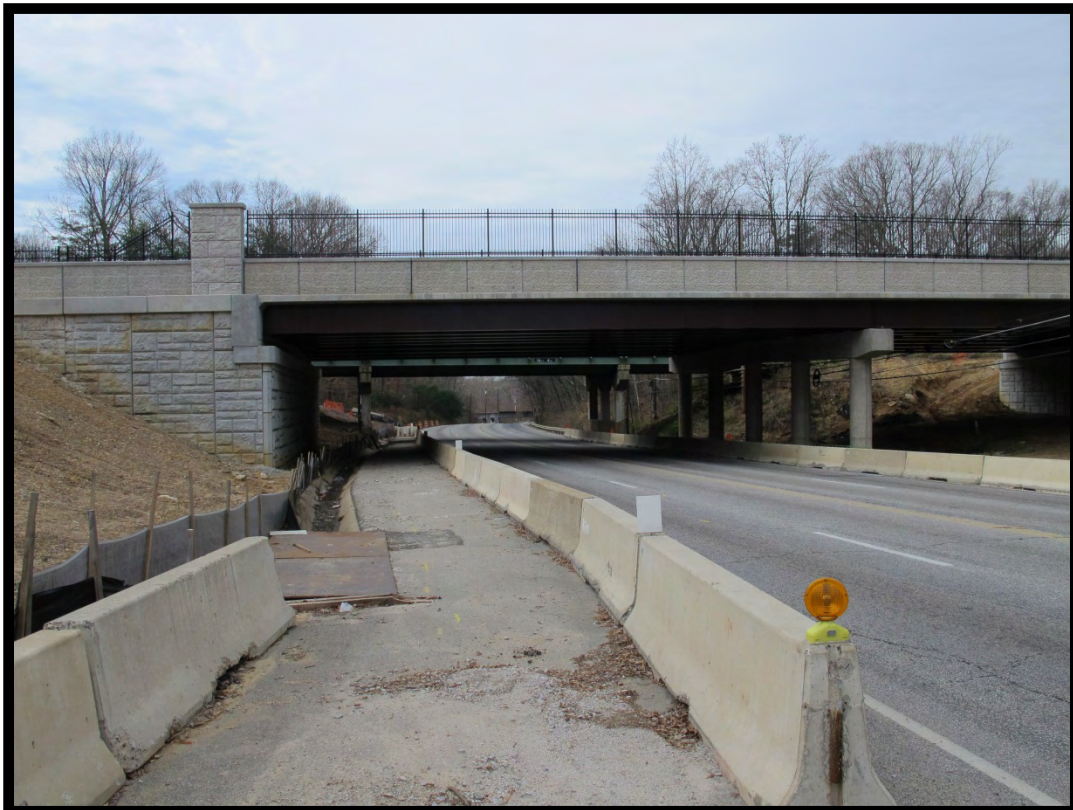
Figure 4.2-17: View of Route 1, (Old) River Road (VDHR # 029-5708), Towards Vehicle Bridge (Facility No. 1443, VDHR # 029-5425), Facing West. Note Vehicle Bridge is (VDHR # 029-5425) the Bridge in the Background.

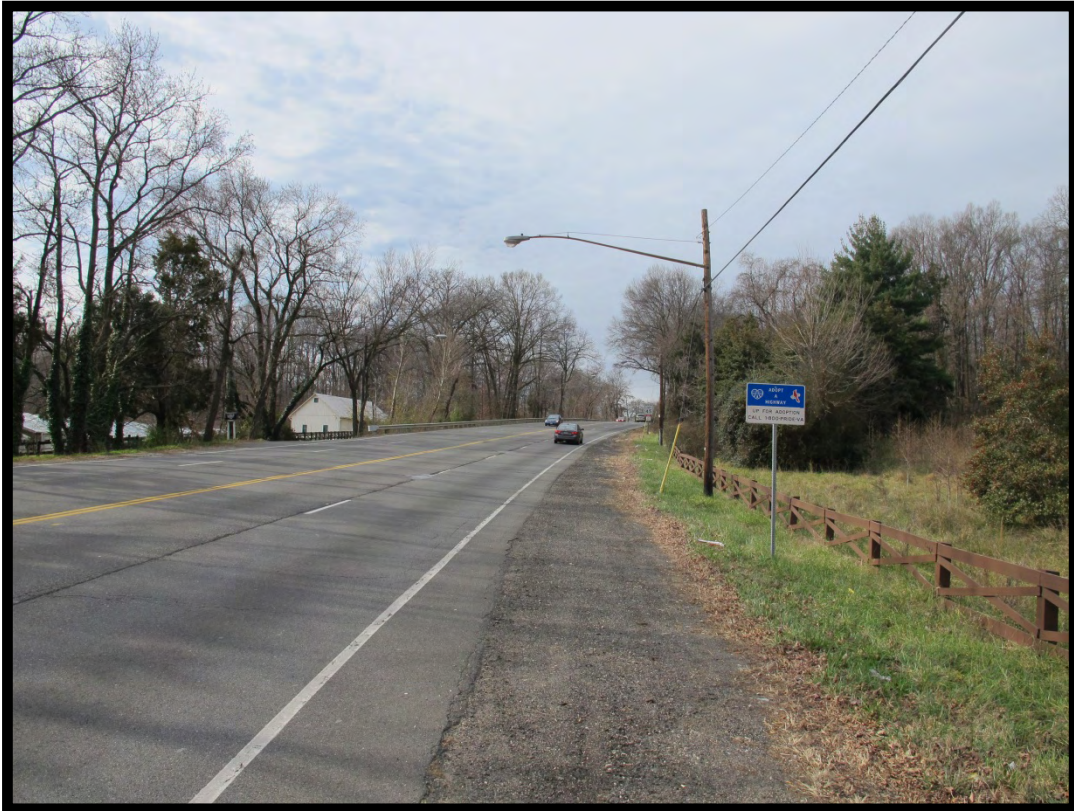
Figure 4.2-18: View of Route 1, (Old) River Road (VDHR # 029-5708), Towards Sharpe Stable Complex, Facing Southwest.

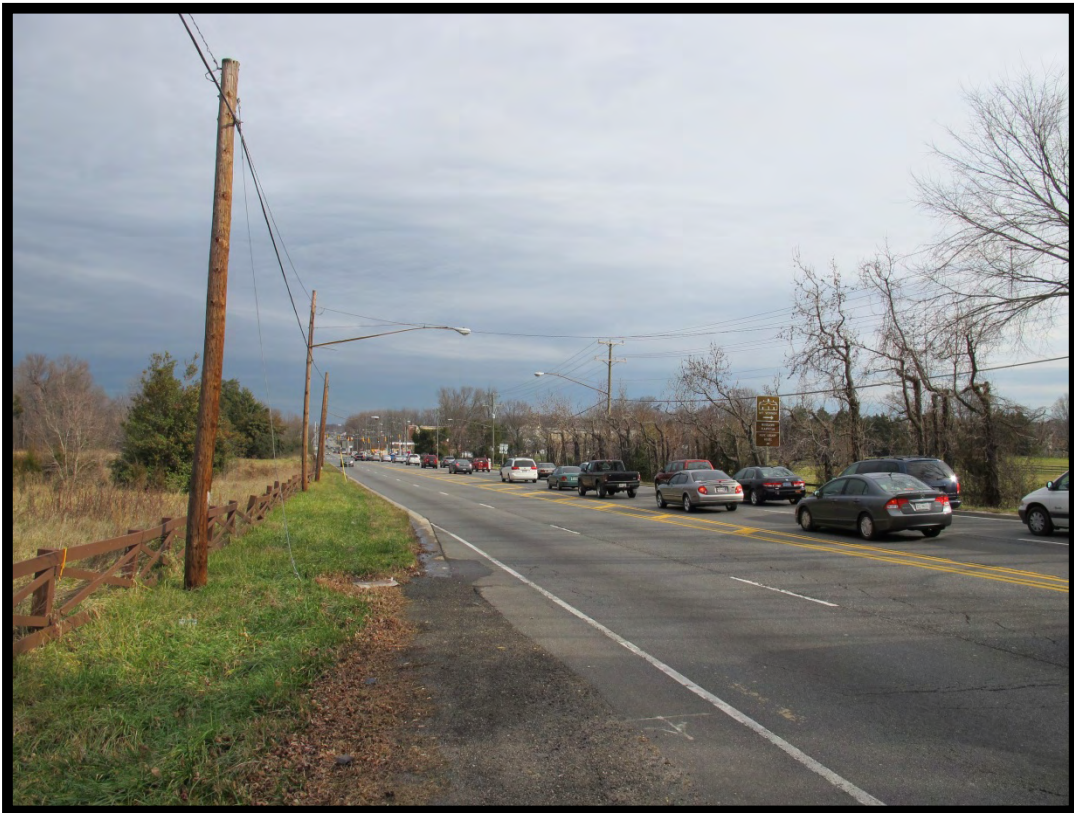
Figure 4.2-19: View of Route 1, (Old) River Road (VDHR # 029-5708), Towards the Intersection with Mount Vernon Memorial Highway (SR 235), Facing Northeast.

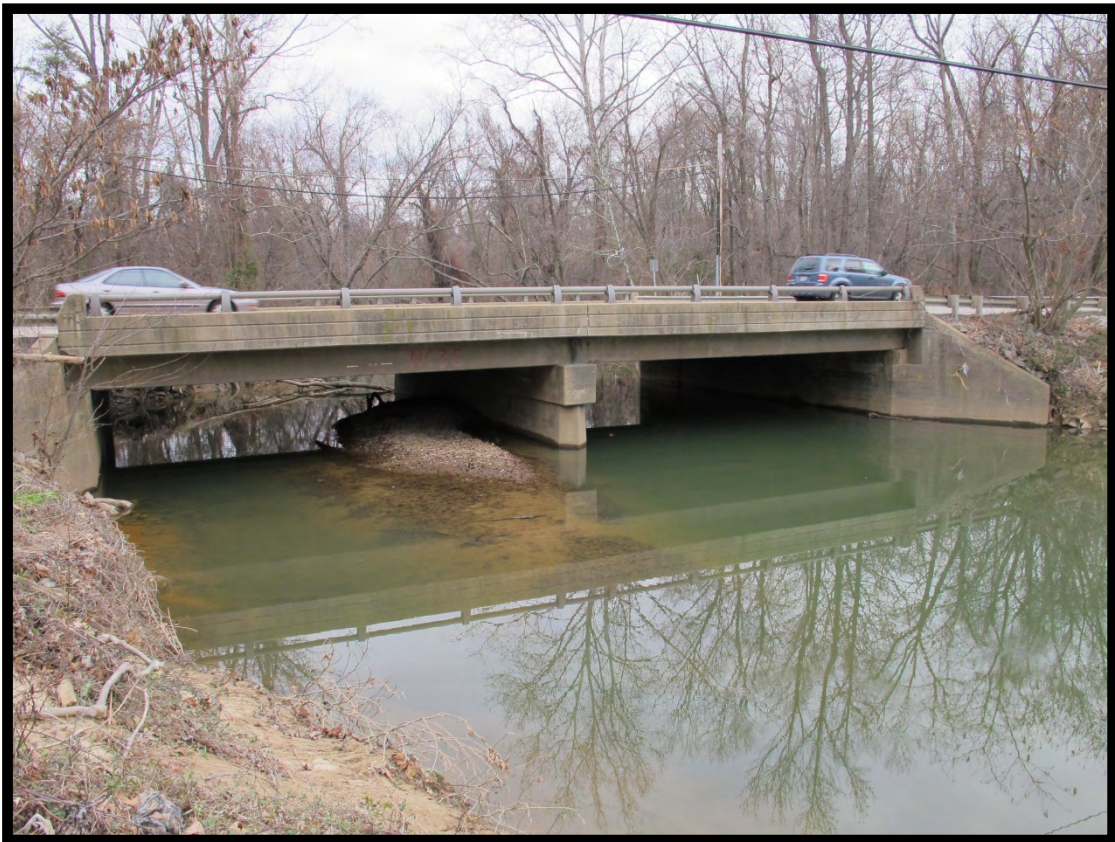
DESCRIPTION: Built in 1927, according to official records, the bridge carries Route 1 vehicular traffic over Accotink Creek (Figure 4.2-21). The 33-foot-long bridge is a double span concrete T-beam bridge, with poured-concrete abutments at the east and west end. A four-lane road runs over the bridge in an east-west direction, with two lanes of traffic traveling in each direction. The bridge deck consists of one fixed concrete span, supported by nine concrete girders running east-west at regular intervals. The barrier is a so-called New Jersey concrete

Figure 4.2-21: View of Bridge over Accotink Creek (VDHR # 029-5709), Facing Northeast.

barrier with a narrow concrete curb and a concrete parapet with a single-pipe aluminum handrail (FHWA 2011).

RECOMMENDATIONS: The design of this utilitarian bridge is common for the period of construction, and elements of the structure, such as the aluminum handrail and parts of the barrier and deck, are likely more recent additions to the original design. The resource has no apparent association with any event or person of outstanding historical importance, lacks architectural/engineering distinction and integrity, and does not have the ability to yield important information. Therefore, the resource is recommended as not eligible for the NRHP under Criteria A, B, C, or D.

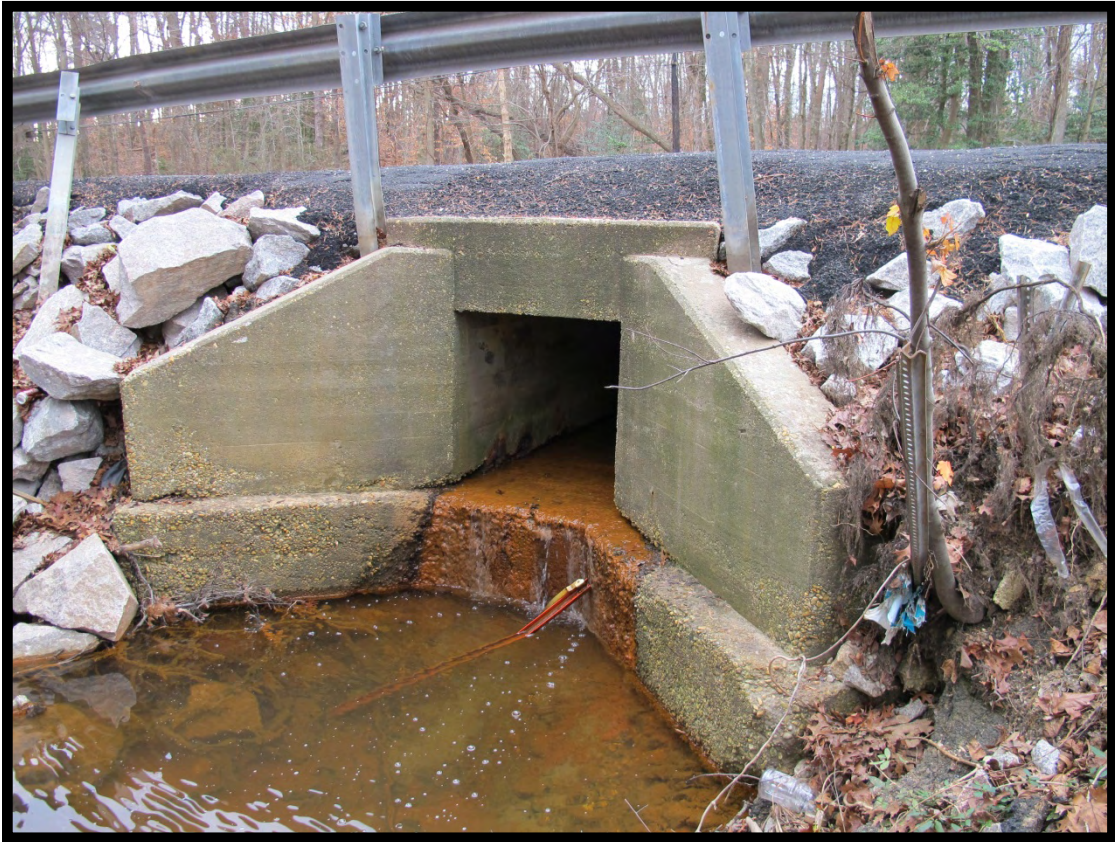
Figure 4.2-22: View of Culvert Under Route 1 (VDHR # 029-5710), Facing Northwest.

RECOMMENDATIONS: The design of this utilitarian culvert is common for the period of construction, and the resource has no apparent association with any event or person of outstanding historical importance, lacks architectural/engineering distinction and integrity, and does not have the ability to yield important information. Therefore, the resource is recommended as not eligible for the NRHP under Criteria A, B, C, or D.

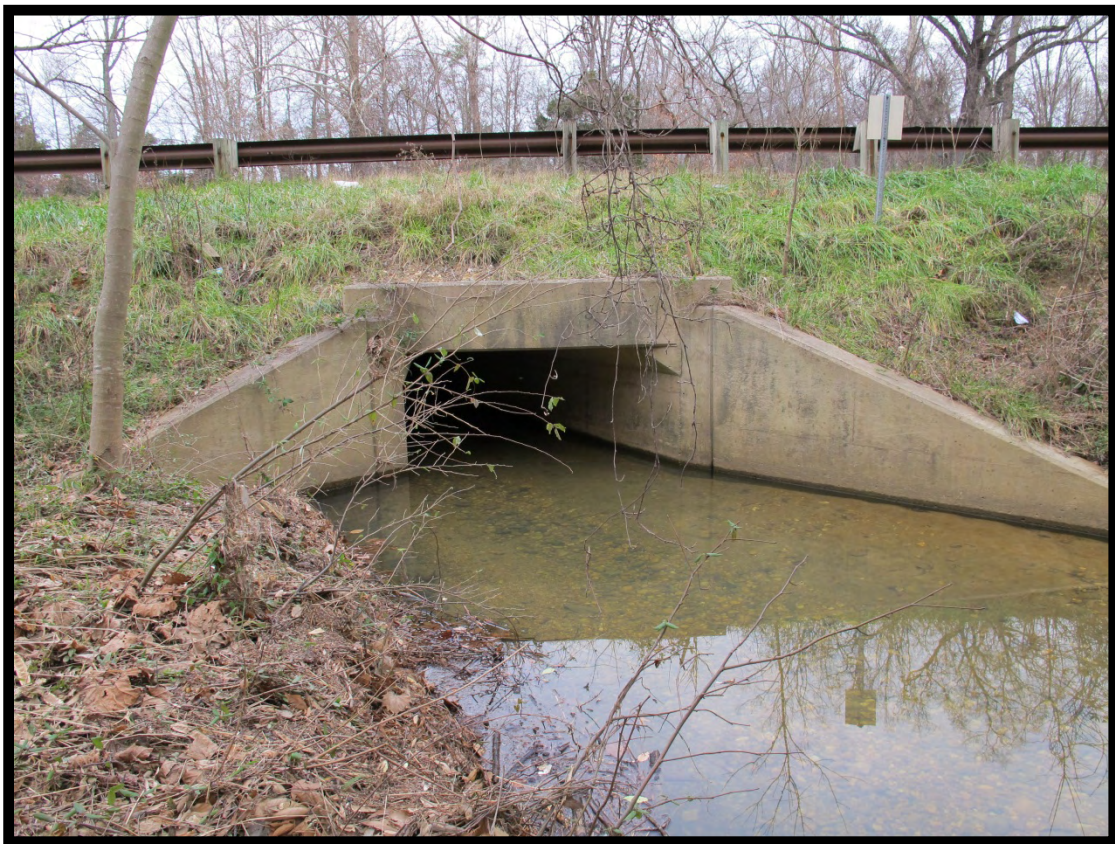
Figure 4.2-23: View of Culvert Under Route 1 (VDHR # 029-5711), Facing North.

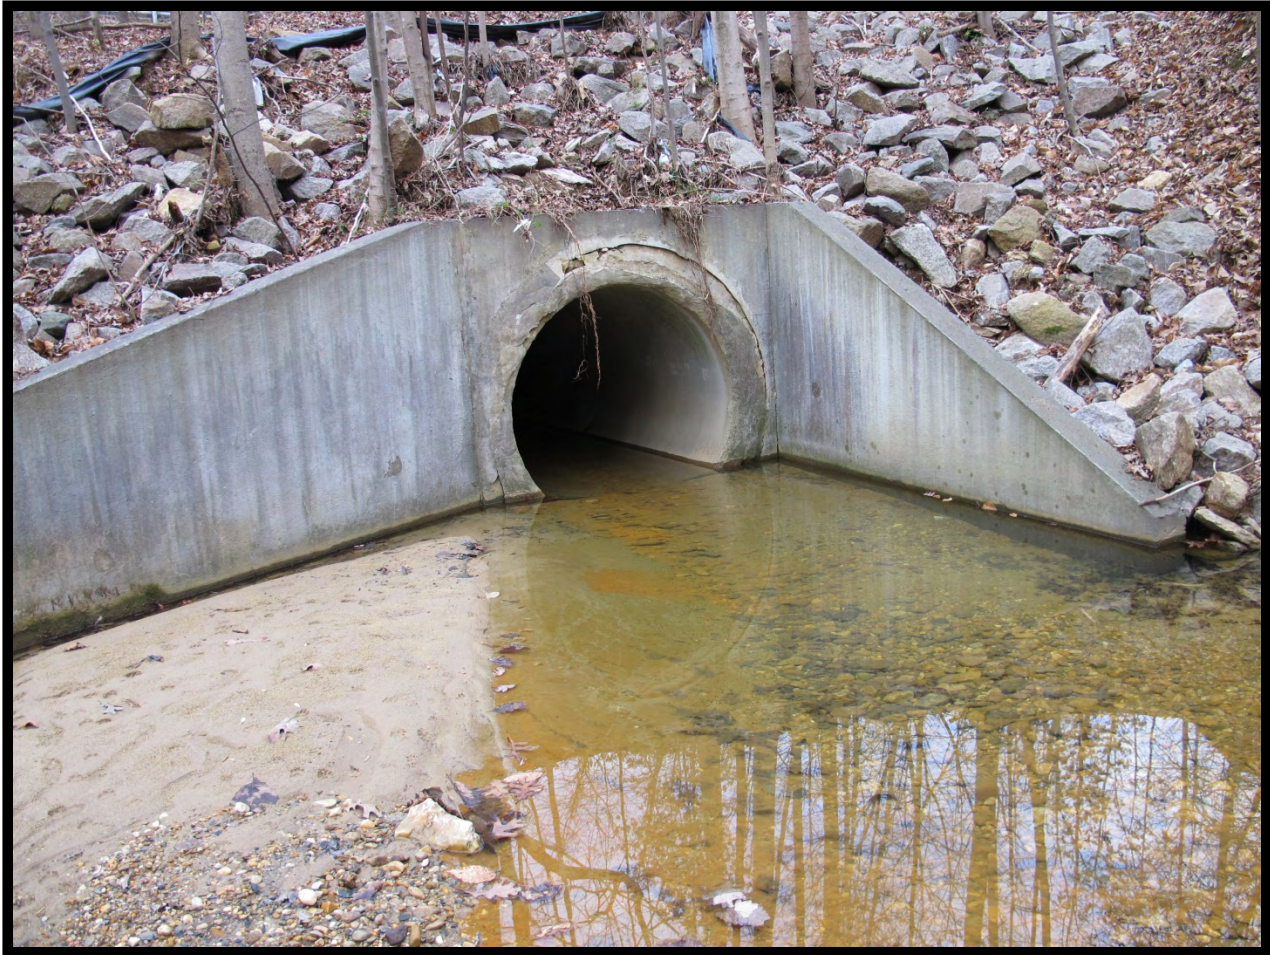
Figure 4.2-24: View of Culvert Under Route 1 (VDHR # 029-5712), Facing Northeast.

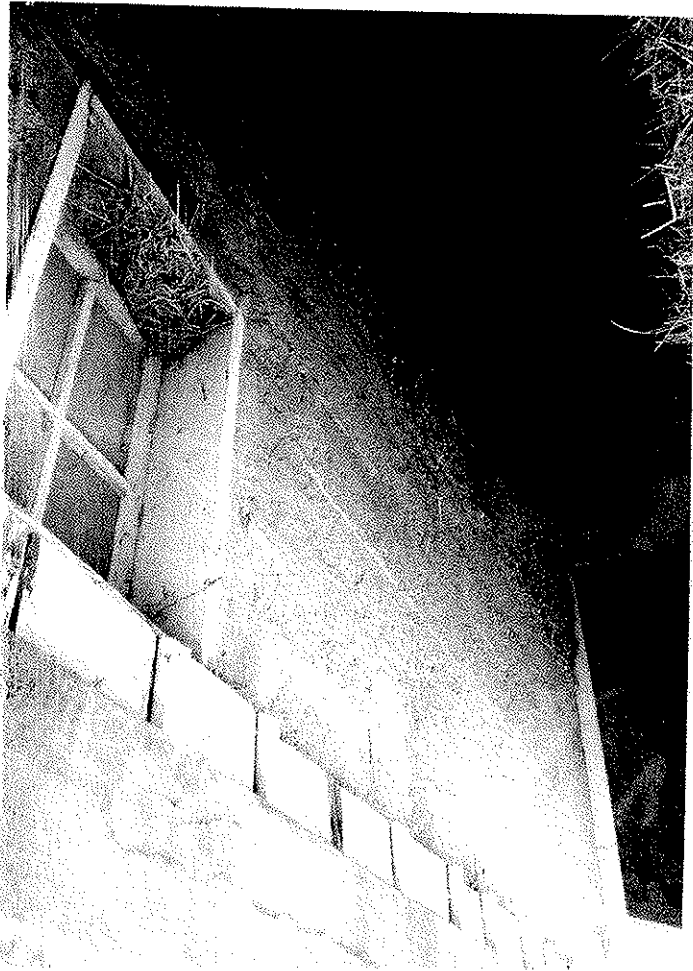
SHARPE STABLE COMPLEX
VDHR # 029-5181-0005
12-19-2011
J. VAN DEN THURK, CCR
DETAIL OF BANK BARN, LOWER FLOOR

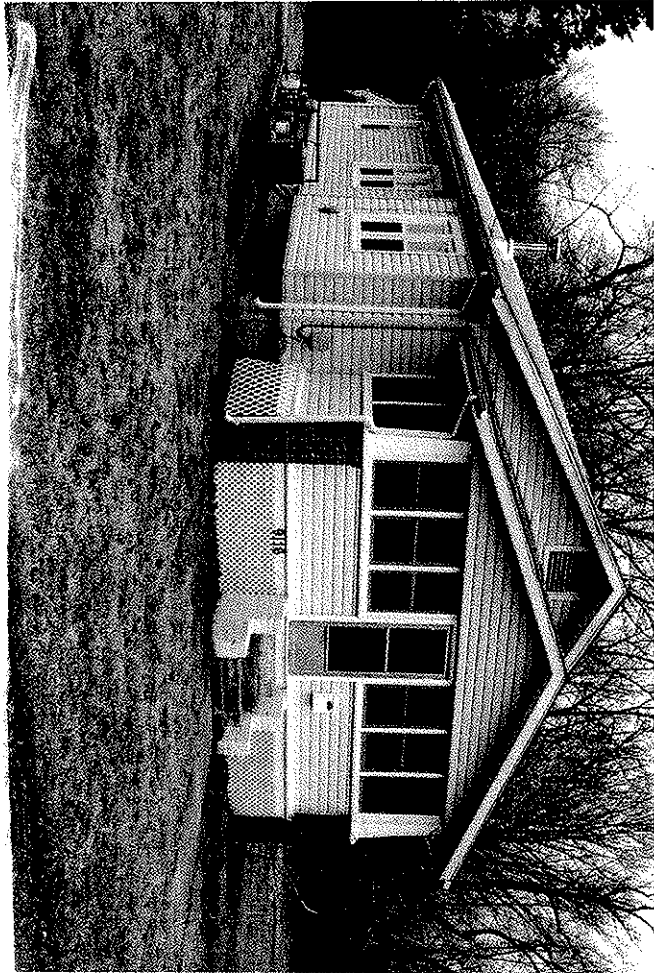
House, Gille Anderson Lane
VOLUME # 029-5686
12-20-2011
L. F. Hood, LLC
VIEW OF HOUSE, LOOKING SW

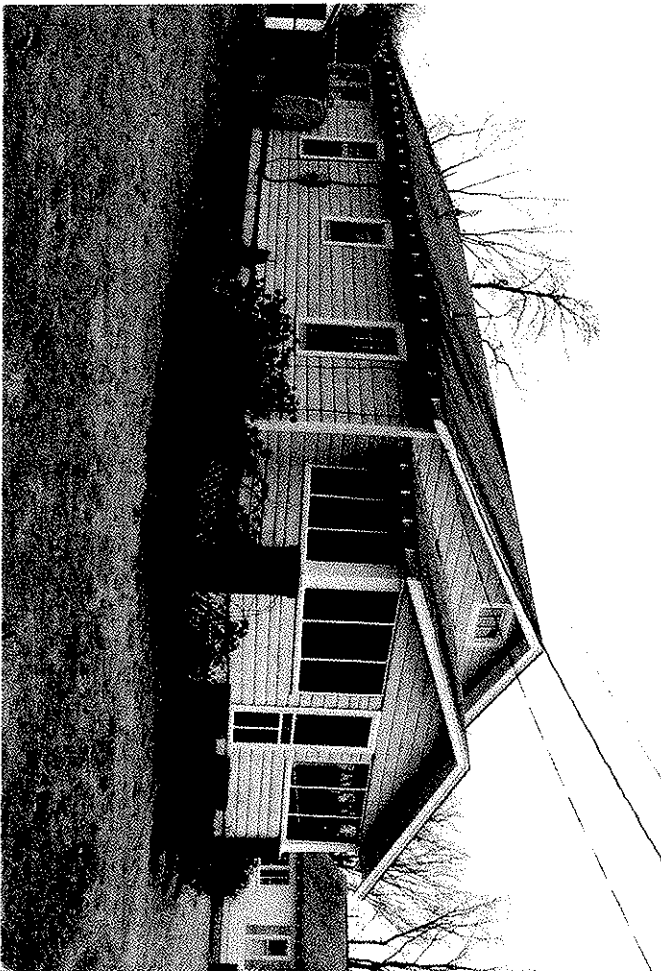
House, 9119 Anderson Lane
VDHR # 029-5688
12-20-2011
L. Flood, CCR
View of house, looking SE
