**ARCHITECTURAL SURVEY
OF PROPOSED AREA OF POTENTIAL EFFECTS
ROUTE 1 IMPROVEMENTS AT FORT BELVOIR
(TELEGRAPH ROAD TO MOUNT VERNON MEMORIAL
HIGHWAY), FAIRFAX COUNTY, VIRGINIA**

VDHR File # 2001-007

DRAFT January 2012

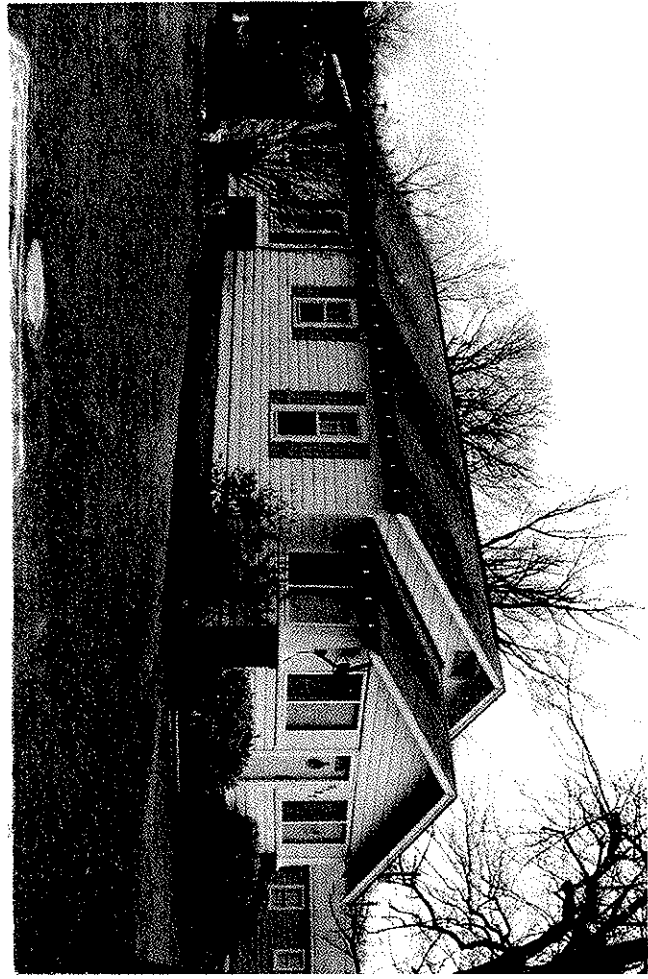
House, 9121 Anderson Lane
VDNR# 029-5689
12-20-2011
L.Flood, CCR
View of house, looking ENE

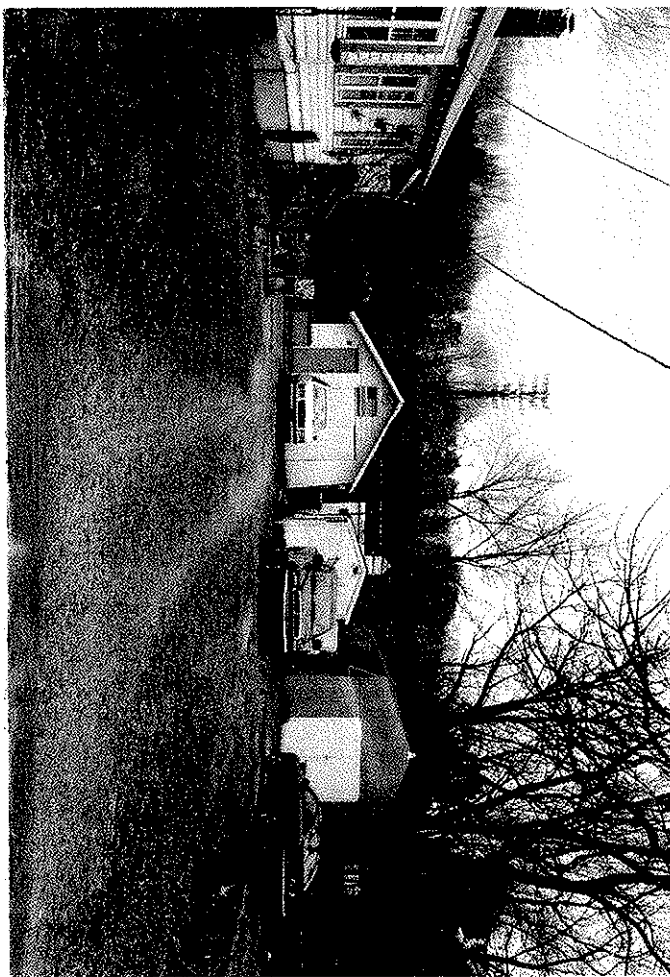
House, 9121 Anderson Lane
VDNR# 029-5689
12-20-2011
L.Flood, CCR
View of house, looking SE

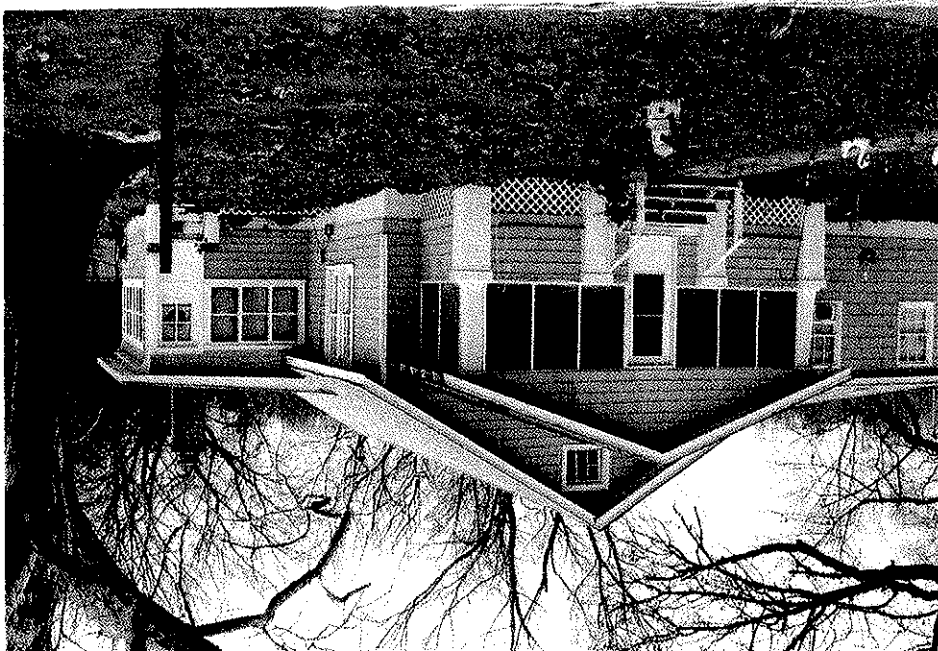
House, 9135 Anderson Lane
VDHR # 029-5690
12-20-2011
L. Flood, CCR
View of house, looking SE

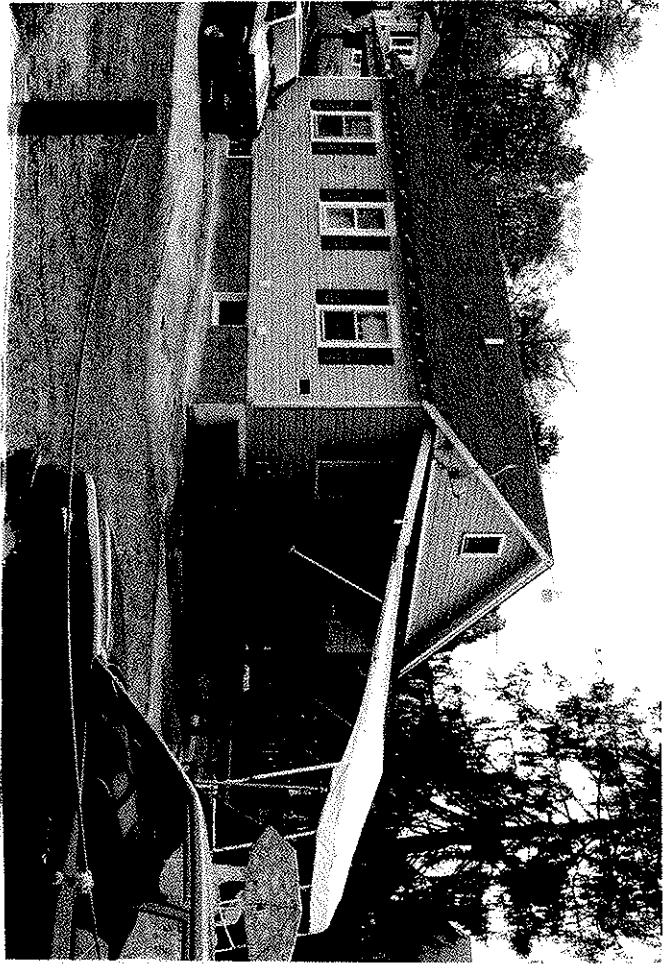
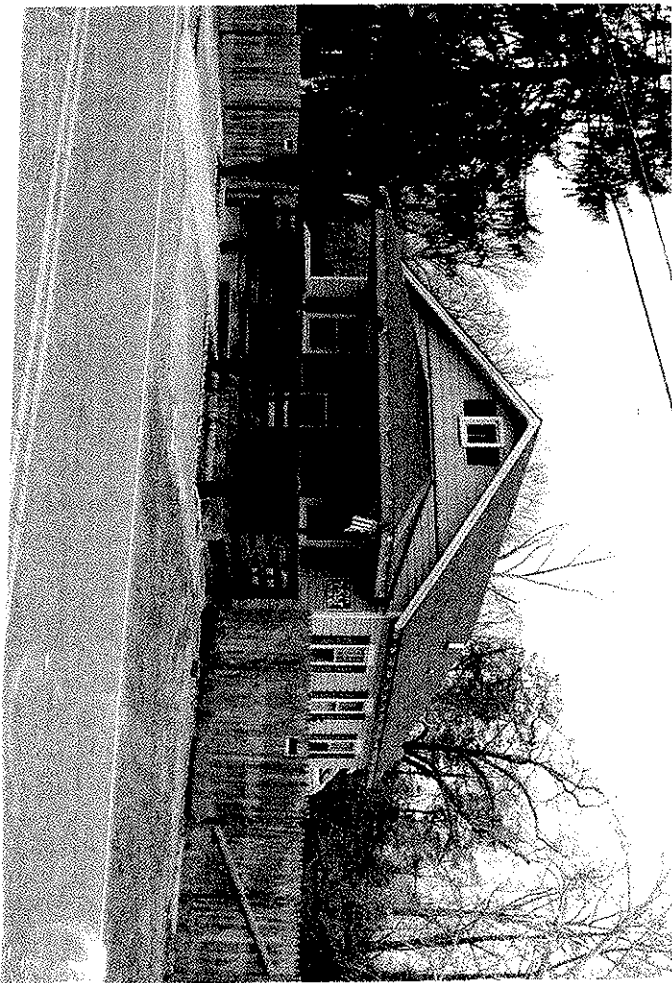
House, Gold Backlick Bend
VDHE # 001 5042
12-20-2011
L. 11000, CCE
VIEW OF HOUSE, LOOKING SSE

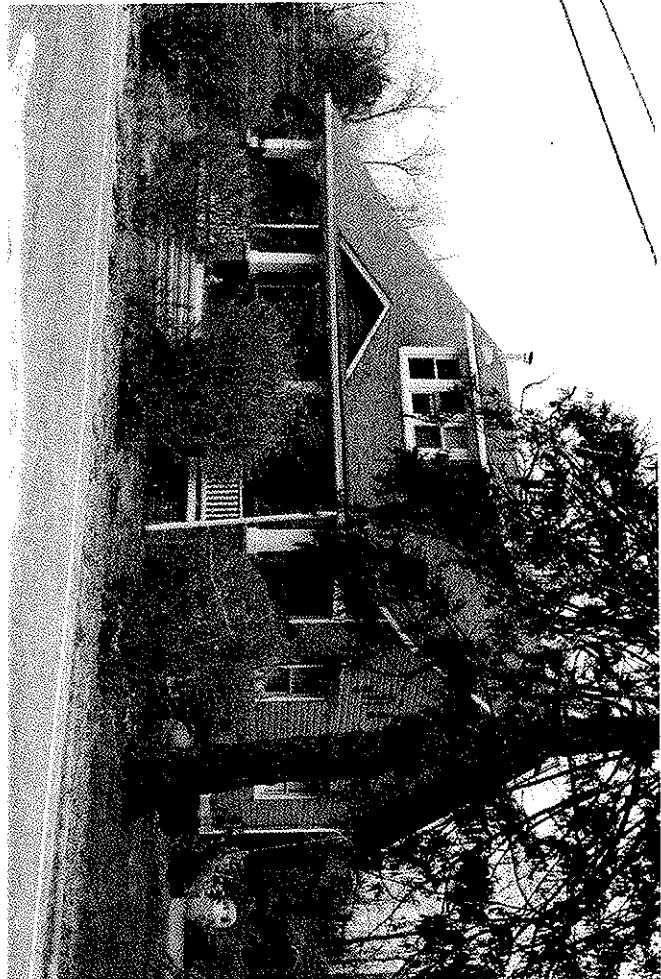
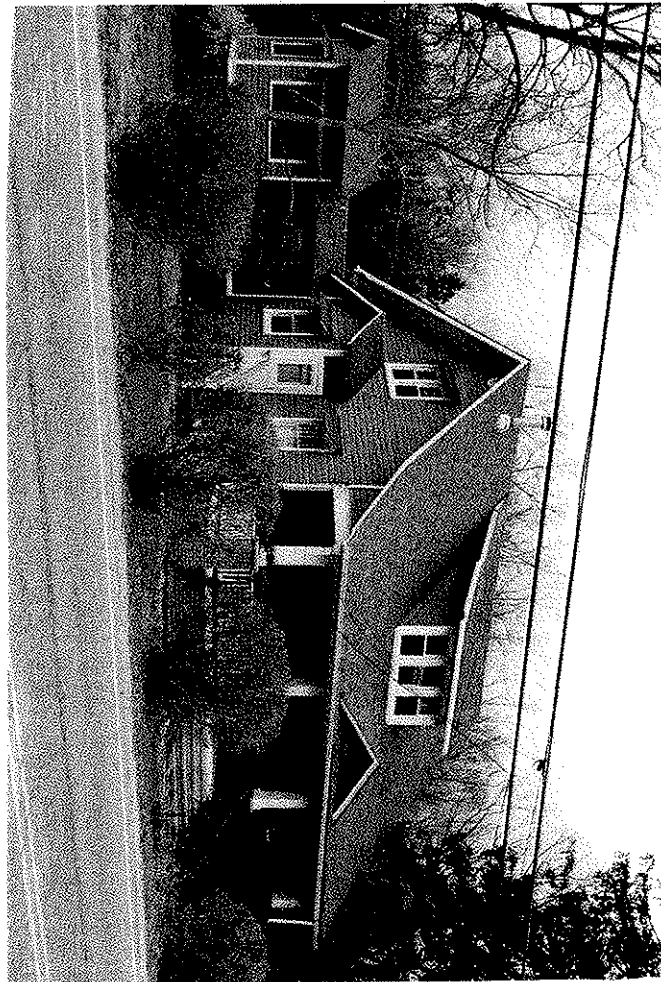
HOUSE, 9034 BRADLICK ROAD
VDHE# 024-5095
12-20-2011
L-FLOOR CLR
VIEW OF HOUSE, LOOKING NW

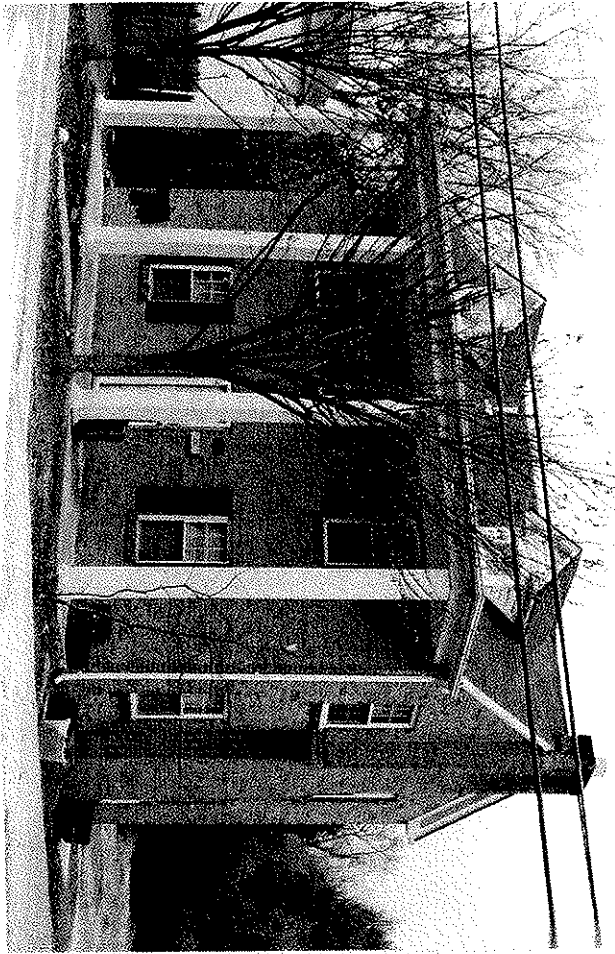
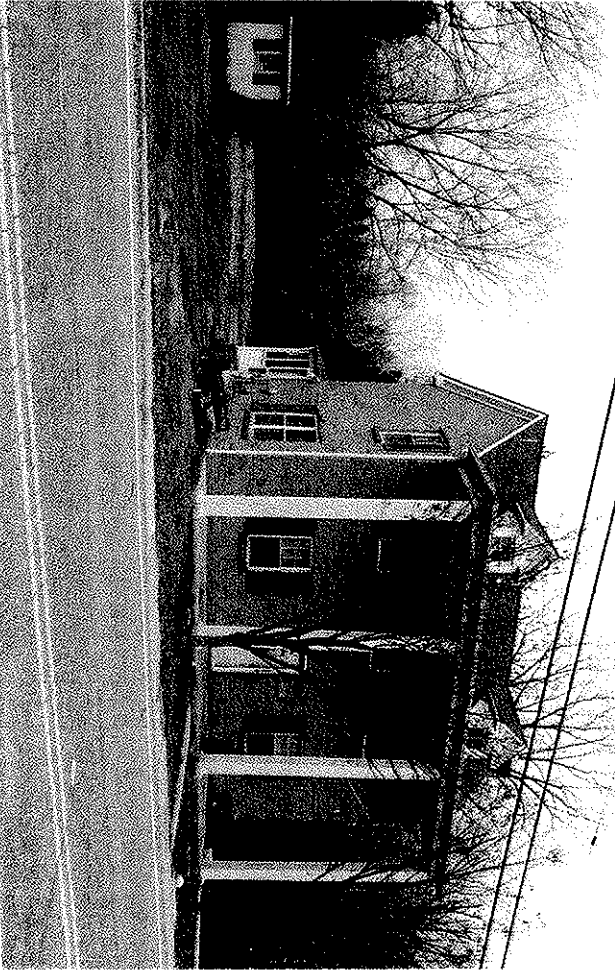
HOUSE 1042 BUCKINGHAM ROAD
VDHC # 0281 SWHP
12-20-2011
L.F. 1000, CLK
VIEW OF HOUSE LOOKING W

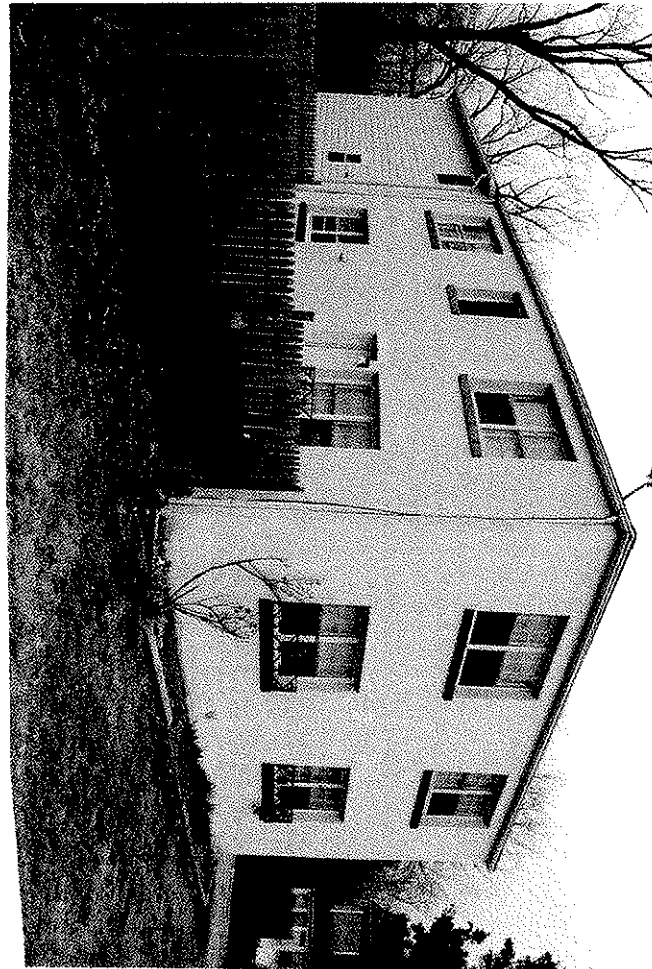
HOUSE: 4104 BACKLICK ROAD
JUNE 19 0211 30-10
12 20 2011
L FLOOR: 1001
VIEW OF HOUSE LOOKING WEST

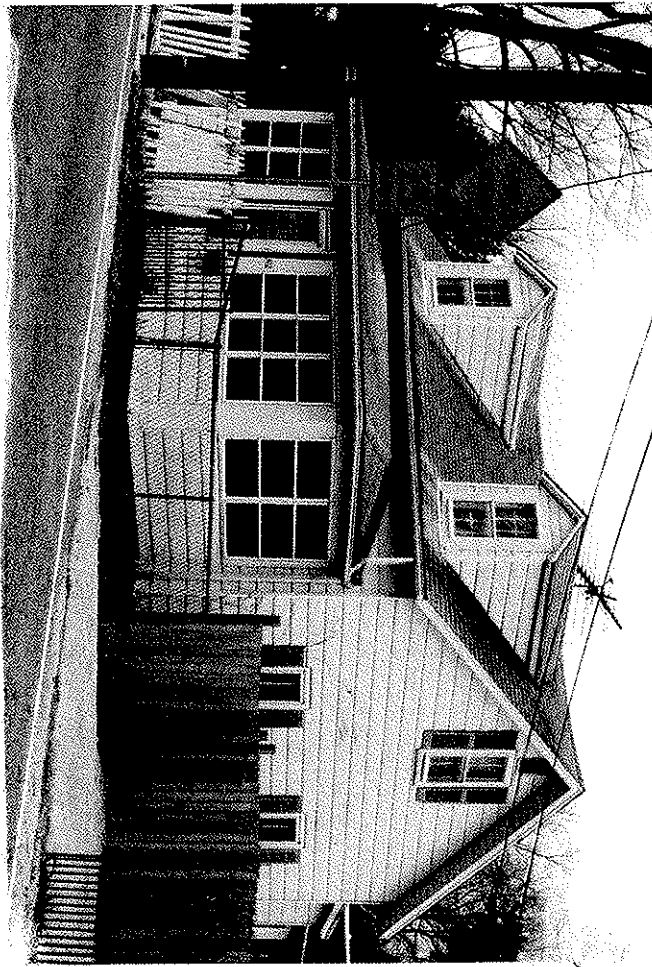
House, 41/2 Boulders Road
VDP# 024-5100
12 20 coil
L.F. 1000, etc
VIEW of SHIRO, looking NW

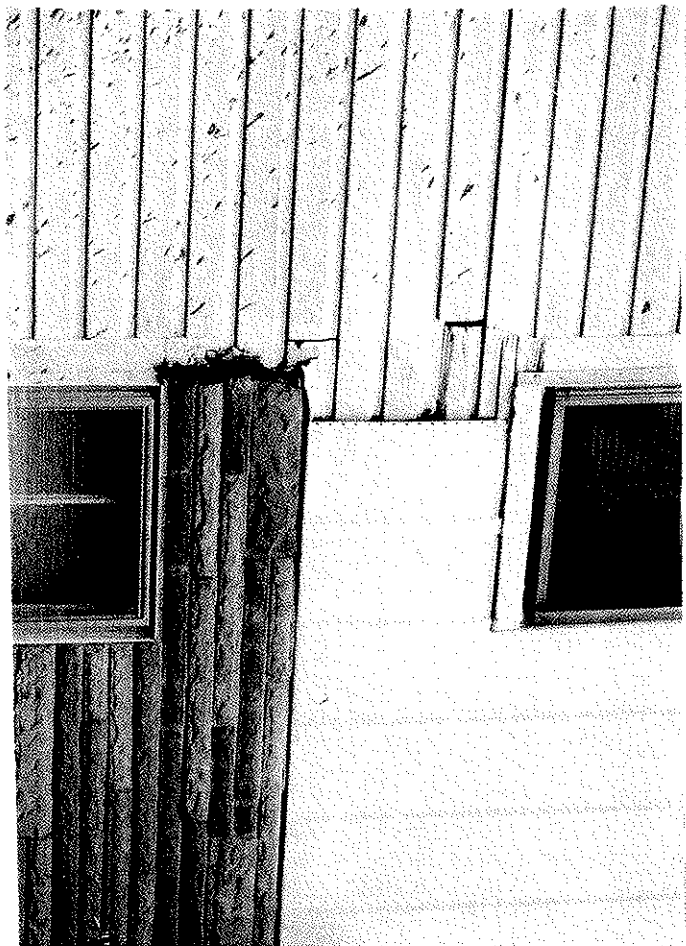
HOUSE, 0120 BACKLICK COND
VDHE # 020 - 5101
12 20 2011
L.F. 1000 C.C.R.
VIEW OF HOUSE, LOOKING SW

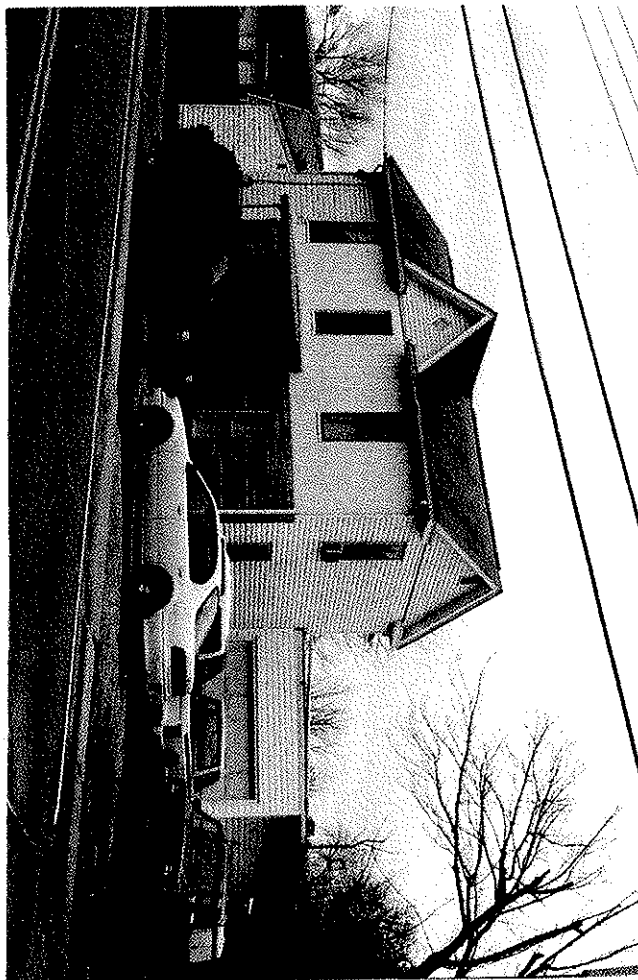
HOUSE, 0120 BACKLICK COND
VDHE # 020 - 5101
12 20 2011
L.F. 1000 C.C.R.
VIEW OF HOUSE, LOOKING NW

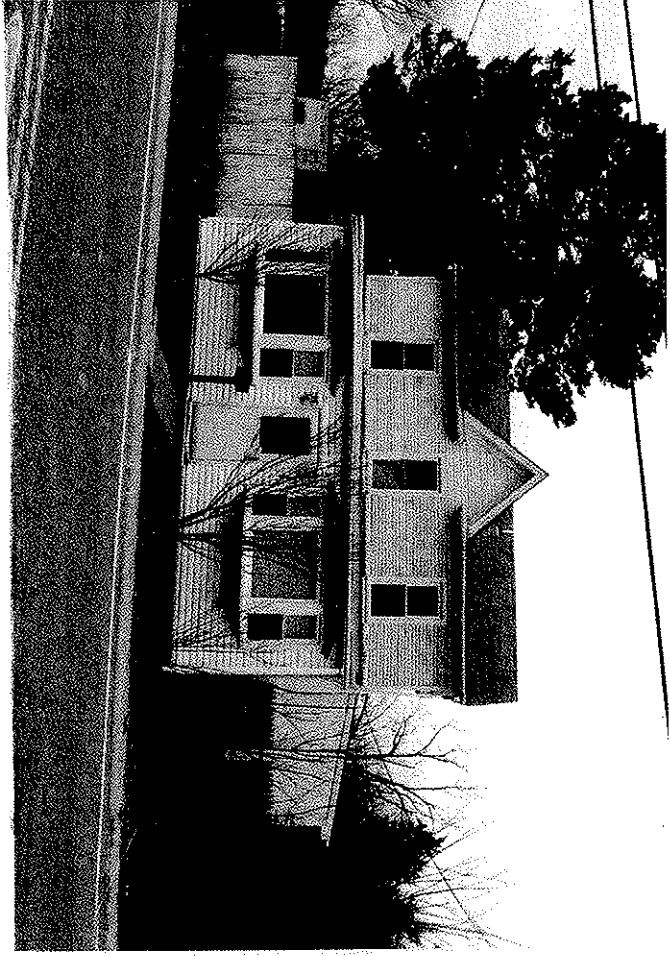
House, 9124 Backview Road
June 7, 024-5703
12-20-2011
L.I. 1000, CCC
VIEW OF HOUSE, LOOKING W-N

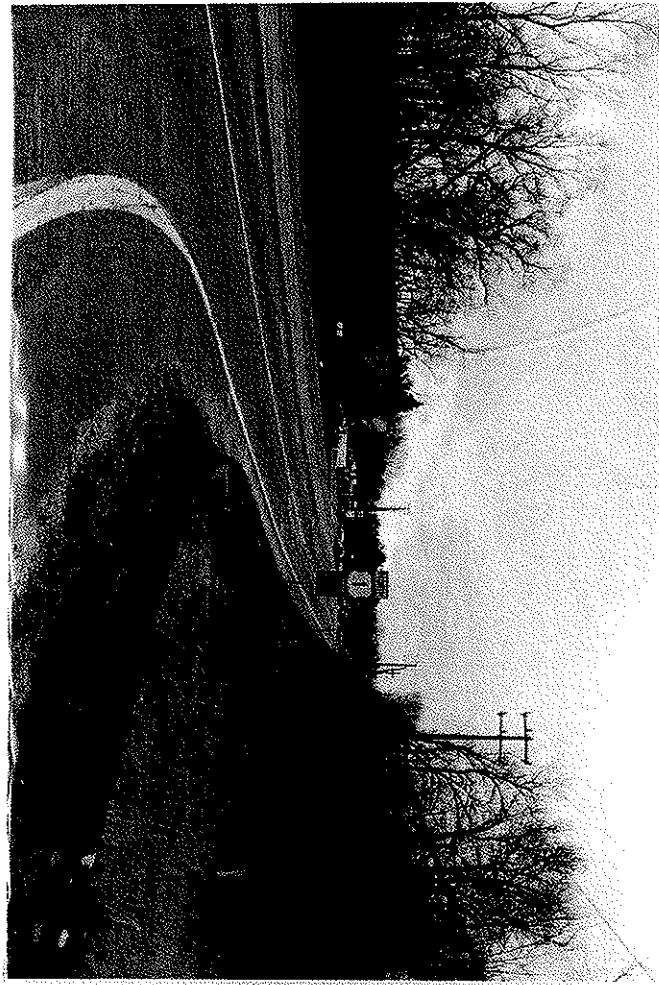
12-20-2011
L. Flood, CCR
View looking toward RR bridge, looking E

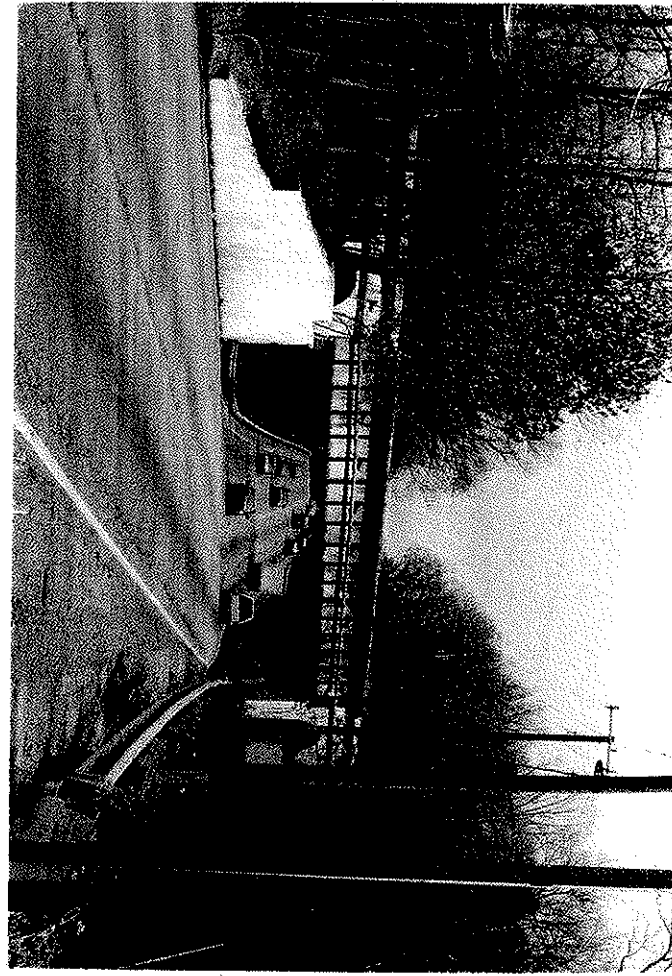
12-20-2011
L. Flood, CCR
View looking toward Accotink Village,
Looking E

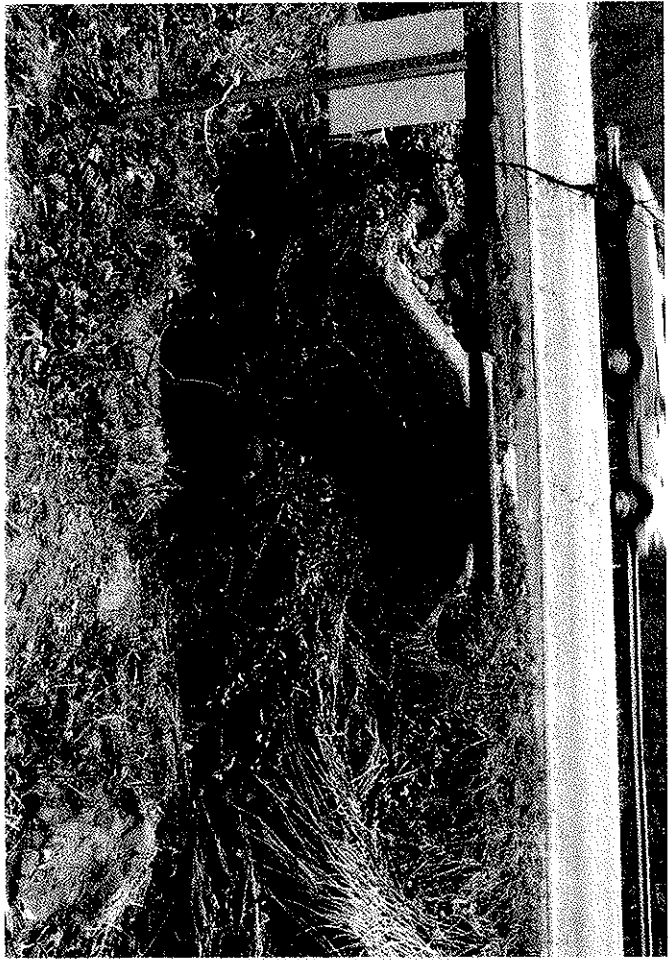
Culvert near Davison Army Airfield

south end are more recent, and probably replaced earlier wing walls.
