**REVISED  
GEOTECHNICAL AND PAVEMENT DESIGN REPORT  
LEES FERRY ACCESS ROAD IMPROVEMENTS  
AZ PRA GCLA 5(2)**

**GLEN CANYON NATIONAL RECREATION AREA  
COCONINO COUNTY, ARIZONA**

**January 16, 2012  
YA Project No. 211-052**

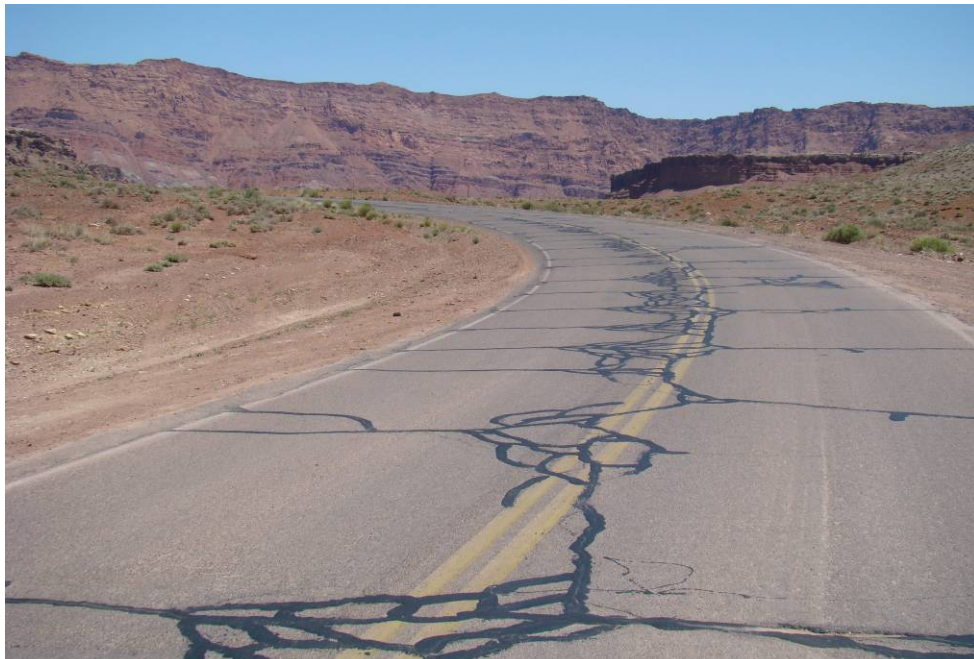
The surface of the two-lane asphalt-paved road is in poor condition. Observed pavement distress includes transverse thermal stress cracks spaced at about 15 to 20 feet and areas where the thermal cracking has progressed to block cracking. Blocks range in size from less than 1 foot to about 5 feet in many locations. The block cracking is most prevalent near the centerline on curves where wheel loads have produced increased lateral forces on the pavement. Figure 3.1 shows typical thermal and block cracking at a curve in the road. The majority of the observed cracks have been filled with bituminous crack sealer. The road has received several chip seal or slurry seal treatments since it was originally paved. The parking lot at the boat ramp received a micro-surfacing treatment in 2010.

**Figure 3.1: Thermal and block cracking patterns at a curve.**

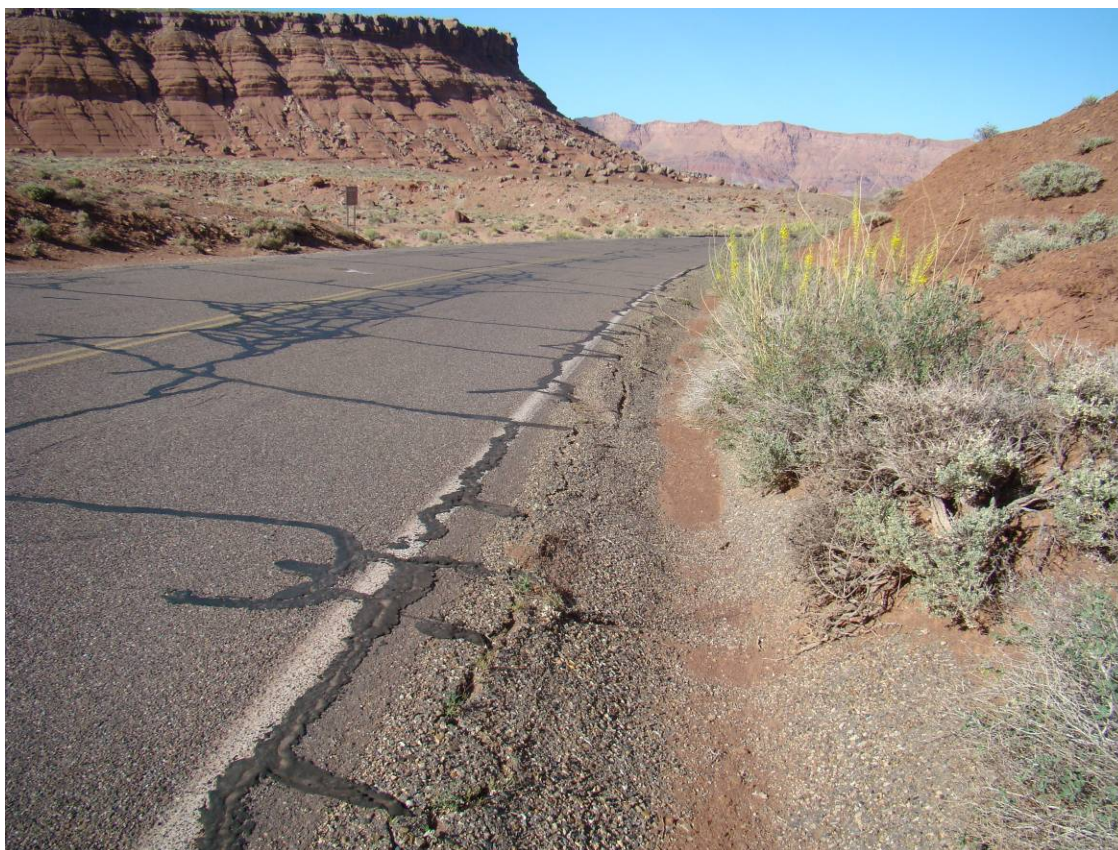
Approximately one mile north of the intersection with SH 89A, where the road climbs and then descends a saddle south of Cathedral Rock, the pavement is very rough due to ridges and depressions in the asphalt surface. The surface unevenness extends for about ¼-mile through an area reported to have poor surface drainage during heavy seasonal precipitation events. Ditches adjacent the road in this area had been paved with asphalt but the ditch paving is displaced, broken or cracked at several locations. Figure 3.2 shows a section of the distressed ditch pavement on the northbound side about 1.4 miles from SH 89A.

**Figure 3.2: Deteriorated ditch pavement, (approx Station 170 - 180)**

Recommended improvements to surface drainage in this area include re-shaping and relining the ditches with impermeable materials such as HACP, Portland Cement Concrete or a suitable Geosynthetic/Clay Liner. Subsurface drains to intercept infiltrated water before it reaches the pavement are also recommended. The subsurface drains should be designed and constructed similar to CFLHD Standard Detail Drawing C605-50. The depth of the drains should be to at least 1 foot below the bottom of the improved pavement subgrade (see Subgrade Improvement Recommendations below). The drains should be installed on both sides of the road, through the areas of pavement distress.

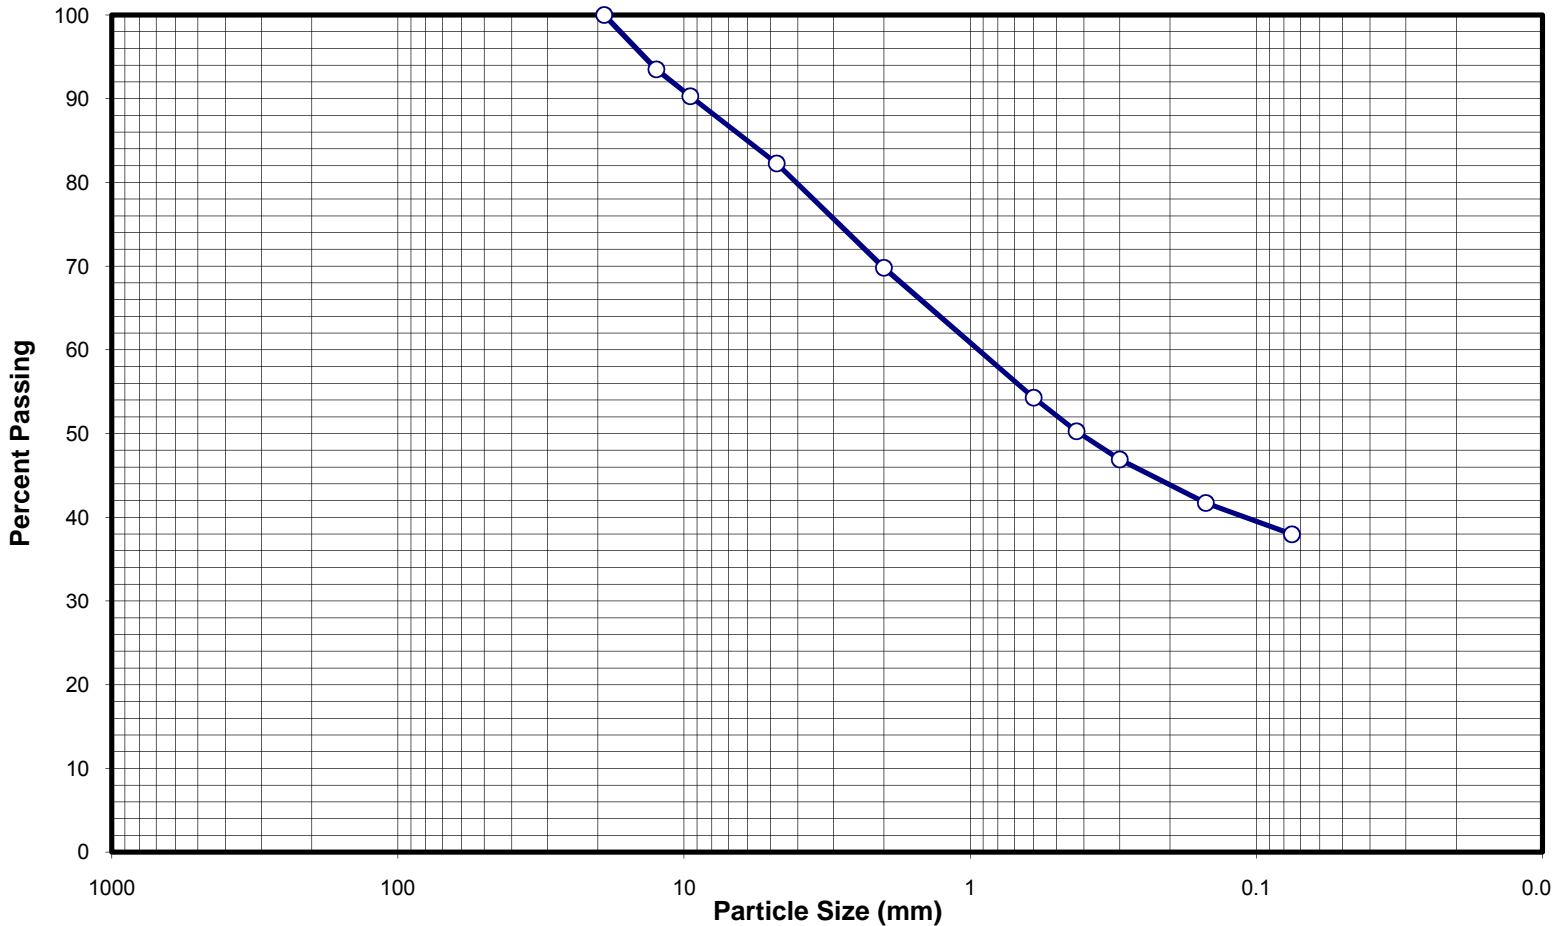
Sieve Size	% Passing
3"	-
2 1/2"	-
2"	-
1 1/2"	-
1"	-
3/4"	100
1/2"	93
3/8"	90
#4	82
#10	70
#40	50
#200	38

Gravel (%)	18	LL	-168	Project Name:	Lee's Ferry Road
Sand (%)	44	PL	-174	Sample ID:	P-4
Fines (%)	38	PI	6	Sample Depth (ft.):	1-3
Sample Description:	SM - SC / A - 4 ( 0 )

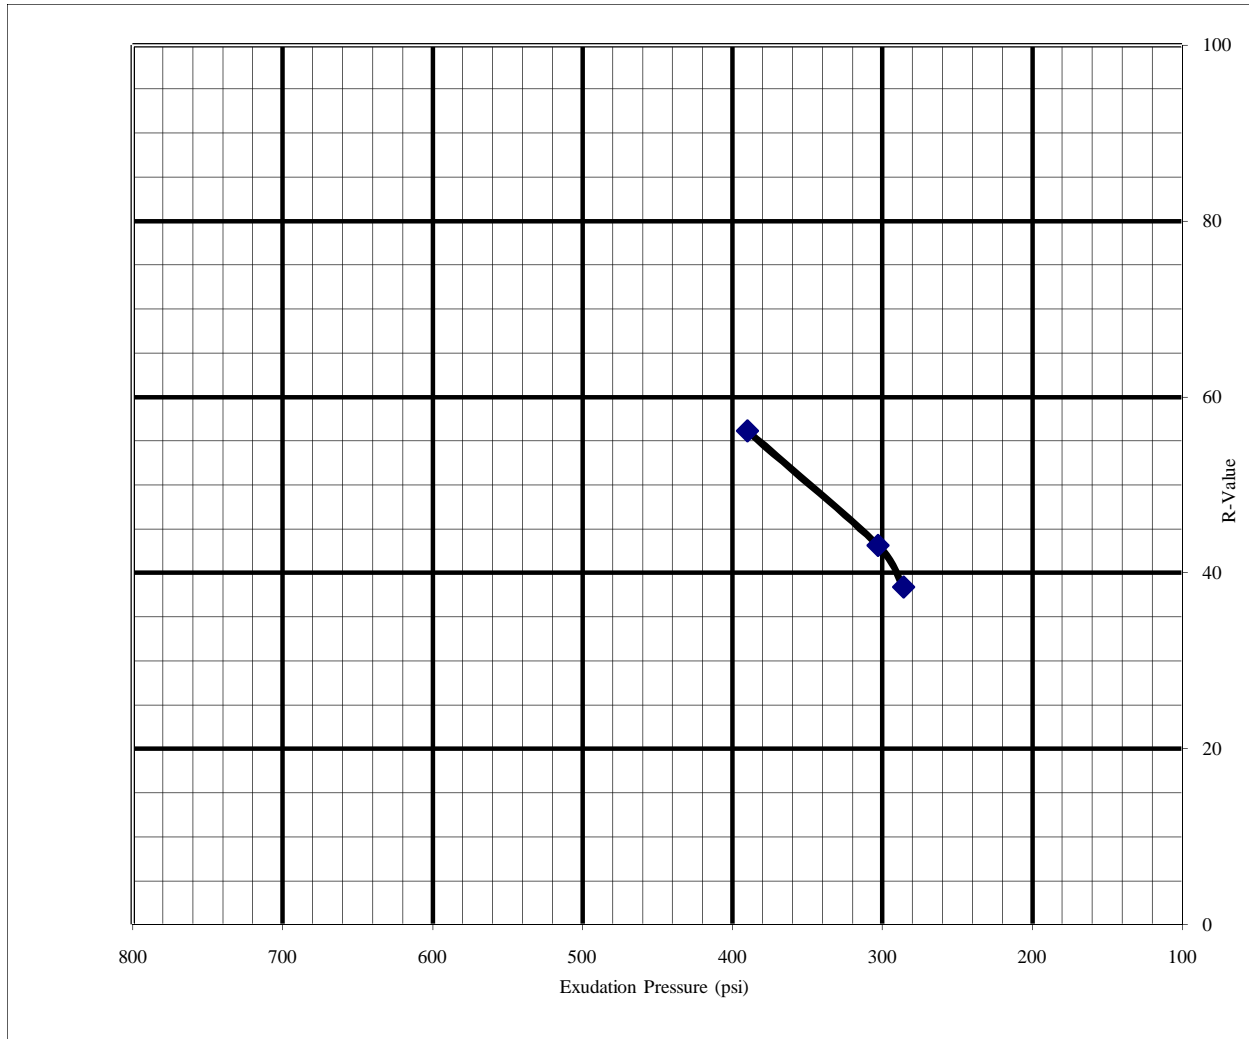
**Project Number:** 211-052                      **Project Name:** Lee's Ferry Road  
**Sample Id:** P-4                                      **Depth (ft):** 1-3  
**Soil Description:** silty SAND with clay              **Classification:** A-4(0)/ SM-SC  
**R-Value at 300 psi exudation pressure =** 42

Test No.	Compact. Press. (psi)	Density (pcf)	Moist. (%)	Horizont. Pressure (psi)'@ 160 psi	Sample Height (in).	Exud. Pressure (psi)	R Value	R Value Correct.
1	300	133.7	11	60	2.51	390	51	56
2	300	133.6	12	66	2.49	303	45	43
3	300	133.3	13	82	2.55	286	33	38

R-values measured in accordance with AASHTO T190 on the soils from the project, were 35, 42, and 65. Using these equations, an R-value of 35 was used to calculate a resilient modulus of 8,065 psi. The R-35 was chosen in order to be conservative and use the same pavement thickness in areas where less pulverized material will be available to meet existing curb lines. This resilient modulus value was used as one of the inputs for the DARWin Pavement Design computer program to determine recommended pavement thickness for Lee's Ferry Access Road. The DARWin pavement design computer program follows the AASHTO 1993 Pavement Design Manual.

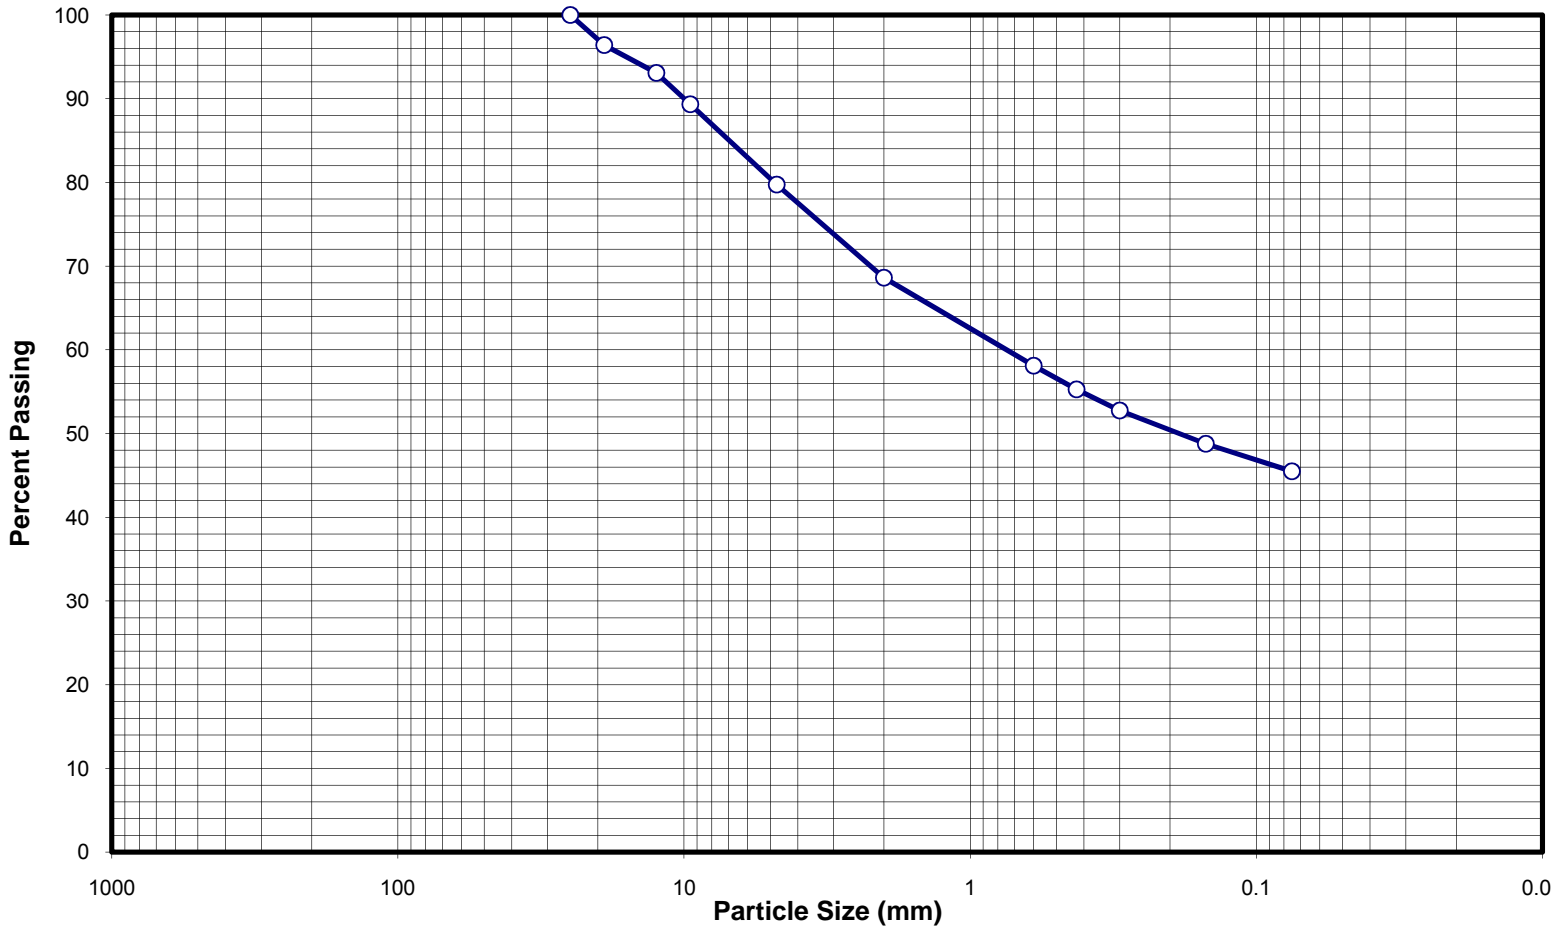
Sieve Size	% Passing
3"	-
2 1/2"	-
2"	-
1 1/2"	-
1"	100
3/4"	96
1/2"	93
3/8"	89
#4	80
#10	69
#40	55
#200	45

Gravel (%)	20	LL	NV	Project Name:	Lee's Ferry Road
Sand (%)	35	PL	NP	Sample ID:	P-10
Fines (%)	45	PI	NP	Sample Depth (ft.):	7"-5
Sample Description:	SM / A - 4 ( 0 )

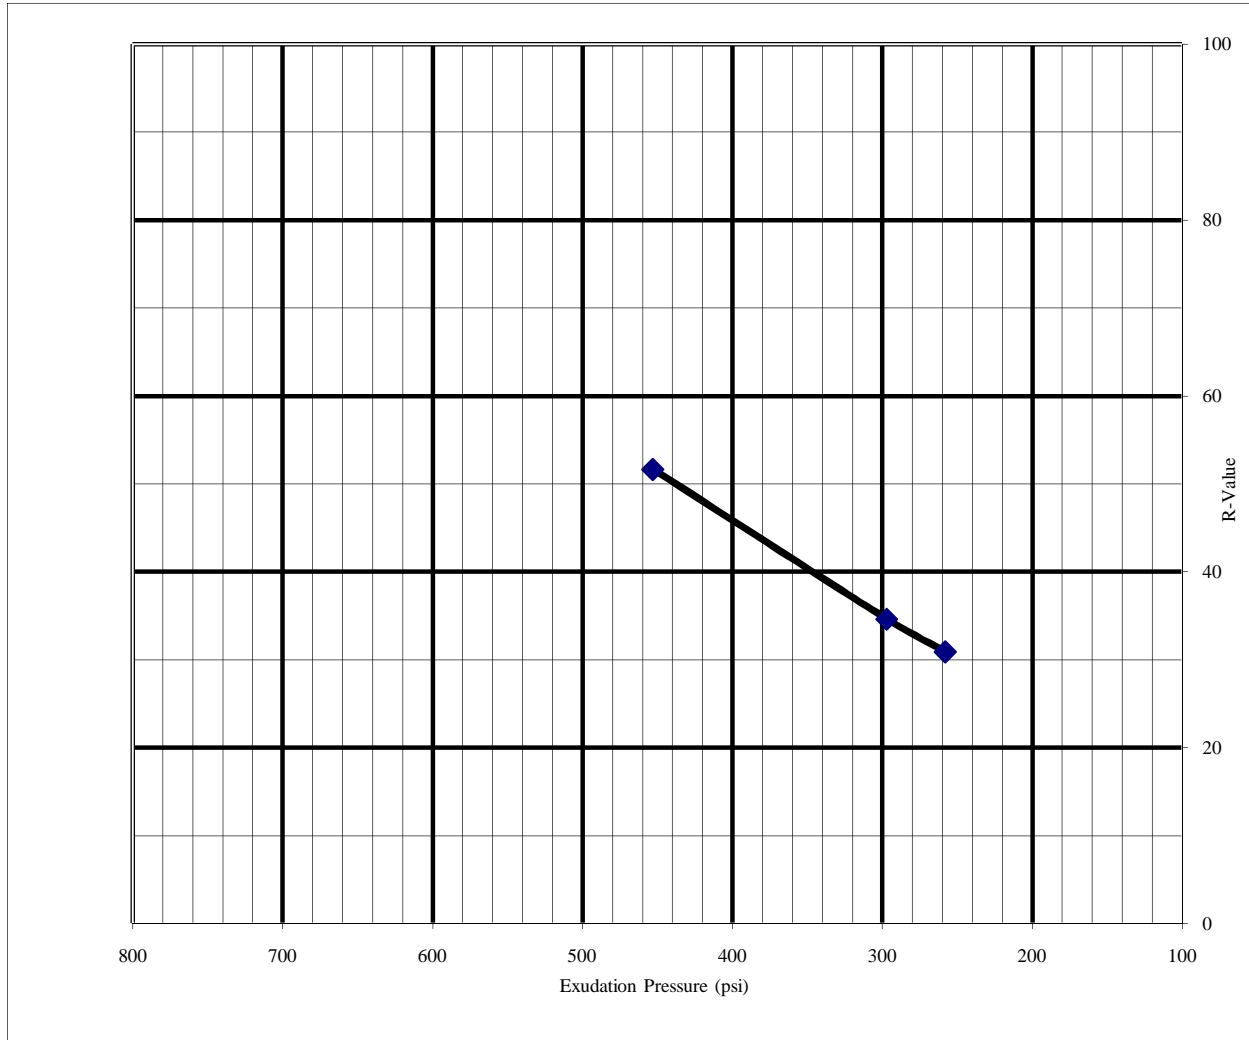
R-Value at 300 psi exudation pressure =

35

Test No.	Compact. Press. (psi)	Density (pcf)	Moist. (%)	Horizont. Pressure (psi)'@ 160 psi	Sample Height (in.)	Exud. Pressure (psi)	R Value	R Value Correct.
1	300	134.0	10	68	2.51	453	47	52
2	300	133.7	11	83	2.60	297	33	35
3	300	133.5	12	93	2.55	258	27	31

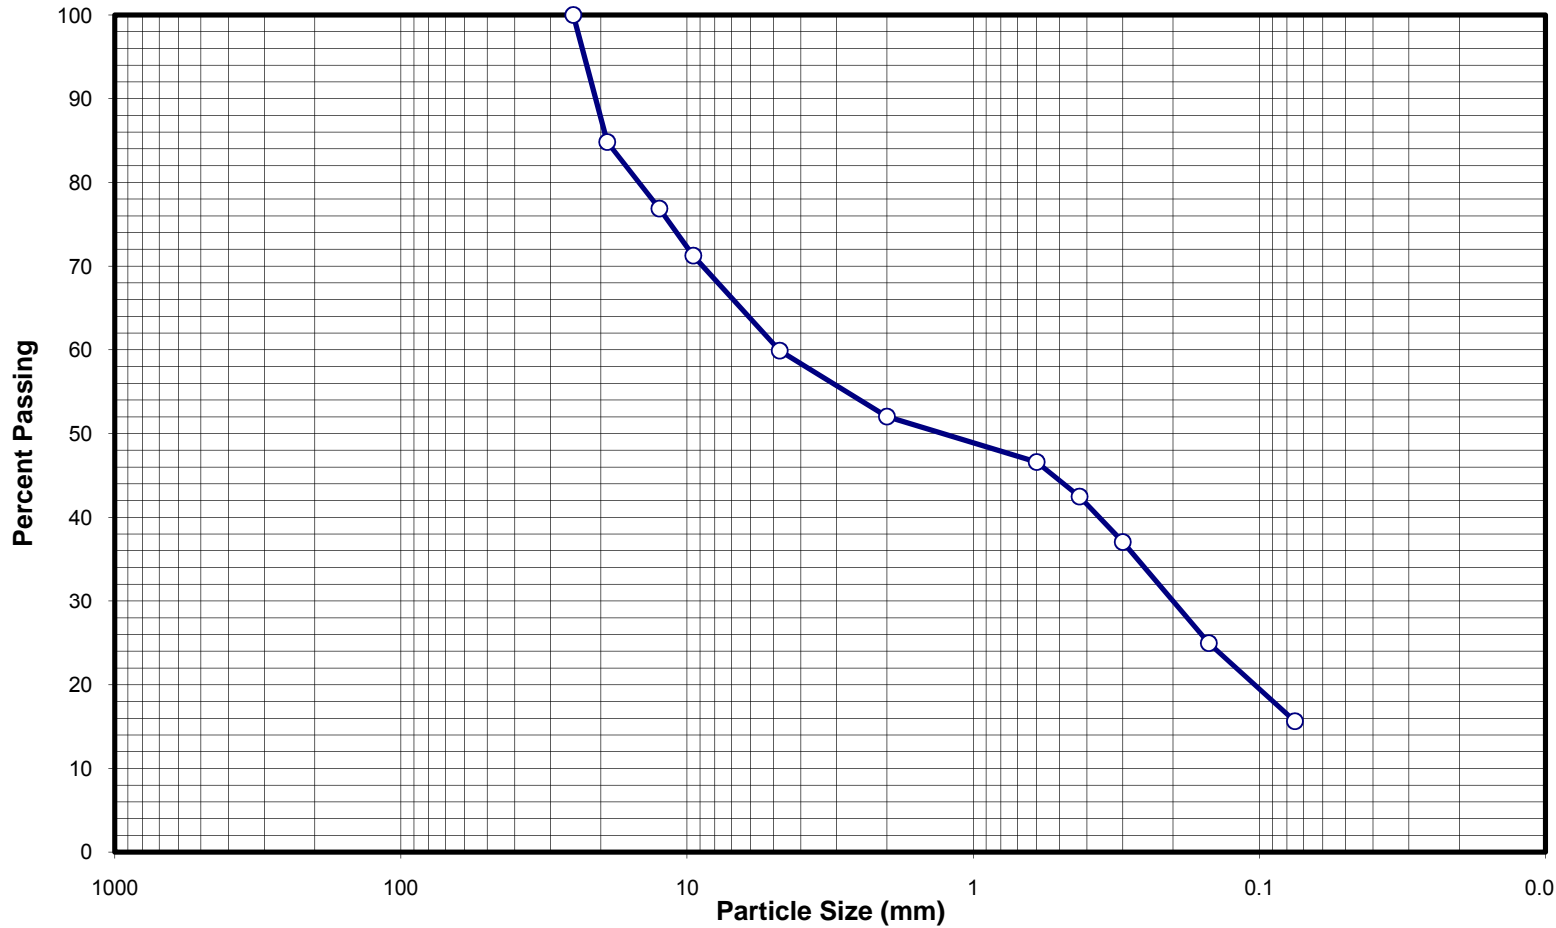
Sieve Size	% Passing
3"	-
2 1/2"	-
2"	-
1 1/2"	-
1"	100
3/4"	85
1/2"	77
3/8"	71
#4	60
#10	52
#40	42
#200	16

Gravel (%)	40	LL	NV	Project Name:	Lee's Ferry Road
Sand (%)	44	PL	NP	Sample ID:	P-18
Fines (%)	16	PI	NP	Sample Depth (ft.):	1-5
Sample Description:	SM / A - 1 - b ( 0 )

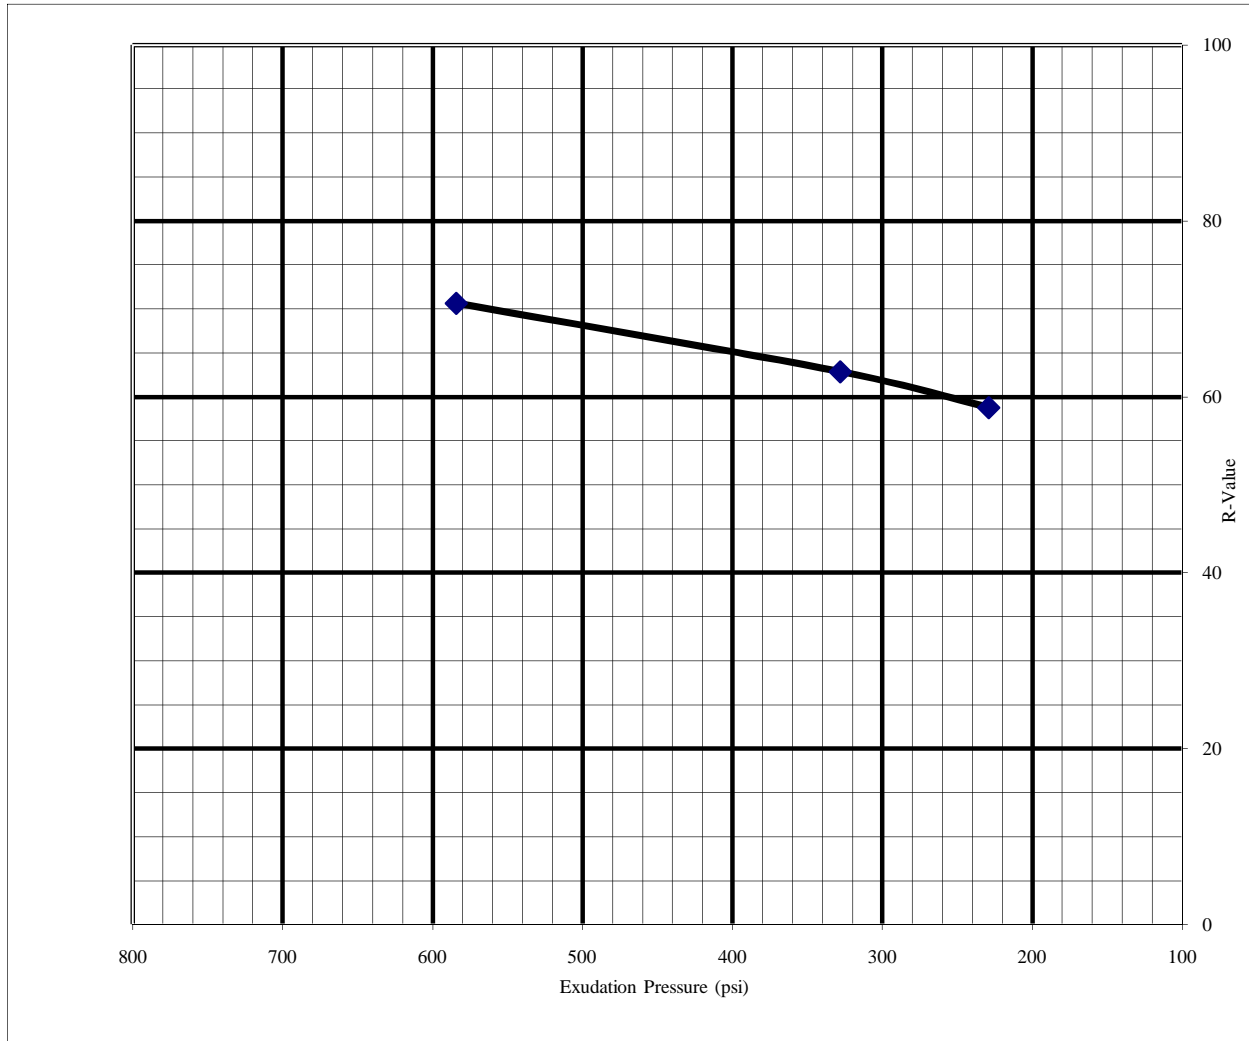
Classification: A-1-b(0)/ SM

R-Value at 300 psi exudation pressure = 61

Test No.	Compact. Press. (psi)	Density (pcf)	Moist. (%)	Horizont. Pressure (psi)'@ 160 psi	Sample Height (in).	Exud. Pressure (psi)	R Value	R Value Correct.
1	300	141.4	7	31	2.49	584	73	71
2	300	141.1	8	49	2.53	328	58	63
3	300	141.0	8	54	2.57	229	54	59

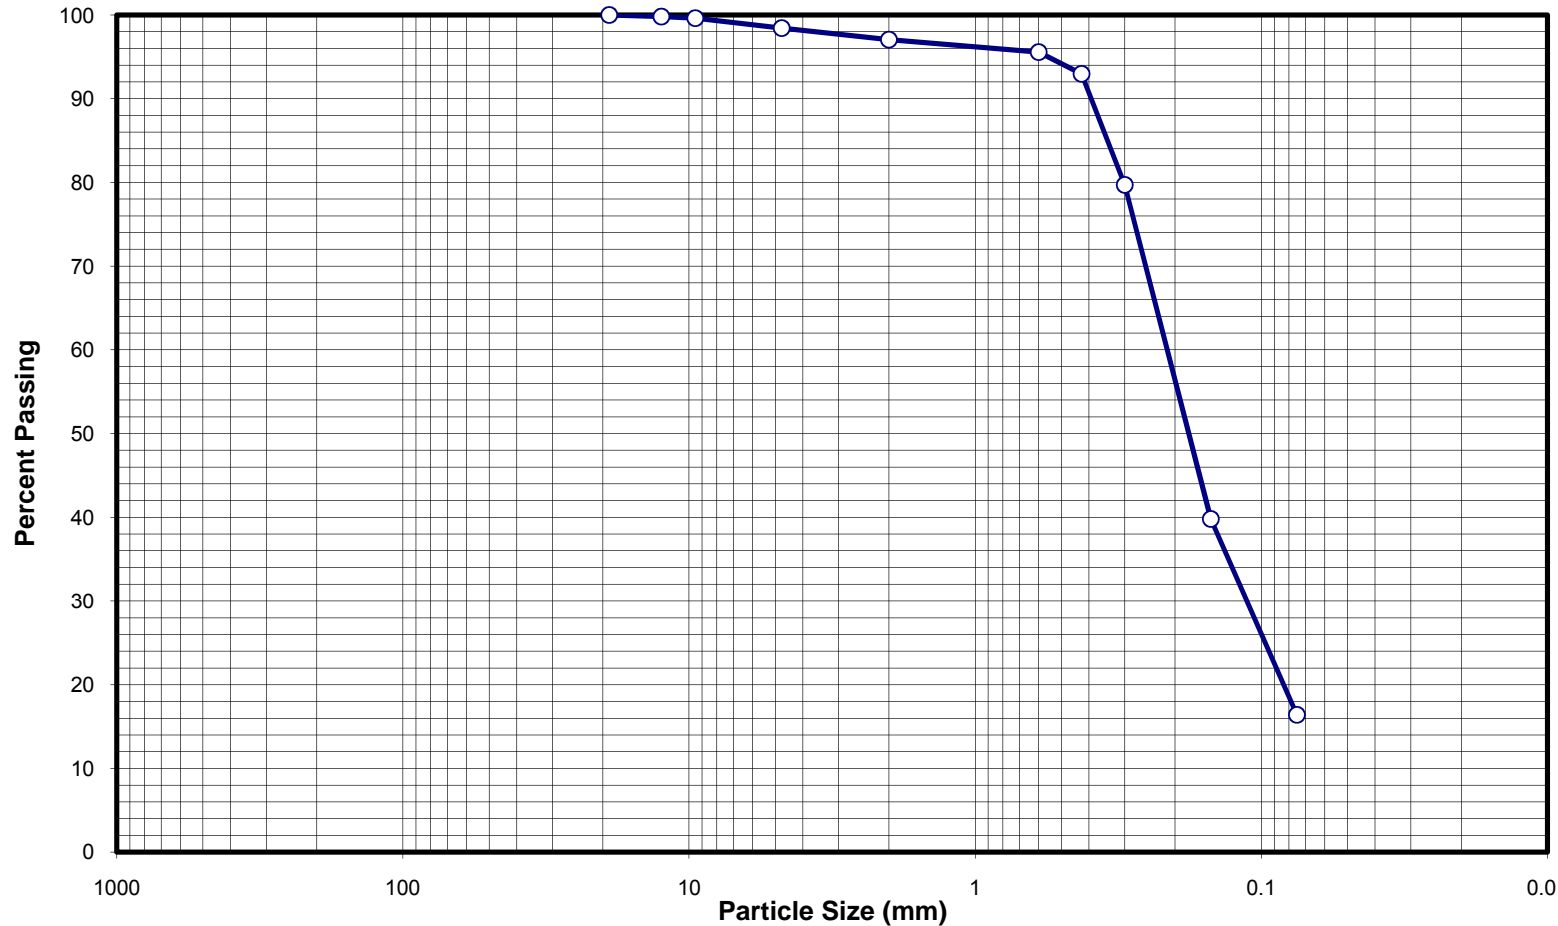
Sieve Size	% Passing
3"	-
2 1/2"	-
2"	-
1 1/2"	-
1"	-
3/4"	100
1/2"	100
3/8"	100
#4	98
#10	97
#40	93
#200	16

Gravel (%)	2	LL	NV	Project Name:	Lee's Ferry Road
Sand (%)	82	PL	NP	Sample ID:	P-21
Fines (%)	16	PI	NP	Sample Depth (ft.):	1-5
Sample Description:	SM / A - 2 - 4 ( 0 )

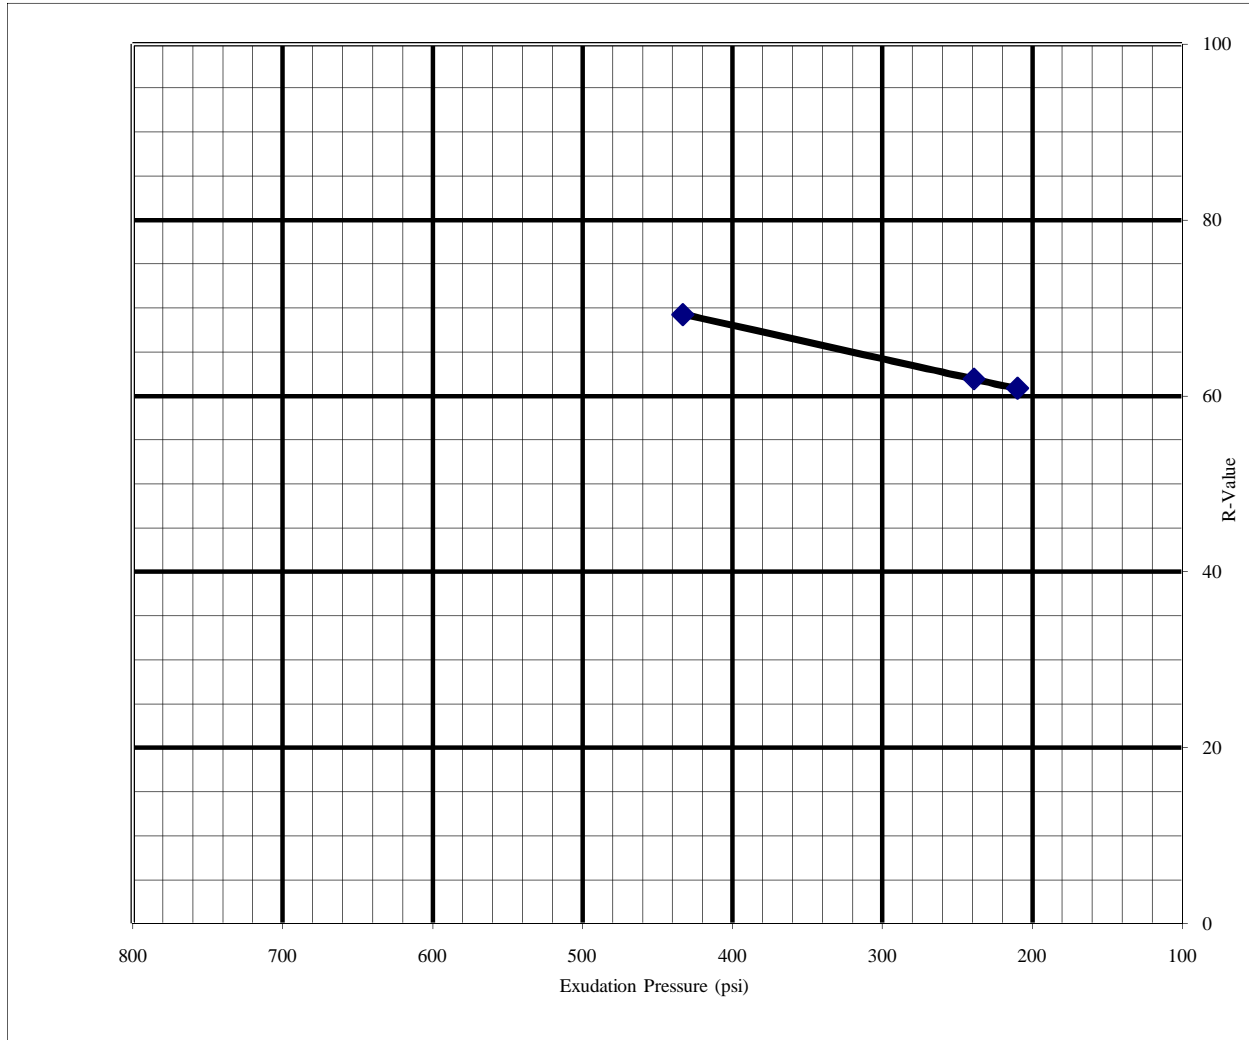
R-Value at 300 psi exudation pressure =

64

Test No.	Compact. Press. (psi)	Density (pcf)	Moist. (%)	Horizont. Pressure (psi)'@ 160 psi	Sample Height (in.)	Exud. Pressure (psi)	R Value	R Value Correct.
1	300	121.4	10	38	2.60	433	67	69
2	300	121.4	11	43	2.50	239	62	62
3	300	121.4	12	51	2.52	210	56	61

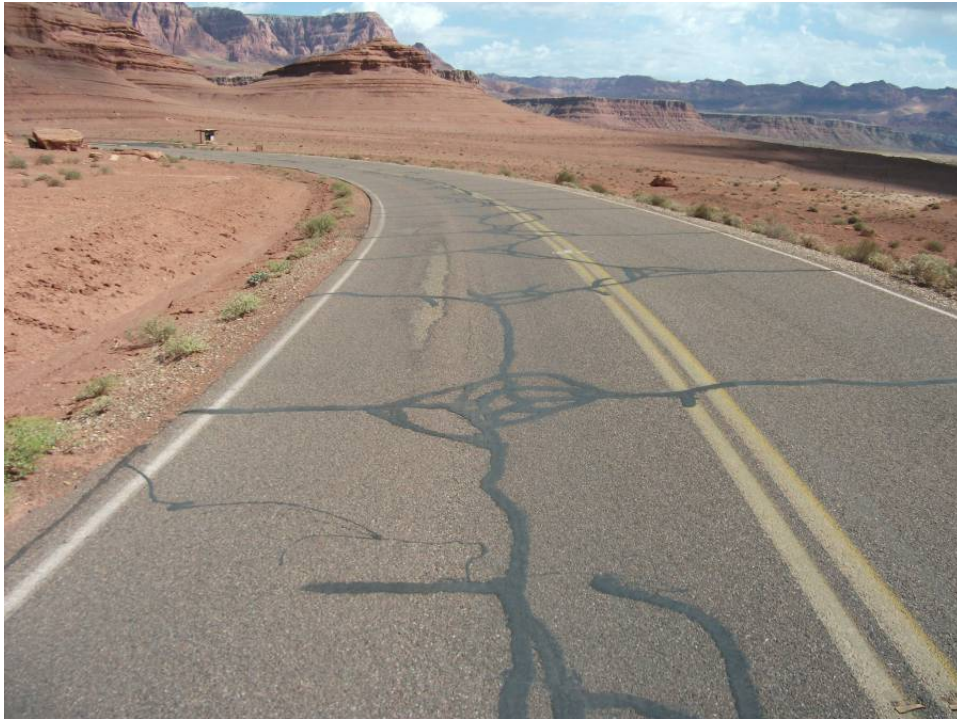
Photo 1 - Typical pavement condition between intersection with US 89 to Pay Station

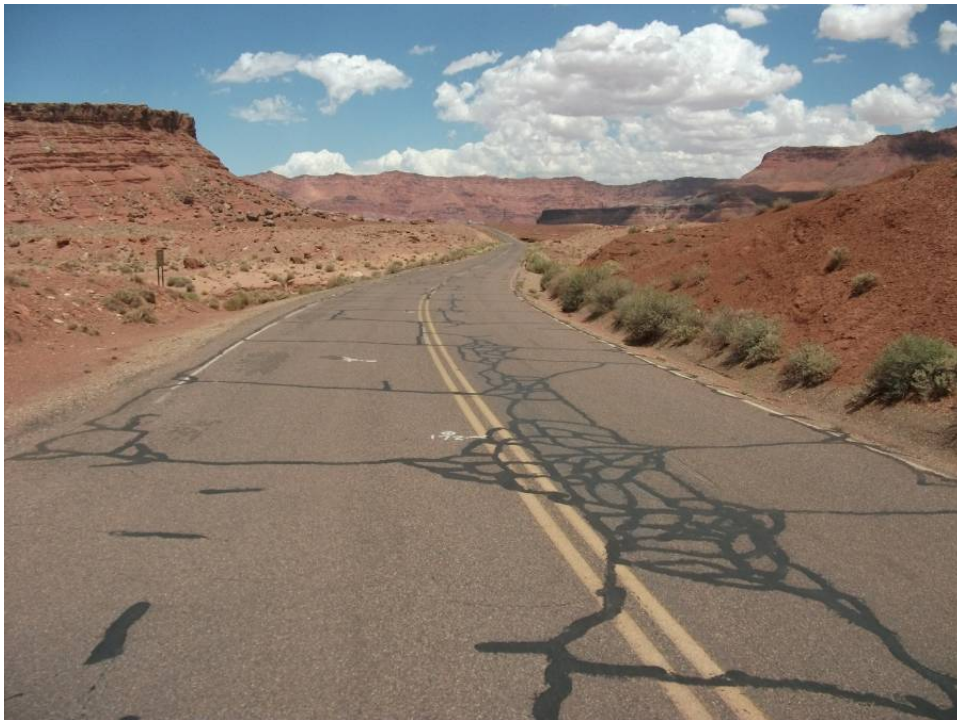
Photo 2 - Start of subgrade problem area near Station 131+00 extra ABC and edge drain recommended

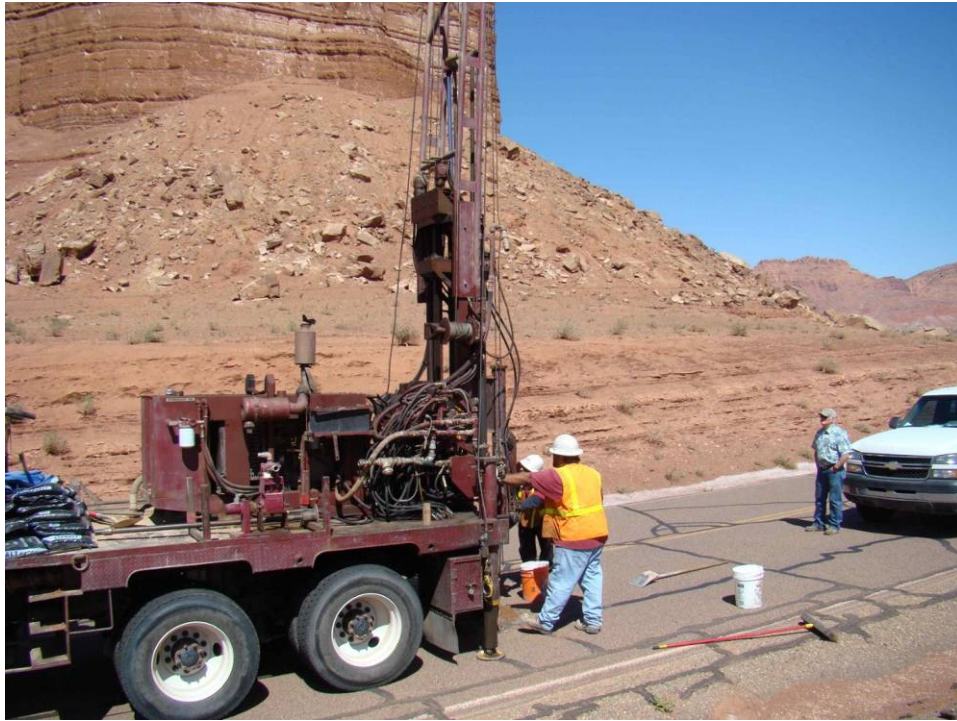
Photo 3 - Drilling P-4 extensive thermal transverse and block cracking in existing pavement

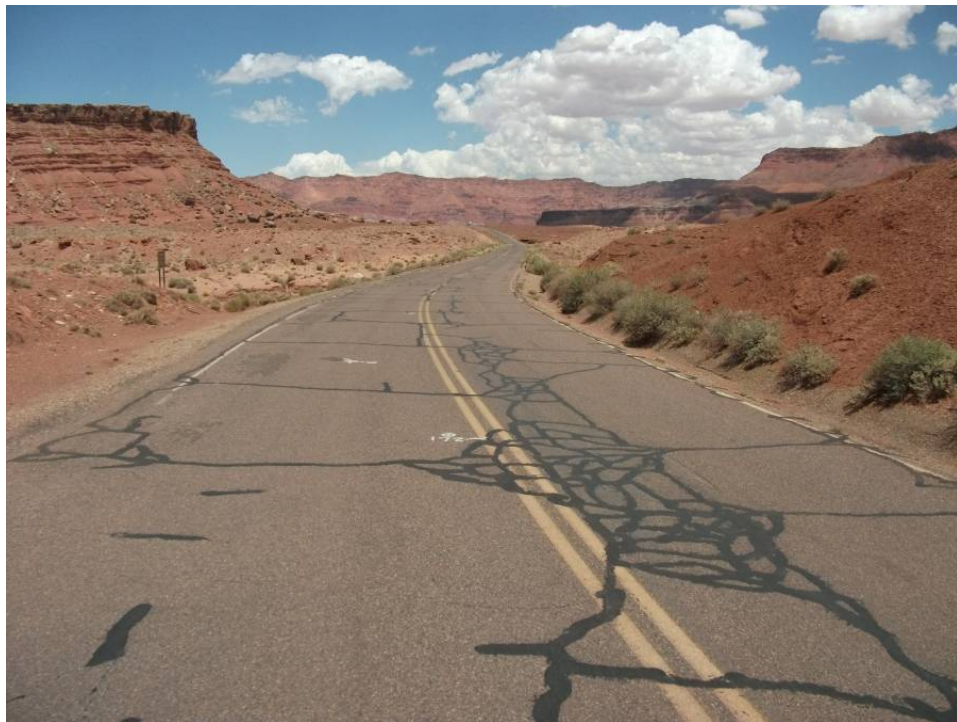
Photo 4 - Lower end of rough section near Sta. 178+00 where edge drain is recommended

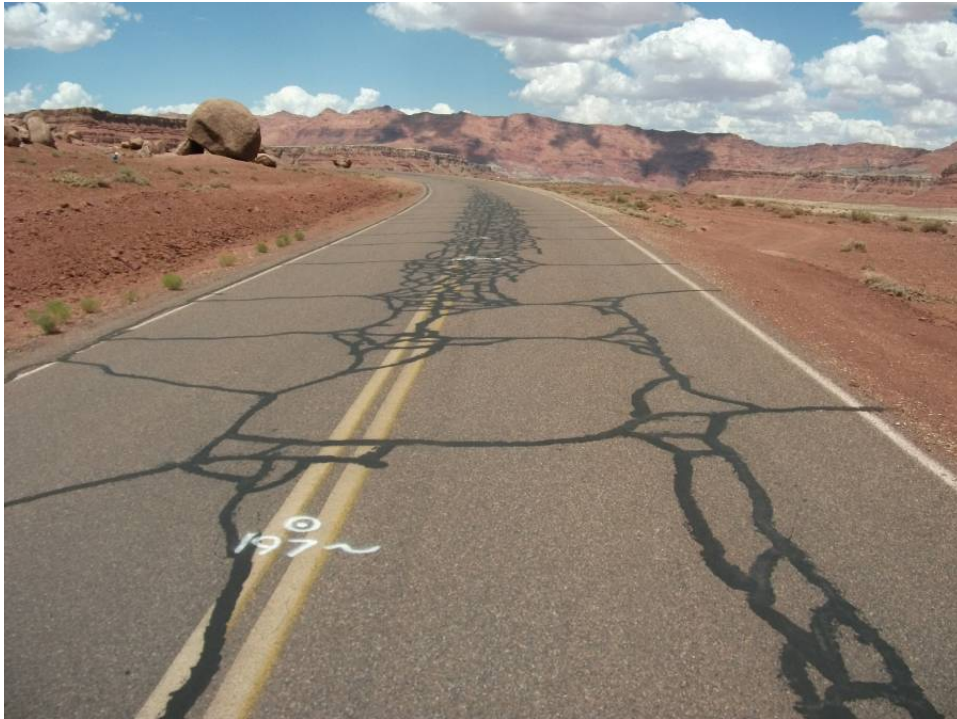
Photo 5 - Typical condition near center of project, thermal cracking with deteriorated center line and some wheel path fatigue cracking

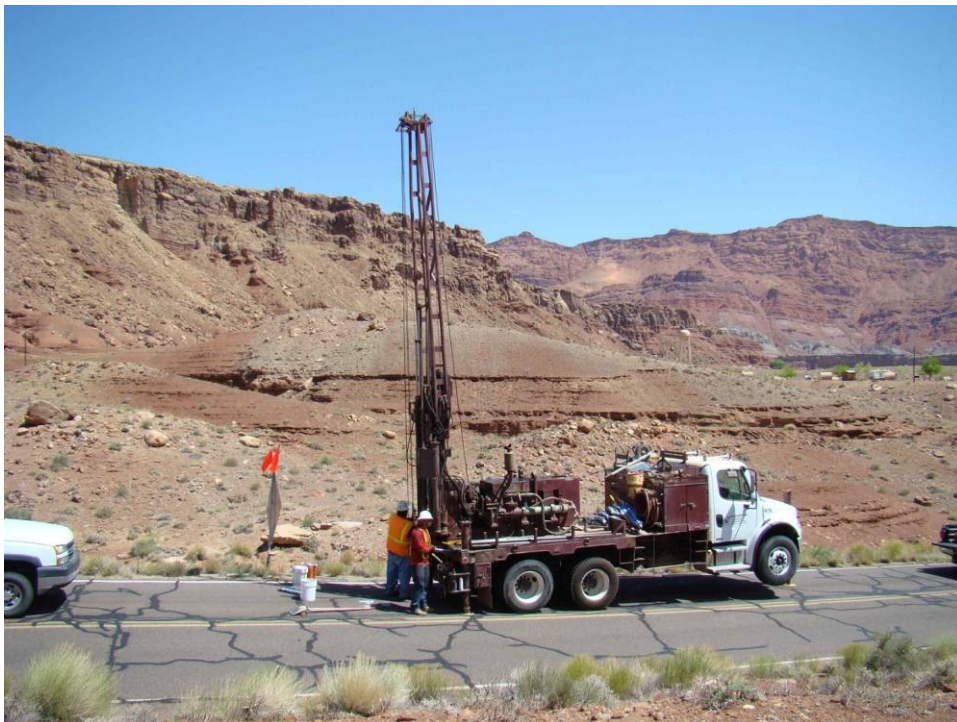
Photo 6 - Drilling P-16 with extensive block cracking

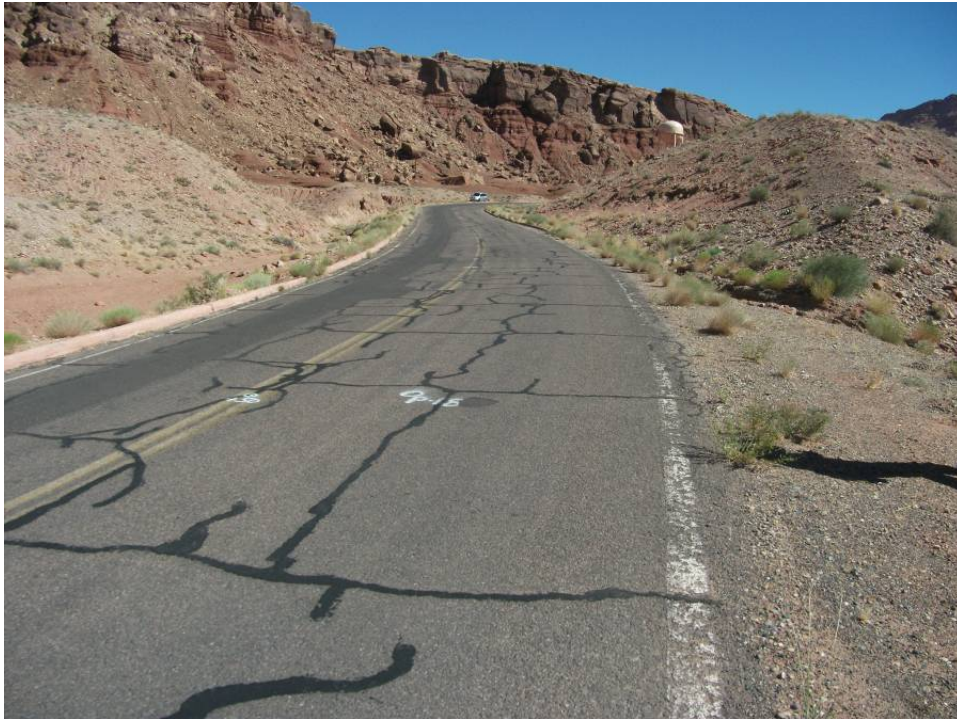
Photo 7 - Near Boring P-18 showing thermal cracks deteriorating to block and utility patch outbound as road descends to Paria River Bridge

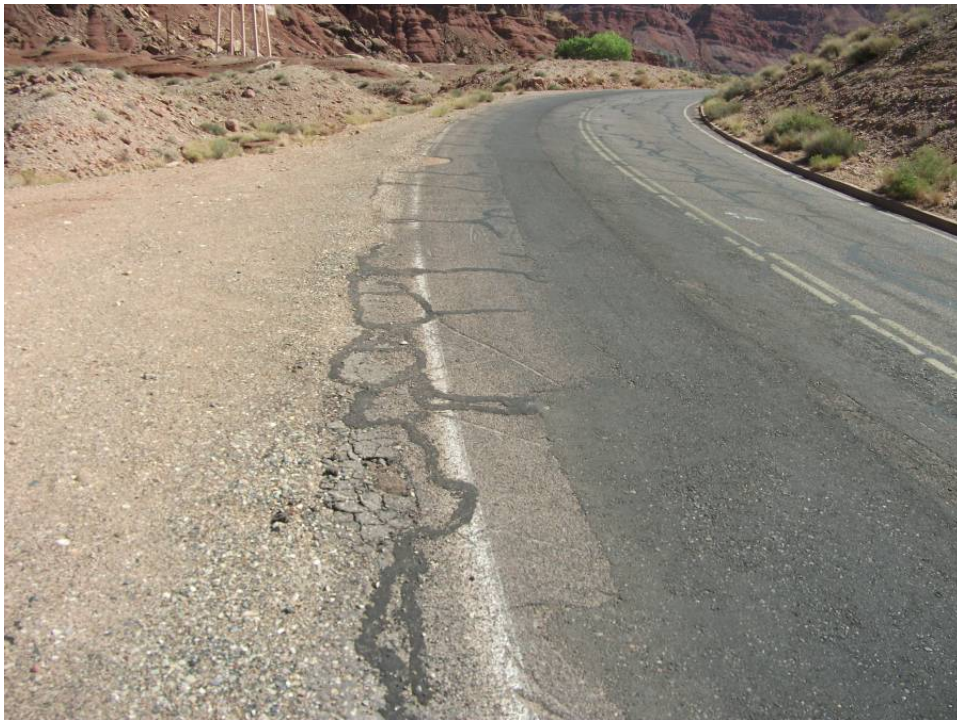
Photo 8 - Edge deterioration and patching from utility installation - block cracking in NB lane

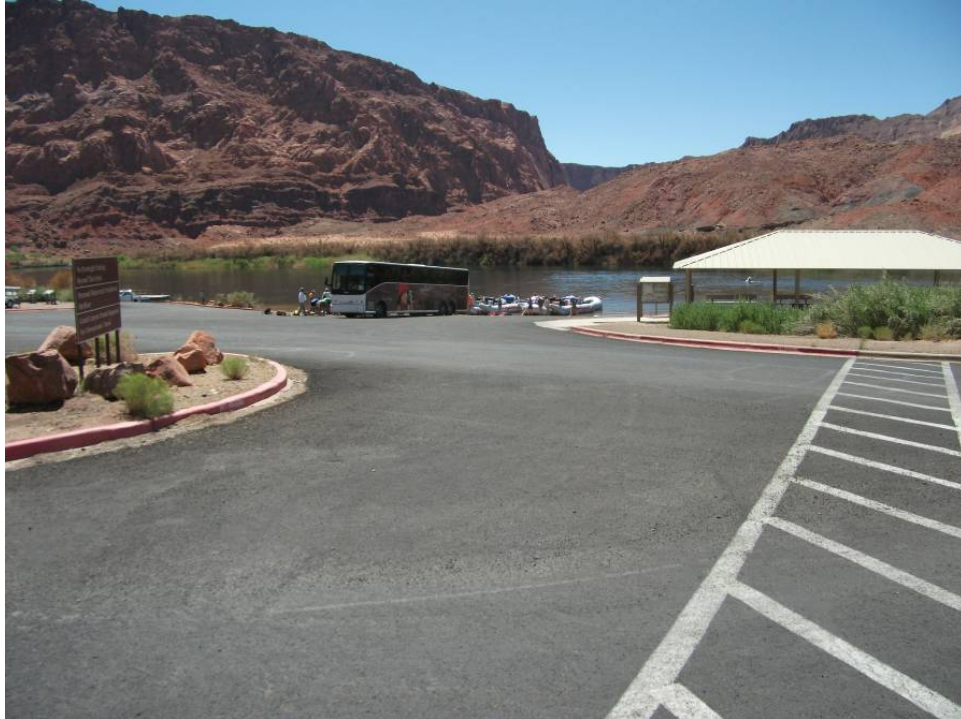
Photo 10 - Launch area with bus recently slurry sealed, good pavement condition
