# Analysis of Elevation Changes Detected from Multi-Temporal LiDAR Surveys in Forested Landslide Terrain in Western Oregon

## ABSTRACT

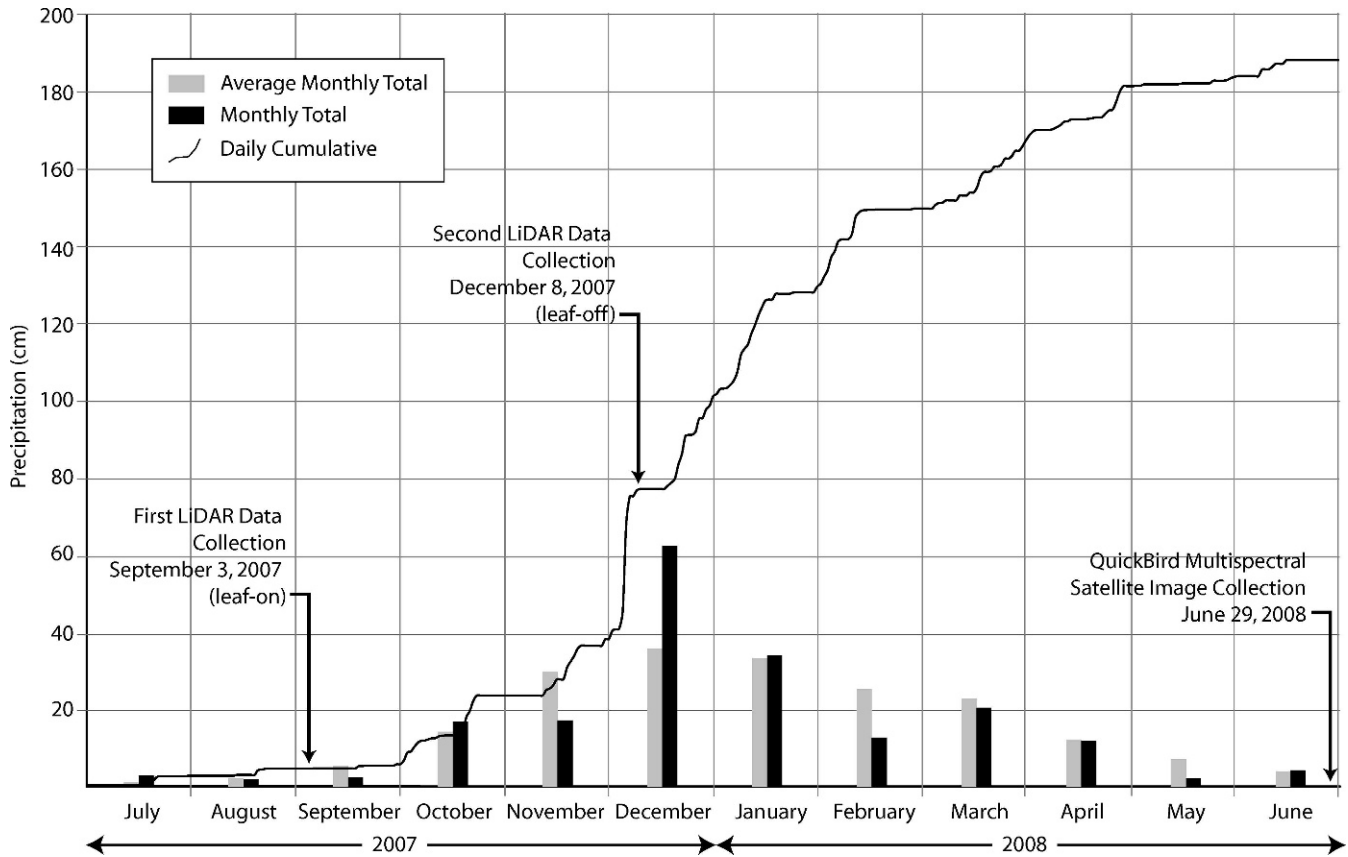
Figure 2. Graph of precipitation with respect to timing of LiDAR data collection between July 2007 and June 2008. The December 8, 2007, LiDAR data were collected right after the large storm of December 2–4, 2007. This storm resulted in more than half (34 cm) of the rainfall total for the month of December 2007 (National Climatic Data Center, 2008).

The study area is situated within 80 km of the Pacific Ocean. Climate in the area is strongly influenced by the close proximity to the ocean. Average annual rainfall in the area is about 200 cm (National Climatic Data Center, 2008) (Figure 2).

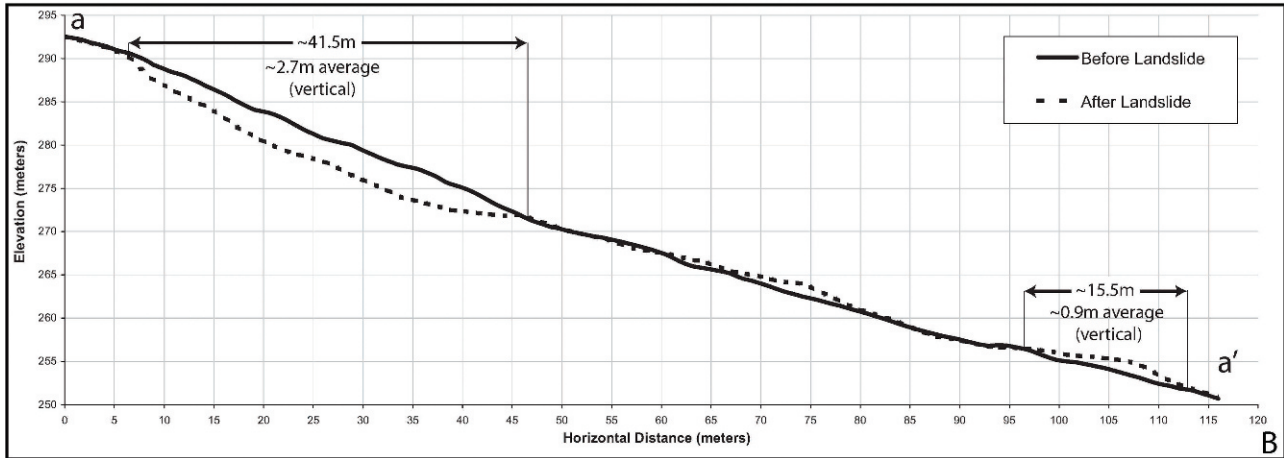
Figure 4. Comparison between LiDAR data and simple survey data at site 3s5w29-2. (A) Map showing areas of negative elevation changes (red colors, landslide depletion areas) and positive elevation changes (blue colors, landslide deposition areas) derived from differential LiDAR data. Inset shows photo taken looking downslope along profile a-a'. Landslide deposit is located in the upper center of the photo (near the dead Douglas fir trees with brown needles). (B) Profile data from the leaf-on and leaf-off LiDAR data sets. (C) Profile data from simple survey. “After landslide” surface was collected by simple survey, and “before landslide” surface was estimated during the simple survey.

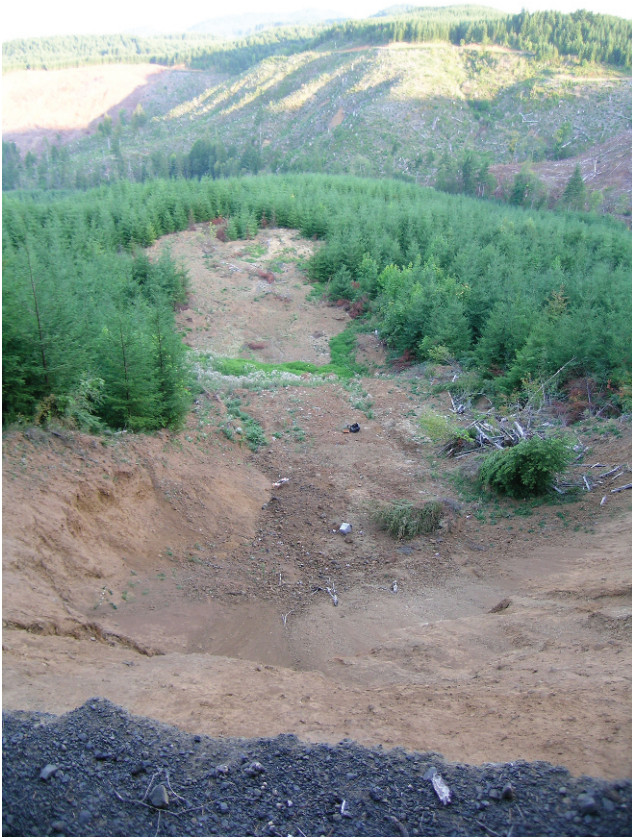
Figure 9. Photo of site 3s5w30-9. Plan and profile data are shown in Figure 5. Edge of road is visible in foreground. Note the young forest surrounding the deposit and the lack of any remaining vegetation in the landslide area.

At site 3s5w30-9 (Figure 5), a large landslide occurred between September 2007 and December 2007 (Figure 9). The landslide resulted from a failure of fill material underlying an active logging road through a forested area. A drainage culvert was present at the site and was visible in the landslide deposit when we visited in September 2008. Elevation changes caused by this landslide are visible when

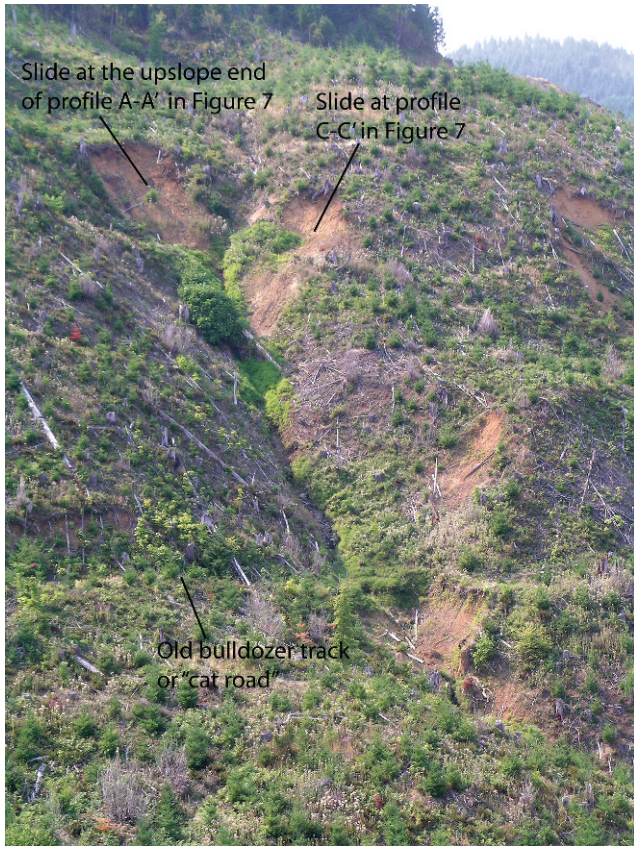
Figure 11. Photo of site 3s5w30-11. Plan and profile data of the site are shown in Figure 7.

slope from point C in Figure 7) between September 2007 and December 2007. Both landslides occurred on natural slopes in a clear-cut area (Figure 11). When we visited the site in September 2008, two small springs were present in the landslide source area downslope from point A, but none were observed in the area downslope from point C. Elevation changes caused by the landslides and subsequent debris flows are visible when comparing profiles derived from bare-earth LiDAR data from September 2007 and December 2007 (Figure 7). Maximum elevation changes were about 3 m in the landslide source areas (Figure 7, profiles A-A', B-B', and C-C') and about 0.5 m in the relatively flat debris-flow deposition area near point A'. The difference between bare-earth and first-return LiDAR data indicates that vegetation in the area prior to the landslide ranged up to about 2 m in height (Figure 7, B-B'), which is in agreement with field observations of vegetation surrounding the site in September 2008 (Figure 11). A comparison of post-event, bare-earth LiDAR data from December 2007 and total station survey data from September 2008 indicates that the overall RMSE of bare-earth LiDAR data at the site is 0.74 m (site 3s5w30-11,

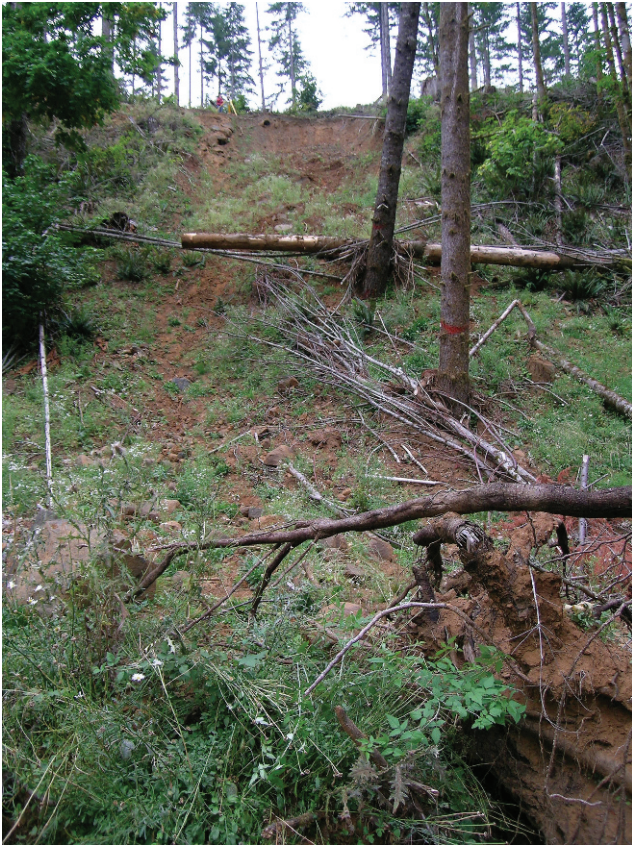
Figure 12. Photo of site 3s5w29-1 taken looking upslope. Plan and profile data of the site are shown in Figure 8. Note boulders from previous retaining wall in the landslide scar, just below yellow total station at top of photo.

At site 3s5w29-1 (Figure 8), a large landslide occurred between September 2007 and December 2007 (Figure 12). The landslide resulted from a failure of fill material underlying an active logging road through a partially thinned, forested area. A drainage culvert was present at the site and was visible in the landslide headscarp when we visited the site in September 2008. Additionally, we observed scattered large boulders (from a previous retaining wall) in the landslide scar and an older, more vegetated landslide deposit near the base of the slope. Both of these characteristics indicate that the site had been affected by a landslide prior to the late 2007 landslide. Elevation changes caused by the late 2007 landslide are visible when comparing profiles derived from bare-earth LiDAR data from September and December 2007 (Figure 8). Maximum elevation changes were about 3 m in the landslide source area (Figure 8, profile B-B') and only a few decimeters in the relatively flat deposition area (Figure 8, profiles C-C' and D-D'). First-return LiDAR data from the
