**Terrestrial LIDAR Investigation of the December 2003 and  
January 2007 Activations of the Northridge Bluff  
Landslide, Daly City, California**

Brian D. Collins<sup>1</sup>, Robert Kayen<sup>1</sup>, Thomas Reiss<sup>1</sup>, and Nicholas Sitar<sup>2</sup>

Open File Report 2007–1079

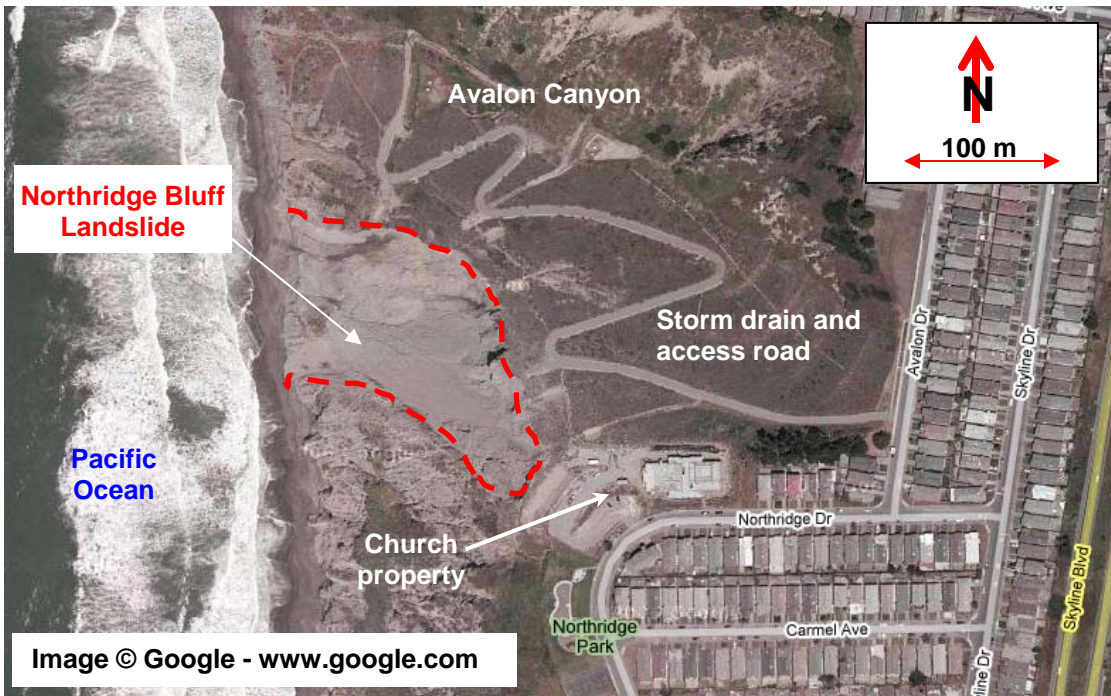
**Figure 2.** Site map of Northridge Bluff Landslide, Daly City, California showing key features

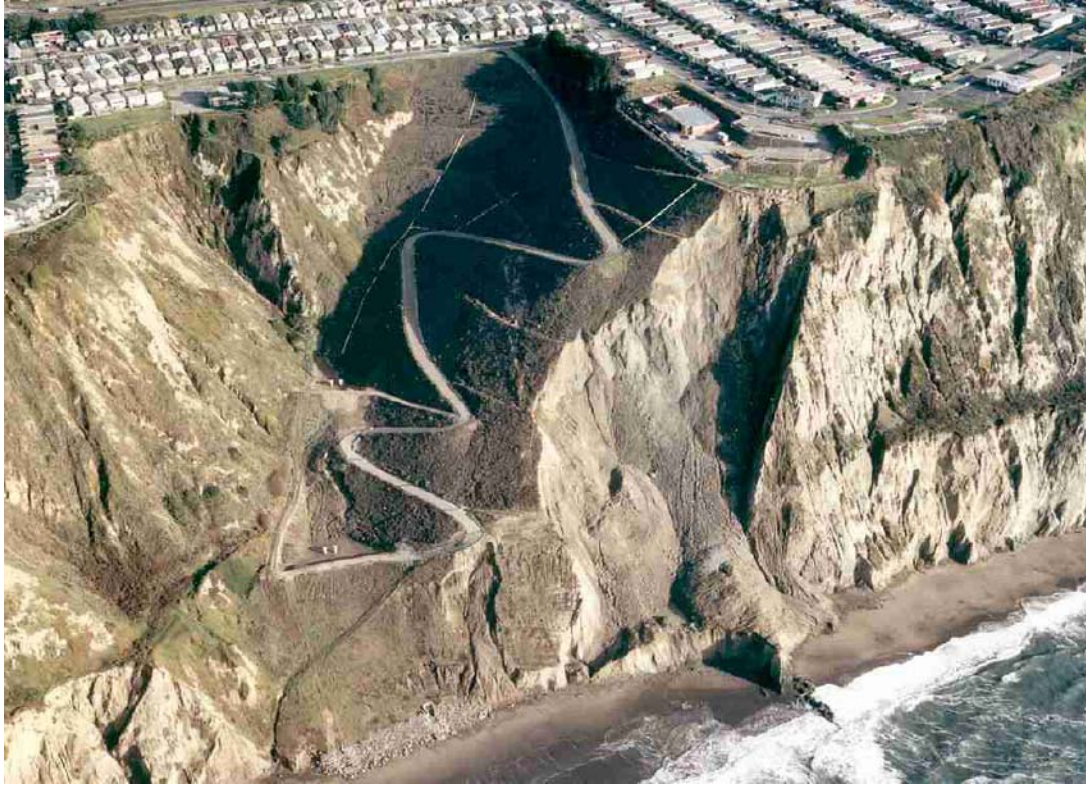
**Figure 3.** The December 20, 2003 Northridge Bluff Landslide Event (Photo from Cotton, Shires, and Associates, 2004b)

On December 20, 2003, part of a steep coastal bluff failed as a complex landslide mass along the cliffs that form the west boundary of Daly City, California (Fig. 3). The main slide mass measured approximately 290 meters in length, 120 meters in width, and 12 meters in depth; the volume of landslide material was estimated to be between 305,800 and 382,300 cubic meters. The failure spanned

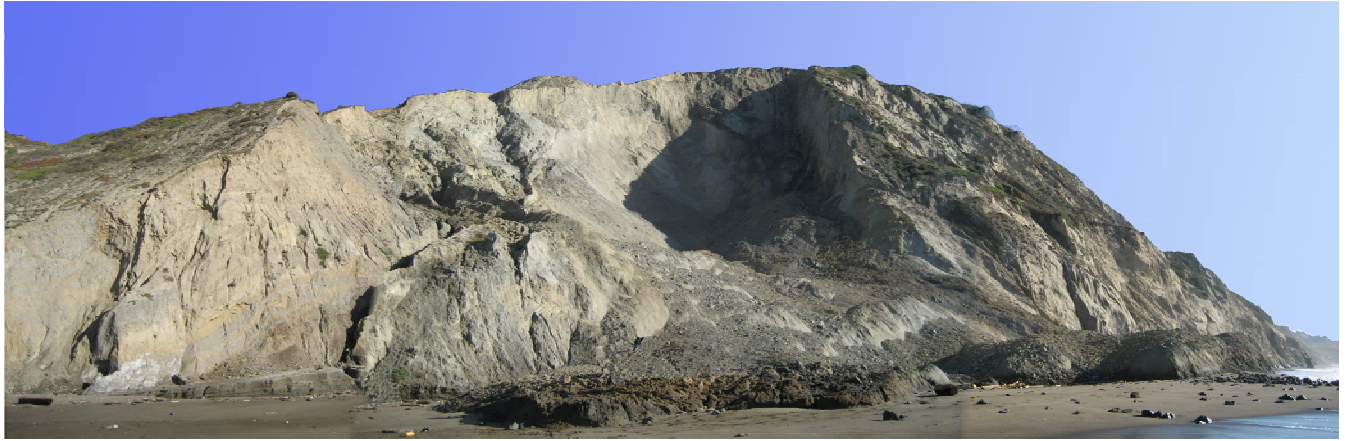
**Figure 5.** The January 1, 2007 Northridge Bluff Landslide Event. Bluff height is about 140 meters.

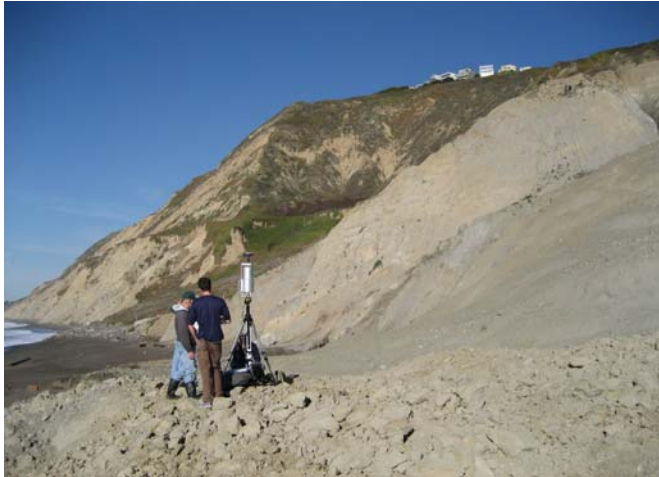
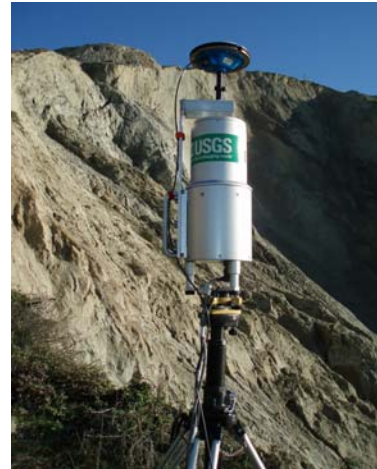
**Figure 6.** The USGS Coastal and Marine Geology program's terrestrial LIDAR unit at the Northridge Bluff Landslide. Close-up shows laser and GPS antenna used for georeferencing instrument location.

In this study, the CMG’s Riegl Z210 laser scanner (Riegl, 2007) was utilized as a tripod mounted survey instrument (Fig. 6) and transported by backpack to each scanning location. Multiple scans were collected during each survey to fill in “shadow zones” of locations not directly in the line of

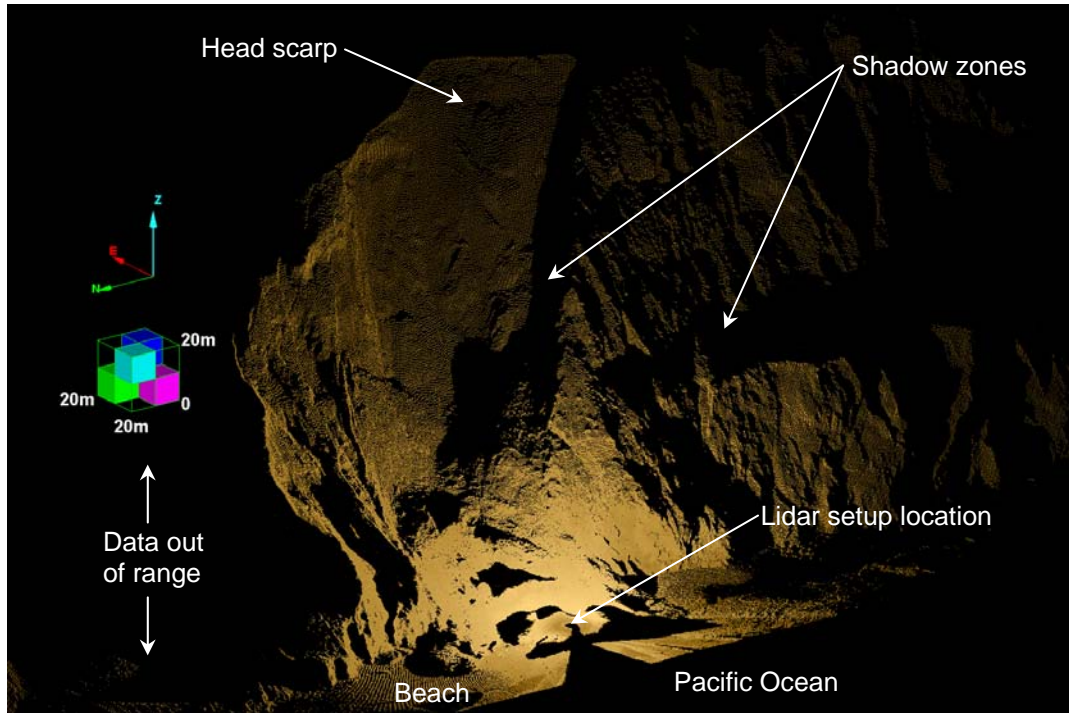
**Figure 10.** Typical point cloud data from a single scan of the Northridge Bluff Landslide following the January 1, 2007 event. Black areas indicates shadow zones, filtered data (ocean) and areas where no data were collected beyond the range of the laser.

The LIDAR data for each landslide event consists of several million points, each describing a three-dimensional coordinate of a point on the ground surface. The full data point cloud for the 2003 event and 2007 event are shown in Figures 7 and 8. A detailed view of a single point cloud (Fig. 10) shows the complexity of the point data, including plainly visible features such as the head scarp and beach area. The non-laser points (termed “sky-points”), collected by the laser’s integrated color sensor, may be used to view the topographic data in relation to its setting for a more realistic perspective (Fig. 11).

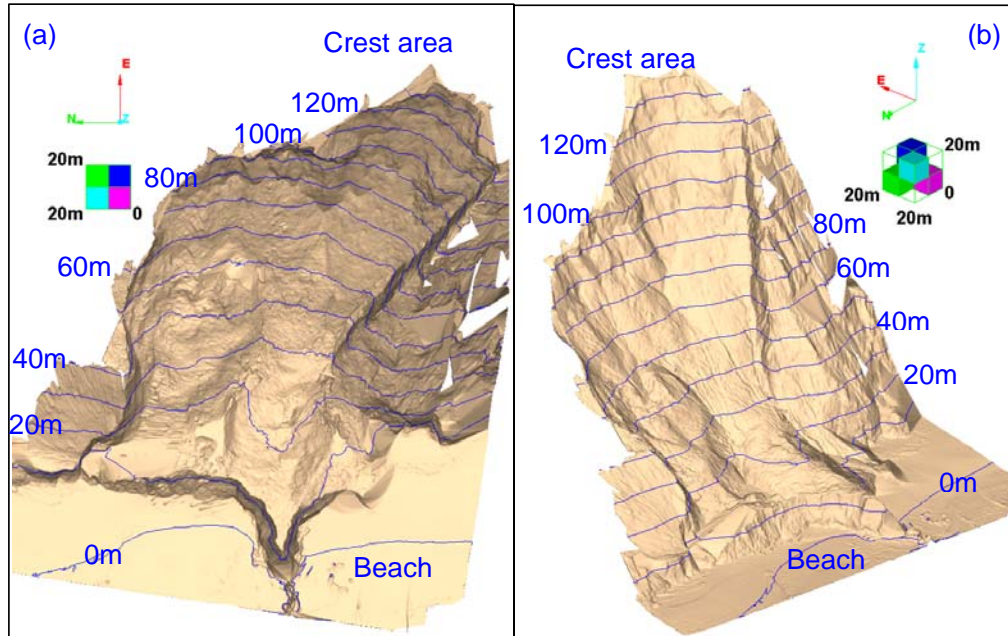
**Figure 12.** Plan (a) and oblique (b) surface views of the December 2003 event with 10-meter contour intervals. Holes (white areas) represent areas where no data were collected.

The final surface for the December 2003 event consists of 712,000 points modeled by 1.4 million triangular facets describing an area 54,600 m<sup>2</sup> in size (Fig. 12). The final surface for the pre-2007 event consists of 682,000 points modeled by 1.4 million triangular facets describing an area 51,300 m<sup>2</sup> in size (Fig. 13). The final surface for the January 2007 event consists of 778,000 points modeled by 1.5 million triangular facets describing an area 57,900 m<sup>2</sup> in size (Fig. 14). Each of these

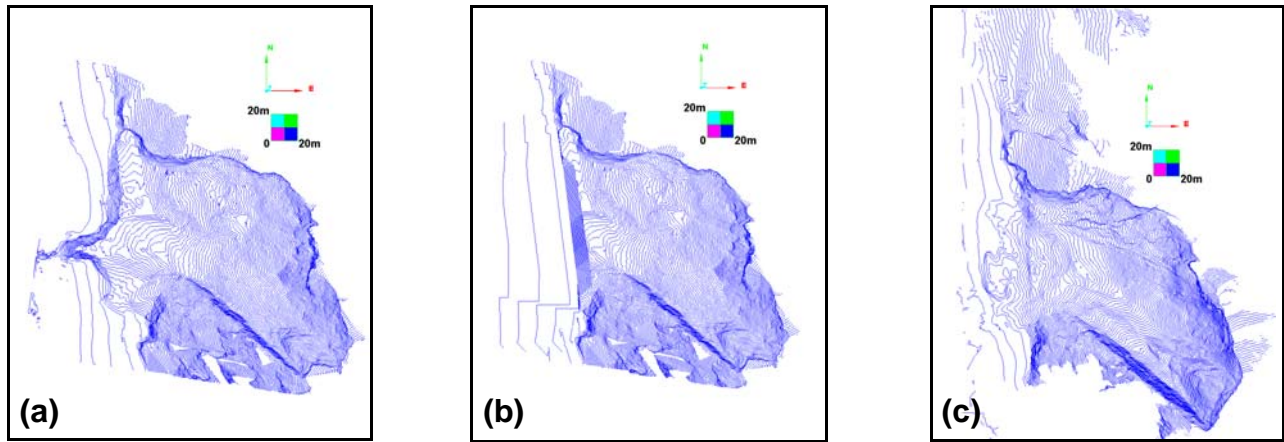
**Figure 15.** Graphics of 1-meter interval contour data available for the Northridge Bluff Landslide LIDAR surfaces (a) December 2003 event, (b) Pre-2007 event, and (c) January 2007 event.

Data coverages, available as topographic maps with 1-meter contour intervals (Fig. 15), are accessible through digital download for each surface. Contour data in XYZ format (.txt), AutoCAD Drawing Interchange format (.dxf), and associated FGDC-compliant metadata for each file are available through the links provided in Table 3. Data files are compressed using WinZip 9.0 (WinZip, 2007). Data in XYZ format consists of an x, y, z point file with the easting, northing, and elevation of each point describing a contour line. Data in dxf format consists of data lines describing each contour line and can be viewed through a number of GIS spatial data processing software platforms. Metadata files are available in four formats: FAQ (Frequently Anticipated Questions), HTML, text, and XML.

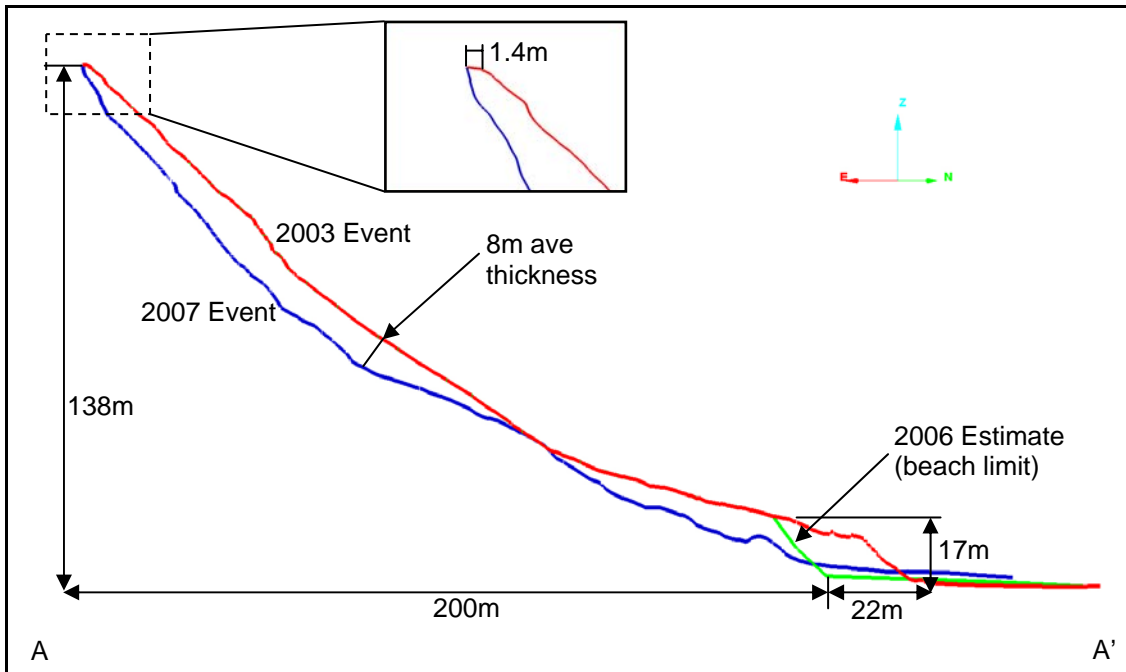
**Figure 17.** Cross-section A-A' (southeast-northwest) showing post-2003 event (red), post-2007 event (blue), and assumed pre-2007 event toe geometry (green).

The cross-sections show that the 2007 event removed a large amount of the debris left within the landslide area following the 2003 landslide. Average change between the two post-event debris surfaces was 8 meters (measured vertically) with localized areas reaching 14 meters depth. The maximum mobilized landslide mass is estimated to be about 12 meters thick (measured slope-perpendicular); however, because the location of the 2007 event failure plane is not known, this is a minimum estimate. Although the 2007 event occurred almost entirely within the footprint of the 2003 landslide area, additional crest retreat did occur on the northern and southern head scarps (~1.5 meters) and to a much larger extent within the central head scarp (~9.3 meters). The maximum change was detected within this central area (Section C'C'). Average slope inclinations of the post-event profiles decreased only slightly from 40° to 38°; however, inclinations of the upper head scarp area increased by 5° to approximately 50° and locally to 90° (vertical).

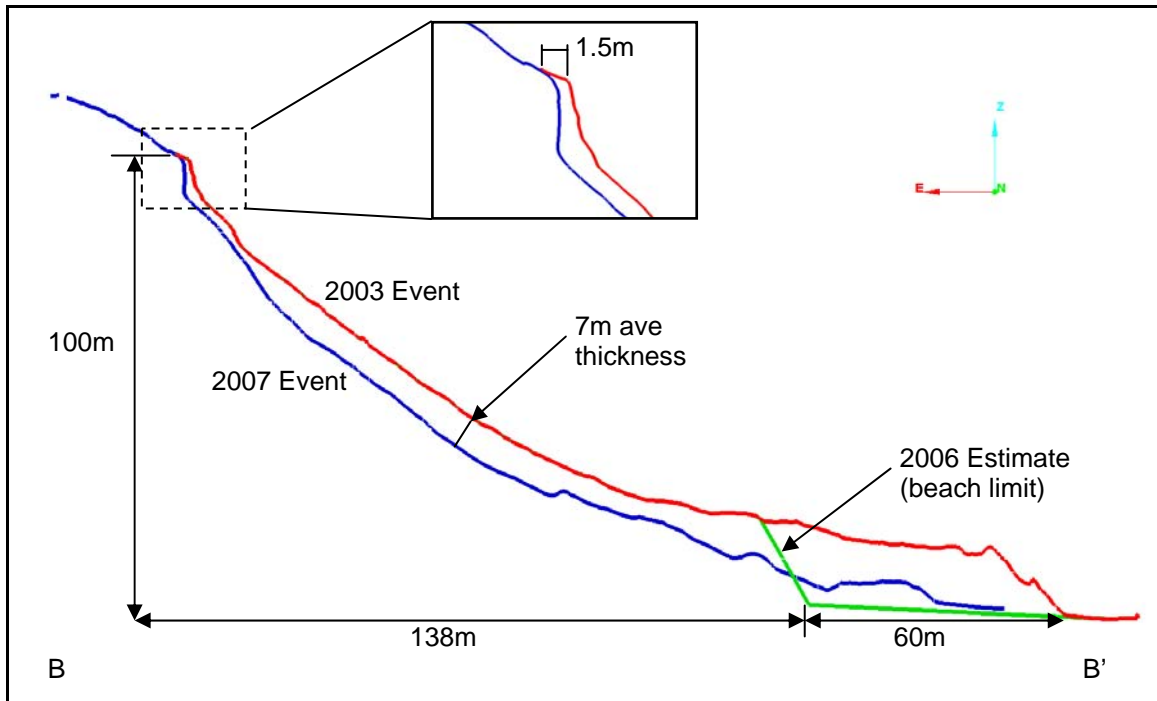
**Figure 18.** Cross-section B-B' (east-west) showing post-2003 event (red), post-2007 event (blue), and assumed pre-2007 event toe geometry (green).

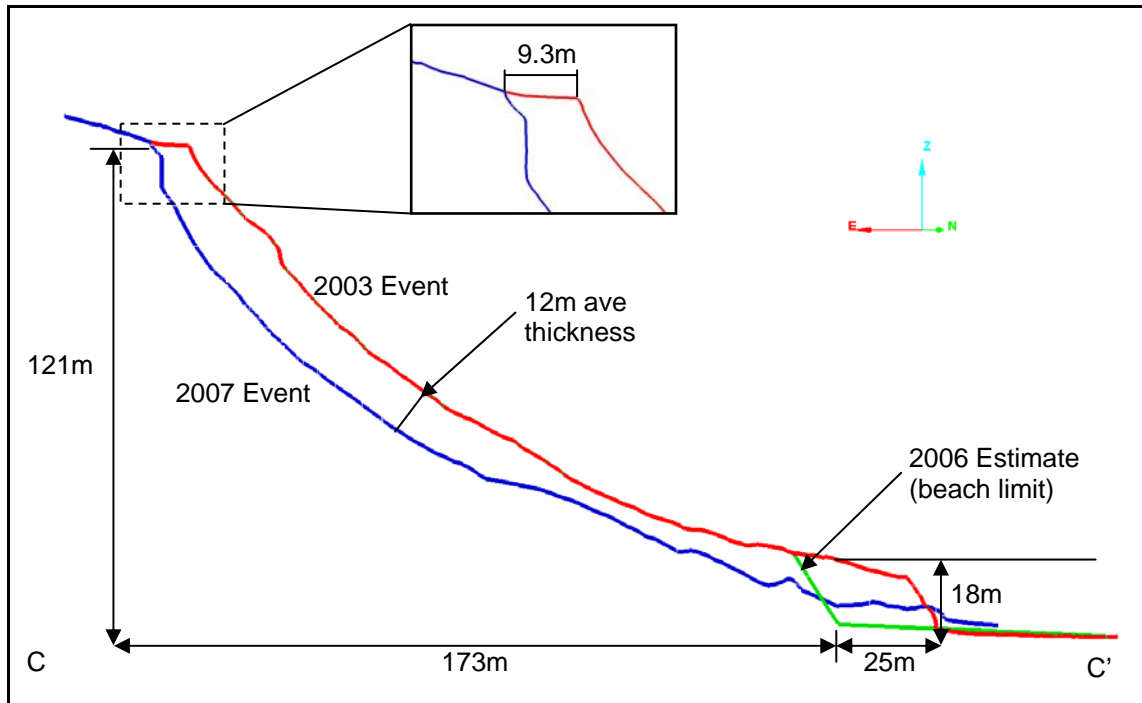
**Figure 19.** Cross-section C-C' (west northwest – east southeast) showing post-2003 event (red), post-2007 event (blue), and assumed pre-2007 event toe geometry (green).
