Federal and Tribal Lands Road Safety Audits: **CASE STUDIES**

FHWA-FLH-10-05

1. Report No. FHWA-FLH-10-05	2. Government Accession No.	3. Recipient's Catalog No.	
4. Title and Subtitle Federal and Tribal Lands Road Safety Audits: Case Studies		5. Report Date December 2009

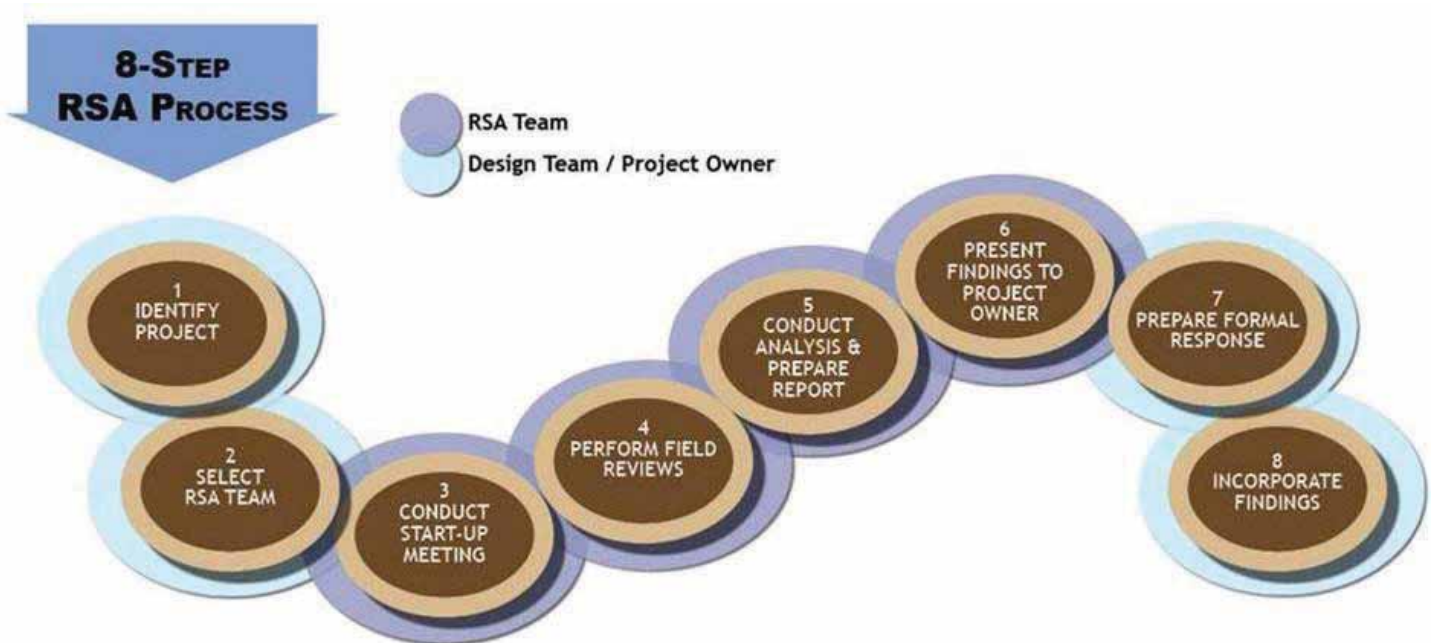
FIGURE 1 RSA PROCESS

The eight steps of an RSA are shown in Figure 1, and are discussed below with some reference to the case studies.

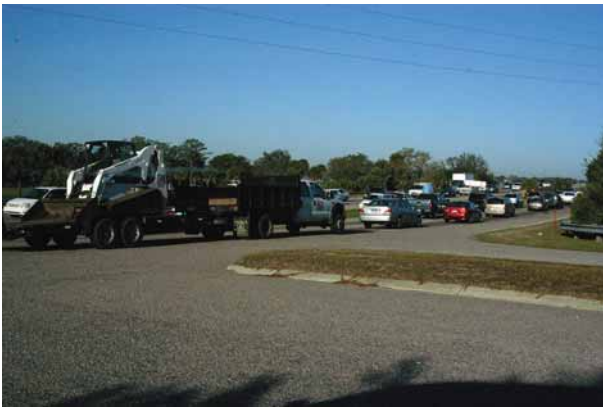
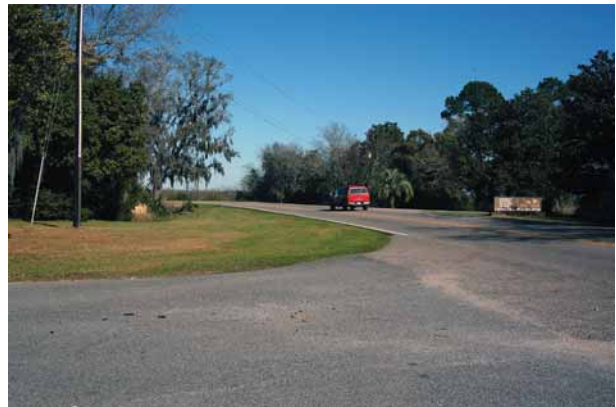
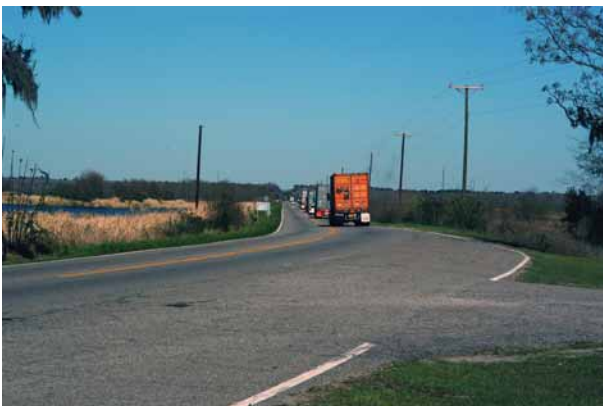
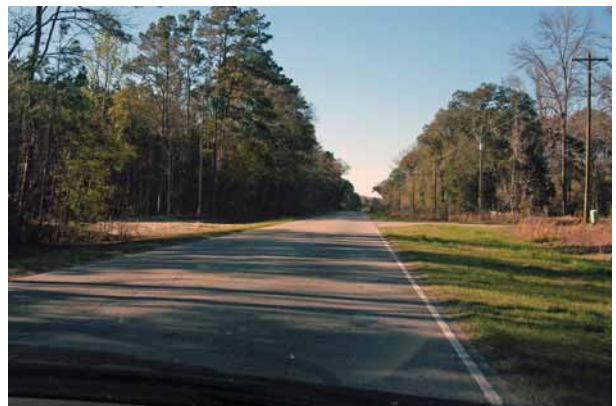
FIGURE A.1 VIEWS OF RSA SITES (PICKNEY ISLAND AND SAVANNAH COASTAL WILDLIFE REFUGES RSA)

ENTRANCE TO PINCKNEY ISLAND NATIONAL WILDLIFE REFUGE, SC

ENTRANCE TO SAVANNAH NATIONAL WILDLIFE REFUGE MAINTENANCE FACILITY, SC

ACCESS POINT TO LAUREL HILL WILDLIFE DRIVE AT SAVANNAH NATIONAL WILDLIFE REFUGE, SC

PROPOSED ENTRANCE TO SAVANNAH NATIONAL WILDLIFE REFUGE VISITOR CENTER, SC

SELECTED SAFETY ISSUE (Number and Description)		SUGGESTIONS
4	<p><i>Roadside Design:</i></p> <ul style="list-style-type: none"> Lack of paved shoulders along US-278, US-17, and SC-170. Rough transition from wildlife drive exit to SC-170. Pavement edge drop-offs. Damaged guardrail on southeast corner of entrance at Pinckney Island. Drop-offs on levees. Narrow bridge widths along SC-170. 	<ul style="list-style-type: none"> improve shoulder width, particularly on horizontal curves and at access points improve transition from wildlife drive exit improve maintenance practices to eliminate pavement edge drop-offs and stabilize shoulders; beveled “safety edge” replace damaged guardrail install guardrail along sections of SC-170 widen shoulders when bridges are replaced
5	<p><i>Nighttime and Poor Visibility:</i></p> <ul style="list-style-type: none"> Lack of nighttime guidance. Fog along US-278 and SC-170. 	<ul style="list-style-type: none"> install or replace raised pavement markers install high-visibility pavement markings install high-intensity signs delineate nose of median openings install double yellow centerline and STOP bar in median openings install fog-warning system

6	<p><i>Bicyclists:</i></p> <ul style="list-style-type: none"> No safe bicycle access between refuge and boat access area at Pinckney Island. Narrow bridge widths are safety hazard for bicyclists. 	<ul style="list-style-type: none"> provide better bike access consider underpass between Pinckney Island Refuge and boat access widen shoulders when bridges are replaced

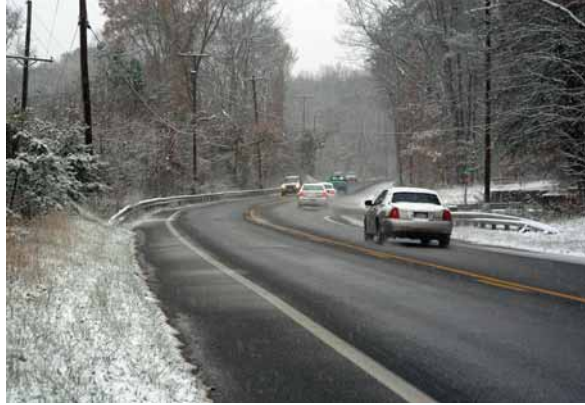
TYPICAL SECTION ALONG MD 197, MD

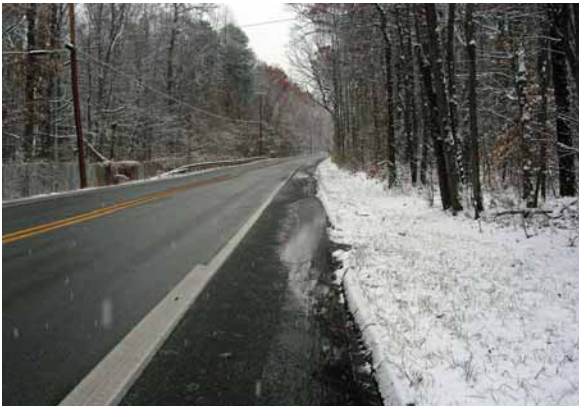
VIEW OF OLD LAUREL BOWIE ROAD, MD

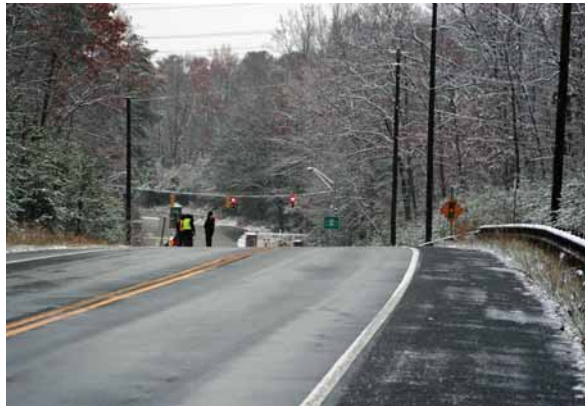
The intersection of Laurel Bowie Road (MD 197) and Powder Mill Road is the only signalized intersection in the study area. MD SHA developed plans to upgrade this intersection which were reviewed by the RSA team as part of this RSA. The scope of the

planned improvements included the construction of turn lanes, drainage improvements, and an upgrade in traffic signal equipment.

SIGNALIZED INTERSECTION OF POWDER MILL ROAD AT MD 197, MD

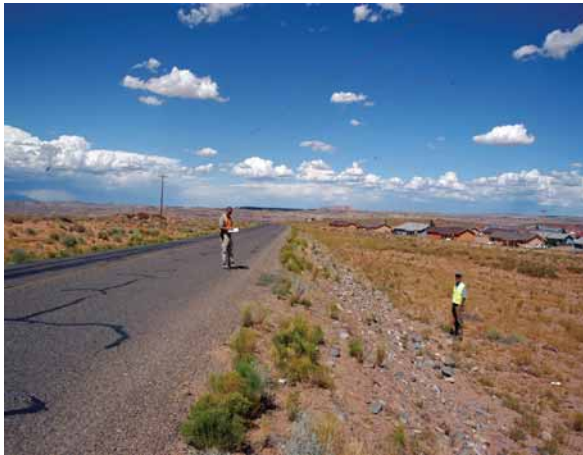
N-35 IN RED MESA, UTAH. PHOTO SHOWS LIMITED PAVEMENT WIDTH, LACK OF DELINEATION, AND CLOSE PROXIMITY OF ROADSIDE HAZARDS.

SELECTED SAFETY ISSUE (Number and Description)		SUGGESTIONS
1	<p><i>Nighttime Visibility/Lack of Delineation:</i></p> <ul style="list-style-type: none"> Faded pavement markings limit conspicuity during nighttime and wet weather conditions. Limited guidance for drivers at night and within horizontal curves. 	<ul style="list-style-type: none"> refresh centerline with high-visibility pavement markings and install edgelines delineate curves and roadside hazards (e.g., embankments) with appropriate object markers or chevrons

SELECTED SAFETY ISSUE (Number and Description)		SUGGESTIONS
2	<p><i>Maintenance Issues:</i></p> <ul style="list-style-type: none"> • Pavement edge drops create a “lip” along the edge of the pavement. • Dirty/faded/illegible signs limit visibility and legibility of signs at night. • Deterioration of pavement edge and erosion near culverts. 	<ul style="list-style-type: none"> • improve maintenance and resurfacing practices to eliminate edge drops and create a beveled “safety edge” • clean or replace damaged/dirty signs and employ educational campaigns targeting young drivers and their peers • pave aprons at intersections and access points and stabilize slopes between intersections to prevent erosion
3	<p><i>Animals on the Roadway:</i></p> <ul style="list-style-type: none"> • Horses, cows, and sheep were observed crossing and grazing along the roadway during daytime and nighttime conditions. 	<ul style="list-style-type: none"> • utilize reflective ear tags, branding, or other strategies to increase conspicuity of animals at night • install animal fence • engage animal owners regarding economic loss and control of animals • prohibit open range grazing with local enforcement

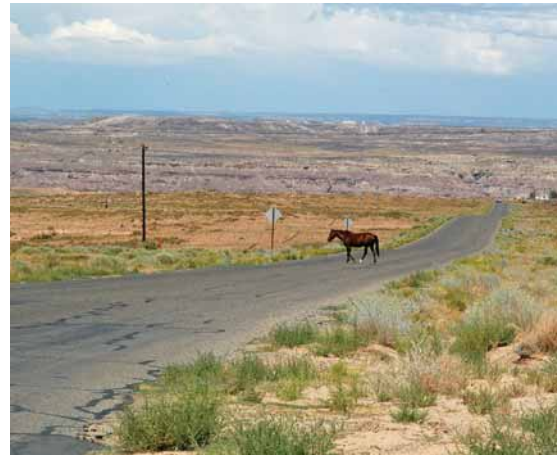
N-35 IN RED MESA, UTAH. PHOTO SHOWS THE ISSUE WITH OPEN GRAZING ALONG THIS ROADWAY.

Open grazing is allowed along N-35 on the Navajo Nation in Red Mesa, Utah. Coupled with a lack of animal fencing, animal crashes represent approximately 25 percent of crashes annually along the corridor. The Patuxent Research Refuge has animal fencing along the road to control animals and, as such, animal crashes are not a significant issue. The animal fence on the Patuxent Research Refuge is often struck, but these crashes are often much less severe than animal crashes and the fence is easily repaired. The fence collisions are partially attributed to roads that are not designed for current traffic use and non-recoverable slopes that lead to the fence.

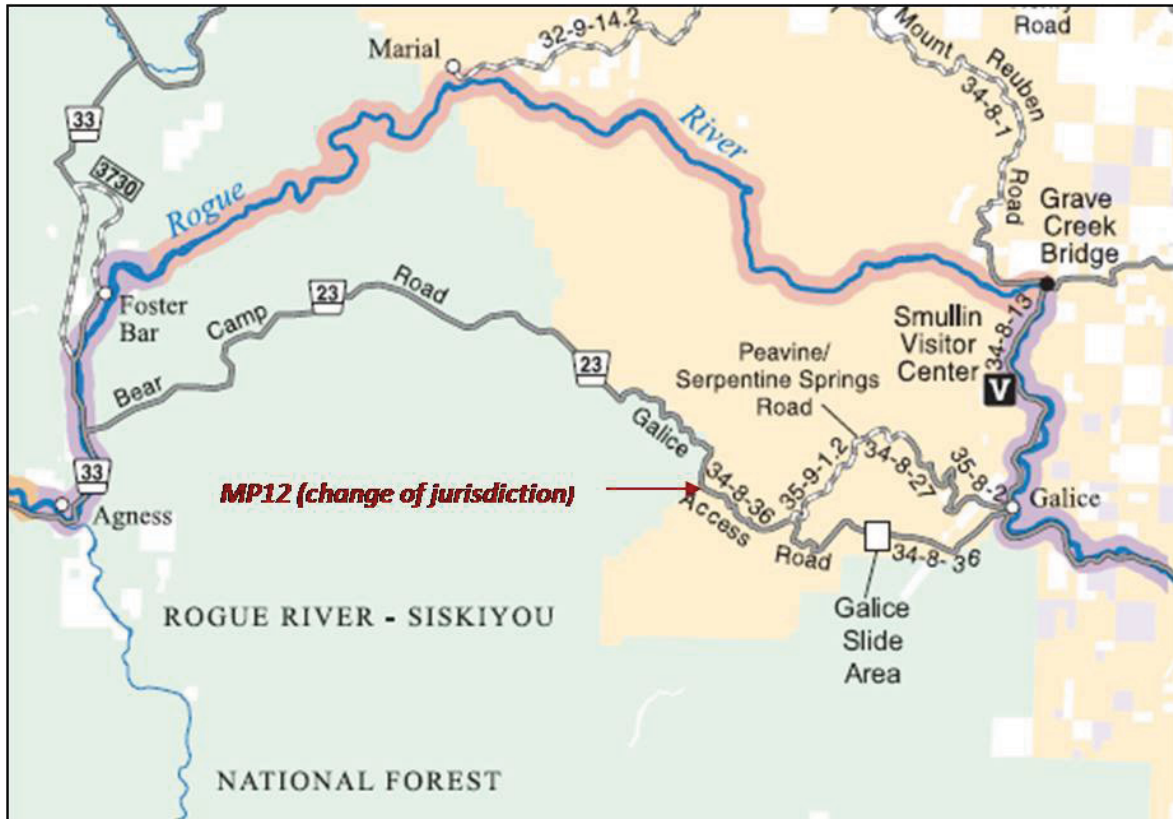
FIGURE A.5-1 BEAR CAMP COASTAL ROUTE RSA SITE

limited maintenance (including winter snow removal), an absence of night-time lighting, and the presence of large or long vehicles (including recreational vehicles and tractor trailers) driven by unfamiliar drivers.

This in-service RSA focused on general issues associated with road safety along the route, rather than specific issues associated with specific sites.

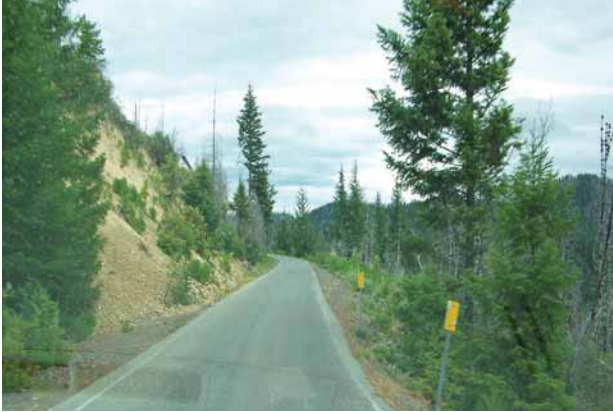
FS SEGMENT (FS ROAD 23), SHOWING A SINGLE-LANE WITH NO TURNOUTS. FOG LINES ARE VISIBLE ON BOTH SIDES OF THE PAVEMENT, ALONG WITH REFLECTIVE DELINEATORS AT RIGHT.

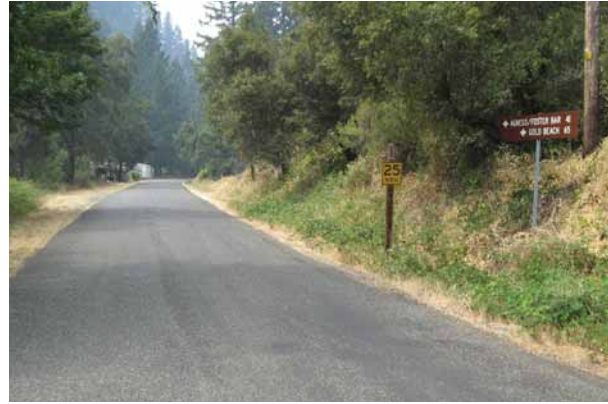
BLM SEGMENT (BLM ROAD 34-8-36), NEAR THE INTERSECTION WITH PEAVINE/SERPENTINE SPRINGS ROAD. A SPEED LIMIT SIGN (25 MPH) IS POSTED AT RIGHT. THE UNMARKED PAVEMENT CAN ACCOMMODATE TWO LANES OF TRAFFIC.

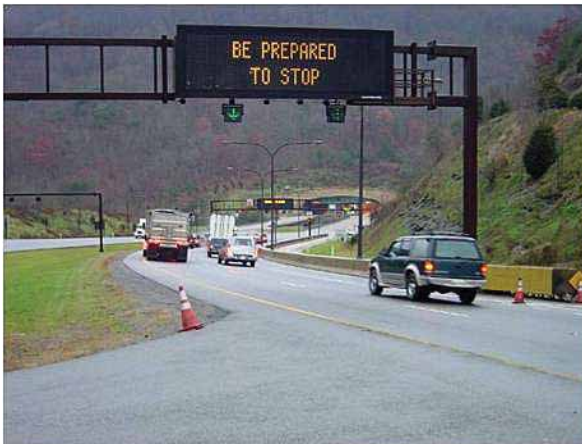
The posted speed limit approaching the tunnels is 45 mph, excluding periods when one of the tunnels is closed due to HAZMAT vehicle escort or during cleaning of one of the tunnels. Approximately 100 HAZMAT / oversize vehicles per day (about 600 per week) are escorted separate from main traffic through the tunnels. During the HAZMAT escort operation, traffic in the direction of the escort is stopped by a traffic signal mounted to an overhead variable message sign structure. The speed limit is reduced from 45 MPH to 35 MPH when resuming normal traffic flow. During periods when one of the tunnels is closed for cleaning, both directions of traffic are diverted and maintained in the other tunnel and the speed limit is reduced to 25 MPH. A speed monitoring study was performed by TDOT on November 27 – 28, 2006. The 85th percentile speed (i.e., the operating speed) along the Tennessee approach to the tunnels is 54.4 MPH in the northbound lanes and 54.2 MPH in the southbound lanes. This indicates that the majority of motorists exceed the posted speed limit.

TDOT reviewed crash data along US Route 25E for two three-year periods, beginning one mile south of the tunnel entrance. From 2002-2004, five crashes occurred, resulting in two injuries. From 2003-2005, four crashes occurred, resulting in three injuries and one fatality. The crash rate for this segment is approximately 0.20 crashes per MVMT, which is less than the Tennessee statewide average rate of 0.80 crashes per MVMT for similar divided rural arterials.

US ROUTE 25E NORTHBOUND DIRECTION

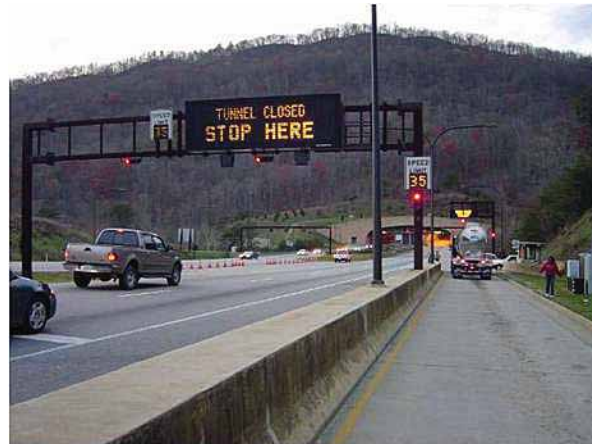
Approaching the CUGA tunnels, US Route 25E is a rural, four-lane, divided arterial with a 24-foot traveled way in the northbound and southbound directions. The median width of approaching the tunnels is 60-feet, with 6-foot inside shoulders (2-foot paved width) and 12-foot outside shoulders (10-foot paved width). The cross section and horizontal and vertical alignment were compared to AASHTO standards and were found to meet or exceed minimum policy criteria for a design speed of 60 mph. The 2006 annual average daily traffic (AADT) volume is 23,740 vehicles per day as provided by Tennessee Department of Transportation (TDOT).

VIEW OF US ROUTE 25E NORTHBOUND APPROACH TO TUNNEL.

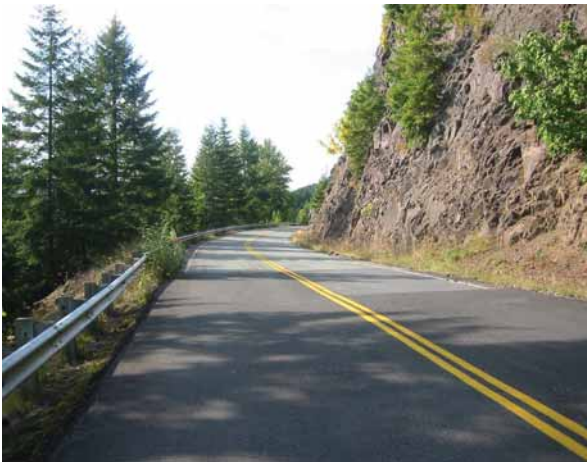
View of the limited recovery area and close proximity of steep rock slopes along Lewis River Road.

3	<p><i>Guardrail/Barriers:</i></p> <ul style="list-style-type: none"> Low mounting height and non-crashworthy terminals. Outdated guardrail with potentially rotting wood posts. Potential inadequate transitions at bridges. 	<ul style="list-style-type: none"> adjust the mounting height of guardrail to meet current standards replace deficient terminals evaluate old guardrail posts and replace as necessary replace/upgrade transitions to bridge rail as necessary
4	<p><i>Bridges</i></p> <ul style="list-style-type: none"> Inconsistent bridge designs along corridor. Lack of delineation on bridge rail and approach. Potentially inadequate transitions to bridge rail. 	<ul style="list-style-type: none"> upgrade transition connections at bridge rails as necessary delineate bridge rail and approaches install 'no fishing from bridge' signs on Canal Bridge upgrade bridge rail and connections to current standards when replaced

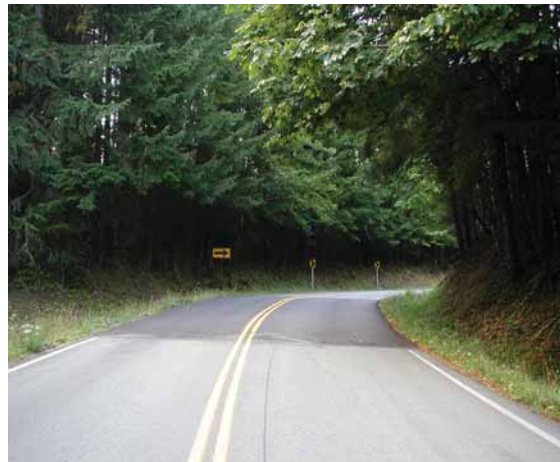
View of a curve along Lewis River Road with existing curve warning signs.

SELECTED SAFETY ISSUE (Number and Description)		SUGGESTIONS
1	<p><i>Signing:</i></p> <ul style="list-style-type: none"> Limited visibility of signs due to fading and vegetation. Improper placement and mounting height of signs. Inconsistency in signing among curves and for opposite directions through the same curve. 	<ul style="list-style-type: none"> upgrade signs to meet current retroreflectivity requirements combine and relocate guide signs at FDR 25 intersection increase the size of warning signs and consider installing additional curve warning signs and arrows as appropriate evaluate use of intersection signs for private driveways and access roads
2	<p><i>Delineation:</i></p> <ul style="list-style-type: none"> While the centerline is newly painted, the edgelines are faded. Delineators are not installed along outside of all curves. 	<ul style="list-style-type: none"> refresh edgeline pavement markings install delineators along the outside of curves delineate roadside hazards that are not protected by guardrail evaluate use of recessed centerline pavement markings through curves and potentially along the entire route
