# Tribal Road Safety Audits: **CASE STUDIES**

| 4. Title and Subtitle<br><br><i>Tribal Road Safety Audits: Case Studies</i> | | 5. Report Date<br>April 2008 | |

Information for the case studies reported in this document was gathered during a series of four RSAs conducted throughout the United States in 2005 and 2006, involving tribal transportation agencies of the Standing Rock Sioux, Santa Clara Pueblo, Jemez Pueblo, and Navajo Nation. FHWA and the authors greatly appreciate the cooperation of these tribes, as well as other participating agencies such as the BIA and state DOTs, for their willing and enthusiastic participation in this FHWA-sponsored RSA series.

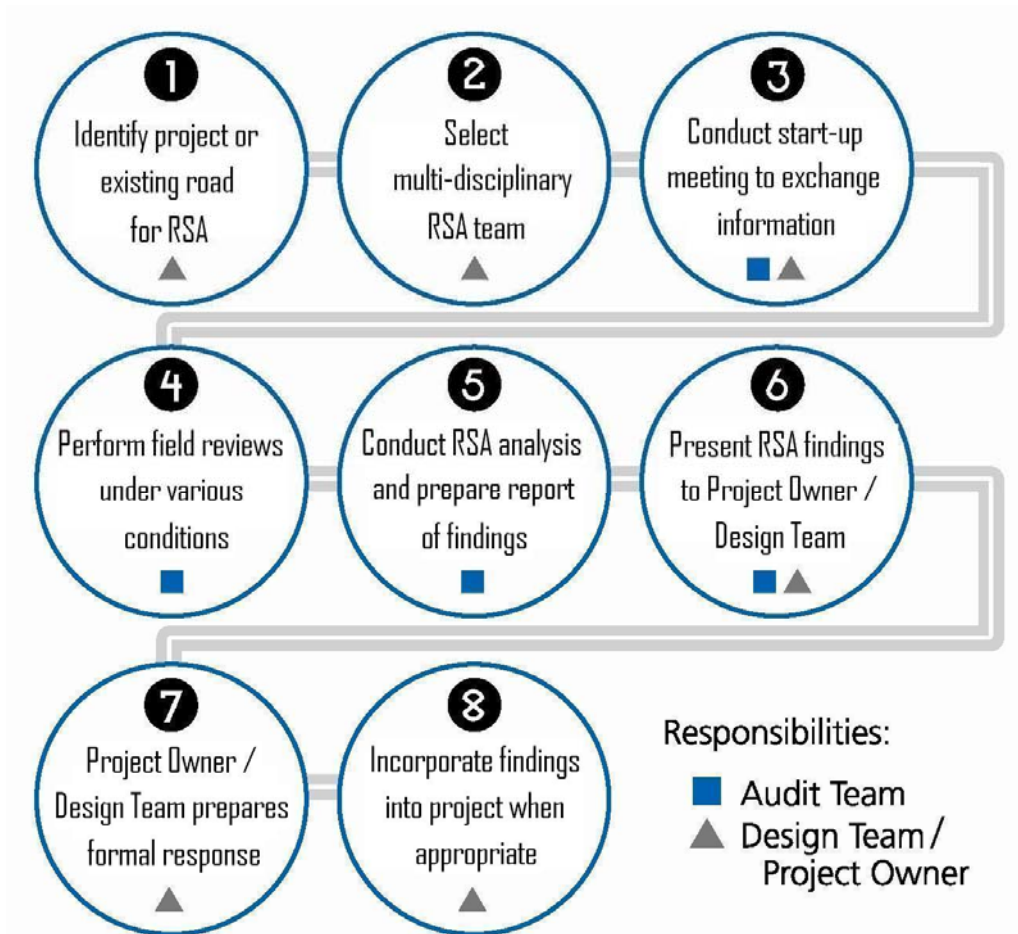
FIGURE 1 RSA PROCESS

The eight steps of an RSA are shown in Figure 1, and are discussed below with reference to the case studies.

**RSA projects** and the **RSA team** (Steps 1 and 2) were pre-selected in this FHWA case studies project. RSA teams were interdisciplinary, including engineering and enforcement staff. A pavement specialist was included in the case of the Standing Rock Sioux RSA.

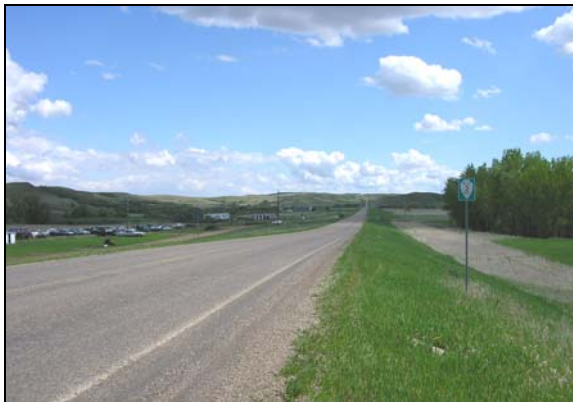
*BIA3 at intersection with ND24 south of Fort Yates, ND*

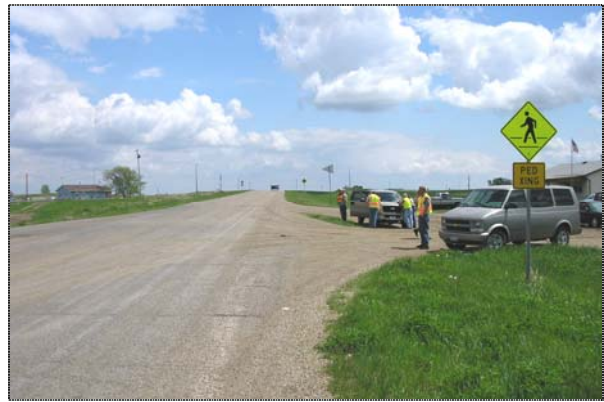
*BIA 3 / Hwy 1806 in Kenel, SD*

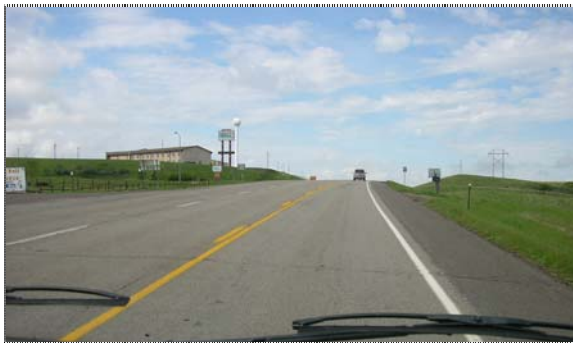
*US 12 at Grand River Casino (left), near Mobridge, SD*

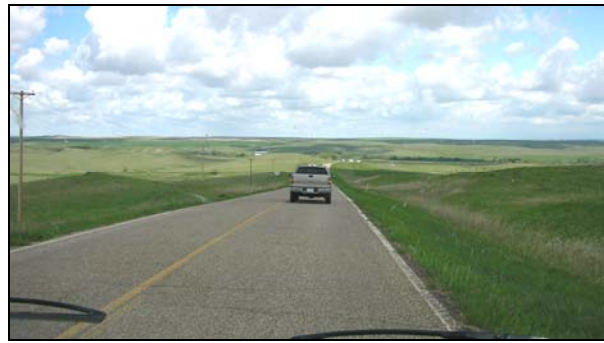
*BIA 44 west of Mahto, SD*

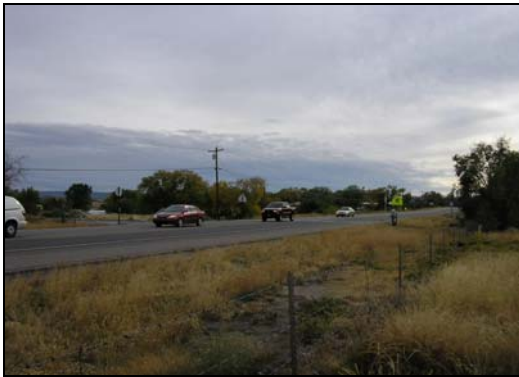
*Looking south along NM 30 toward a signed and marked school zone crosswalk near the Pueblo's main residential area.*

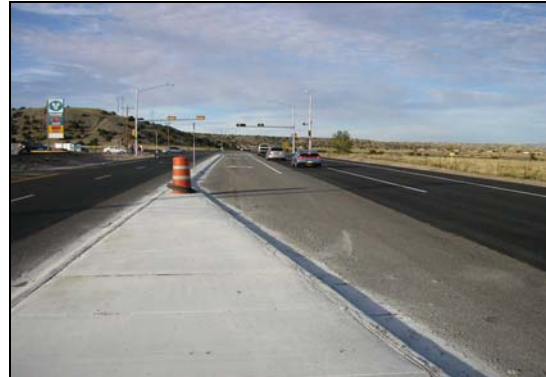
*Looking north along NM 30 toward a recently improved intersection adjacent to a convenience store/gas station. The full traffic signal was in place, but not operational, at the time of the audit.*

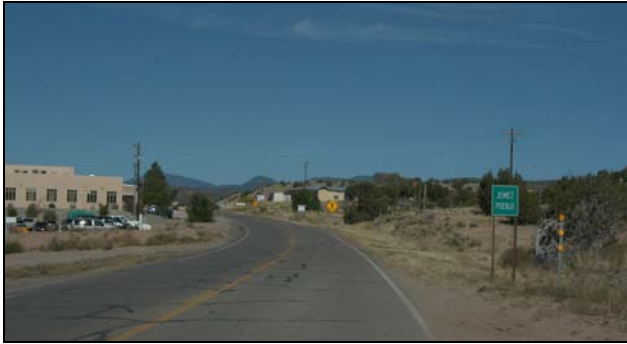
Looking north along NM4 at the entrance to the Pueblo of Jemez. NM4 is predominantly a two-lane rural road with wide shoulders, with a speed limit of 30 mph along this segment.

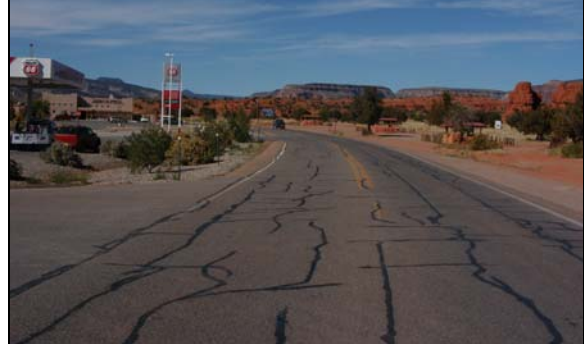
Looking north along NM4 at the Red Rocks recreational area. Roadside land uses include the commercial area (service station and Walatowa Visitors Center) visible at left, and the recreational area (where small-scale vending takes place during the summer) at right. The speed limit along this segment of the highway is 50 mph.

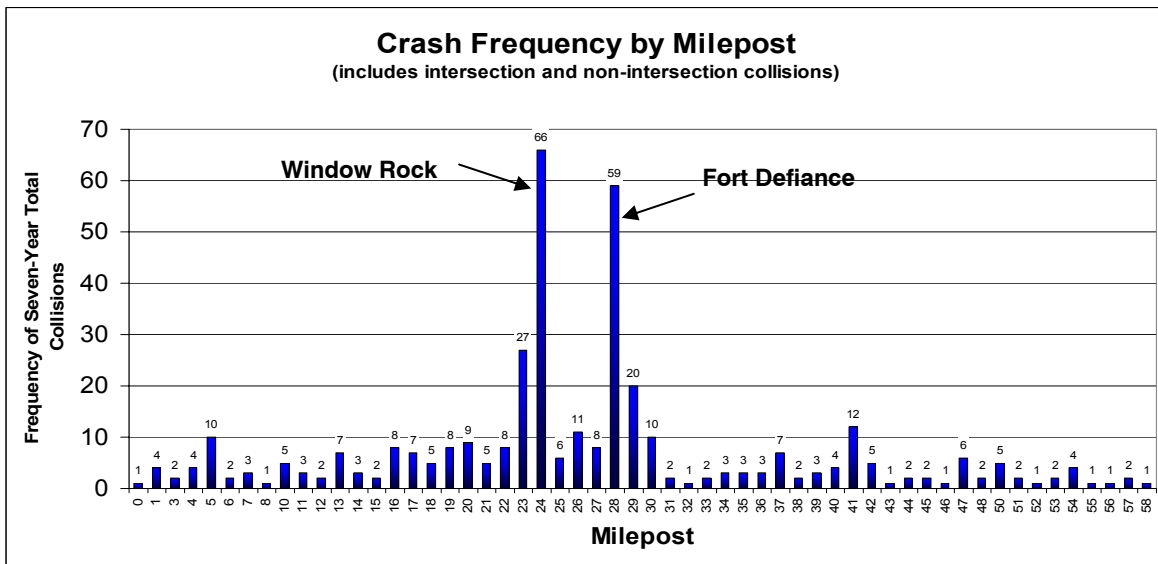
**FIGURE A.4 COLLISIONS ALONG HIGHWAY N12**

Seven years (1999 through 2005) of collision summaries along N12 were reviewed as part of this RSA. Over seven years, a total of 386 collisions were reported along N12. Annual collision frequency peaked in 2002 with 60 reported collisions, and declined each subsequent year to a low of 21 reported collisions in 2005. FIGURE A.5 shows the spatial distribution of collisions along the entire highway segment from MP 0.0 to MP 58.5. Peaks are evident around MP 23/24 and MP 28/29, which correspond to the Window Rock and Fort Defiance areas.

**NOTE:** Shows collision locations reported on N12 over seven years (1999 through 2005). Distribution is shown in one-mile segments, so (for example) all collisions at MP 24.0 through 24.9 are shown at "MP24" in the chart.

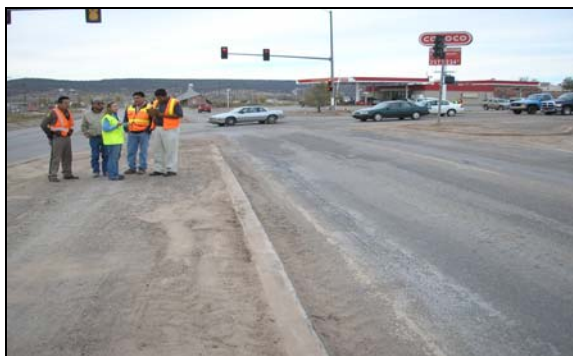
Looking north along N12 at the intersection with N110 (near Fort Defiance). A 62-foot urban cross-section is provided, consisting of two through lanes in each direction, with curb and gutter and turn lanes (or a raised median) at intersections.

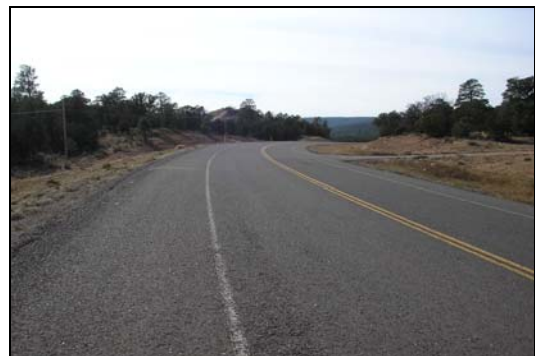
Looking south along N12 at audit site south of Highway 264. The cross-section is a two-lane rural road with wide paved shoulders.
