# OSM MID-CONTINENT REGION TECHNOLOGY TRANSFER AMD WORKSHOP Collinsville, Illinois

## Participants Contact Information Presentation Abstracts

**Carbon Recovery versus  
Prevention and Passive  
Treatment for the  
Elimination of AMD at an AML  
Eligible Slurry Impoundment;  
a  
Case Study of the Chinook  
Slurry Pond**

# AMD REMEDIATION AT THE SUPERIOR C.C. #4 MINE

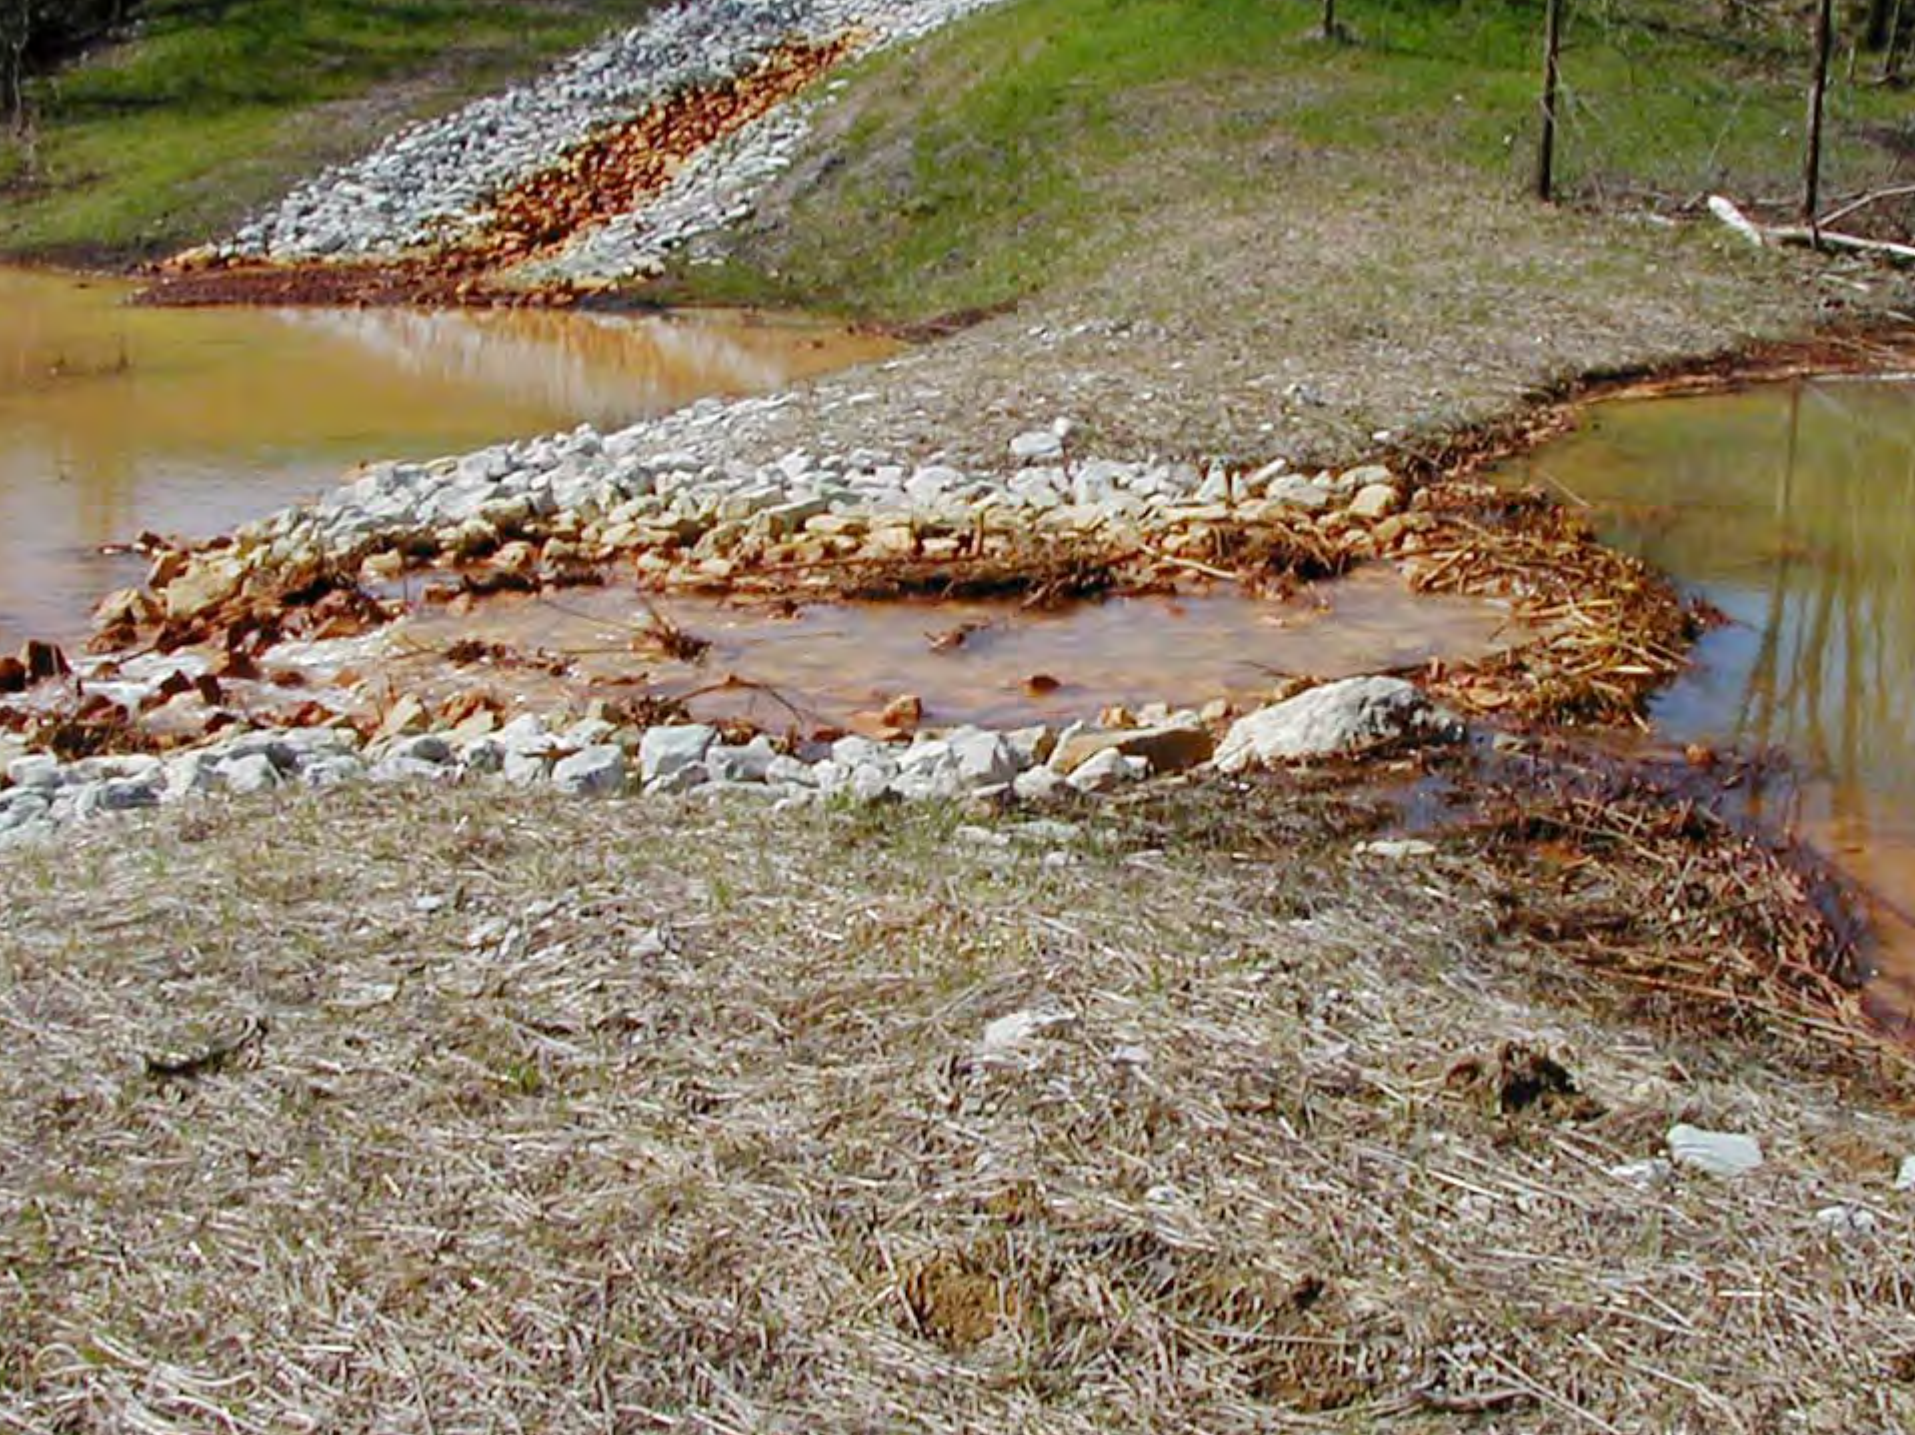
# Chinook Hydrologic Monitoring Stations

- Monitoring Wells
- Major Seep
- Precipitation and Pond Stage

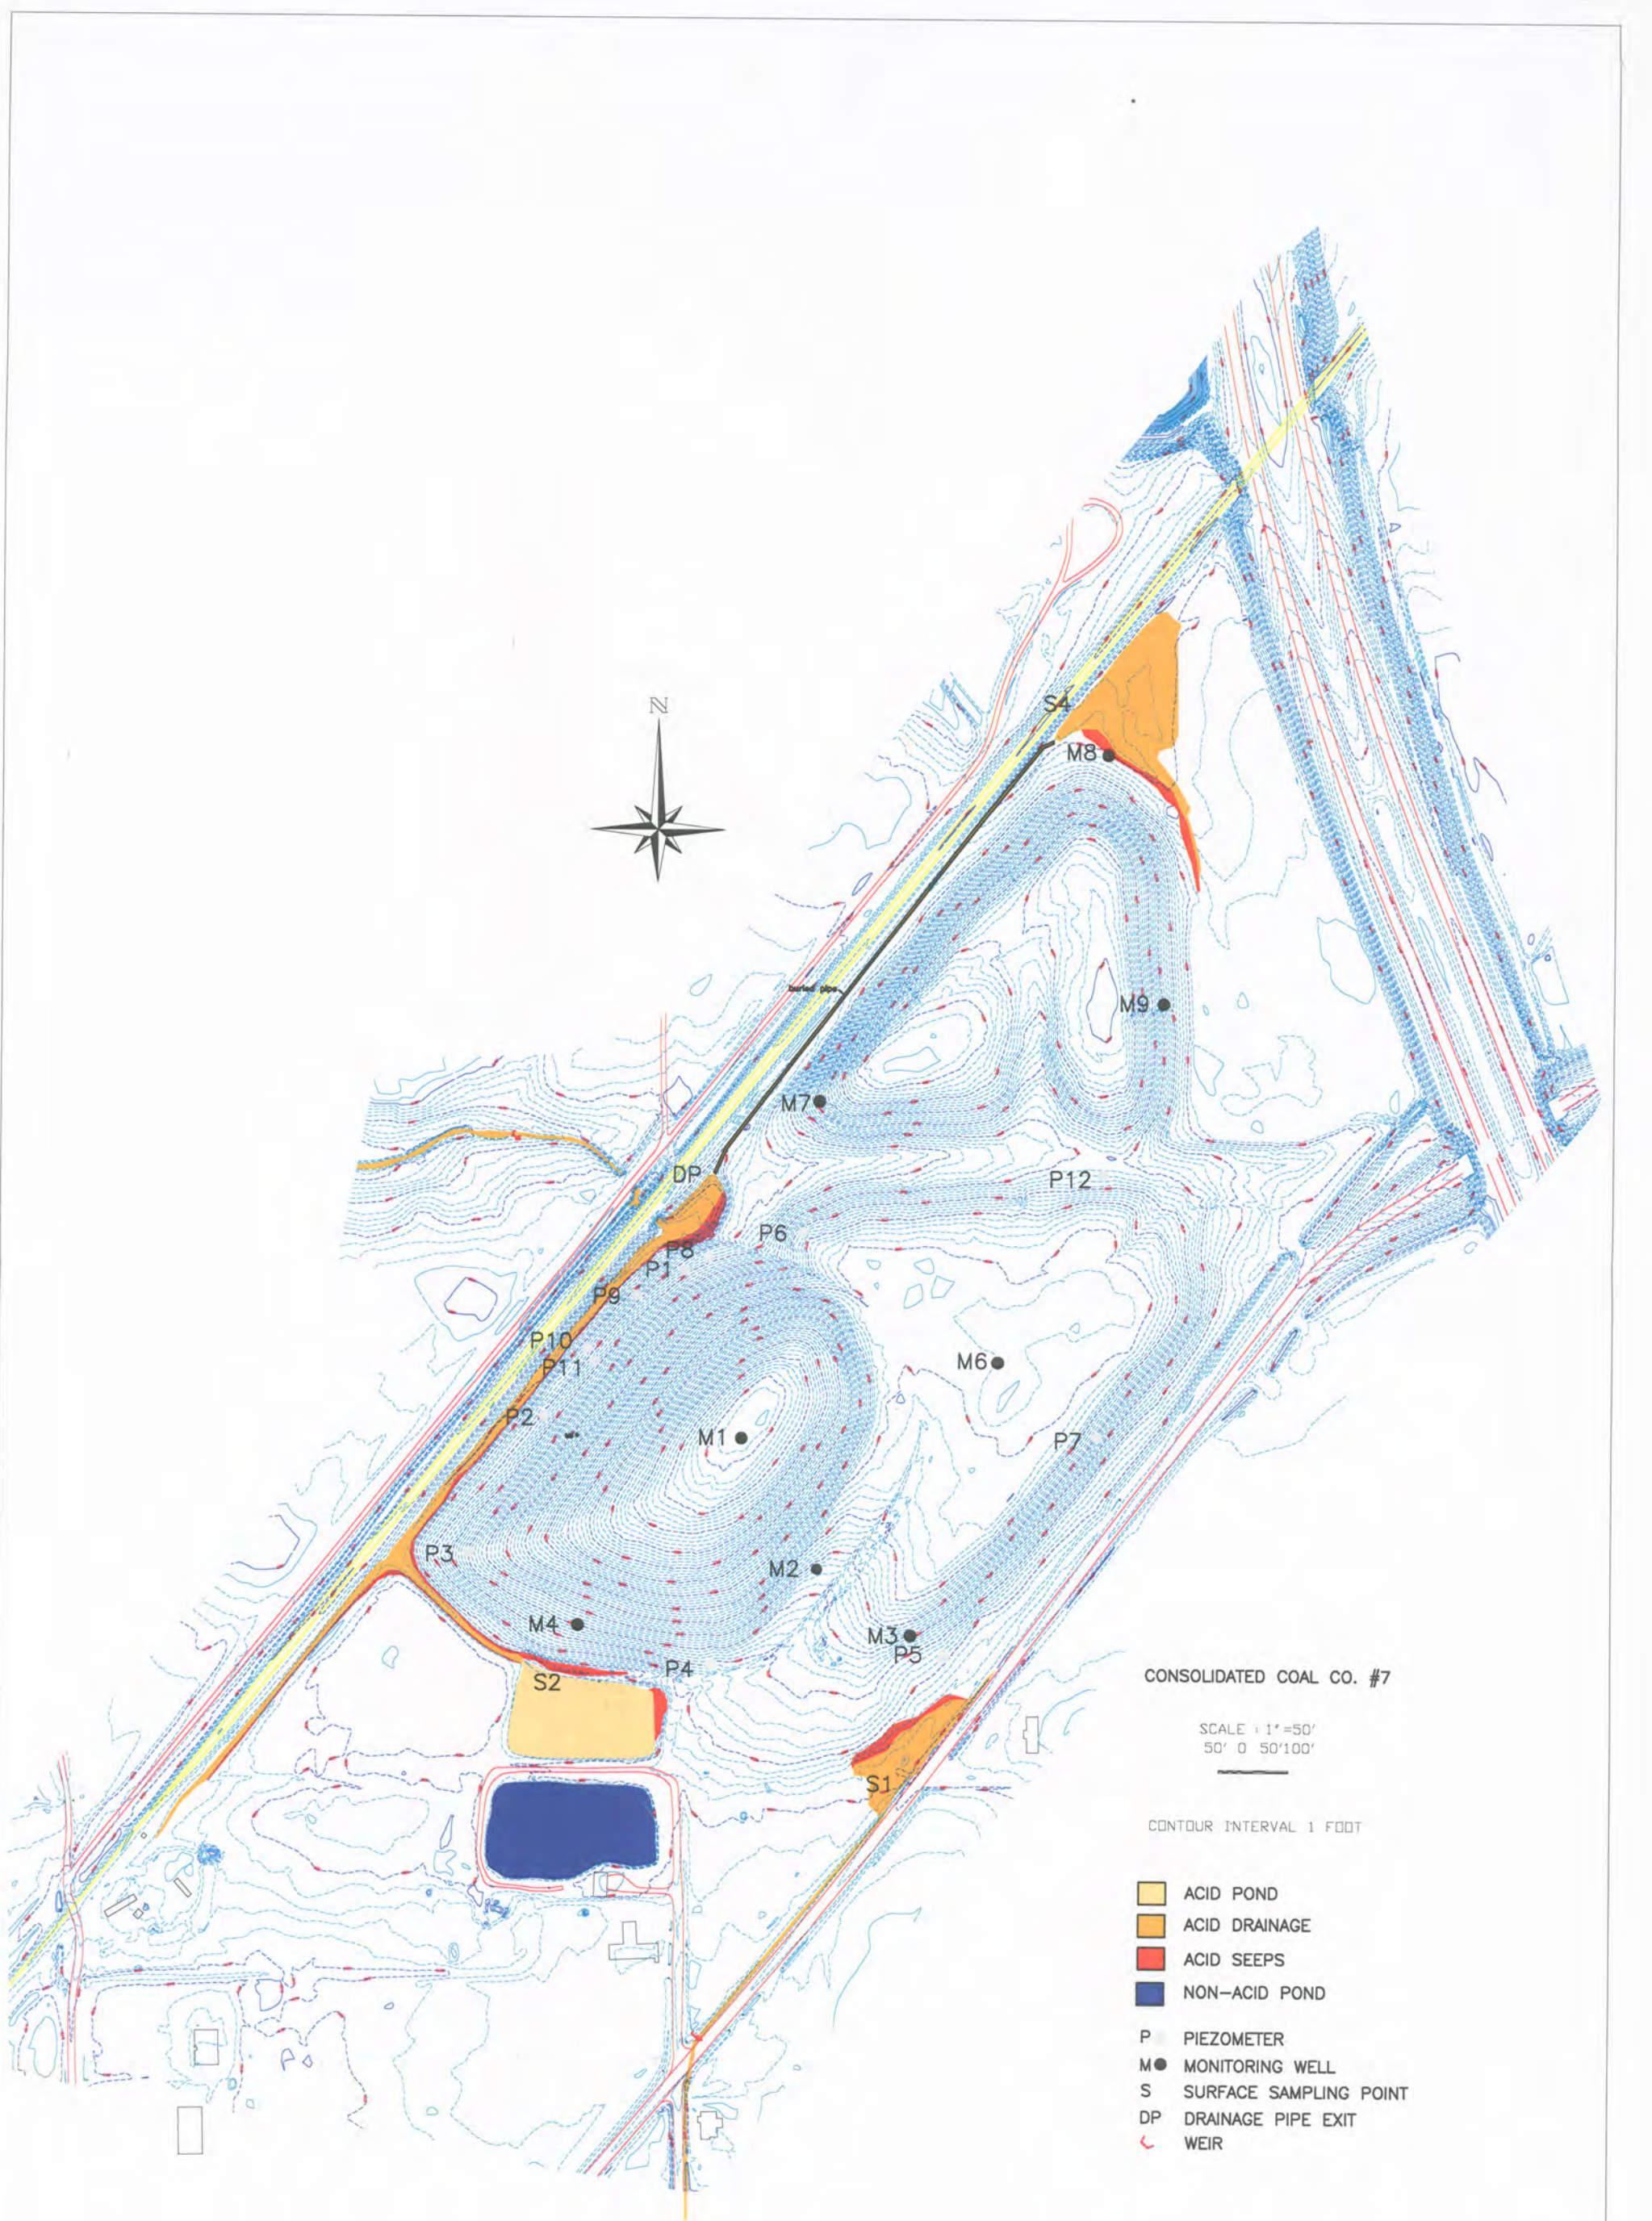
CONSOL. #7  
Water Table Contours  
Low Water Table

contour interval 1 ft.

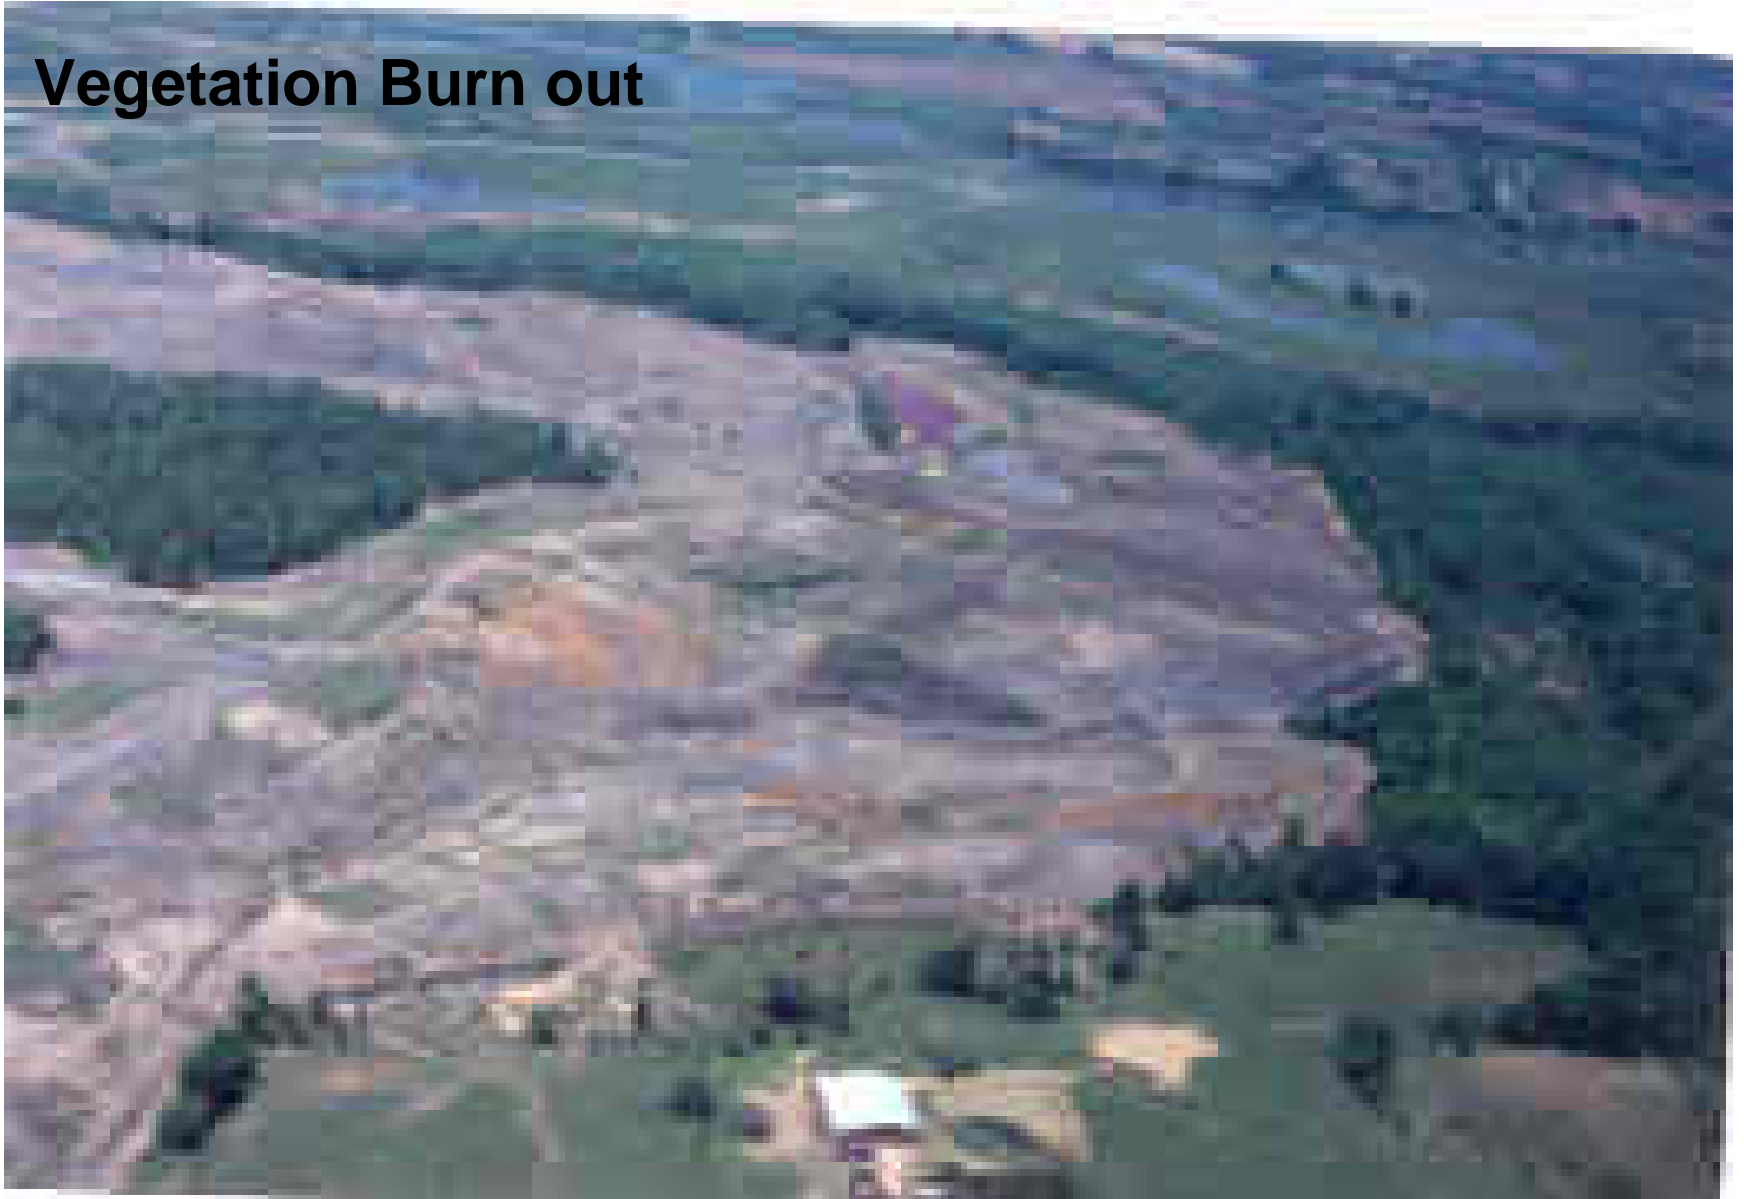
# Palzo, 1984 Aerial

**Vegetation Burn out**

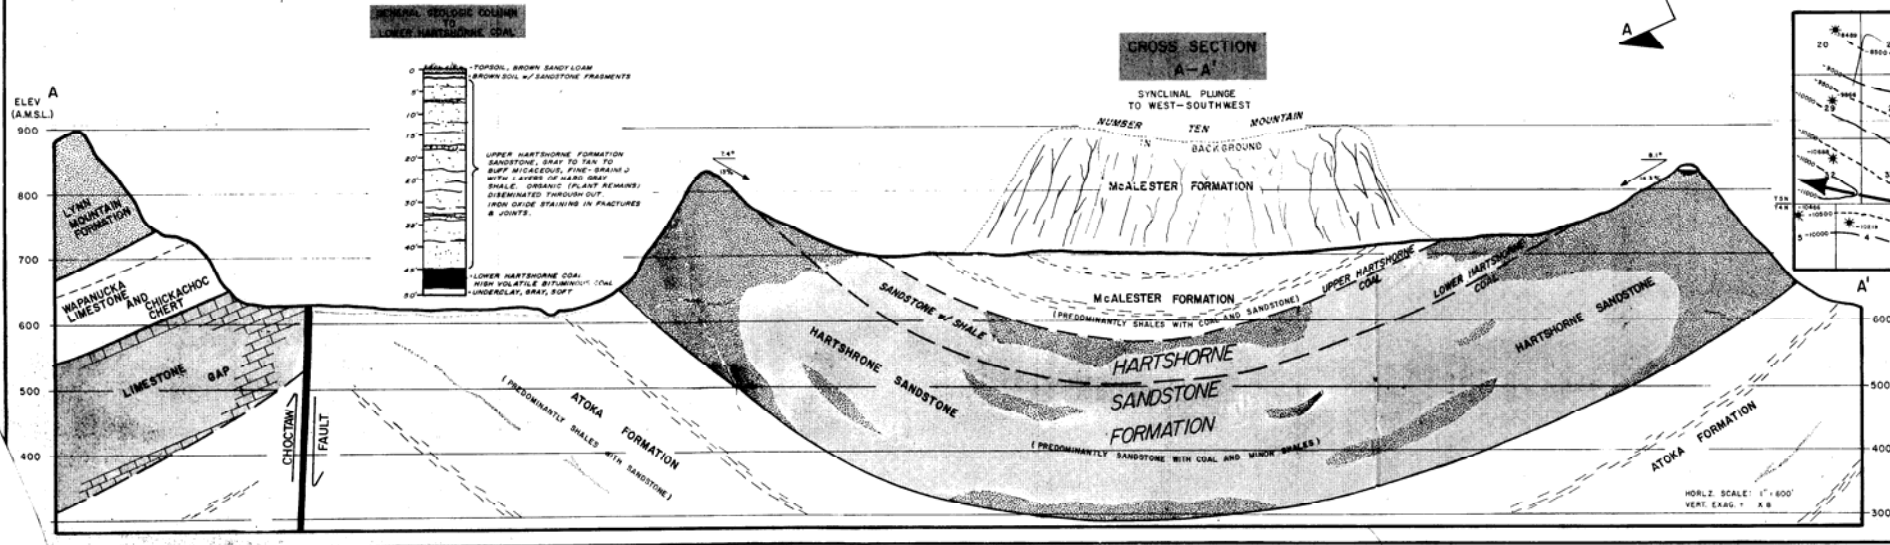
# The Hartshorne Coal Basin: Synclinal Mountain Range

The underlying Hartshorne Sandstone Member is a fractured-rock aquifer confined by the overlying shale units in the Upper Hartshorne Formation.

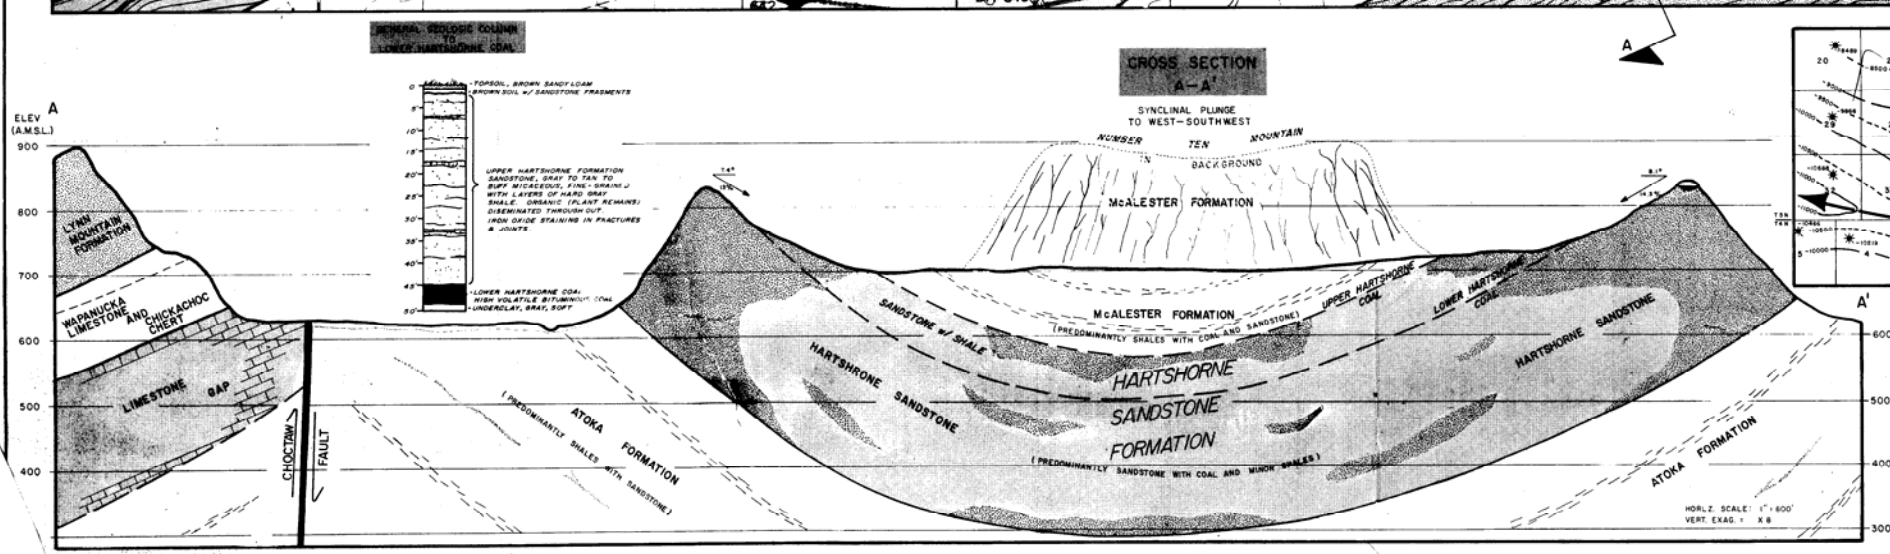
# The Hartshorne Coal Basin: Synclinal Mountain Range

The underlying Hartshorne Sandstone Member is a fractured-rock aquifer confined by the overlying shale units in the Upper Hartshorne Formation.
