# Fact Sheet

### Site Assessment of the February 2009 Jet Fuel Pipeline Leak

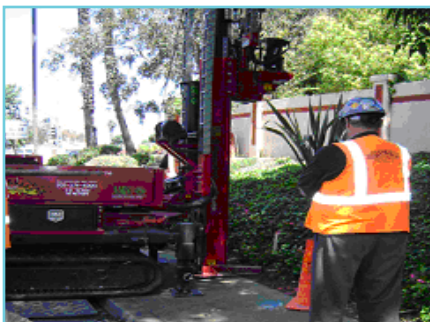
A drilling specialist positions a direct push rig into position. The rig uses hydraulic pressure to push a water sampling probe into the ground.

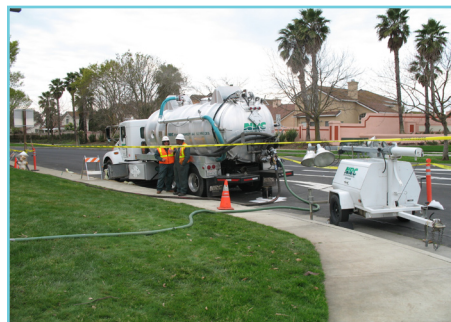
Two field technicians monitor the performance of a vacuum truck as it removes jet fuel from a soil boring near the fuel leak.

During the initial response and recovery effort, a vacuum truck was used to remove about 805 gallons of fuel from nearby utility vaults, storm drains, and soil borings that were placed near the leak area. They also carried out a geophysical survey to confirm the locations of the pipeline and buried utilities; this was a precautionary measure to prevent damage to fiber optic cables, water pipes, and other utilities that may be in the area.

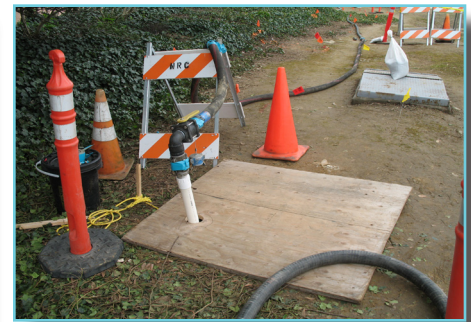
A suction tube that is connected to a vacuum truck removes jet fuel in the ground after it was released from a leaking valve.

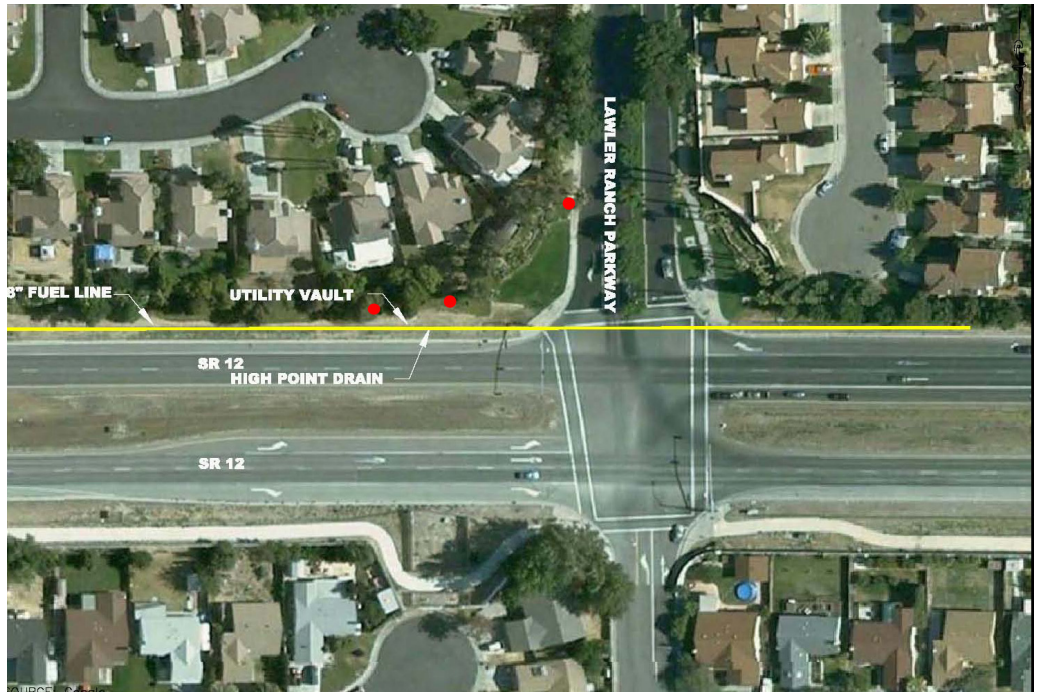
The daily inspections detected no jet fuel sheen or odors in the storm water drains and outfall that lead to the marsh. However, fuel was discovered in soil and groundwater at various locations near the pipeline and utility trenches along SR 12 and Lawler Ranch Parkway. The highest fuel concentrations were found in samples adjacent to, and southeast and southwest of, the leak area. A second area of high concentrations is about 100 feet south of the intersection of Lawler Ranch

Parkway and SR 12, on the east side of Lawler Ranch.

Overhead View of the Jet Fuel Leak Area. South is to the top of the photograph. The red dots represent the highest fuel concentrations found in groundwater samples.

Travis will collect additional soil and groundwater samples south and southwest of the fuel pipeline, nearby utility lines and in the SR 12 median. The samples will help determine how far the jet fuel traveled from the leak's source and identify the most effective way to clean up any contaminated areas.

The new samples will be collected about 25 feet to 100 feet south and southwest of the leak area.
