NEPA Environmental Assessment

**Undeveloped Enhanced Use Lease Site
VA South Texas Veterans Health Care System
Kerrville Division
Kerrville, TX 78028**

**Prepared for:
Emax Financial & Real Estate Advisory
Services, LLC
60 Broad Street, 35th Floor
Suite 3501
New York, NY 10004**

July 2012

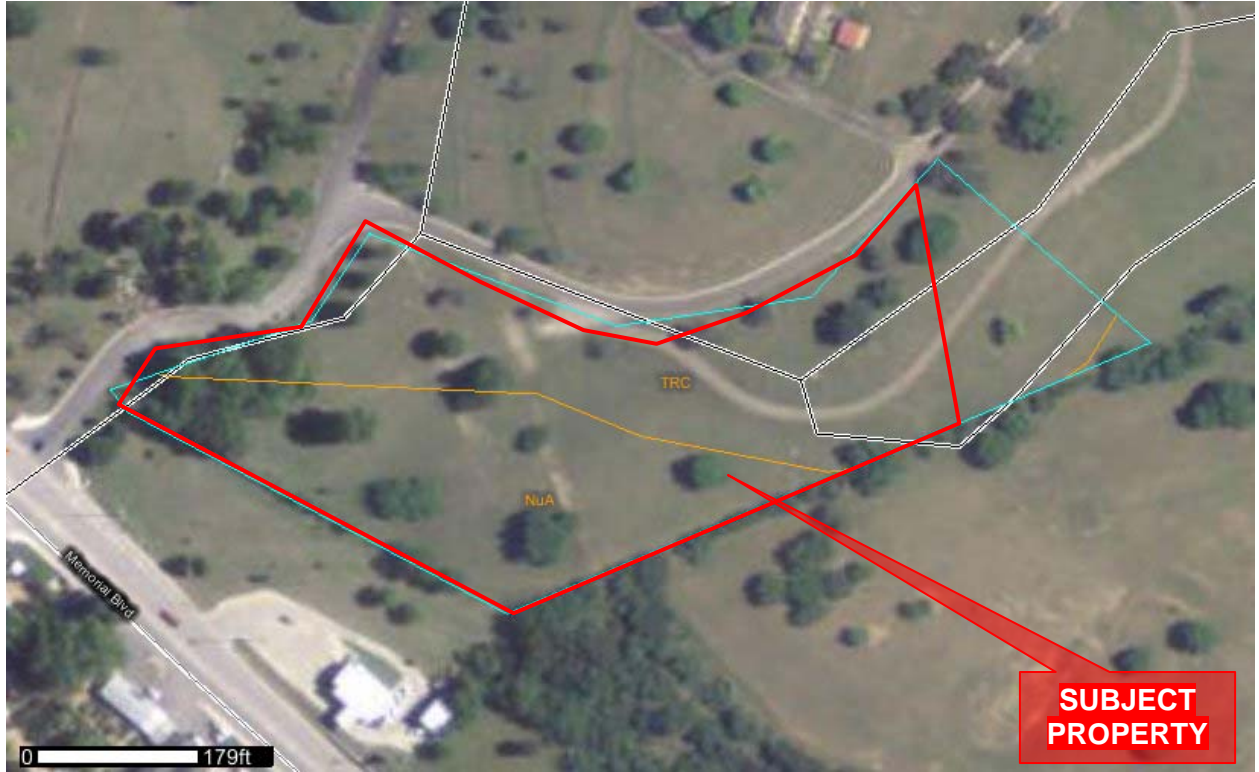
FIGURE 7-USDA SOIL MAP

Moderately deep to very deep friable clayey uplands with slopes 0 to 5 percent; friable when moist; somewhat sticky when wet; high natural fertility; medium to high water holding capacity and fair to good plant-soil moisture relationship; high production potential. These soils make up approximately 70 percent of the site.

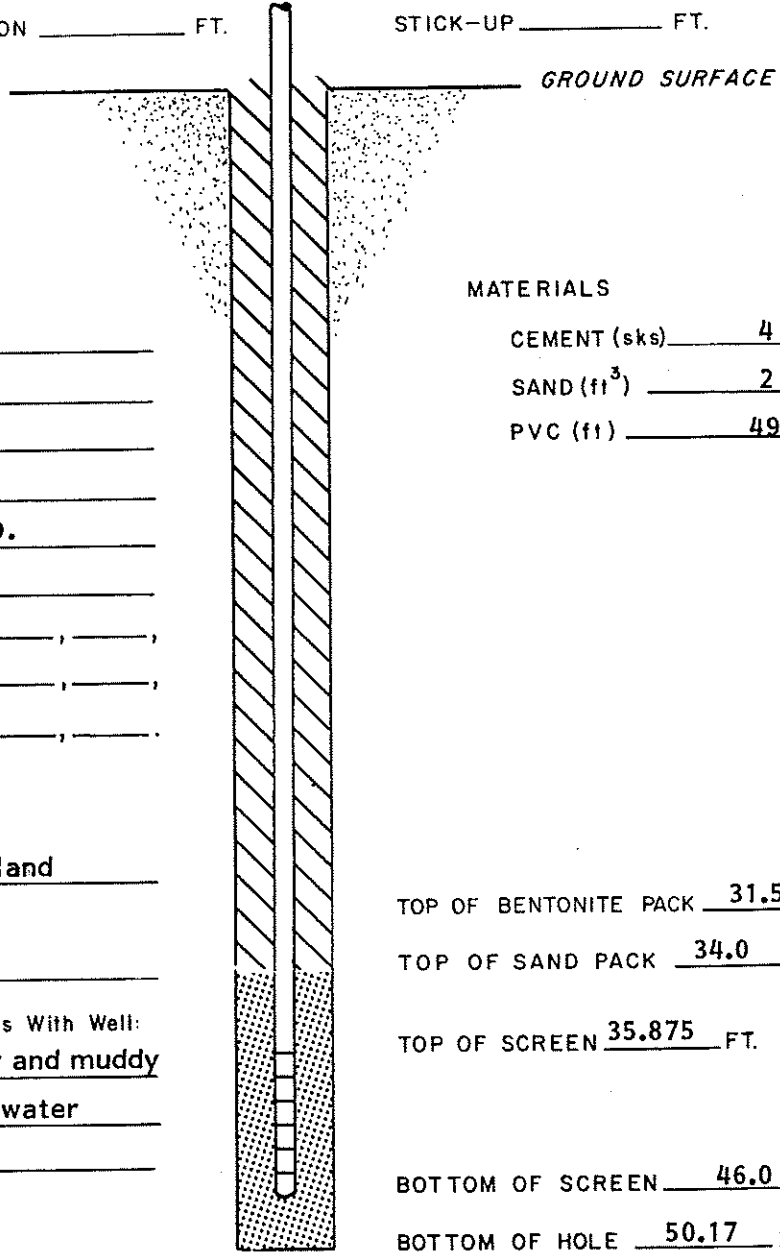
DETAILS OF CONSTRUCTION:

Date Completed 9-30-87
 Hole Diameter (in) 6
 Screen Size (in) .010
 Screen Length (ft) 10.125
 Casing Size (in) 2.0 I.D.
 Packer Depth (ft) _____
 Centralizer Depths (ft) _____, _____, _____,
 _____, _____, _____, _____,
 _____, _____, _____, _____.
