SONGS U2C17 Steam Generator Operational Assessment for Tube-to-Tube Wear

### 3.0 INTRODUCTION

#### 4.0 OPERATIONAL ASSESSMENT STRATEGY

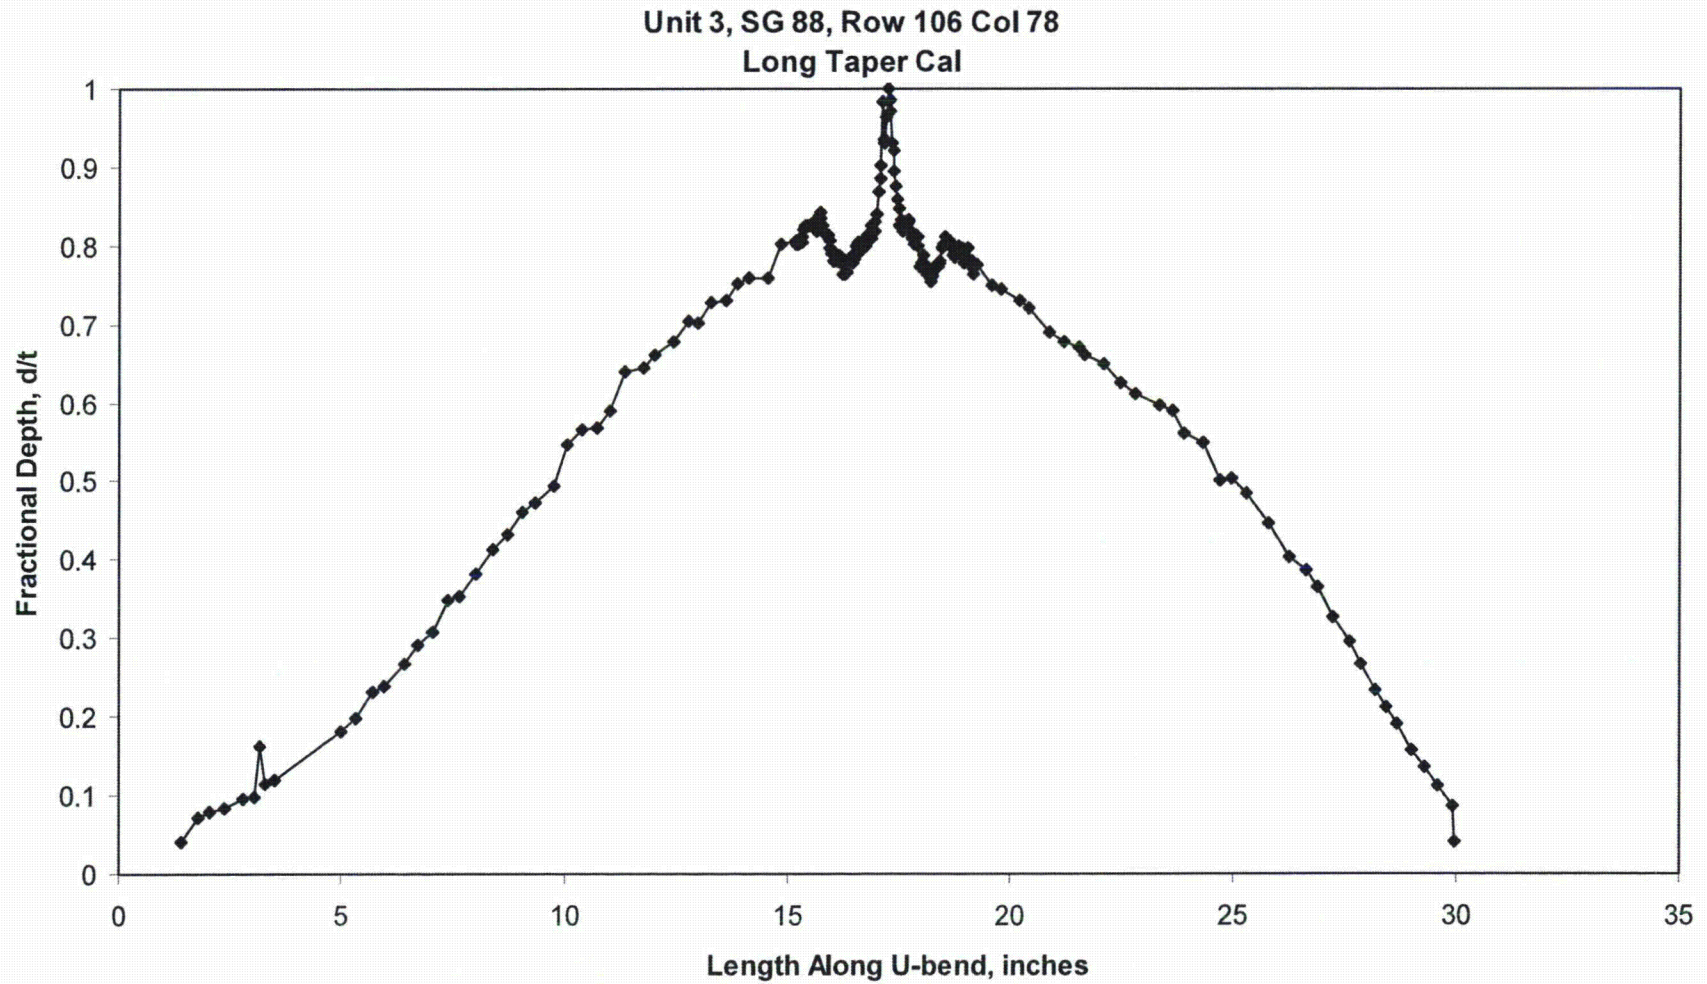
Figure 4-1: Depth versus Axial Length Profile for the Leaking Tube in Unit 3, SG E-088

Both steam generators in Unit 3 had more than 160 tubes with TTW indications in U-bends. The three most degraded tubes exhibited wear scars that were more than 28 inches long with central regions of essentially uniform wear depths that were greater than 80 %TW. These central regions of uniform wear depth were about 5 inches long. One of these regions contained a pinhole wall penetration that led to a small primary-to-secondary leak, resulting in the shutdown of Unit 3. Figure 4-1 shows the profile of wear depth versus axial length for the leaking tube, R106 C78, in Unit 3 SG E-088.

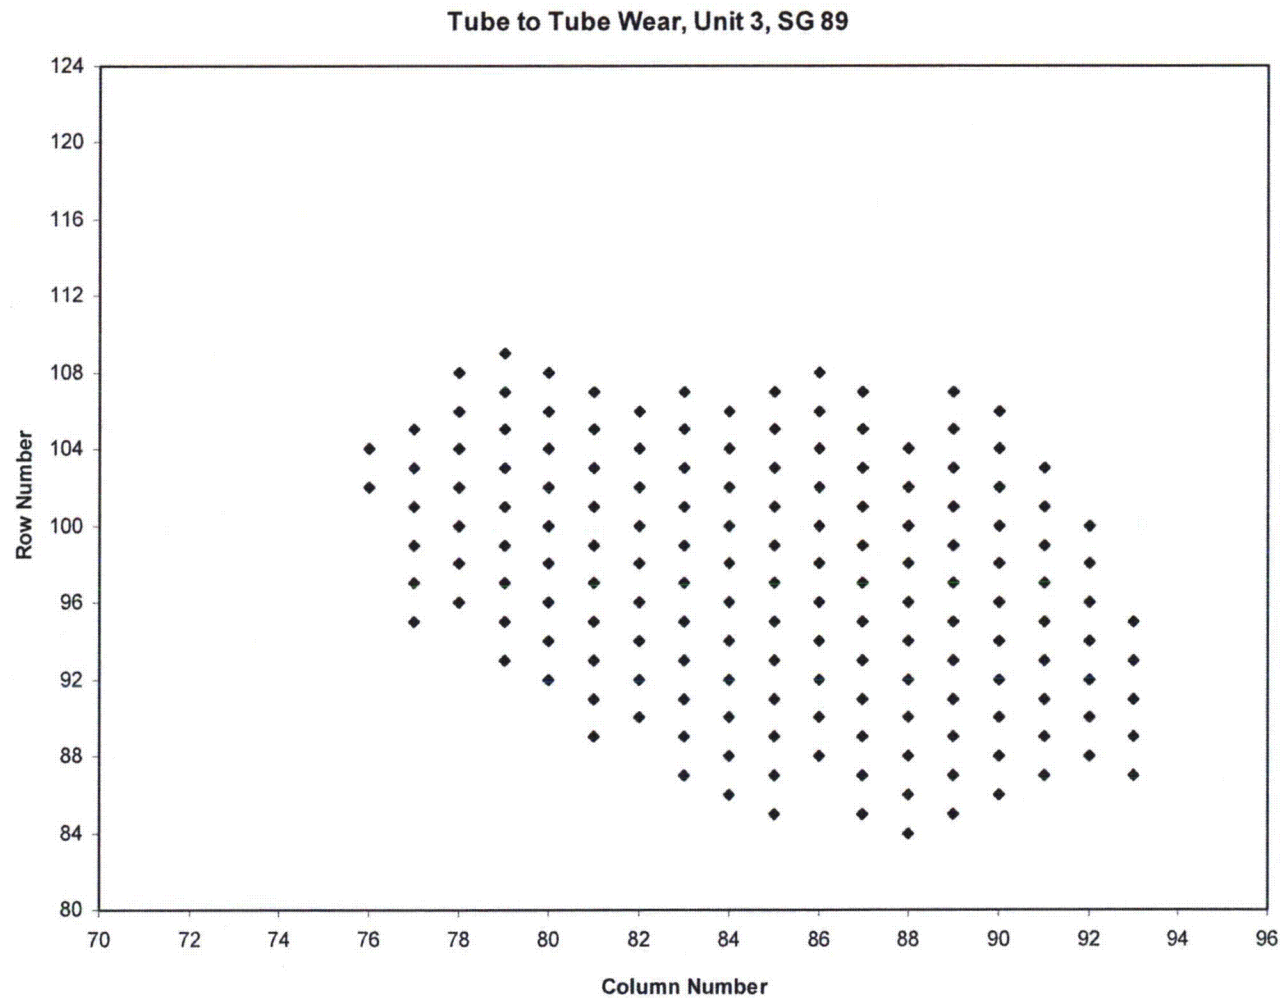
Figure 4-7: Expanded View of TTW Indications, Unit 3, SG E-089

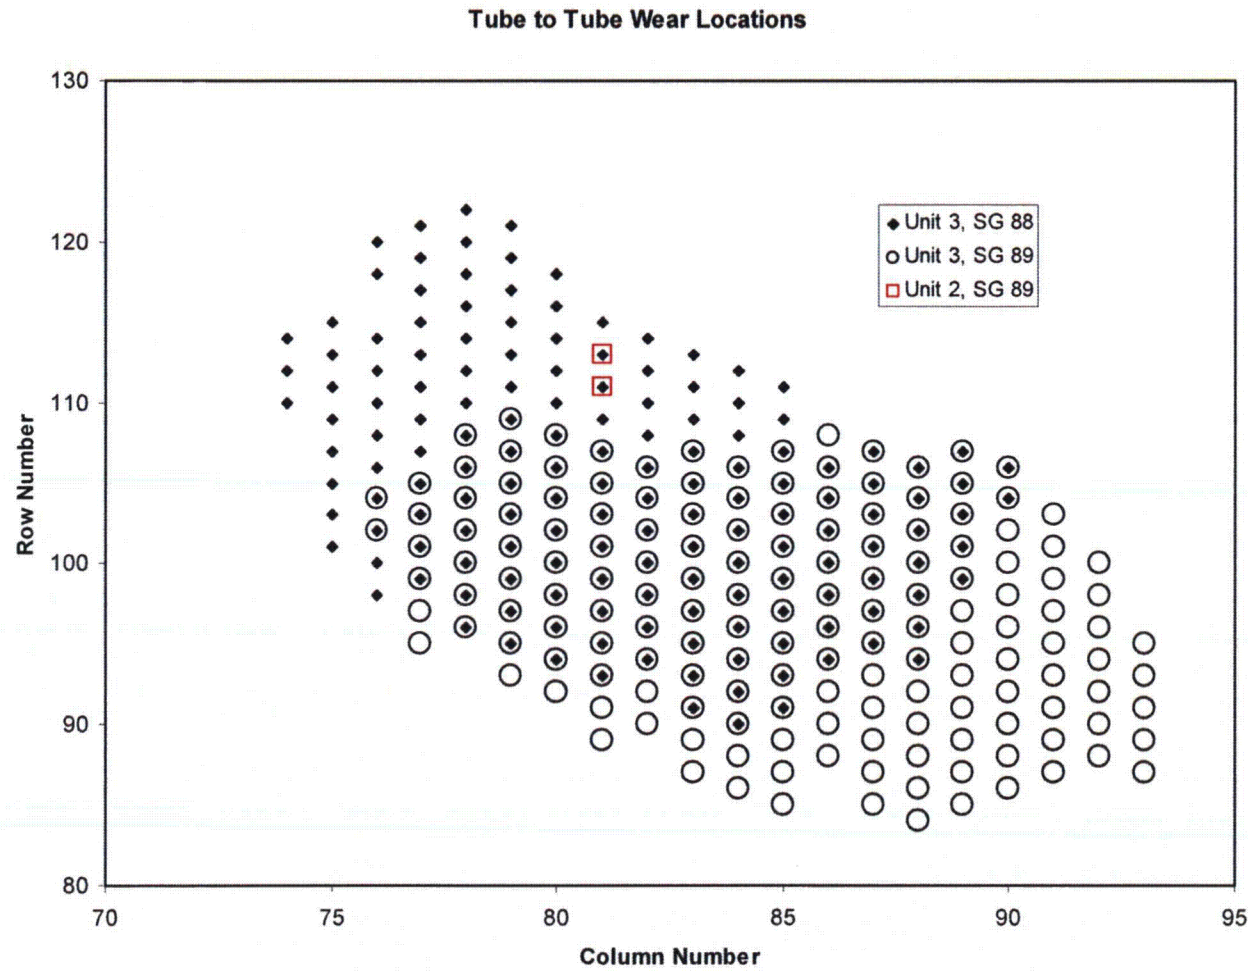
Figure 4-8: Combined View of TTW Indications

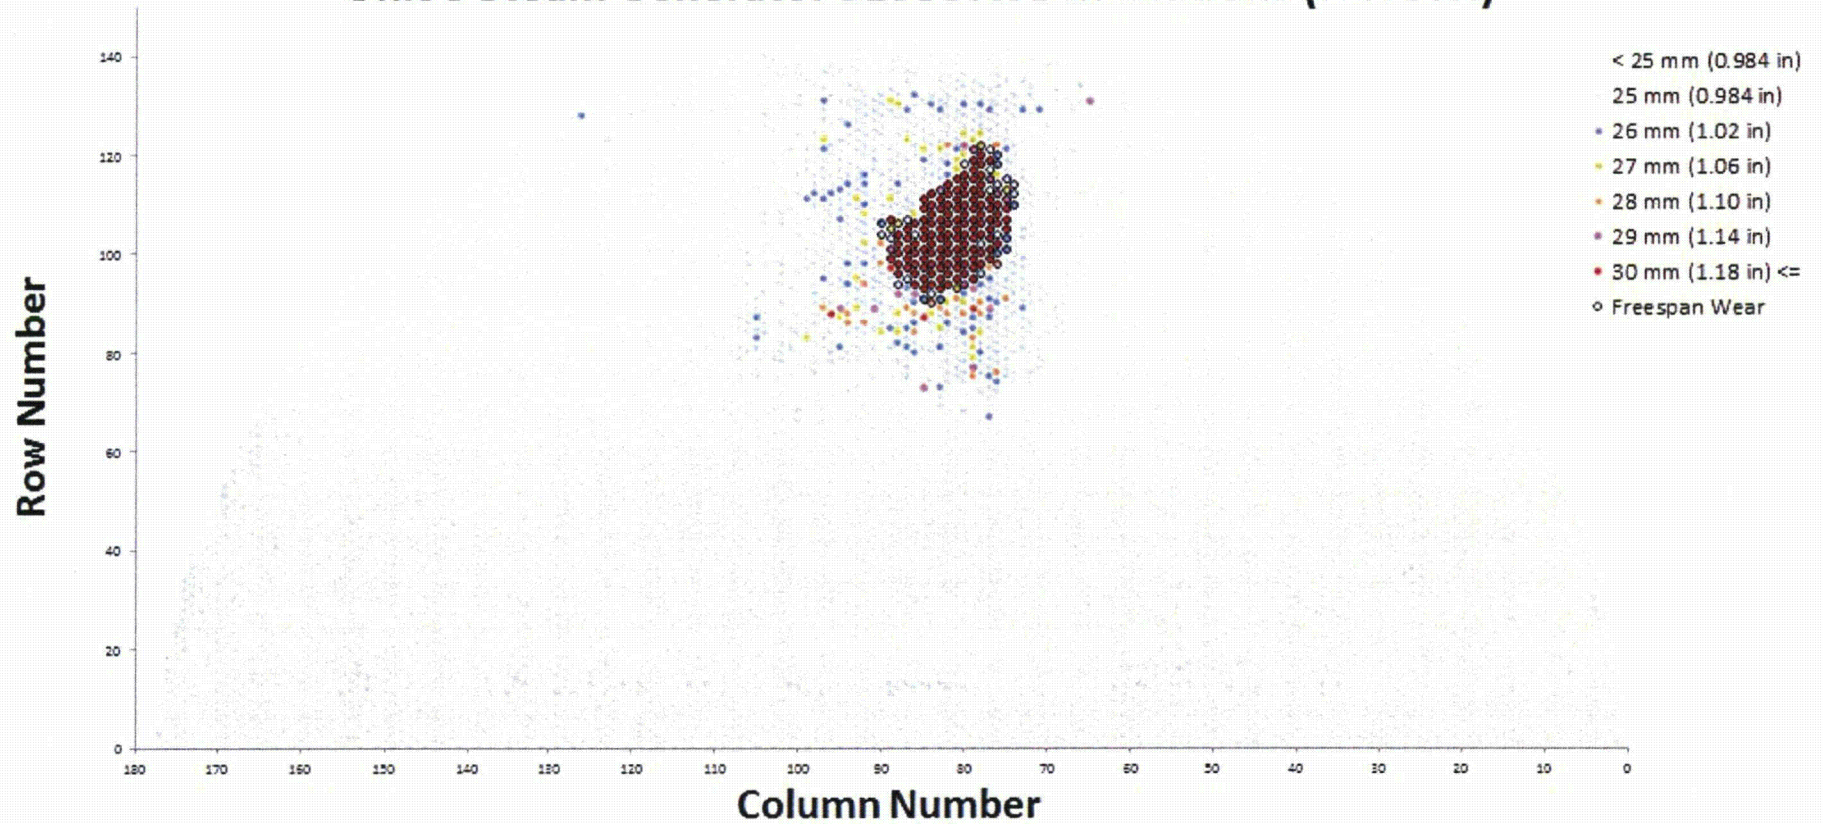
Figure 4-13: Tube Wear Length at AVBs for Unit 3 SG E-088

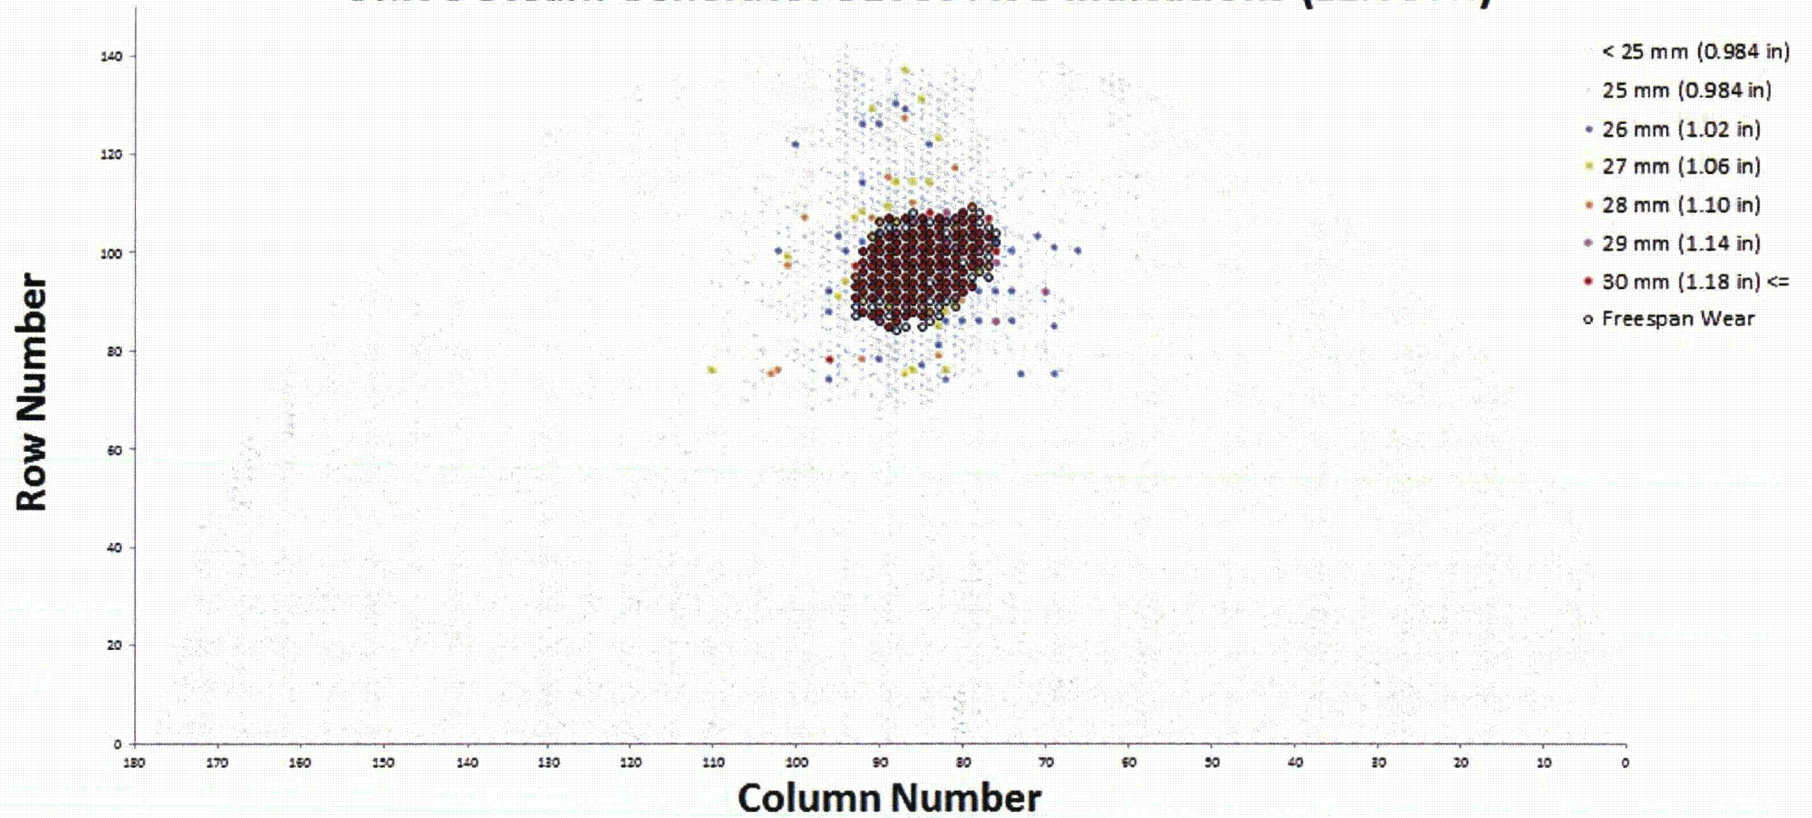
Figure 4-14: Tube Wear Length at AVBs for Unit 3 SG E-089

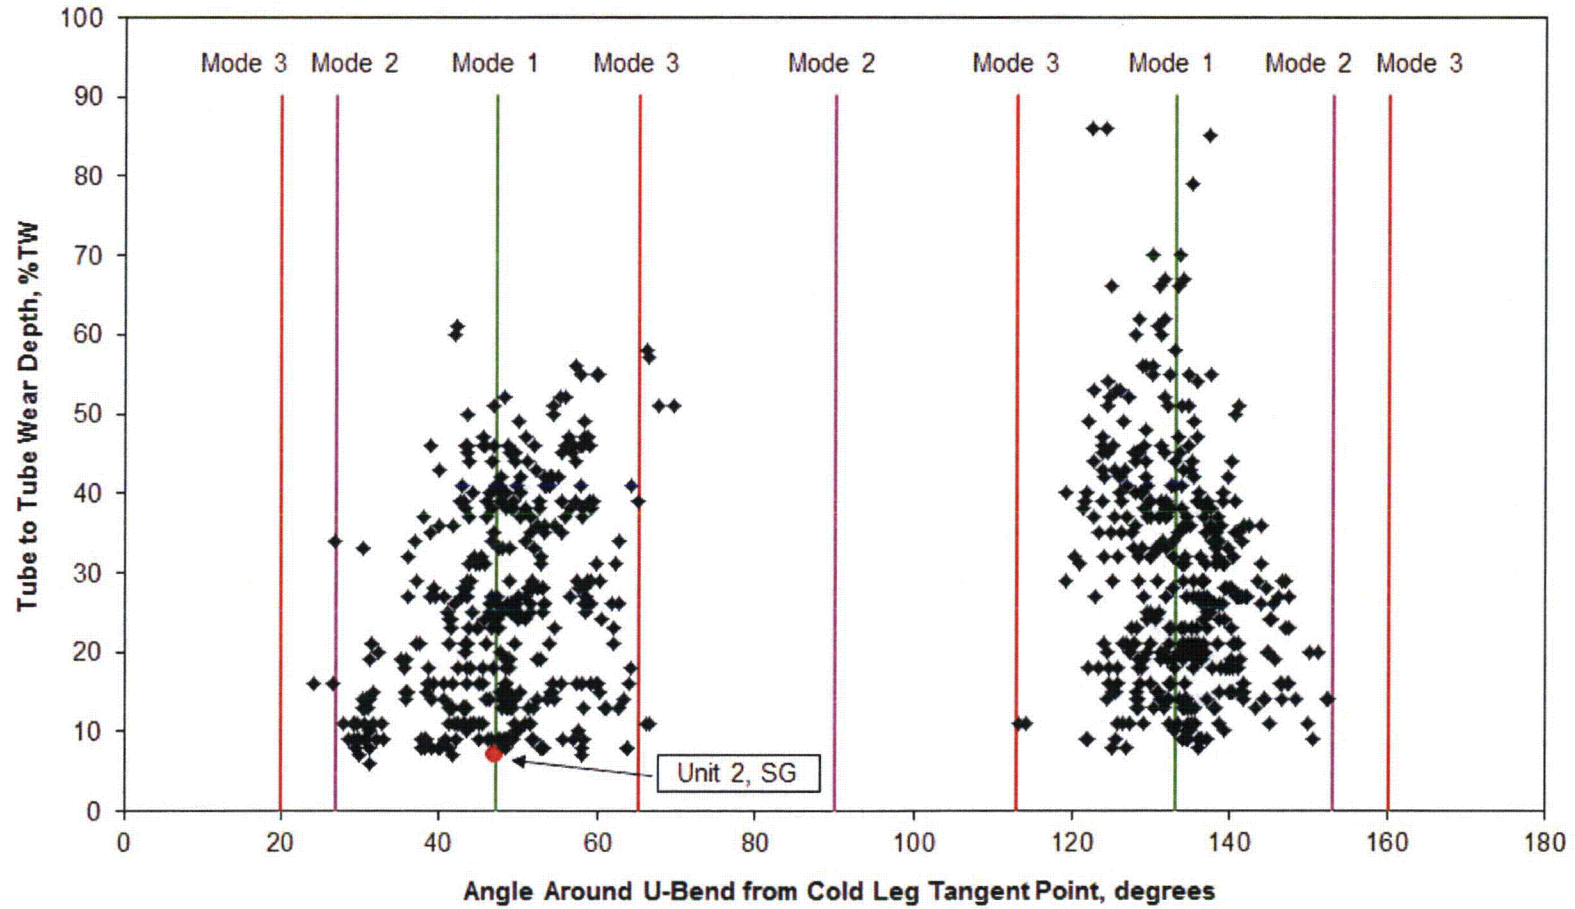
Tube to Tube Wear Depths Versus Angle Around U-Bends

Figure 4-17: Impact Locations of Unstable Tubes

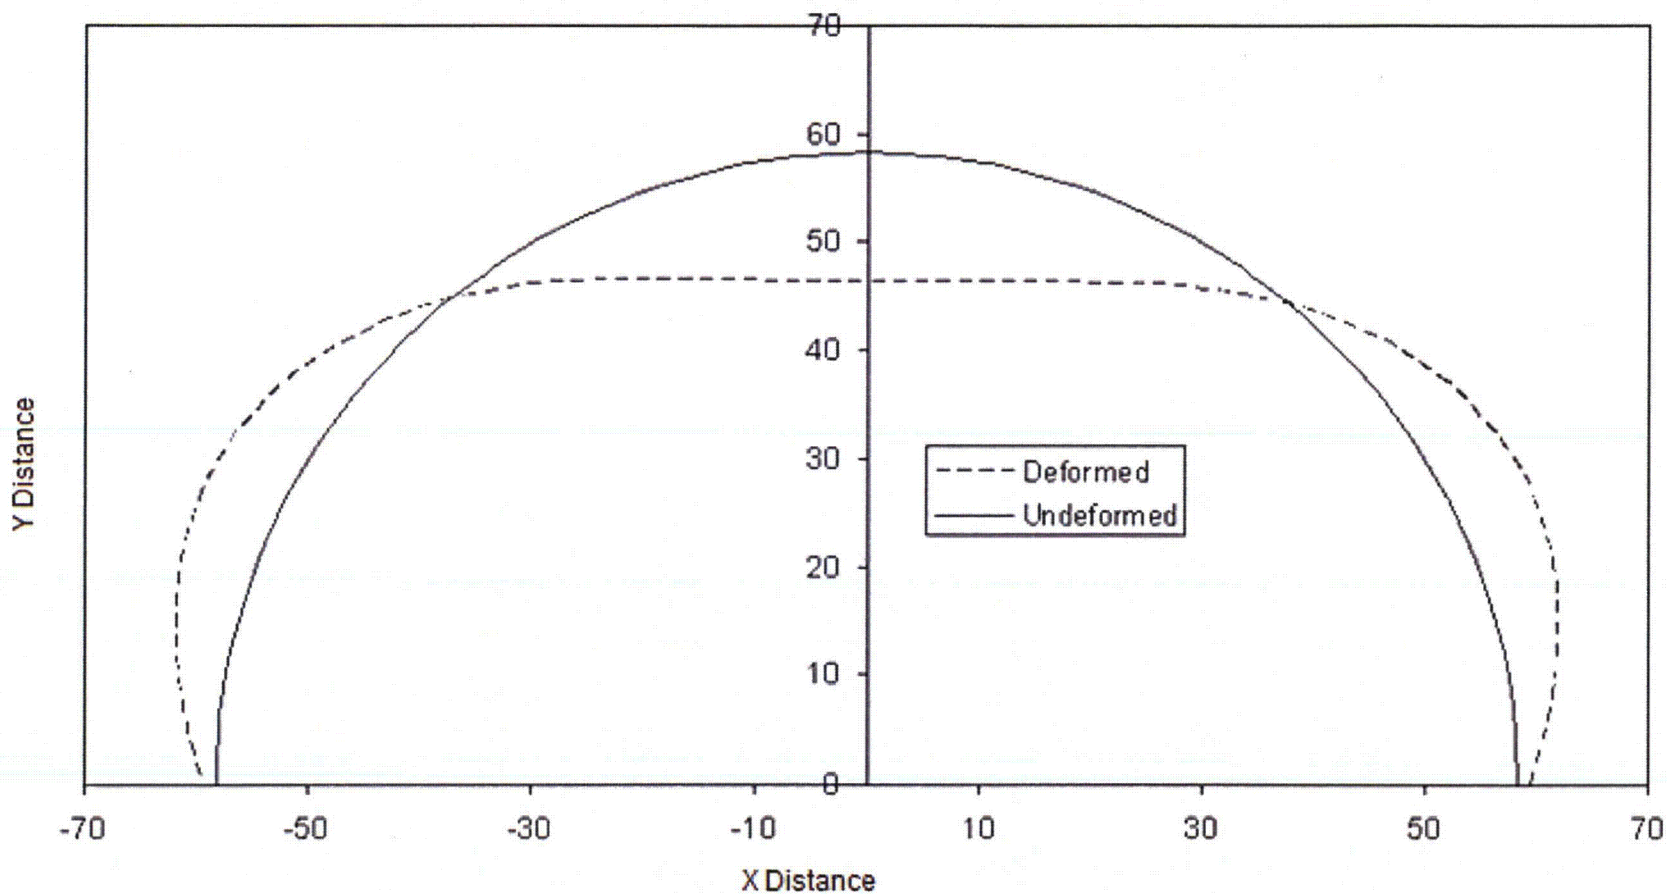
Deformed and Undeformed U-Bend Row 106 Mode 2

Figure 4-18: Mode 2 Displacement Pattern

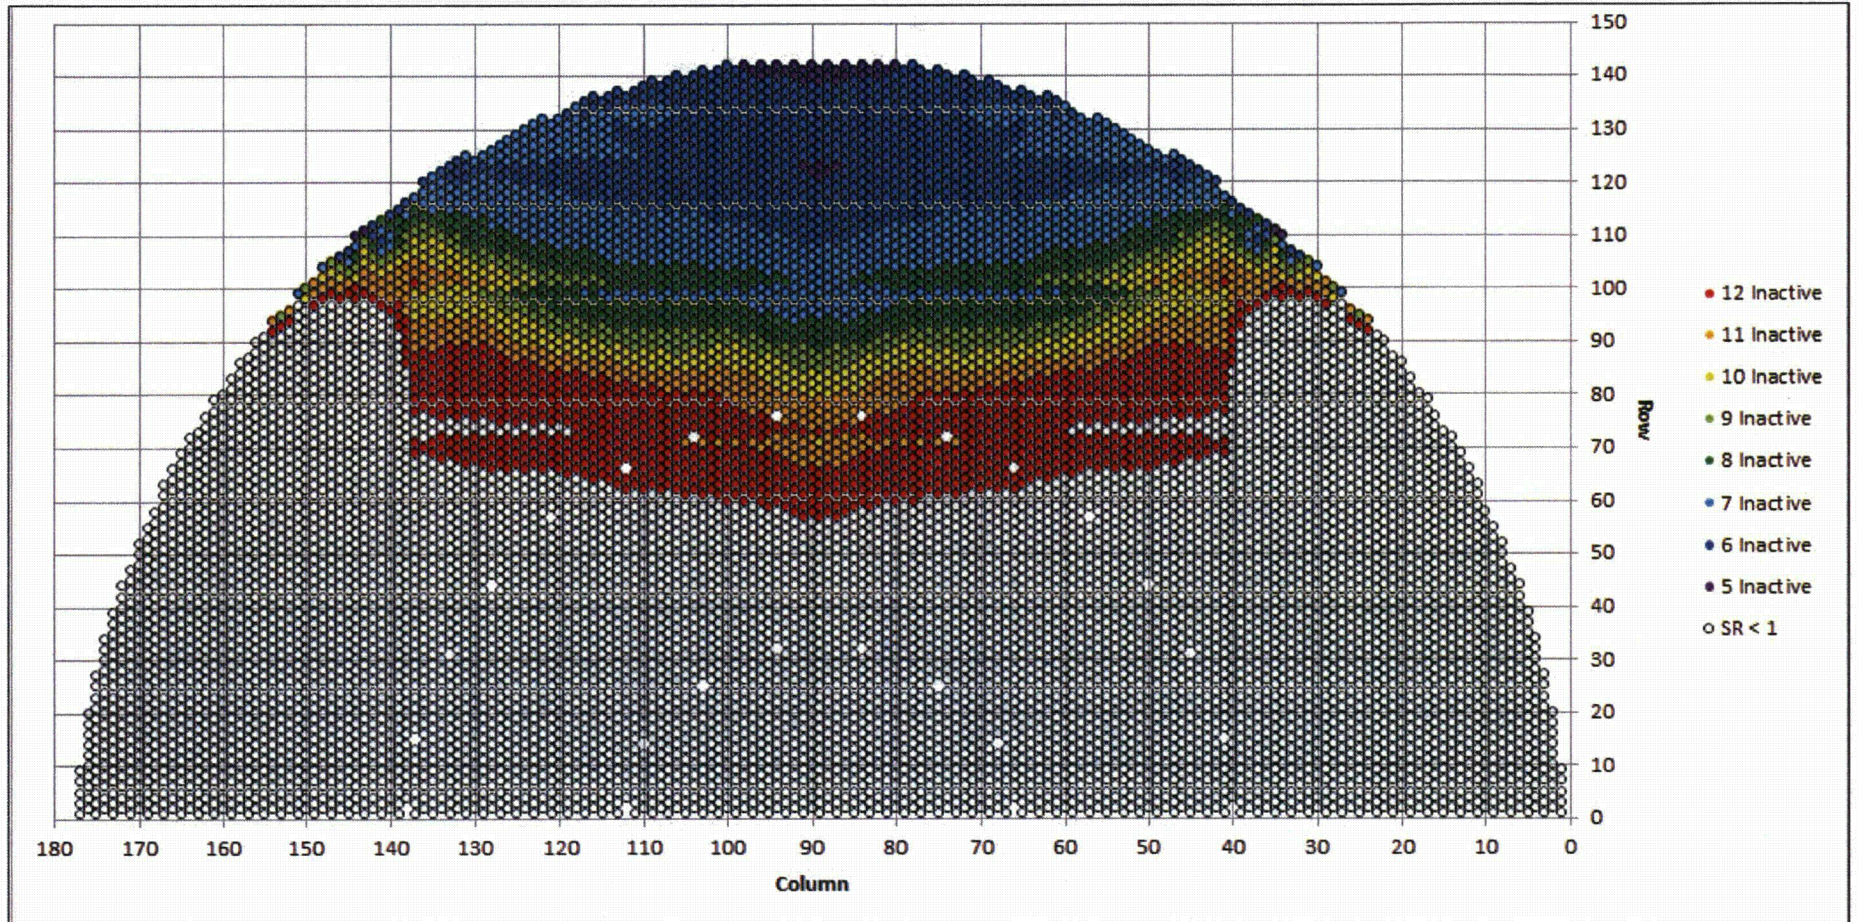
Figure 5-3: Stability Map at 100% Power, No Plugging, 95<sup>th</sup> Percentile SR, SR ≥ 1

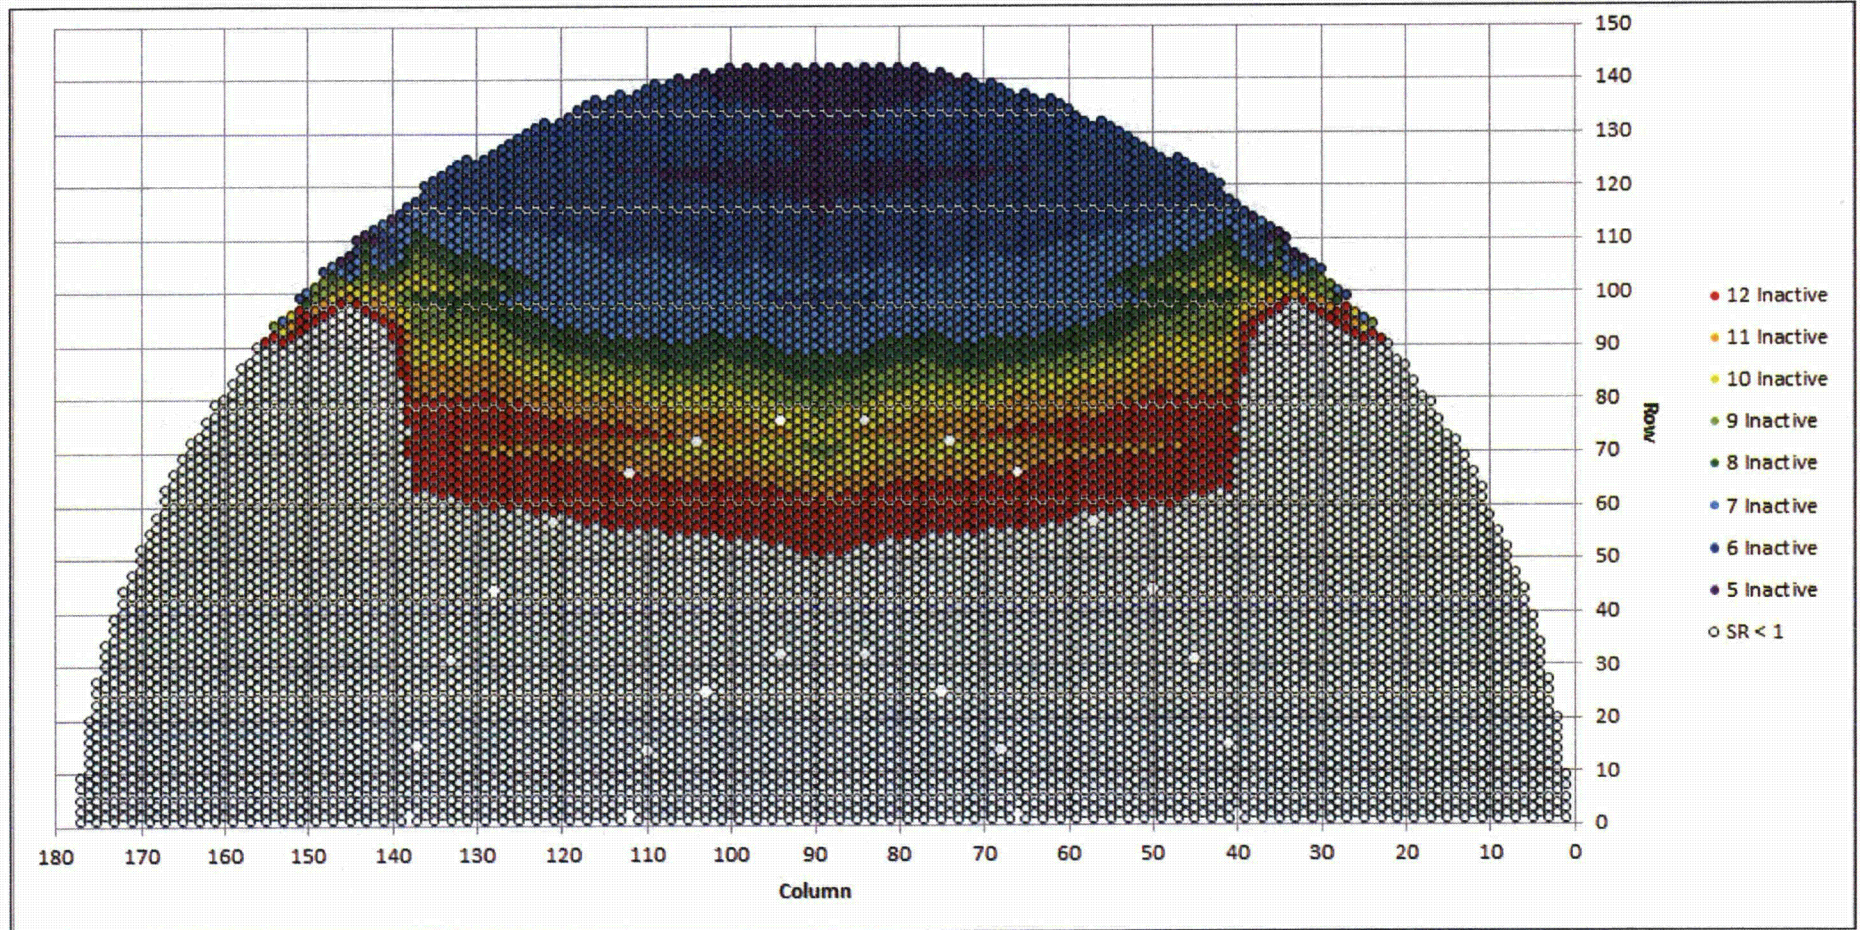
Figure 5-6: Stability Map at 100% Power, 99<sup>th</sup> Percentile SR, SR ≥ 1

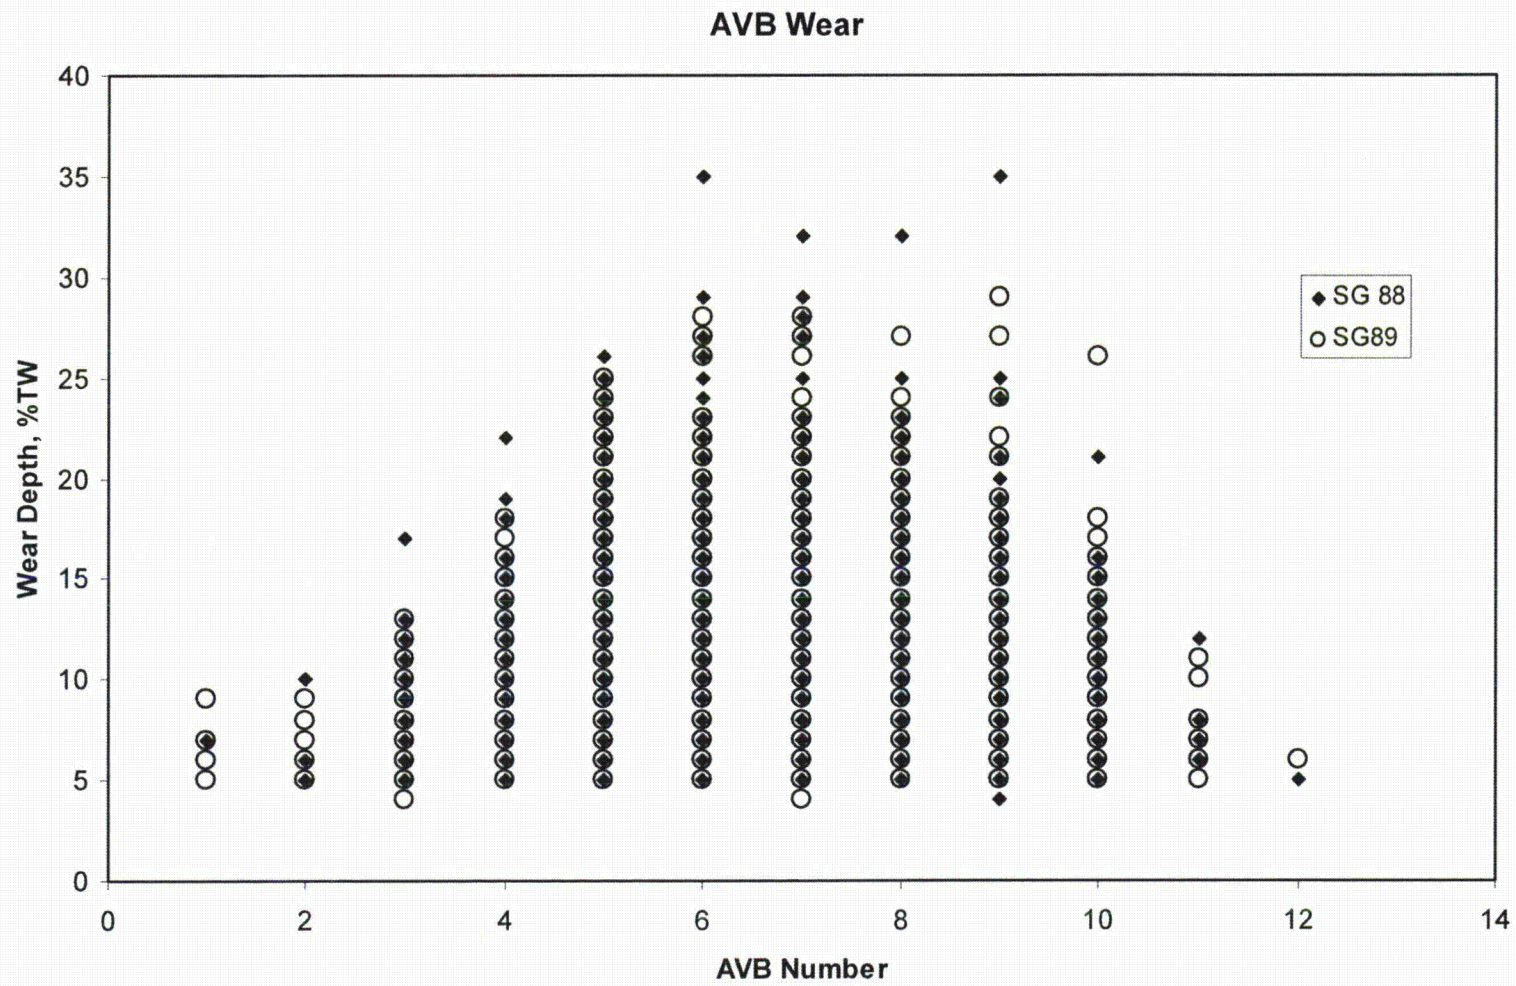
Figure 5-8: Depth of AVB Wear Indications versus AVB Number, Unit 2, SG E-088 and SG E-089

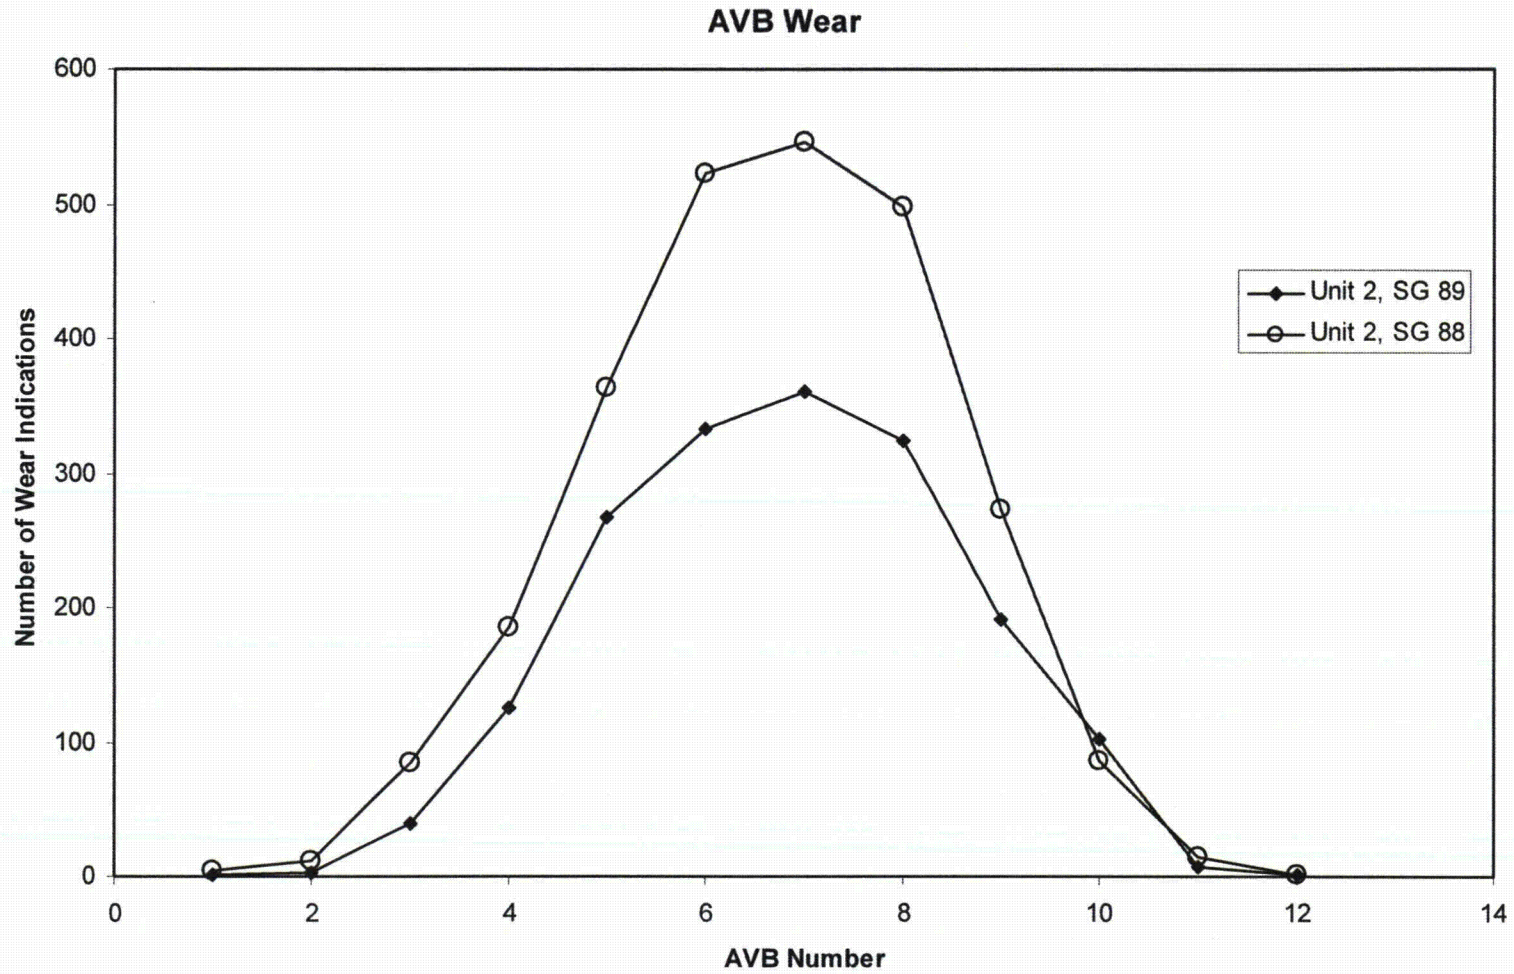
Figure 5-9: Number of AVB Wear Indications versus AVB Number

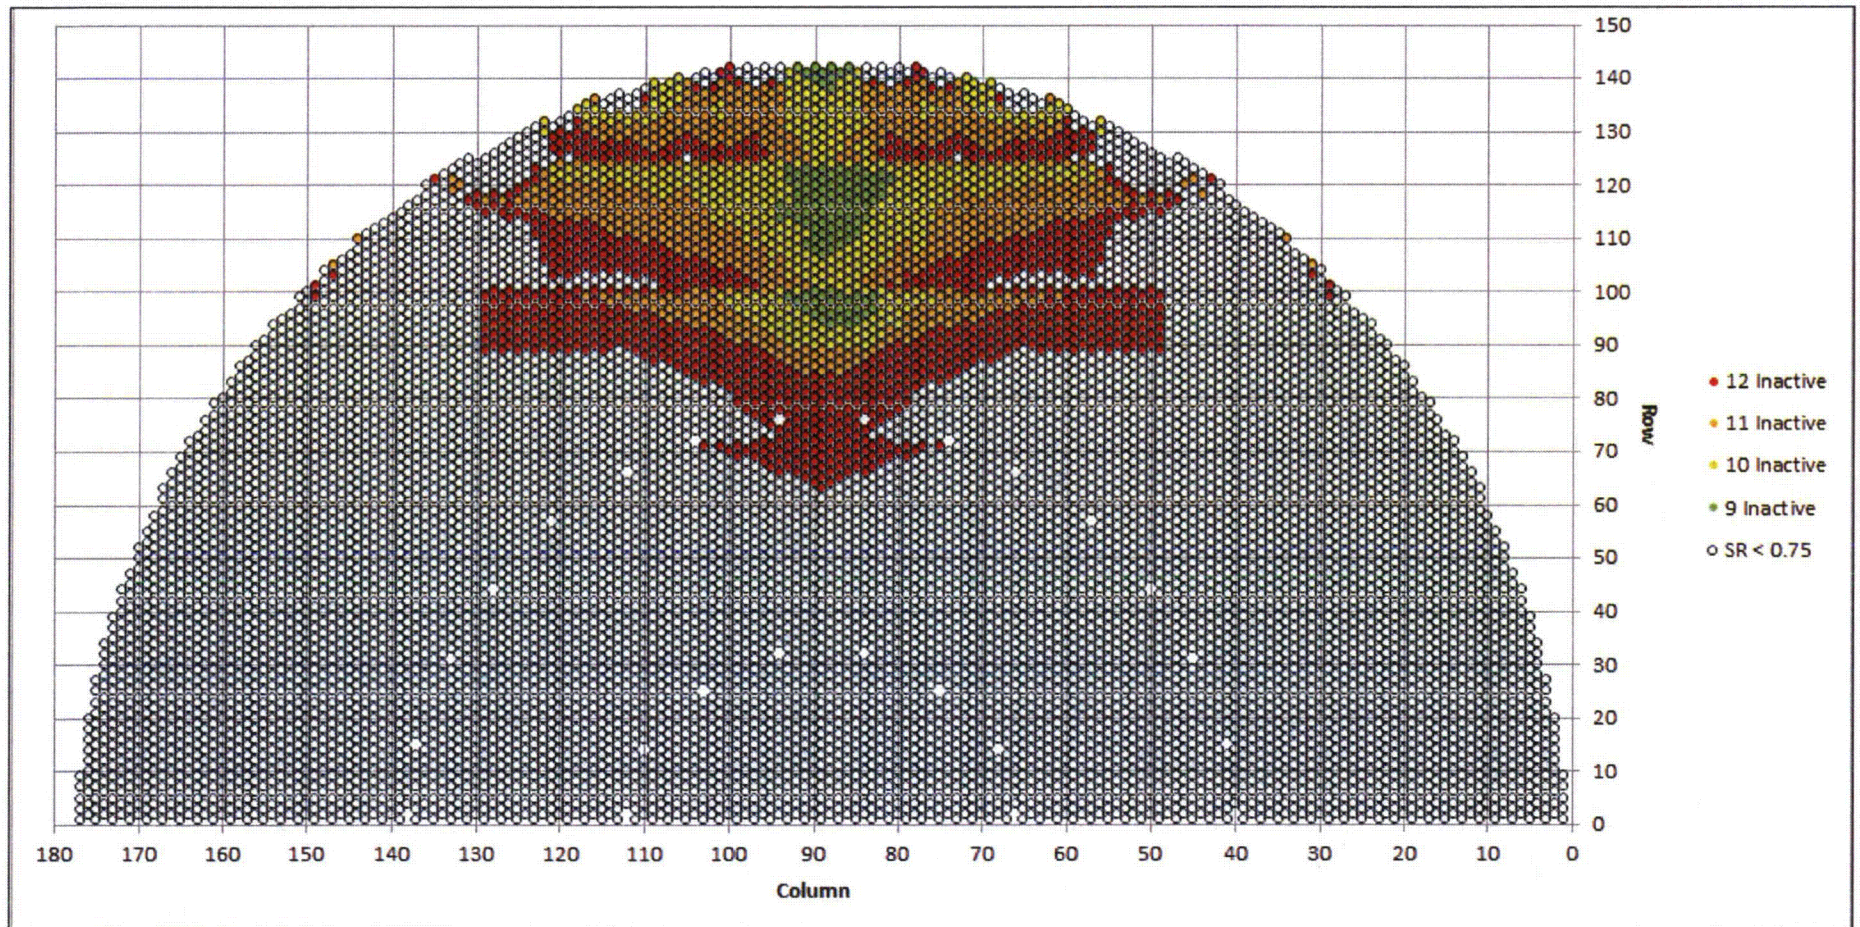
Figure 5-10: Stability Map at 70% Power with Plugging and Split Stabilizers, 95<sup>th</sup> Percentile SR, SR ≥ 0.75

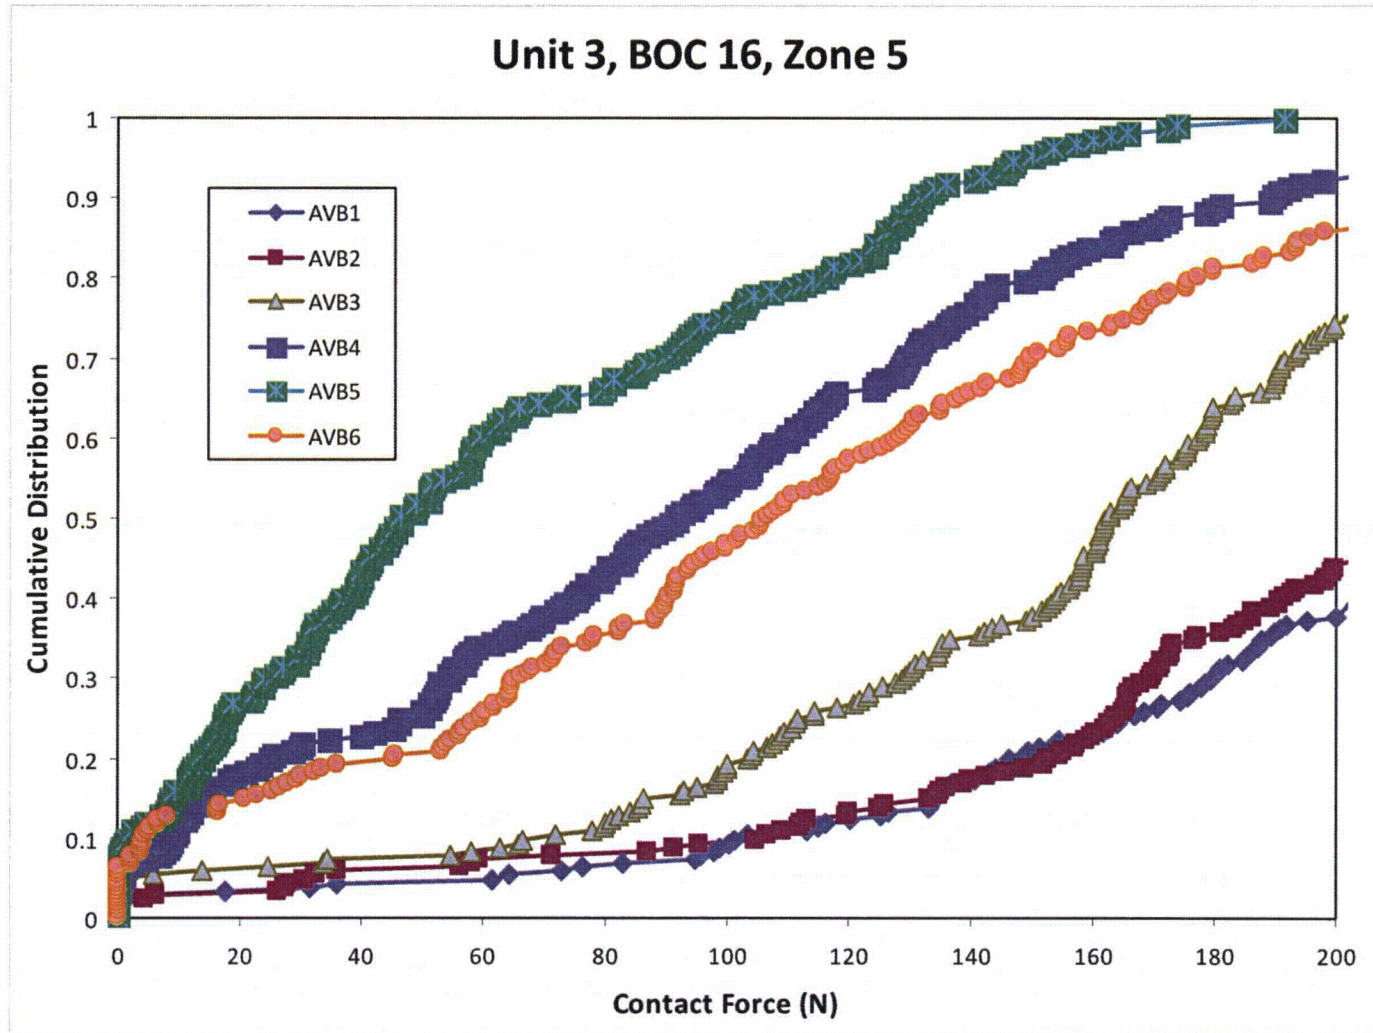
Figure 6-3: Cumulative Contact Force Distributions, Zone 1, Unit 3, BOC 16

Figure 6-4: Cumulative Contact Force Distributions, Zone 3, Unit 3, BOC 16

Figure 6-5: Cumulative Contact Force Distributions, Zone 5, Unit 3, BOC 16

Figure 6-6: Cumulative Contact Force Distributions, Zone 8, Unit 3, BOC 16

Figure 6-7: Cumulative Contact Force Distributions, Zone 29, Unit 3, BOC 16

Figure 6-8: Cumulative Contact Force Distributions, Zone 35, Unit 3, BOC 16

Figure 6-9: Cumulative Contact Force Distributions, Zone 32, Unit 3, BOC 16

Figure 6-10: Cumulative Contact Force Distributions, Zone 56, Unit 3, BOC 16

Figure 6-11: Cumulative Contact Force Distributions, Zone 5, Unit 3, BOC 16 + 3 Months

Figure 6-12: Cumulative Contact Force Distributions, Zone 5, Unit 3, BOC 16 + 11 Months

Figure 6-13: Cumulative Contact Force Distributions, Zone 1, Unit 2, BOC 16

Figure 6-14: Cumulative Contact Force Distributions, Zone 3, Unit 2, BOC 16

Figure 6-15: Cumulative Contact Force Distributions, Zone 5, Unit 2, BOC 16

Figure 6-16: Cumulative Contact Force Distributions, Zone 8, Unit 2, BOC 16

Figure 6-17: Cumulative Contact Force Distributions, Zone 5, Unit 2, EOC 16 (BOC 16 + 22 Months)

Figure 6-18: Cumulative Contact Force Distributions, Zone 5, Unit 2, BOC 17 + 6 Months

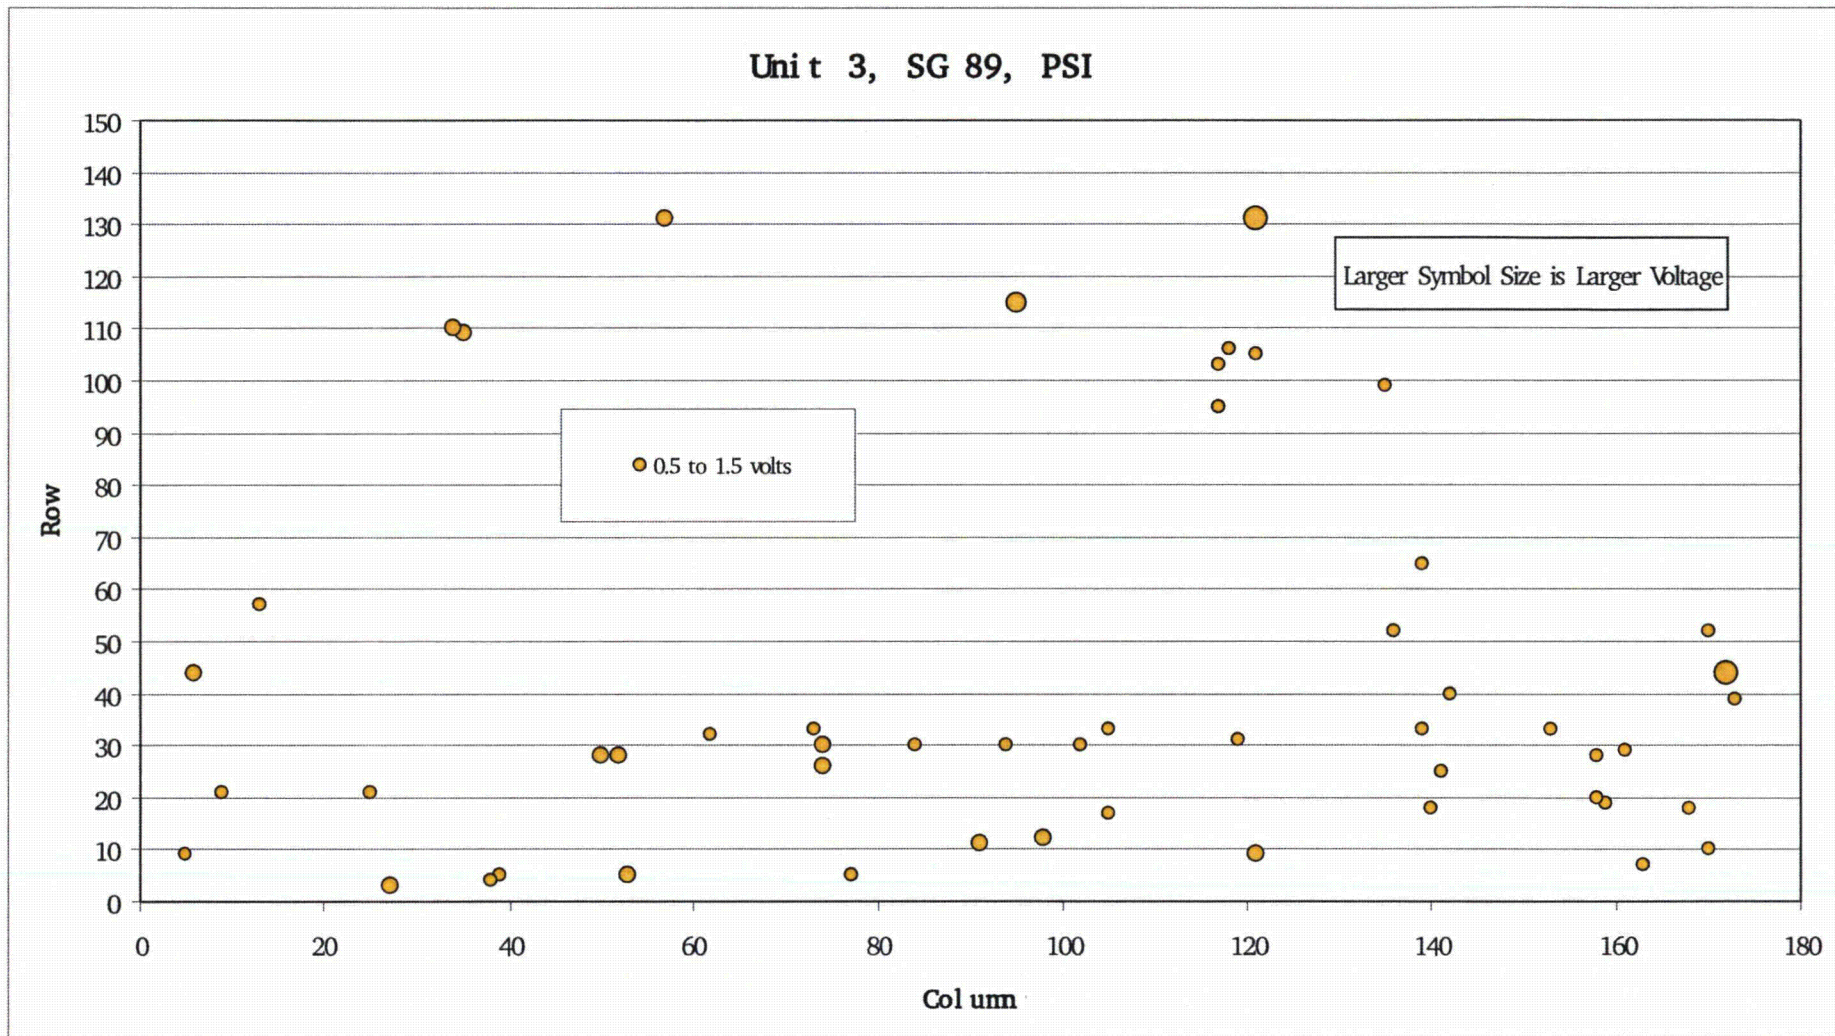
Figure 6-19: Tubesheet Map of Dents Found in Pre-Service Inspection, Unit 3, SG E-089
