SONGS U2C17 Steam Generator Operational Assessment for Tube-to-Tube Wear

### 3.0 INTRODUCTION

#### 4.0 OPERATIONAL ASSESSMENT STRATEGY

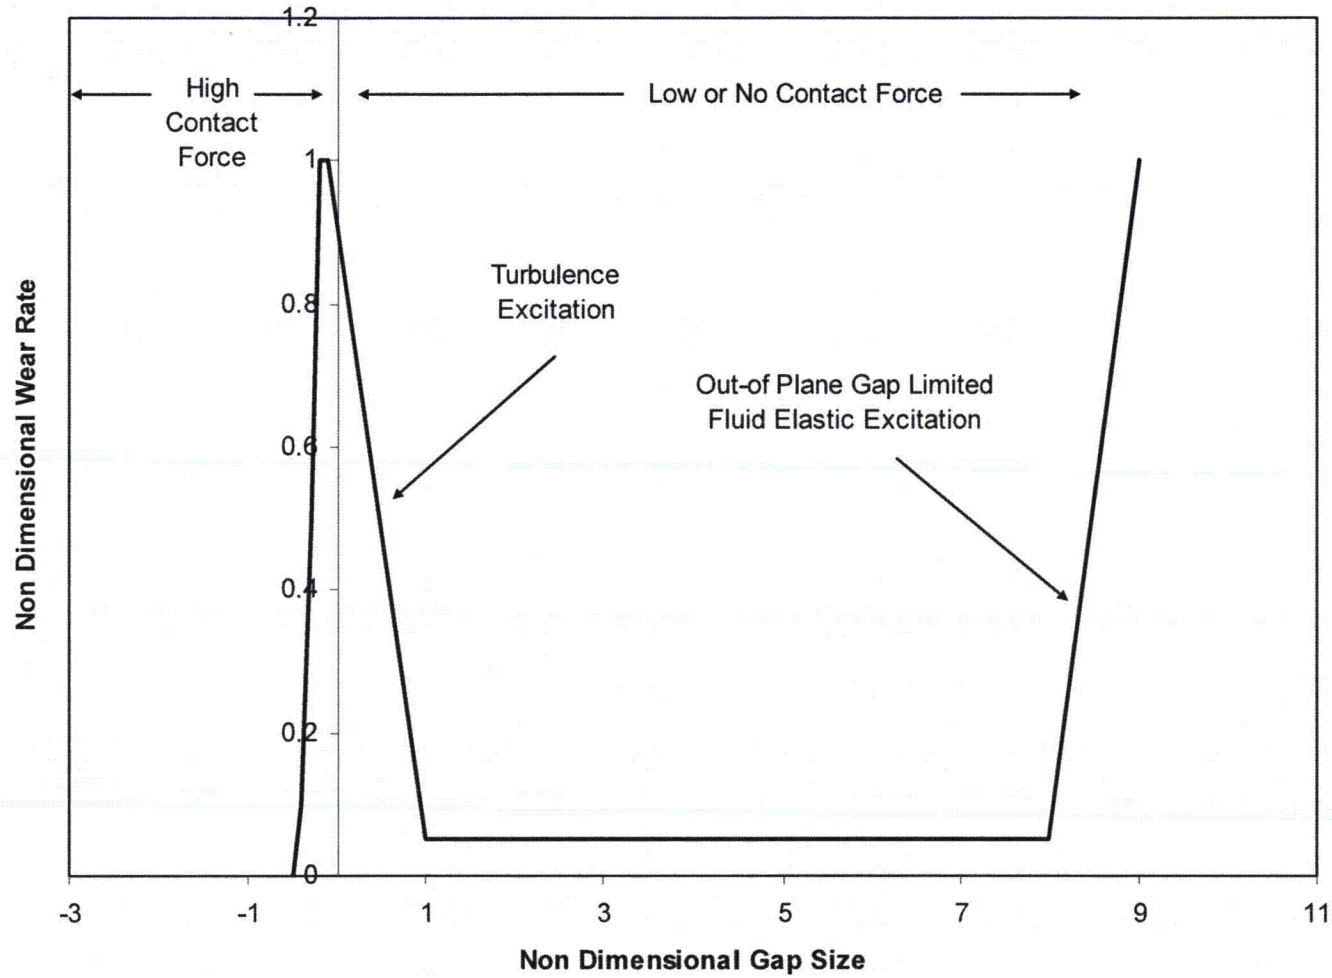
**Illustrative Schematic, Wear Rate versus Gap Size**

**Figure 6-31: Illustrative Schematic of AVB Wear Rates, High Wear Rates are Possible for Very Small or Large Gaps**

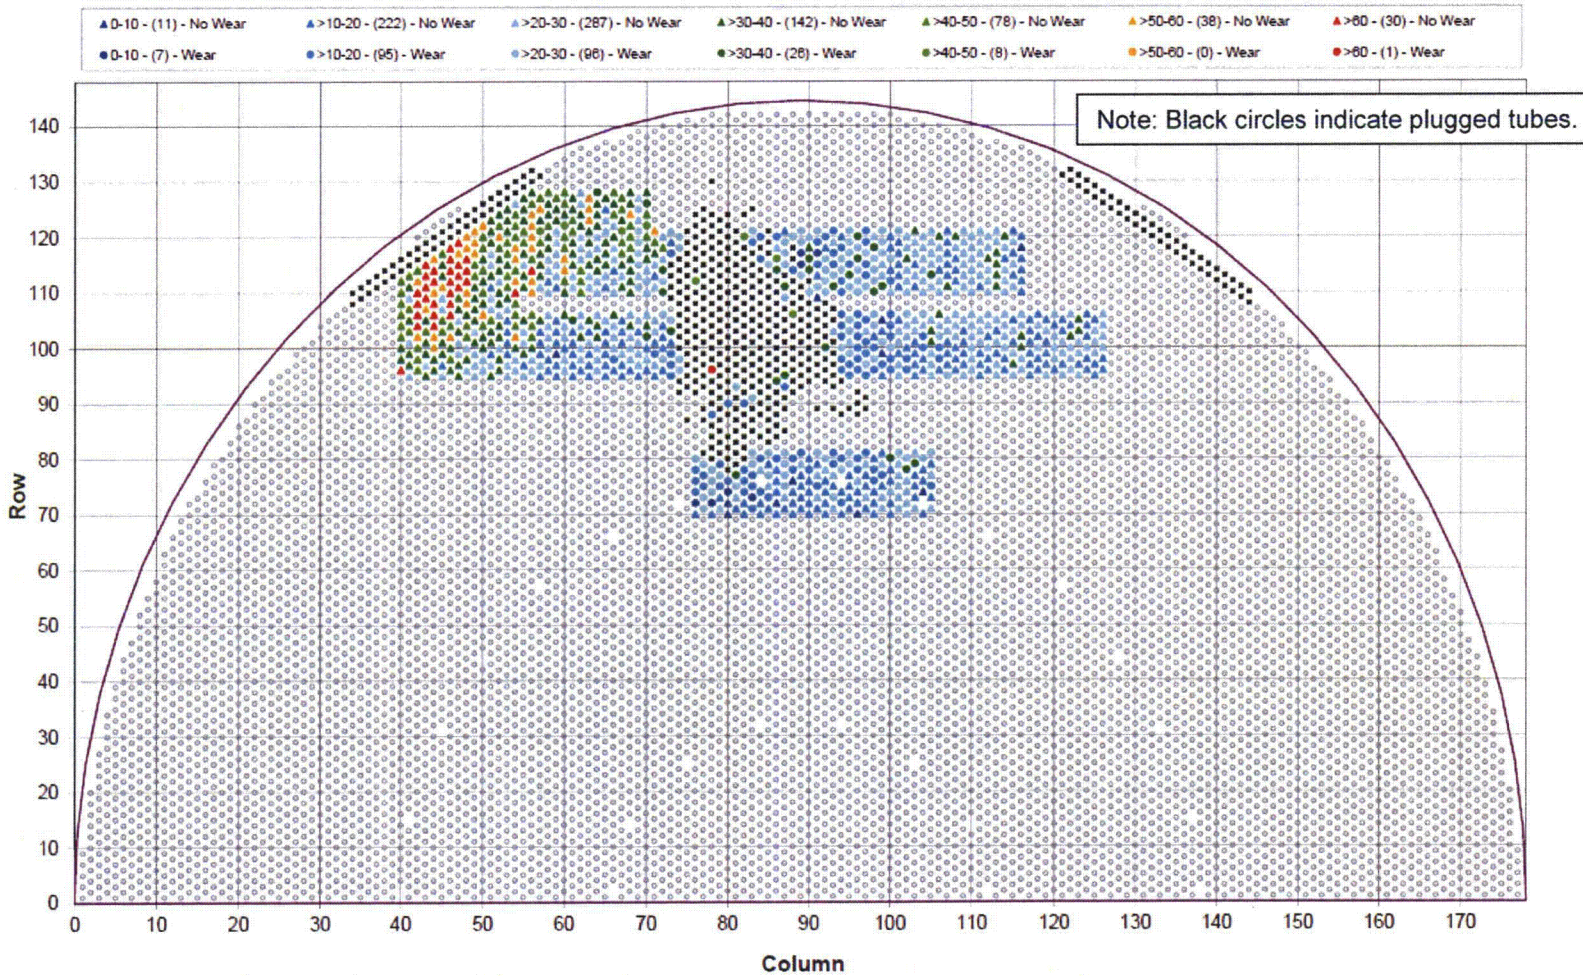
Figure 6-32: Tubesheet Map of ECT Gap Measurements, Total Gap for All AVB Locations per Tube, Unit 3, SG E-088, ISI
