Landslides Triggered by the 2004 Niigata Ken Chuetsu, Japan, Earthquake

The Niigata Ken Chuetsu earthquake triggered a vast number of landslides in the epicentral region. Landslide concentrations were among the highest ever measured after an earthquake, and most of the triggered landslides were relatively shallow failures parallel to the steep slope faces. The dense concentration of landslides can be attributed to steep local topography in relatively weak geologic units, adverse hydrologic conditions caused by significant antecedent rainfall, and very strong shaking. Many of the landslides could be discerned from high-resolution satellite imagery acquired immediately after the earthquake. [DOI: 10.1193/1.2173021]

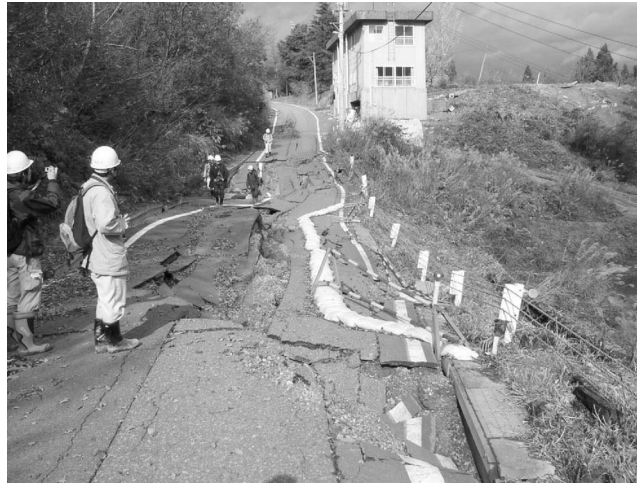
Figure 3. Headscarp of a rotational failure along Highway 23 in the Yamakoshi epicentral area.

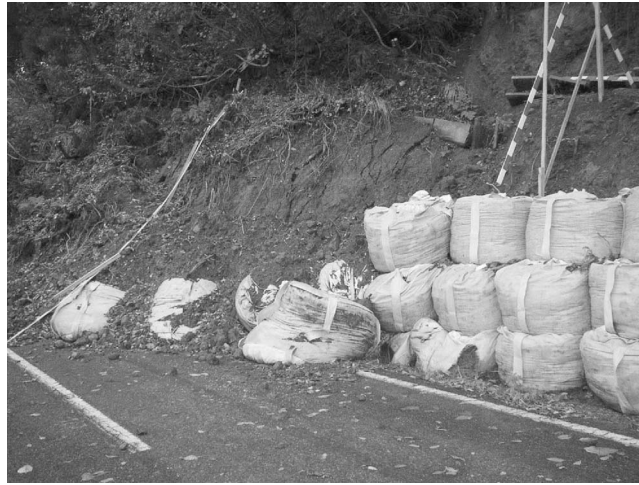
Figure 4. Slide debris deposited on sandbags that had been placed to stabilize a pre-existing rainfall-induced landslide along Highway 9 east of Nagaoka.

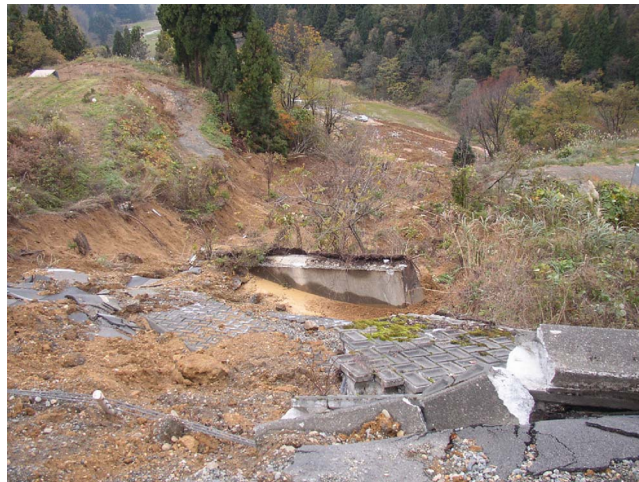
Figure 5. Damage to the roadway and to a retaining wall on Highway 9, east of Nagaoka.

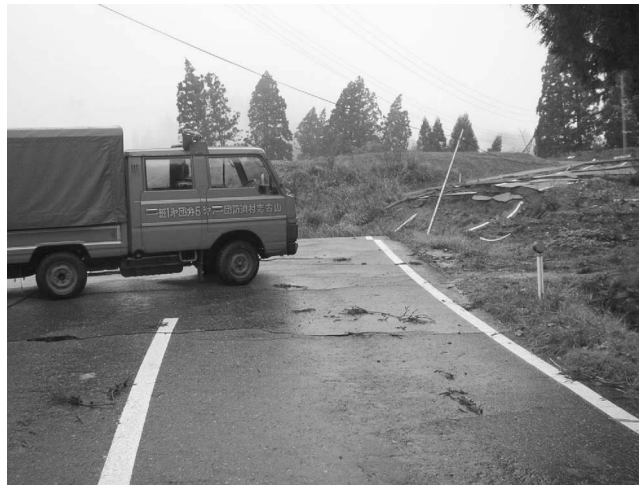
There was also evidence that some failures had begun in response to aftershocks and/or rain that fell after the main shock. Figure 6 shows a fire truck parked across Highway 291 southeast of Yamakoshi City Hall, presumably to prevent vehicles from driving off a headscarp. Figure 7 shows the same fire truck in the distance and additional landslide damage in the foreground. The relatively intact section of road on which the fire truck is parked is only about 30 m long and has no fire station. This suggests that the truck was parked after a landslide that had been triggered during the main shock, but before a second landslide occurred that stranded the truck.

Figure 6. Looking northwest, toward a fire truck that was parked across Highway 291 southeast of Yamakoshi City Hall to prevent vehicles from driving off a headscarp.

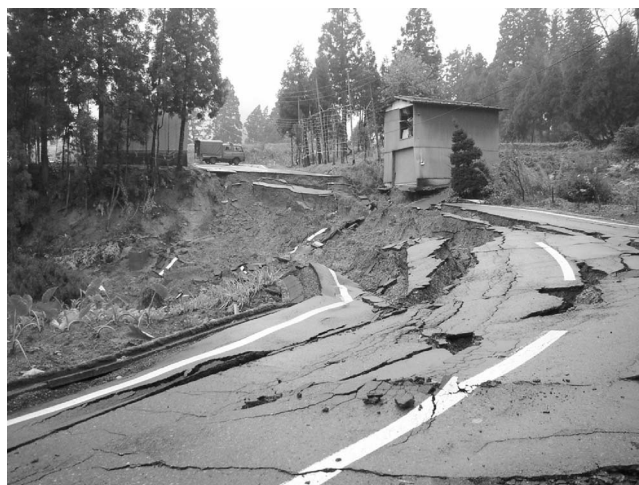
Figure 7. Looking northwest on Highway 291, toward the same fire truck as in Figure 5. In the foreground is an additional roadway section destroyed by landsliding.

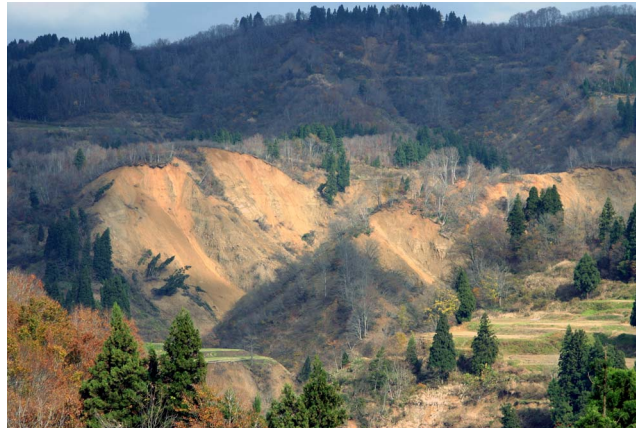
Figure 8. Shallow slope-parallel translational landslides along steep slopes near Yamakoshi.

floodplains (Figures 8 and 9). The failure surfaces commonly developed along the boundary with more intact and less weathered bedrock. Some slopes showed evidence of strong shaking that had stripped off most of the overlying soil mantle, leaving only a few fragments of partially mobilized soil mats (Figure 10). Typically, all vegetation was stripped off the surface, along with the soil cover.

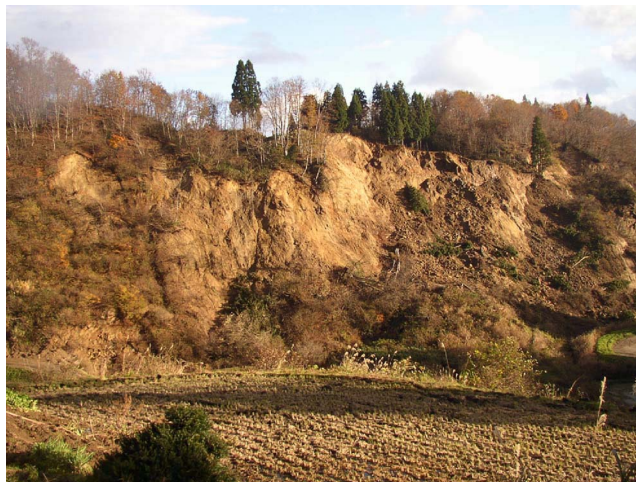
Figure 9. North-facing valley wall, showing extensive translational soil sliding into the valley bottom in the Yamakoshi epicentral area.

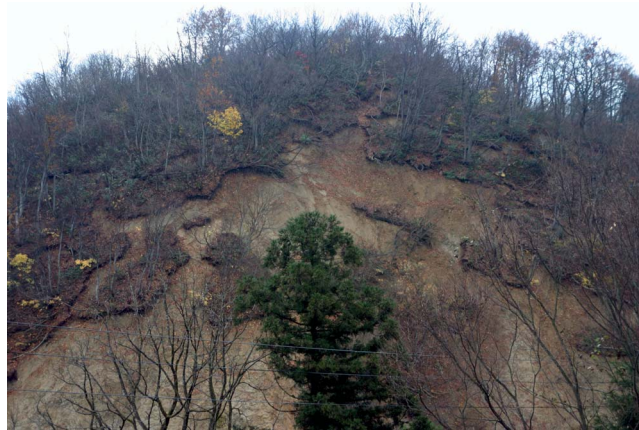
Figure 10. Slope whose soil mantle was stripped off by strong shaking.

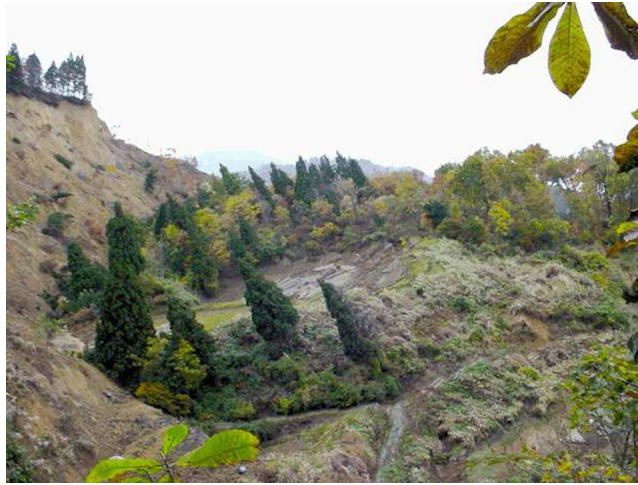
Figure 11. Deep rotational bedrock slump northeast of Shiotani.

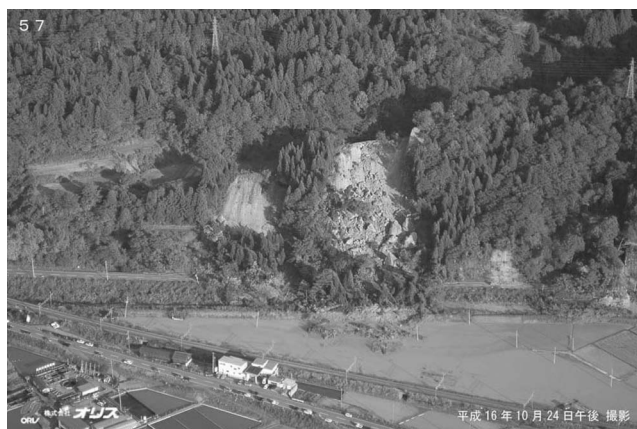
with the Asahi River, just west of Uragara (at the west end of the “Nov 19” track in Figure 1). Figure 12 shows two adjacent block slides approximately 300 m south of the confluence. These slides developed along a hogback composed primarily of Pliocene sandy mudstone of the Shiroywa (White Rock) Formation (Yanagisawa et al. 1986); bedding dip slopes on the hogback are inclined at about 25°–30°. The ridge on which the slides occurred could represent the remnant of a much older and larger relict block slide from the higher ridges above.

Figure 12. Two adjacent rock-block slides south of Uragara, along Highway 291 (photo: Original Research Ideal Survey, http://www.oris.co.jp/jishin2004/h16jisin_k.htm).

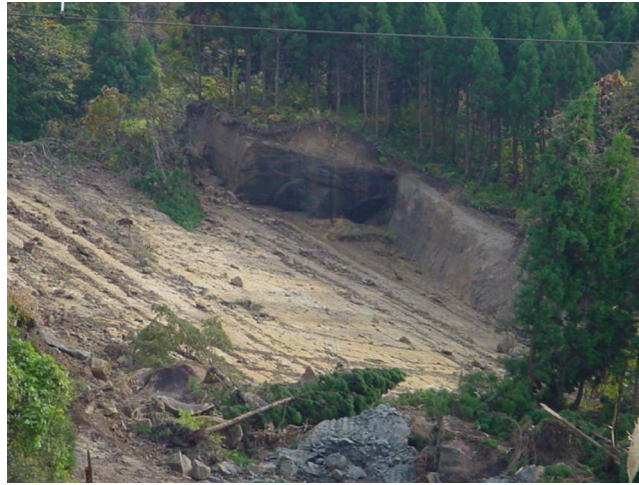
Figure 13. Uragara rock-block slide formed by a bedding plane (sliding surface) and two sets of vertical joint release surfaces.

Figure 13 is a closer view of the block slide that appears at left in Figure 12. Sliding occurred along a dip-slope bedding plane and was facilitated by lateral releases provided by two sets of vertical joint surfaces. Figure 14 is a downslope view of the sliding plane and slide debris. The upright trees at the slide toe indicate pure translation of the debris over a distance of several tens of meters.

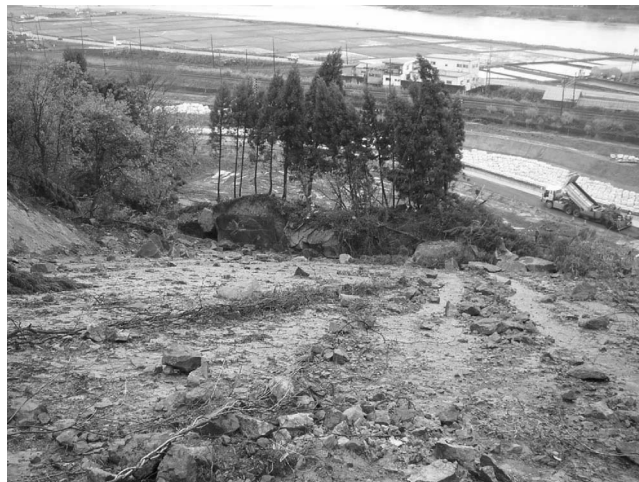
Figure 14. Downslope view of the Uragara slide plane and debris. The Shinano River is in the background.

Exposed along the left lateral scarp of the block slide shown in Figures 13 and 14 is a geologic contact suggesting prior, perhaps ancient, slide movement. As shown in Figure 15, an intact block of bedrock has a steeply dipping and sharp contact with colluvial debris. This is interpreted as representing past block sliding of the material downslope of the contact, with subsequent infilling of the headscarp area with colluvial debris.

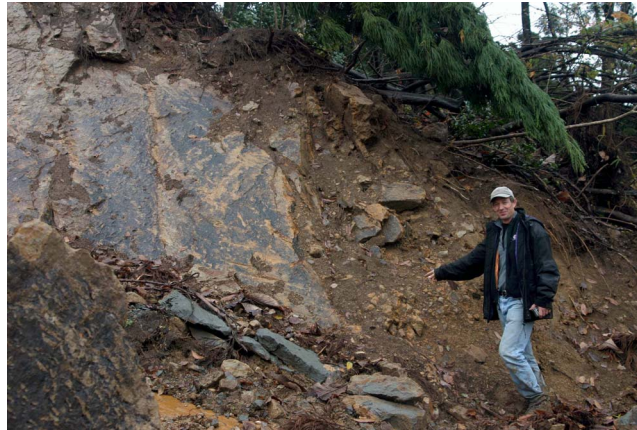
Figure 15. Intact block of bedrock (to the left) contacting colluvial debris (to the right).

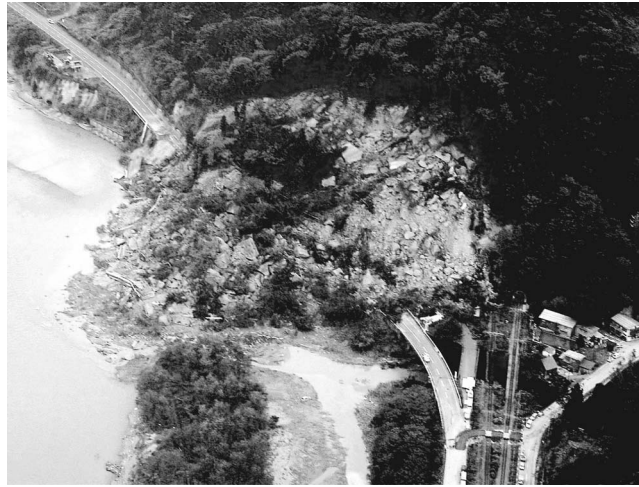
Immediately north of the confluence of the Shinano and Asahi rivers is the Shiroiwa landslide. This failure drew international attention because the landslide buried a mother and her two young children in their car. They were recovered about four days after the earthquake, and only one child survived. The ridge along which this failure occurred represents the northern extension of the hogback shown in Figure 12, and the bedrock again consists of Pliocene sandy mudstone of the Shiroiwa Formation (Yanagisawa et al. 1986). As shown in Figure 16, the block slide occurred at a re-entrant corner developed at the intersection of the eastern and southern sides of the Shinano and Asahi rivers, respectively. The compound slope configuration may have had two effects on the slide development: potential focusing of seismic energy and a reduction of kinematic constraint. For a structurally controlled slide to develop, whether a block slide or wedge slide, a minimum of four surfaces must be involved. The four surfaces are created by combinations of free surfaces as well as discontinuity surfaces. As Figure 16 shows, the hogback ridge and reentrant corner provide three free surfaces, so only one structural surface (a bedding plane) is required to liberate the mass. This is in contrast to the block slides shown in Figure 12, which necessitated structural release surfaces in addition to the bedding plane.

Figure 16. Looking northeast toward the Shiroiwa block slide at the confluence of the Shinano and Asahi rivers (photo: I. Yasuda, Hasshu Company).

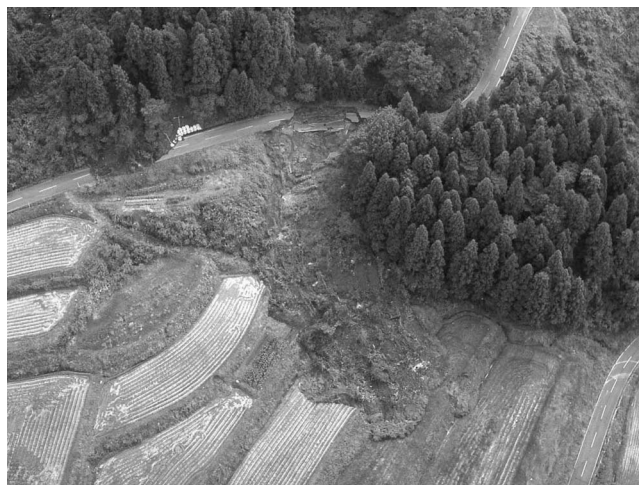
had very long runout distances, probably because of the high antecedent moisture conditions. The slump-flow complex in Figure 17 ran out over multiple rice paddy terraces.

Figure 17. Slump-flow complex in a colluvium-filled swale along Highway 9 east of Nagaoka (photo: I. Yasuda, Hasshu Company).

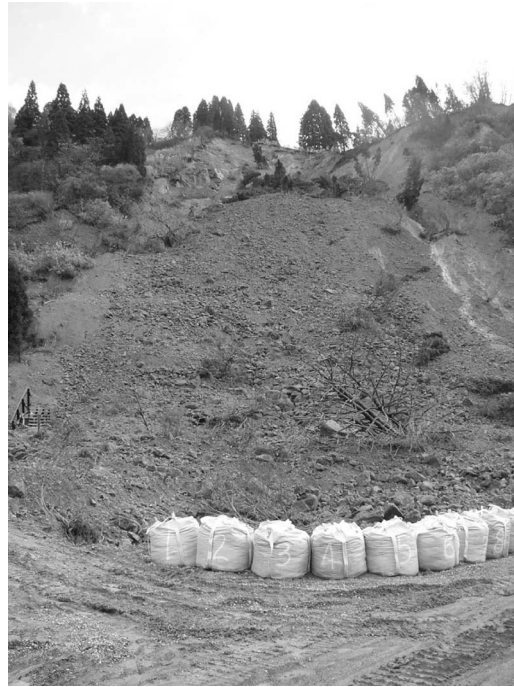
Figures 18 and 19 show a slump-flow complex along Highway 24 northeast of Ya-

Figure 18. Northwest-facing slump-flow complex with a large headscarp at the top and debris in the foreground, on Highway 24 northeast of Yamakoshi City Hall.

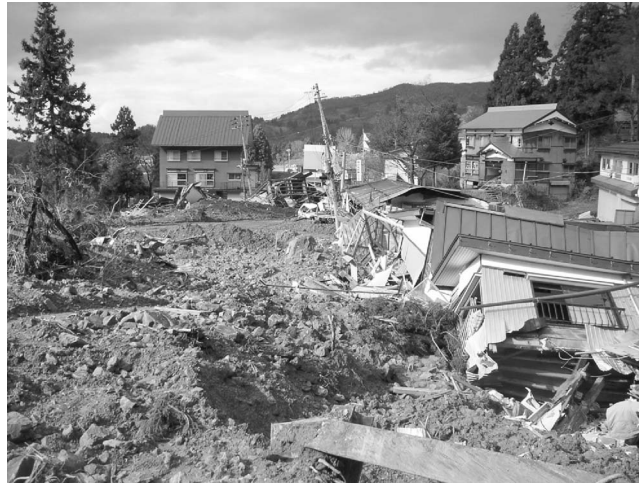
makoshi City Hall. Figure 19 also shows the typical runout characteristics of slump-flow complexes triggered by the earthquake, which in this case destroyed several residential structures along its path.

Figure 19. Debris deposited by a northwest-flowing slump-flow complex, with destroyed buildings along the right margin, on Highway 24 northeast of Yamakoshi City Hall.

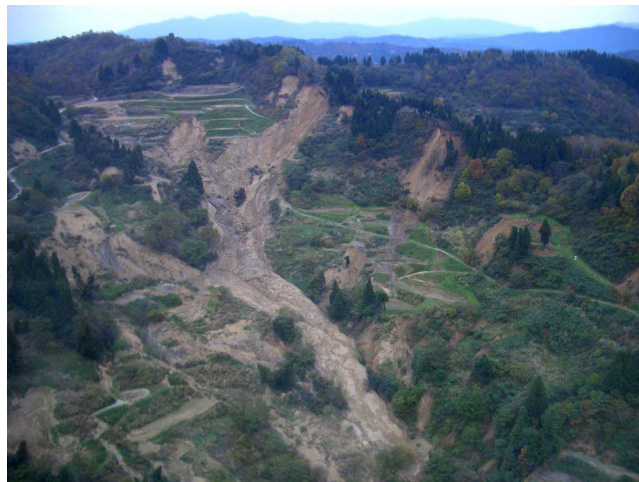
The earthquake triggered many debris flows that had significant runout distances (Figure 20). In previous earthquakes worldwide, debris flows have occurred much less commonly than other types of landslides (Keefer 1984). However, owing to heavy antecedent rainfall, this earthquake triggered many large debris flows, some of which traveled long distances and were devastating.

Figure 20. Large debris flow, exhibiting a narrow path and a long runout.

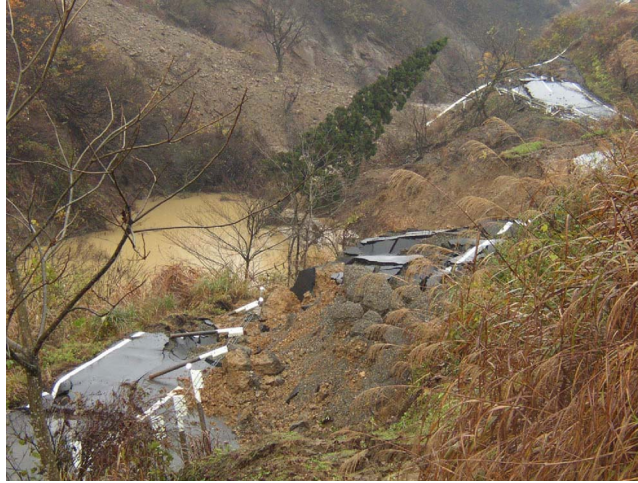
The earthquake triggered numerous landslide dams—at least dozens, and perhaps hundreds, of them—in the mountainous area around Yamakoshi. Most of the dams were relatively small blockages created by deposits of shallow landslides from steep-walled stream valleys (Figure 21). Typically, the impounded water extended only a few tens of meters upstream, but in some cases much larger reservoirs were created, some of which submerged roads and partially inundated small villages (Figure 22). At the time of the

Figure 21. Damming of a tributary valley caused by rotational slides and roadway embankment failures in the Yamakoshi epicentral area.

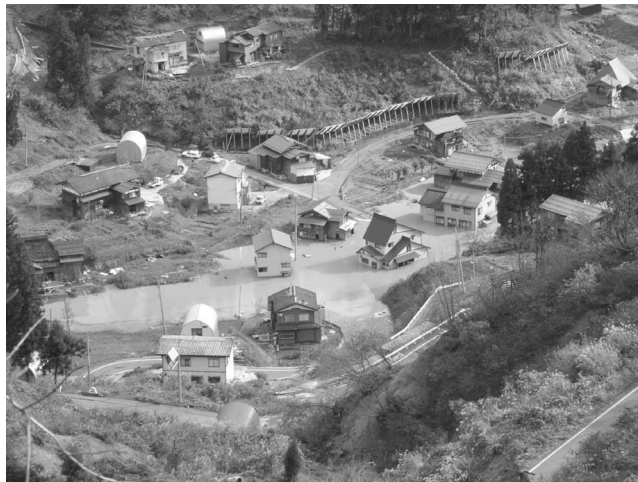
Figure 22. Looking east from Road 23 at the inundation of a tributary valley and houses upstream of a landslide dam in the Yamakoshi epicentral area.

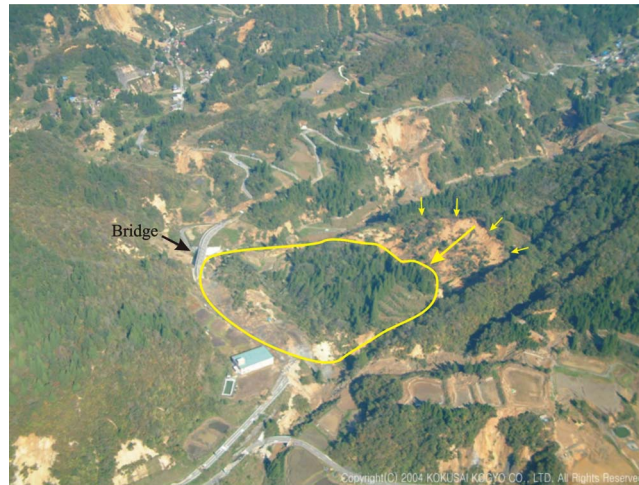
(Figure 23) was a block slide along a dip slope composed of Pliocene sandy mudstone of the Shiroyiwa formation (Yanagisawa et al. 1986), dipping about 20° west. A large graben formed at the head of the landslide as the slide mass moved across the canyon and completely blocked the drainage (Figure 24). At that date, the reservoir was rising about 15–20 cm/day, despite efforts to convey water over the dam in a controlled manner.

Figure 23. Oblique aerial view of a landslide dam west of Komatsugura before the reservoir filled. The area in the center, which is enclosed by a line, shows the extent of the slide mass; small arrows show the uppermost extent of the main scarp; and the large arrow shows the movement vector. The bridge at left was completely submerged at the time of the reconnaissance, and the reservoir had backed up as far as the village shown in the upper left (photo: Kokusai Kogyo Company, Ltd.).

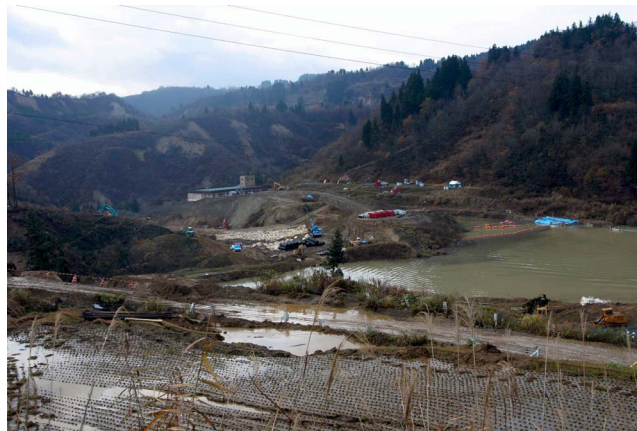
Figure 24. The upstream face of the Komatsugura landslide dam. The reservoir extends upstream to the right. The light gray area in the center left is a spillway being excavated and armored. Note several shallow landslides on the slopes in the background.

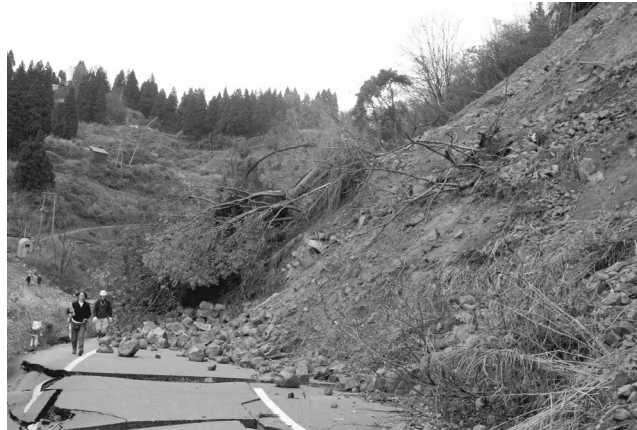
Figure 25. Landslide from a slope above a road east of Yamakoshi.

Observed landslide damage to the roadways occurred principally from three basic mechanisms: slope failure above roadways that had been excavated into steep hillsides (Figure 25), undermining of roadways because of slope failure below the roads (Figure 26), and failure of unsupported embankment fill (Figure 27).

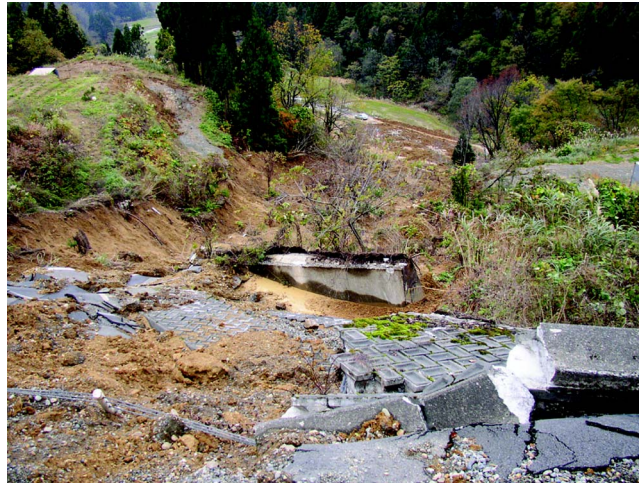
Figure 26. Source area of a slump-flow complex south of Yamakoshi.

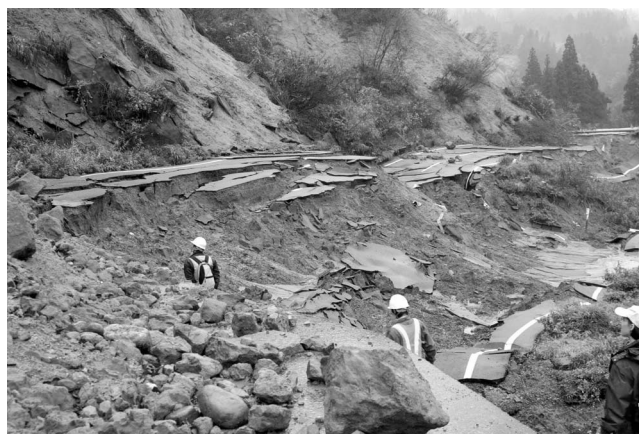
Figure 27. Failure of a roadway embankment fill south of Yamakoshi.

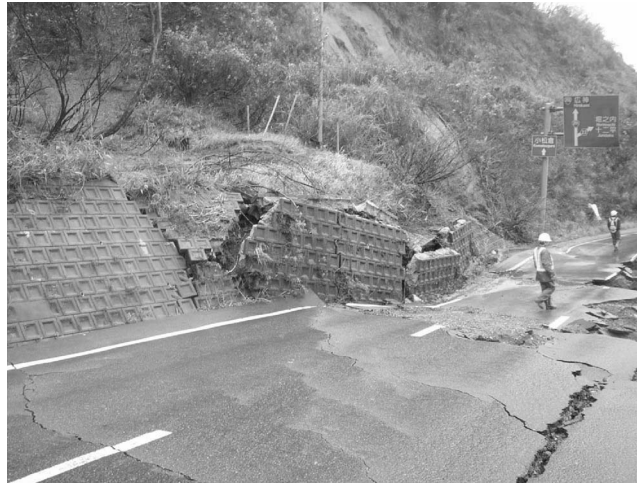
Landslides damaged several retaining walls along roadways. Typically, the retaining walls were rather modest, presumably having been designed for active lateral earth pressures. Such walls cannot be expected to withstand forces induced by significant slope failure (Figure 28). Although slumps and slump-flow complexes were the most commonly observed types of landslides causing roadway damage, many damaging landslides were more complex. Figure 29 shows a slope failure involving back rotation (slumping) of the roadway. Close examination, however, shows that portions of the slide mass have rotated forward, indicating complex interaction between different blocks within the sliding mass.

Figure 28. Landslide damage to a retaining wall and adjacent roadway on Highway 291, south-east of Yamakoshi City Hall.

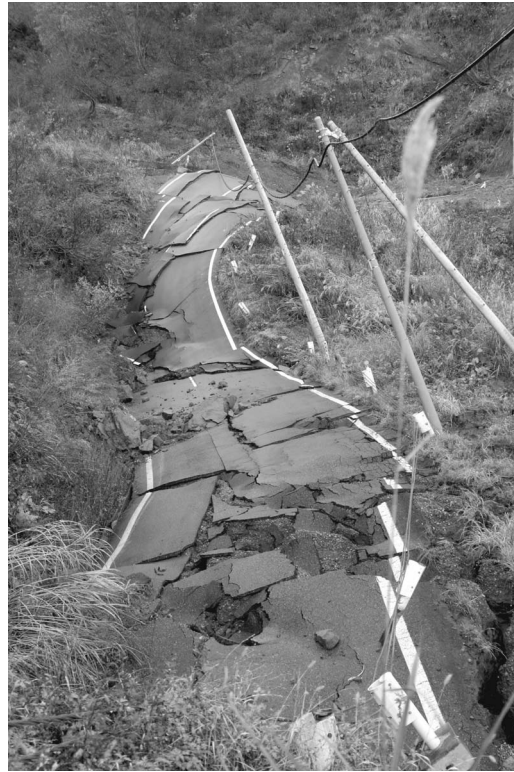
Figure 29. Landslide damage to a roadway east of Yamakoshi. Note the backward rotation of the roadway and utility poles in the foreground, together with their forward rotation in the background.
