Landslides (2006) 3: 73–78
 DOI: 10.1007/s10346-005-0011-2
 Received: 17 March 2005
 Accepted: 4 July 2005
 Published online: 2 December 2005
 © Springer-Verlag 2005

Randall W. Jibson

The 2005 La Conchita, California, landslide

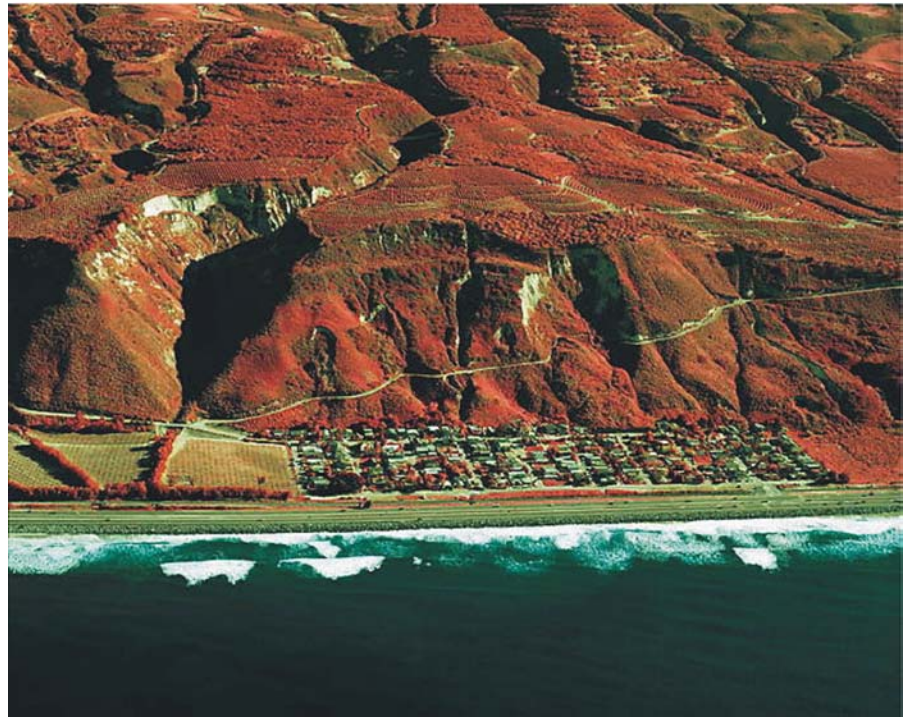
Fig. 3 Oblique false-color infrared photo of La Conchita taken in 2002. The arcuate bench near the top of the bluff in the center of the photo is the main scarp of an ancient landslide that involved the entire bluff. The 1995 landslide is visible in the right center of the photo. Other landslides of various ages and sizes are visible on the slopes. Photo courtesy of Robert A. Larsen, GeoArchives Photography

inundated roads, railroads, cultivated land, and, in 1995, the La Conchita community (O'Tousa 1995). Figures 3 and 4 show false-color infrared and LIDAR images, respectively, of the bluff above La Conchita and the surrounding area, and several sizes, types, and ages of landslides are visible. The ravines that incise the bluff have produced

debris flows both recently and in the past. The arcuate bench at the top of the bluff is the head of a very large pre-historic landslide that affected the entire bluff. Several smaller, more recent slumps and earth flows are also visible, as is the 1995 slump-earth flow described below.

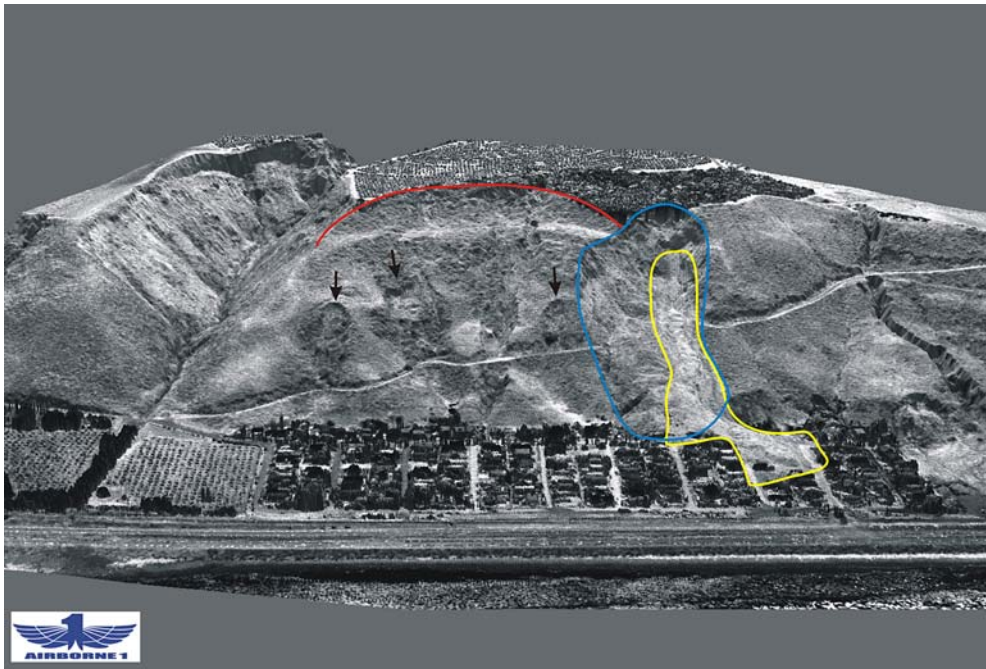
Fig. 4 Oblique LIDAR image of La Conchita after the 2005 landslide. Outline of 1995 (blue) and 2005 (yellow) landslides shown; arrows show examples of other landslides in the area; red line outlines main scarp of an ancient landslide that involved the entire bluff. The deep canyon

on the left produced major debris flows in both 1995 and 2005. Image courtesy of Airborne 1 Corporation, El Segundo, CA

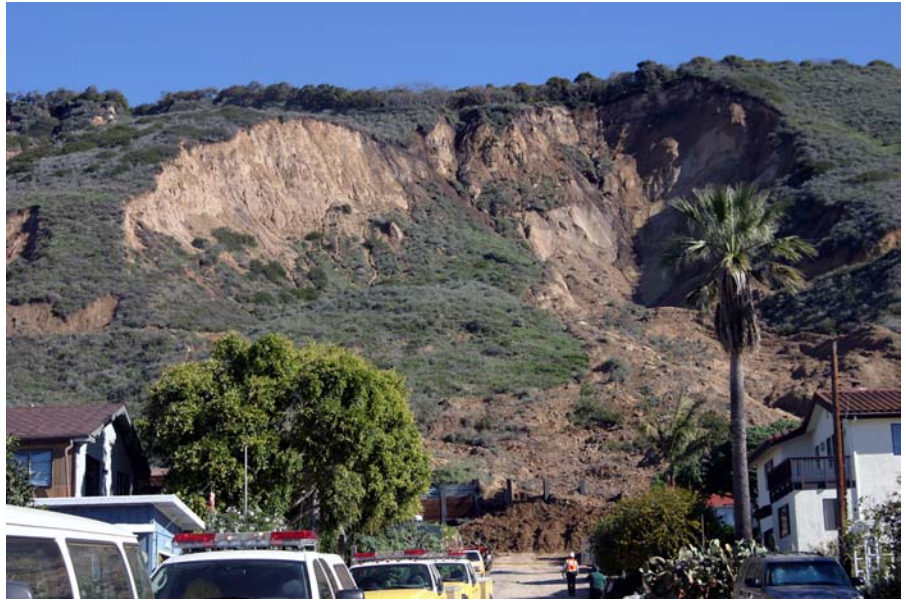
Fig. 5 View of the La Conchita landslide taken 14 January 2005. The light-colored, exposed rock in the upper part of the photo is the main scarp of the 1995 slide. The southeast part of the 1995 deposit (*right side of photo*) remobilized in 2005. At the bottom center of photo, a wall built after the 1995 slide is visible; the 2005 slide overtopped and tilted forward parts of the wall

13 houses and severely damaging 23 others (Figs. 5 and 6). There were 10 confirmed fatalities.

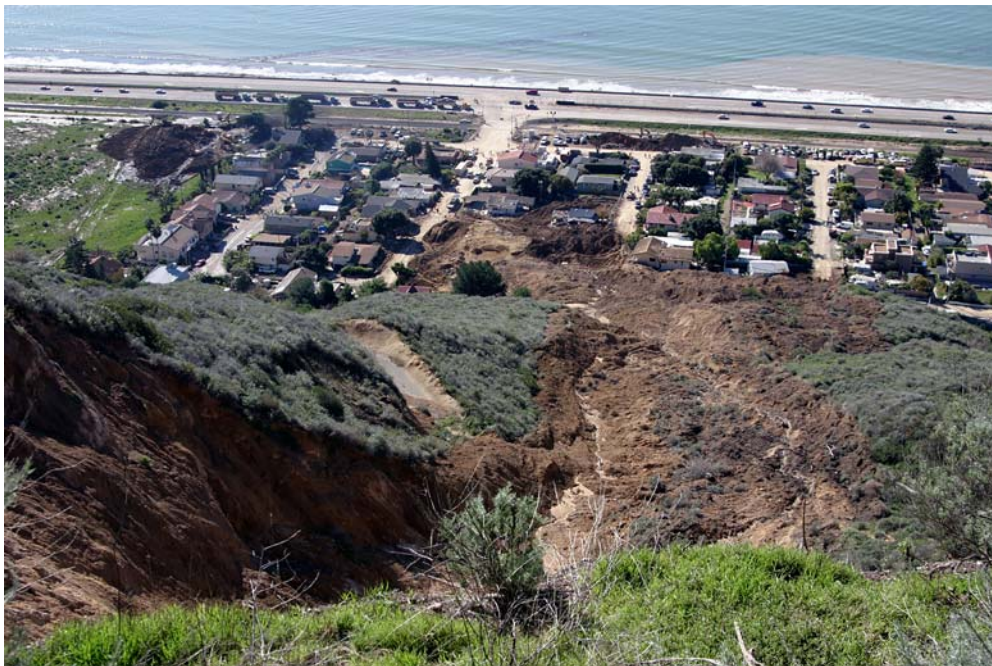
Fig. 6 View from the main scarp down the length of the 2005 La Conchita landslide. Water visible in the center of the photo was issuing from the base of the main scarp when the photo was taken (14 January 2005). The 2005 landslide remobilized about 15% of the 1995 deposit

and followed the left margin (*looking downslope*) of the 1995 slide. The vegetated ridge in the left part of the photo is intact material that did not fail in 1995 or 2005; the material in the right part of the photo is 1995 deposit that is still in place

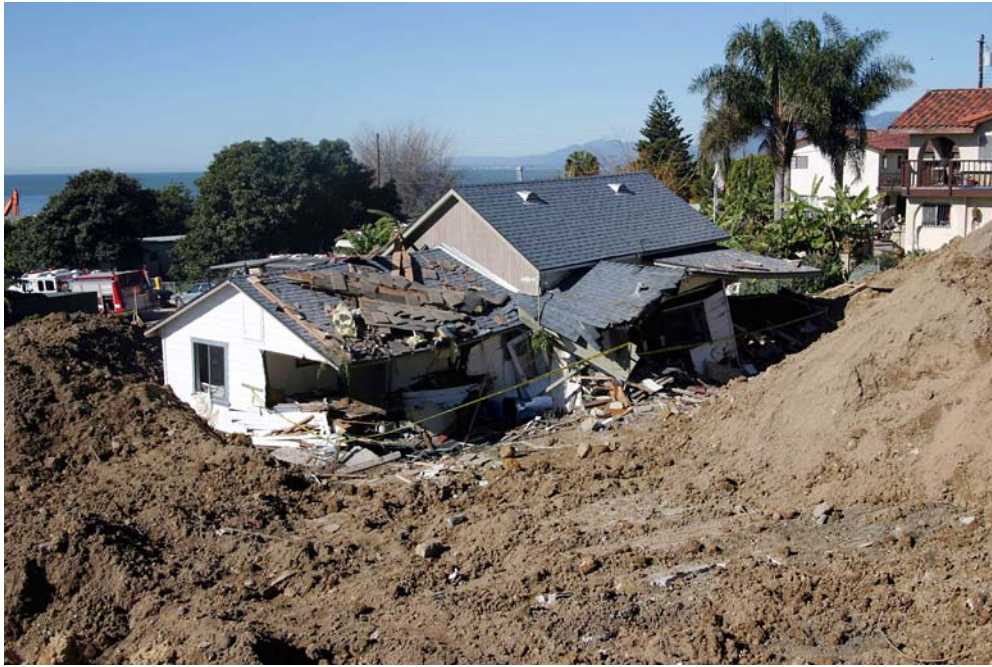
Fig. 9 The 2005 landslide moved as a rapid debris flow, but it was quite viscous and pushed houses in its path rather than flowing around or through them. Debris on the roof of the house is from an adjacent house that was pushed downslope by the landslide

The 2005 landslide pushed many of the houses off their foundations and into each other at the toe of the landslide (Fig. 9). A wall built after the 1995 landslide to keep minor-landslide debris off the road was tilted forward and overtopped in places by debris from the 2005 landslide (Fig. 10). This indicates that the landslide material, although it flowed rapidly, was quite viscous and pushed structures in front of it rather than either flowing around them or filling them with mud, as sometimes occurs with fully saturated debris and mud flows. This apparently resulted from a highly hazardous situation involving a two-phased landslide mechanism: (1) a saturated, highly fluid layer at depth on which the landslide mobilized that (2) carried a thick layer of drier, much more viscous material that effectively acted as a battering ram.

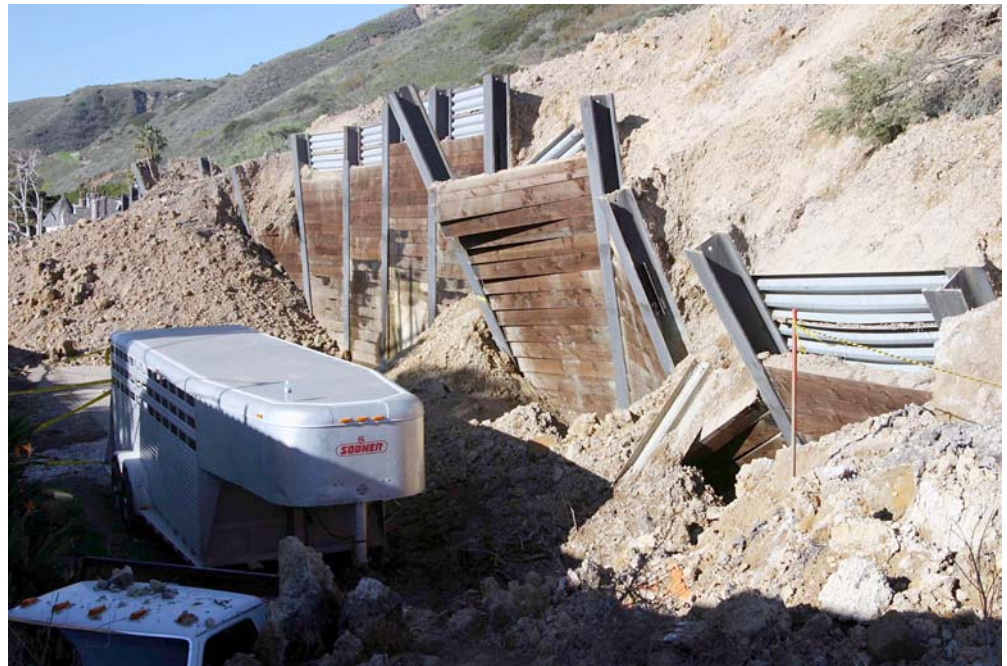
Fig. 10 Steel-and-timber wall built after the 1995 landslide was overtopped and tilted forward in places by the 2005 landslide
