Engineering Geology 80 (2005) 336–348

Seismically induced rock slope failures resulting from topographic amplification of strong ground motions: The case of Pacoima Canyon, California

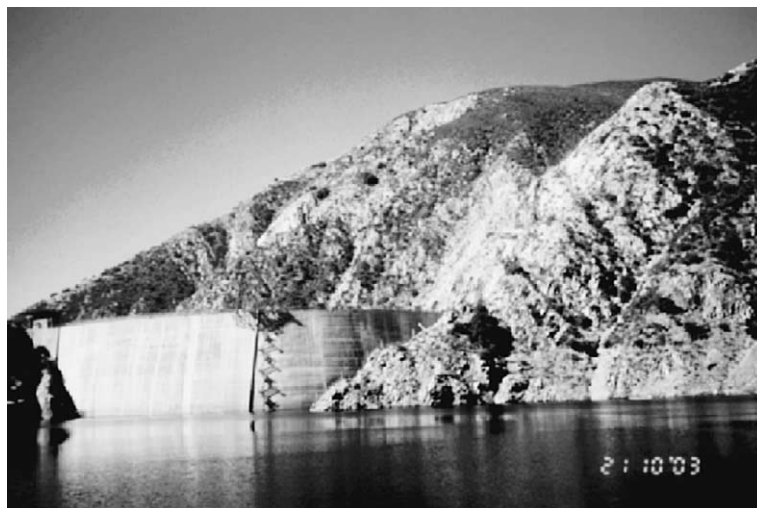
Fig. 2. Pacoima dam and reservoir, and rock mass of the right dam abutment.

yon is located in the San Gabriel Mountains, on the north border of the Los Angeles metropolitan area, near the city of San Fernando, about 20 km northeast from the 1994 epicentre (Fig. 1). In the lower part of the canyon, Pacoima Dam (a concrete arch dam completed in 1929) impounds a reservoir used for water storage and flood control (Fig. 2).

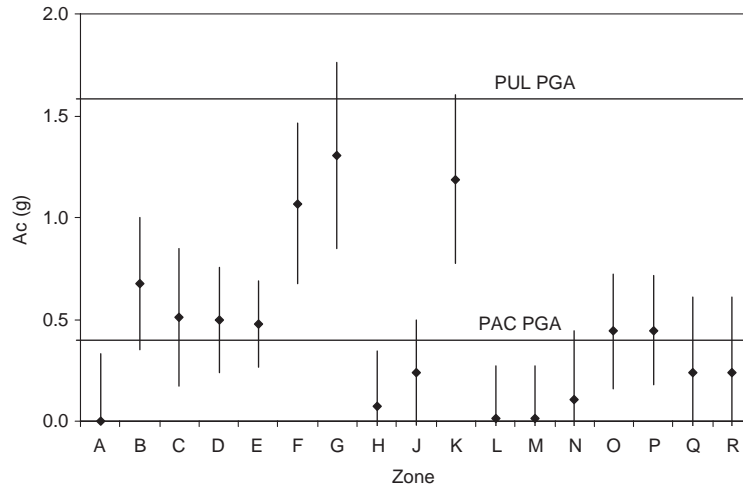
Fig. 8. Mean plus/minus one standard deviation (bars) values of the lowest critical acceleration for sliding (A_c) calculated for potential block sliding failure modes at Pacoima Canyon. Peak ground accelerations (PGA) at stations PAC and PUL are shown for comparison.

Figs. 7 and 8 show that levels of uncertainty, represented by standard deviations, are significant and should be considered during interpretation. As a means of testing the reliability of assessments, we calculated the probabilities of factors of safety being below 1.0, indicative of failure, by the calculation of cumulative distribution functions of the factors of safety using @Risk. The analyses return very high probabilities (mostly over 95%) for sliding under the amplified conditions recorded at station PUL. However, mixed results were obtained from analyses using unamplified conditions, represented by station PAC: maximum probabilities of failure (among different possible failure modes) were below 10% for five
