Orbital Debris Quarterly News

Volume 15, Issue 1
January 2011

A publication of
the NASA Orbital
Debris Program Office

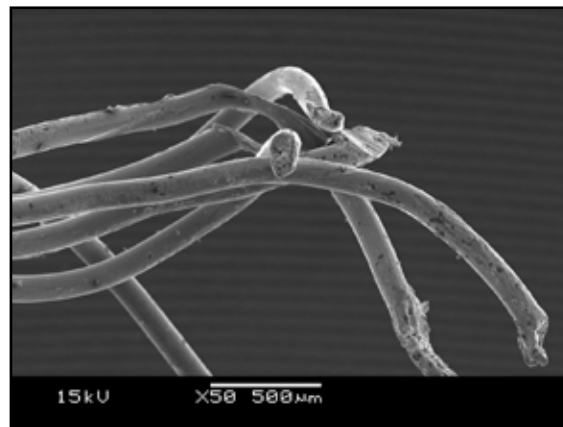
Figure 2. Frayed end of 4B SAW guidewire. Wires at bottom and in lower right-hand corner exhibited melt near ends.

The frayed end of the guidewire was examined by scanning electron microscopes (SEM) at the JSC Astromaterials Research and Exploration Science (ARES) Directorate by personnel of the Hypervelocity Impact Technology (HVIT) Team. Seven individual wires that had been broken at the frayed end (Figures 2-3) were identified. Near the broken ends of three wires, the SEM examination discovered a large amount of material that appeared to have been melted at one time (Figure 4). The presence of melt is a clear indication that the damage to these three wires was caused by micrometeoroid or orbital debris (MMOD) impact. (MMOD particles typically impact at high speed and release a large amount of energy, resulting in the displacement of target material with a mass 10 to 100 times the projectile mass, due to melting and plastic flow local to the impact site.)

Other wires in the bundle appear to have been broken by mechanical action. A likely scenario that explains the observed guidewire damage is that MMOD impact broke a few of the wires, which allowed the guidewire to snag in a SAW grommet during deployment. Subsequently, as the process of deployment continued with a snagged guidewire, additional wires were sheared as they were pulled against the grommet.
