ORNL/CON-434

Five Case Studies of Multifamily Weatherization Programs

Weatherization Assistance Program

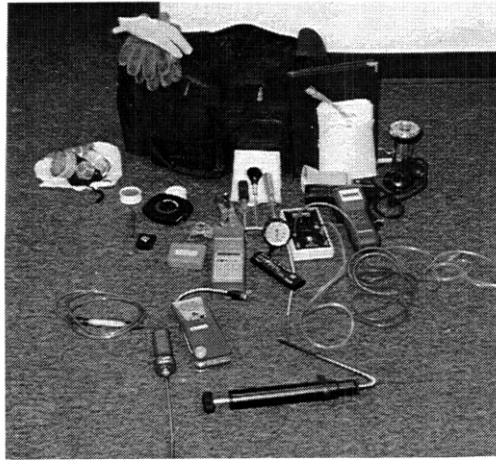
Fig. 2.2. Weatherization Coalition auditors in New York City must pack their tools of the trade in a container suitable for transport on the subway. This kit contains thermometers, a combustibile gas sensor, a combustion analyzer, a CO sensor, a CO sensor, a draft gauge, and a digital pressure sensor, plus sundry hand tools, tape measures, lights gloves, and safety equipment

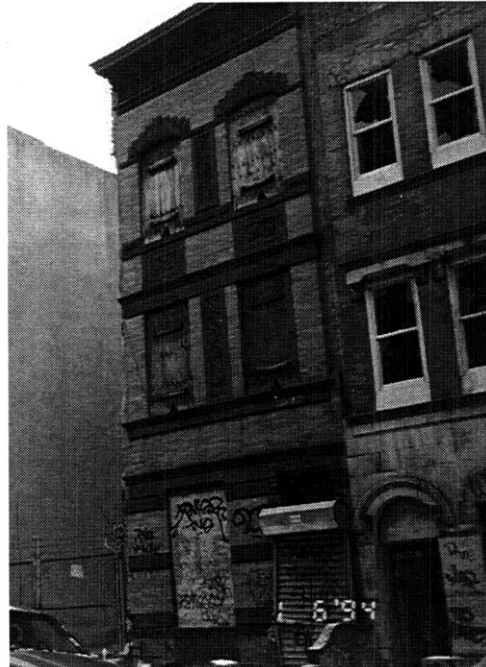
Fig. 23. Window openings in most buildings are the same size—and with these it's easy to decide which need replacing.

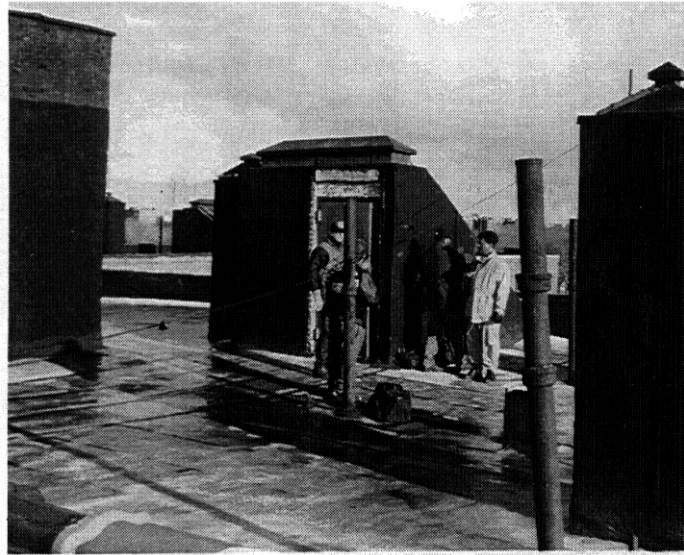
Fig. 2.4. Rooftops have lots of penetrations, some of which cause substantial heat loss.

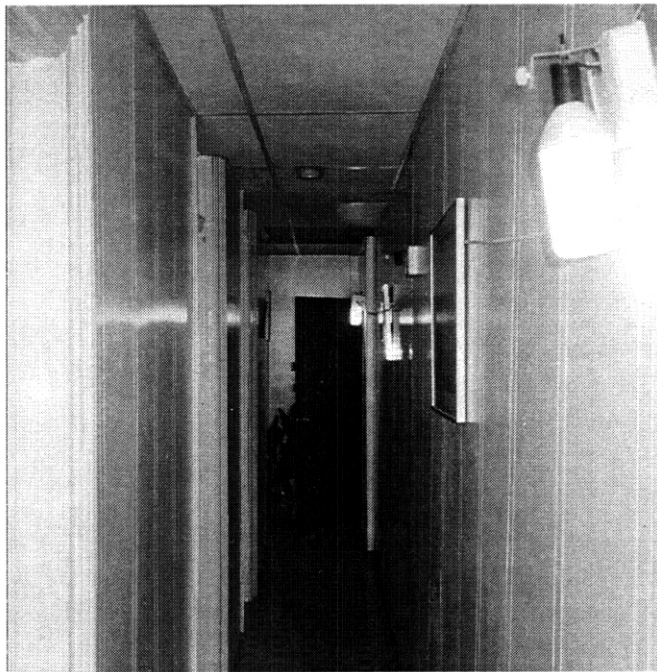
Fig. 2.6. Compact fluorescent fixtures were installed using DSM funds from Consolidated Edison. The kitchen and bathroom have energy-efficient f i r e s installed, too.

“We view this program **as** designed to benefit the tenants,” Rieber explains. “We **try** to **maximize** the number of fixtures in each apartment. The criterion we **try** to meet is to install lights anywhere the lights can be placed, verifying with tenants that it’s okay with them.” Installers also **try** to match the lumen output of the compact fluorescents with that of the existing incandescent fixtures. In practice, 23-W compact fluorescent fixtures **are** installed in most cases (Fig. 2.6). These have a bit more lumen output than do 75-W incandescent bulbs. “The fixtures we **use are** quite versatile, have electronic ballasts, and give out a lot of light,” **Rieber** claims. “Once in a while we find a defective fixture, and there is some breakage, but by and large, we’re pleased with them and

with the program.” Twenty-seven-watt fixtures, which have the lumen output of 100-W incandescent bulbs, **are** due out soon, and will **be** integrated into NMIC’s **DSM** program **as** soon as possible.

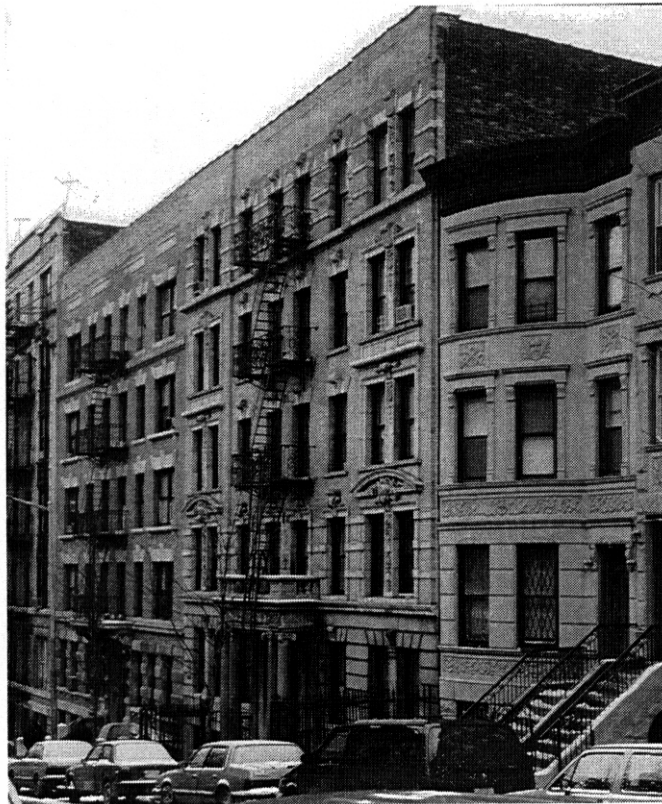
Fig. 2.8. New windows like these in Northern Manhattan *can* bring beautiful old buildings back to lie.

carrots (tax abatements and partial relief from rent controls) and sticks (energy codes) favor replacement windows (Fig. 2.8).

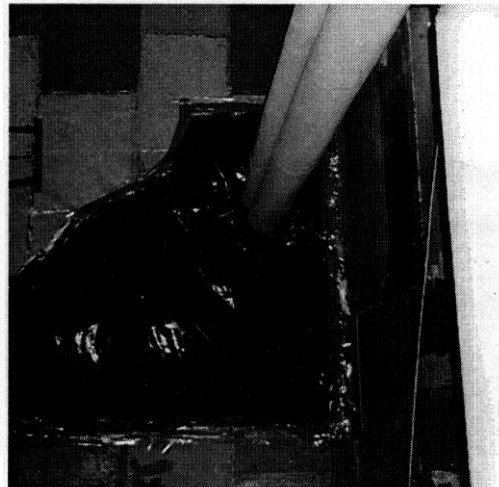
Fig. 2.11. Air sealing work completed by the building superintendent.

This is an example of a creative and successful multifamily weatherization job. Contributions by all participants were necessary for success in a project **as** complex **as** this one. One **of** the most critical participants is the building superintendent. He is the **person** who manages the new **system** and **consequently** will have an **impact** on future savings. In this case, the building superintendent had good knowledge of heating systems and great interest in understanding the new system. He took the initiative to act on opportunities to enhance energy savings by actions such **as** improving air sealing (Fig. 2.11)

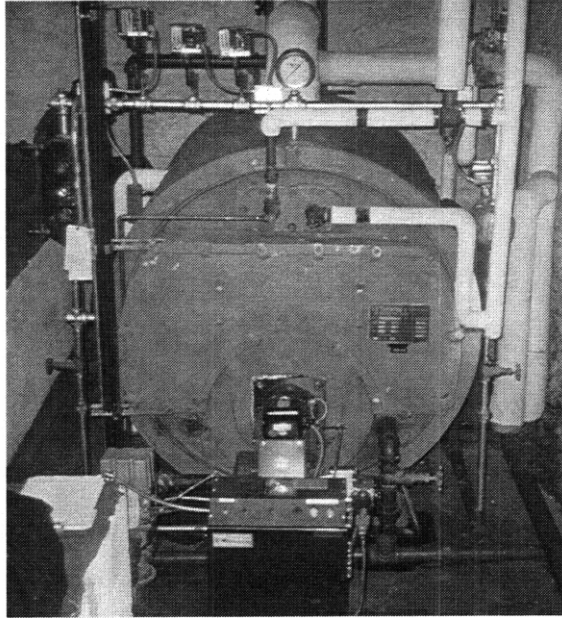
Fig. 2.13. New besting system installed in Northern Manhattan weatherization project.

The **primary** weatherization work **was** installing a new boiler with a power burner and controls, along with **repairing** the existing distribution system, including the radiators, valves, and vents (Fig. 213). Additionally, related boiler room work (i.e., whitewashing walls, insulating pipes, adding door closers and minimum ventilation) was specified according to the building code. Related to the boiler work were **reductions** in the supply temperature of **DHW** and the installation

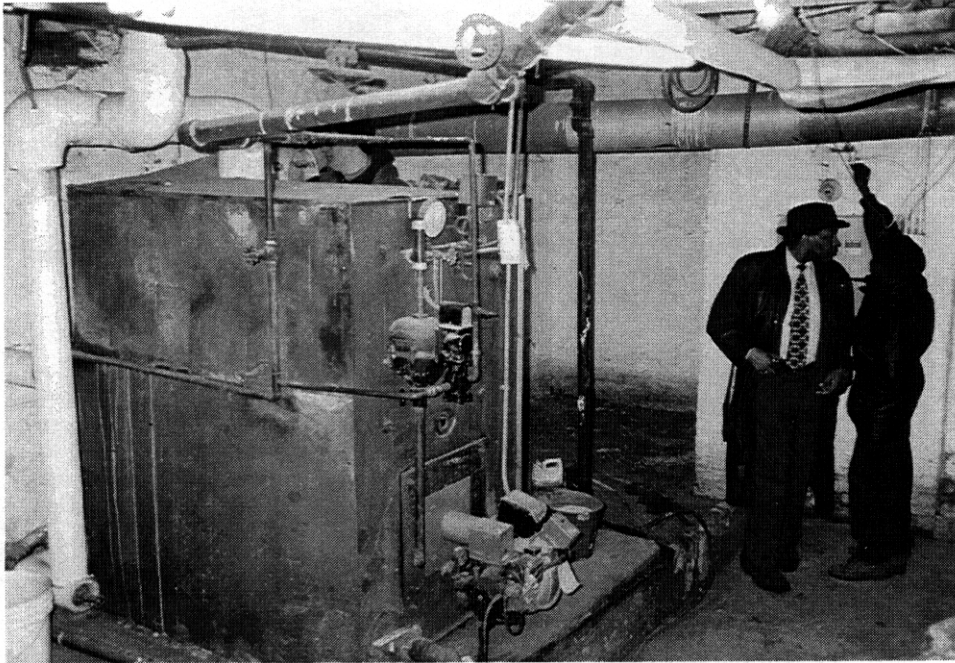
Fig. 2.16. Newly insulated distribution pipes at an existing heating system.

The heating system is an old 35-hp oil-fired steam boiler. Upgrade work called for cleaning and tuning the existing system, adding a barometric damper as well as a new heat timer, repairing and insulating distribution system piping (Fig. 2.16), repairing the radiator, air-sealing the boiler room area, and installing a new sump pump in the drain pit area.

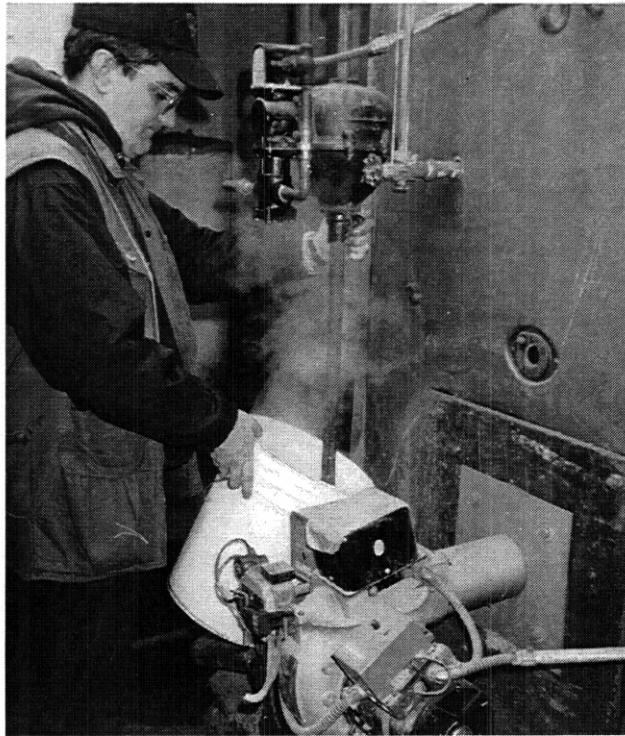
Fig. 2.17. Auditor venting steam heating system after discovering improper pressure setting.

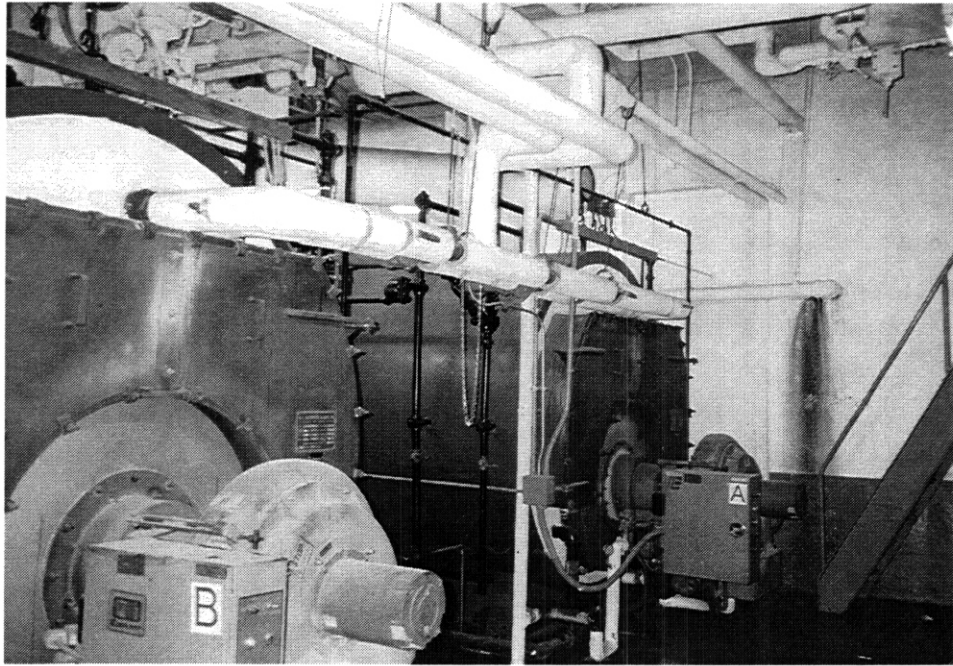
Fig. 2.19. Twin 200-hp steam boilers provide heat and domestic hot water to a 19-story high-rise in the South Bronx.

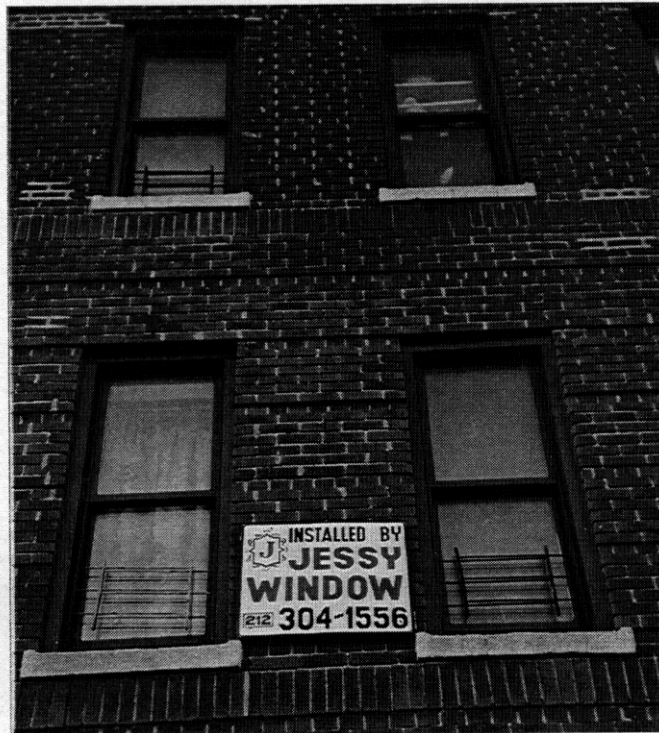
Fig. 2.31. New replacement windows were required to **make this** building habitable.

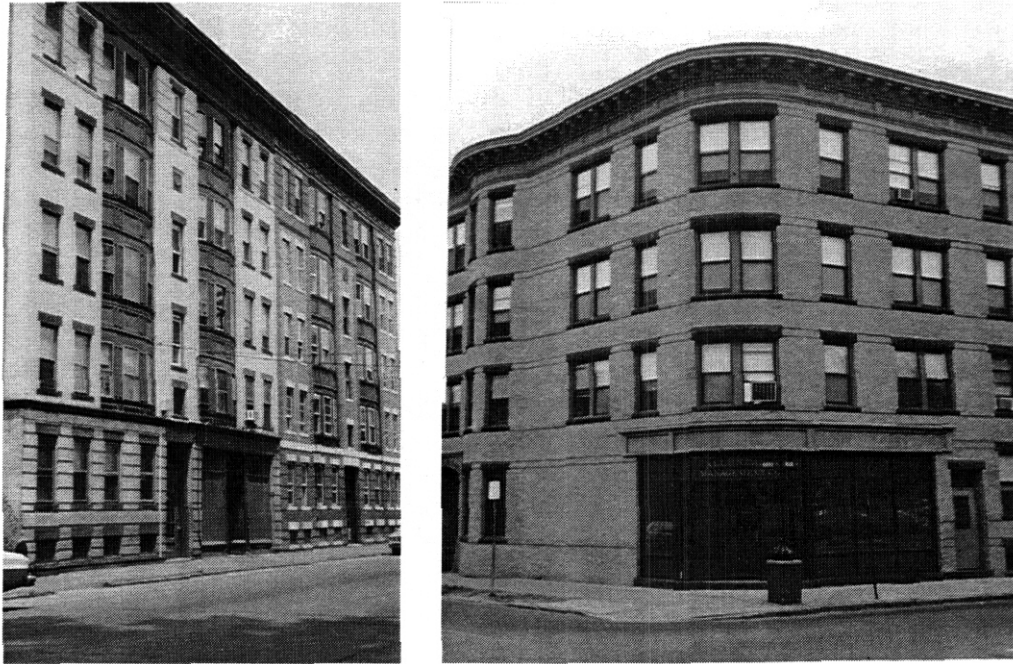
Fig. 3.1. Multifamily buildings in Holyoke.

The multifamily housing **stock** that is the subject of this case study is in the city of Holyoke, close to Springfield (and HAP's main **office**) in southwestern Massachusetts. It is composed primarily of wood-framed, brick-veneer buildings with flat **roofs**. These structures were built in a variety of early-twentieth-century architectural styles and **are** generally between three and five stories tall (Fig. 3.1). Buildings observed ranged from a dozen to as many as 80 **units**.

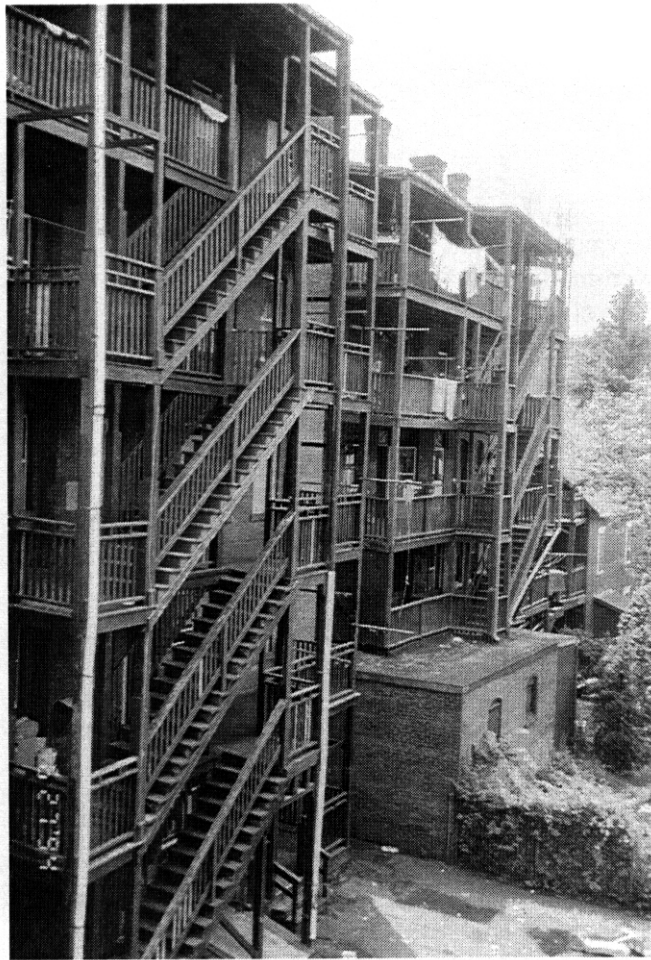
Fig. 3.2. Typical exterior wood stain found on many multifamily buildings in Holyoke.

Most buildings have exterior wood *stairs* as a second **means** of egress (Fig. 3.2), and interior light and ventilation shafts or building configurations which include *courtyards*. The attics are typically below a low-pitched, flat roof and **are** accessible only through an interior trap door which most **often** is installed during weatherization. **Basements are not accessible to tenants**. Figure 3.3 shows two buildings typical of those weatherized by HAP.

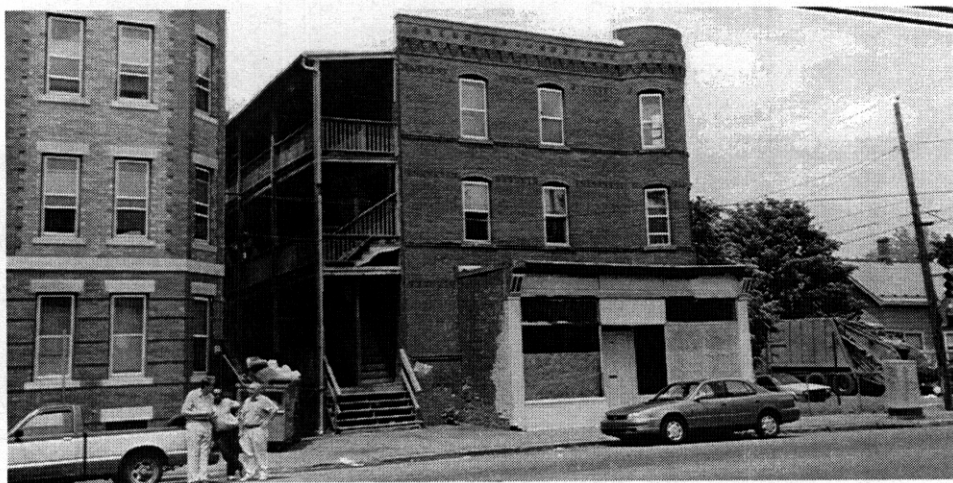
Fig. 3.3. Both of these buildings in Holyoke were weatherized by HAP.

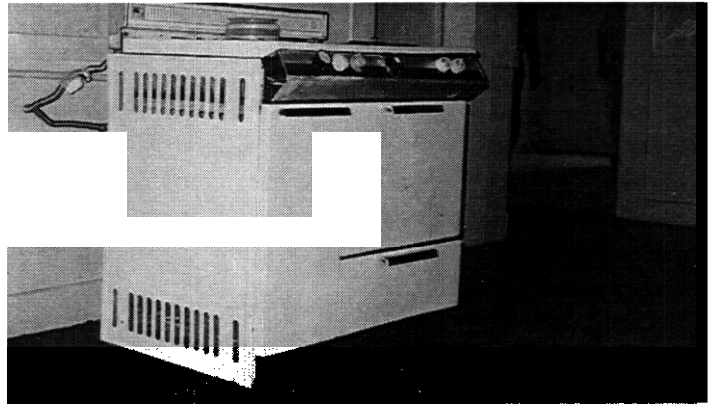
Fig. 3.4. This stove provides cooking and heating energy for an 800 ft² apartment.

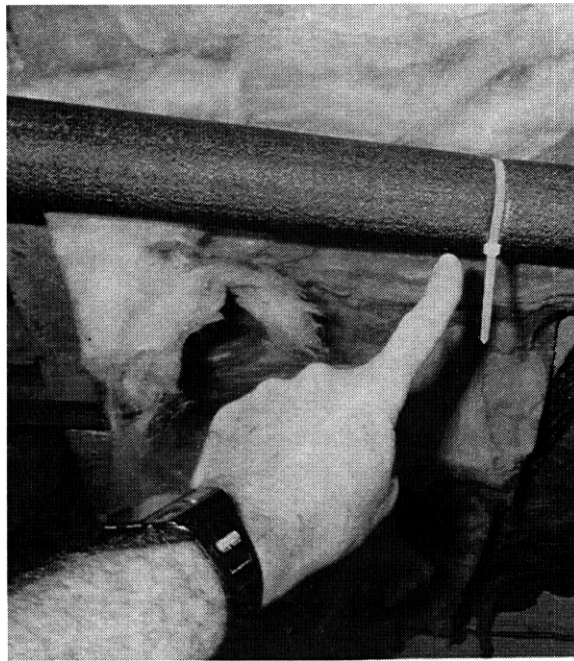
Fig. 36. When basement floors are insulated, it is all the more important to insulate pipes, both hot and cold.

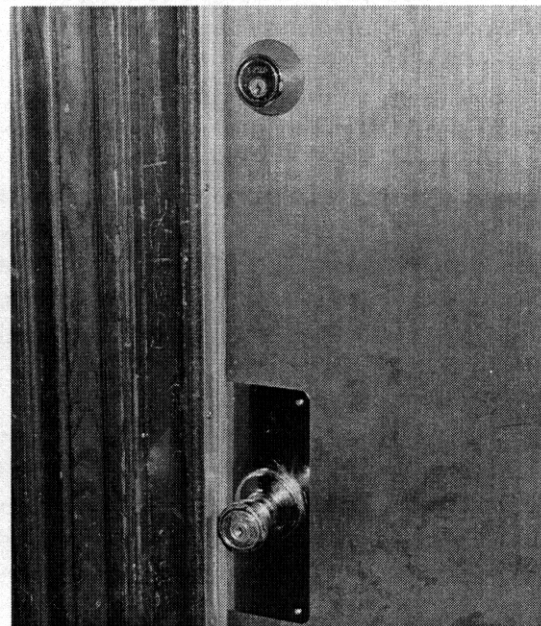
Fig. 37. New door-locking mechanisms and weather stripping provide security and lower convective losses.

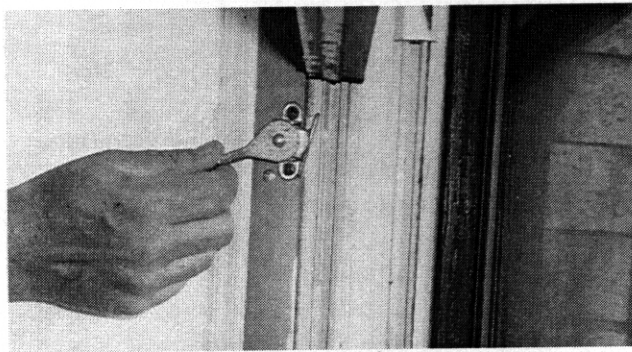
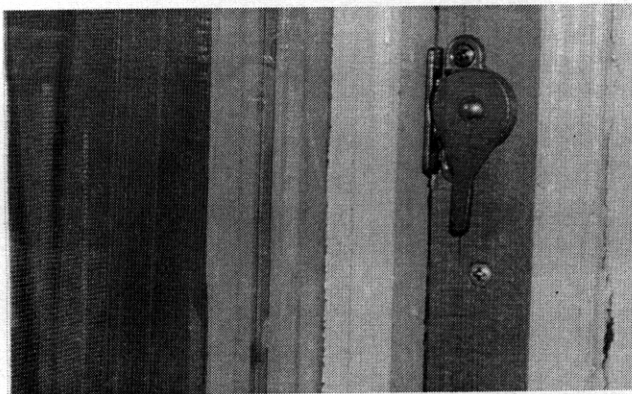
Fig. 3.8. This mechanism has a cam lock which squeezes a window against a blind stop or weather strip. The open position is shown in the top photo, and the closed position in the bottom. The mechanism is used by HAP contractors in the repair of existing windows.

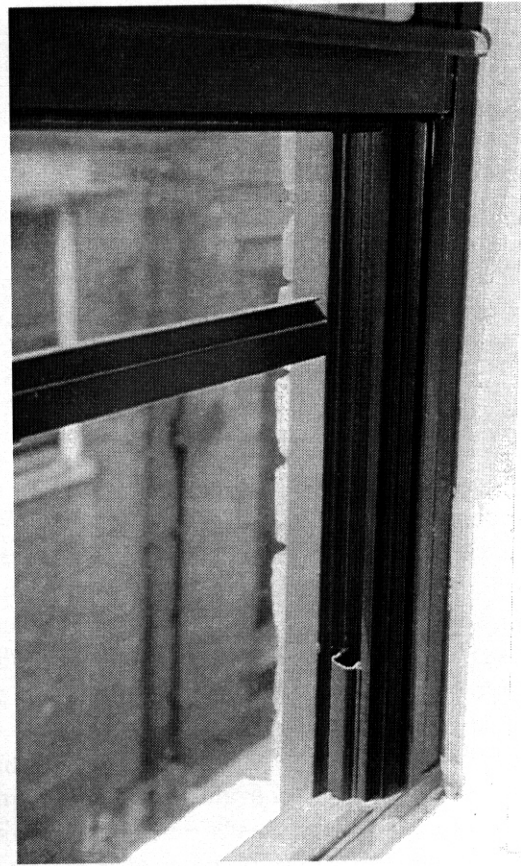
Fig. 3.9. Good-quality, double-glazed vinyl replacement windows are used in HAP's program. Installed costs are \$150 to \$200.

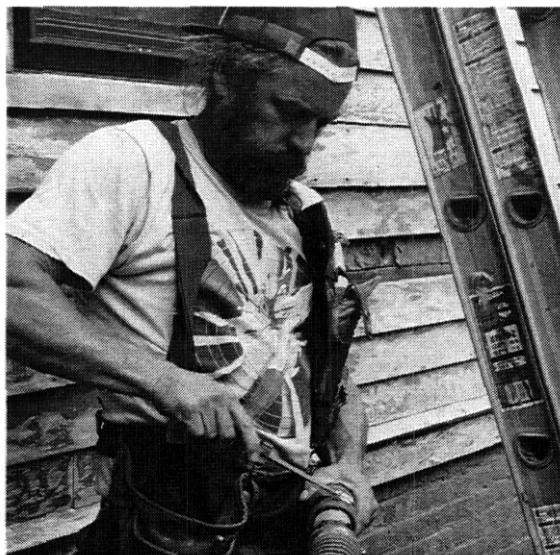
Fig. 3.10. Bill Kelly unclogs a blowing tube, a tedious job that must be done quickly to avoid slowing production.

Insulation installed in the attic is routinely blown cellulose, which has the advantage of being transported to its final resting place by means of a blower motor (Fig. 3.10). Of course, tight spaces make distribution to the entire attic difficult, but experienced hands have developed special tricks for getting the widest distribution possible. For example, Bill Kelley of K&B Energy Associates, Inc., uses a technique of pushing the blowing hose as far into tight spaces as possible, then rolling it around while blowing insulation with a bit of extra air. "The extra air allows for the hose to spray insulation further," Kelley explains. "But, since it tends to settle more, we blow to a higher level than usual, ten inches or so."

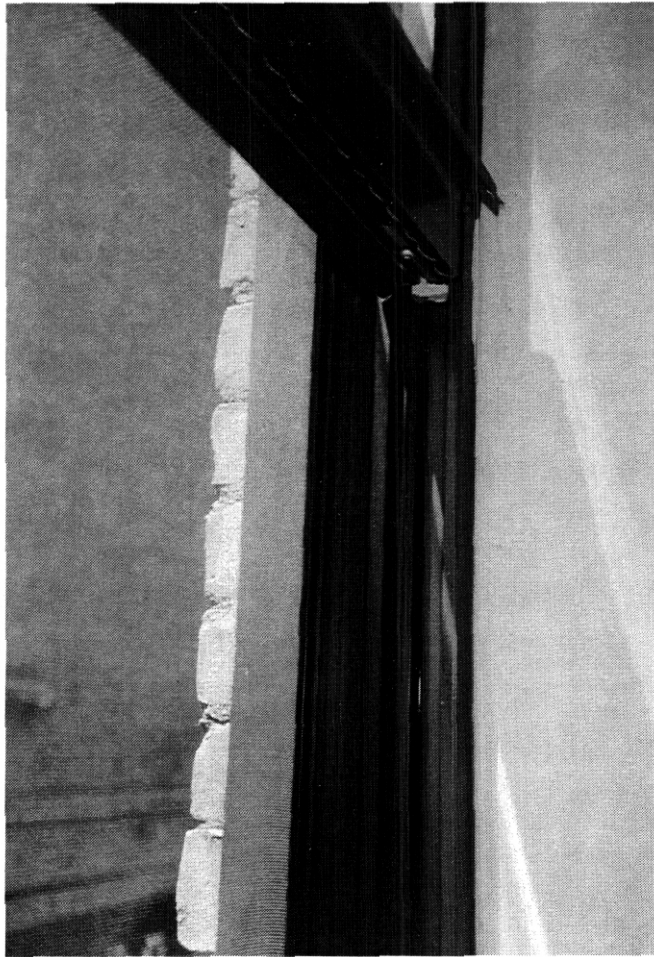
Fig. 3.12. Detail of new replacement window installed at 197 High Street.

Weatherization measures were applied to the residential units only and were selected to satisfy a state-mandated priority list. The audit surveyed the building for application of measures from a predetermined list. Even without the benefit of an instrumented audit, the weatherization staff was able to find floor cavity bypasses and attic spaces with insufficient levels of insulation. Ventilation, which is a routine feature of attic insulation work, was completed along with domestic hot water pipe insulation and door weather stripping. Eighty-six percent of the job dollars went for replacement windows throughout the building (Fig. 3.12).

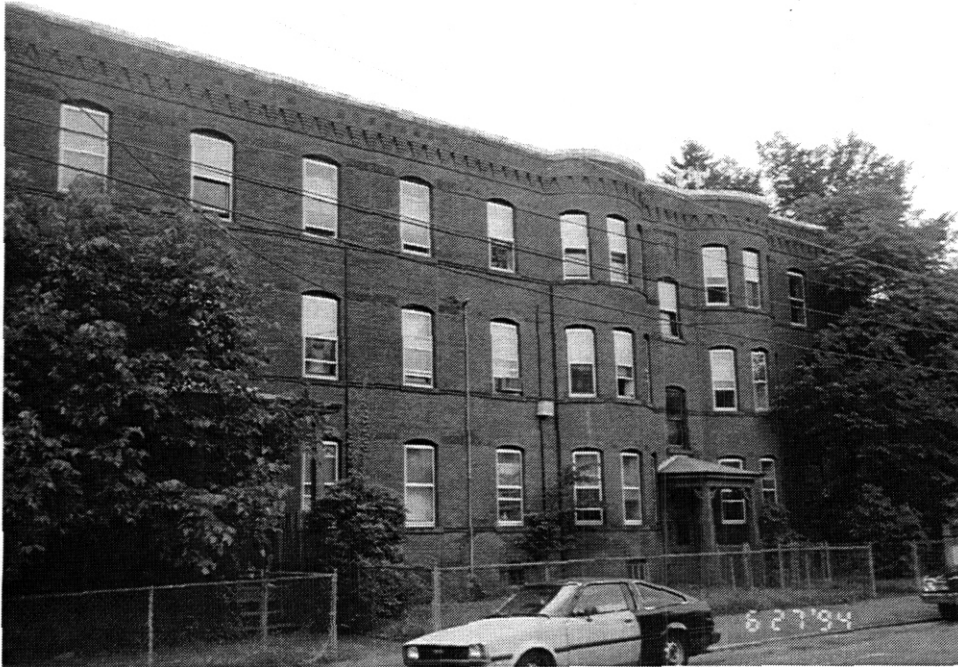
Fig. 3.13. The building at 47–49 Vernon Street in Holyoke.

This three-story, wood-framed brick veneer building was originally built by a local manufacturer to house employees. It is actually two distinct structures with a common firewall partition that divides the building from attic to basement.

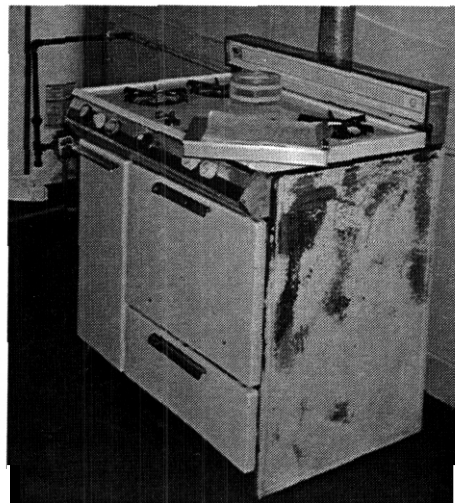
Fig. 3.14. Heat for the apartment is provided by this combination unit. Hot water units are located within each apartment.

There are a total of ten apartment dwelling units and one commercial unit (which is not in use) contained in the combined structures. Individual heating and domestic hot water units are located in each apartment. The hot water units are gas-fueled with stand-alone storage tanks. The heating units are in combination with the cookstove (Fig. 3.14). The heating portion of the unit is controlled by a thermostat and is vented; however, the cooktop is not vented.

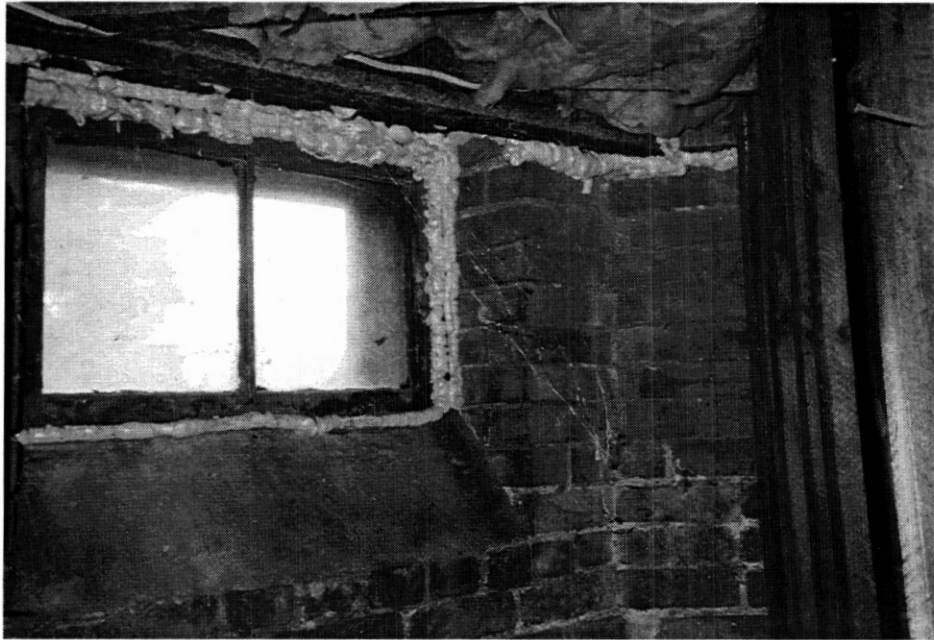
Fig. 3.15. Basement air sealing at 47—49 Vernon Street, Holyoke.

Priority was given to controlling heat loss at the bottom of the building envelope. Air sealing with spray foam was completed at the basement sill, basement windows, and mechanical penetrations (Fig. 3.15); additionally, bypasses were blocked with blue foam board. The batt insulation installed at the basement ceiling was doubly secured by staples and wire supports (Fig. 3.16). However, air sealing beneath the existing fiberglass batts in the attic was omitted.

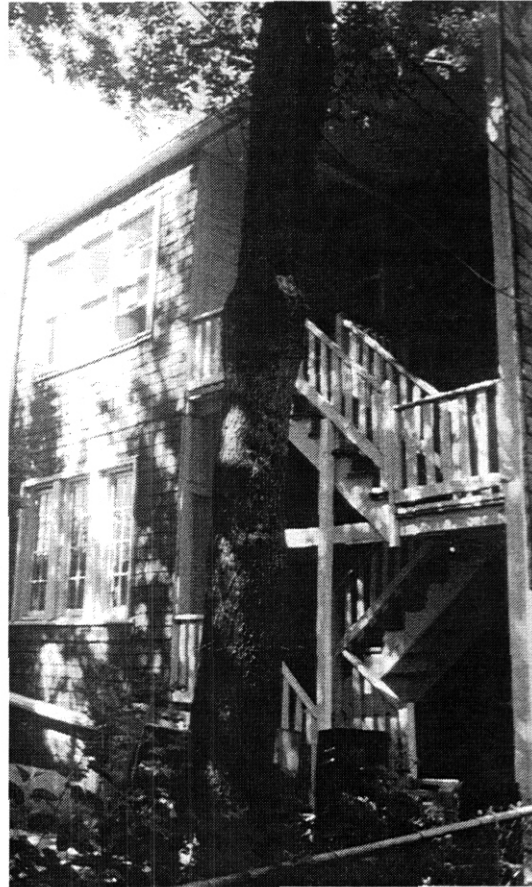
Fig. 4.5. Enclosed porches provide real challenges for Chicago multifamily contractors.

The main body of the building is brick with what was originally a two-story frame rear porch. The porch has since **been** enclosed and is now considered part **of the** heated space of the **two** rear apartments (Fig. 4.5).

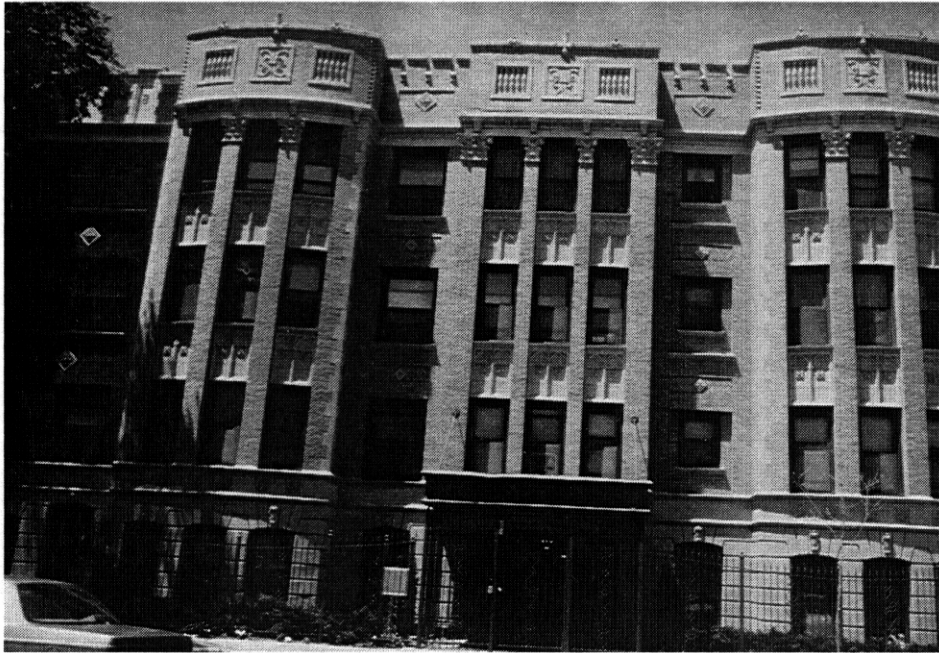
Fig. 4.8. The elegance of **this** larger building is maintained while serving primarily lower-income tenants.

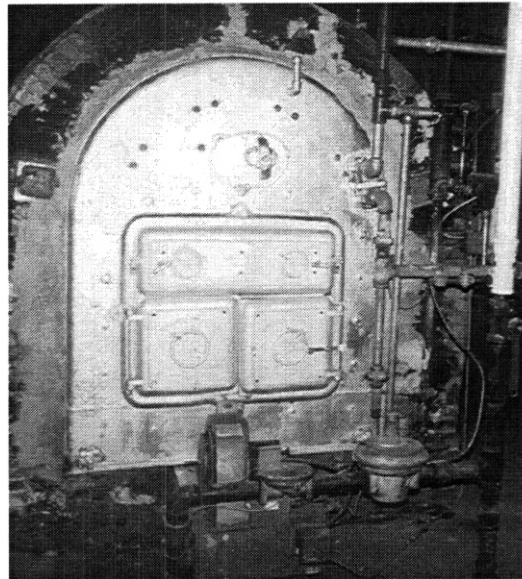
Fig. 4.9. Under present city policy, this aging 2 MBtu/h boiler would likely now be eligible for replacement, with the building owner contributing 50% of the replacement costs.

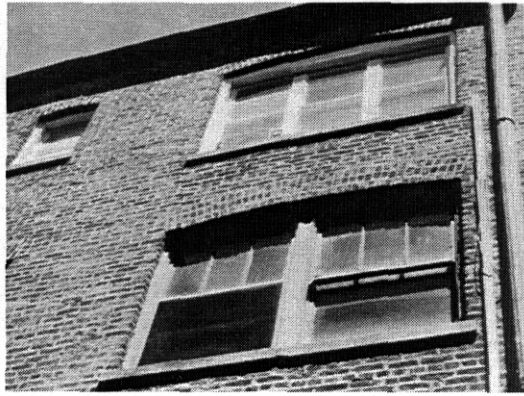
Fig. 4.10. Replacing two oversized windows with three narrower units does not detract from the aesthetics of this property.

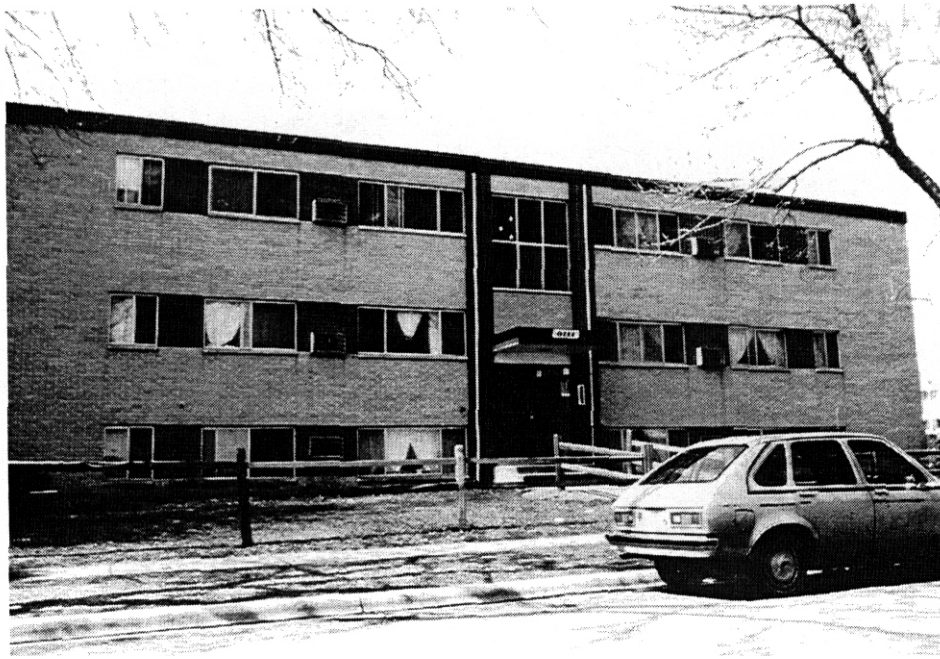
Fig. 5.3. Three-story walk-ups are typical of the Twin Cities multifamily housing stock.

The most common buildings in the St. Paul area are clusters of fairly similar two- and three-story walk-ups, built by the same contractor, which may or may not be under the **same** management **firm** (Fig. 5.3). To the extent that these clusters can be processed and retrofitted at the **same** time, substantial economies of scale can be attained. Not only may multiple **unit** completions be achieved in the same audit and contract process, but also multiple buildings may be simultaneously processed.

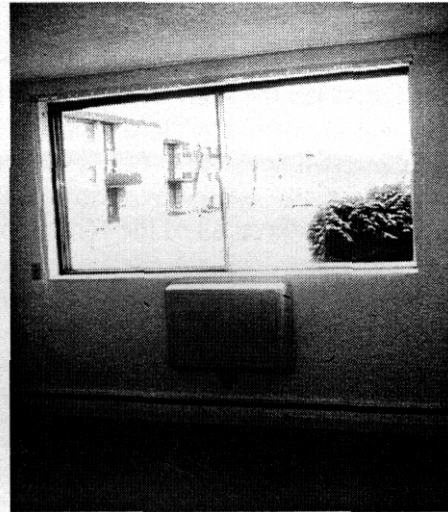
Fig. 5.5. Air conditioner covers are one of the few building shell retrofits regularly applied in the **RAP** multifamily program.

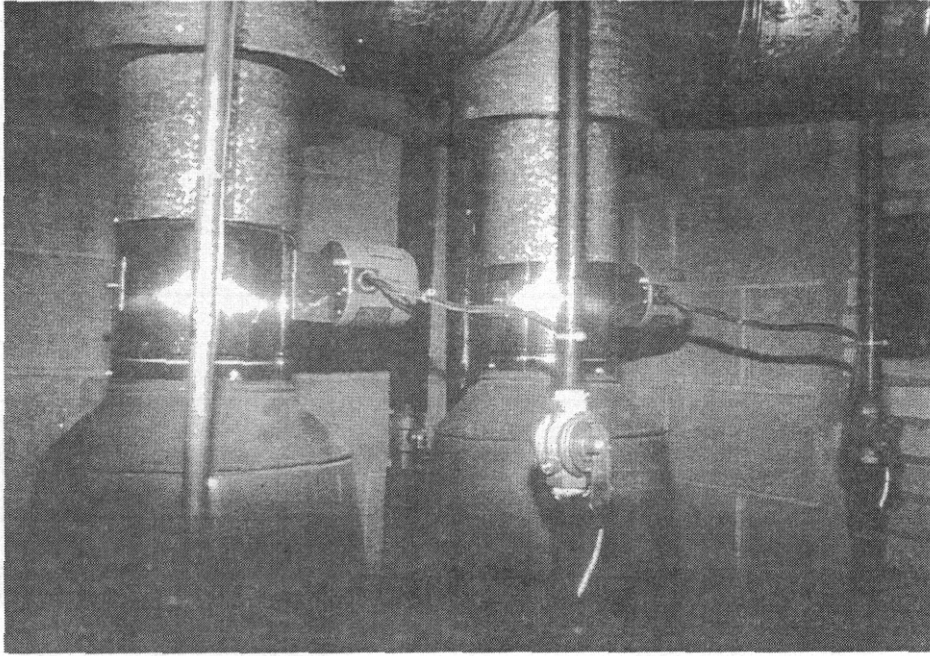
Fig. 5.8. Mechanical retrofits including these electro-mechanical vent dampers resulted in better than 25% savings in all four buildings included in this case study.

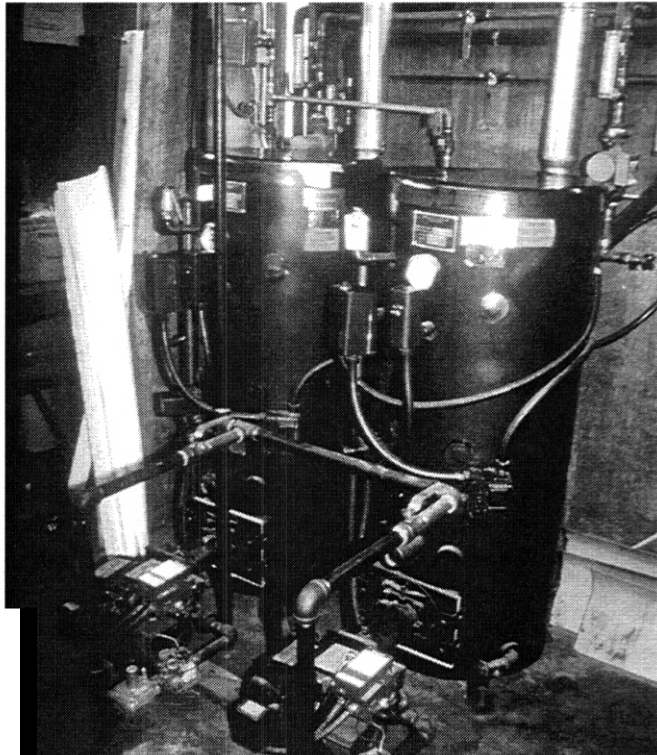
Fig. 5.11. The addition of these two-staged boilers provide adequate hot water for **151** units. These units showed significant savings while operating only during the summer months.

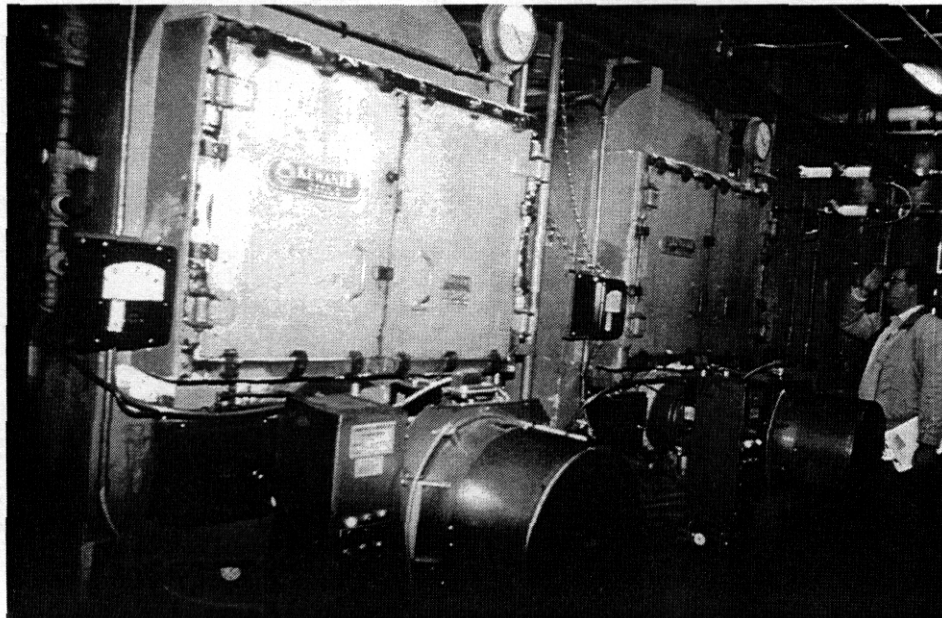
Fig. 5.12. **Although** either of these boilers could heat this building during most of **the** winter, the building operator **runs** both units all heating **season**.

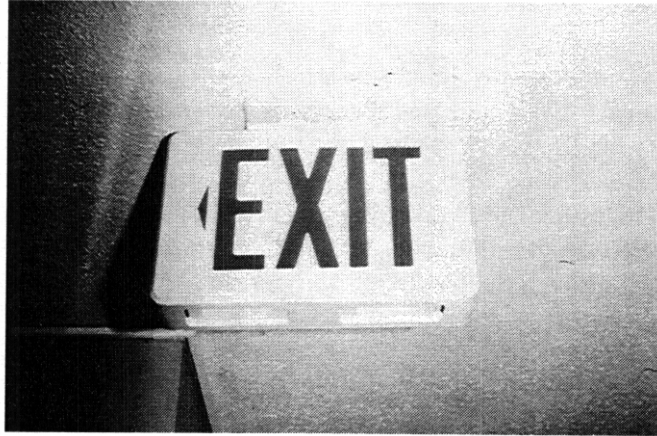
Fig. 5.13. Lights that burn 24 hours a day are particularly attractive retrofit options.

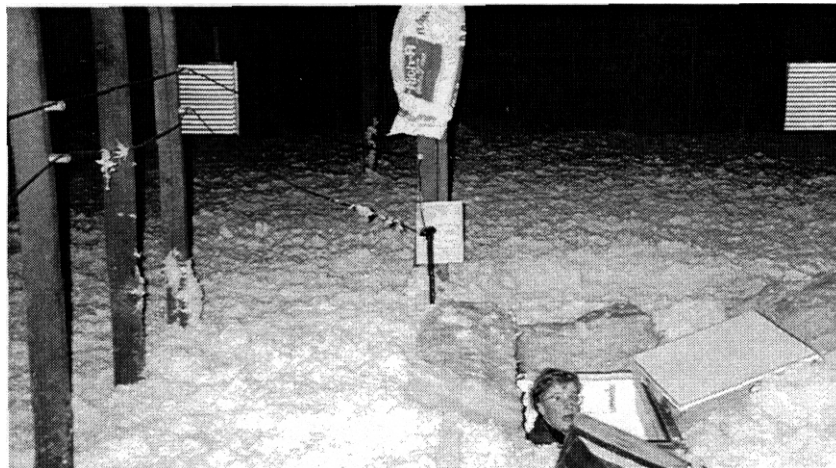
Fig. 6.6. A completed attic insulation job in an apartment building. Blown cellulose is used except in the hatchway area, where fiberglass batts provide a better, cleaner fit. The empty bag near the hatch provides product information for inspectors and others.

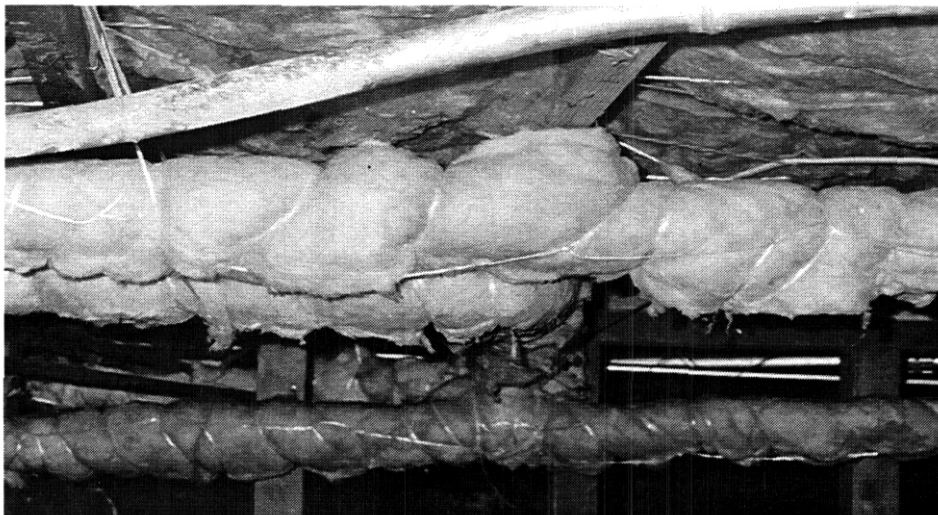
Fig. 6.10. Detail of floor and pipe insulation. Note the extensive use of nylon twine.

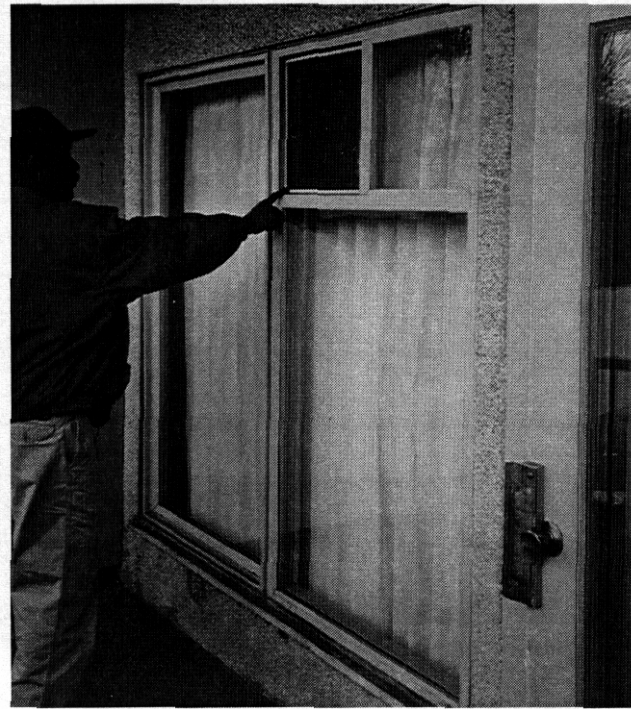
Fig. 6.11. The window wall on the interior circumference. Each of these complex units ~~was~~ replaced as part of the weatherization work. The upper light pointed out by Joseph Fans *can* be slid open to provide ventilation.

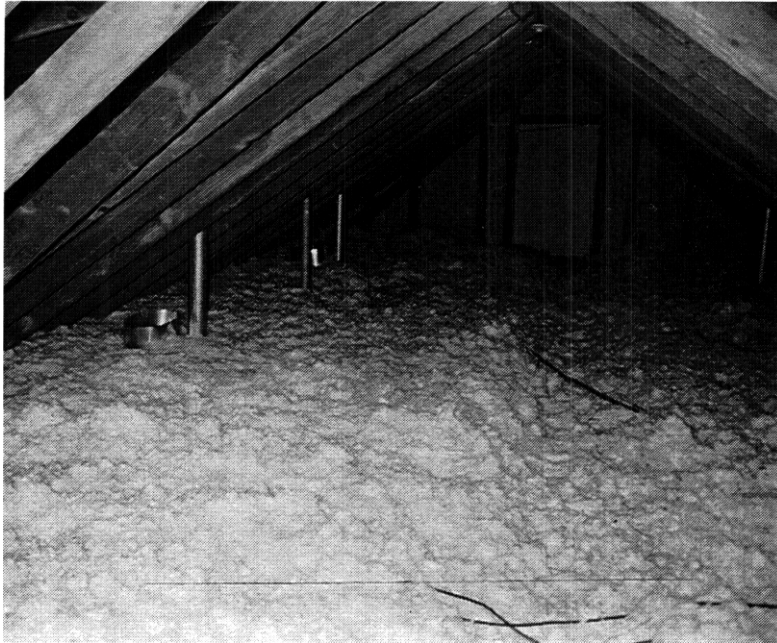
Fig. 6.15. Part of the finished attic insulation. The air from ventilation fans no longer comes into the attic.

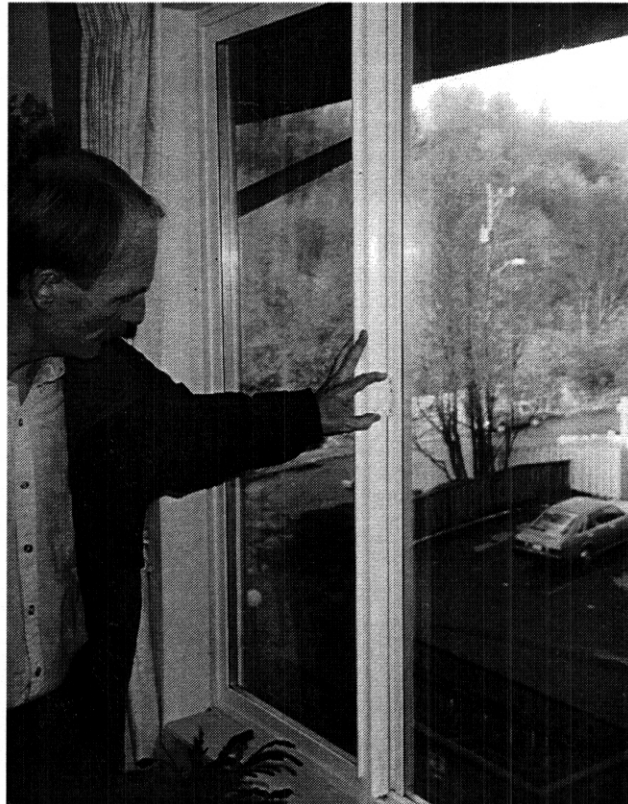
Fig. 6.16. Energy conservation representative Vince Feltes inspects the locking mechanism on a newly installed window.

Extensive air sealing in the attic and related repairs to prepare it for insulation were needed. This included sealing around fixtures and installing exhaust fans from kitchens and bathrooms. Subsequently, insulation was installed (blown cellulose to R-38) and attic hatches were sealed (Fig. 6.15). New windows were also installed throughout the complex, and hard-wired fluorescent fixtures were installed in all common areas (Figs. 6.16, 6.17, and 6.18).

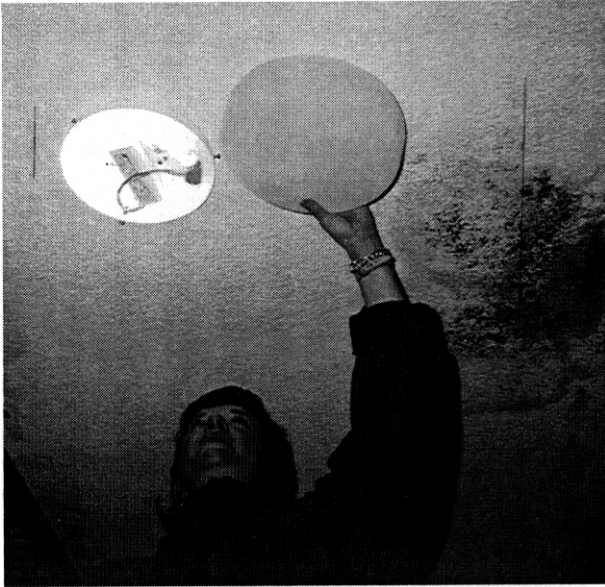
Fig. 6.17. **Gail** Travers, of the Department of Housing and Human Services, examines fluorescent fixtures installed at the Lam-Bow apartments. Note the evidence of a moisture problem (now cured) in the ceiling.

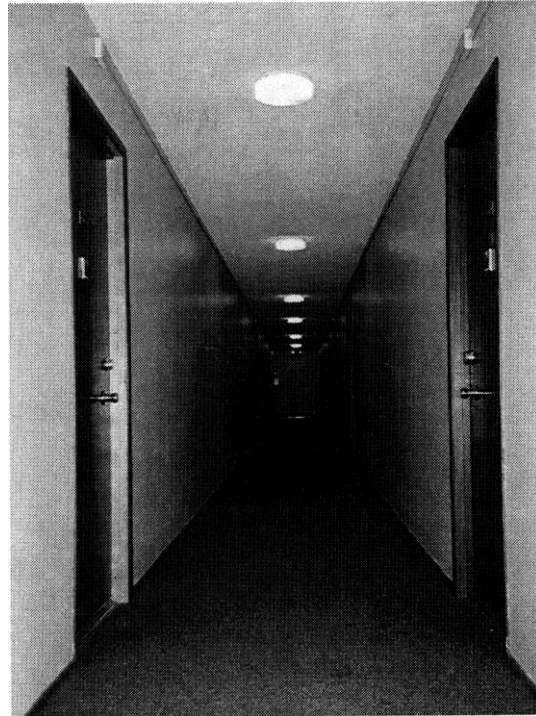
Fig. 6.18. The interior doors are weatherstripped to provide thermal and sonic isolation. The energy-efficient lighting fixtures are cost effective since they are on 24 hours a day.

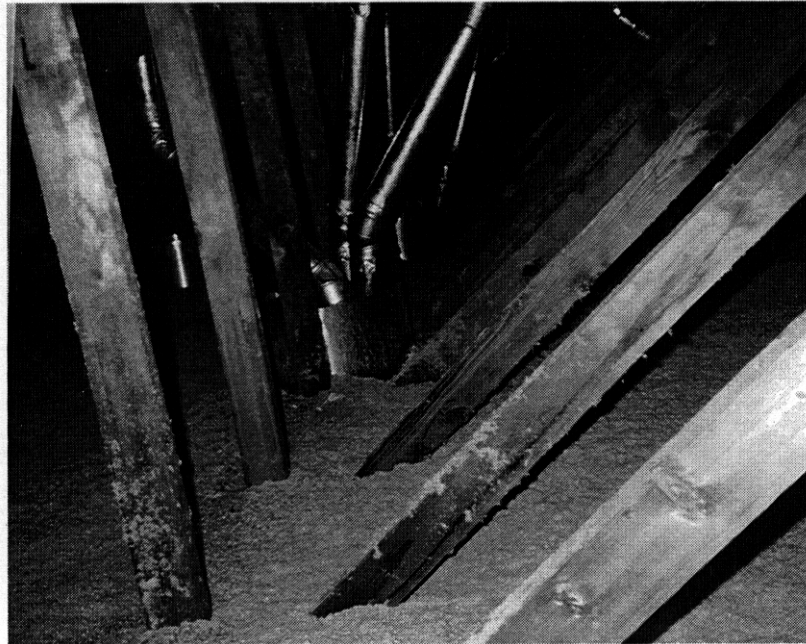
Fig. 6.21. It is difficult to prepare an attic for insulation when ventilation pipes are so closely interwoven with trusses.

The attic was prepared for insulation in the standard way. Seventeen soffit vents totaling almost 7 ft² were added, as was a ridge vent of the same cross-section. Then cellulose was blown to produce an overall estimated R-value of 38 (Fig. 6.21). At the bottom of the structure, the small

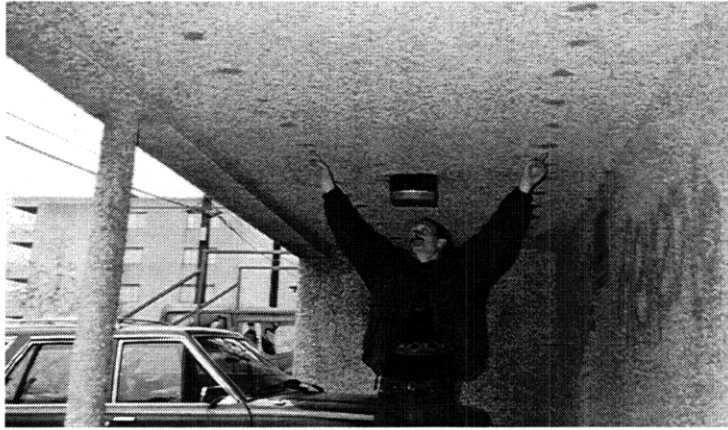
Fig. 6.22. Vince Feltes points out where holes were made to accommodate the hose for blowing cellulose in the overhang area.
