ORNL/CON-434

Five Case Studies of Multifamily Weatherization Programs

Weatherization Assistance Program

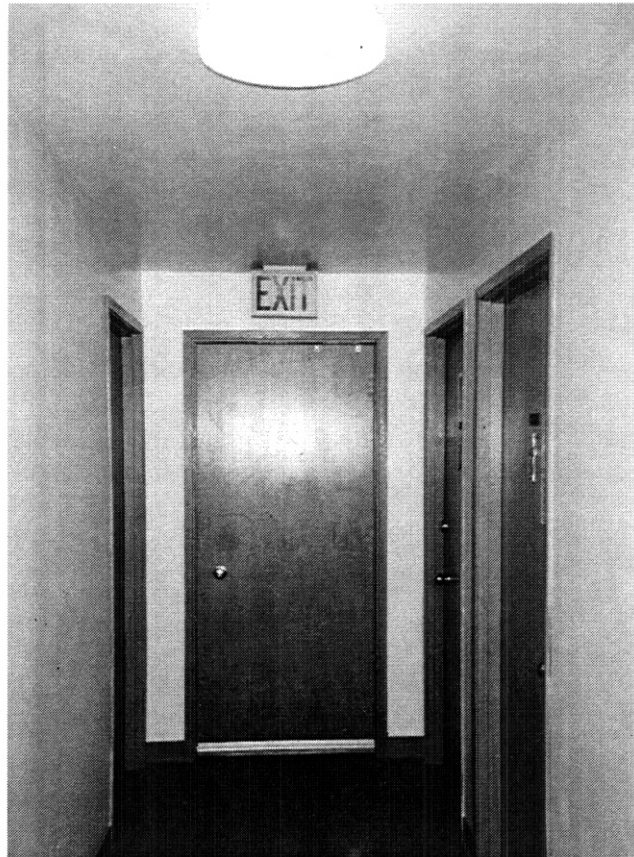
Fig. 6.23. The exit doors at the end of the common hallway were weatherstripped and new energy-efficient light fixtures installed.

Weatherstripping was installed on the hallway exit doors (Fig. 6.23), and new thresholds were installed in high-traffic entryways. New door sweeps (the kind *that* flip up when doors are opened so that doors can swing freely) were installed on the three apartments that needed them. Twentyeight circle light fixtures were hard-wired in the hallways. These 32-W fixtures produce the light of 100-W incandescents and have a rated lifetime of over 10,000 hours. Even with Seattle's low electric rates and an installed cost of \$68 apiece, the payback period for this measure is less than 100 days.

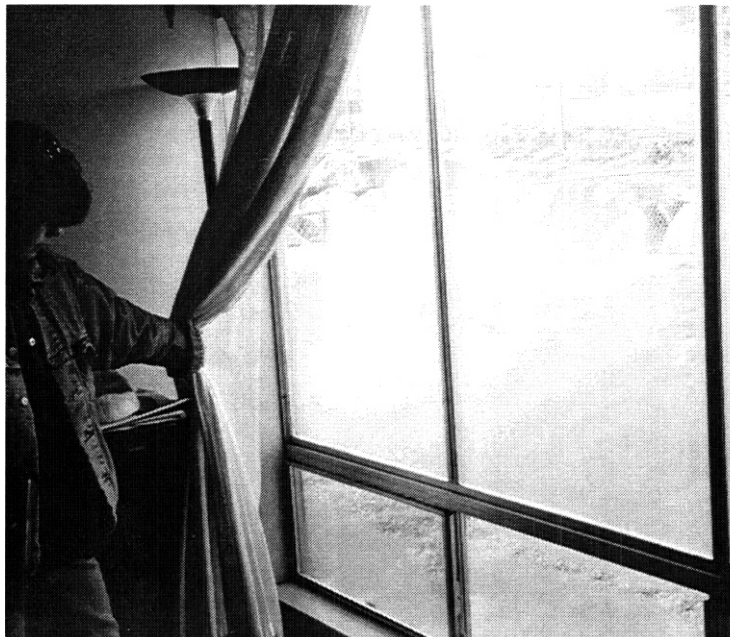
Fig 6.28. Energy conservation representative Tracey Reid shows the aluminum-framed window area.

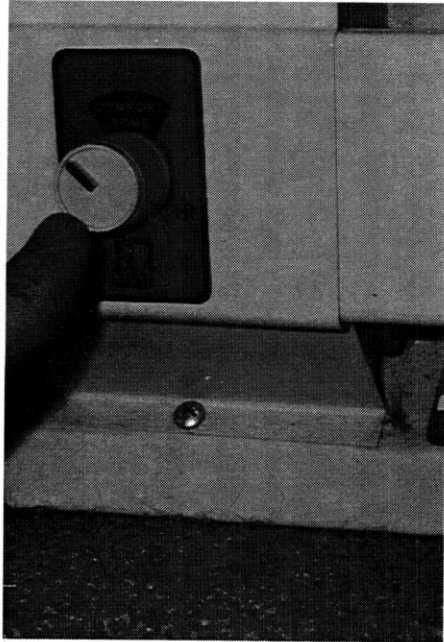
Fig. 6.31. This is the control for the 1000-W strip heater found in the main room of most apartments.

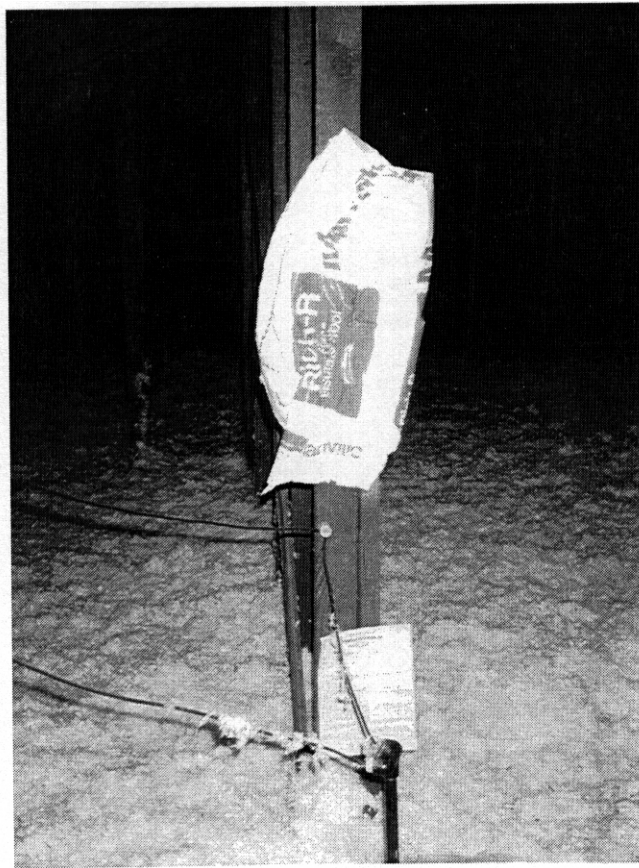
Fig. 6.33. The attic insulation job shows good, even coverage to R-38 (12 inches).

The principal work **on** the dwelling **was** accomplished in the attic (sealing, insulating, and venting) (Figs. 6.33 and 6.34) and in individual apartments (new windows) (Fig. 6.35 and 6.36). Insulation was also added in a **small** (445 ft²) section of the crawl space. All work appears to be of excellent quality. The attic preparation included installing sheet metal ducting around ventilation ducting and electric conduit where wires pass through the attic floor (Fig. 6.37).

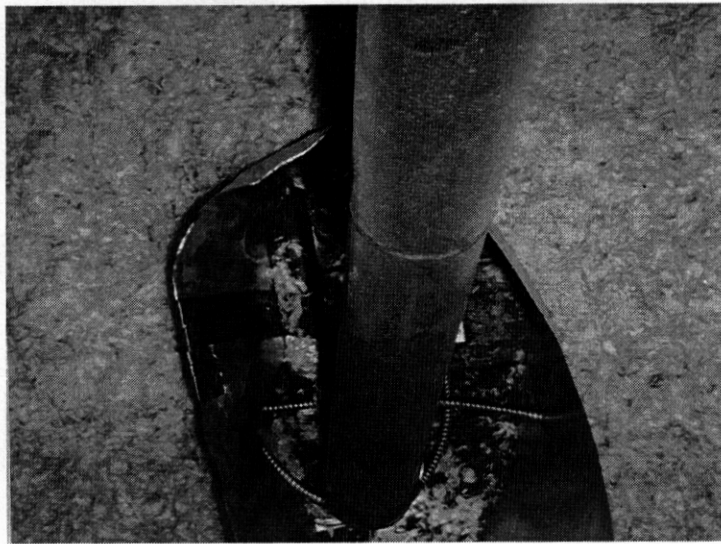
Fig. 6.36. Sheet metal around the electric conduit and ventilation pipe. The finished job appeared tight, but a bit of foam around the metal sheathing around the electric cable where it comes through the attic floor would be useful without being unsafe.

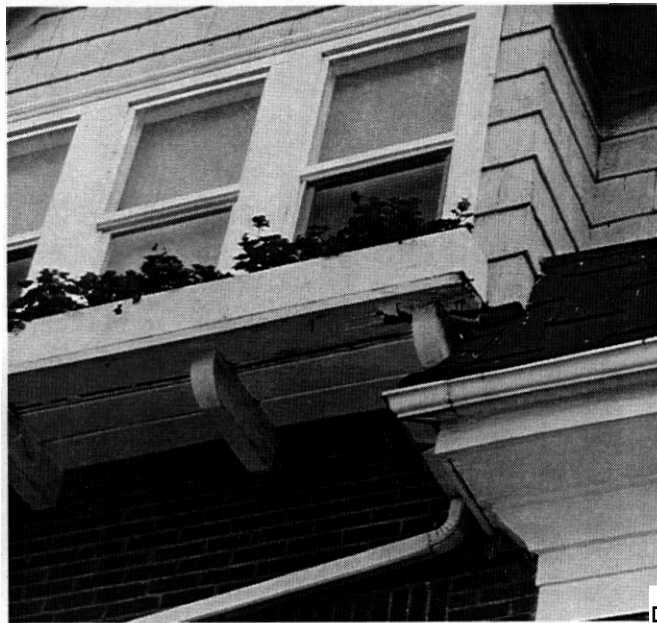
Fig. 6.37. Window and flower box detail.
