Investigation of materials performances in high moisture environments including corrosive contaminants typical of those arising by using alternative fuels in gas turbines

Gerald Meier, Frederick Pettit and Keeyoung Jung
Department of Materials Science and Engineering,
University of Pittsburgh
Pittsburgh, PA 15260

Peer review Workshop III
UTSR Project 04 01 SR116

October 18-20, 2005

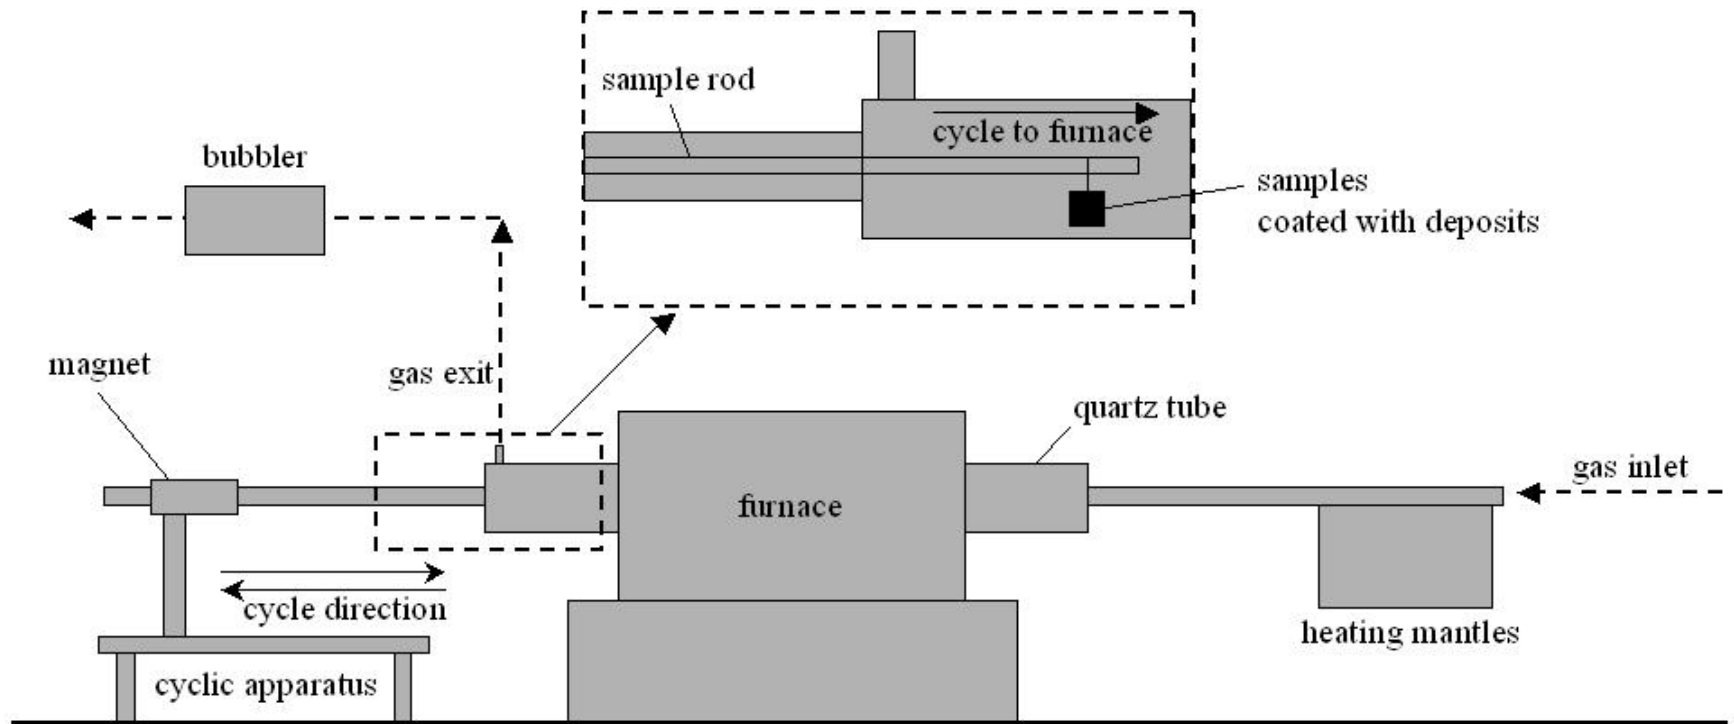
Experimental

- Coupon Specimens (15×10×4mm with a 2mm-φ hole)
- Grit-blasted at 30psi for 45 minutes
- 1~2mg/cm² Na₂SO₄, CaO, CaSO₄ applied every 20 hrs
- Weight change measurements every 20hrs after washing off deposits
- Dry air : -46°C dew point
- Wet air : P_{H₂O} = 0.1atm
- 45 minutes hot zone/15 minutes cool zone cyclic test

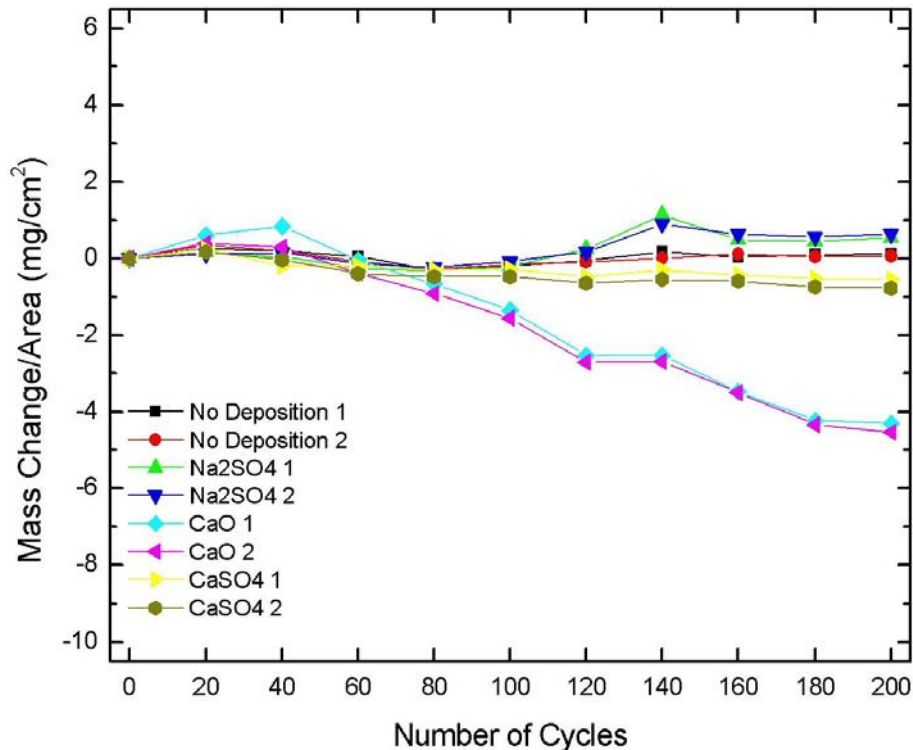
Weight change versus time measurements

Rene' N5 + Platinum Aluminide samples

with different deposits cyclically exposed at 950°C for 200 hours

(a) In wet air

Substantially large weight losses for specimens with CaO deposits compared to Na₂SO₄ and CaSO₄ deposits as well as specimens with no deposits.

1. Substantial attack induced by deposits of **CaO** compared to other deposits.
2. Attack with **all deposits** was more severe **in wet air**.
3. In case of **no deposits**, significant amount of degradation **in wet air**.

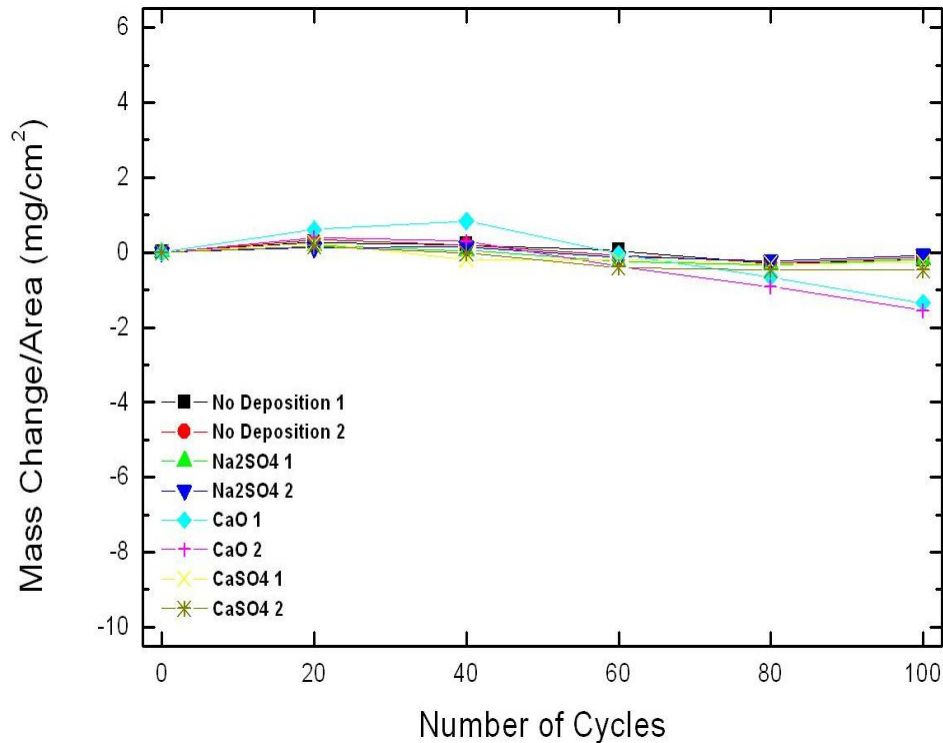
Weight change versus Time measurements

Rene' N5 + Platinum Aluminide samples

with different deposits cyclically exposed at 1150°C in wet air for 100 hours

(a) at 950°C in wet air after 100 cycles

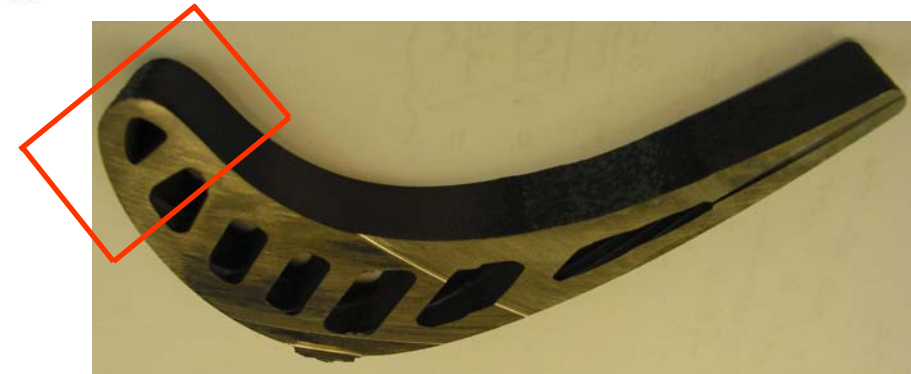
Observation : Service Exposed Turbine Buckets from TECo Polk 1 Gas Turbine

1. Deposits from gas turbine burning syngas have been analyzed.
 - Deposits of Fe_2O_3 with traces of Ca and S were determined.
 - Substantial erosion was observed.

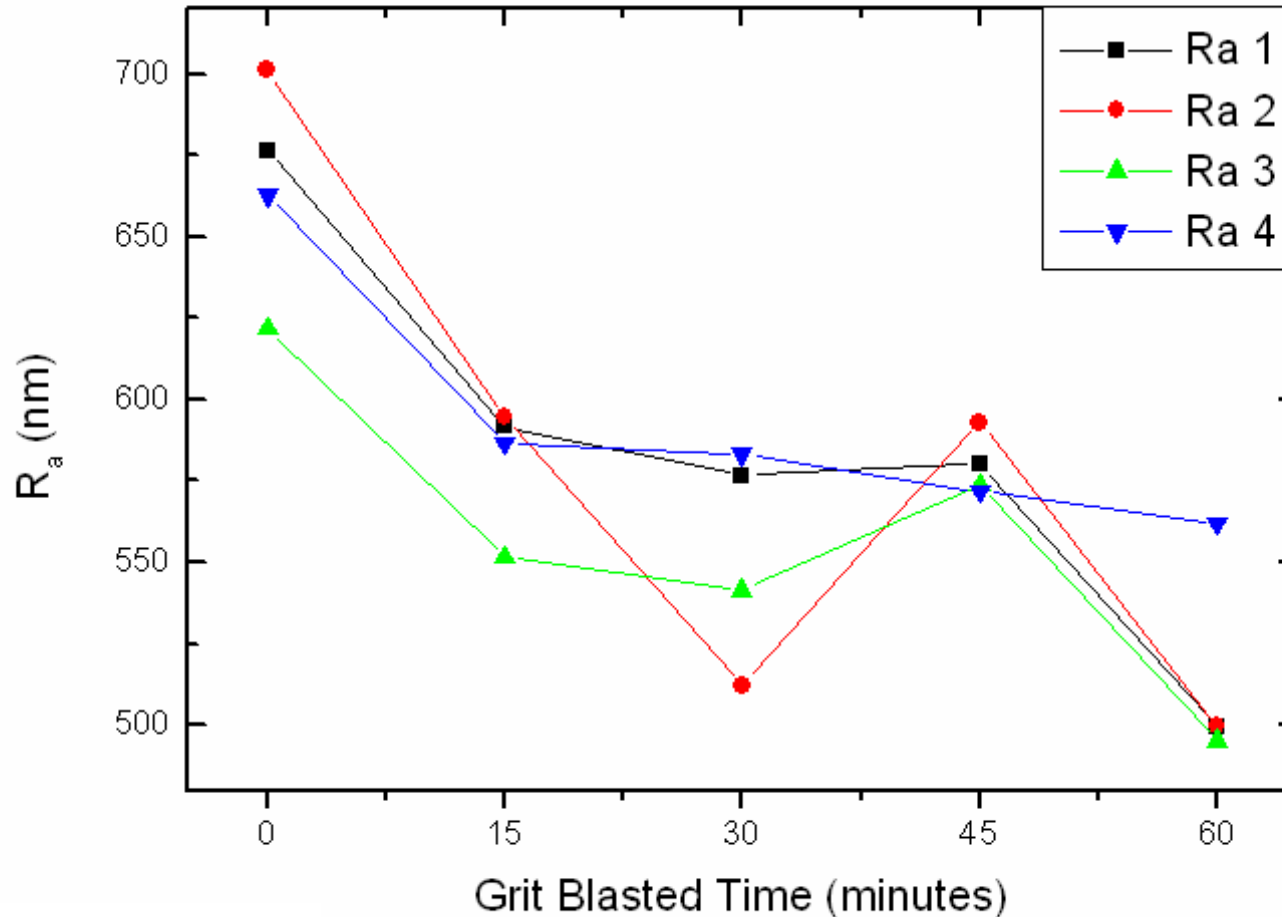
R_a vs. Grit Blasted time at 30psi (GTD111 with Pt Aluminide)

$$R_a = \frac{1}{L} \int_0^L |y(x)| dx$$
