Tunneling in the Park

By David Weber, Khalid T. Mohamed, P.E., and Matthew DeMarco

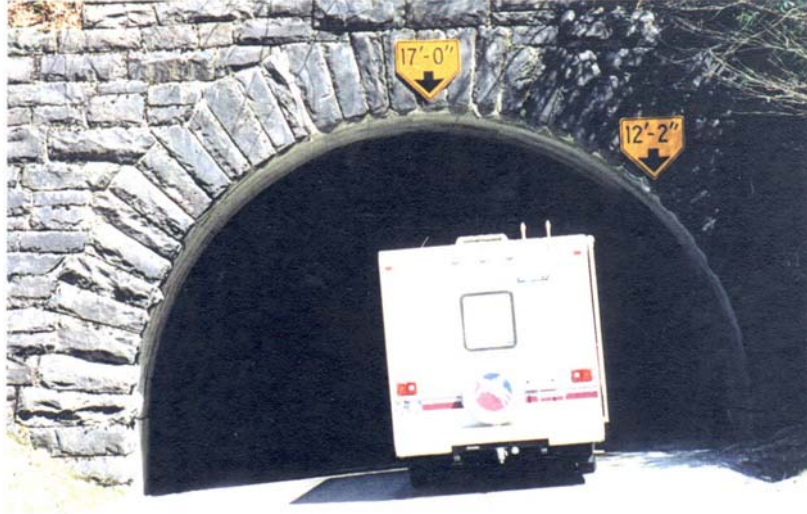
Figure 1. Condition prior to improvements – this is intended to be a two-way highway.

The Morton Mountain and Chimney Tops Mountain tunnels are located on the Tennessee side of Newfound Gap Road. These 253- and 286-foot long tunnels were built in the 1930s when vehicle heights and traffic volumes were lower than today. While commercial vehicles are prohibited on this road, many tour buses and RV's are now approaching the maximum legal height of 13'-6". This was problematic because the vertical clearance in both arch-roofed tunnels was 12'-2" at the edges of the 10-foot wide striped lane. Drivers of buses, RV's, and trailers close to the legal height tended to "hug," and cross the centerline into the opposing lane to avoid the low clearance at the lane-edge, thus creating a potential for head-on collisions (Figure 1). The situation was aggravated by sharp curves inside the tunnels that restricted visibility from one end of the tunnel to the other. Frequently, taller vehicles struck the tunnel roofs, peeled off sidewall reflectors, and on at least one occasion collided with another vehicle in one of the tunnels.

As traffic increased during the 1980s and early 1990s, the low clearance of the tunnels became a greater concern. In the mid-1990s, a number of options were reviewed to address this concern. They included: 1) abandoning the tunnels and relocating Newfound Gap Road around each tunnel, 2) removing the top of each tunnel with an open cut, and 3) lowering each tunnel by removing rock out of the floor of the tunnels. But regardless of the option selected, portions of the road would have to be closed for a period of time during construction. During an early meeting with community officials, it became clear that an Environmental Assessment (EA) would be required to close the road for any period of time. The EA was the avenue for involving the local communities in the decision-making process and obtaining their consent on the project.

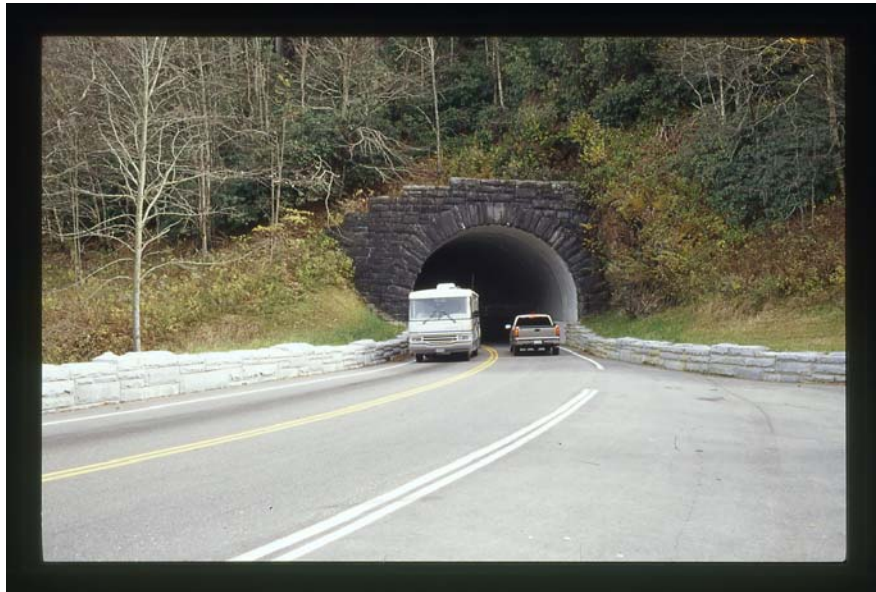
Figure 2. Finished Morton Mountain tunnel with lowered grade and new approach walls to match historic masonry.

To obtain a 13'-6" minimum vertical clearance at each tunnel sidewall, the Park opted to lower the grade in the tunnel floor by 4 to 5 feet. The approach roadways were lowered to transition into each side of each tunnel. The contractor used controlled blasting techniques to excavate the rock and lower the grade, and installed rock bolts to stabilize the existing tunnel walls during construction. The tunnel linings were repaired and painted, and new drainage lines were installed. The riding surface was constructed of asphalt pavement with new striping and reflectors for improved visibility. The guard walls along the approach roadways were reconstructed using a concrete core and new stone masonry facing. The finished product looks much the same as the original, yet with greatly improved capacity and safety (Figure 2).

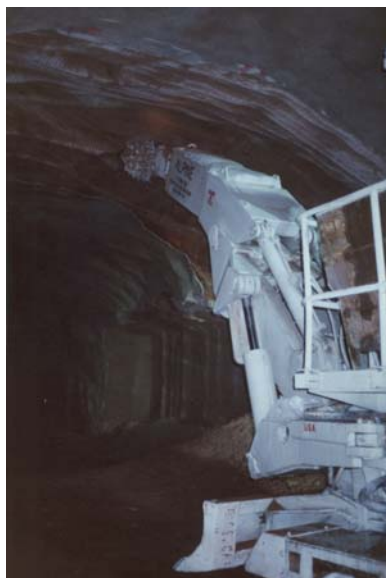
Figure 3. Road header used at Zion National Park for conventional tunnel widening.

Tunnels within Zion National Park, in southern Utah, experienced similar safety issues to those tunnels in the Great Smoky Mountains National Park. The Mount Carmel tunnel (5,600-feet long) and the East “Short” Tunnel (490-feet long) were constructed with conventional drill and blast methods in the 1920s and had since become safety hazards for the large recreational vehicles trying to pass through. The FHWA and NPS completed widening of the shorter, East Tunnel as an initial phase of improvement. A roadheader was used to excavate the sandstone tunnel walls (Figure 3). Enlargement of the tunnel was restricted to nighttime hours during winter to reduce impact on the traveling public. The lack of handcrafted and historic portal structures – and the softer rock – made this widening project considerably less complex than the Great Smoky Mountains project.

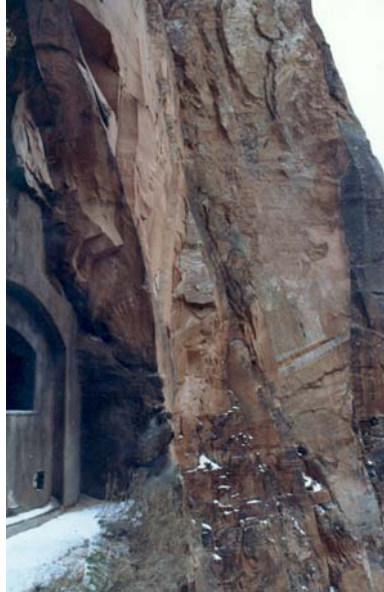
Figure 4. Column collapse at Gallery 3, Mt. Carmel tunnel, Zion National Park.

The Mount Carmel tunnel is more spectacular and longer than the tunnel widened by roadheader. It was constructed through Navajo sandstone very near the canyon wall and has several open galleries to the canyon, originally used as construction access. Vertical jointing in the Navajo sandstone has led to numerous collapses along canyon walls within the park and at the tunnel. Figure 4 shows the view west along the canyon wall from Gallery 3, where in 1958 a canyon wall collapse occurred. The collapse caused a local tunnel failure and exposed tunnel lining (most of the tunnel is unlined) as seen in the figure. In this more critical geologic setting, work is proceeding more slowly here than it did for the East Tunnel. At this time we have begun evaluating the feasibility of either widening the original tunnel or constructing a new one. Seismic reflection tomography was used to map large rock fractures immediate to the existing tunnel and in the pillar of rock between the tunnel and the near-vertical canyon wall. The technique satisfied the criteria of speed and low impact, using a sledgehammer as an energy source and geophones affixed to the tunnel walls, but provided more limited information on rock quality beyond tunnel walls than anticipated.
