EFFECTS OF MAGNITUDE AND DURATION
OF LARGE FLOODS
ON CHANNEL MORPHOLOGY:
A CASE STUDY OF NORTH FISH CREEK,
BAYFIELD COUNTY, WISCONSIN, 2000–2005

by
Marie C. Peppler

A thesis submitted in partial fulfillment of
the requirements for the degree of

at the
University of Wisconsin—Madison
2006

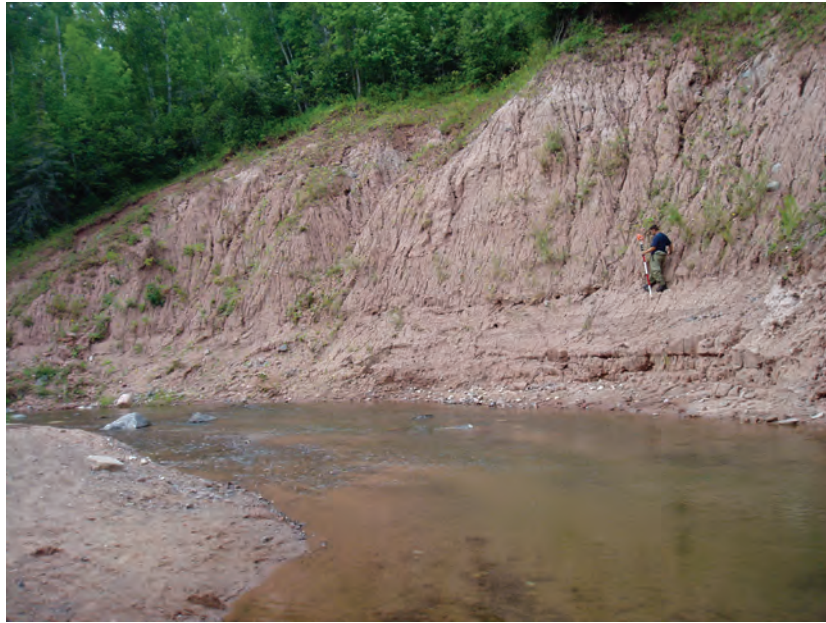
Figure 5. Photo of scour line left by the July 2005 flood in the bluff at site 12.2. Eric Dantoin is surveying the line.

Proxy stage indicators, such as high water marks, were used to approximate maximum flood stage at sites where stage recording equipment was not available. Peak flood stages at individual sites were indirectly determined, if possible, from high water marks retained in the clay along the bluff faces, trash lines, and sand deposition (minimum level). At site 12.2, highly visible high water marks on the bluff face were left by each of the 2005 floods (fig. 5). The lines developed as flow passed along the outside bend of the channel along the base of the bluff. The bluff's clayey material has sufficient strength that it maintained the scour line after the flood. These lines were surveyed and the elevations were averaged to come up with a maximum flood stage. Additional proxy data included flood trash in trees on the point bar that was also surveyed.

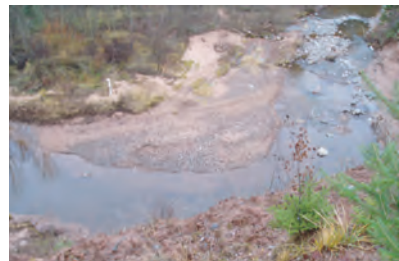
Figure 12. Photographs of the bluff and channel at site 16.4, 1993–2005, North Fish Creek, Wis. Flow direction is from lower left to upper left. Bottom three photographs show the point bar from the top of the bluff, 2005.

A series of photographs of the channel and bluff at site 16.4 show how the site changed over 10 years in response to floods and the presence of the vanes (fig. 12). Photographs at site 16.4 extend back 7 years before the vanes were installed because the site was part of the previous geomorphic assessment of North Fish Creek (Fitzpatrick, 1998; Fitzpatrick and others, 1999). The face of the bluff changed over time as blocks of the top and upper part of the bluff failed, and failed debris built up along the bottom half of the bluff during low-flow periods between large

Also during the record 2001 flood, a large block failure occurred from the top of the bluff near cross-section 5 (fig. 12, large tree). The block remained at the toe of the bluff and was not washed away during the flood or by any subsequent floods through September 2003. Boulders also fell from the upper half of the bluff and hit some of the vanes, bending them out of alignment. The damaged vanes were replaced in summer 2001 (Whitman, 2002; Fitzpatrick and others, 2005).

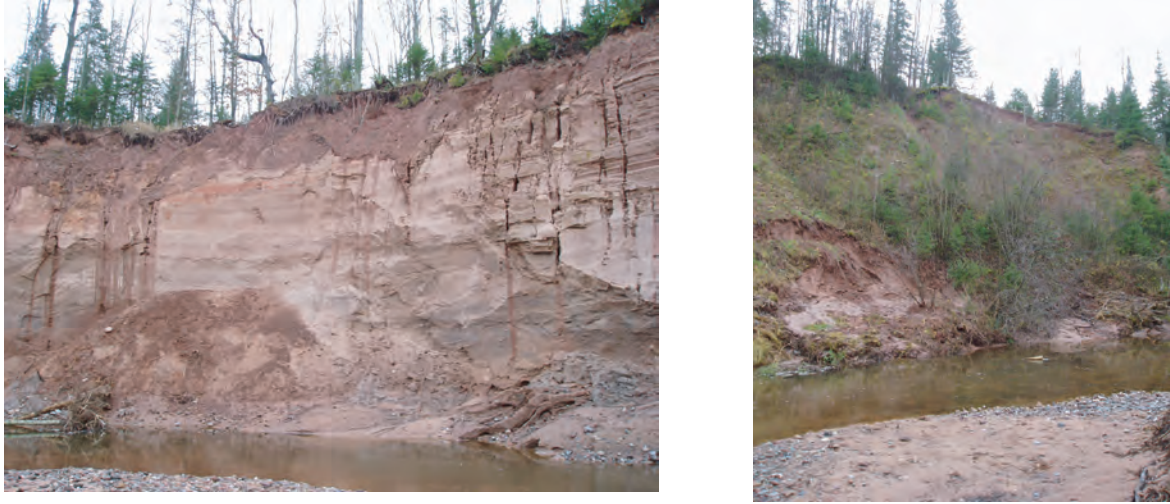
Figure 14. Photographs of site 16.4: the vertical bluff face between cross-sections 4 and 5 and upstream slump between cross-sections 2 and 3 after the October 2005 flood. See figure 4a for cross section locations. Photographs by C. Storrar, November, 2005.

At the upstream end of the reach at site 16.4, a new bank/bluff slump failed in response to erosion of the bluff toe in an area that was vegetated (fig. 14). This bluff section was previously stable, but now may destabilize as the vegetation was removed at the toe of the bluff. At the upstream end of the reach, considerable amounts of gravel and cobble sediments formed the channel, point bar and instream bars, as opposed to sand-sized sediment that was present in July. The fines may have been washed out of the deposits, leaving behind the larger materials, or the area could have been completely eroded and the gravels deposited from upstream. The middle ground is probably likely, with some gravel inputs from upstream and many of the fines washed away by the sustained high flood waters.

the most accurate of those documented for all the floods because a larger portion of the bluff face was able to be surveyed. Similar to previous floods, channel bed and channel bars gained material. But, both left and right banks lost considerable amounts of sediment and overwhelmed the net measurements. The right bank lost over 10,000 cubic feet of sediment along the bluff toe throughout the reach. Similarly, the bluff lost large volumes throughout the reach, totaling over 44,000 cubic feet of sediment (table 2). In fact, the only place that the bluff gained sediment was in cross-section 2 as a result of the upstream slump that was not washed away (fig. 14).

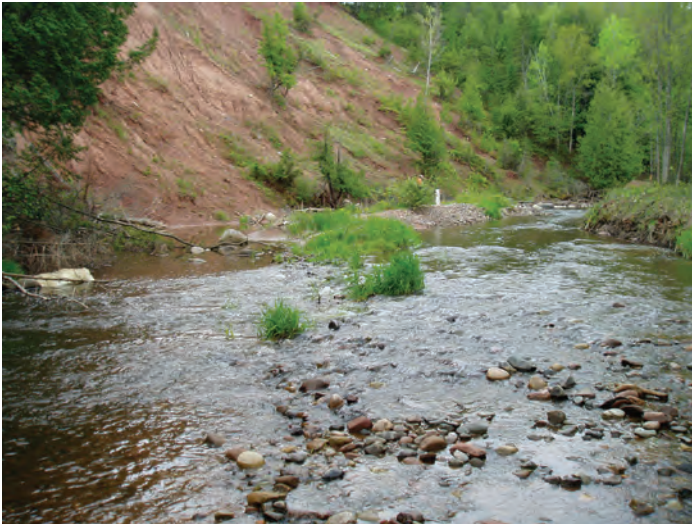
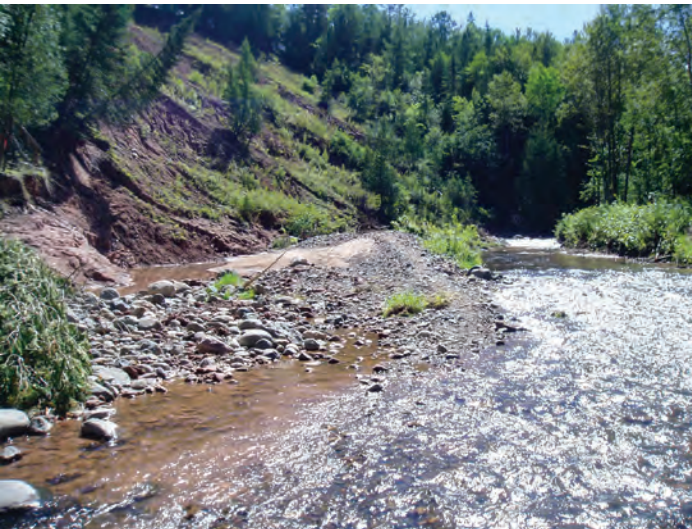
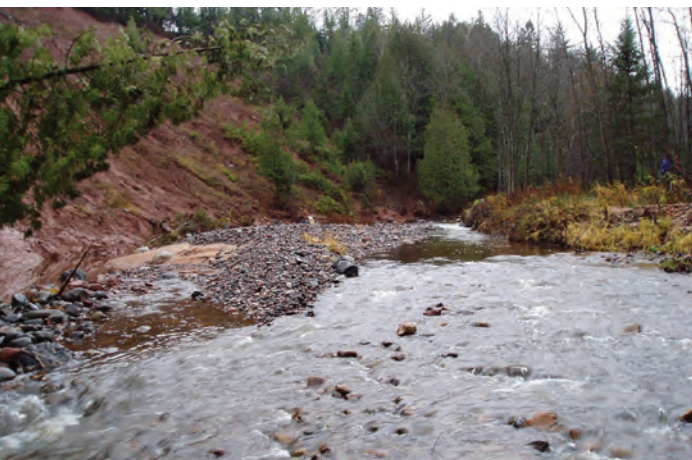
Figure 15. Photo series looking up the reach at site 14.4 from downstream of cross-section 1, North Fish Creek, Wis.

The morphologic changes to site 14.4 began before the first survey was completed. The changes in volume and channel position measured between July, 2004 and May, 2005 are primarily due to the engineered alterations to physically move the channel away from the bluff (fig.

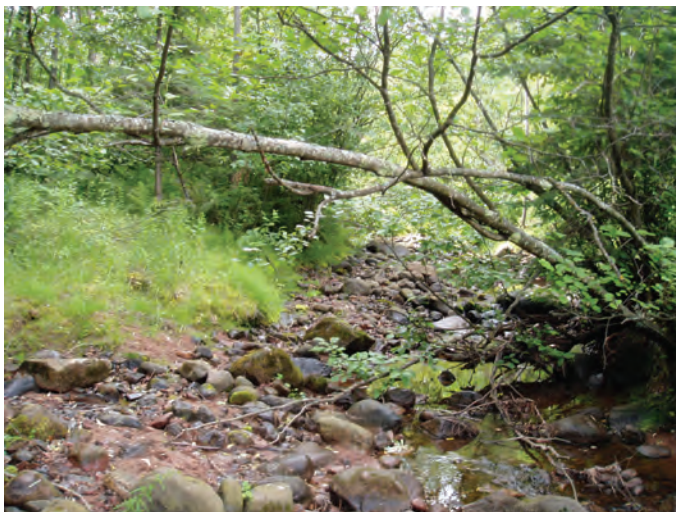
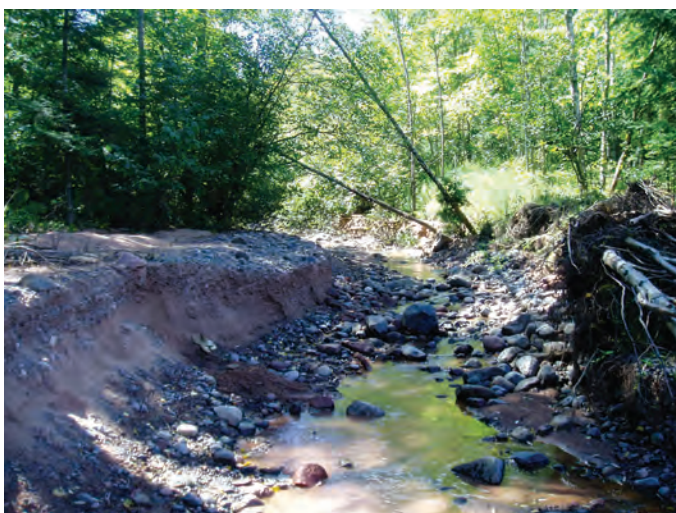
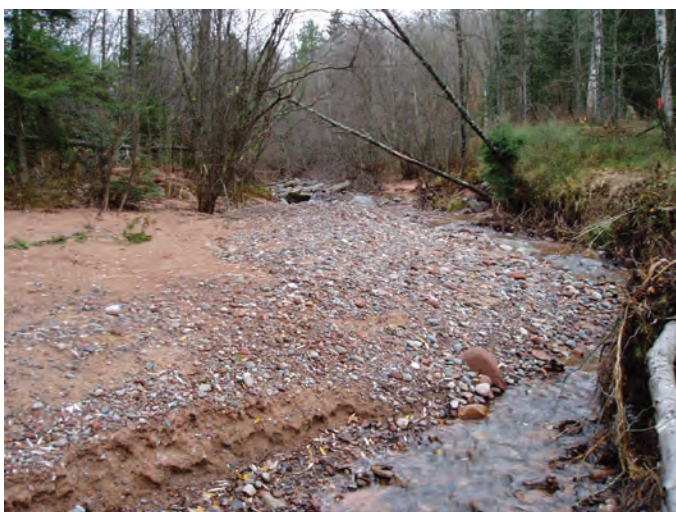
note: trees that were across in the upper photo are moved to the right side of the frame

Figure 16. Photo series looking up the mouth of the tributary that enters site 14.4.

Also influencing the morphology at site 14.4 is the presence of a large tributary (1.7 square mile drainage area) that enters North Fish Creek at cross-section 6. The tributary also has a large bluff just upstream of the confluence and is also a large sediment contributor to the reach. Cross-section 8 monitors the tributary and there is a photo point that highlights the significant changes that the tributary has experienced (fig. 16).

The upstream terrace at cross-section 7 also slumped with a loss of about 830 cubic feet of material. The tributary recorded similar losses in cross-section 6 (table 3), and cross-section 8 experienced a loss of 21.7 square feet of cross-sectional area. The tributary channel reworked and removed much of the remnant sand and gravel from the July 2005 flood and began to form a more confined, sinuous channel in the lower reach of the tributary (fig. 16).

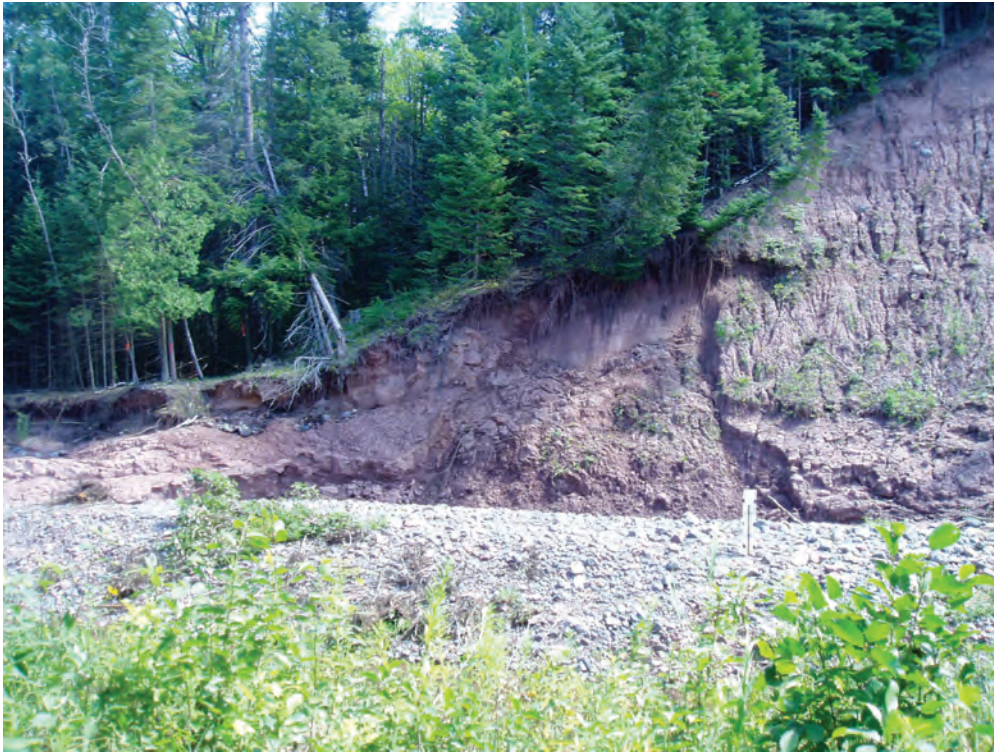
Figure 17. August 23, 2005 photo of failure at downstream end of bluff at site 14.4.

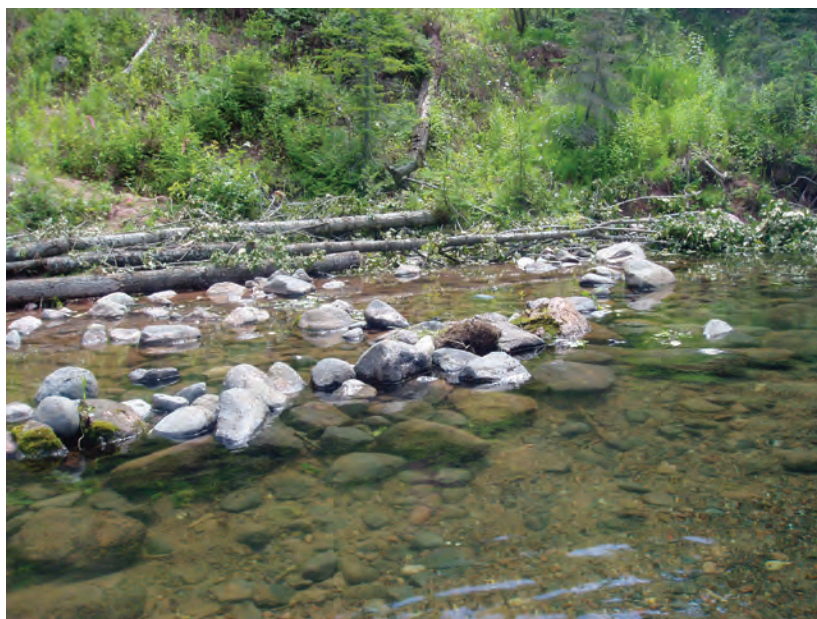
Figure 19. July, 2004 photo of rock dam and cabled logs at base of bluff at site 14.4.

The October 2005 flood damaged many of the rock structures and vanes, but the cabled logs remained in place at the upstream end of the bluff. The logs were undercut by the flood, but remained in place and retained their ability to capture sediment from the bluff. The logs are the likely reason that losses were not observed in the bluff area along cross-section 4 (fig. 19).

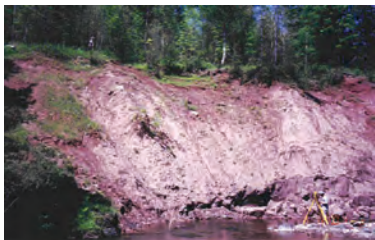
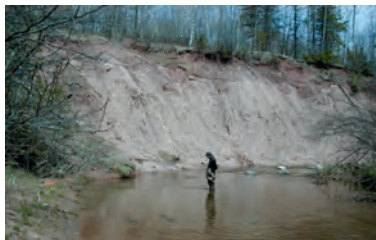
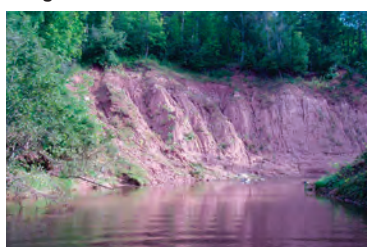
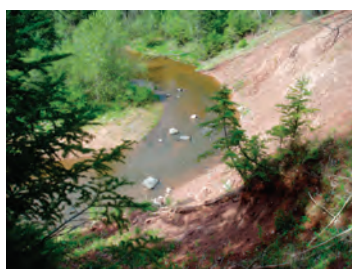
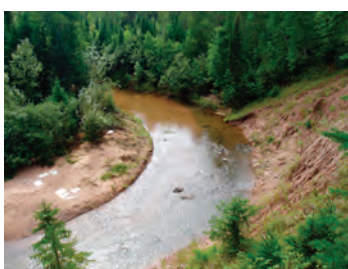
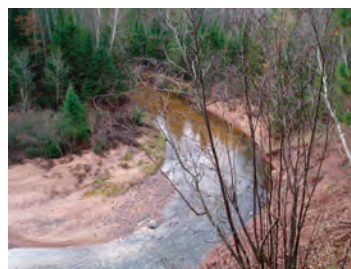
Figure 20. Channel and bluff at site 12.2, North Fish Creek, Wis.,. Flow is generally from left to right in the upper photos, taken from instream, upstream of the bluff, near cross-section 1. Flow is from top to bottom in the lower photos taken of the point bar from the top of the bluff.

The photo points at this site are not as encompassing or consistent as the vantage points at site 16.4 or 14.4. The photos from photo point 1 show the upstream part of the bluff and bed (fig. 20). The photos from photo point 2 show the bed and point bar looking down from the top of the bluff (not available for all years) (fig. 20 and 4c). The eroding bluff face was virtually vertical to slightly convex from 2001 to 2005, with minimal or no vegetation. Rills were common in the face of the bluff and the toe of the bluff was eroded. The bluff was steepened and partially failed as a result of the 2005 floods.

The bluff at site 12.2 sits on a much sharper curve than the other two sites, which affects the flow into the bluff and away from the bluff. The face of the bluff must deflect all of the flood flow, unlike site 16.4 where the flow expands through a floodplain and vegetated section of the bluff before coming to the exposed portion of the bluff and at site 14.4 where the flow is mediated by flow from the tributary and a vegetated bank on the outside of the apex of the curve. For this reason, the vanes were installed farther upstream than at site 16.4 and may have been slightly less effective at deflecting flow over the higher, well vegetated point bar. The vanes successfully

cut the point bar back and down several feet over the first part of the study, but the 2005 floods show that it was not enough to alter the flow around the sharp bend at the bluff site.

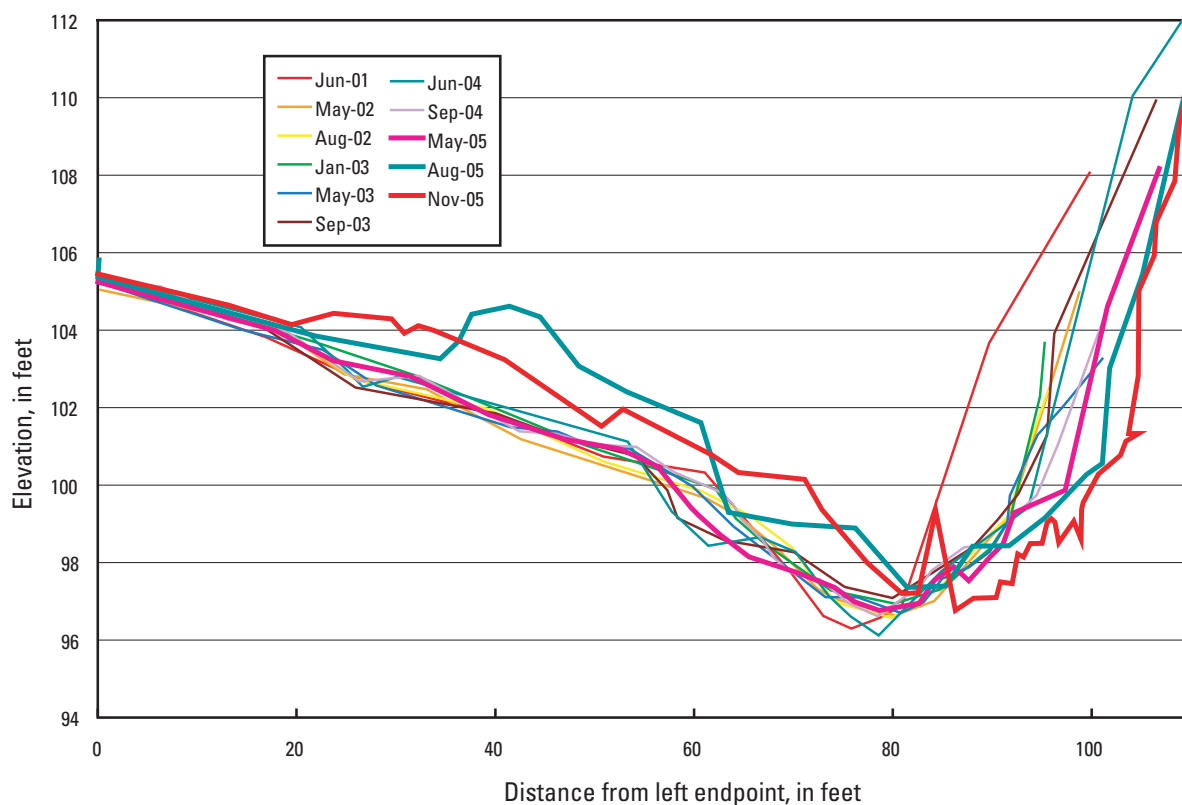
Figure 21. Cross-section 4 showing the changes at site 12.2, North Fish Creek, Wis.

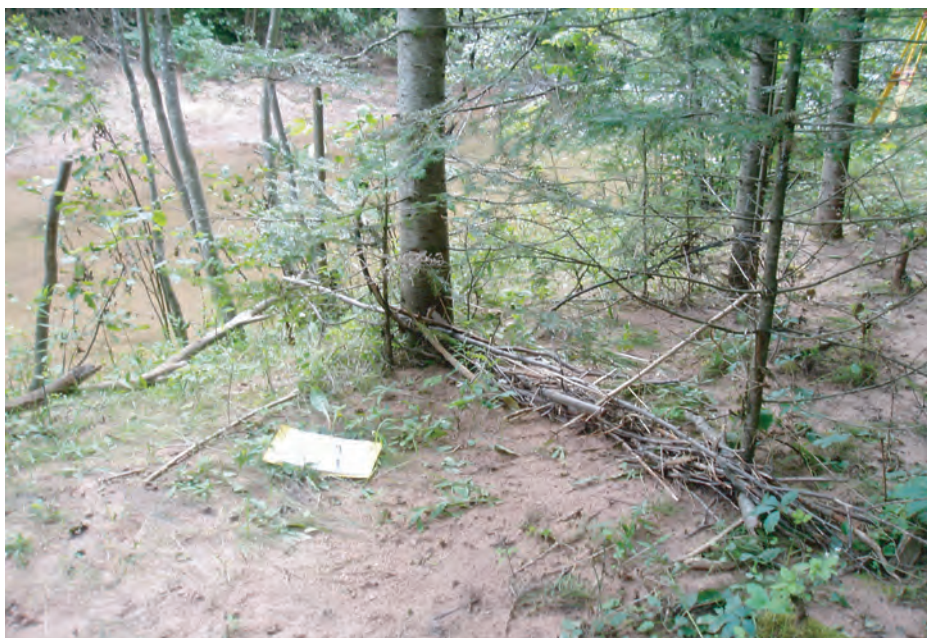
Figure 22. Photo showing unusual placement of flood debris at site 12.2 following the July 2005 flood. Flow is from right to left. The field book is for scale and the total station in the background is setup over the left endpoint of cross-section 1.
