River Corridor Closure Project

Recovery Act Weekly Report

For the week ending June 17, 2011

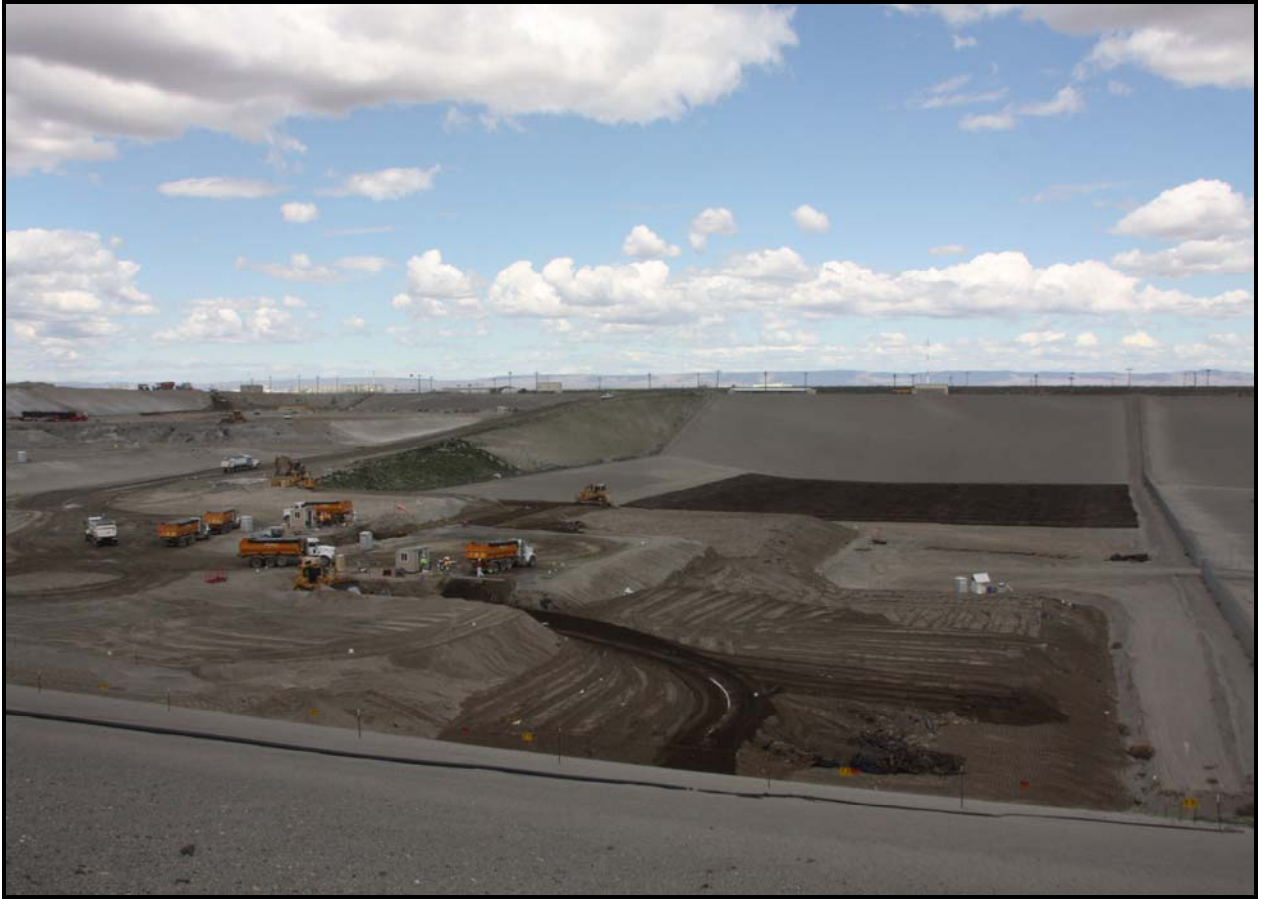
Washington Closure Hanford continues to dispose waste in super cell 9 at the Environmental Disposal Facility. The super cell was placed into service in February. (Photo 1)

WCH and subcontractors TradeWind Services and DelHur Industries completed construction of super cells 9 and 10 in February. Super cell 9 was placed into service in February, and super cell 10 was authorized for use in early May. A project startup review package for super cell 10 is under development.

The project team used lessons learned from previous cell construction to devise the design for the super cells. A super cell is equivalent to an existing pair of cells – 1,000 feet long, 500 feet wide, and 70 feet deep – and is more cost-efficient because it simplifies the leachate collection system. The super cell design eliminated 12 inches of drainage gravel and requires fewer pumps, motors, crest pads, valves, and other pieces of equipment. The result was a cost reduction of \$1.5 million per super cell.

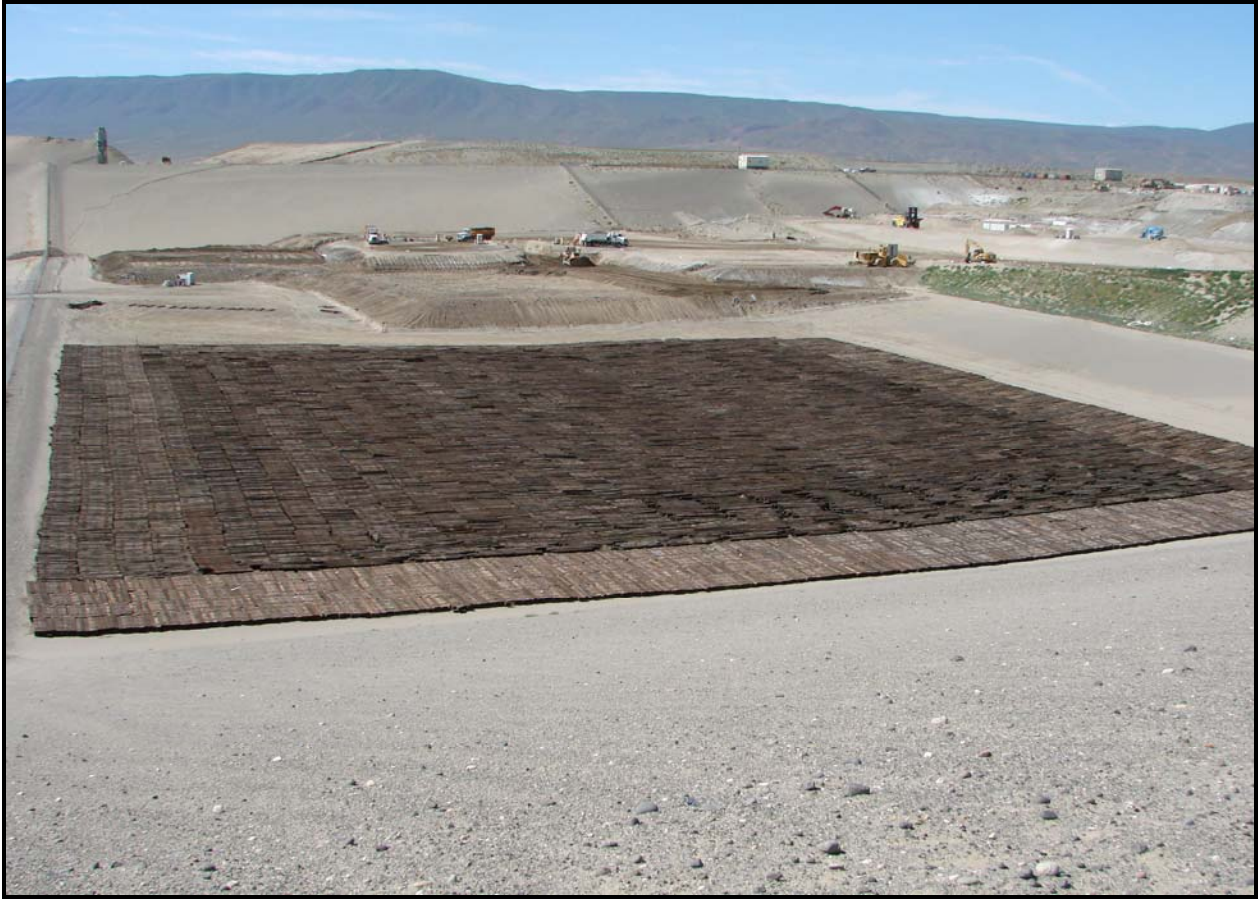
ERDF received the final shipment of 58,500 railroad ties from the Hanford Site. The railroad ties were disposed in super cell 9. (Photo 2)

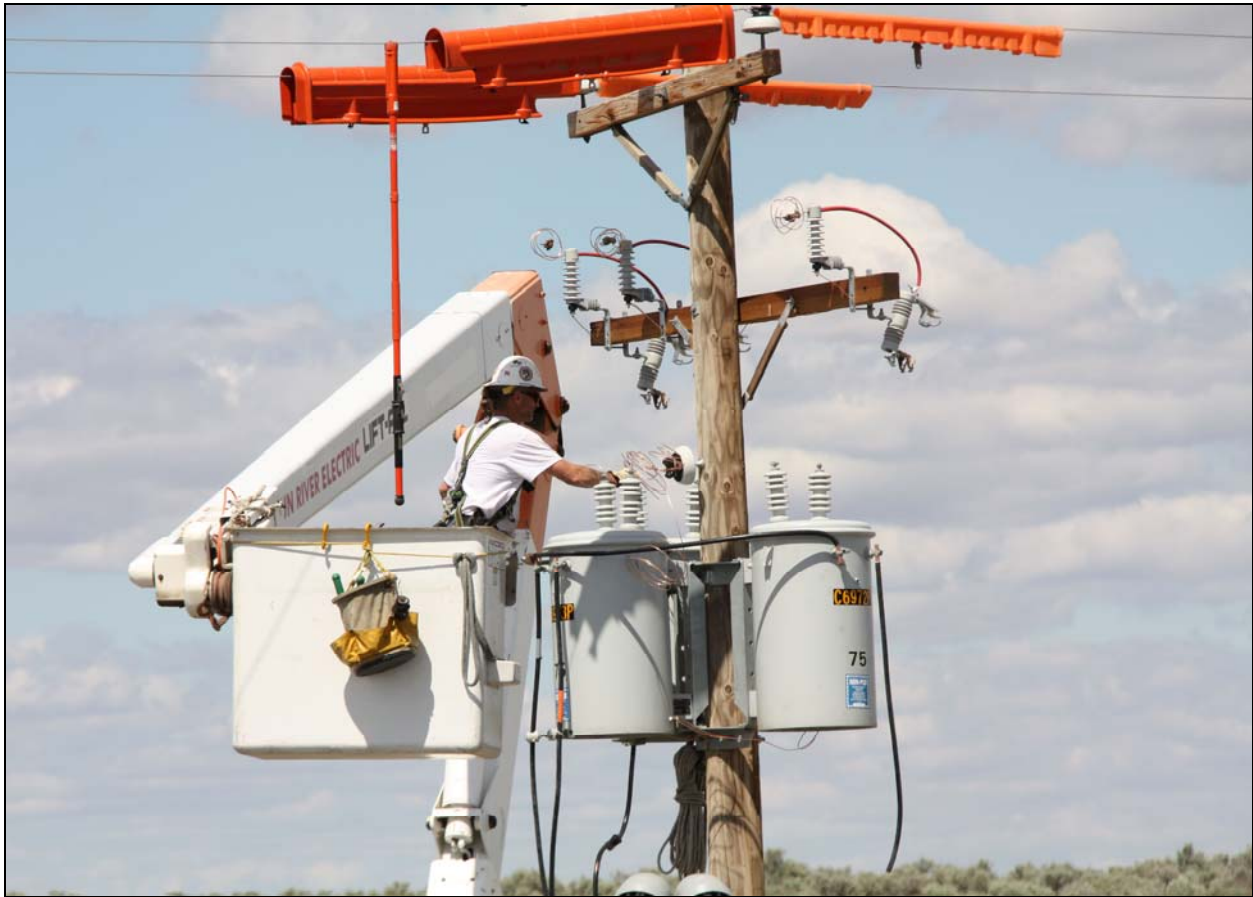
A worker with Washington Closure Hanford subcontractor ELRFowler performs electrical work for the equipment maintenance facility/operations center. (Photo 3)

Construction continues on ERDF's new maintenance facilities. The project team completed testing of the HVAC system and continues touch-up work in the container maintenance facility. Power was hooked up to the equipment maintenance facility/operations center. Installation of the floors and acoustical ceilings continued. In the transportation maintenance facility, the air, water, and lubrication lines are being installed. Flooring also is being installed.

The container maintenance facility will include a large container repair line, a maintenance shop, and a weld area. The equipment maintenance facility will include two service lines, an operational storage facility, a large concrete pad, and an exterior awning over a smaller concrete pad. The new operations center will help alleviate severe overcrowding of personnel and also accommodate new employees hired to handle the increasing waste volumes.

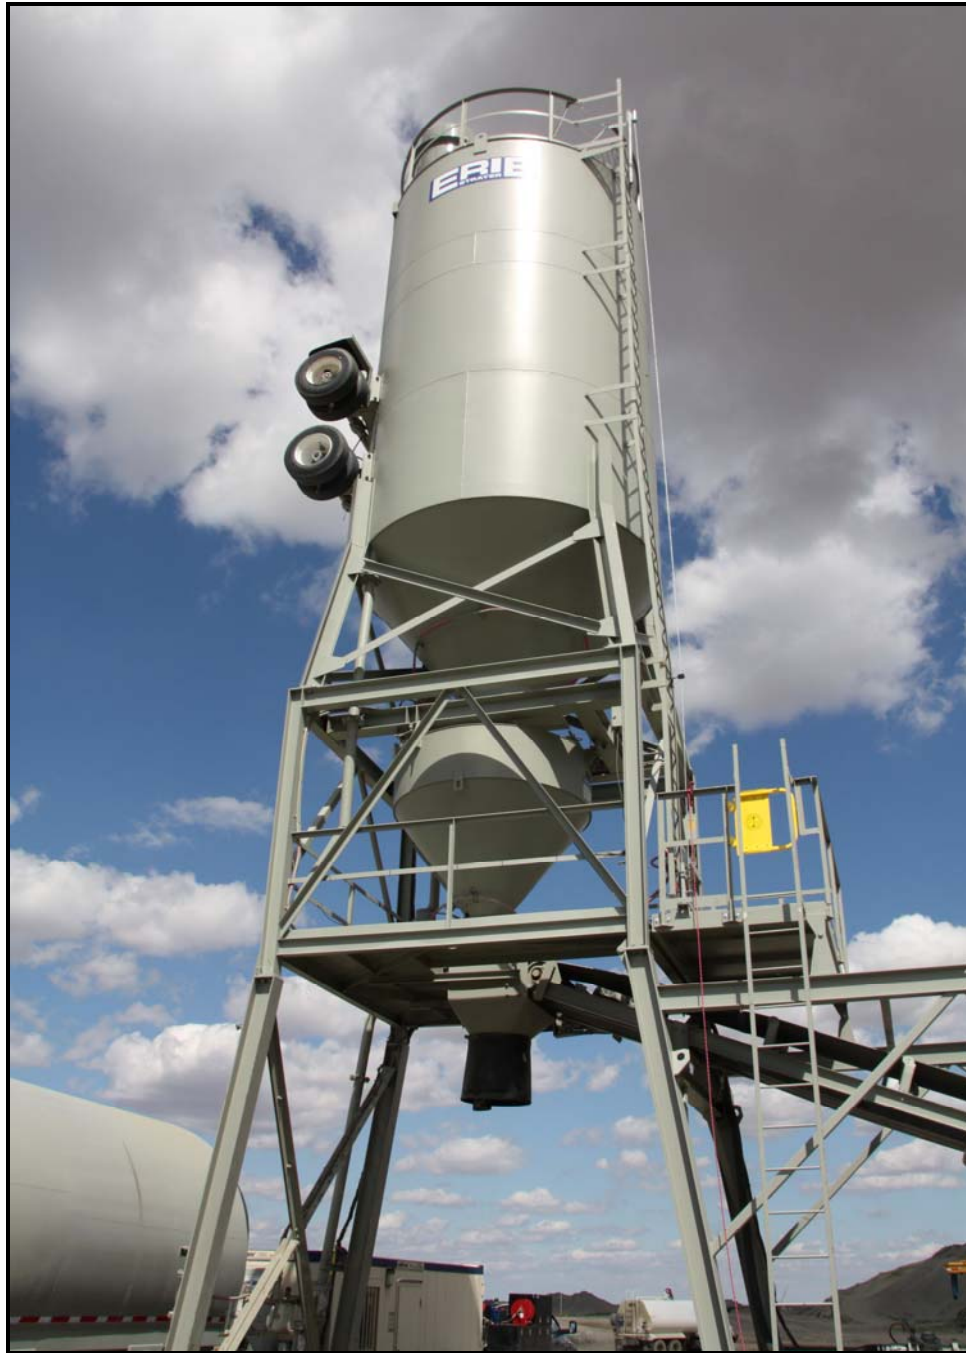
ERDF's new batch plant will manufacture concrete used to mix with debris, ensuring no void space during disposal operations. (Photo 4)

Operational testing was completed at ERDF's new batch plant. Testing produced approximately 220 yards of concrete, which was used for disposal operations. The batch plant is expected in service by the end of the month.

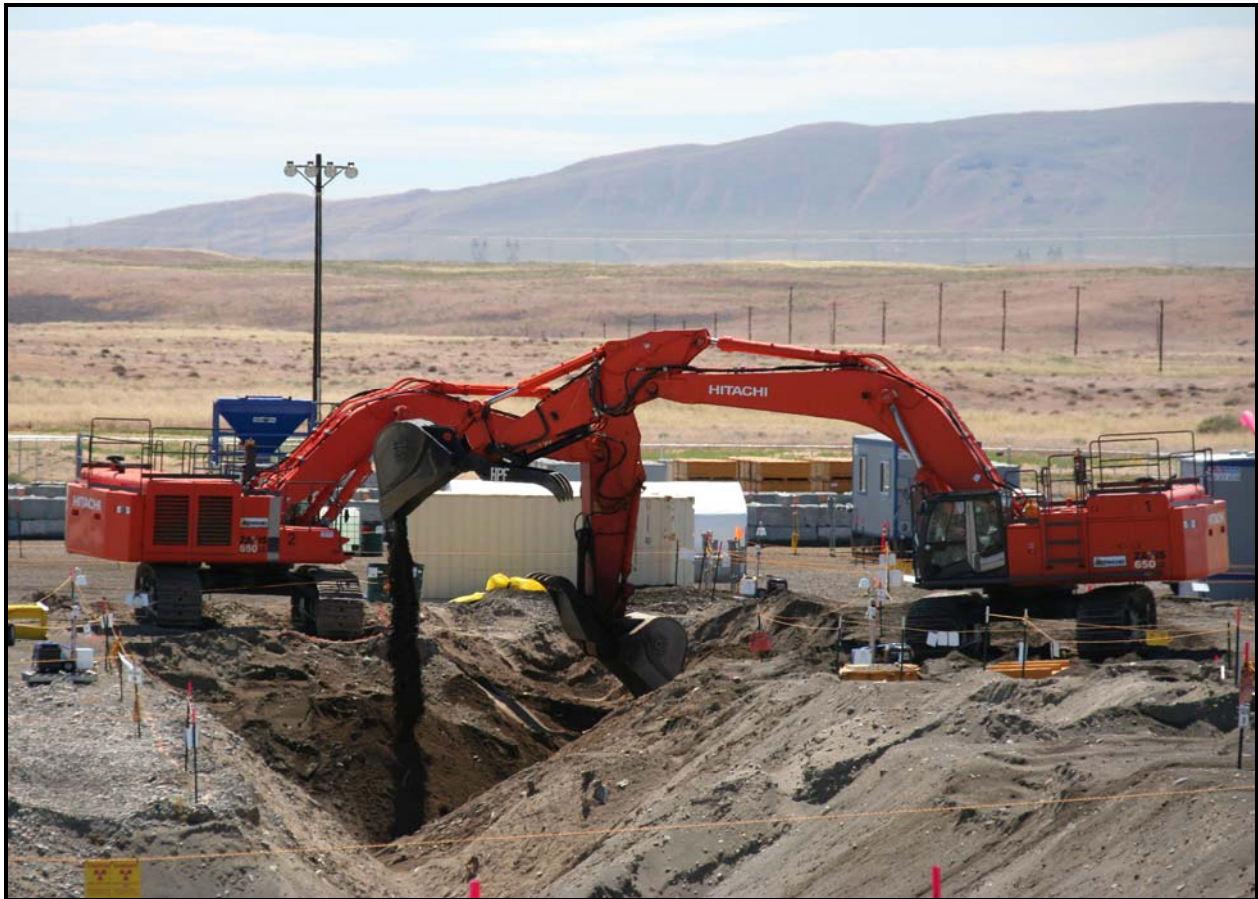
Washington Closure Hanford continues to excavate the waste trench on the north side of the 618-10 Burial Ground. (Photo 5)

WCH continued trench excavation of the 618-10 Burial Ground. As of June 16, a total of 25,000 bank cubic meters has been removed. Last week, the project team processed 35 bottles and several concreted drums. It also performed sampling of powder and resin anomalies.

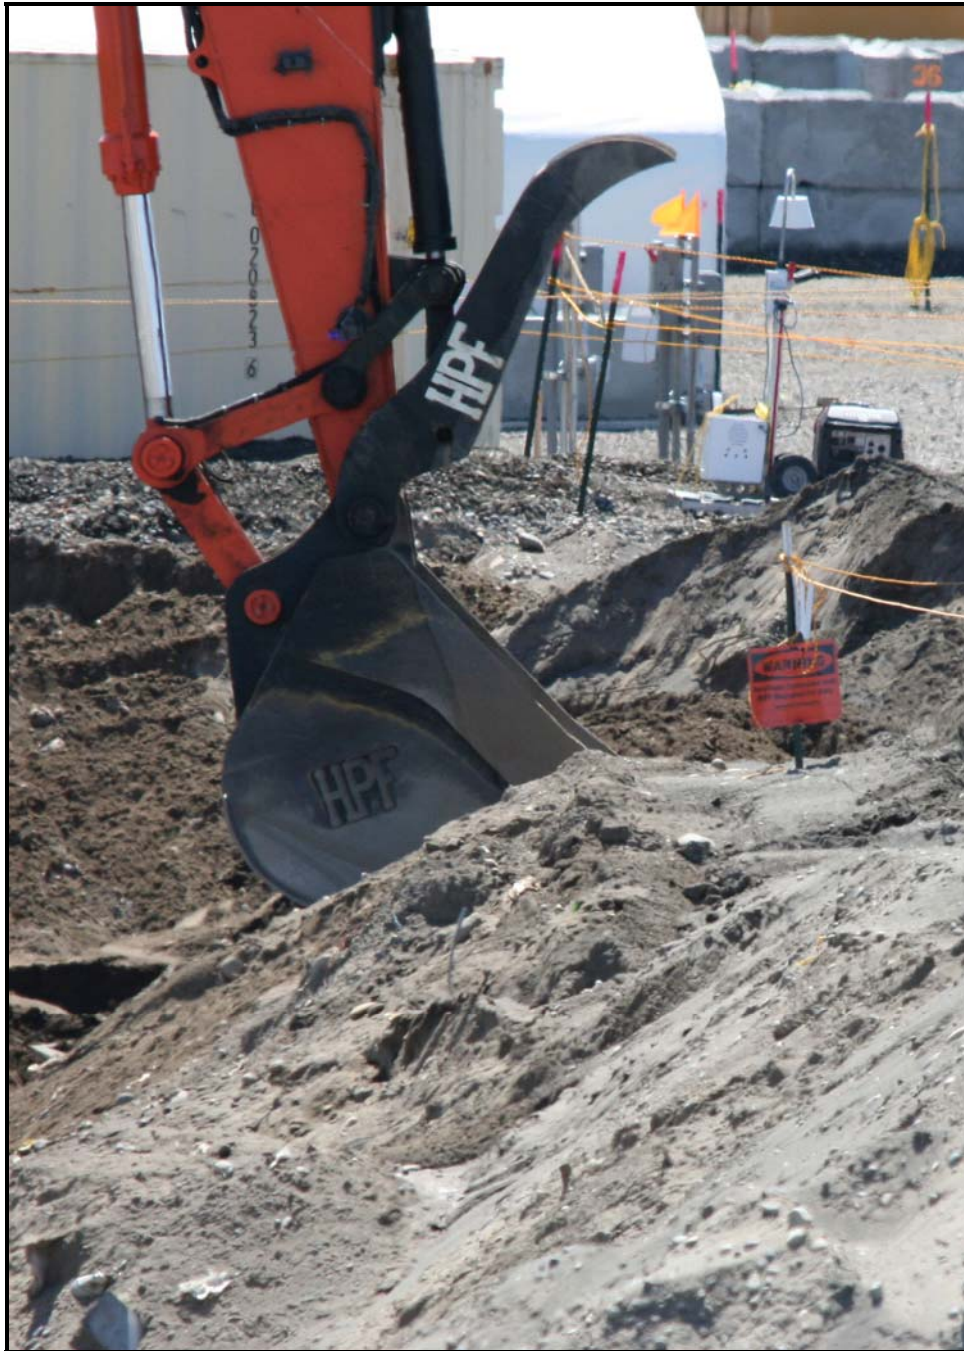
Washington Closure has excavated 25,000 bank cubic meters from the 618-10 Burial Ground. (Photo 6)

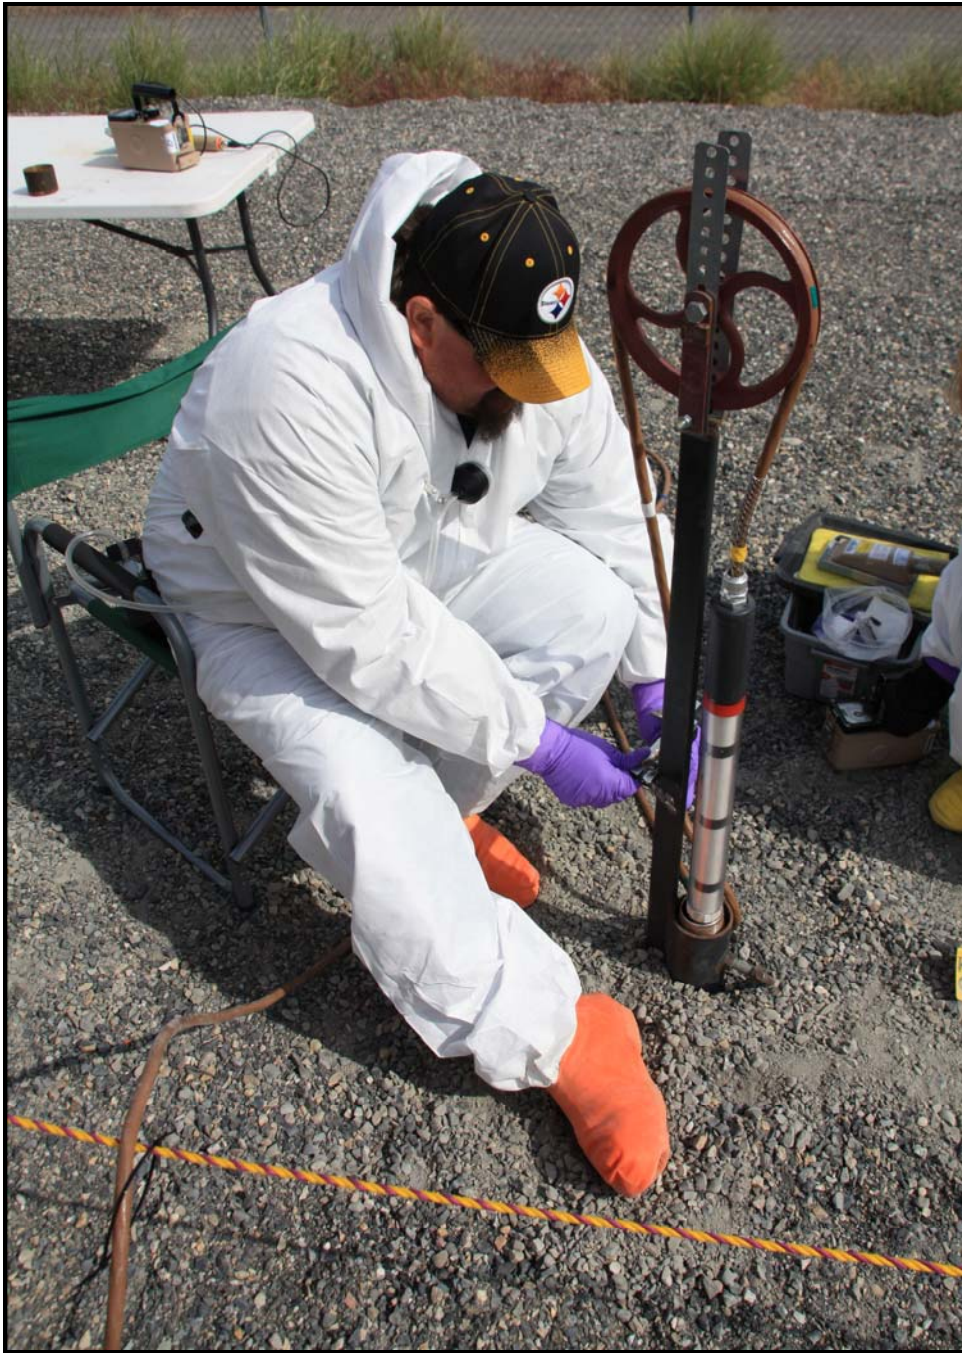
An employee with Washington Closure Hanford subcontractor North Wind lowers a multi-detector probe into a cone penetrometer at the 618-11 Burial Ground. (Photo 7)

The project team is inserting a gamma-logging probe into the cone penetrometers to identify the location of radioactive materials within the VPUs. Earlier this month, North Wind installed two cone penetrometers (narrow steel tubes) about 6 to 8 inches from the exterior of each VPU and to an approximate depth of 6 feet below the VPU. To date, 46 VPUs have been characterized.

Prior to cone penetrometer installation, the project team conducted geophysical delineation to determine the number and location of the burial ground's VPUs and caissons. The delineation was determined using reconnaissance-level magnetic field survey, detailed-level magnetic and time-domain electromagnetic induction (TDEMI) survey, and ground-penetrating radar (GPR) survey.

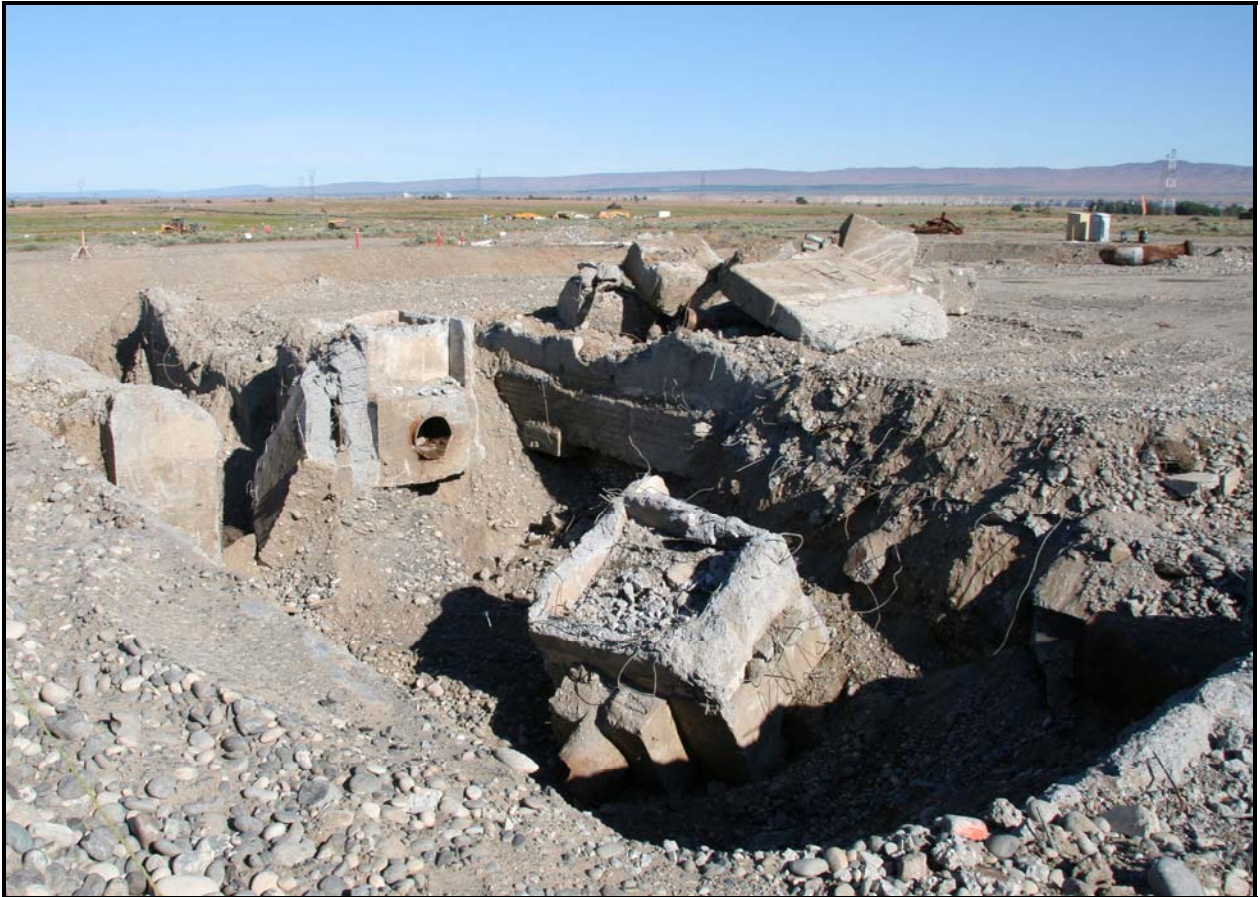
Washington Closure Hanford subcontractor Ojeda Business Ventures is demolishing concrete at 100-F-57. The site is a former water pumphouse and contains hexavalent chromium. (Photo 8)

The project team also continues to demolish concrete at 100-F-57 and load out concrete and underlying soil from the western portion of the site. The site is a former water pumphouse that contains hexavalent chromium.

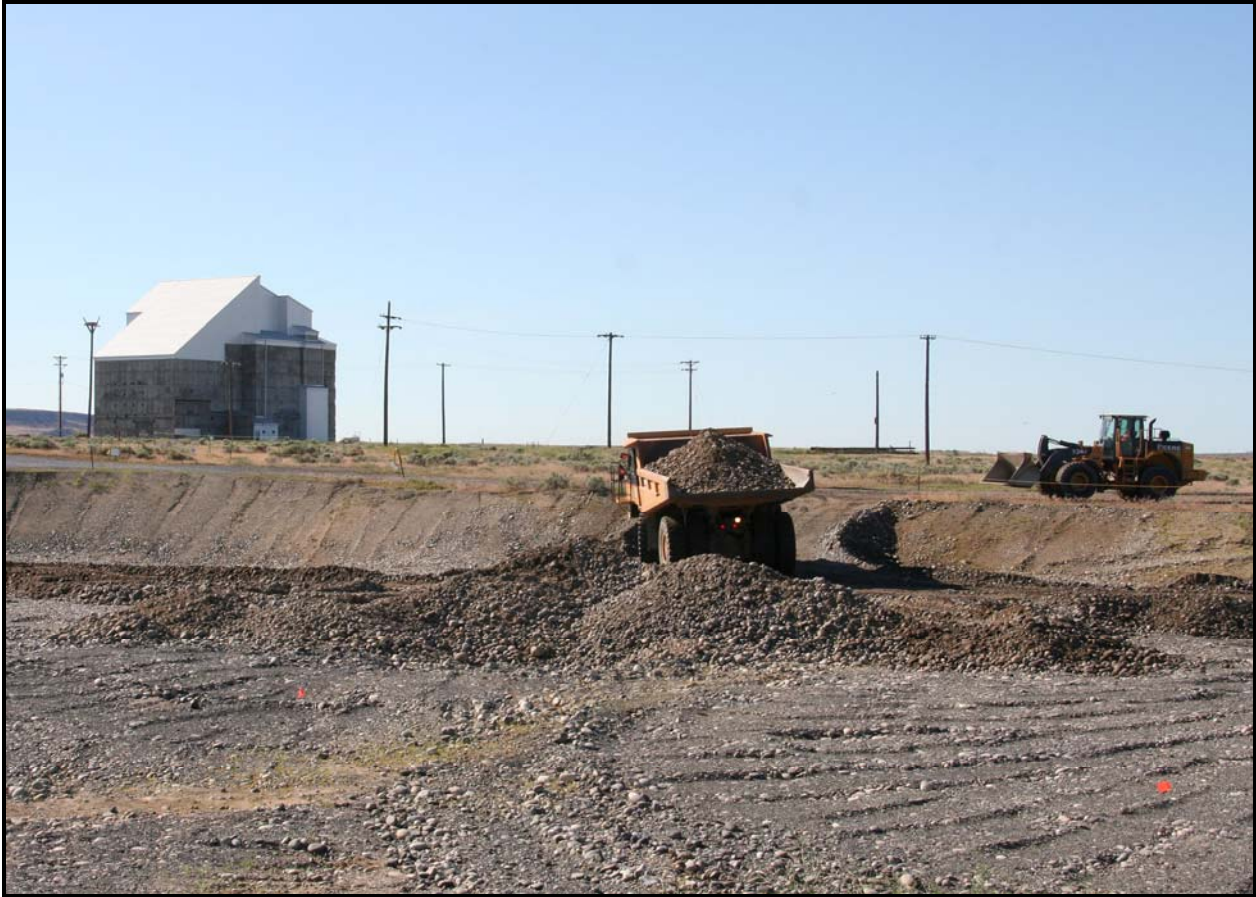
Ojeda constructs a clean path for its trucks as Washington Closure prepares 100-F-47 for further excavation. The site is a former substation. (Photo 9)

Washington Closure Hanford continues with remediation of 19 waste sites at 100-F Area. Subcontractor Ojeda Business Ventures is working at two sites – 100-F-47 and 100-F-44:8 – that required additional cleanup. Site 100-F-47 is a former electrical substation, and 100-F-44:8 contains old fuel oil pipelines.
