River Corridor Closure Project

Recovery Act Weekly Report

For the week ending July 22, 2011

Contract DE-AC06-05RL14655

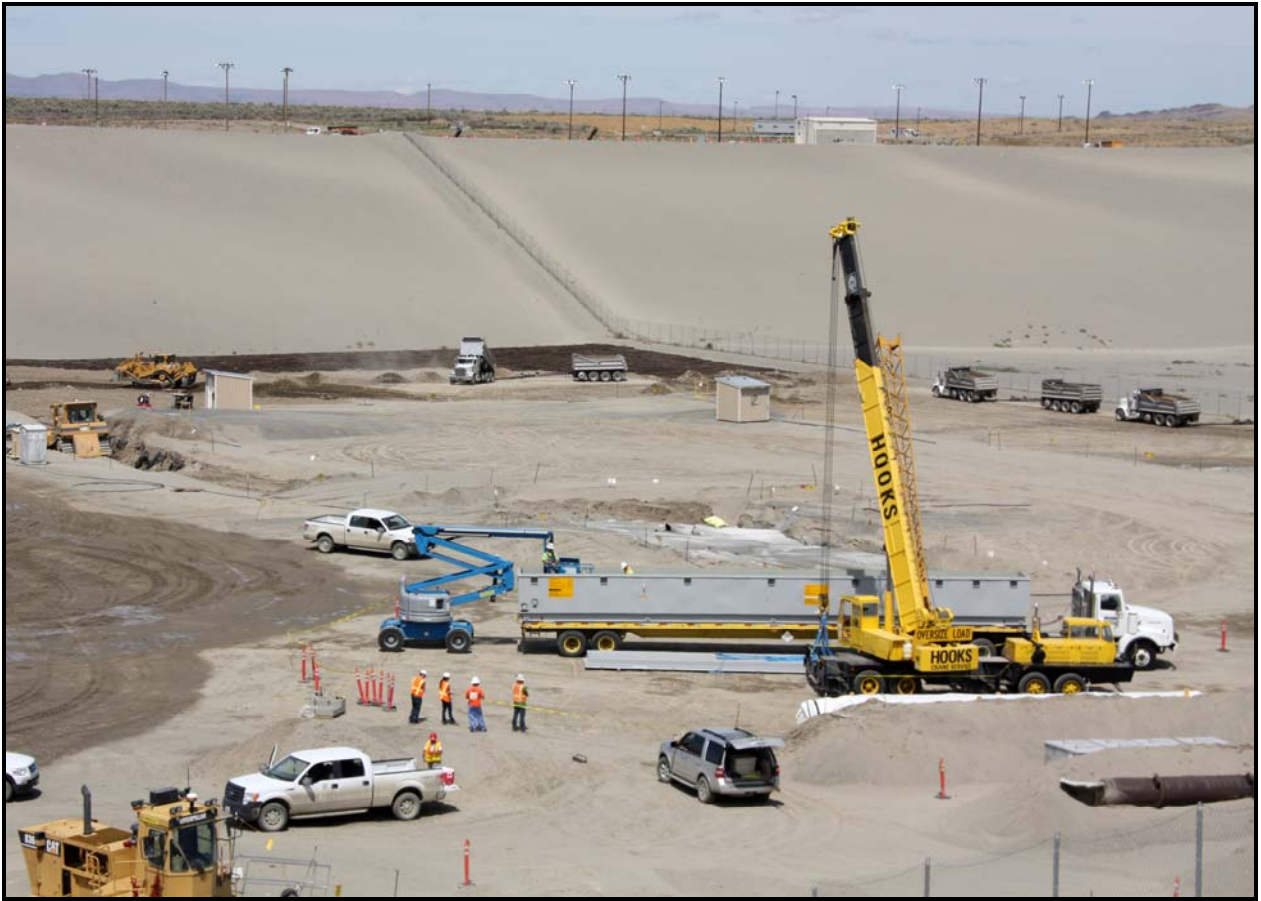
A pump from Tanks Farms is delivered to super cell 10 at the Environmental Restoration Disposal Facility. (Photo 1)

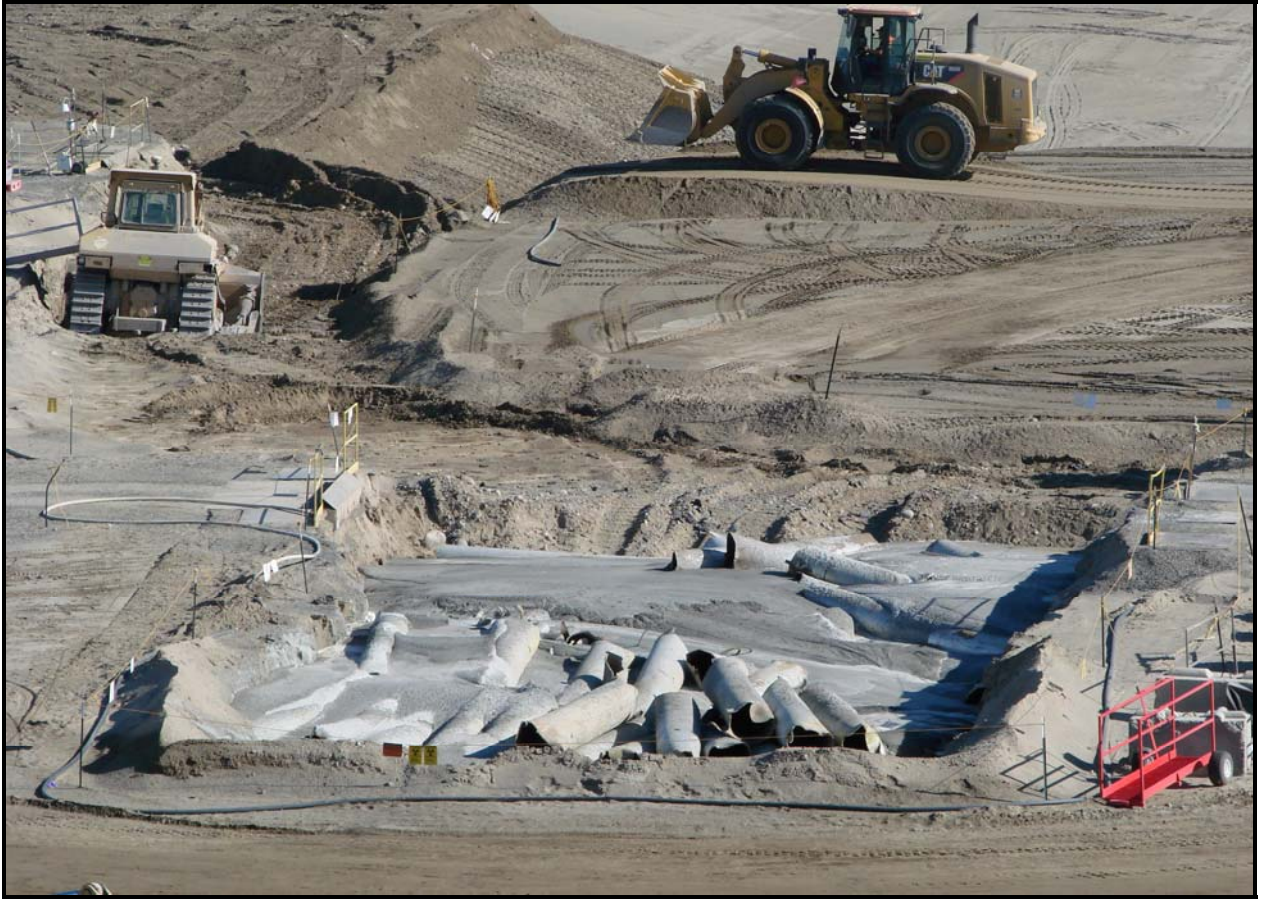
Piping from the water intake structures at K East and K West reactors is disposed in super cell 9 at the Environmental Restoration Disposal Facility. (Photo 2)

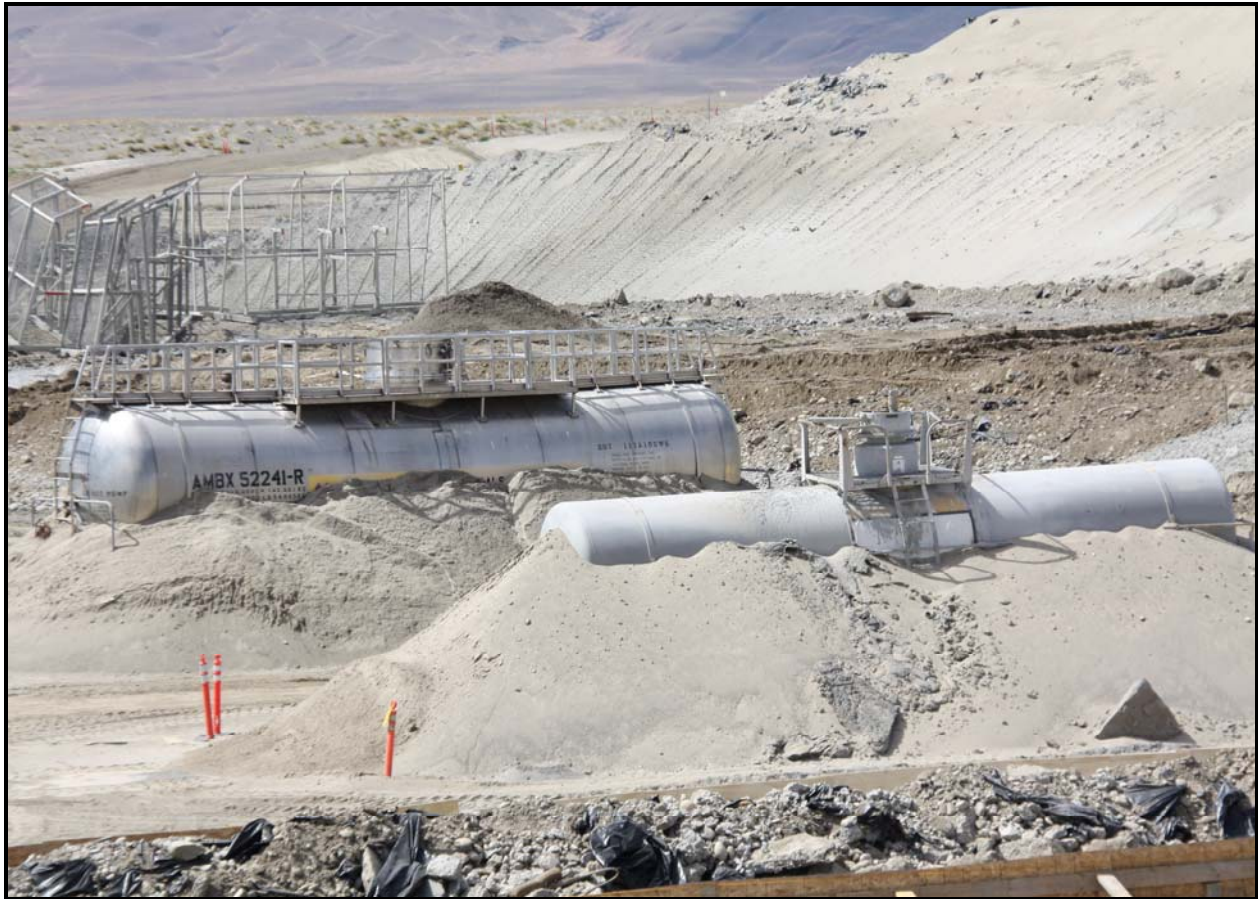
*Two Hanford Site tanks cars are being disposed at the Environmental Restoration Disposal Facility.
(Photo 3)*

ERDF has received the final two Hanford Site railcars from the 212-R rail spur. Nine of the railcars contained lead-lined casks and were used to transport irradiated fuel. The railcars are referred to as well cars because they held water for cooling and shielding. The final two railcars delivered to the facility were tankers. Previously, 58,500 railroad ties from the Hanford Site were disposed at ERDF.

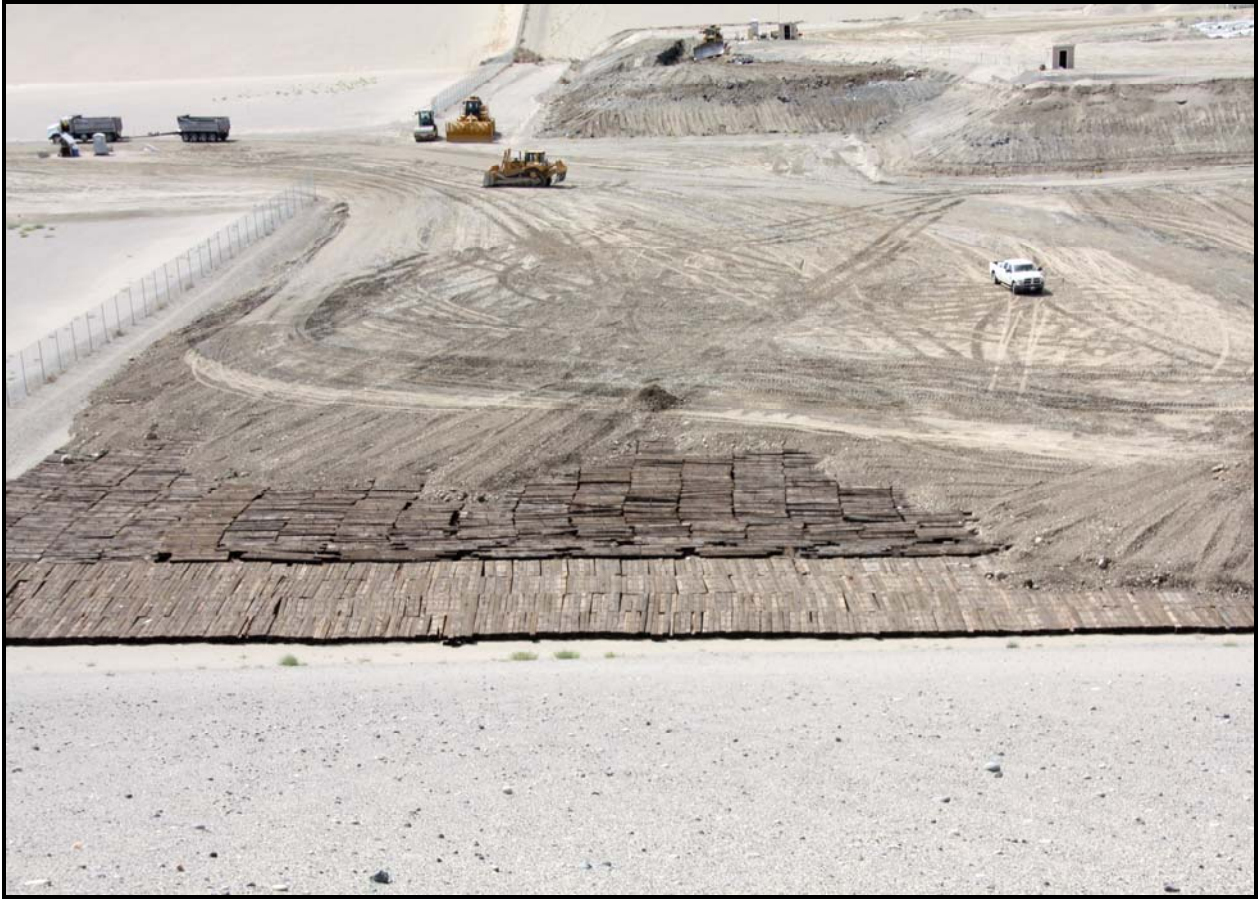
The ERDF disposal team covers nearly 58,500 Hanford Site railroad ties in super cell 9 at the Environmental Restoration Disposal Facility. (Photo 4)

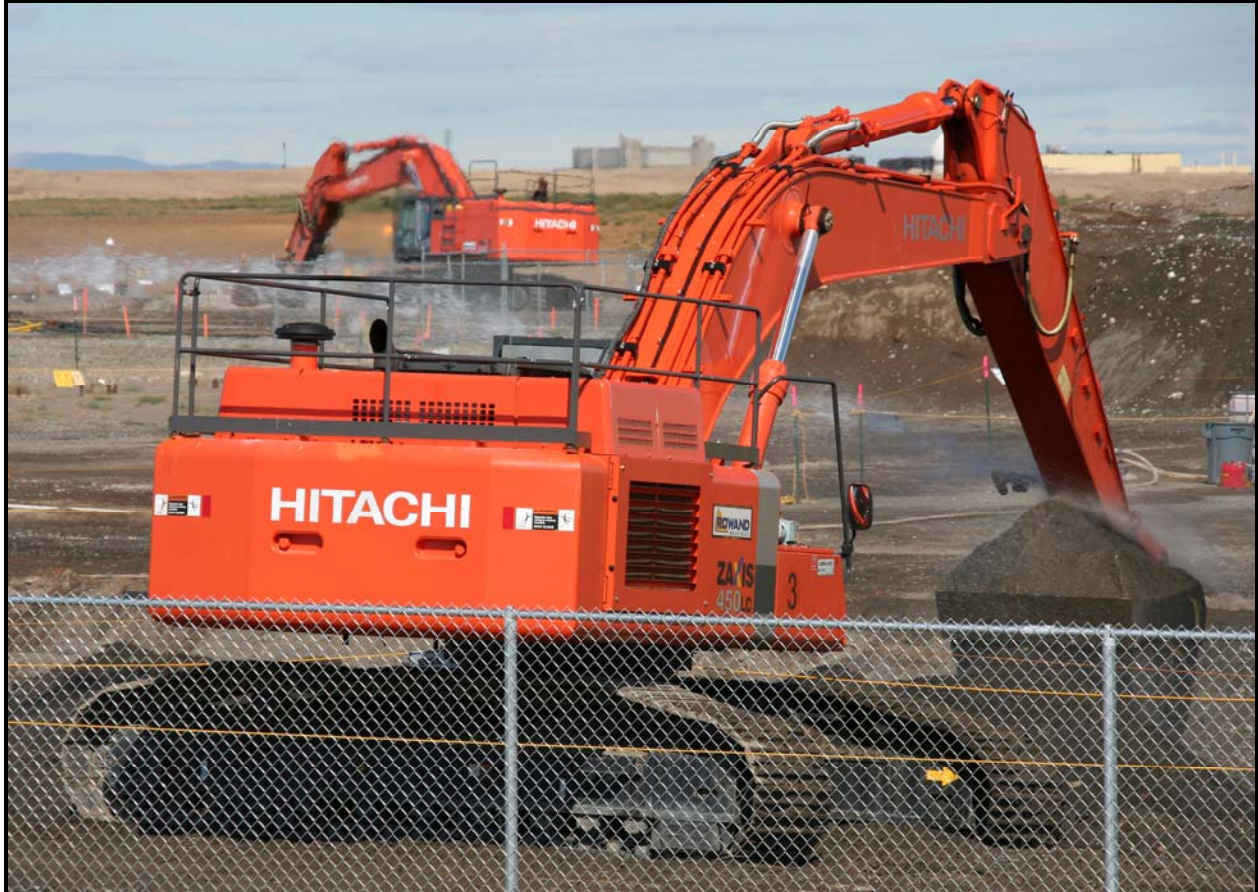
Excavation of the waste trenches continues at the 618-10 Burial Ground. The project team is working in the south trench. (Photo 5)

WCH continued excavation of waste trenches and processing of anomalies (drums and bottles) at the 618-10 Burial Ground. The project team is focusing on the south trench of the site. As of July 20, about 35,179 bank cubic meters have been removed.

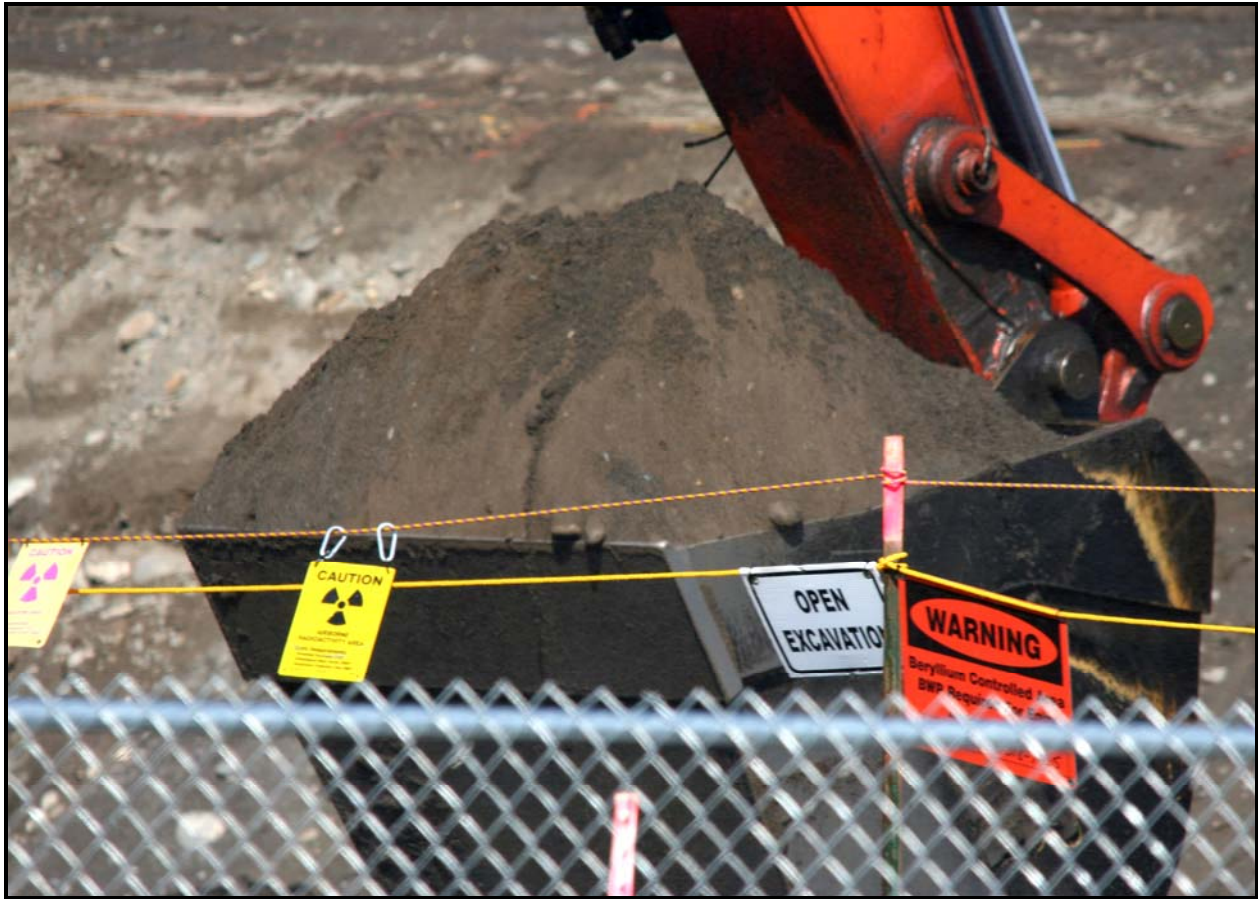
More than 35,000 bank cubic meters have been removed since excavation of the waste trenches began in April. (Photo 6)

The 618-10 Burial Ground operated from 1954 to 1963, receiving low- and high-activity radioactive waste from 300 Area laboratories and fuel development facilities. Low-activity wastes were primarily disposed in 12 trenches, while the moderate- and high-activity wastes were disposed in 94 vertical pipe units (VPUs). The VPUs were constructed by welding five bottomless drums together and buried vertically about 10 feet apart.

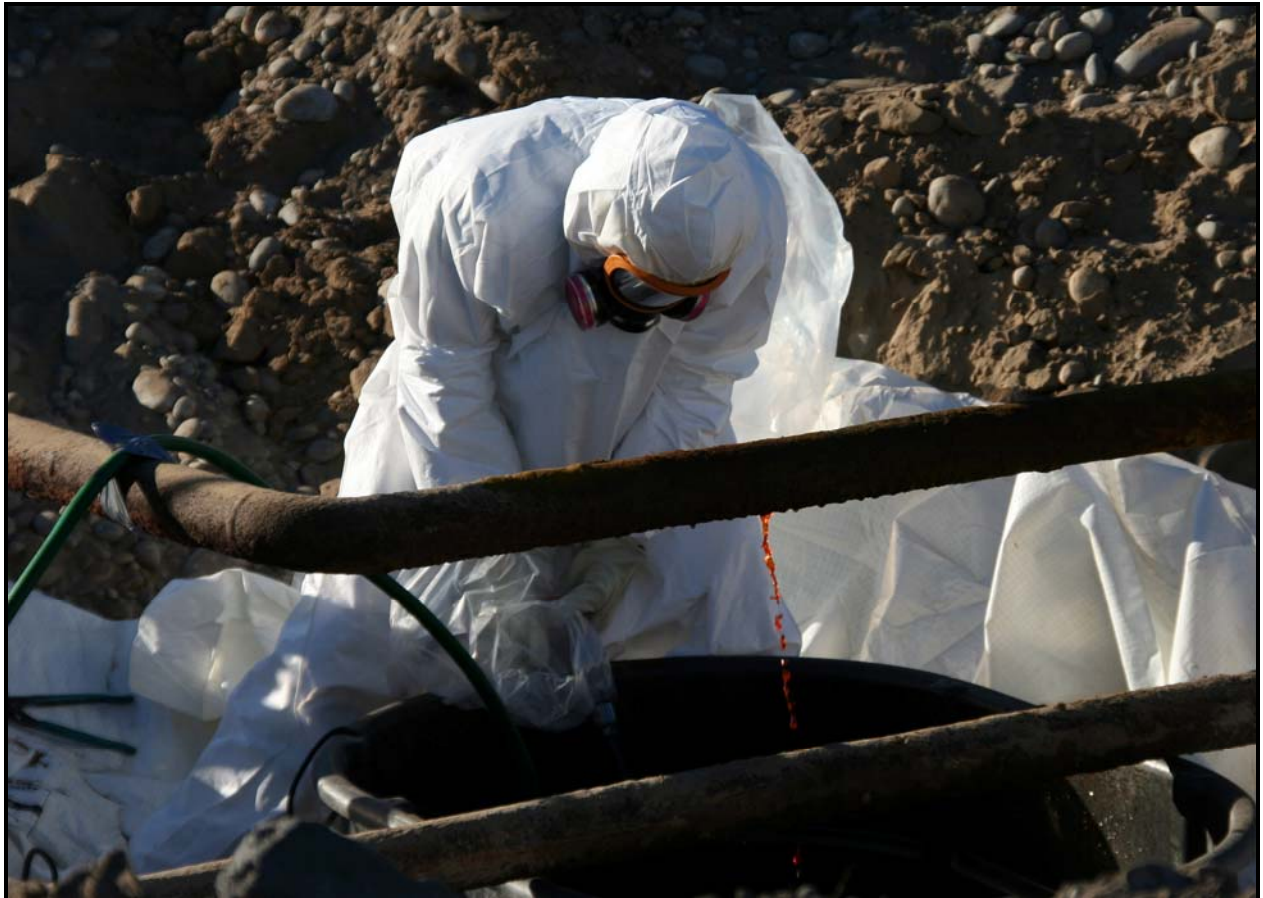
In February, a Washington Closure Hanford subcontractor safely drained sodium dichromate from a pipe at 100-F-26:7. (Photo 8)

In February, the project team completed recovery of approximately 200 gallons of sodium dichromate from pipelines at 100-F-26:7. The safe and efficient removal of the toxic liquid by WCH and its subcontractors prevented potential leaking and groundwater contamination.
