*River Corridor Closure Project*

# **Recovery Act Weekly Report**

For the week ending October 29, 2010

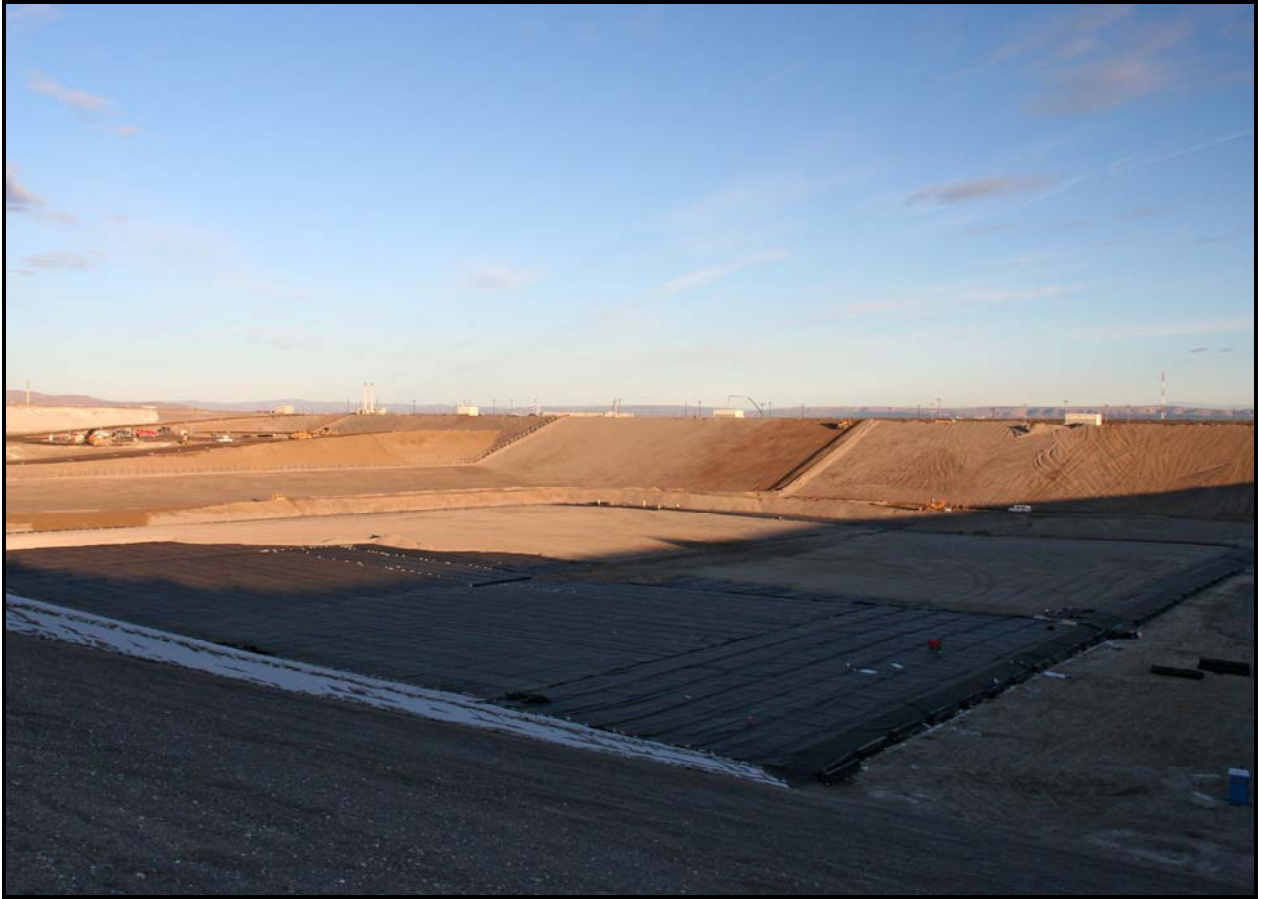
*A view from the southeast corner of the Environmental Restoration Disposal Facility shows liner construction progress in super cells 9 and 10. (Photo 1)*

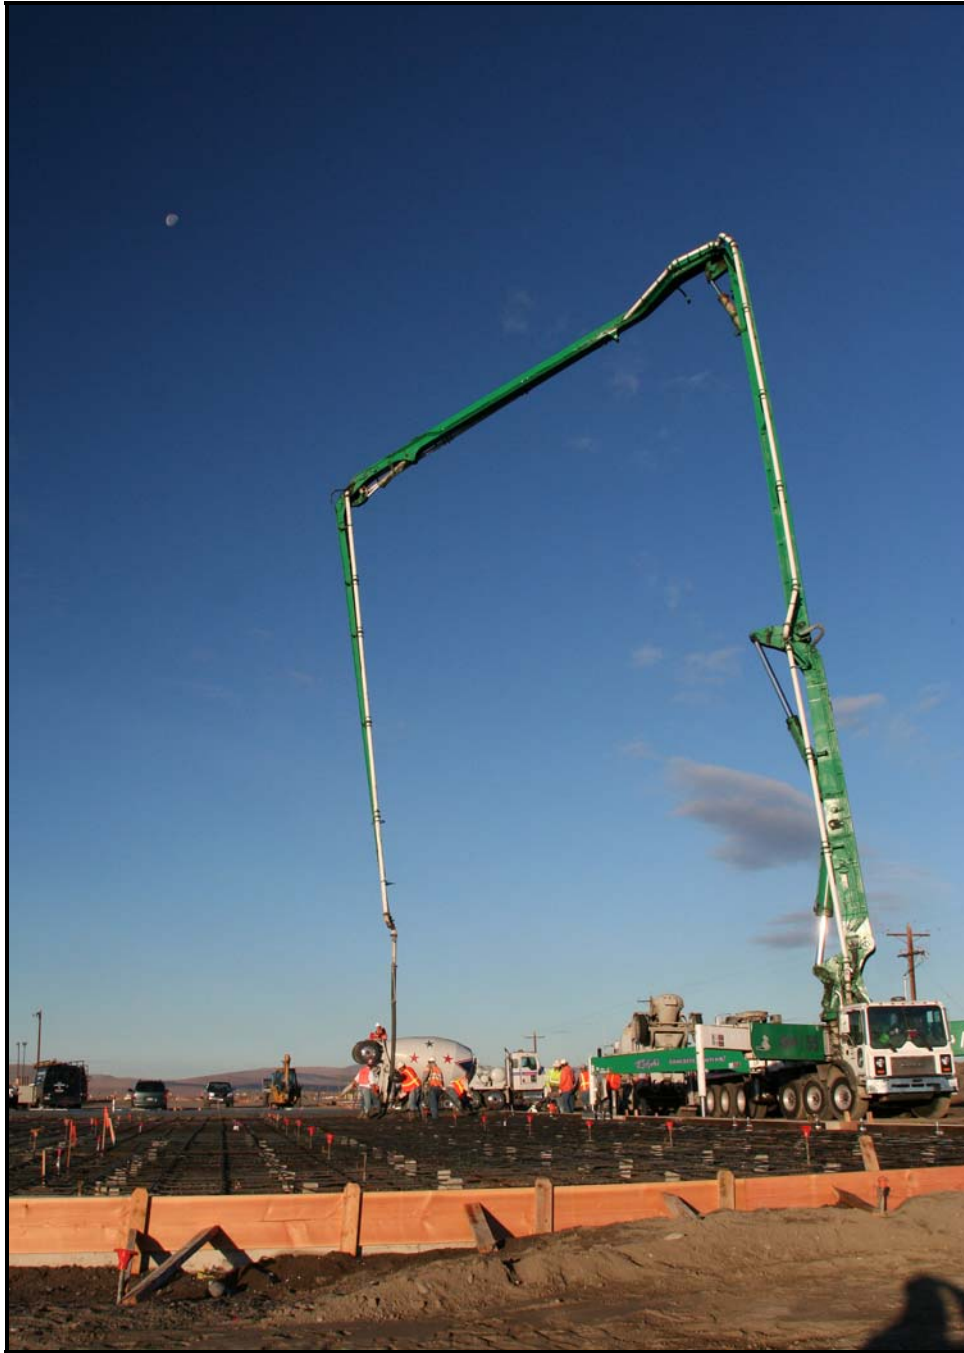
*Workers begin to pour the concrete slab at the Environmental Restoration Disposal Facility's container maintenance facility. (Photo 2)*

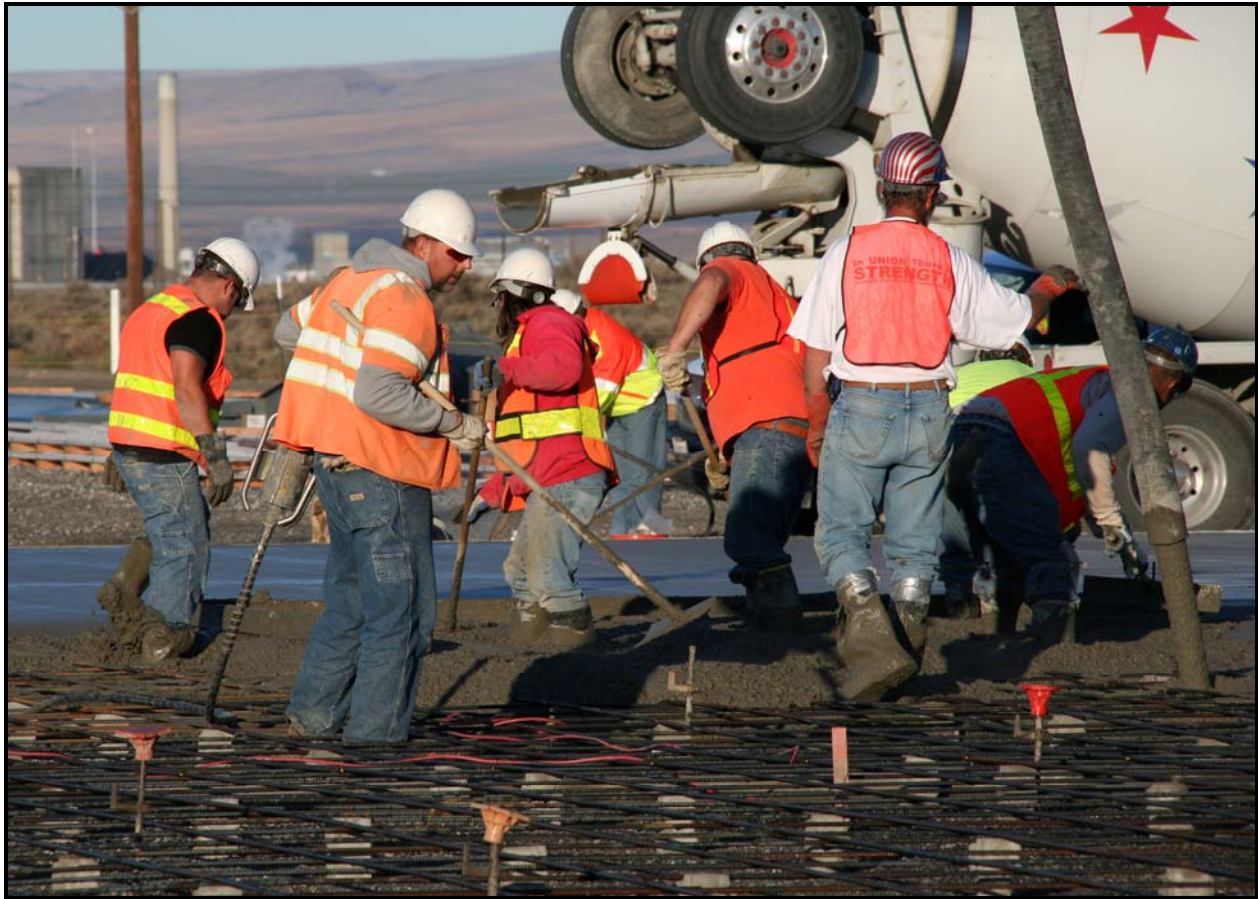
*A team from Washington Closure Hanford subcontractor Fowler General Construction spreads concrete at the container maintenance facility. (Photo 3)*

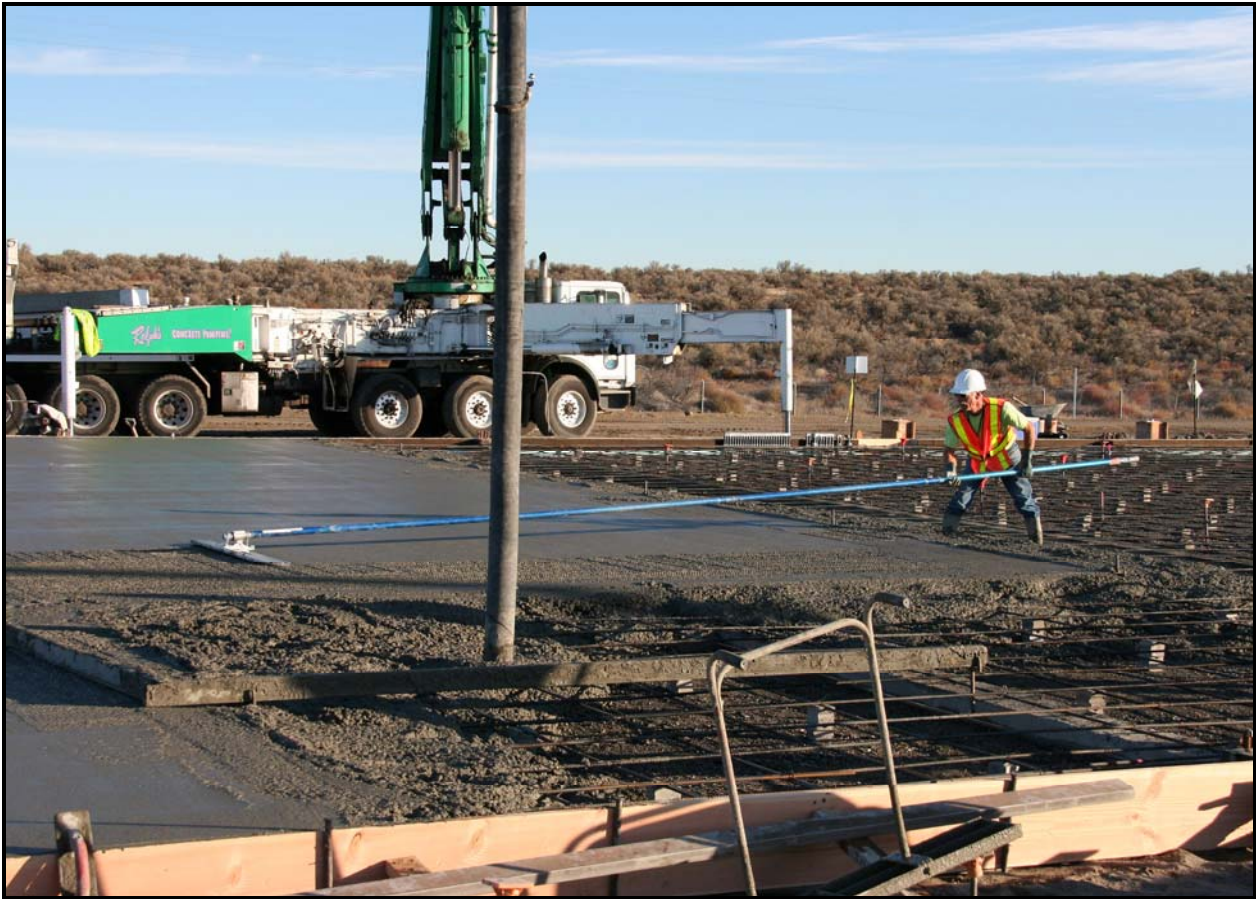
*A Fowler General Construction employee works to smooth recently poured concrete at the container maintenance facility. (Photo 4)*

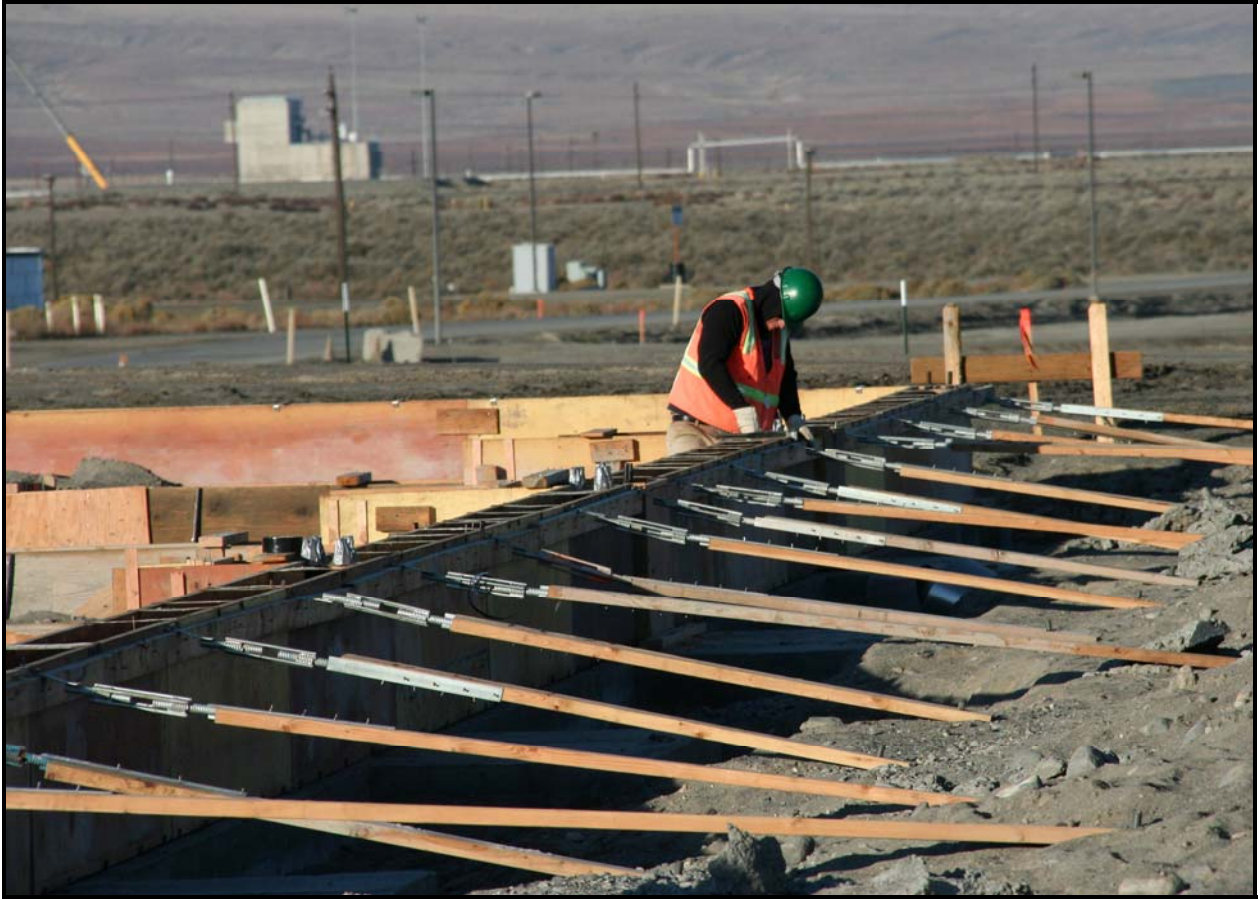
*Fowler General Construction continues to construct the stem walls at the Environmental Restoration Disposal Facility's maintenance facility/operations center. (Photo 5)*

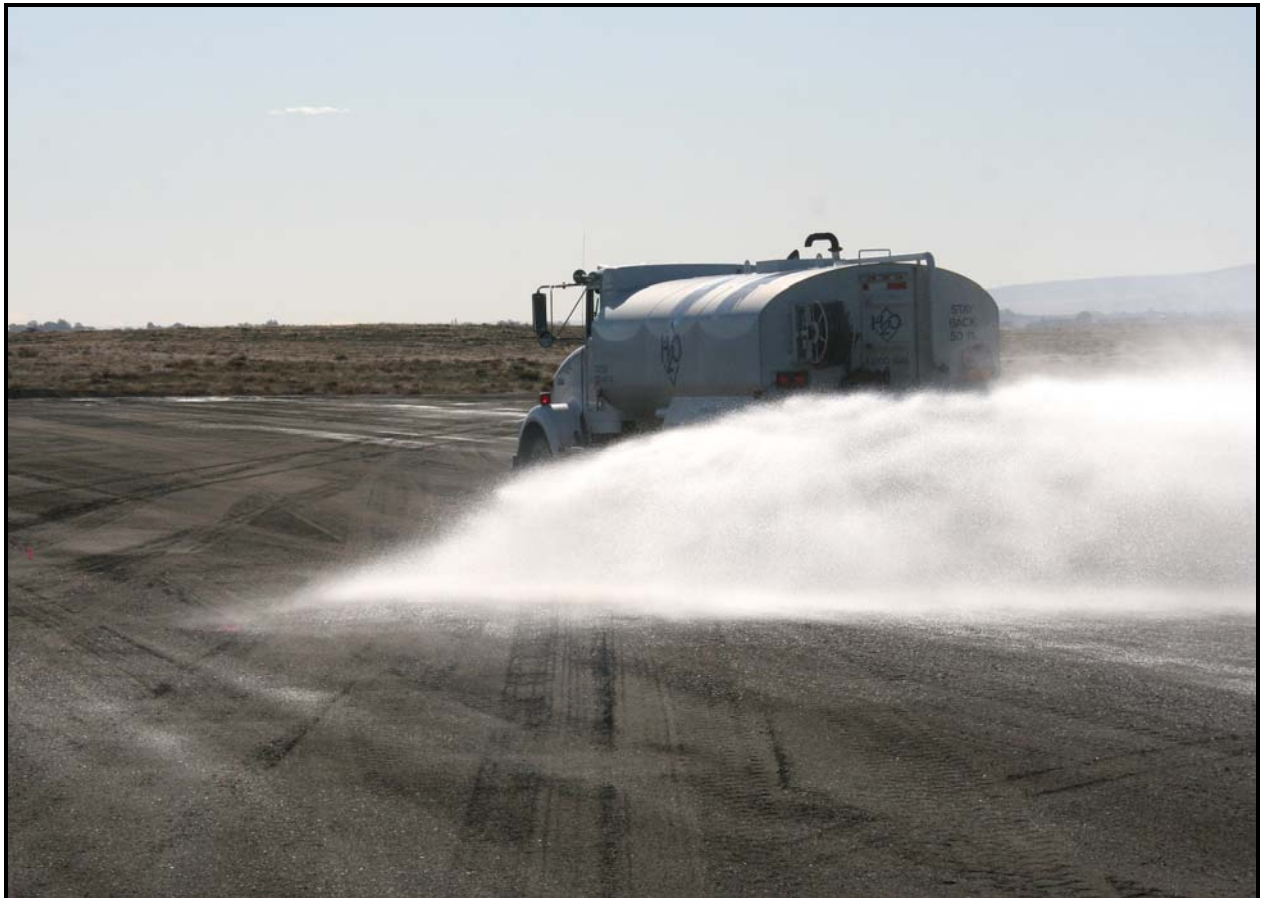
Washington Closure Hanford subcontractor White/Shield Apollo completed construction of the site to be used for office trailers at the 618-10 Burial Ground. (Photo 6)

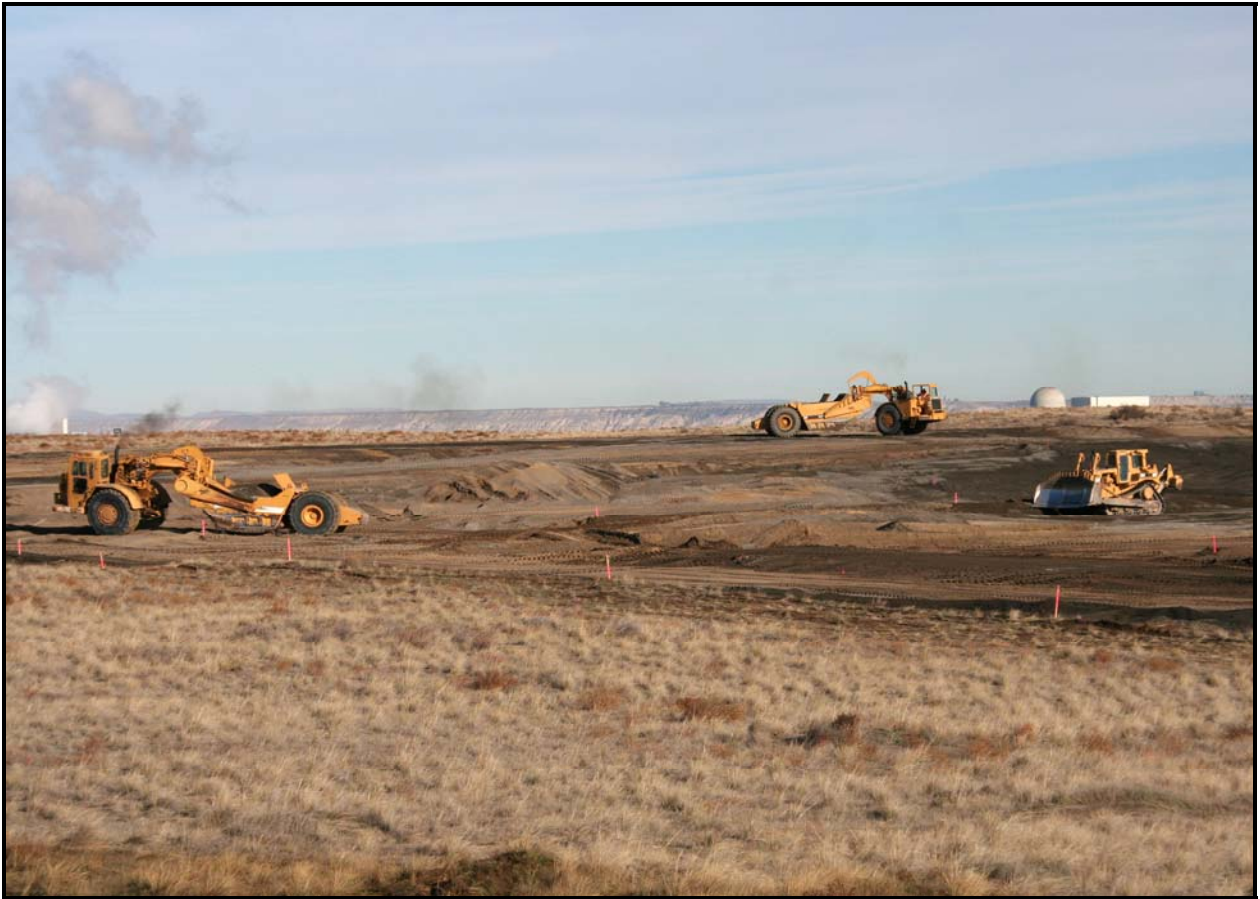
*White/Shield Apollo continues construction of site roads at the 618-10 Burial Ground. (Photo 7)*

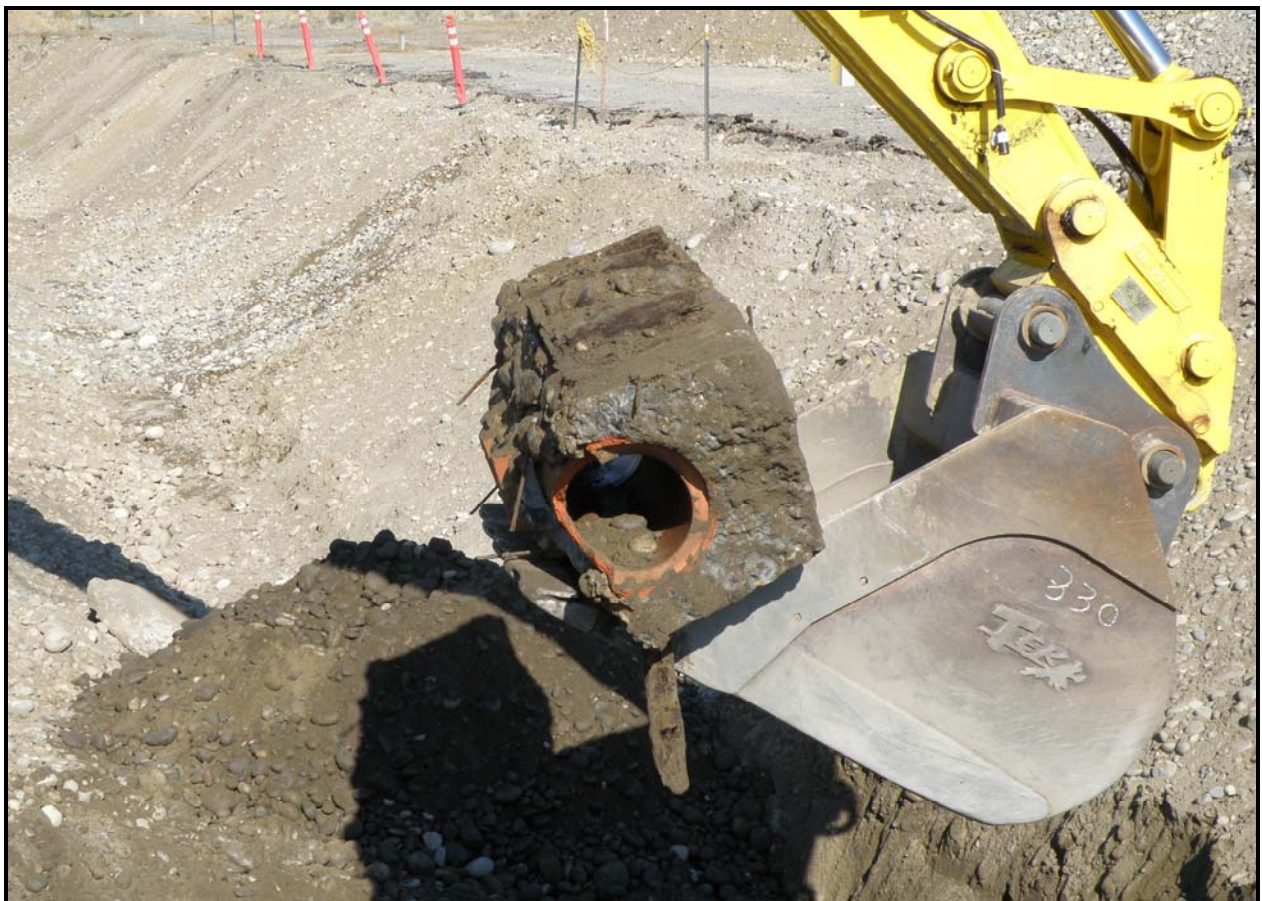
Washington Closure Hanford subcontractor Ojeda Business Ventures removes a section of processed sewer line at 100-F-26:4. (Photo 8)

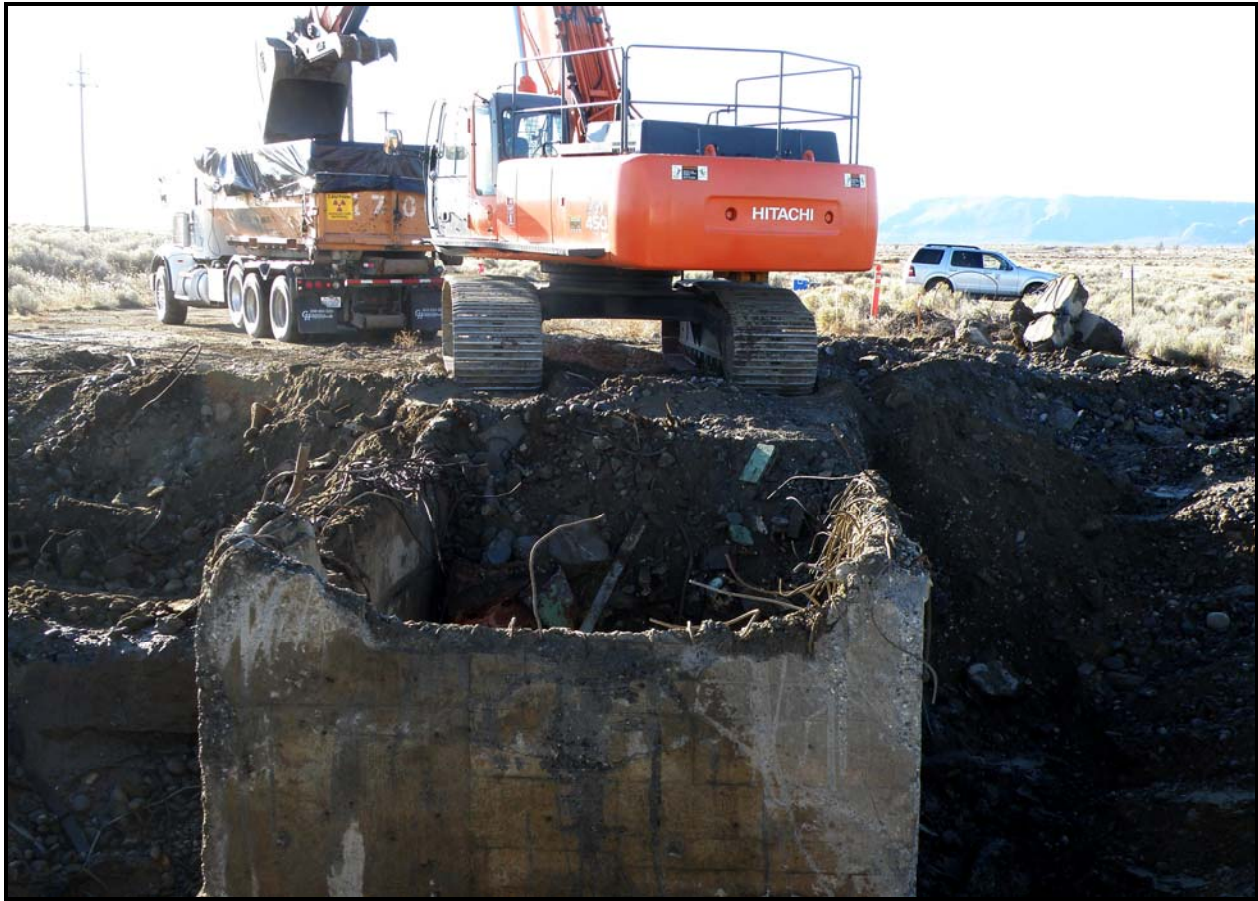
*A transformer pad is exposed during remediation activities at 100-F-47 – an electrical substation foundation. (Photo 9)*
