# Maine Forestry Best Management Practices Use and Effectiveness 2008

Department of Conservation  
Maine Forest Service  
22 State House Station  
Augusta, Maine 04333  
Forest Policy and Management Division

**August 2009**

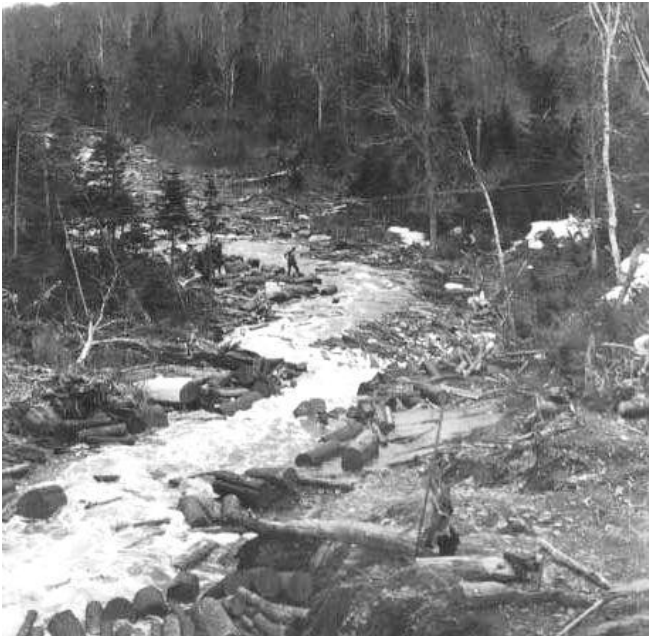
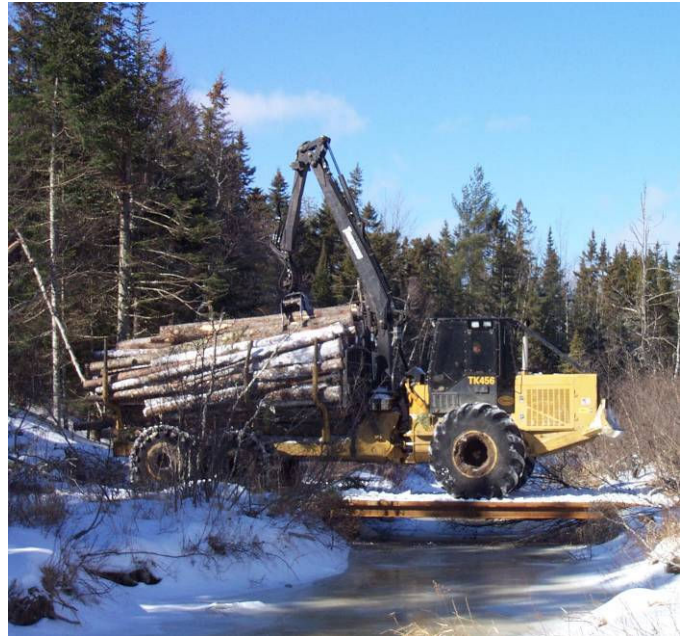
*Then and now. As recently as the 1970’s little consideration was given to protecting water quality on timber harvests as the highly eroded banks in the log drive photo on the left illustrates. In contrast, today there is a general acceptance of BMPs by the forestry and logging professions. Sights like forwarders being used to minimize ground disturbance and temporary bridges to protect the integrity of stream channels indicate how far BMPs have come.*

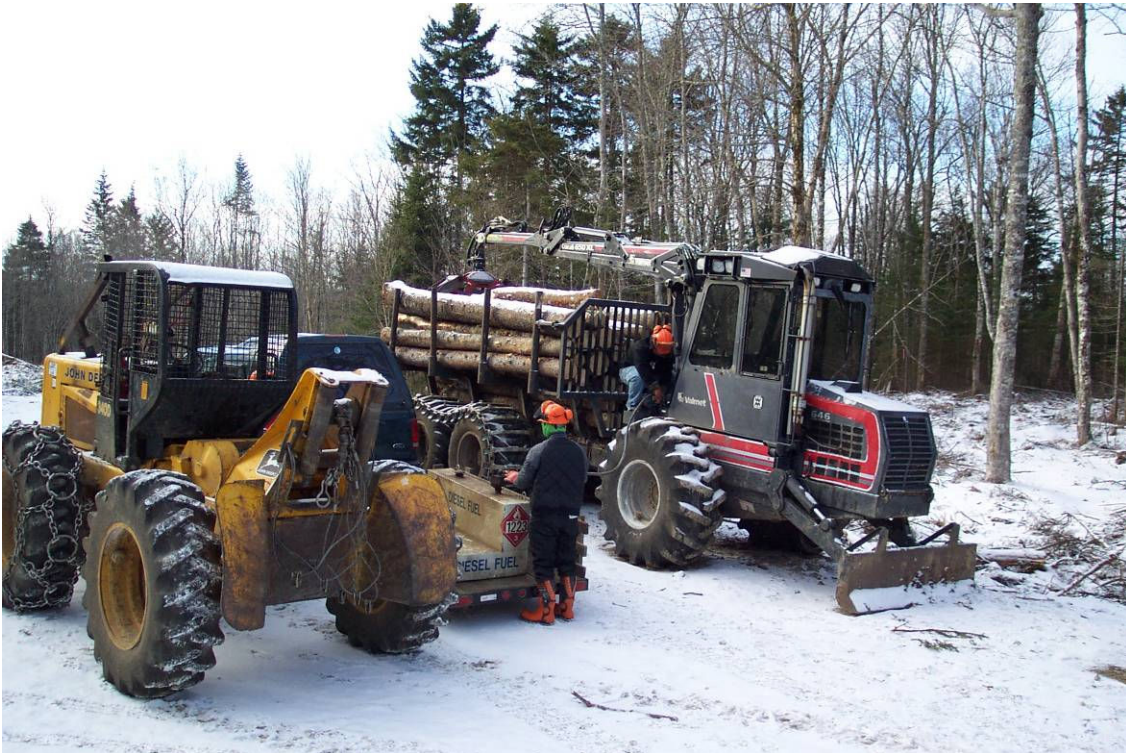
*When used properly carried wood systems (e.g. the forwarder seen on the right) can result in less soil disturbance vs. dragged wood systems (e.g. the cable skidder seen on the left). Regardless of the type of system used, operator skill and training are critical to good results.*

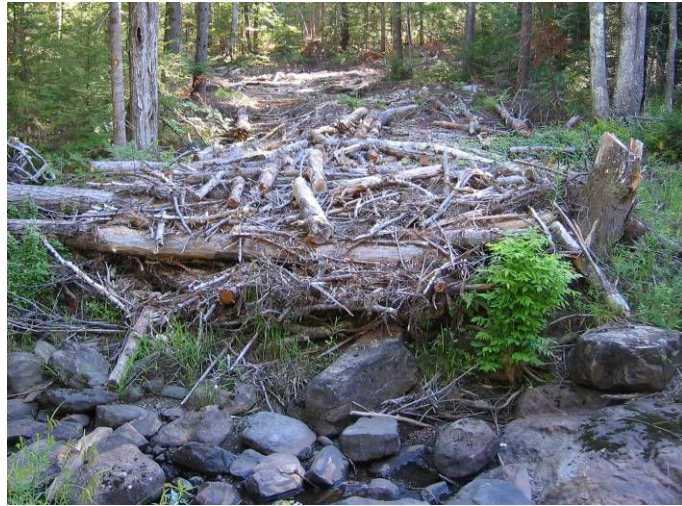
*Well designed temporary crossings can be very cost effective and minimize disturbance to the waterbody. Pictured is the same crossing during use and after removal. Note that slash has been left on the approach to the crossing to stabilize any exposed soil. No sediment was deposited below the bankfull elevation of the channel.*

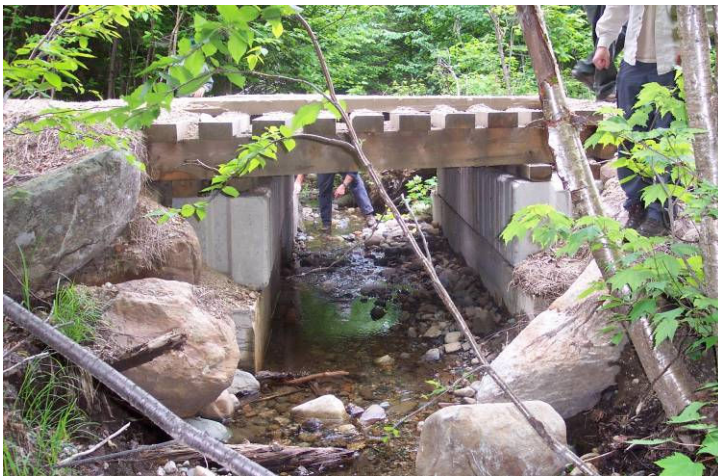
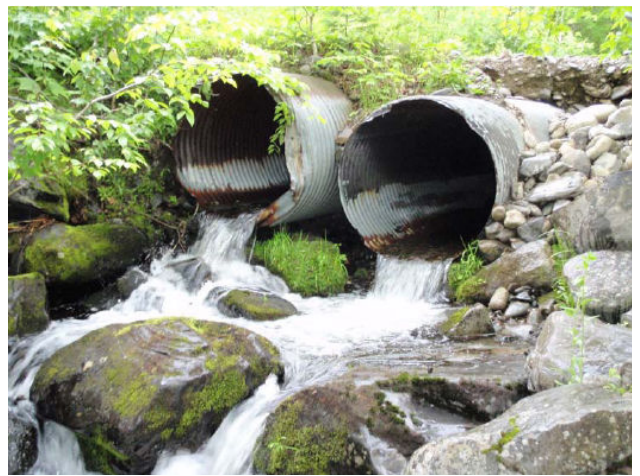
*Crossing structures that are open to the natural stream bottom allow for fish passage. Closed bottom structures that do not span the stream channel or are improperly installed can become perched, making it difficult for fish to move upstream.*

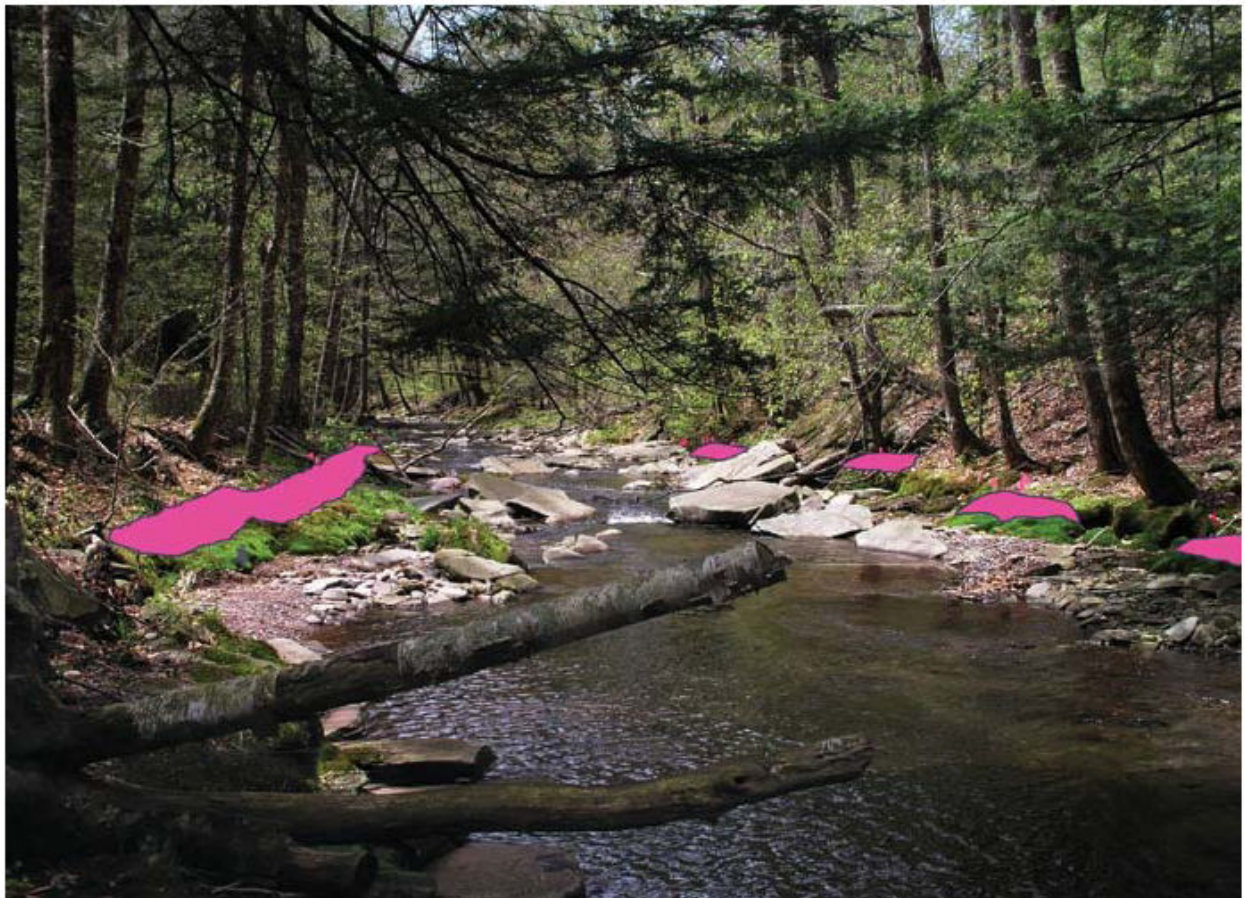
Bankfull width is the channel width from the bankfull elevation on the one side of the channel to the bankfull elevation on the other side of the channel.

**Figure 19** Bankfull indicators visible at low flow. The bankfull elevation is indicated by the first depositional flat above the channel. On very confined channels, the bankfull elevation may only be evident as the discontinuous flat depositional areas shaded on the photo.
