# FORESTRY BEST MANAGEMENT PRACTICES IN MARYLAND: Implementation and Effectiveness for Protection of Water Resources

Maryland Department of Natural Resources Forest Service

April 2009

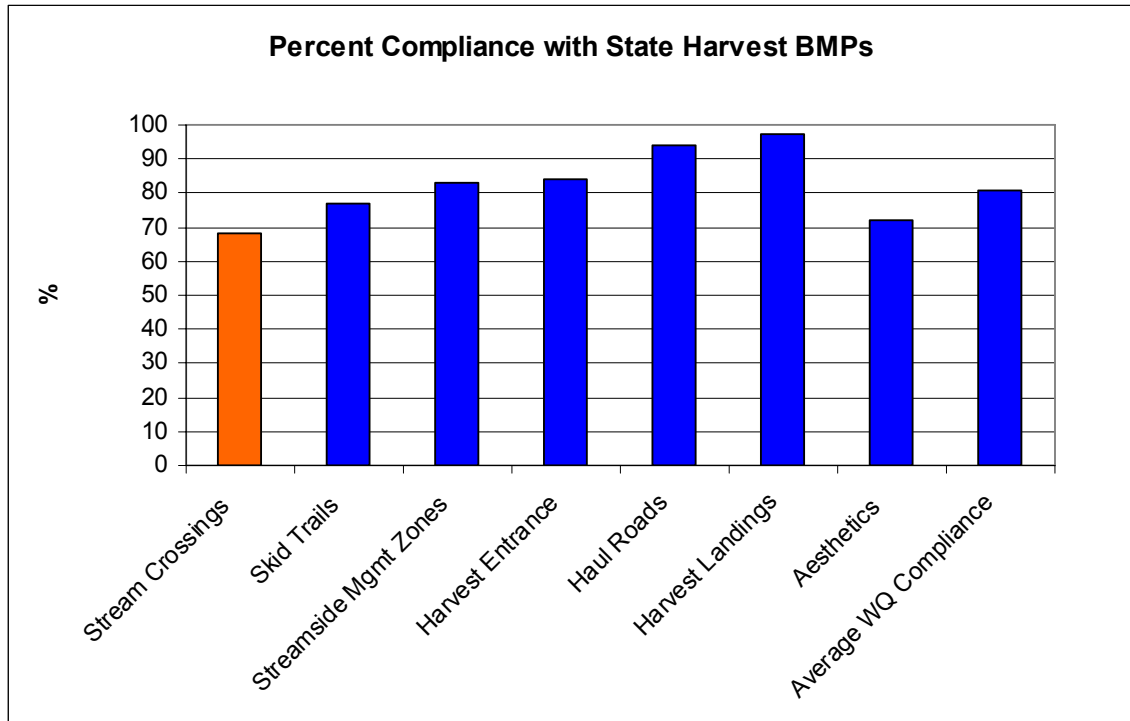
Figure 7: Percent compliance with Maryland Harvest BMPs, 2003-2004 (n=39)

The average compliance with harvesting BMPs in Maryland for 2003 to 2004 was 81%, focusing on harvest sites with water features and the greatest likelihood for water quality impacts (Figure 7). This rate is similar to the overall 82% harvest BMP compliance in Maryland found by Koehn and Grizzel (1995). Harvest landings had the highest compliance, located properly away from streams, on low slopes, and being kept free of trash. Haul roads consistently met slope restrictions, avoided rutting, and were located away from stream buffers; the greatest room for improvement lay in roads that needed more cross-drainage (16% of sites sampled). For harvest entrances, there was little evidence of road damage or mud tracked onto public roads, but improvements could have been made on cross-drainage at the entrance (32% of sites) and better stabilization at the entrance (23% of sites).

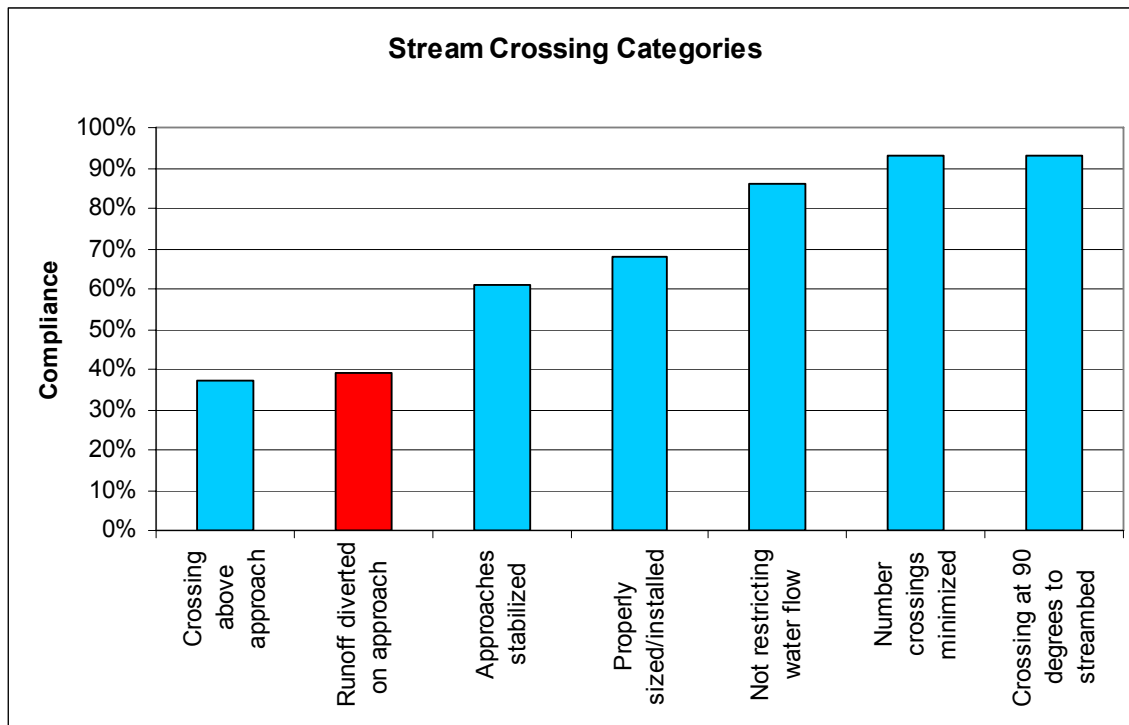
Figure 10: Compliance categories and rates with Stream Crossing BMPs in Maryland, 2003-2004

Stream crossings are the most difficult area for BMP compliance in Maryland, similar to the situation in most states. Many of the basic BMPs like minimizing stream crossings and installing crossings at right angles to streams were consistently implemented (Figure 10). More improvements were needed on properly sizing crossing structures such as culverts, stabilizing approaches, and diverting runoff prior to approaches to the stream. These could be focus areas for future BMP trainings and the Master Logger Program.

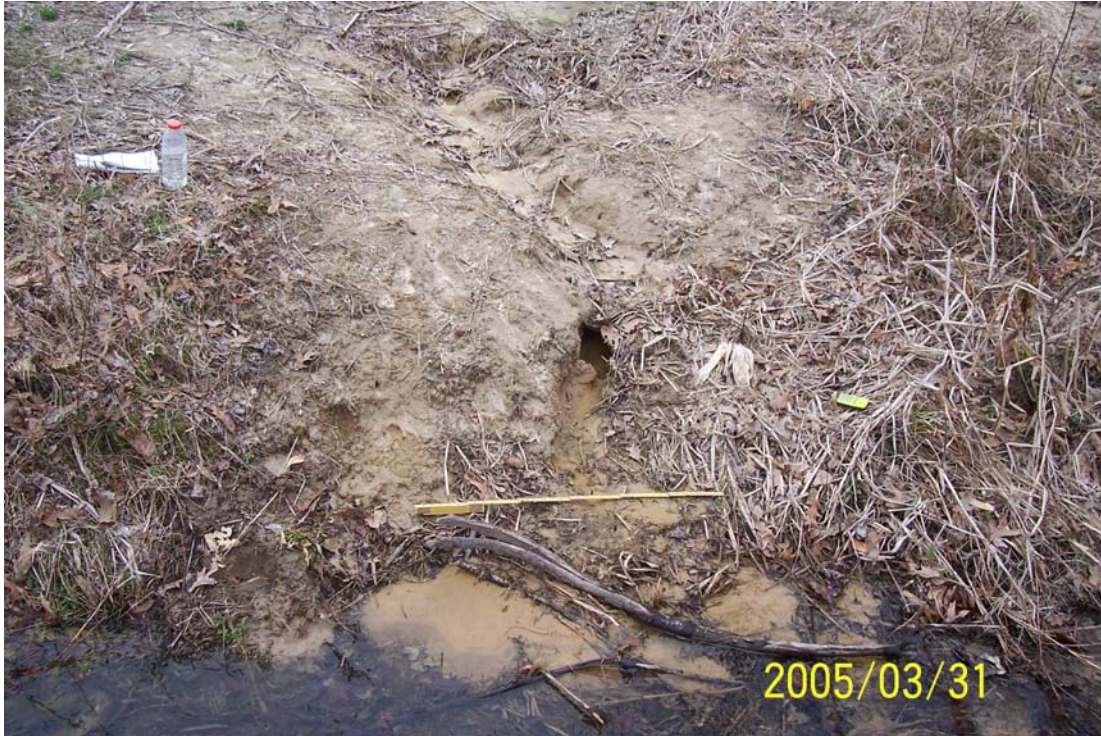
Sediment is the most common pollutant associated with forest harvests, and most erosion usually is associated with forest roads, (Aust and Blinn, 2004). In the NA BMP Protocol, there are five opportunities to observe the occurrence of soil movement, soil sedimentation, or stabilization for each sample unit. They are on the harvest roads or skid trails at Approach A outside the buffer, Approach A inside the buffer, the crossing structure, Approach B inside the buffer, and Approach B outside the buffer. The protocol uses estimates of eroded and deposited soil to quantify sediment, and includes observations of sediment films as trace sediment. Proportions in this section are based on the total number of opportunities to make observations about soil conditions. For the 75 sample units, there are 375 opportunities to observe soil conditions.

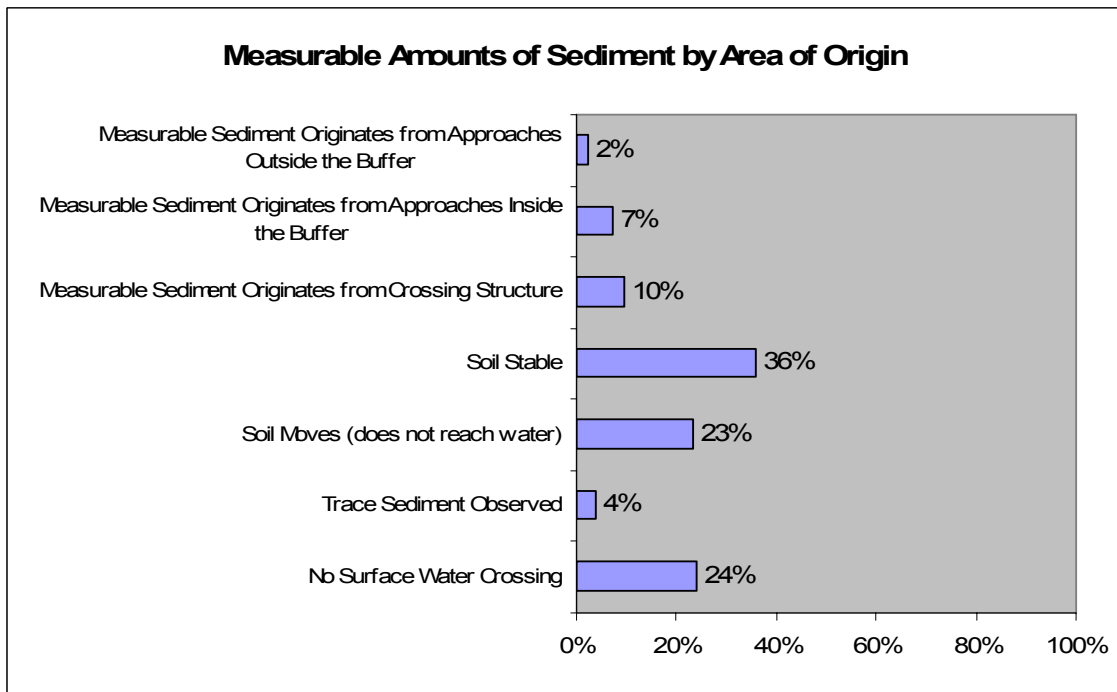
Figure 15: Sources of measurable sediment only on Maryland harvests (n=375).

Looking only at the measurable sources of sediment, the crossing structure again had the greatest likelihood of contributing measurable sediment (Figure 14). This is a typical outcome since there is usually little opportunity for sediment to be trapped elsewhere before entering the stream. The next greatest contributor of sediment was the approaches inside the buffer, again closer to the stream with less opportunity for being trapped and settling out before reaching a water body.

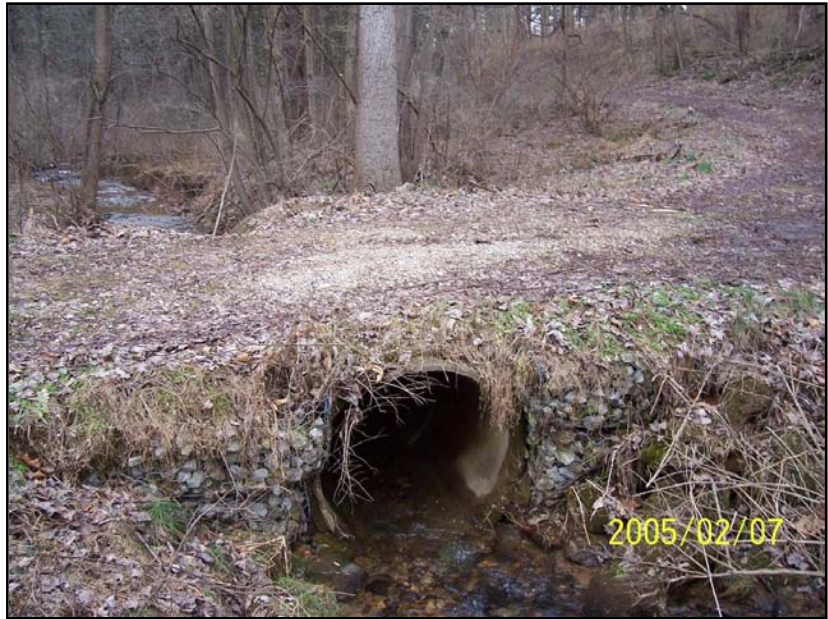
Figure 18: Sediment movement observed at crossing structures (n=75)

At crossings, sediment usually reached the water body or depositing within the bankfull channel in measurable quantities, observed at 57 locations at all types of crossings (Figure 18). The 7 observations of trace amounts of sediment were associated only with fords and culverts. Culverts were most commonly used on haul roads, while temporary crossings were most common for skid trails crossing streams (Figure 19).

Crossing structures were the most frequent contributor of sediment, since this area is within the stream cross-section. Although most harvests avoided stream crossings, when stream crossings had to be made, sedimentation was frequently seen (Figure 18). The protocol allows comparison of different types of stream crossings, whether it is associated with haul road or skid trail, and stream sizes. Crossing types are not uniformly represented, so results based on a small sample size should not be extrapolated broadly.

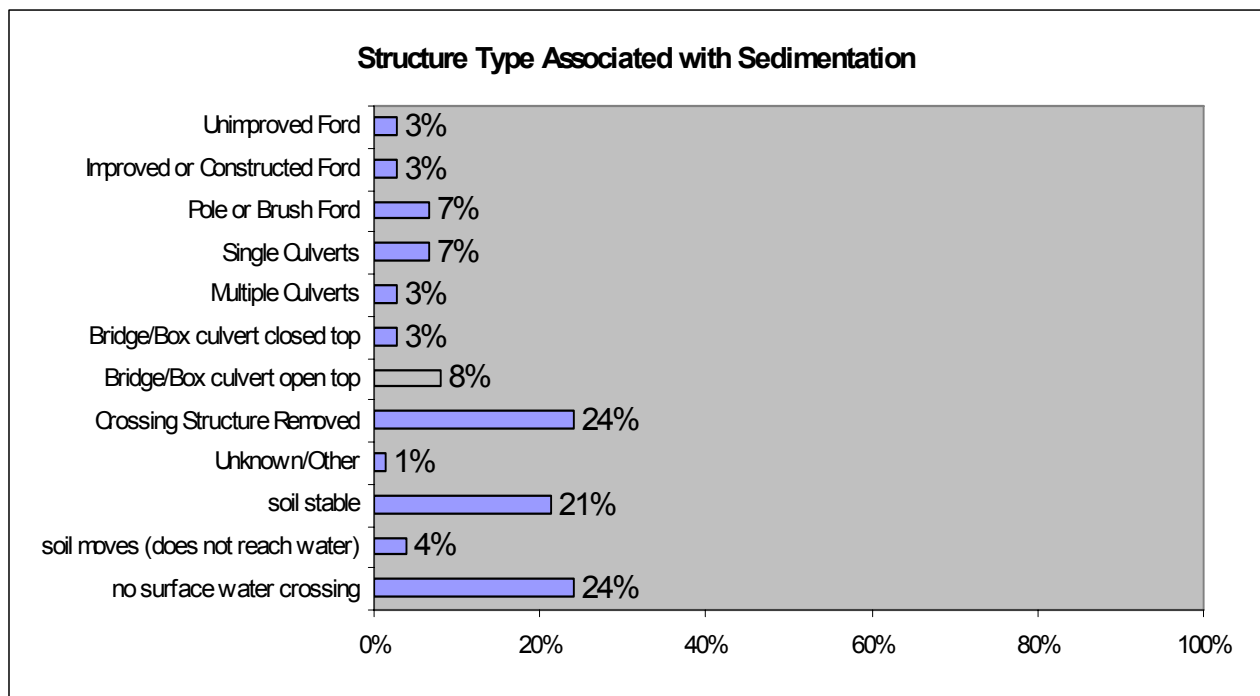
Figure 20: Observations of measurable and trace sediment at stream crossings by crossing type (n=75)

No crossing structure type is immune from sediment entry (Figure 20). Temporary crossings had the greatest number of observations of delivered sediment (24%), but also represented over 50% of the crossings (Figure 19), so it is not disproportionate to the level of use. Most instances where sediment was delivered were attributed to improper installation or closeout (Figure 21). Given the frequency of use of temporary crossings and potential of any crossing to contribute sediment, some additional guidance on how to leave banks in a more stable condition following removal of a temporary crossing structure might be useful in BMP training.

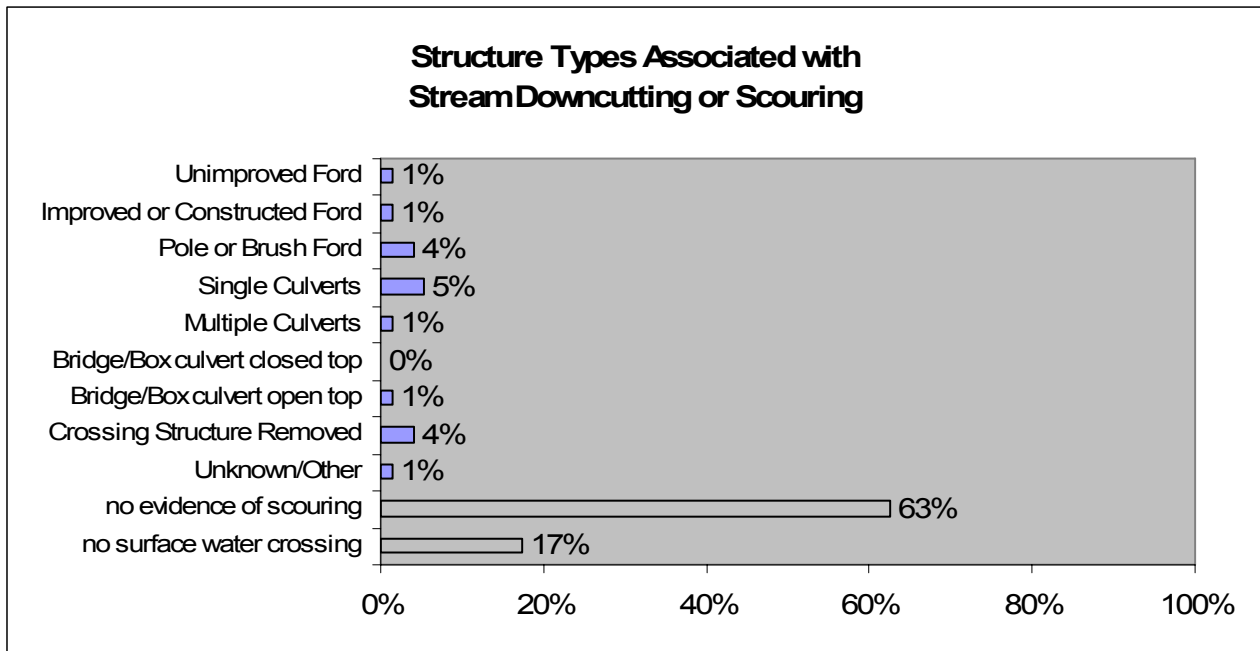
Figure 25: Stream crossing structure types associated with stream downcutting or scouring (n=75)

There are 15 observations of stream downcutting or scouring within 100 feet of the outlet end of the structure, but 47 sample units show no evidence of stream downcutting or scouring (Figure 25). Although removed crossing structures were most frequently used, especially on skid trails, the practice was not strongly associated with scouring. Culverts and other closed-bottom structures have greater potential to cause scouring, but rates of association with scouring seemed proportional to use for culverts and fords. Bridges had proportionately less scouring than either single or multiple culverts.

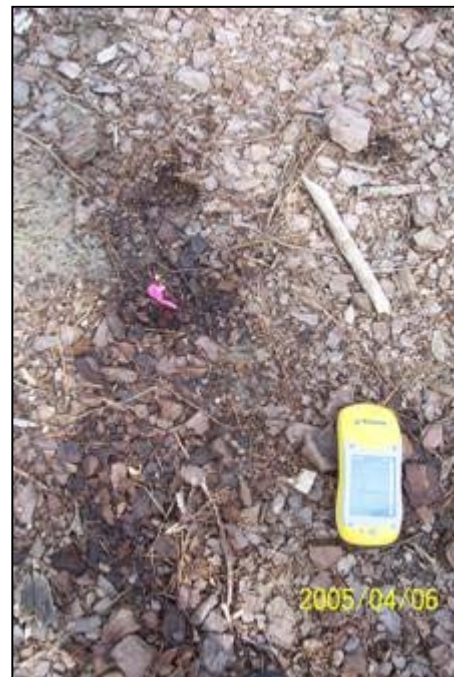
Figure 34: Evidence of Chemicals or other Pollutant Spills (n=75)

Of the 75 sample units, 3 sample units had evidence of lubricant, fuel, hydraulic fluid and/or anti-freeze spillage resulting from harvest operations. 89% of sites had no evidence of any chemical pollution or trash. No stains greater than 10 sq. ft. were seen (Figure 34).

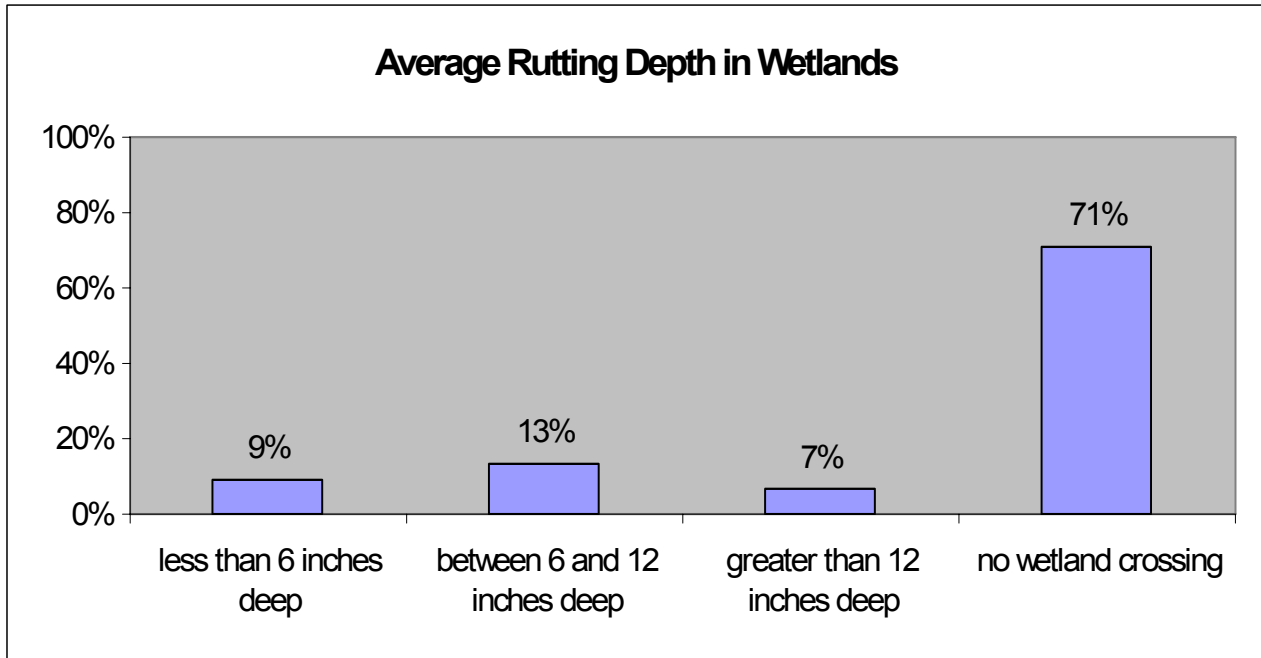
Figure 37: Average rutting depth for harvest operations crossing wetlands (n=75)

Operations in wetlands are supposed to avoid creating ruts more than 6 inches deep. Although most operations avoided wetlands, 2/3 of the operations in wetlands created ruts that were not repaired before leaving the site (Figure 37). Sediment movement was also commonly noted, but mostly occurred in very small amounts (Figure 38).
