# Office of River Protection

HANFORD SITE

#### **Tank AY-102 Status**

September 7, 2012

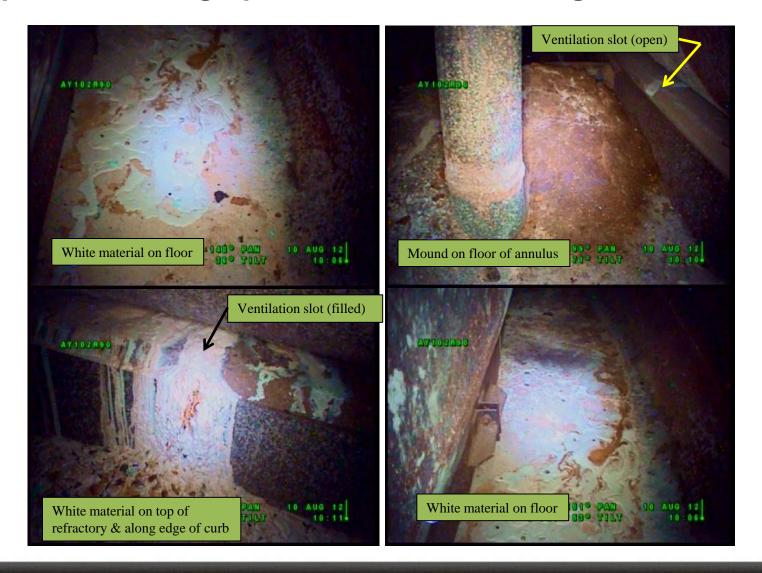
#### Inspection Photographs from Riser 90 - August 10, 2012

- Material found in three locations (risers 83 & 90) source unknown
  - Dark brown mound (approximately 2 ft. x 3 ft. x 8 inches) riser 90
  - White material on both the refractory (tank sits on refractory) and annulus floor riser 90
  - Unknown material adjacent to ring riser 83
- Material is dry (i.e., no standing water or indications of moisture)
- Leak Detection and Continuous Air Monitor (CAM) operable in annulus (real time monitoring)
- Camera equipment removed from annulus without incident (i.e., no contamination on equipment)
- Contamination present when annulus floor sample was taken from riser 90

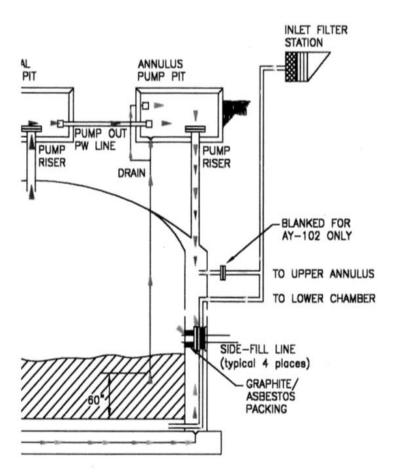
- Double-Shell Tank (DST) AY-102 built in 1970 and placed into service in 1971 as an aging waste spare tank and received waste in 1977
- Annulus ventilation used to remove tank residual heat
- Liner provides secondary containment of waste
- Primary waste types are B Plant evaporated waste and Sludge from single-shell tank (SST) C-106 Sluicing
- No other Hanford waste tank closely approximates this composition of sludge
  - High H<sub>2</sub> Generation
  - Sludge contains solution low in Nitrate, Nitrite,
     and pH < 12</li>
  - High heat generation
- Current volume 857,000 gallons of sludge and supernatant
- No unexplained primary tank level changes
