INITIAL ASSESSMENT STUDY OF
MARINE CORPS BASE CAMP LEJEUNE
NORTH CAROLINA

NEESA 13-011

INITIAL ASSESSMENT STUDY
OF MARINE CORPS BASE CAMP LEJEUNE, NORTH CAROLINA
UIC-M67001

Prepared by:
WATER AND AIR RESEARCH, INC.
Gainesville, Florida

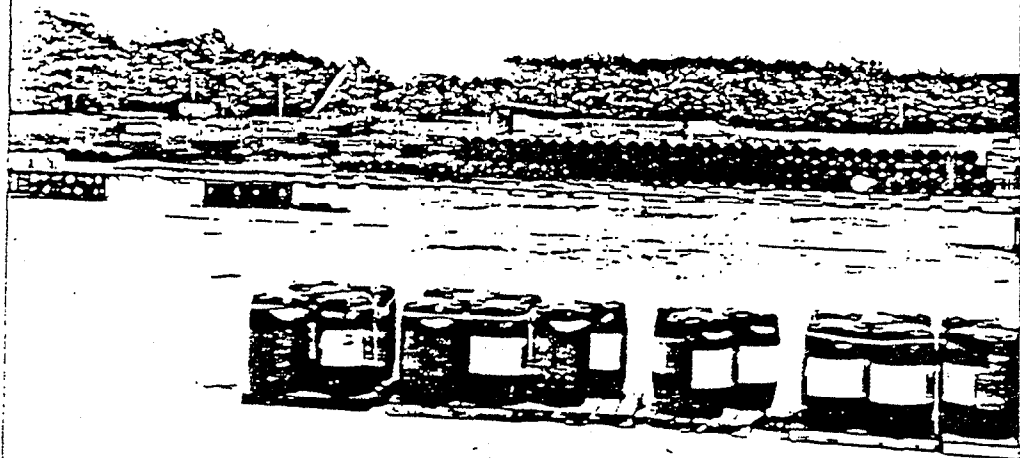
FIGURE 6-8a
Site No. 6 - Storage Lots 201-203

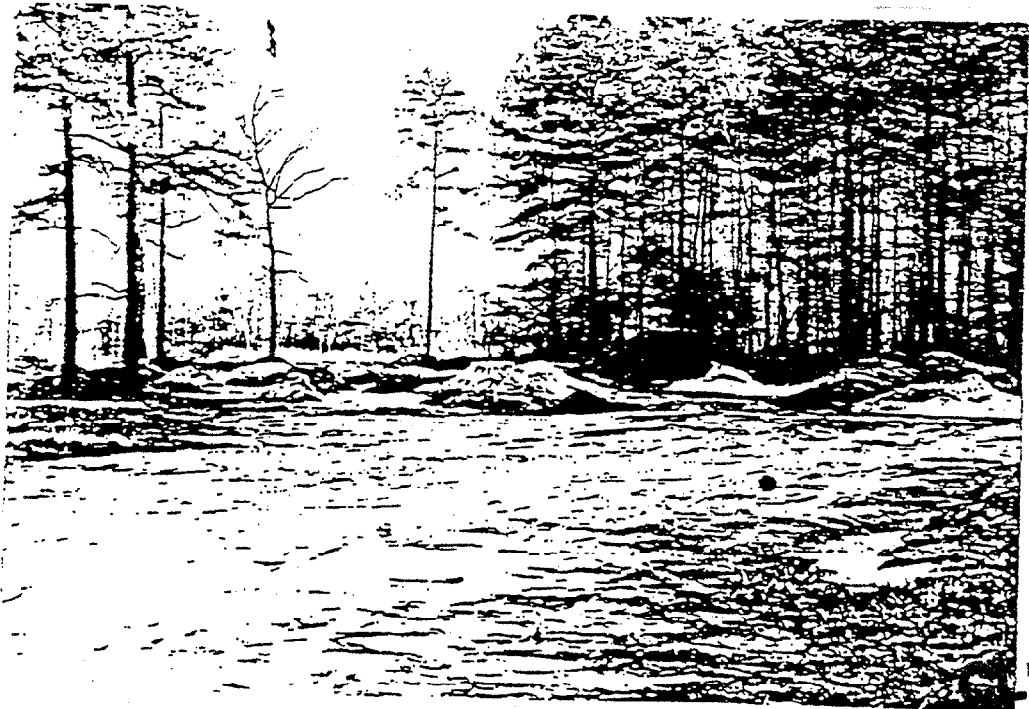
FIGURE 6-13b
Site No. 24 - Industrial Area Fly Ash Dump 000000842

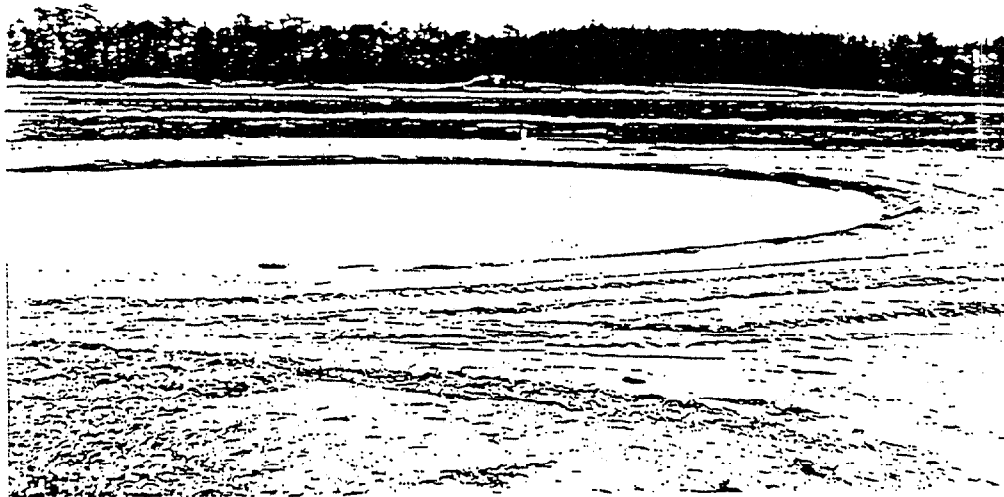
FIGURE 6-28
Site No. 54 - Crash Crew Fire Training Burn Pit

2.4.16 Site No. 54: Crash Crew Fire Training Burn Pit. This site (PWDM coordinates 23, O24-25/P24-25) is an area off Runway 5-23 that has been used since the 1950s for crash crew training with various POL compounds. Originally, training was on the ground surface with the area surrounded by a berm. Later, a pit was used, which was eventually lined. The area is about 1.5 acres. Based on present annual POL usage of 15,000 gallons, nearly one-half million gallons of these compounds have been used at this site. Most of the POL was burned, but as many as 3,000 to 4,000 gallons may have soaked into the soil.
