# Runaway Train

## Introduction

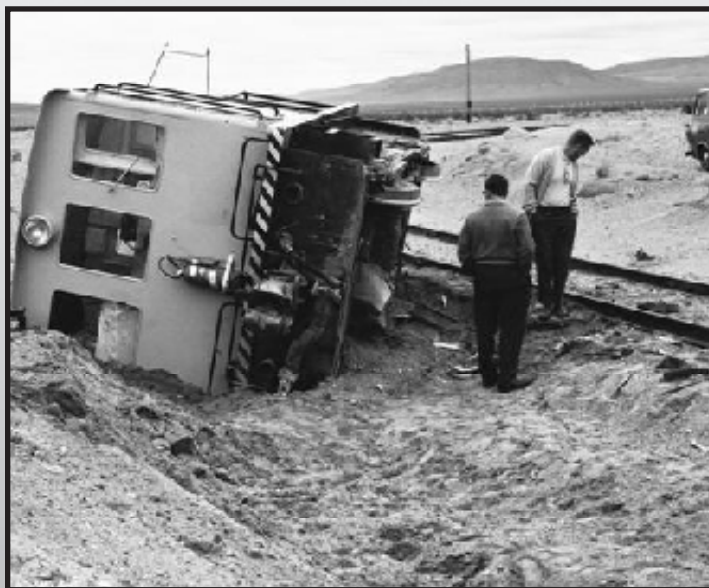
*The derailed locomotive lies 180 degrees from its direction of travel as investigators inspect the site.*

Careful examination of the runaway train's wheels found that all four wheels had flat spots on one side as a result of brake locking.

Approximately 200 feet of track required replacement but the two casks exhibited only superficial external damage, leading one investigator to state "All in all, this looks more like a test of railroad track than of shipping casks."

The final investigation report concluded that the accident was caused by too great a load for the locomotive. Grease and moisture on the tracks, lack of sanding equipment on the locomotive, and no brakes on the flatcar were all contributing factors to the wreck.

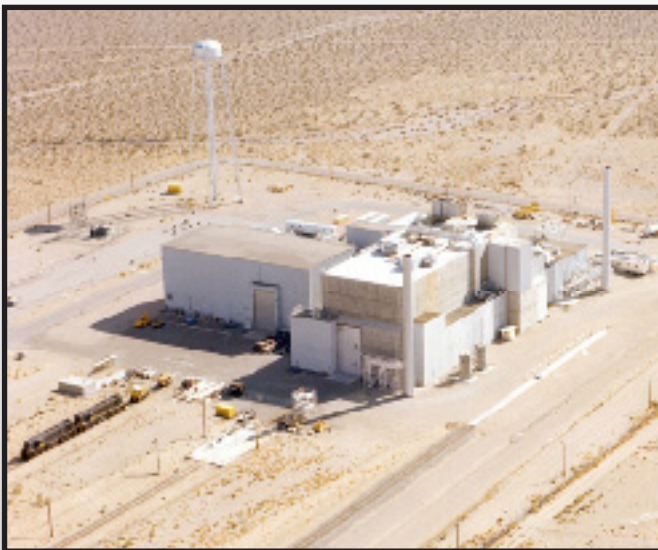
*The Jackass & Western Railroad (lower left) at the Engine-Maintenance Assembly Disassembly facility.*
