**U.S. Army Corps
of Engineers**
Alaska District

Economic Analysis for City of Dillingham Shoreline Emergency Bank Stabilization

Dillingham, Alaska

June 2009

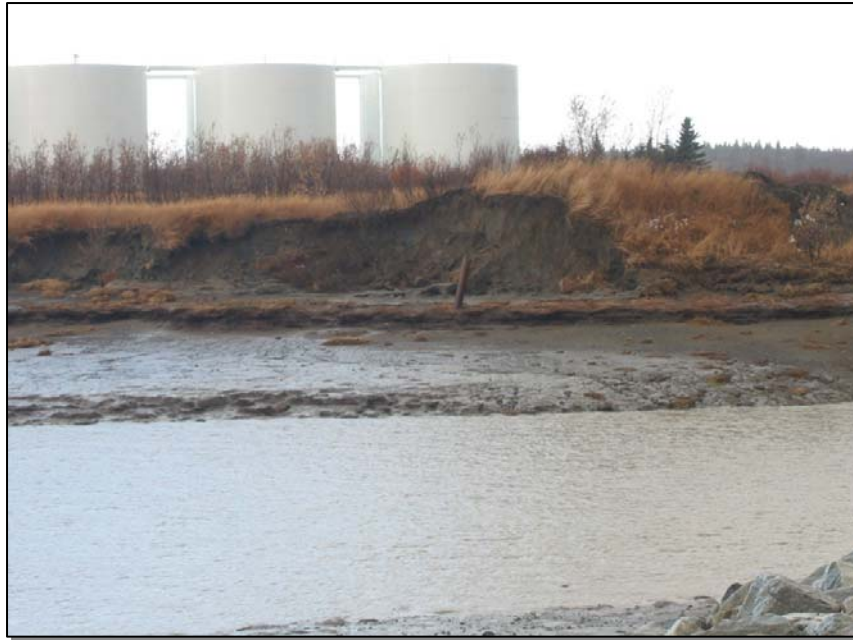
Figure 5: Erosion/Land Loss, West End Erosion Zone 1

<i>ZONE 1</i>		
Linear Feet of Landward Bank Erosion:		316
	Lost Acreage:	4.5
	Value of Lost Acreage:	\$124,800
<i>ZONE 2</i>		
Linear Feet of Landward Bank Erosion:		40
	Lost Acreage:	0.4
	Value of Lost Acreage:	\$11,600
<i>ZONE 3</i>		
Linear Feet of Landward Bank Erosion:		40
	Lost Acreage:	0.8
	Value of Lost Acreage:	\$21,600
<i>TOTAL ZONES 1-3</i>		
Linear Feet of Landward Bank Erosion:		396
	Lost Acreage:	5.7
	Value of Lost Acreage:	\$157,900

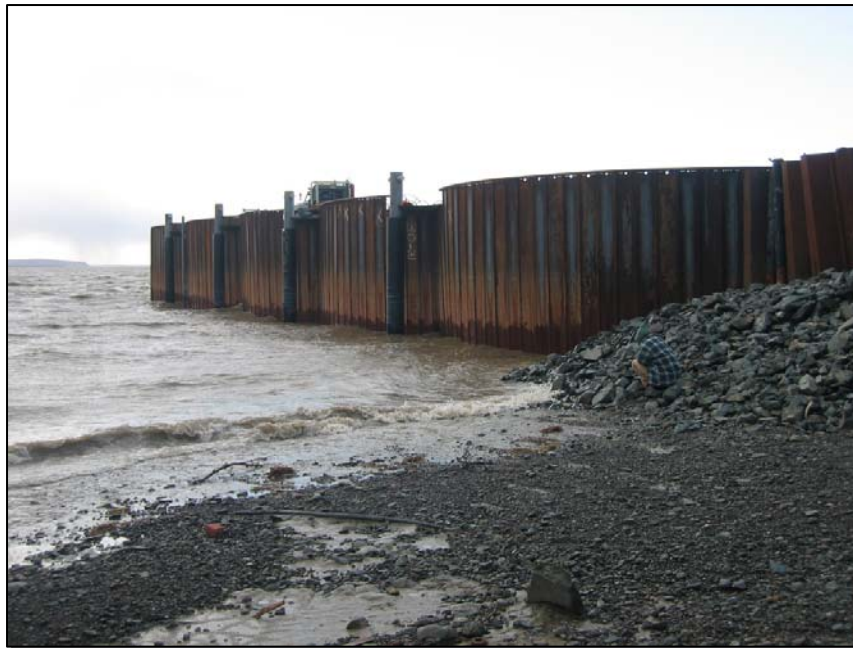
Figure 6: Dillingham Fuel Tank Farm Dock Protection

Bristol Alliance Fuels (BAF) owns the land to the west of the harbor and also owns the fuel tanks that presently hold the fuel supply for the City of Dillingham (shown in **Figure 6**). The fuel farm is the largest fuel facility in the Bristol Bay area. BAF also supplies fuel to surrounding communities when the need arises (in recent years to Aleknagik, Manokotak, Clarks Point, and Koliganek) and to snowmachiners and boat operators in the region. BAF stores fuel for Crowley Marine barges (formerly Yukon Fuels) so that Crowley can avoid sending large barges upriver

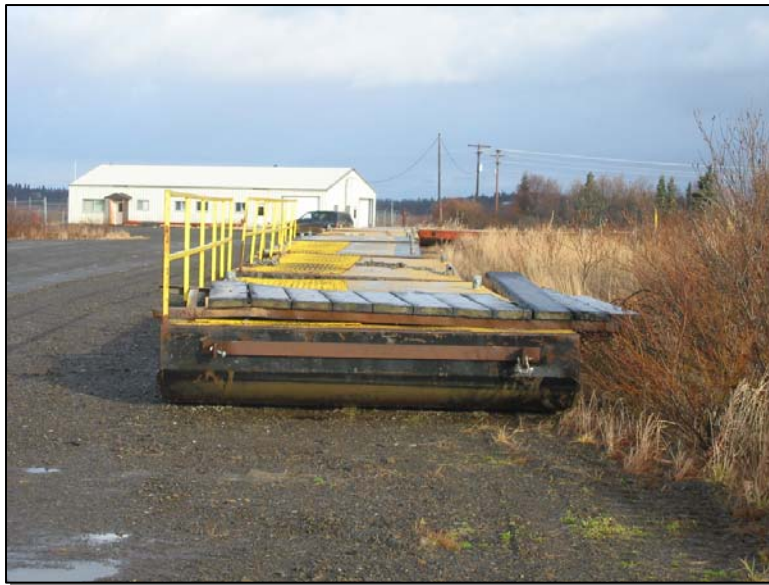
Figure 7: Dillingham Harbor Float Modules (on shore for winter) – West End study area

The Dillingham Harbor moorage float system is made up of three float systems, one each at the north, south, and east sides of the harbor. Each of the systems is comprised of multiple modular floats which are connected and secured to the shore with driven swing arm piles. The float system is comprised of 34 floats 30' in length that provide 1,020' of moorage space for Dillingham Harbor users on a first-come first-served basis. Photos of the floats and swing arms are included as **Figures 8** and **9**, respectively.

Wave action in the harbor as a result of erosion at the harbor entrance results in excessive banging of vessels against one another and the floats. As a result, the floats require annual maintenance and repair for damages in excess of normal wear and tear. Dillingham harbor staff report the increased damage to floats attributable to erosion necessitates repairs to three harbor

floats every three years. Replacement of harbor floats is estimated at \$31,600 every 30 years. Estimated annual repair costs of harbor floats in excess of normal wear and tear is \$3,900 annually. Costs associated with repair of the floats includes planning, project management, supervision and administrative costs; equipment and labor for loading, transport, and offloading of floats to repair shop; and labor and equipment for repairs. Additionally, the Dillingham Department of Public Works estimates that erosion results in a reduction in the useful life of the moorage floats from 30 to 20 years. It is expected that the 34 existing floats will require replacement in 2010 at a cost of \$1,072,700. The advanced replacement cost of the floats is addressed in **Section 4.2.2.1** of this report.

The estimated annual cost of additional float repairs due to erosion identified in **Section 3.2.1.3** for existing conditions is expected to continue over the period of analysis. This expected annual value for additional float repairs is estimated at approximately \$3,900 as reported by Harbormaster and Dillingham Public Works Department.

As identified in **Section 3.2.1.3**, the cost for float replacement is \$1,072,700 (\$31,551 per float x 34 floats). Under without-project conditions it is expected that the float system would need to be replaced every 20 years. Under more typical wave conditions the float system would be expected to last 30 years. Under without-project conditions, the floats are expected to be replaced in 2010, 2030, and 2050. Under normal conditions with a 30-year float life, replacement would be required in 2020 and 2050.

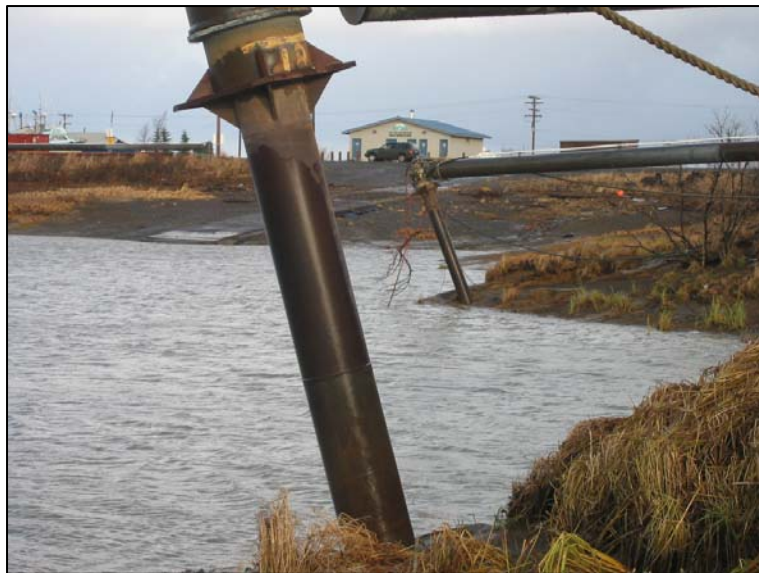
**Figure 9: Damaged Swing Arms on East Bank of Dillingham Harbor
West End study area**

Damages to the harbor's moorage float swing arms are occurring as a result of harbor erosion. Three swing arms need to be reset approximately every 20 years as a result of this activity. As shown in **Figure 9**, the swing arms on the eastern bank of the harbor are listing westward and require pulling and resetting the arms landward. The photo shows two of the three damaged swing arms in the harbor. These were repaired in 2005. The existing swing arms were manufactured in 1985 with a life expectancy of 40 years. As a result the existing swing arms will need replacement in 2025. An estimated total damage cost of \$36,000 is expected 20 years after replacement for the three swing arms. This cost includes planning, project management, supervision and administration of the project; labor and equipment for pulling out existing piles and for moving swing arms into new locations to be driven; and labor and equipment for driving the swing arm piles.

Section 3.2.1.4 identified the estimated cost of pulling and resetting three moorage float swing arms at \$35,900. The swing arms life expectancy is 40 years and will require replacement in 2025 and it is anticipated that under without-project conditions, these swing arms will need to be repaired in 2045 during the 50-year period of analysis.

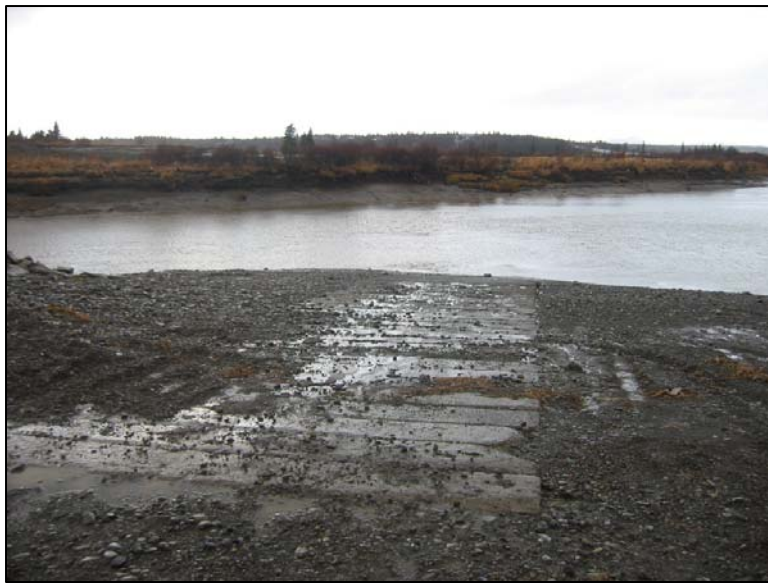
Figure 10: South Boat Ramp, Dillingham Harbor - West End study area

Damages to the harbor's north and south concrete boat ramps result from erosion, which undermines the seaward terminus of the ramps and causes loss of prefabricated concrete modular sections and foundation material. Repair cost components include planning, project management, supervision and administration of the project; labor and equipment for spreading gravel base and placing concrete sections; purchase of 12"x 16"x 20' prefabricated concrete sections; and delivery of concrete sections and gravel to the ramp site. The estimated cost of boat ramp repairs is \$30,120 for the north ramp and \$42,170 for the south ramp. Both the north and the south boat ramps require repair every three years. A photo of the south ramp in 2004 is provided as **Figure 10**. The south ramp is just east of the harbor's entrance channel.

Section 3.2.1.5 identified the estimated cost of boat ramp repairs from erosion damage at \$85,100 (\$35,500 for the north ramp and \$49,700 for the south ramp). Under without-project conditions, it is expected that damages to the north and south ramps will require repairs in 2008 and every three years thereafter over the period of analysis. Erosion from the City Dock Side is expected to impact the south ramp in 2020 so repairs will end at that time.

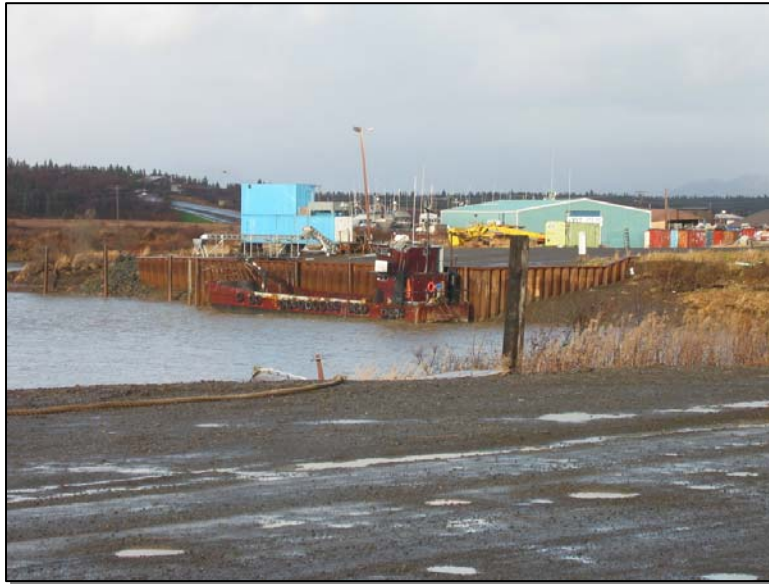
**Figure 11: Harbor Bulkhead, North End of Dillingham Harbor
West End study area**

Damages at the north end of the harbor are occurring as a result of erosion. The damages are occurring at the western end of the bulkhead. **Figure 11** shows the city dock looking northwestward from the east bank of the harbor. **Figure 12** shows a close up of the erosion-problem area. The erosion has resulted in the bulkhead listing seaward, requiring repair every two years. As shown in the figure, rip-rap was placed at the western end of the bulkhead to protect against further erosion damage. Cost components for required repairs involve: planning, project management, supervision and administration of the project; labor and equipment for uncovering turnbuckles, straightening piles and placing riprap; and delivery of rip-rap to the bulkhead site. The estimated cost is approximately \$20,900 and repairs are required within two years.

Section 3.2.1.6 identified the cost of repairs to erosion damage to the harbor bulkhead at approximately \$20,900. Under without-project conditions it is expected that these repairs will need to be made in 2007 and every two years thereafter over the period of analysis.

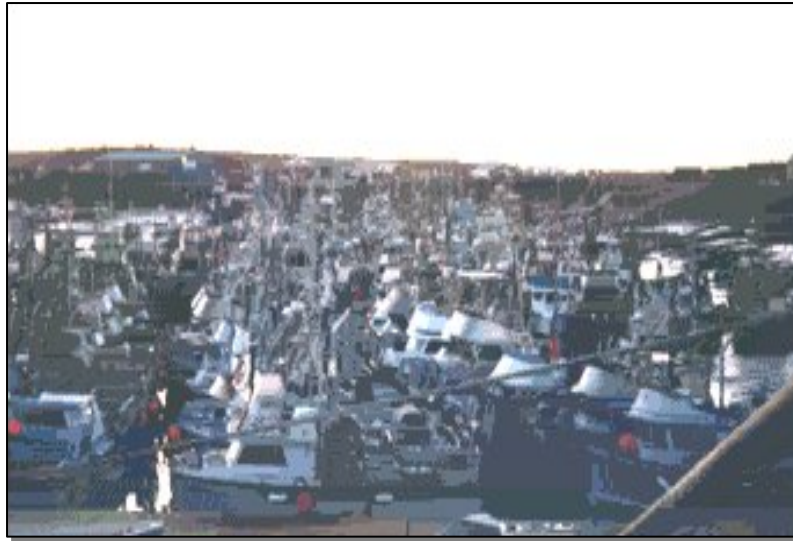
Figure 13: Fishing Vessels in Dillingham Harbor

The 2004 commercial fishing fleet utilizing Dillingham Harbor included 750 vessels. The commercial fishing season out of Dillingham Harbor extends primarily from May through July. Herring vessels (approximately 15) can enter the harbor as early as April. Halibut vessels (approximately 15) can enter the harbor as early as May. The remaining vessels fish for salmon during June and July. The majority of fishing vessels are 32' gill net harvesters. **Figure 13** shows Dillingham Harbor during fishing season.

In 2004, the peak number of commercial vessels that utilized the harbor at any one time was approximately 450 during a salmon fishing closure. The typical number of vessels utilizing the harbor at any one time during the fishing season is between 250 and 300 vessels. To accommodate harbor demand, vessels are rafted 15-20 deep at the dock and reach as high as 30 deep during peak periods.

The 2004 commercial fishing fleet utilizing Dillingham Harbor included 750 vessels. The commercial fishing season out of Dillingham Harbor extends primarily from May through July. Herring vessels (approximately 15) can enter the harbor as early as April. Halibut vessels (approximately 15) can enter the harbor as early as May. The remaining vessels fish for salmon during June and July. The majority of fishing vessels are 32' gill net harvesters. **Figure 13** shows Dillingham Harbor during fishing season.

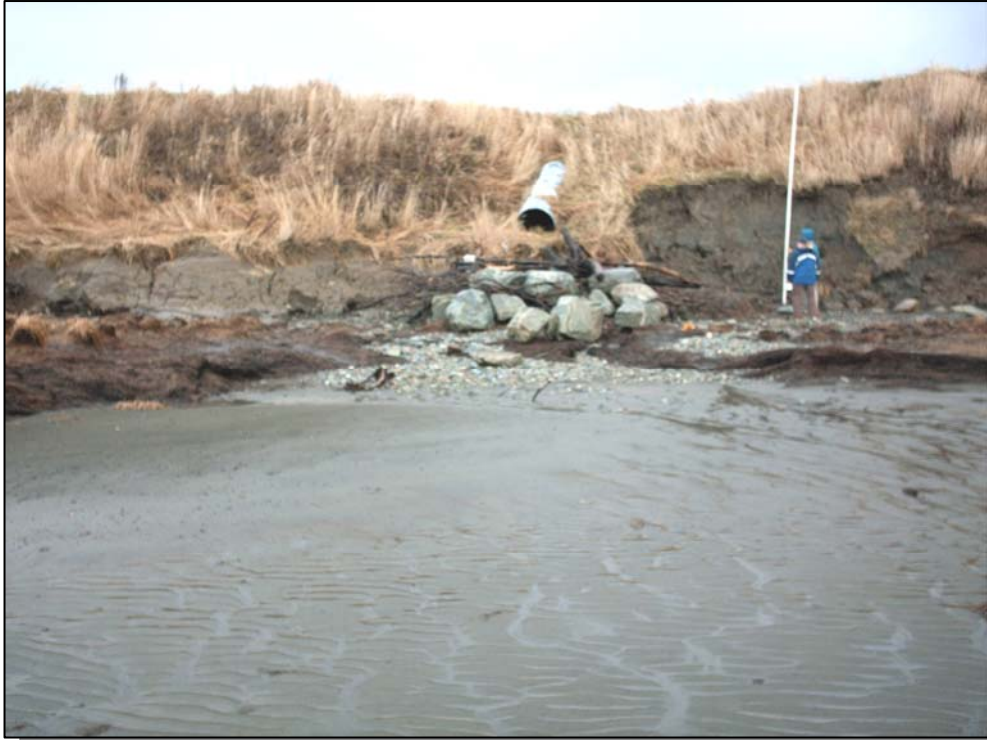
Figure 14: Disposal Area Berm at South Outfall, October 2004

The south disposal site berm is actively in the process of failure from erosion which poses an imminent threat of loss of the contained dredged materials into the river. Erosion at the west end of the berm has resulted in damage to Dillingham's public park in the area and currently poses a threat to public safety.

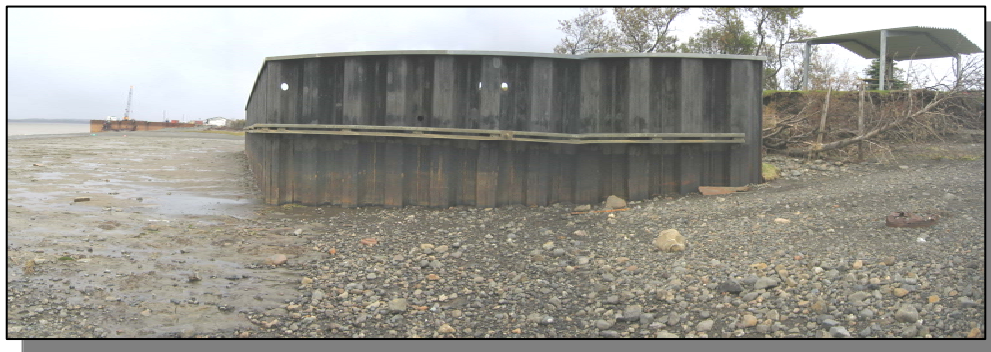
Figure 16: Erosion Outflanks West Terminus of Seawall – City Dock Side (September 2005)

In 1999, the Corps of Engineers constructed 613 feet of bank protection along the bluff in front of the Dillingham small boat harbor. The west end of the bluff is bordered by Scandinavian Creek as it enters the Nushagak River. Scandinavian Creek is the entrance channel to the Dillingham small boat harbor. On this western end of the bluff, approximately 184 feet was protected by a rock riprap revetment. The remainder of the shoreline protection, approximately 429 feet, was protected by a sheetpile seawall with gravel backfill (~4,200 cy of gravel). The construction cost of the sheetpile portion of the project in 1999 prices was \$1,160,000. Using the Civil Works Construction Cost Index for Breakwater and Seawalls, the 2008 indexed cost for constructing this project is \$1,425,500. In recent years, land at the eastern terminus of the seawall has experienced continued erosion. A large storm in September of 2005 resulted in significant erosion in this area that resulted in the seawall being outflanked and erosion behind the seawall. Photos of this area taken after the storm are presented in **Figures 16-18**.

Erosion is expected to continue in this area with no action and it is estimated that the structural integrity of the sheetpile wall would be lost in 2015. The design life of the sheetpile wall was 25 years. The construction cost of the sheetpile seawall in current prices is \$1,561,400. Given the 25-year design life of the sheetpile, the fact that the existing sheetpile failed within ten years of construction, and the 50-year period of analysis, it is expected that the sheetpile will fail again several more times. The present value of the difference between normal replacement at 25 years and the accelerated replacement at 10 years for sheetpile costs is \$2,536,900.

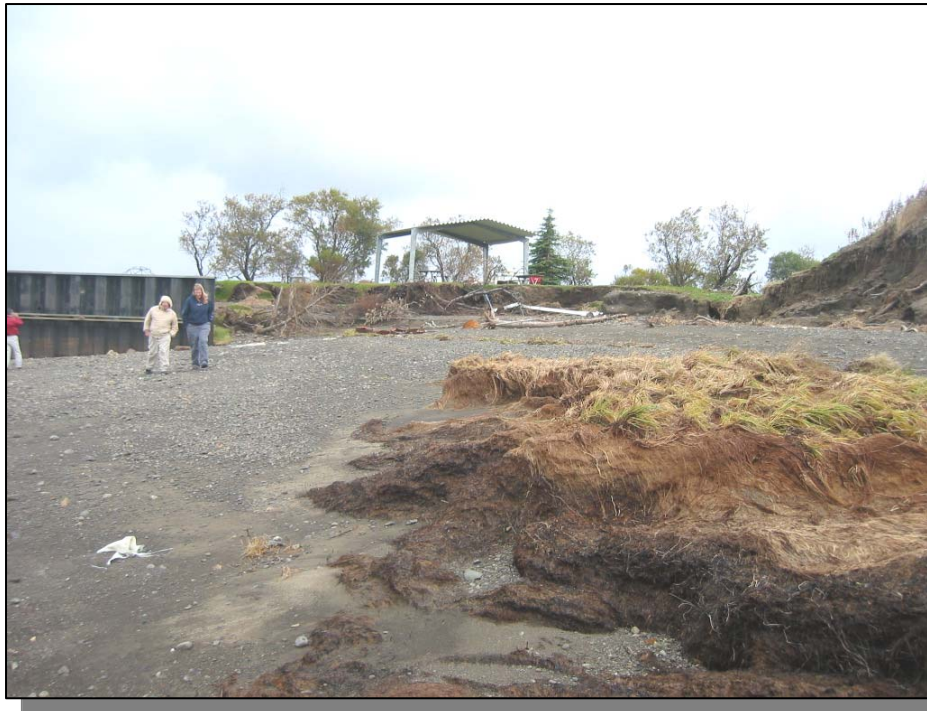
Figure 19: Erosion at Dillingham City Park looking North (September 2005)

Erosion in the area between the east terminus of the sheetpile seawall and the northwest corner of the disposal berm is impacting Dillingham’s City Park. This park is a popular local attraction for residents during the summer and hosts community events. The park includes recreational features and a covered picnic shelter facility. Erosion along the south end of the park has created a public safety concern. Storm surge in the September 2005 storm swept a picnic table from the park area several hundred feet eastward. Erosion in the western end of the park is evident in **Figure 16**. **Figures 19 - 21** depict the effects of erosion within the park.

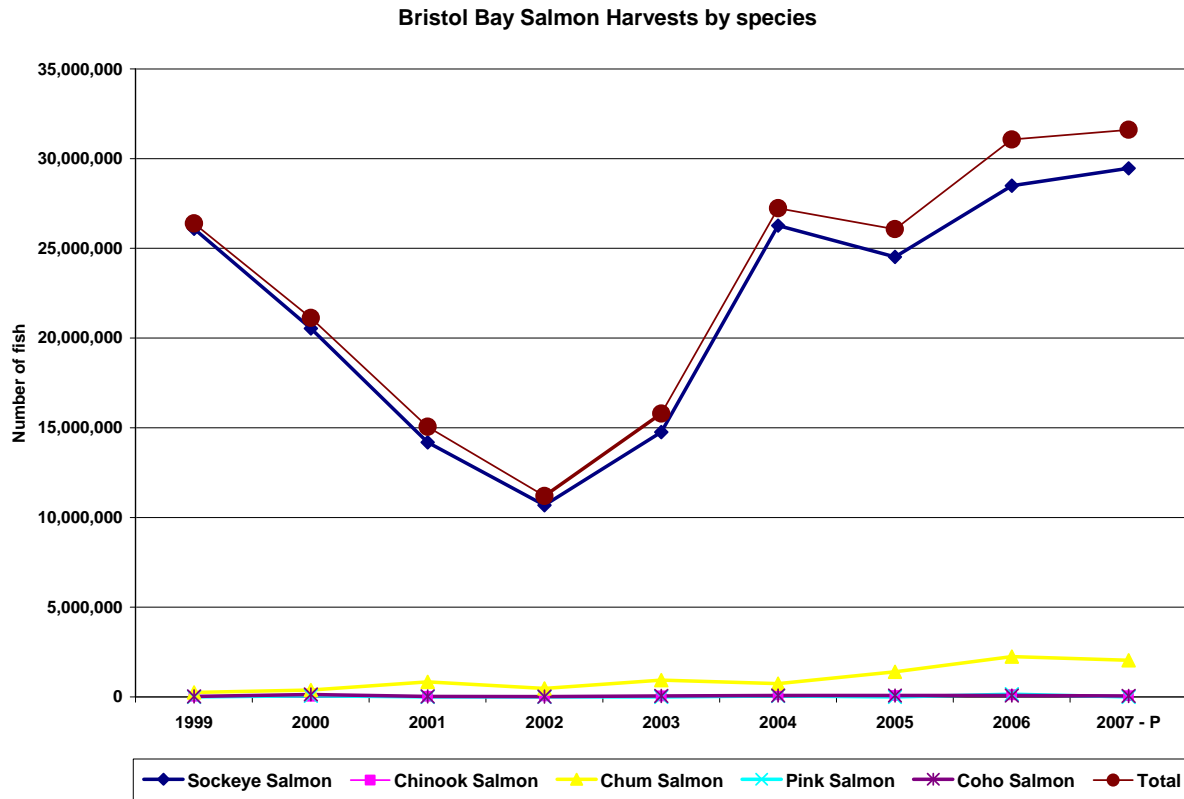
Figure 22: Bristol Bay Salmon Harvest by Species (1999-2007)

It is expected that use of the harbor by commercial fishing vessels would remain at similar levels as the existing conditions. Most Bristol Bay commercial fishing vessels fish for salmon. Review of historical Bristol Bay salmon catch data published by the Alaska Department of Fish and Game (ADF&G) indicates that catch in 2004 (27.3 million fish) was above the average catch over the previous six years (19.4 million fish). **Table 9** presents the annual Bristol Bay salmon harvest by species from 1999-2004. This data is presented graphically in **Figure 22**.

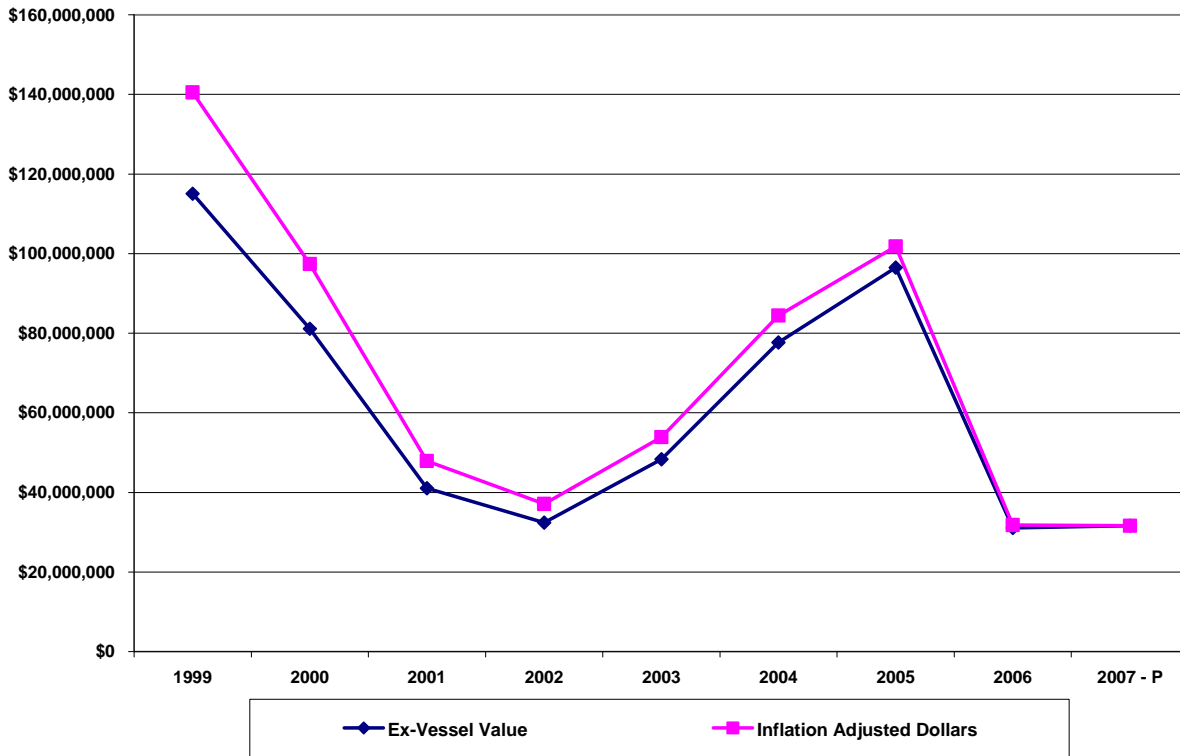
Figure 23: Ex-Vessel Values for Bristol Bay Salmon Harvest (1999-2007)

Table 10 presents the ex-vessel value of the catch identified in **Table 9**. The 2005 ex-vessel value of the Bristol Bay salmon harvest was estimated at \$101,796,000, which is above the nine year average catch ex-vessel value of \$61,940,000; but below the recent 20-year average value of \$121 million published by ADF&G. **Figure 23** is a graph of the **Table 10** ex-vessel value data.
