Chapter 3 Stability Problems with Flood Control Channels

Section I

Types of Channel Modification for Flood Control

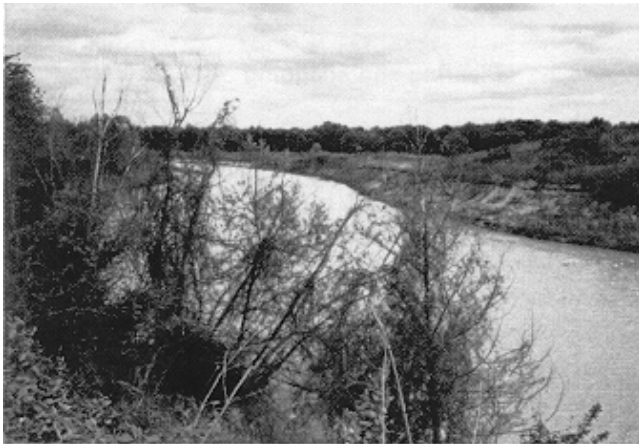
a. Channel enlargement is normally used when hydraulic capacity must be significantly increased (Figure 3-2). Examples include a channel through a formerly rural area that has undergone suburban or urban development, or the upgrading of an urban channel to carry a 100-year flood or of a rural channel designed to minimize flood damages on crops and residences. Modes of enlargement include increased bottom width, flattening of side slopes by excavation, channel deepening, side berm cuts, or a combination of two or more of those.

Figure 3-2. Channel enlargement

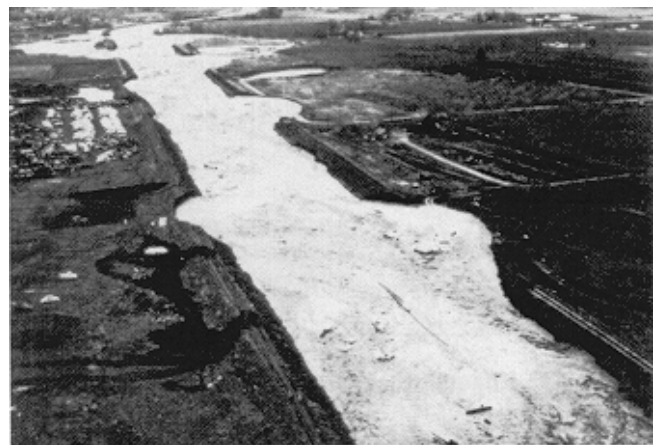
Figure 3-6. Lateral instability in realigned channel

b. The response of a stream to realignment can vary greatly depending on the stream characteristics and the environment. In some environments, streams with stable contorted meanders, flat slopes, and erosion-resistant boundaries can be considerably realigned without serious consequences (Figure 3-5), especially if there are flood-regulating reservoirs. In other environments, straightening of meandering streams to enhance flood capacity has led to serious problems of channel degradation, bank erosion, and tributary incision (Figure 3-6). In such cases realignment may be viable only if accompanied by grade control structures to check velocities and bank protection to control development of new meanders.

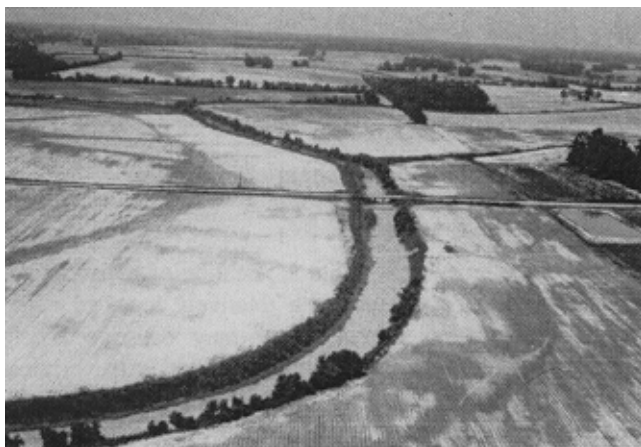
Figure 3-5. Realigned channel without serious instability problems

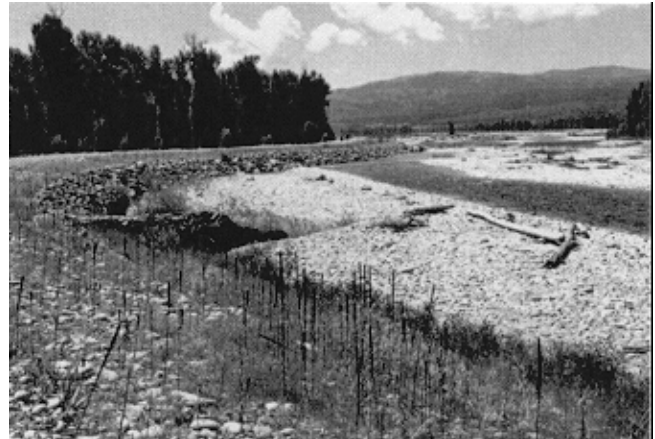
d. In actively meandering channels, the danger exists that continued meander migration, perhaps aggravated by increased in-channel discharges, will encroach on levee setback distances and attack the levee itself at various points. If populations depend on the levees for security, this may pose a critical situation in large floods. As time passes, levee projects in this type of situation tend to require ever-increasing vigilance and maintenance. Eventually large portions of the stream may be effectively canalized by bank protection of one form or another (Figure 3-8).

Figure 3-8. Bank protection necessitated by encroachment on levee setback

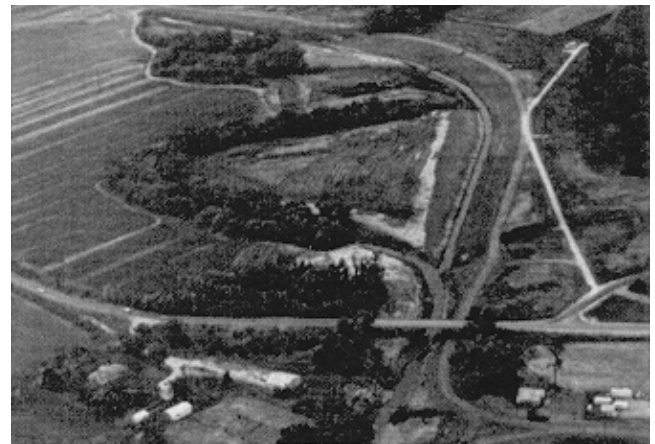
designed to supplement. In some cases the two channels may intersect at intervals as in the case of high-level bend cutoffs (Figure 3-9).

Figure 3-9. Flood bypass channel formed by high-level bend cutoffs

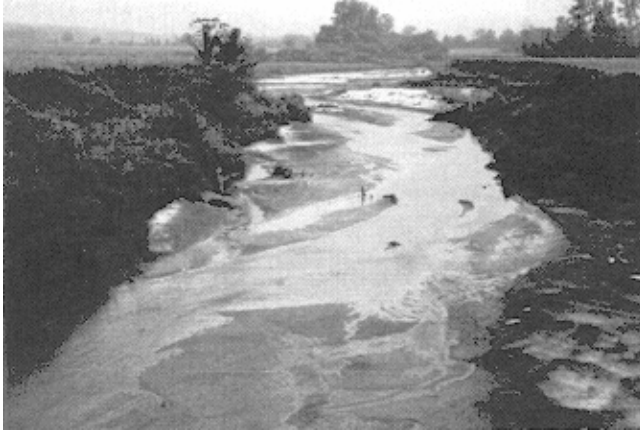
(3) The bed degraded by headcutting, the channel widened, and meanders developed over a length of stream extending at least 7 miles upstream of the head of the project (Figure 3-11).

Figure 3-11. Induced instability upstream of channel enlargement, Twenty Mile Creek

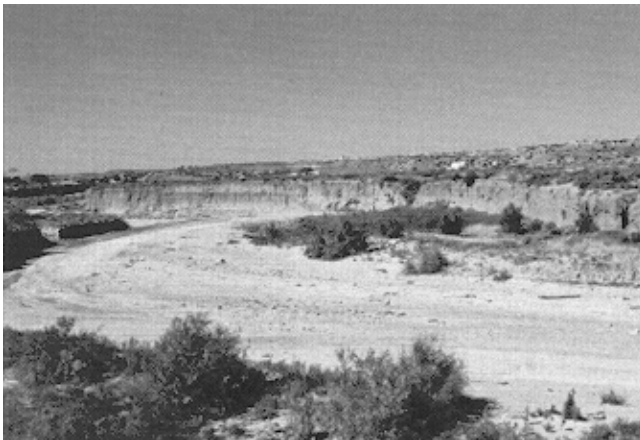
Figure 3-12. Entrenched reach of Puerco River

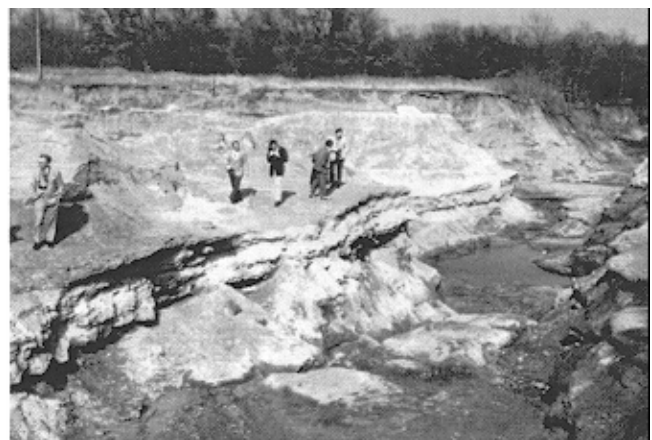
Figure 3-13. Grapevine Spillway Channel after erosional episode

b. The main point demonstrated by this case is the potential for extremely rapid enlargement and downcutting, even in partly consolidated materials, when a

channel is subjected to flows grossly in excess of the channel-forming discharge. The damaging flows exceeded the channel-forming discharge of the creek by one to two orders of magnitude.

c. Rehabilitation involved construction of a \$10 million concrete chute and stilling basin to carry flows from the end of the existing spillway slab down to the new base level of the creek.

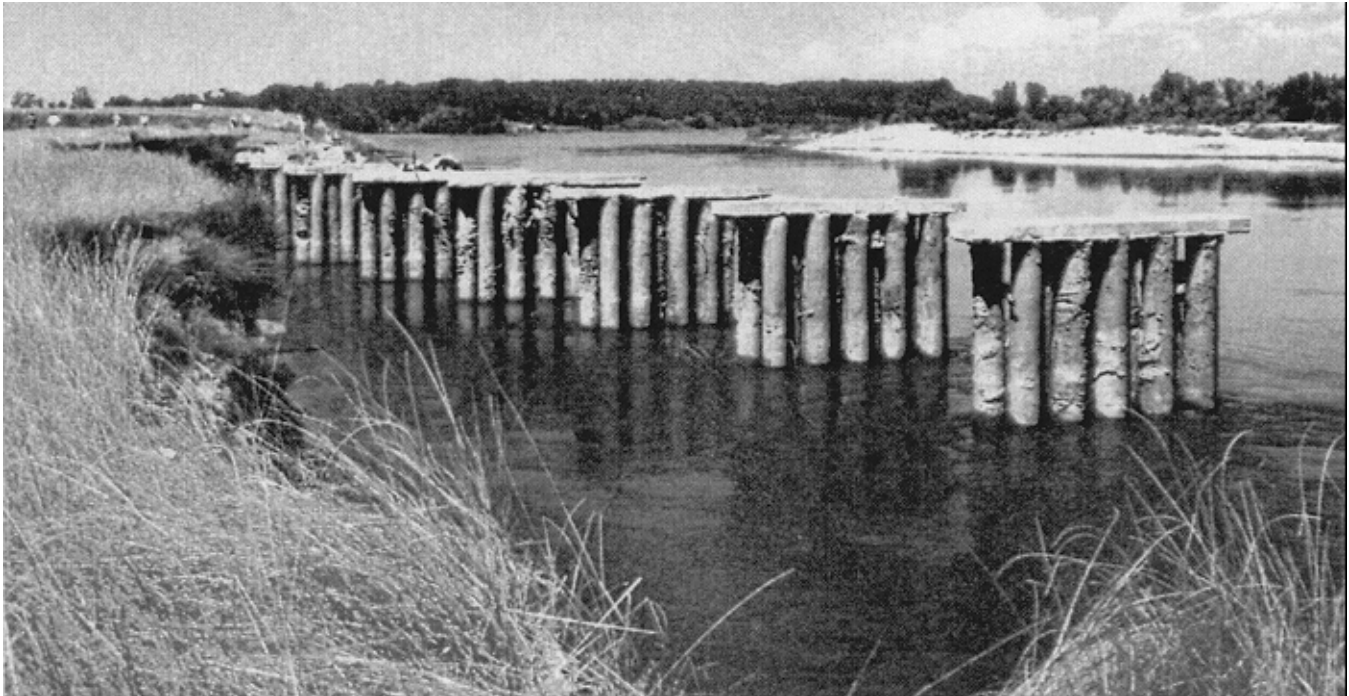
b. Recent studies show no systematic trend of changes in the longitudinal profile. Rates of bank erosion apparently reduced by about 25 percent after construction of Shasta Dam in 1943, but remain troublesome for security of the levees and loss of valuable agricultural land. Various methods have been tried for bank protection in response to environmental concerns over use of riprap, but success with alternative systems has been limited (Figure 3-18).

Figure 3-18. Flanking of experimental bank protection on Sacramento River

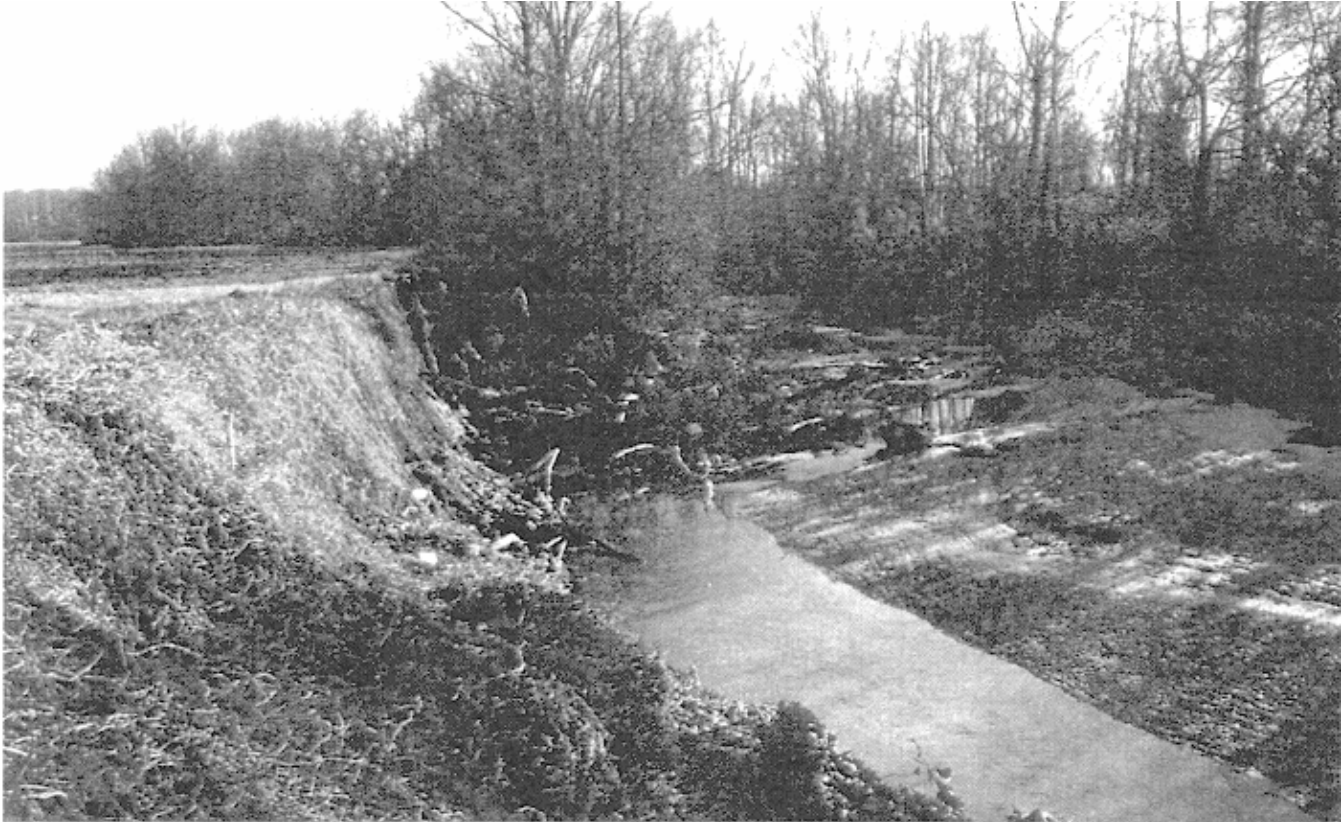
Figure 3-19. Incised channel in Long Creek basin

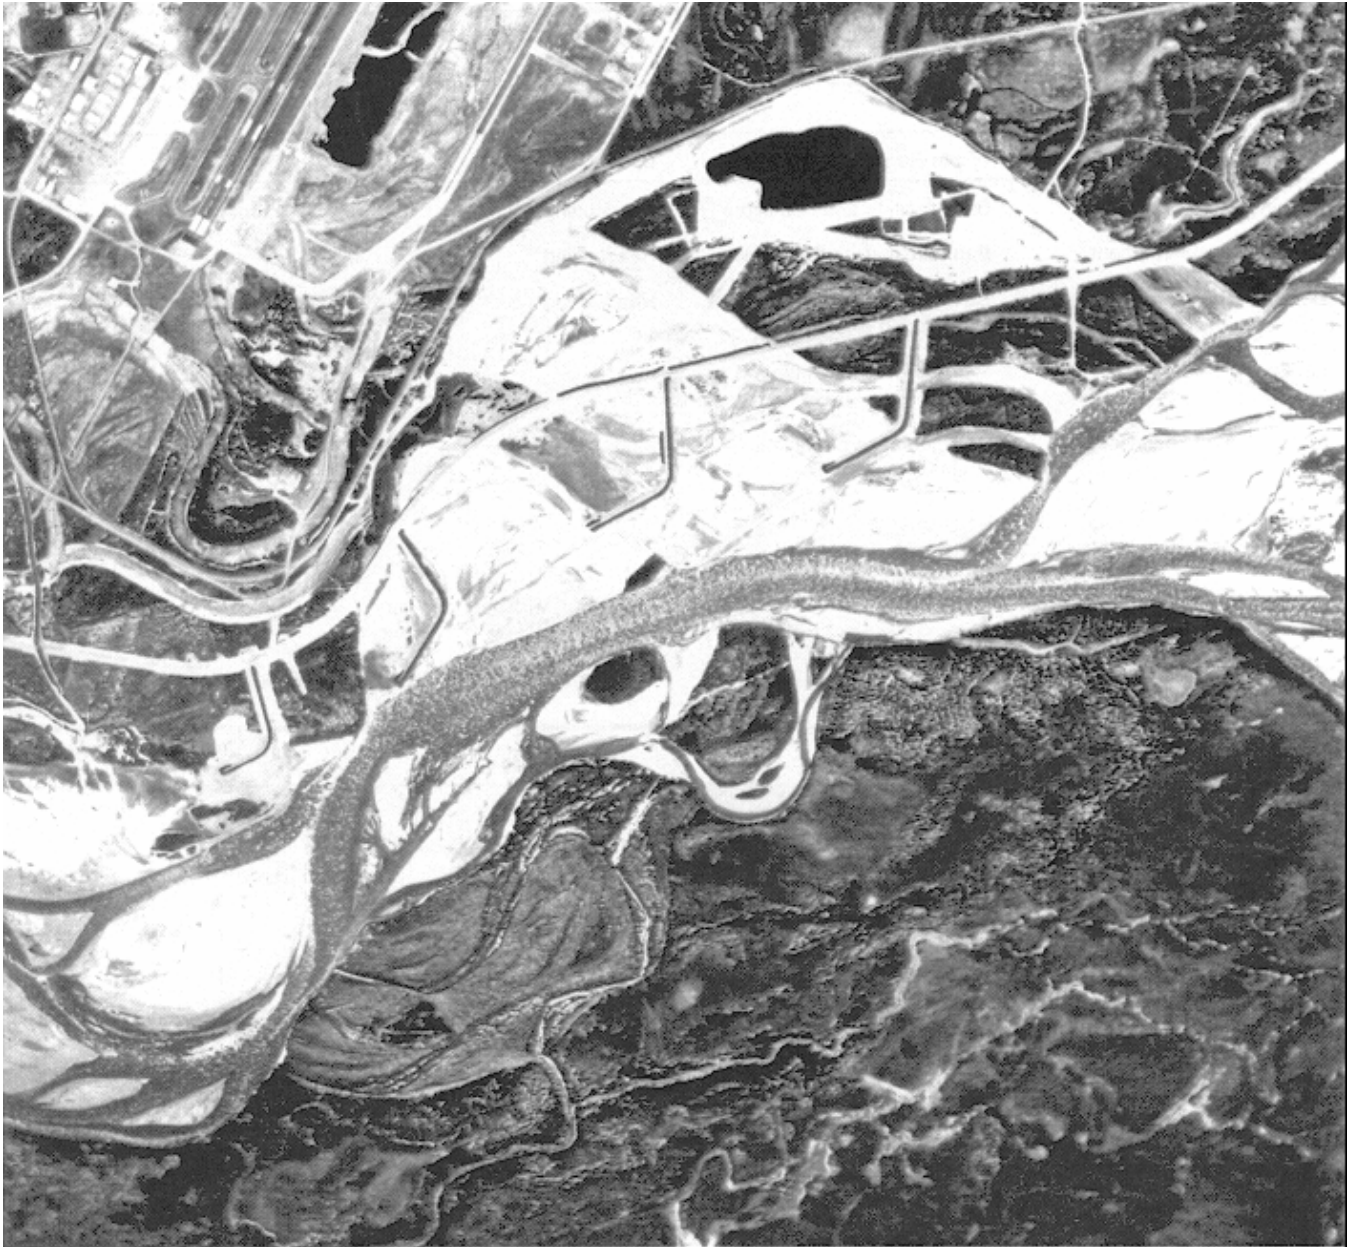
Figure 3-20. Tanana River at Fairbanks showing in-river levee and groins

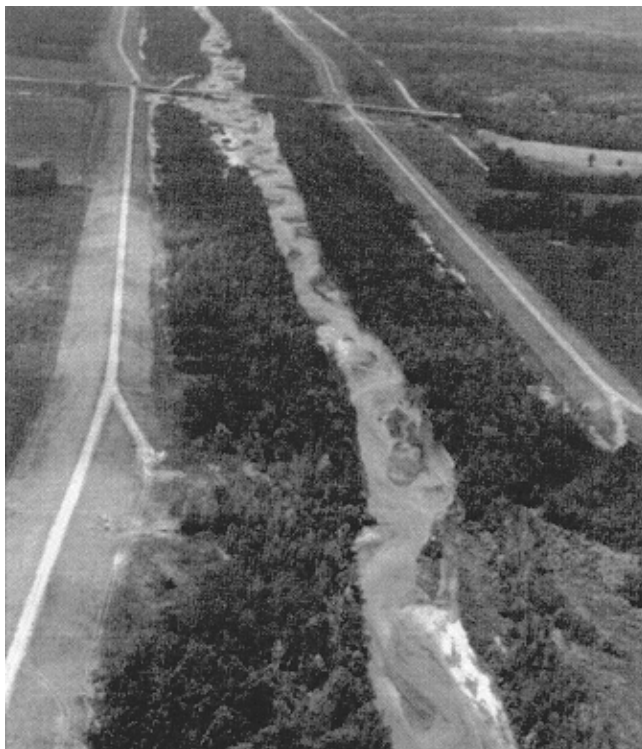
(2) Meanders can start in straight channels as a result of side bar deposition from bed material transport (Figure 3-21), but the question of whether bed material transport is necessary for initiation of meanders is unsettled. Meander development and migration involve sediment exchange between eroding and depositing locations (Figure 3-22).

Figure 3-21. Side bar deposition and sub-meandering in straight channel
