Remediation of Petroleum Hydrocarbons Released to the Subsurface

Petroleum Storage Tank Bureau
New Mexico Environment Department

Case History Hobbs City Wells

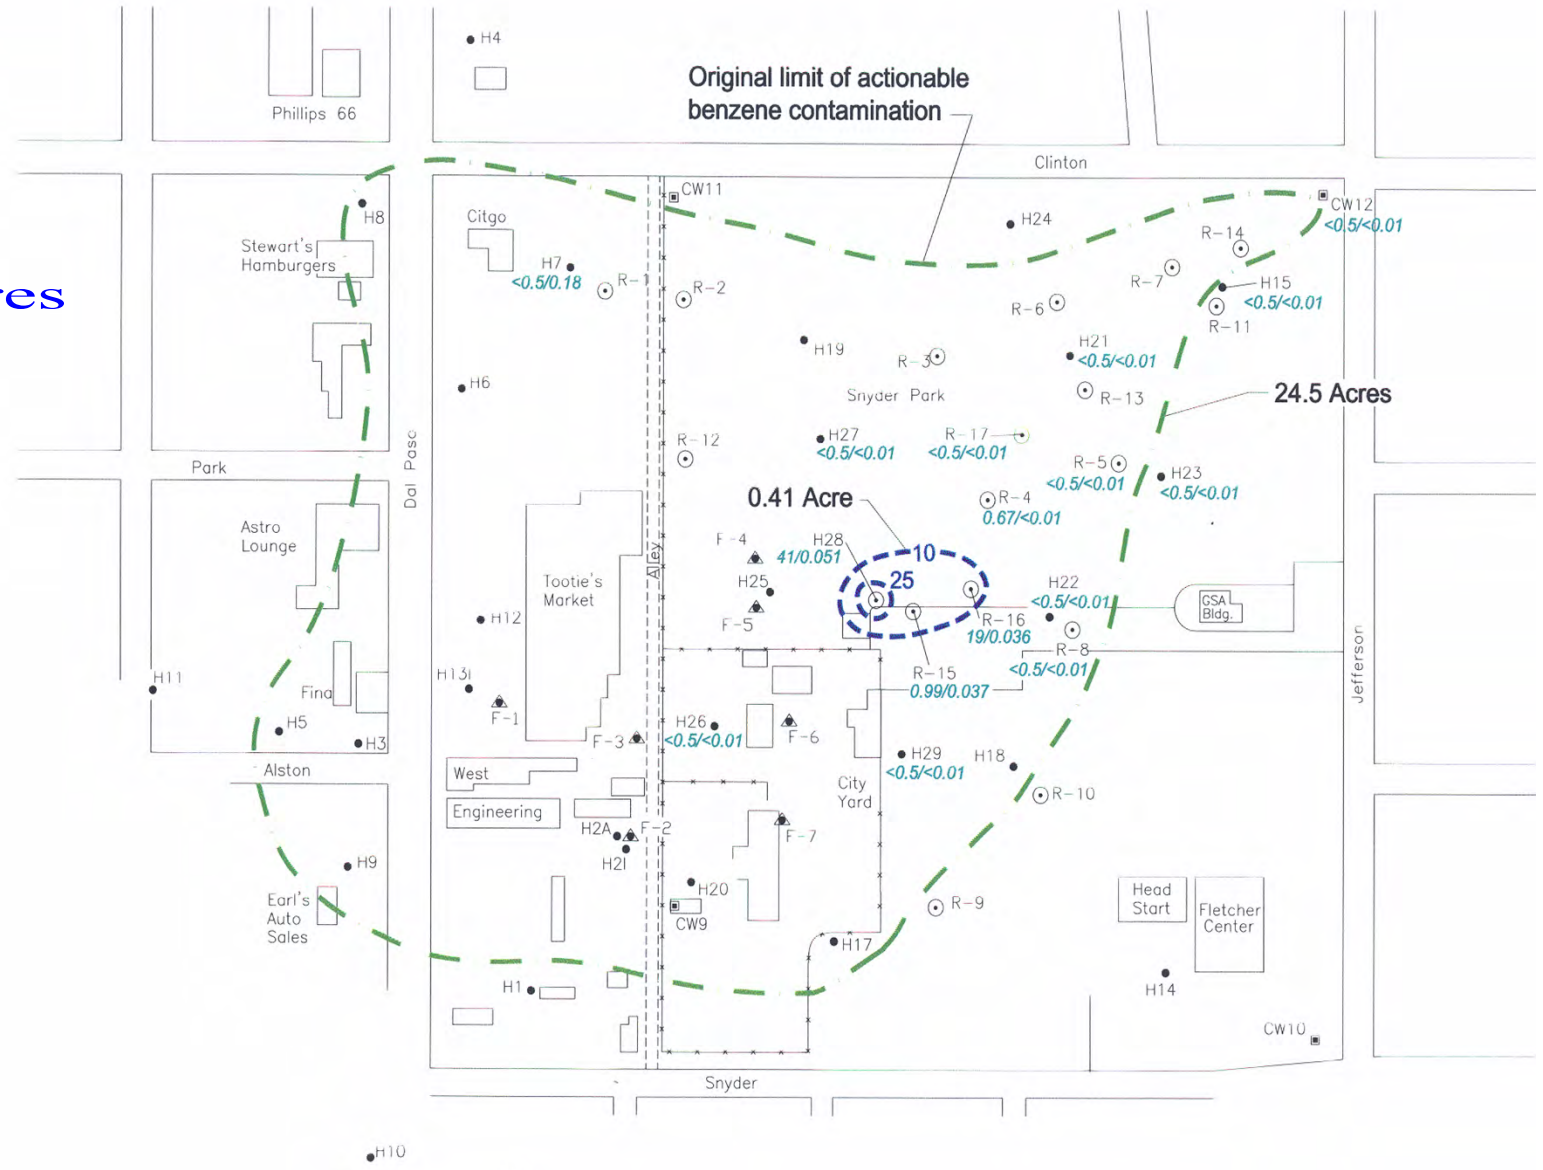
Contaminant Plume after 8 yrs

0.41 acres
