Structural Inspection of Processing Plants

PowerPoint prepared by Terry Taylor, P.E.,
Senior Civil Engineer, PSHTC

Inspection of Processing Plants

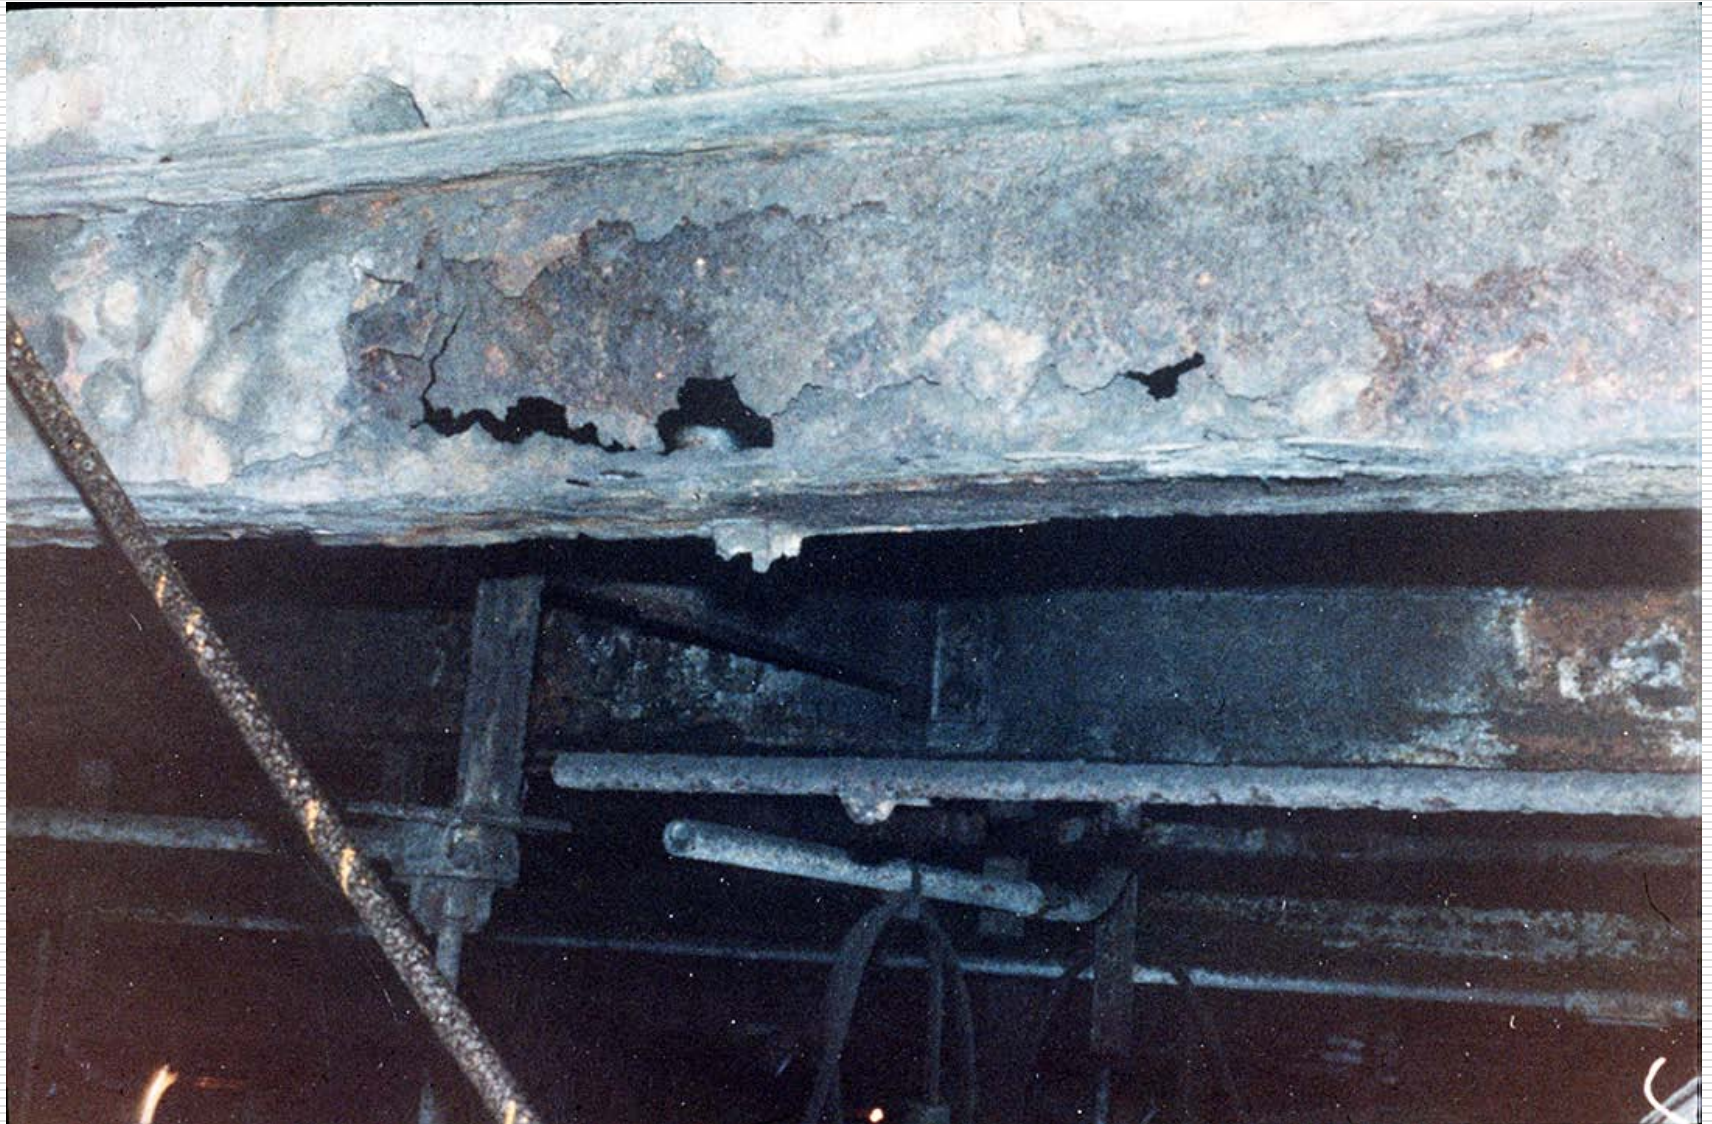
Corrosion holes & delamination

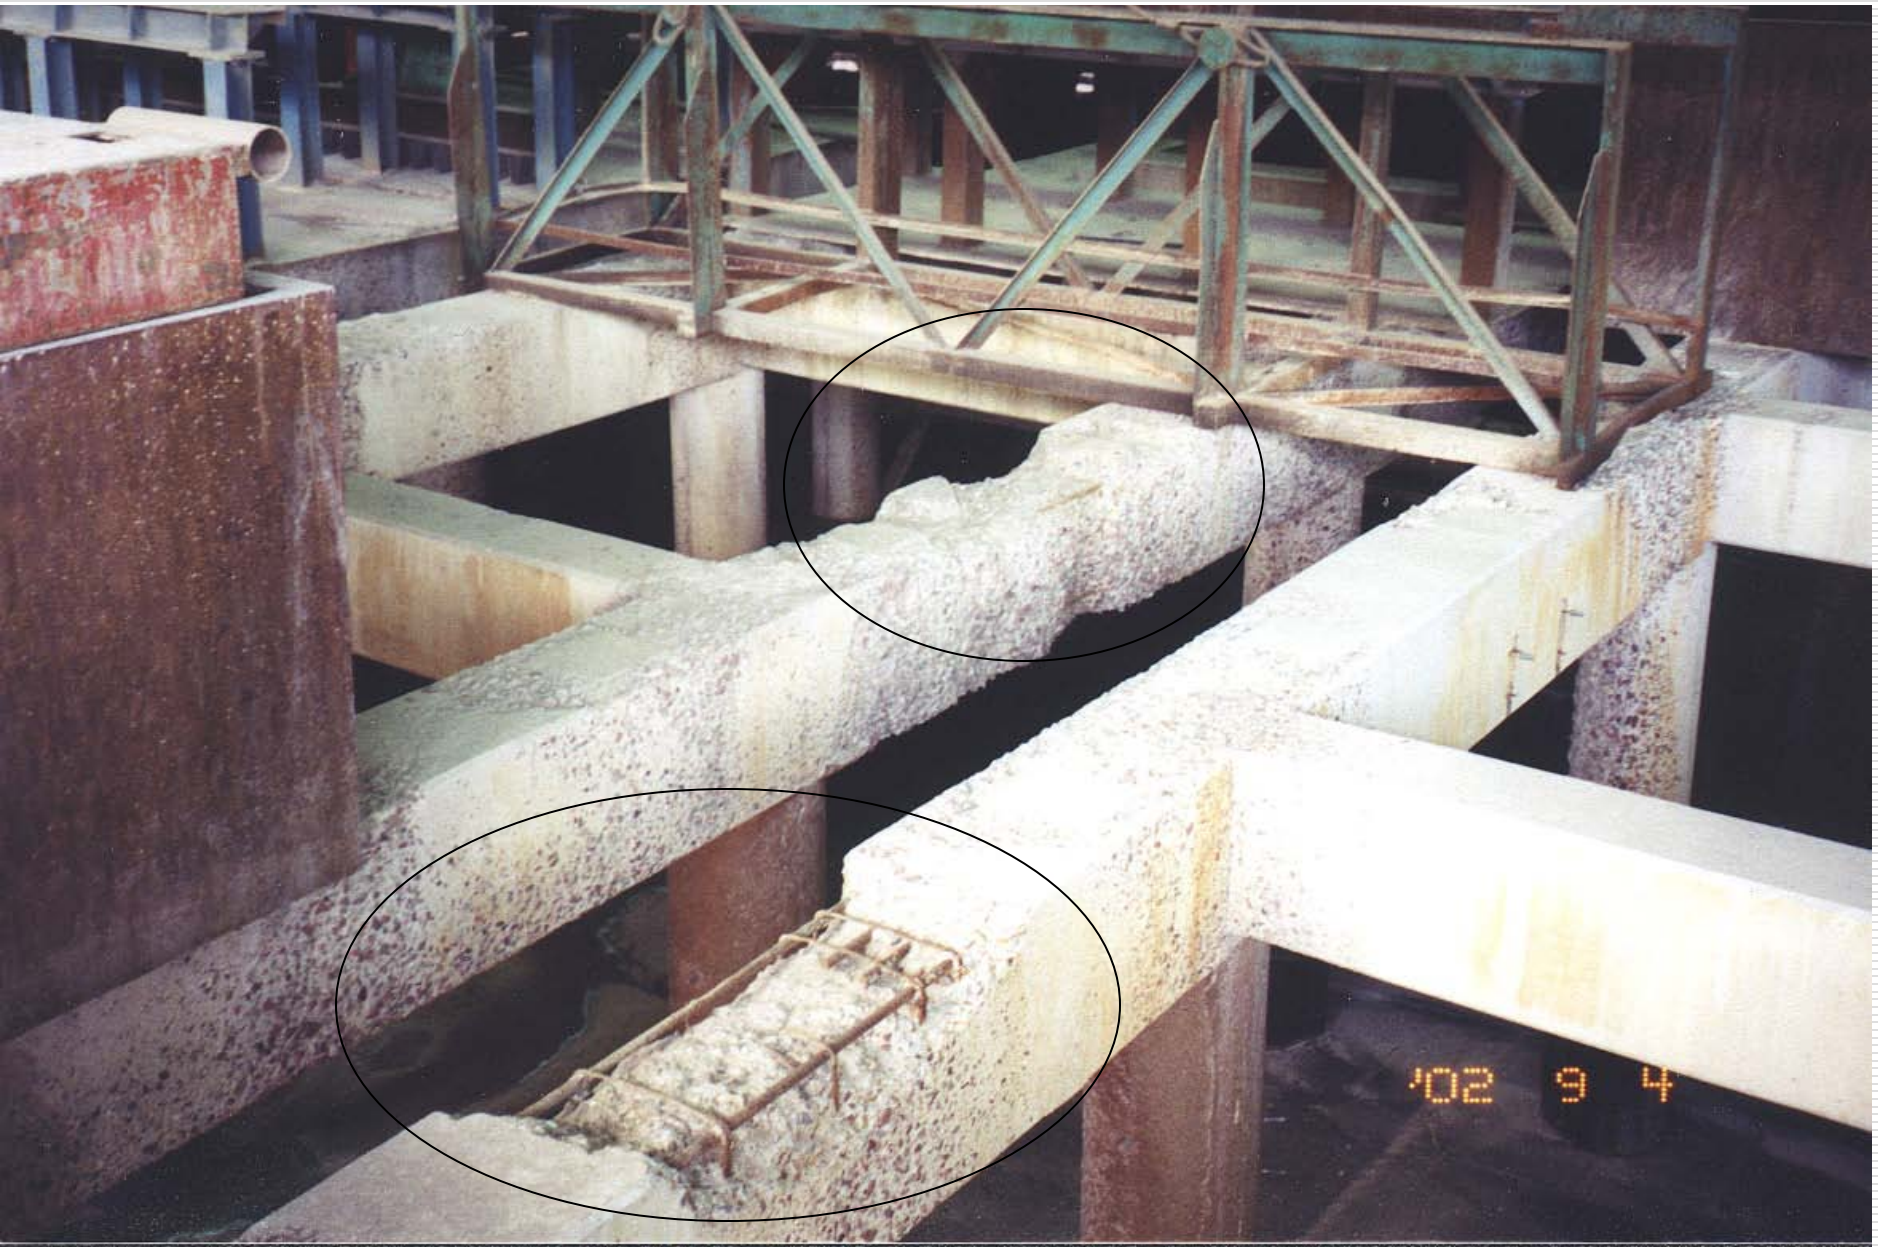
Spalling & Corrosion from Exposure to Chemicals

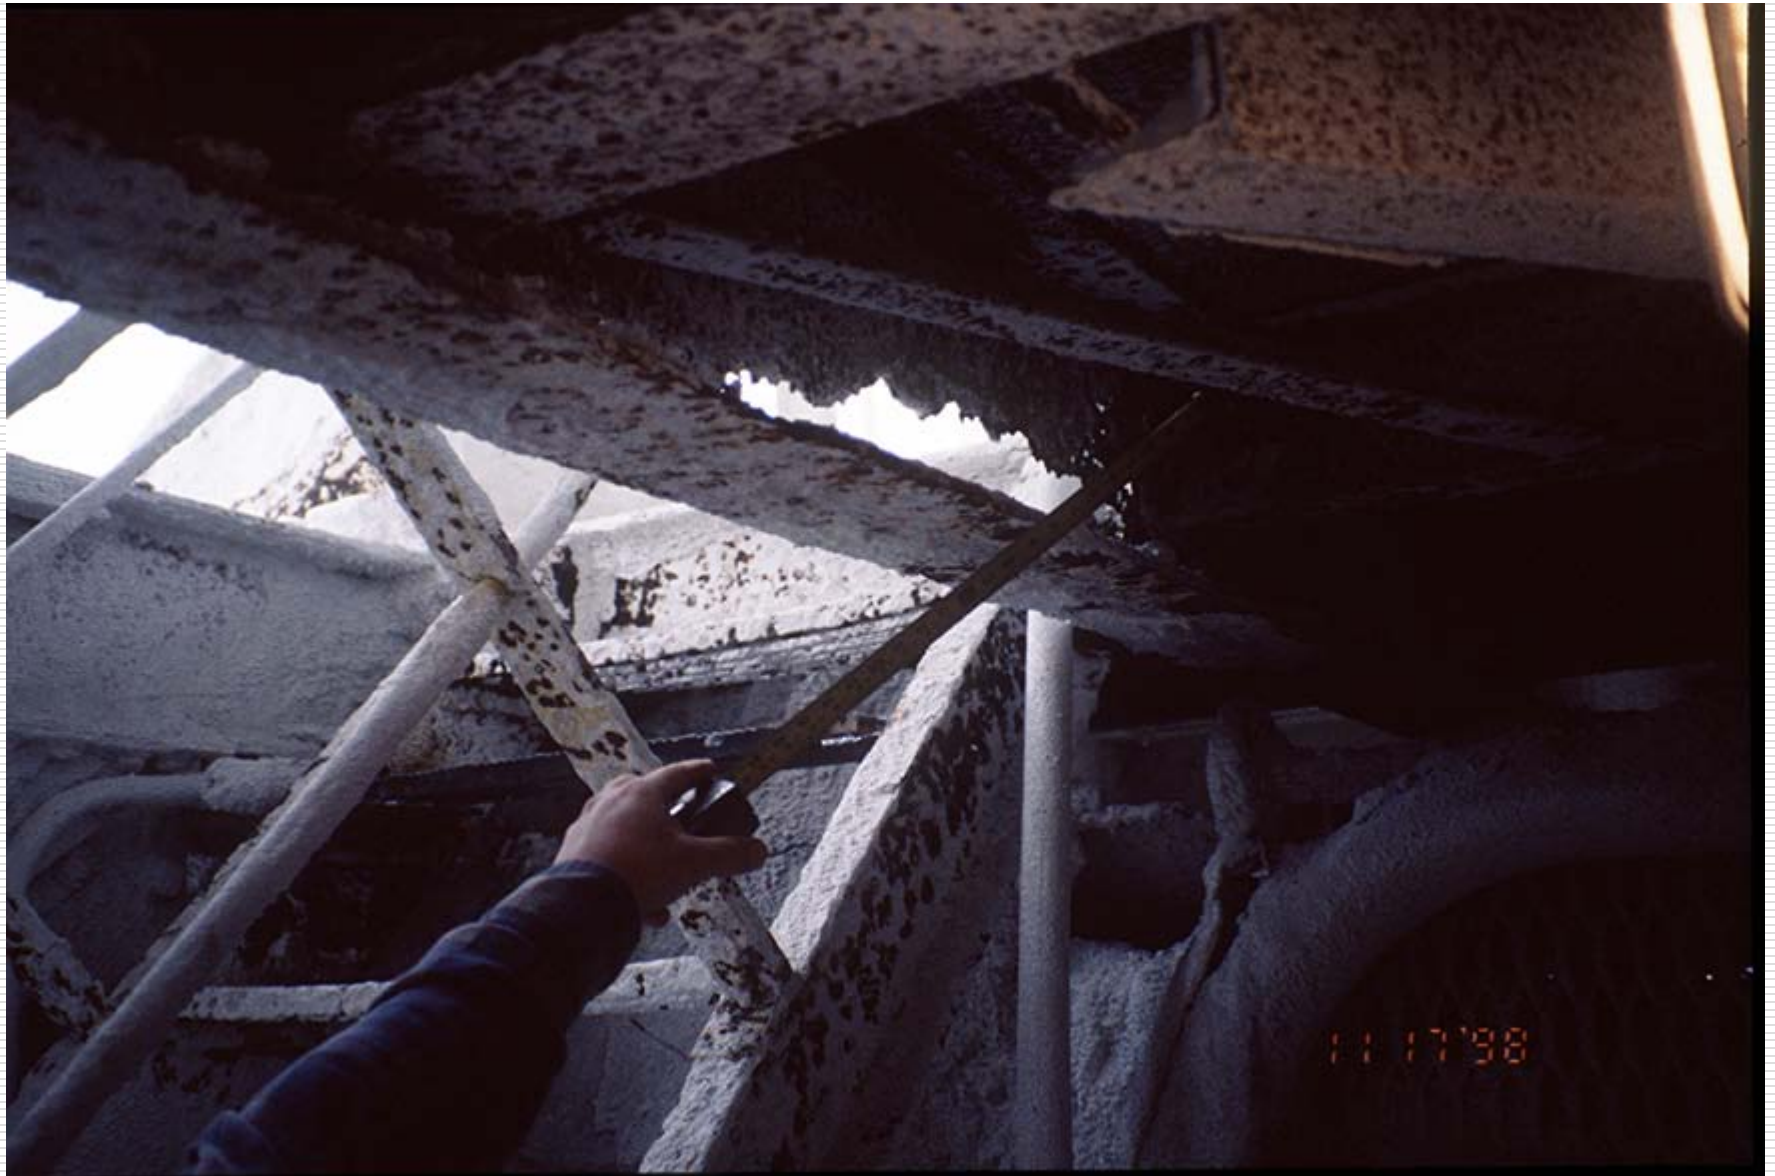
Corroded web of wide flange beam

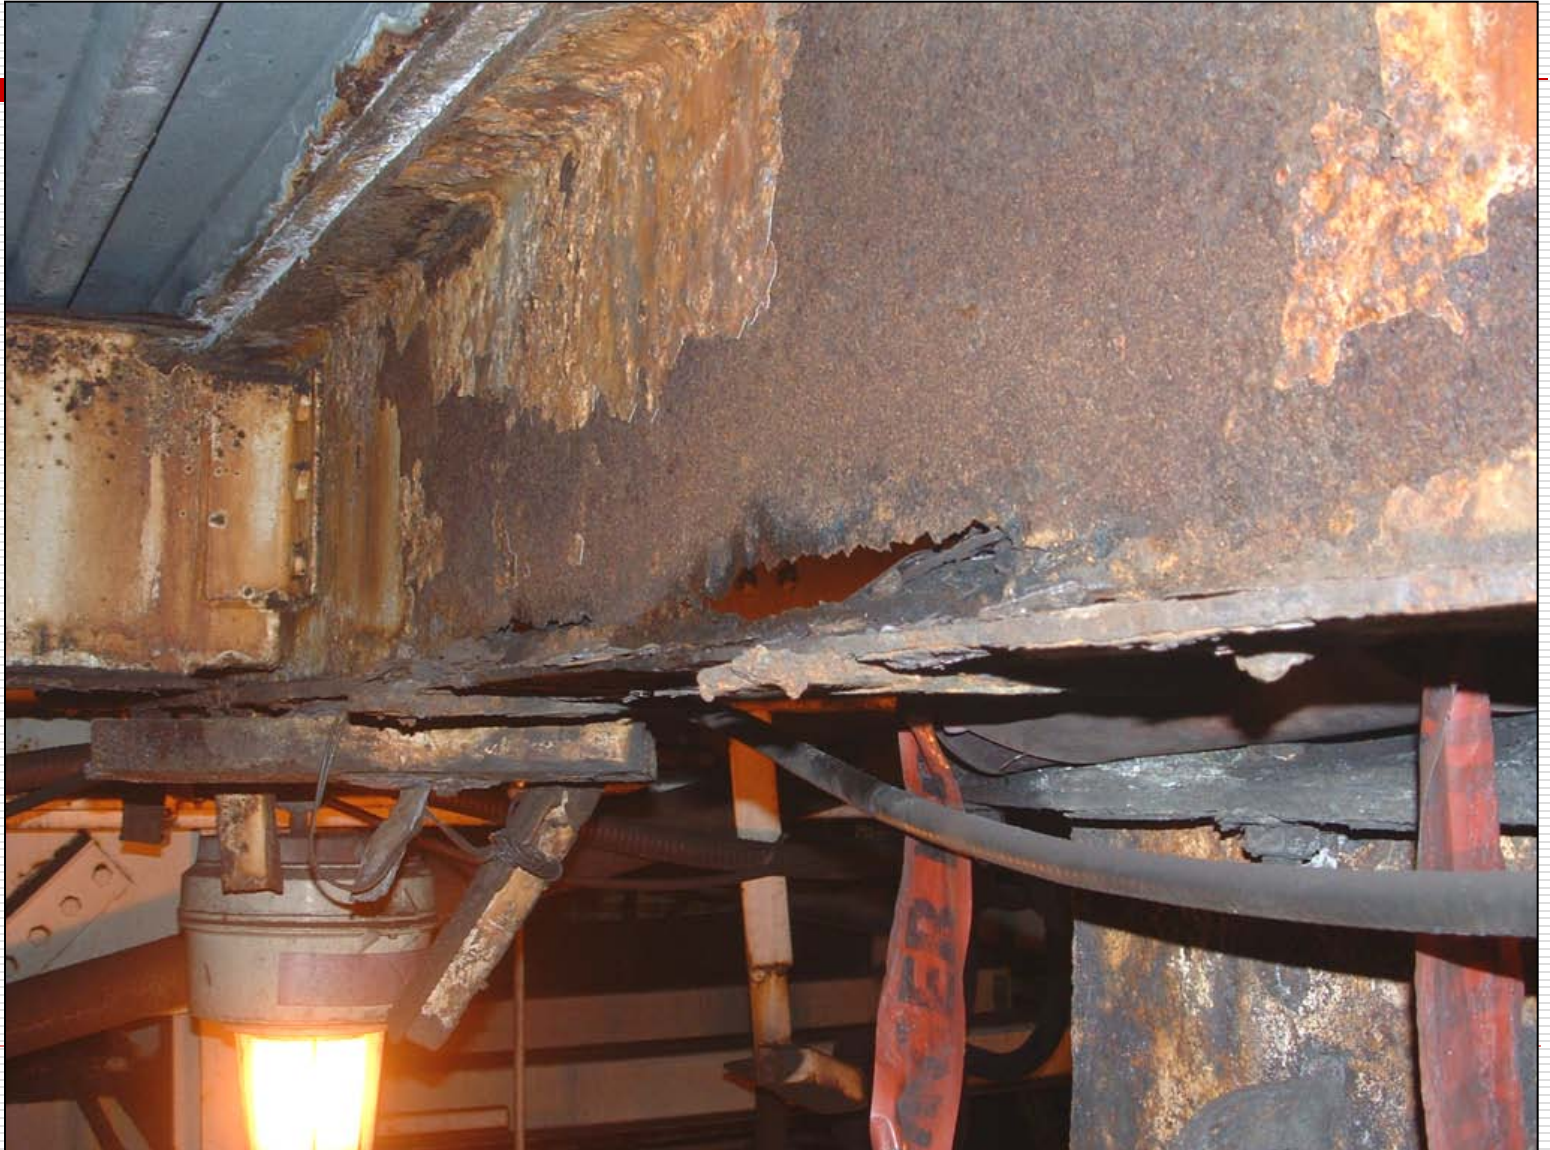
Long corrosion hole at web to flange interface

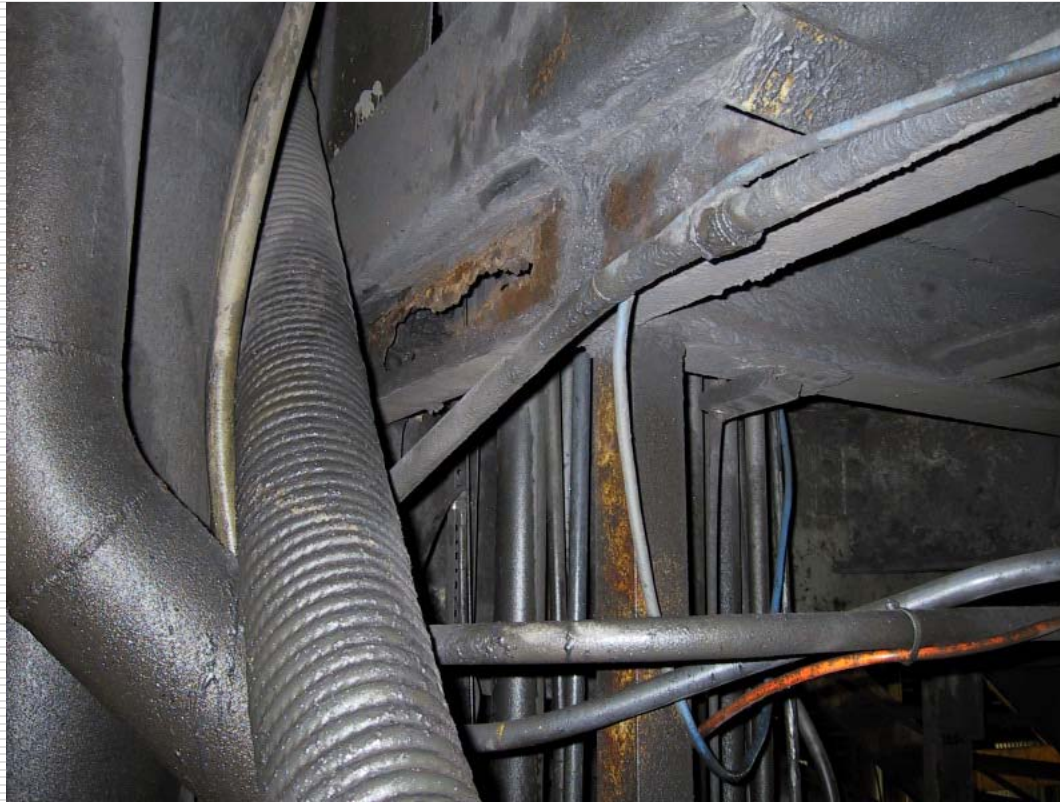
Corrosion hole in web of beam (hidden by piping)

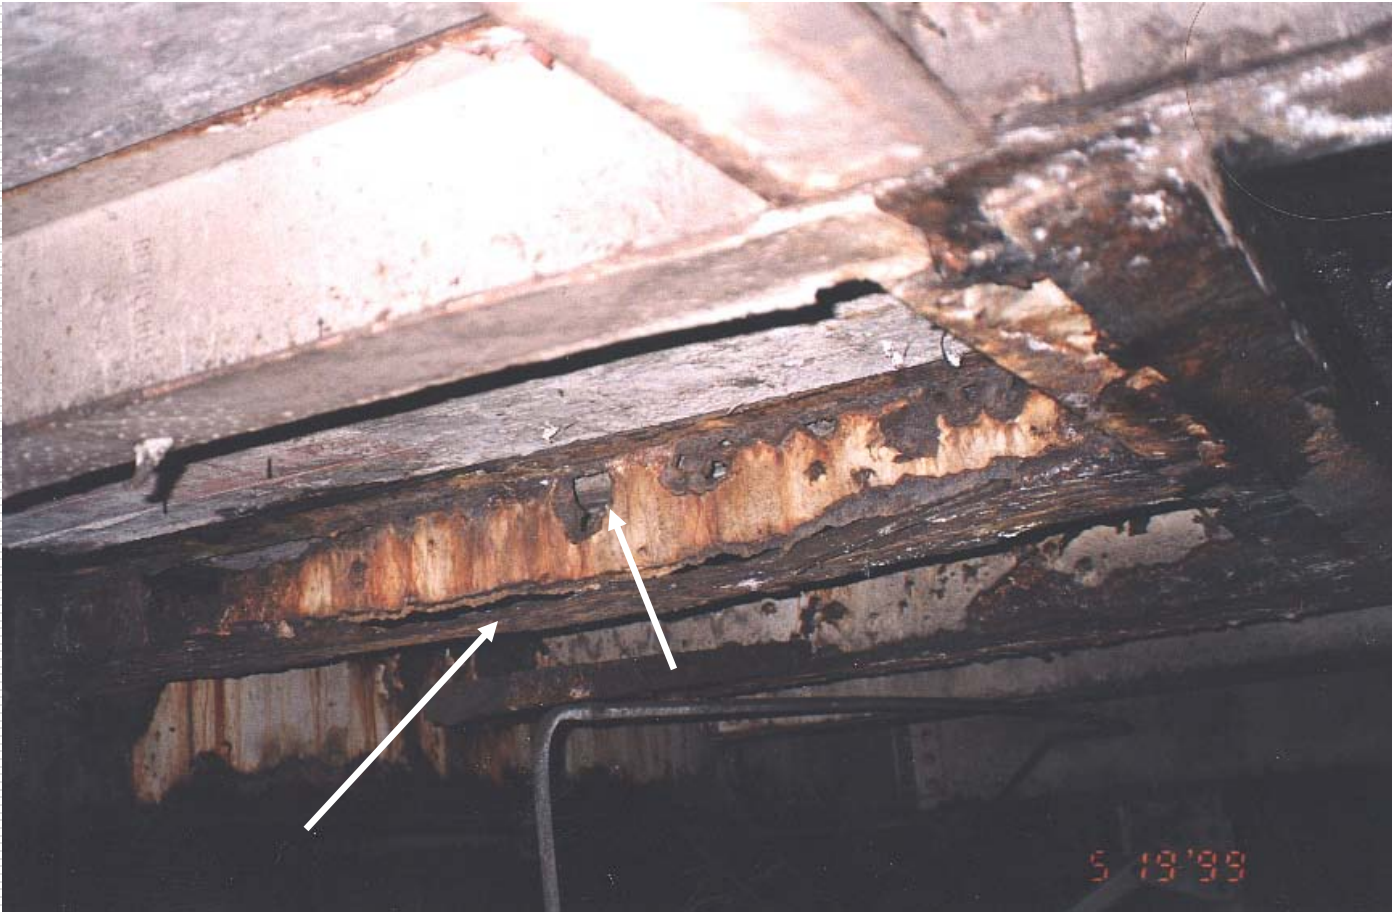
Corrosion holes in web of beam

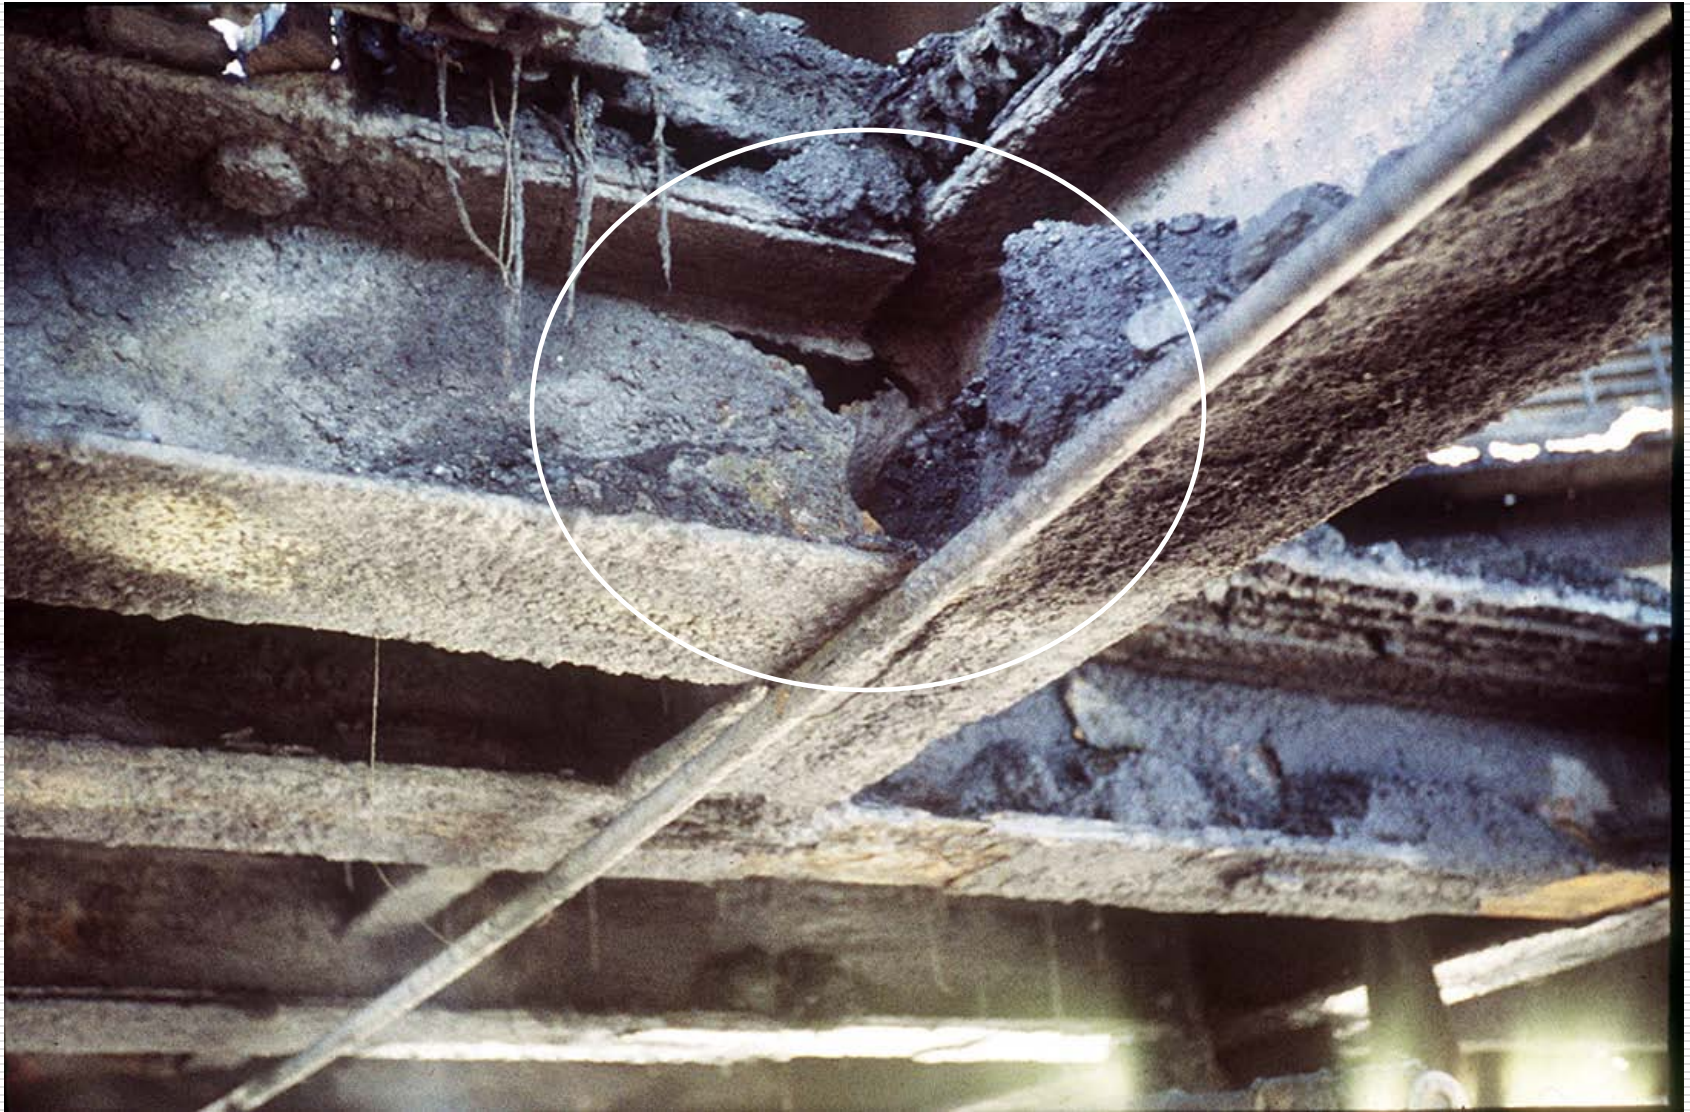
Corroded web @ end of beam

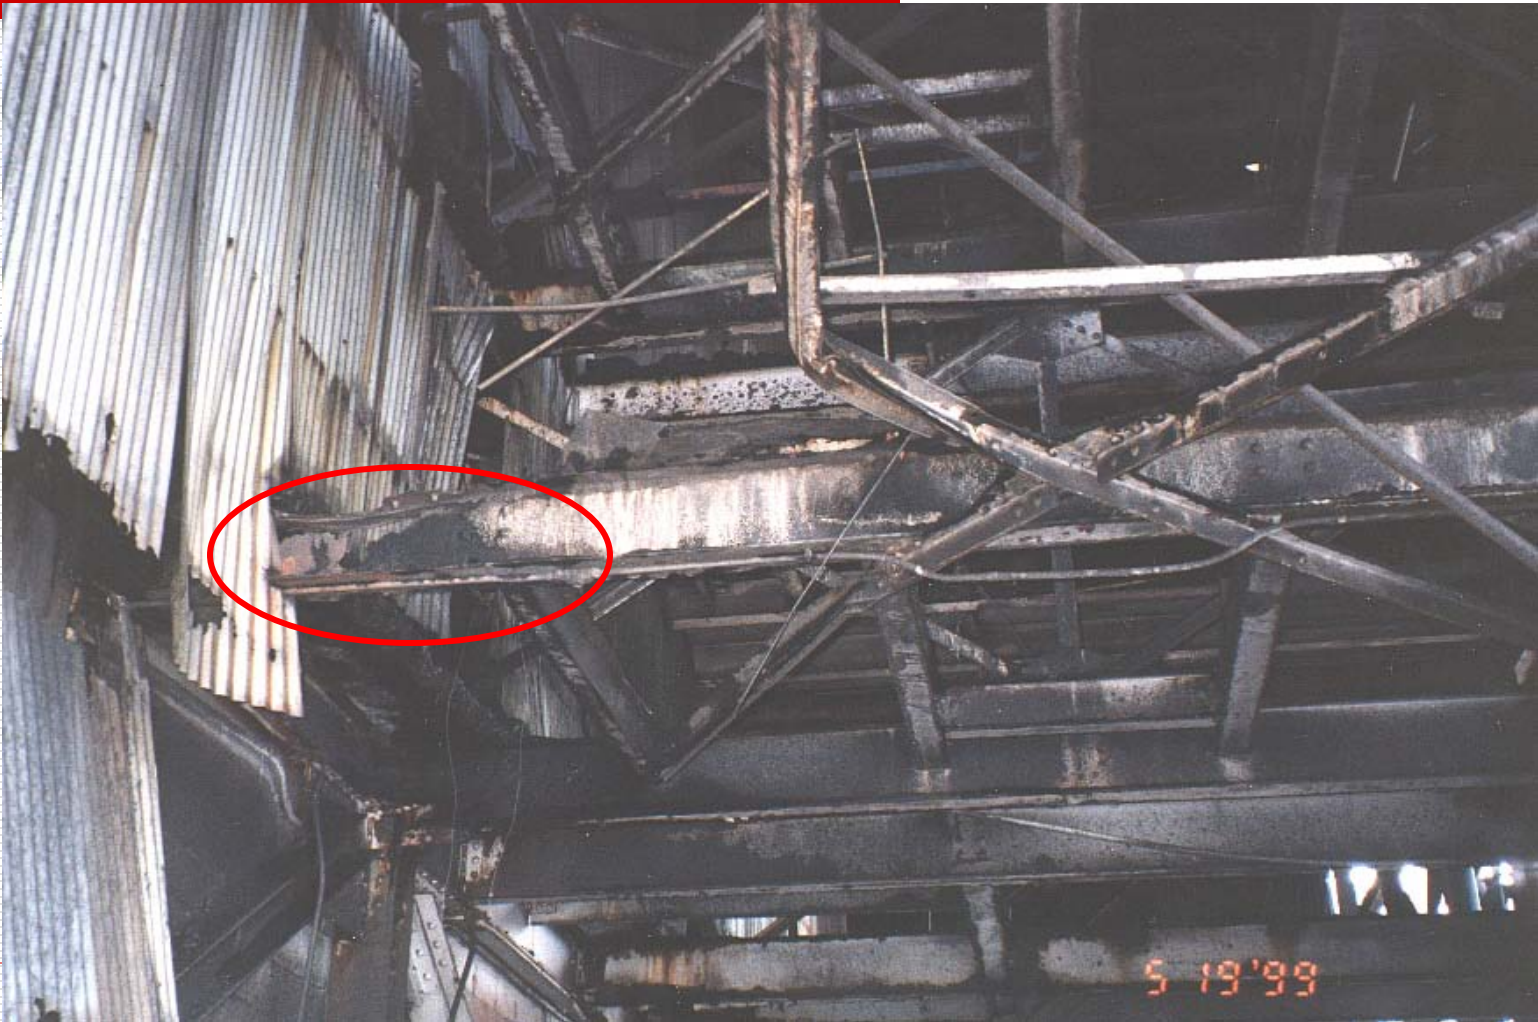
Corrosion hole in web & buckled top flange

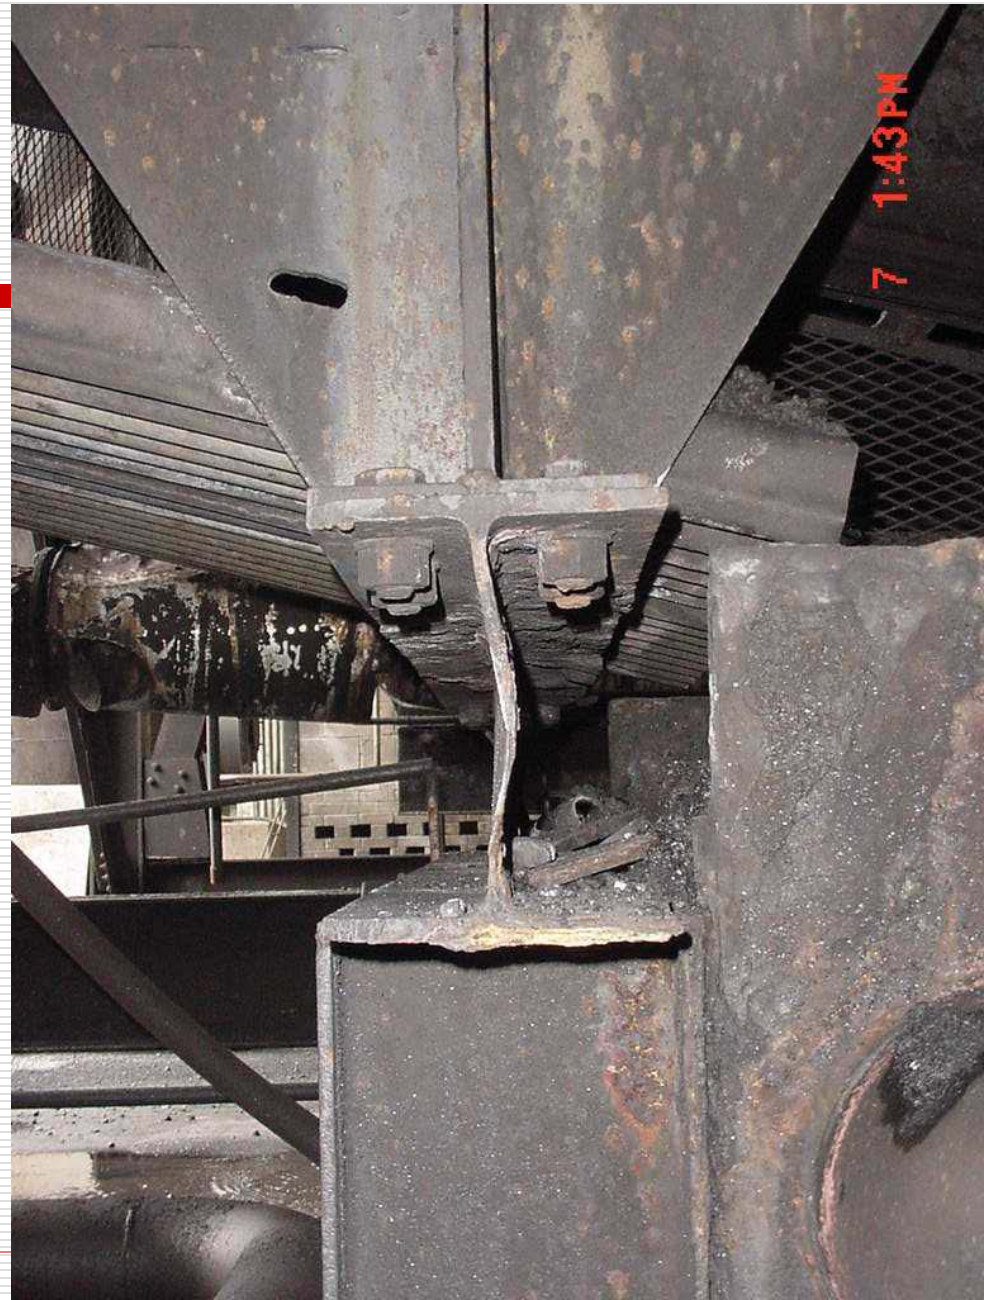
Buckled web

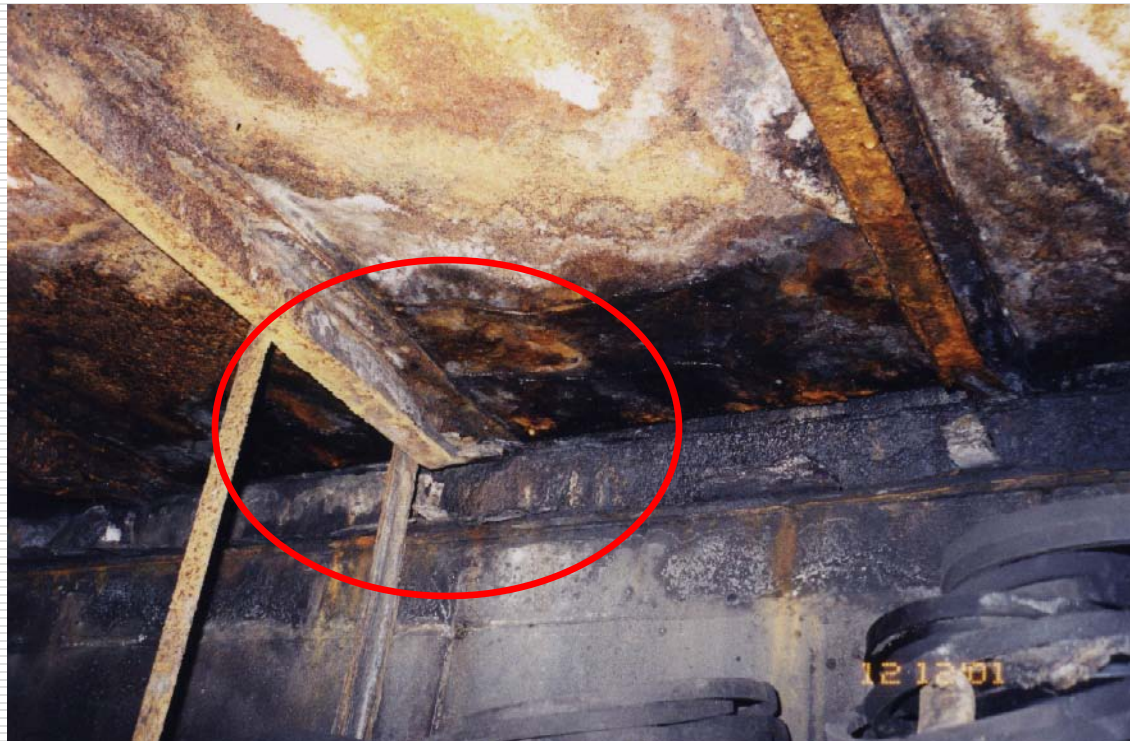
Buckled webs of corroded channels

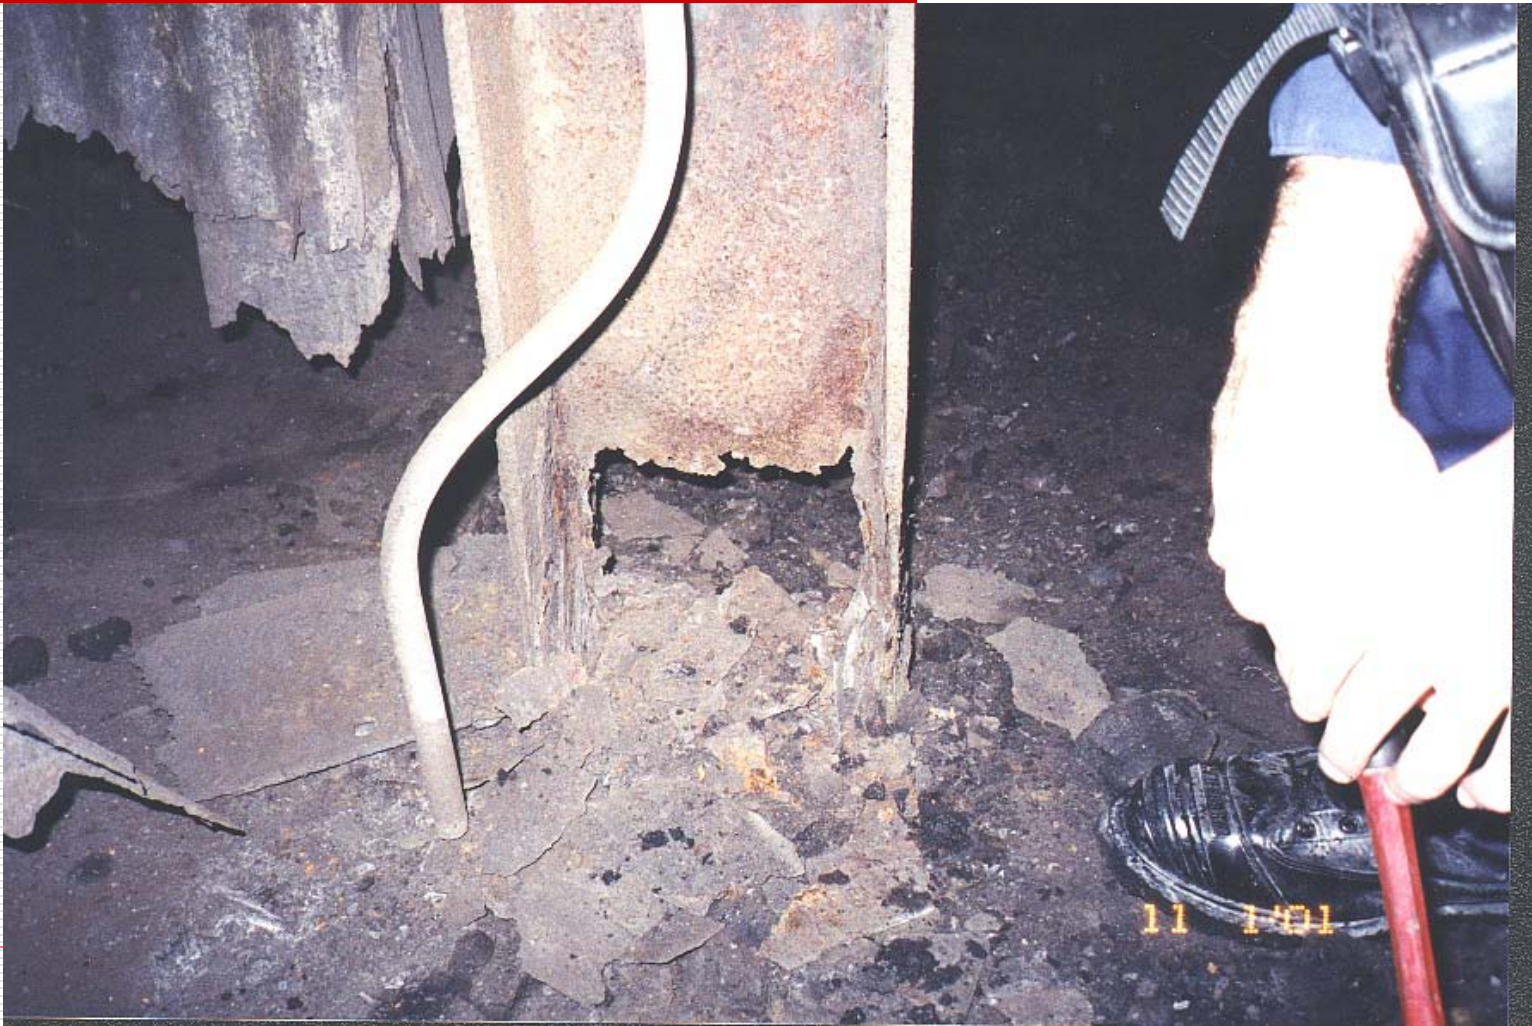
Buckled column flanges @ web corrosion hole 29

Corrosion hole in web of column

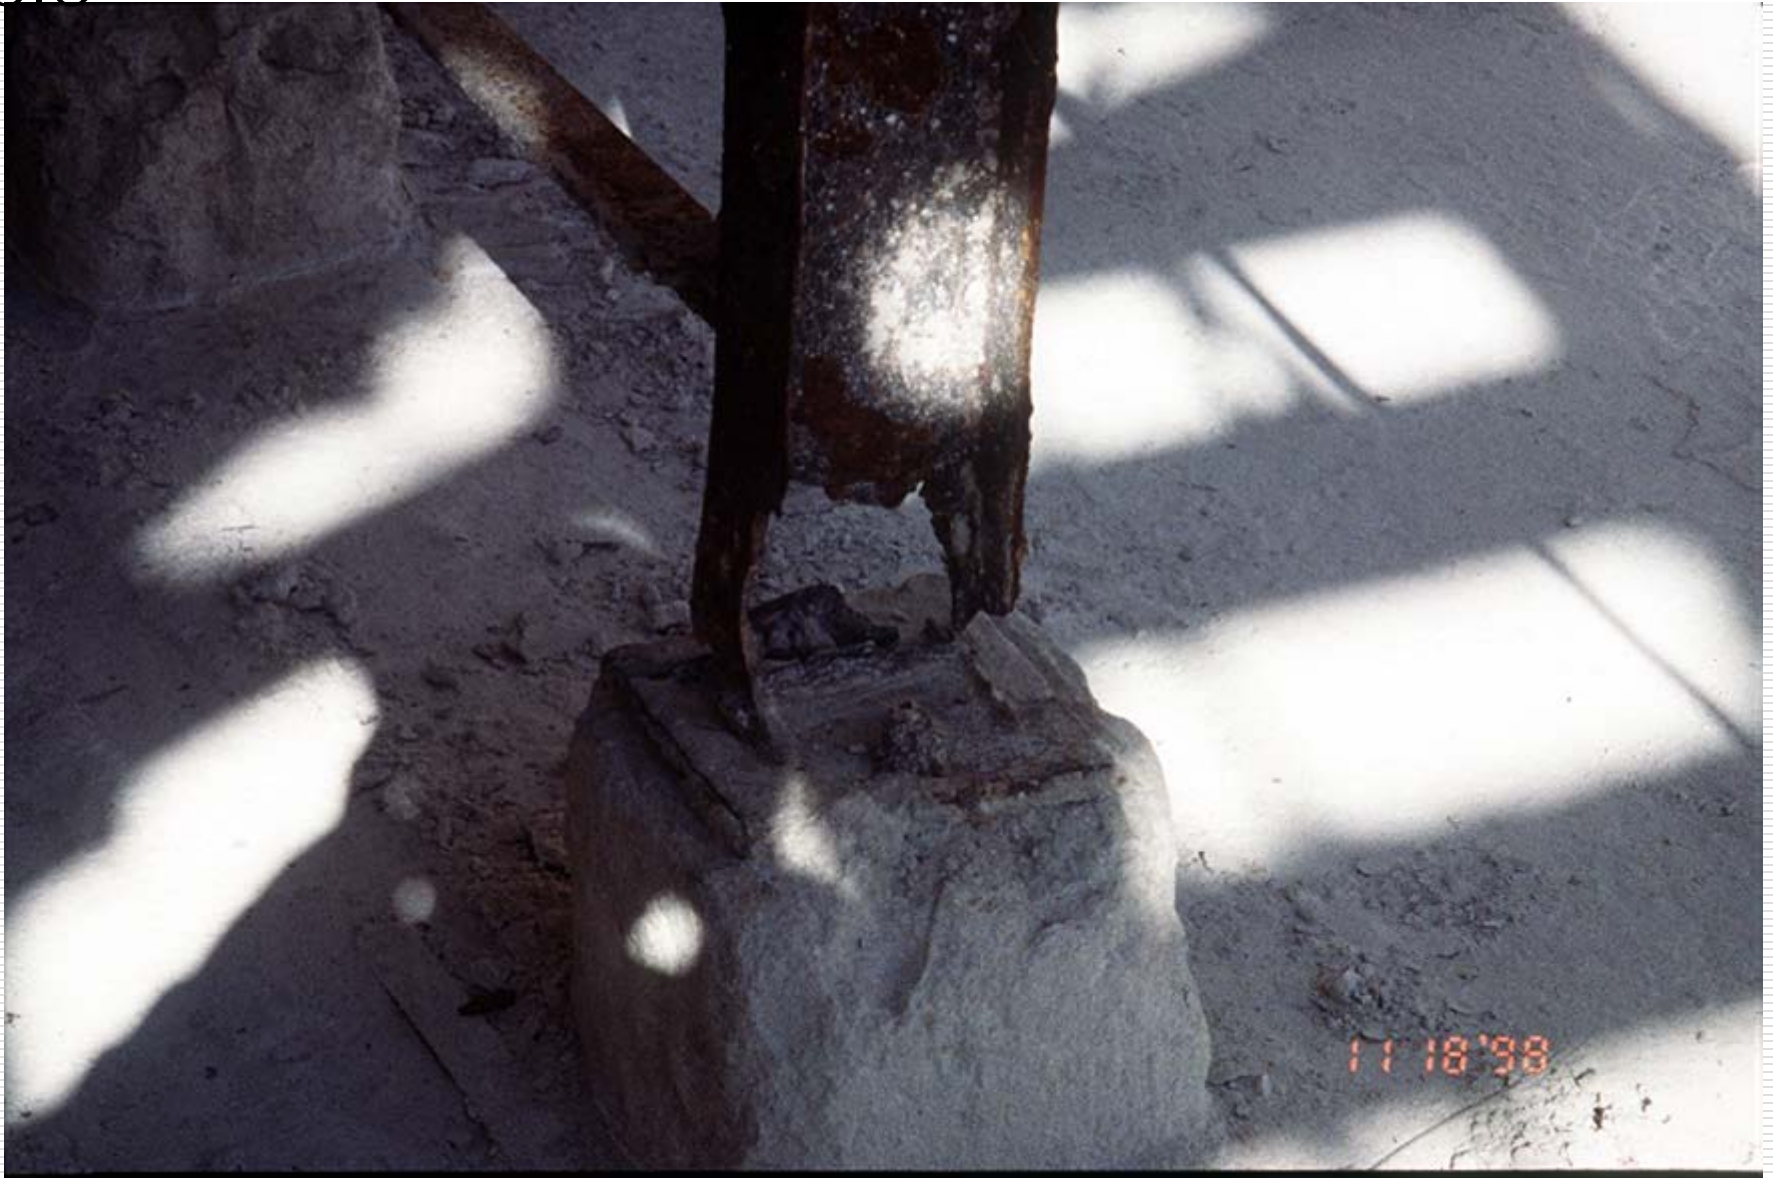
Buckled flanges at bottom of column @ corrosion hole

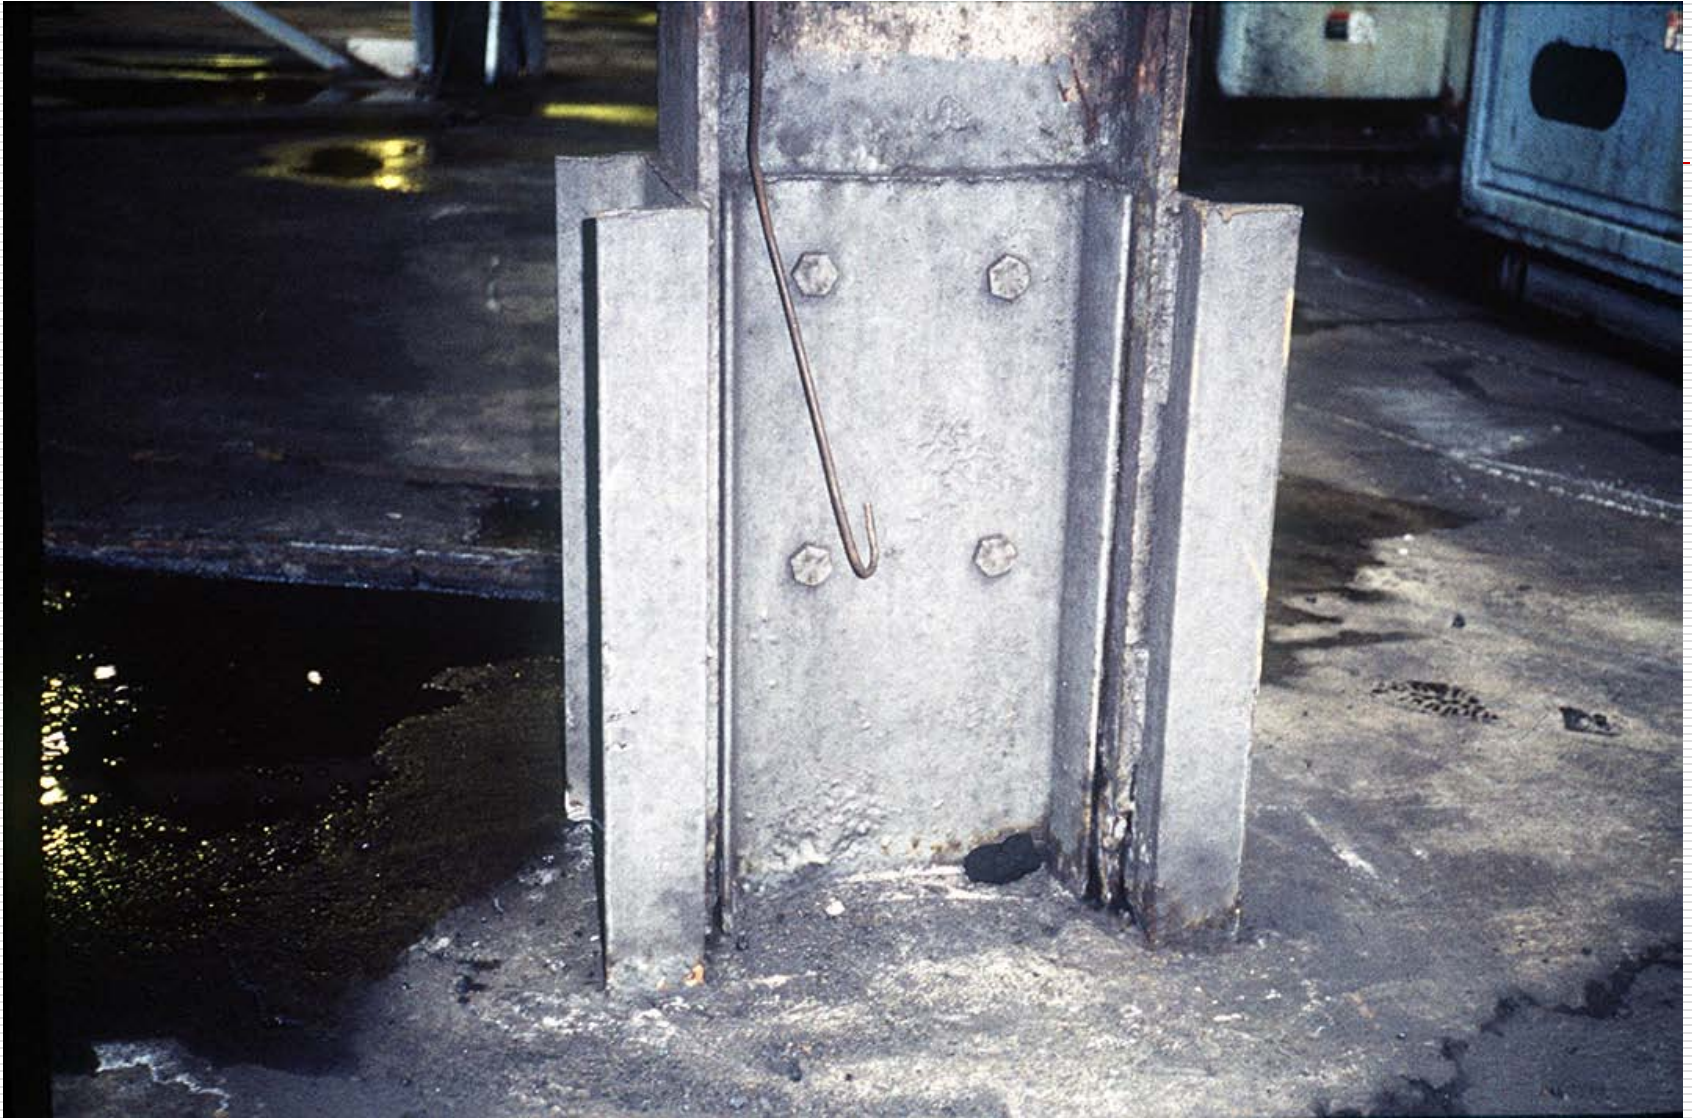
Repaired column base (appears good)

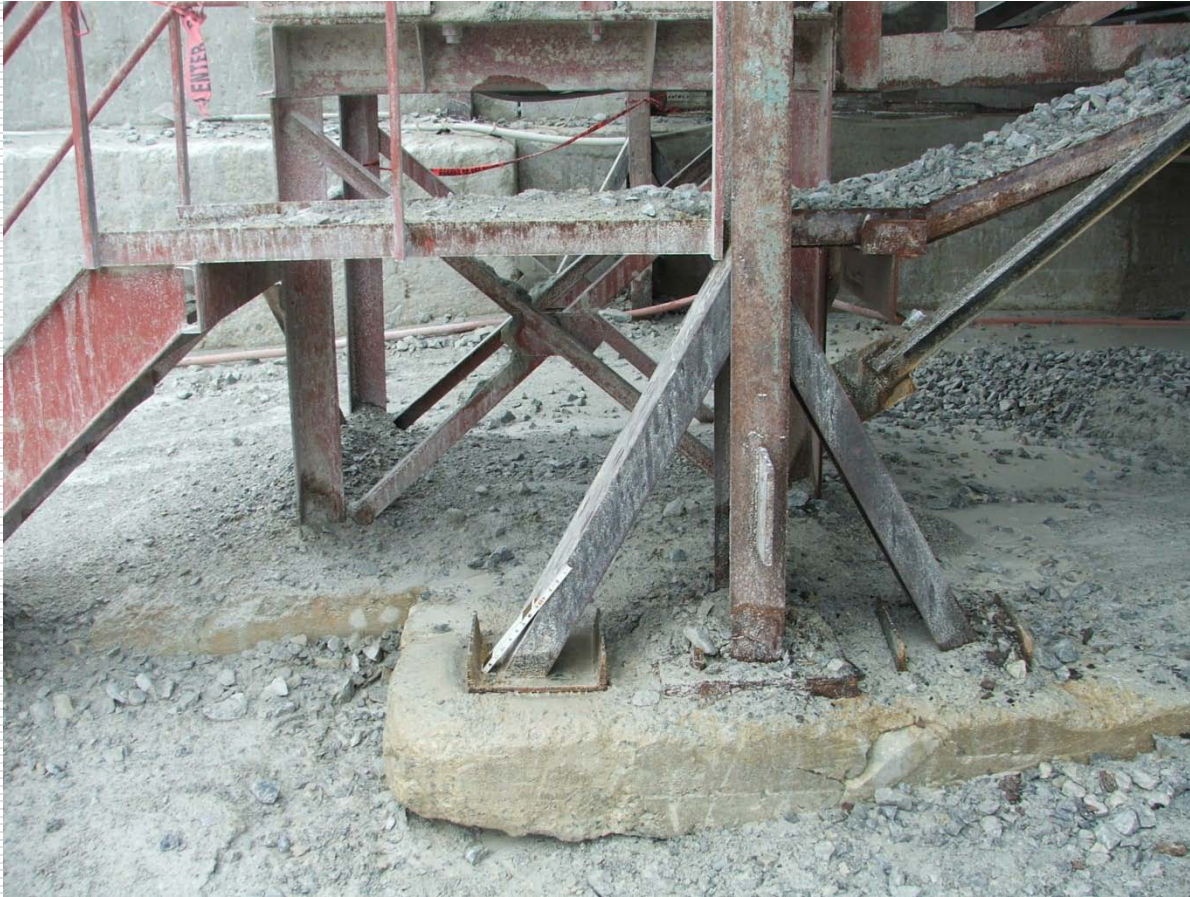
Bad Repair At Column Base
