Structural Inspection of Processing Plants

PowerPoint prepared by Terry Taylor, P.E.,
Senior Civil Engineer, PSHTC

Inspection of Processing Plants

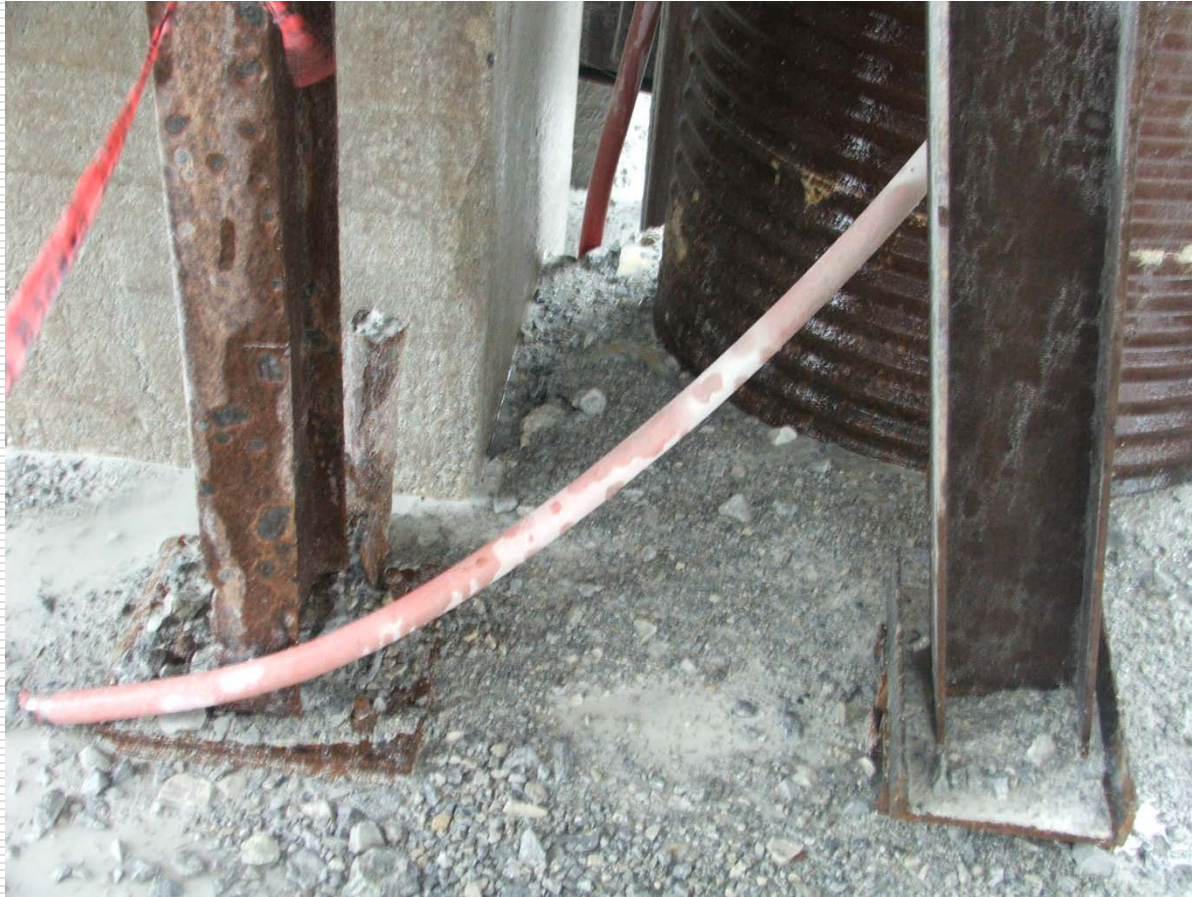
Another Bad Column Repair (base)

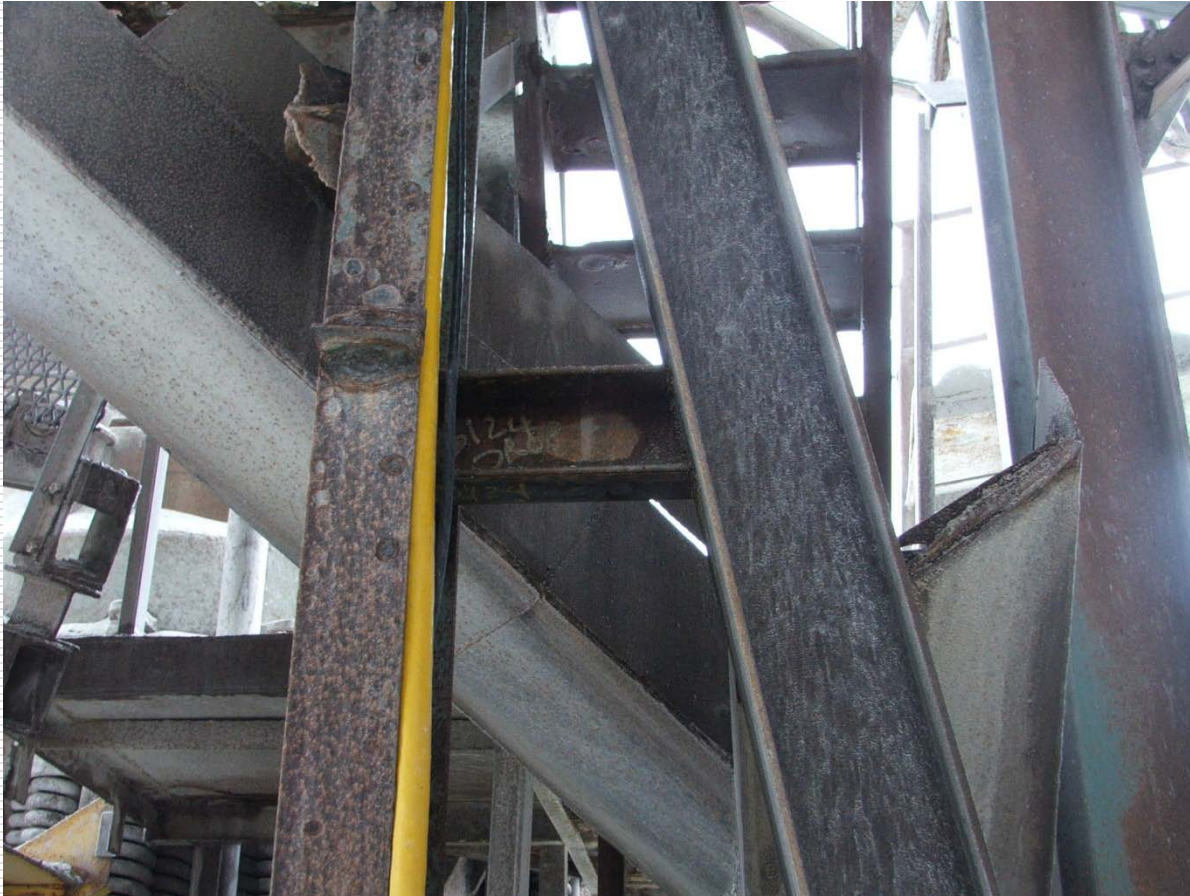
... a few feet up from base

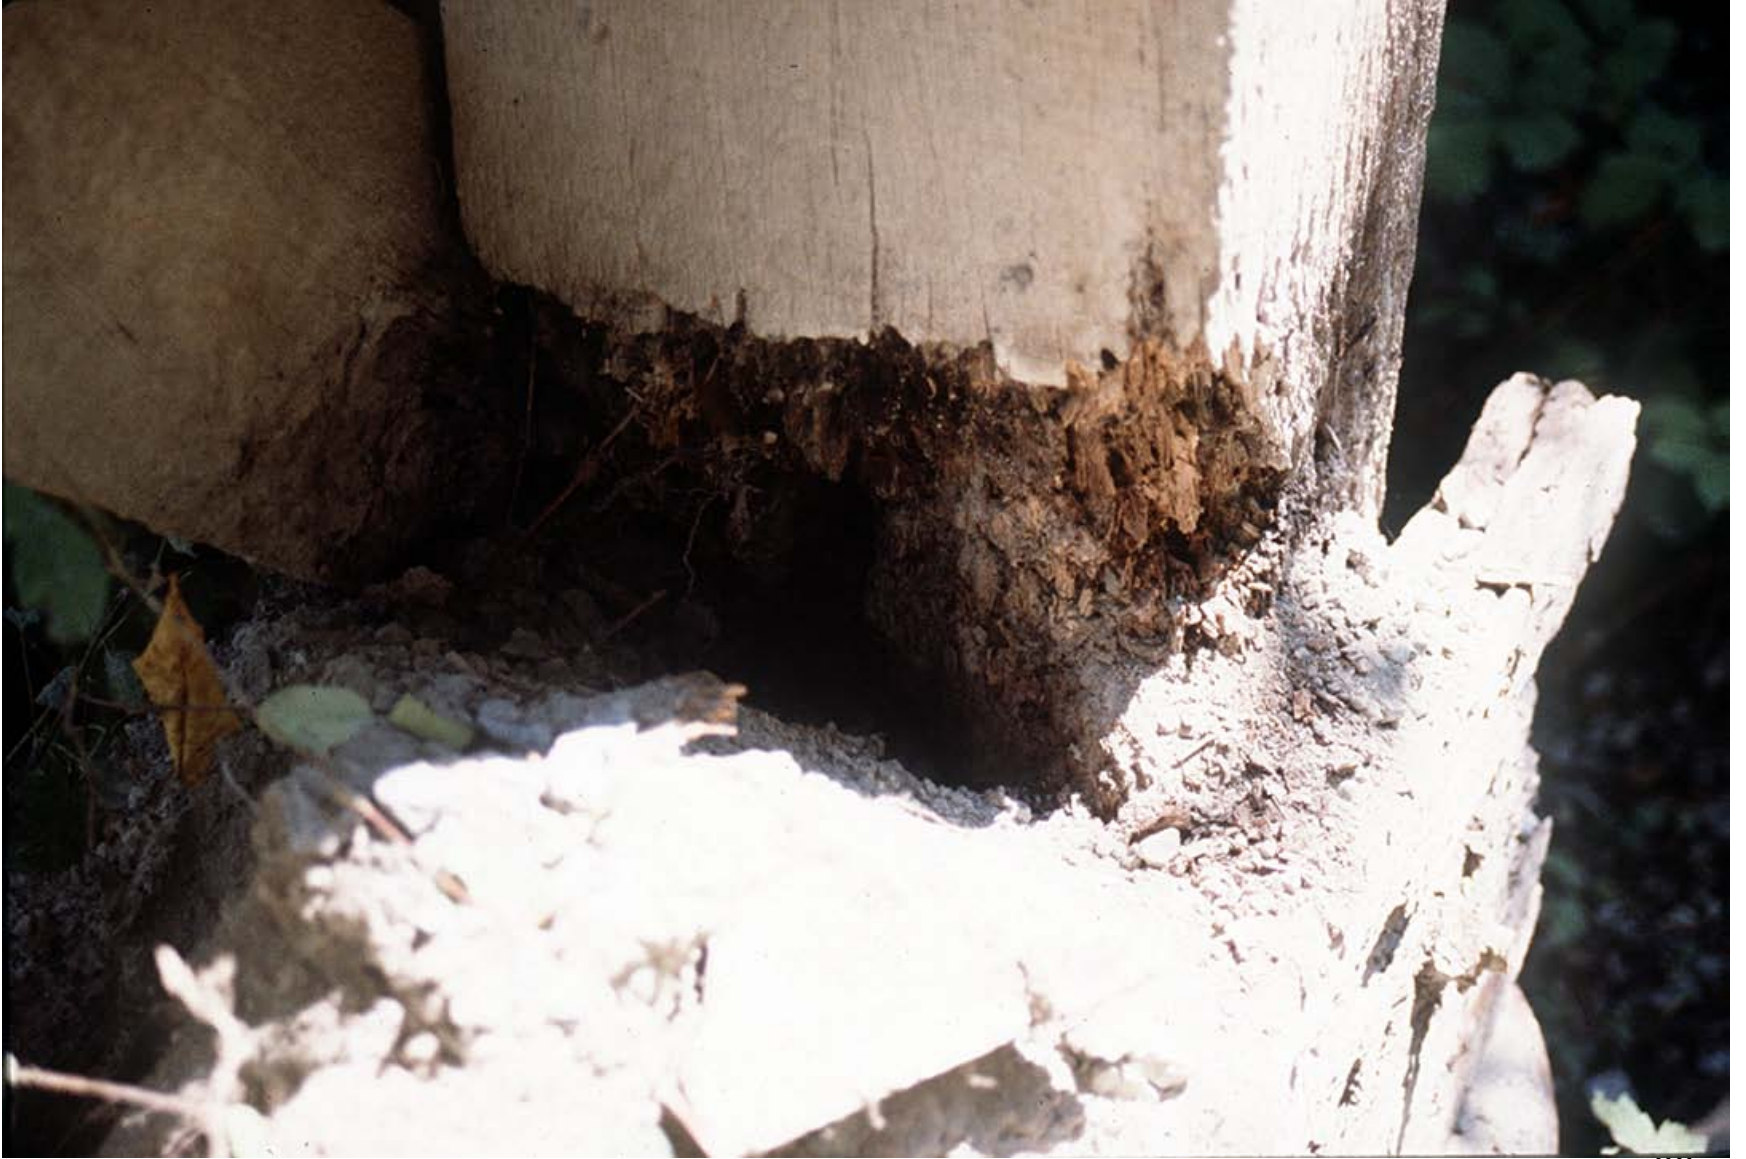
Rotted timber column

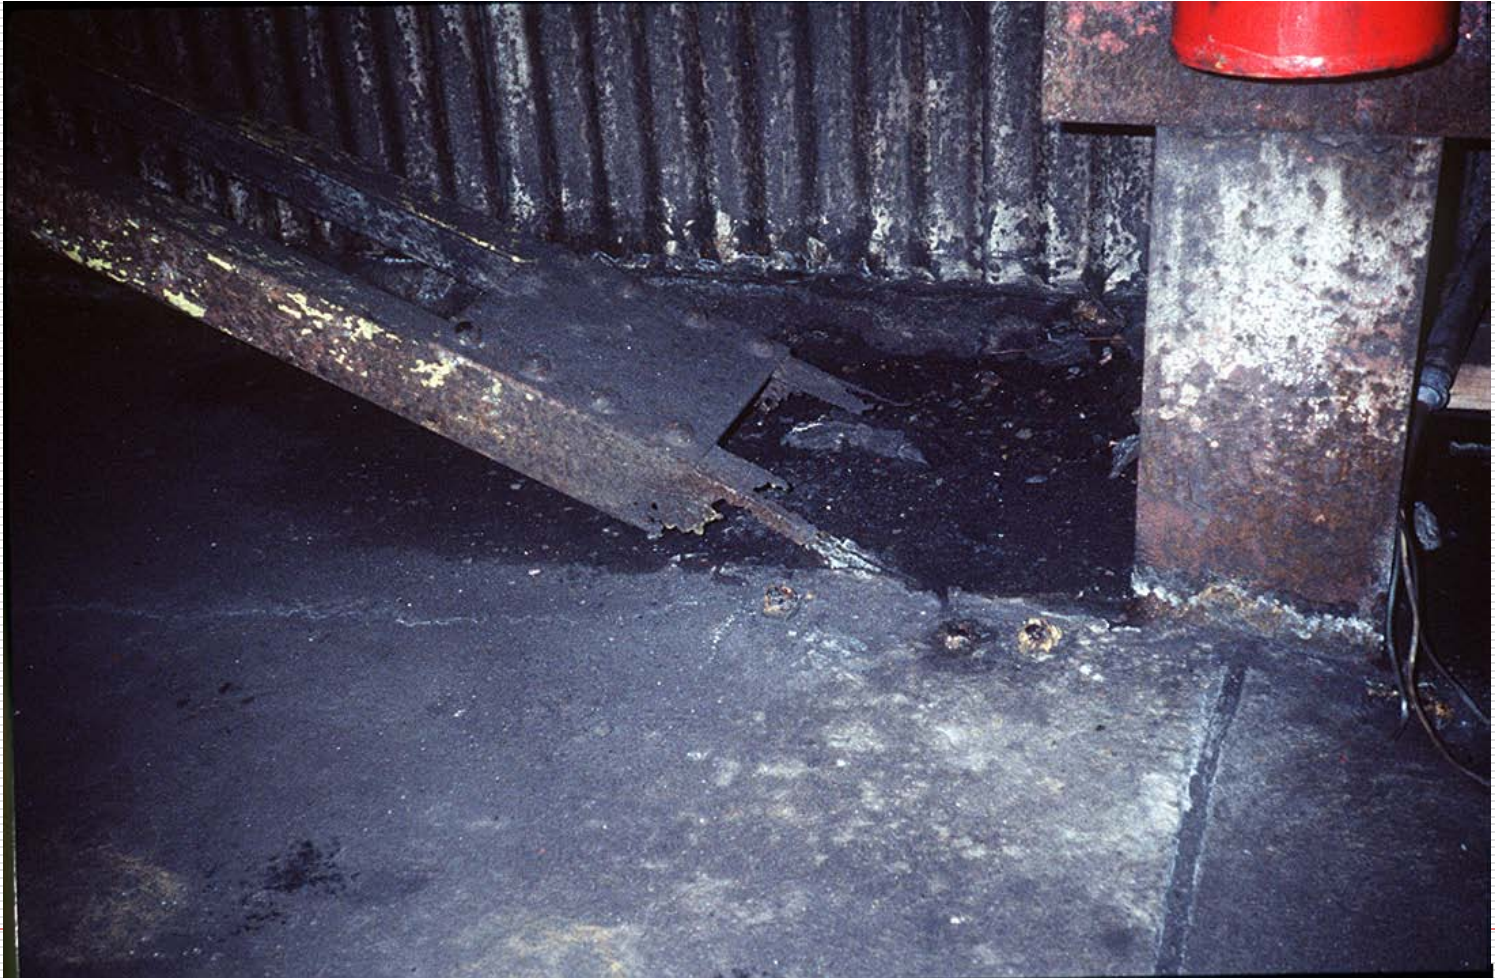
Corroded diagonal brace

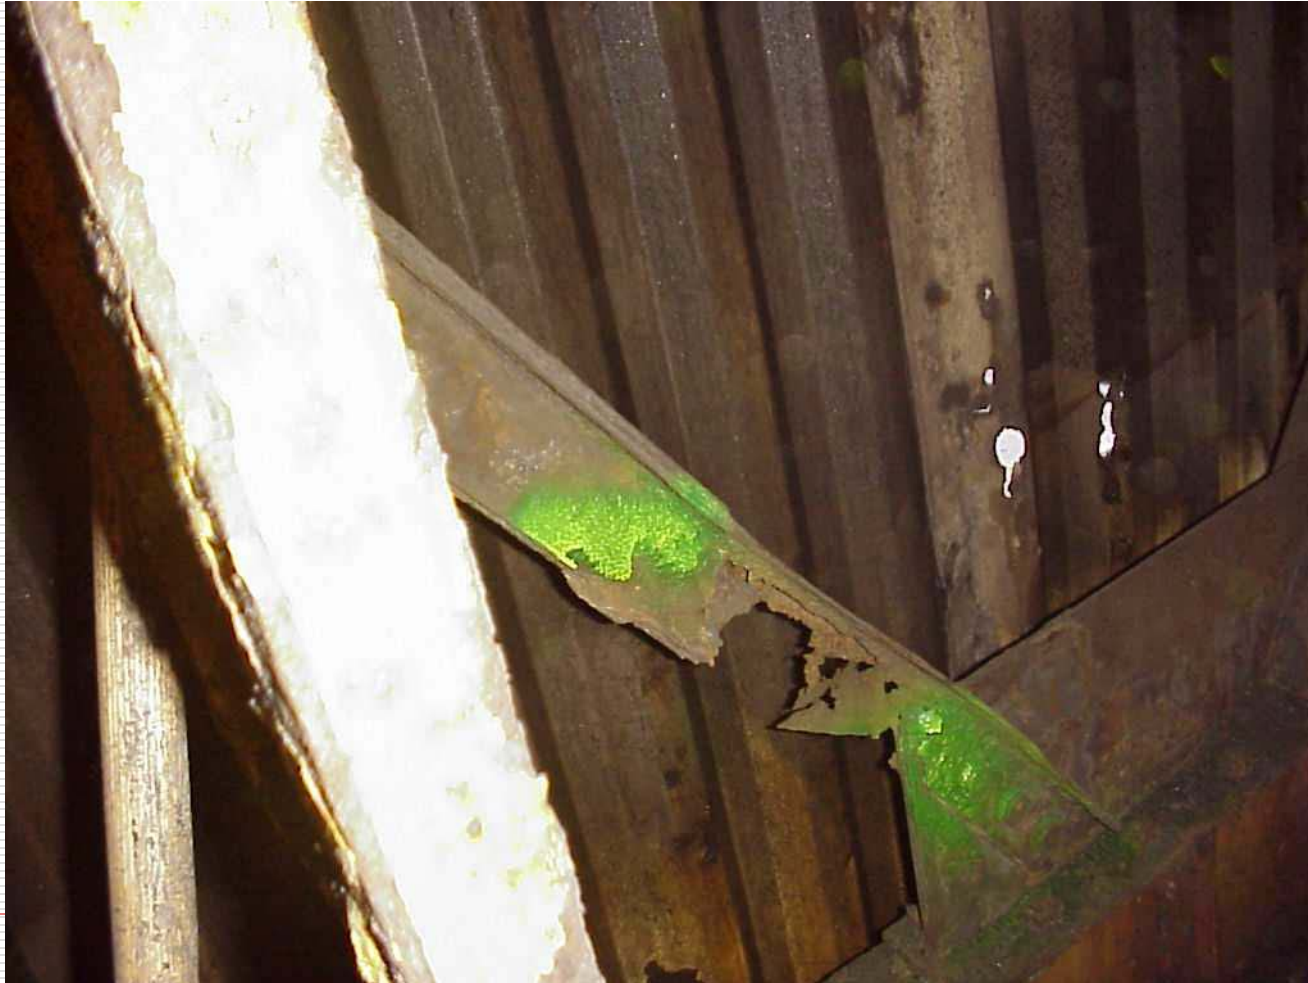
Corroded diagonal

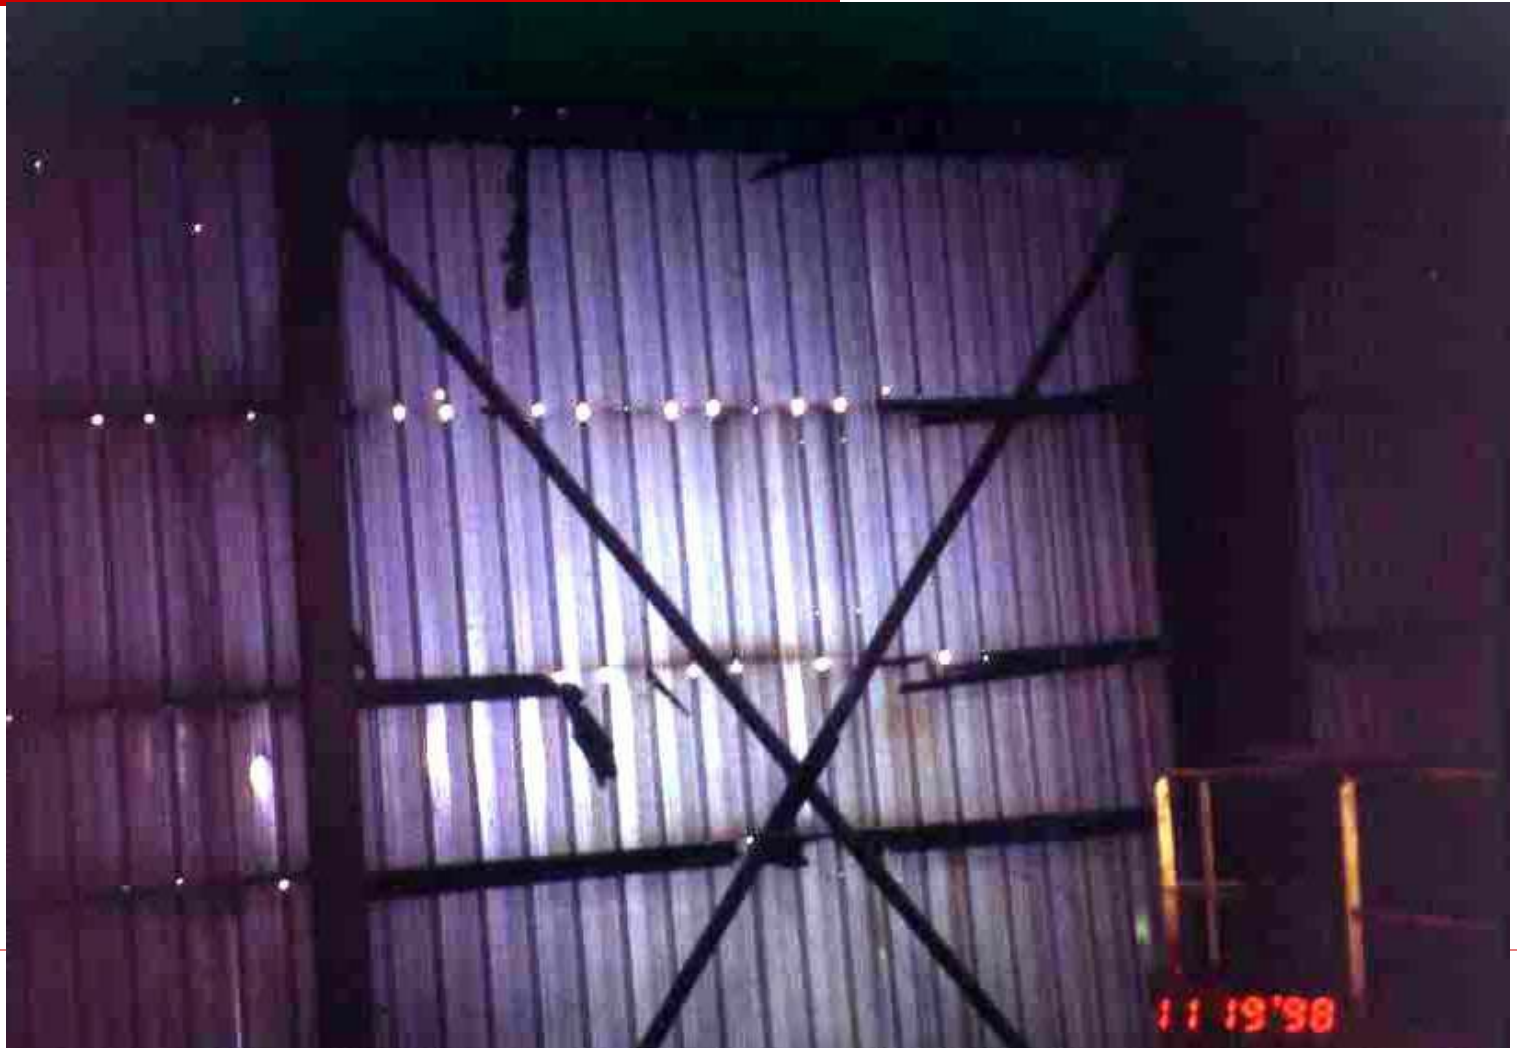
Corroded channels/girts supporting the siding

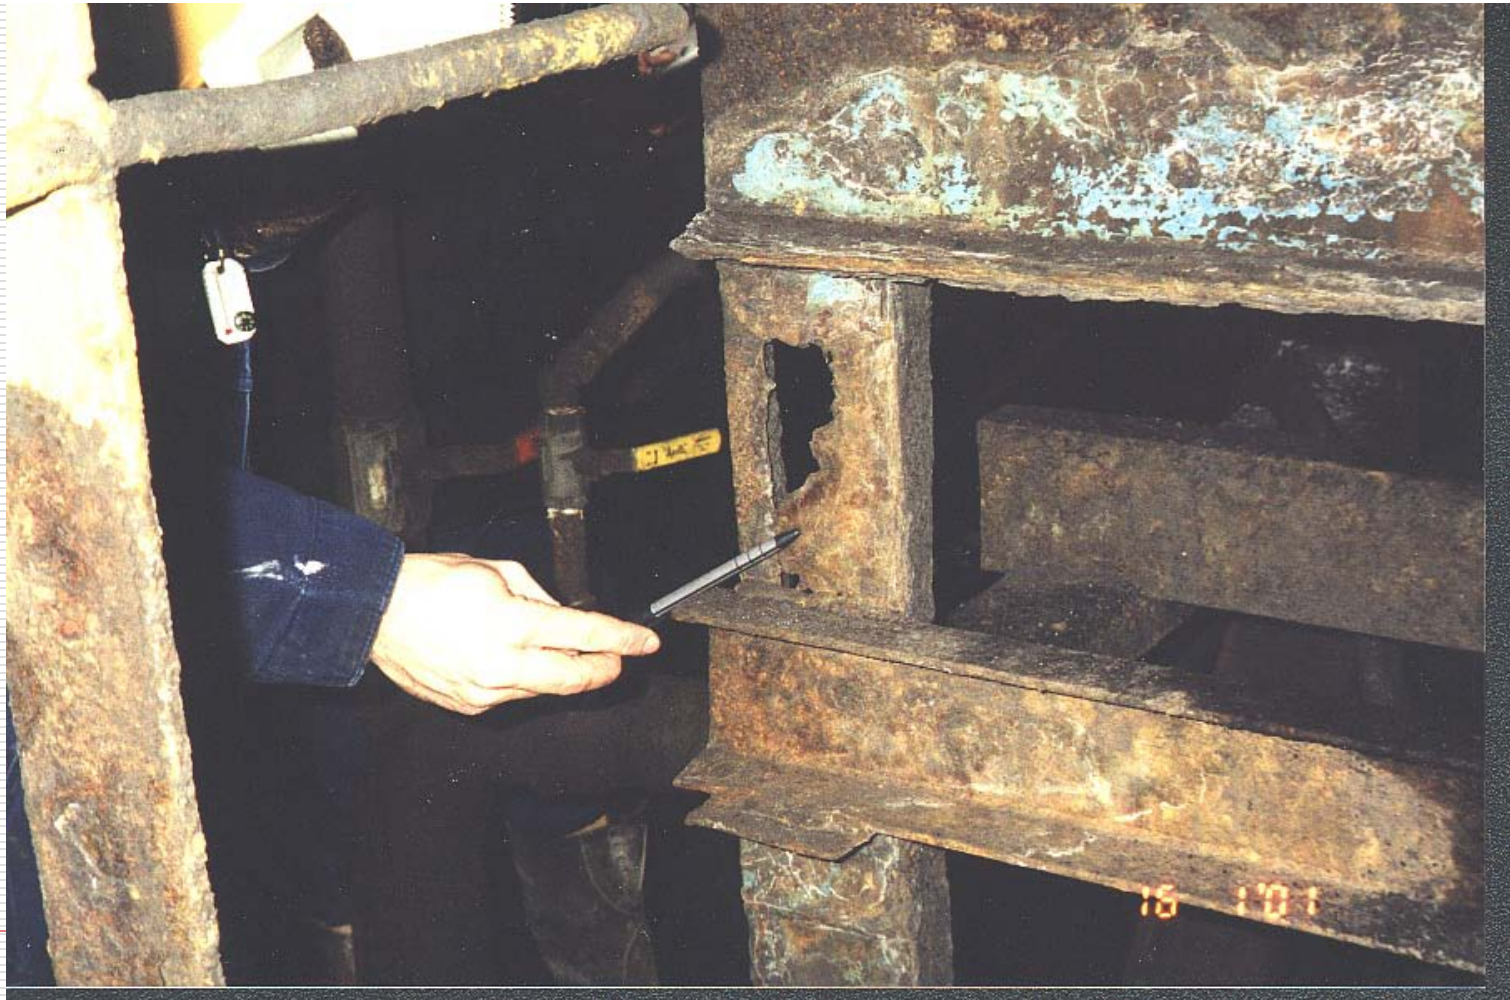
Check equipment supports! Corrosion hole in channel post for a magnetic separator

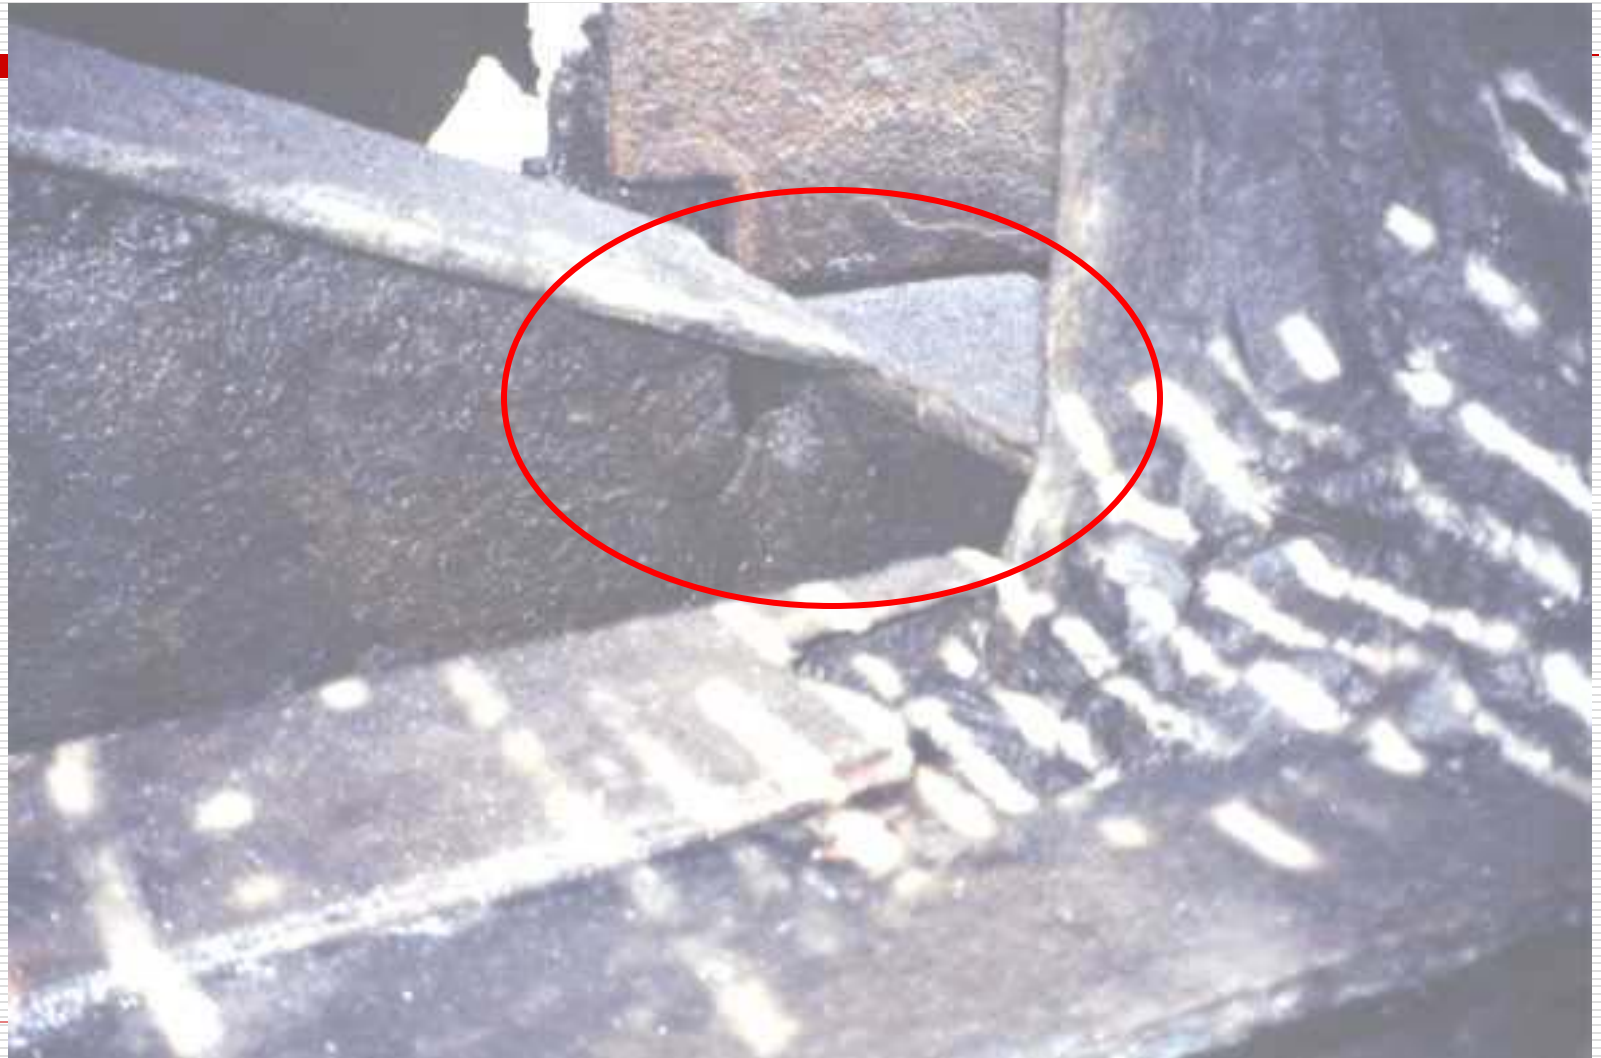
Crack in a support beam for a shaker screen

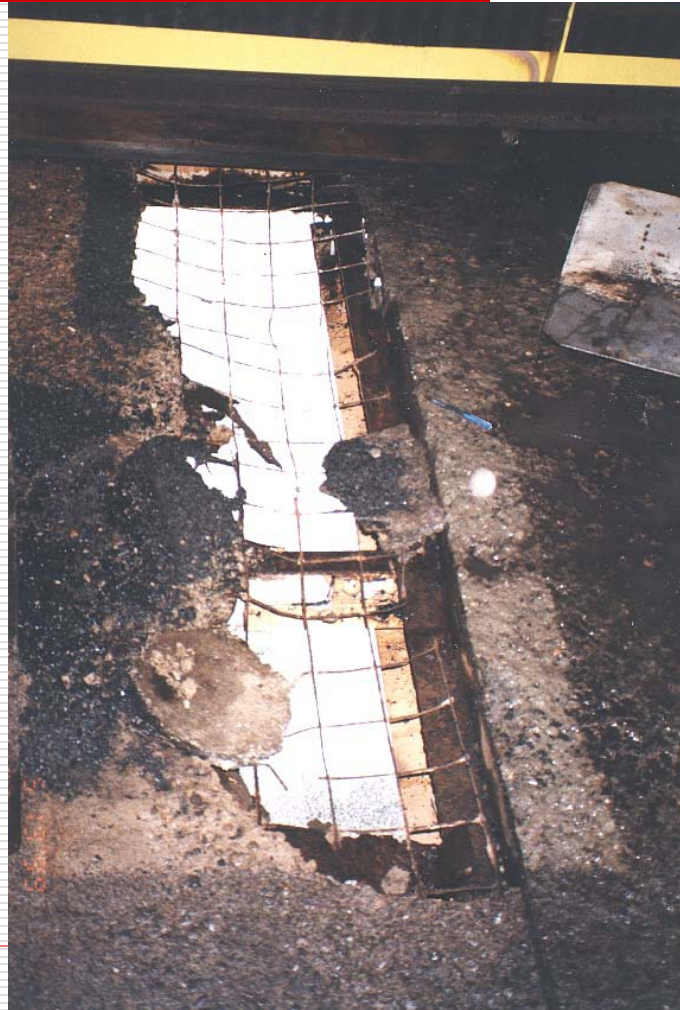
Deteriorated concrete flooring

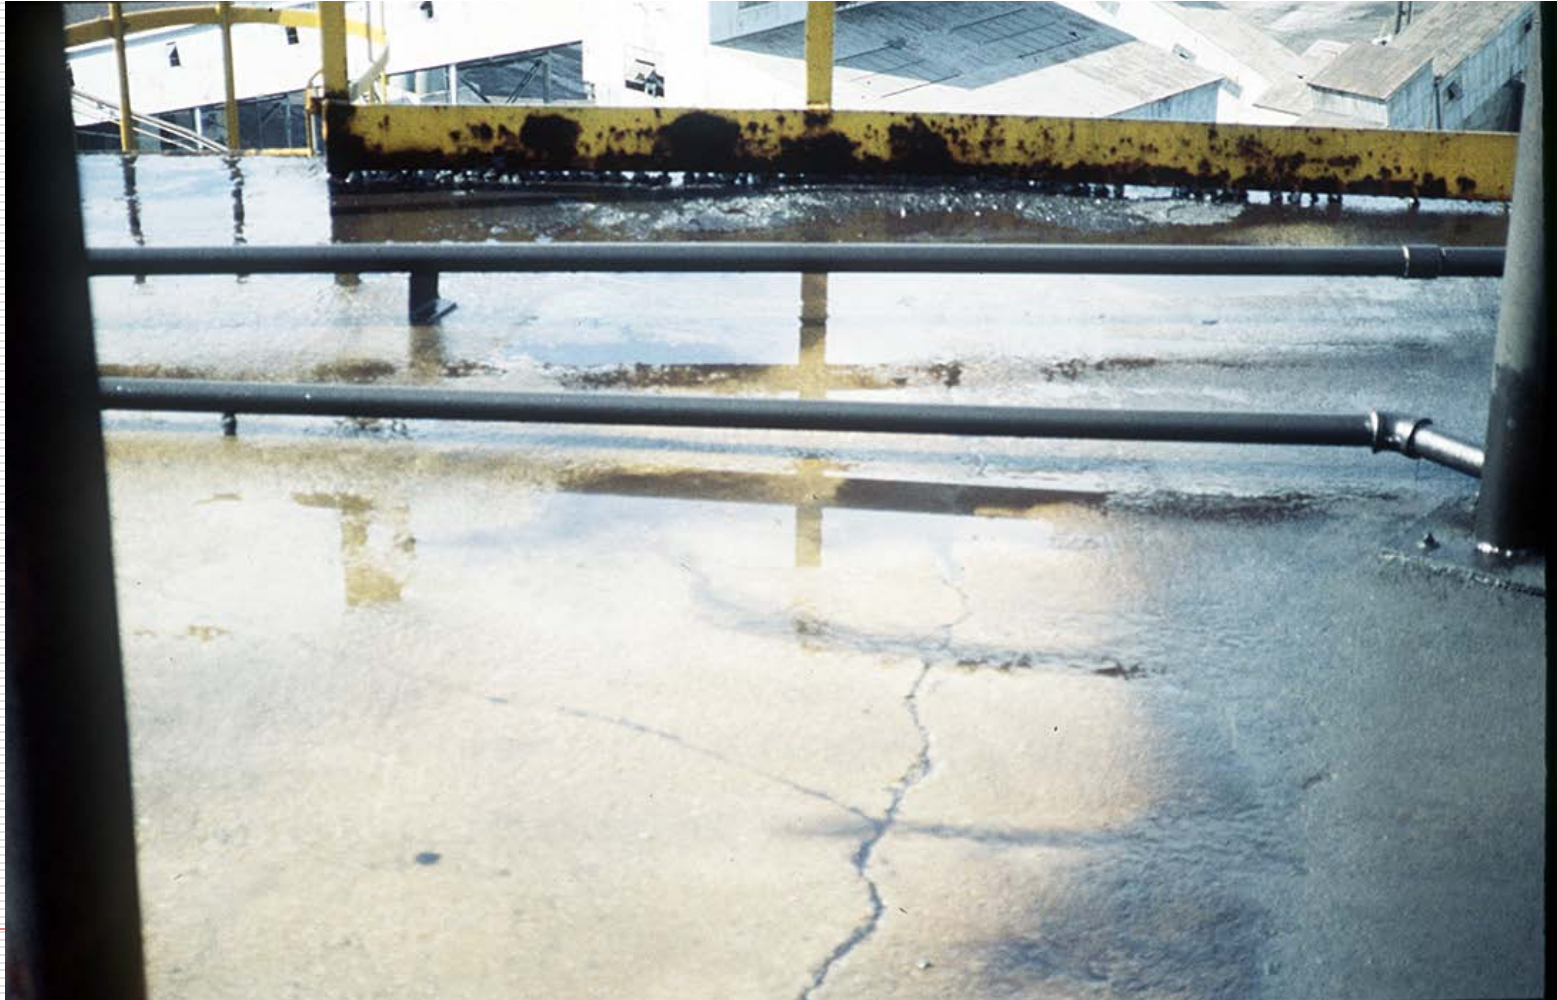
Floor slab cracks - a potential source of rebar corrosion

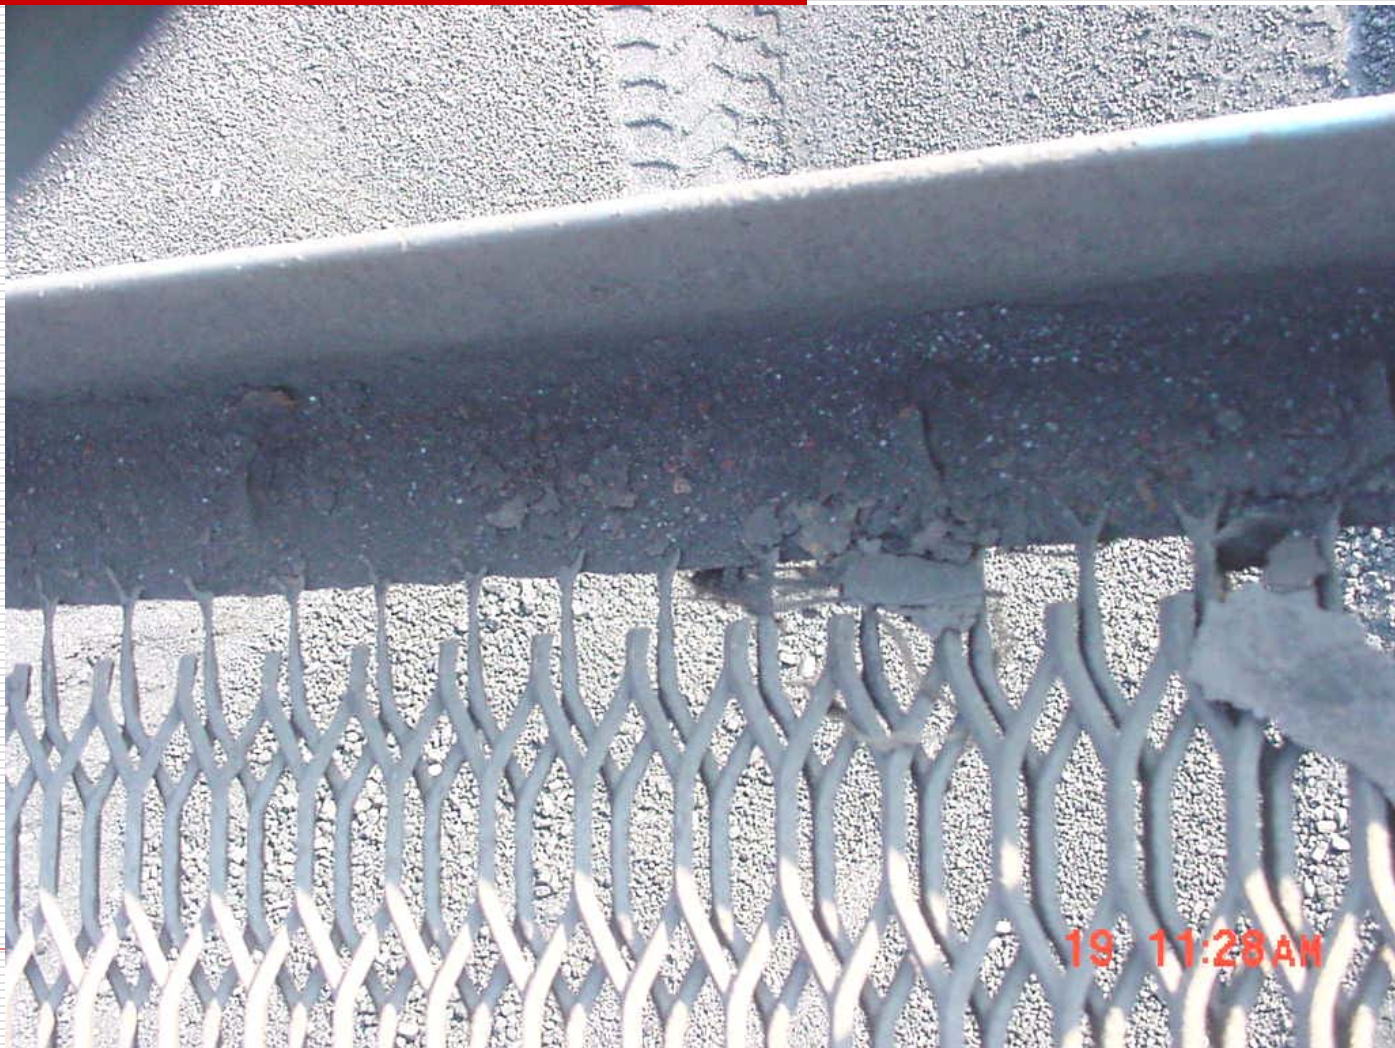
Corrosion at support edge of grating

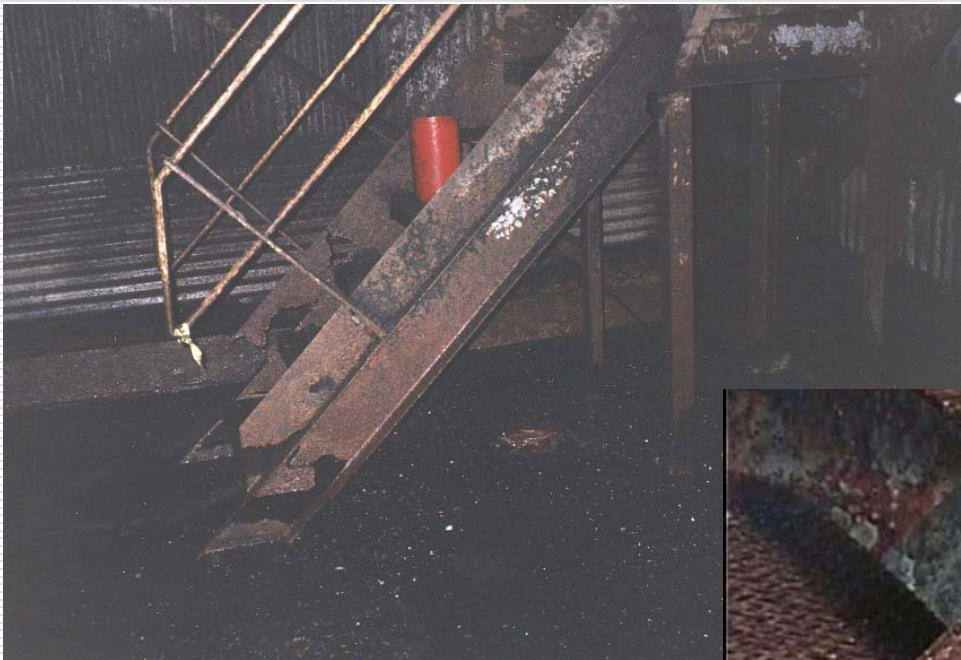
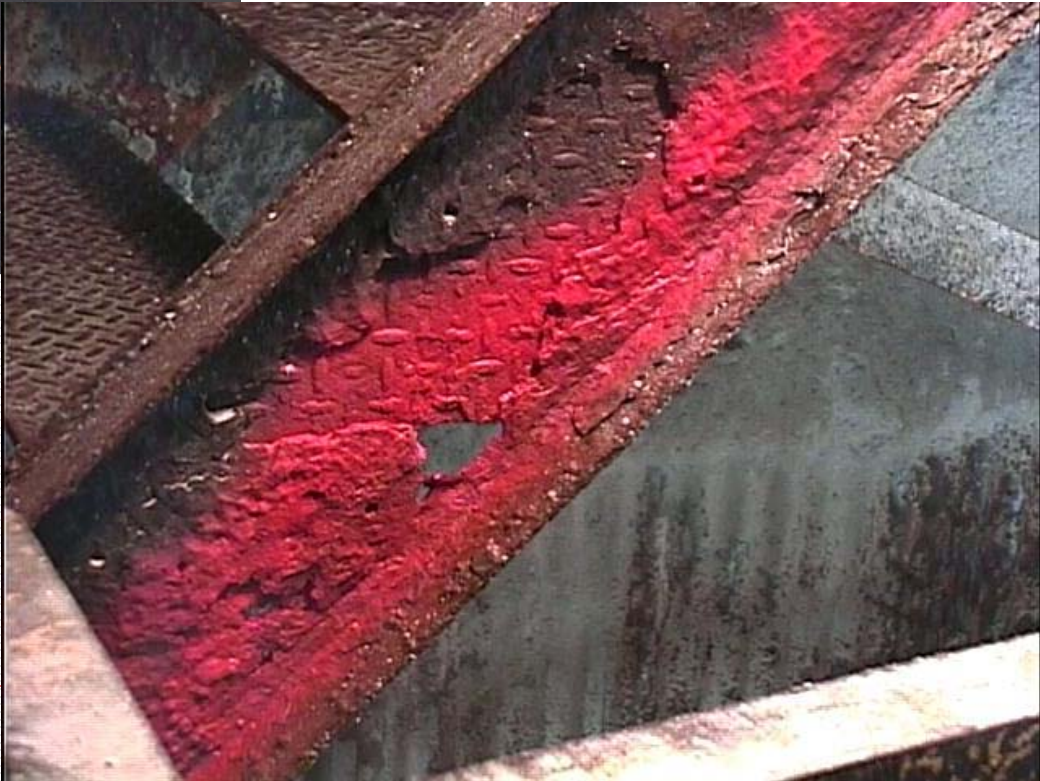
Corroded stair channels

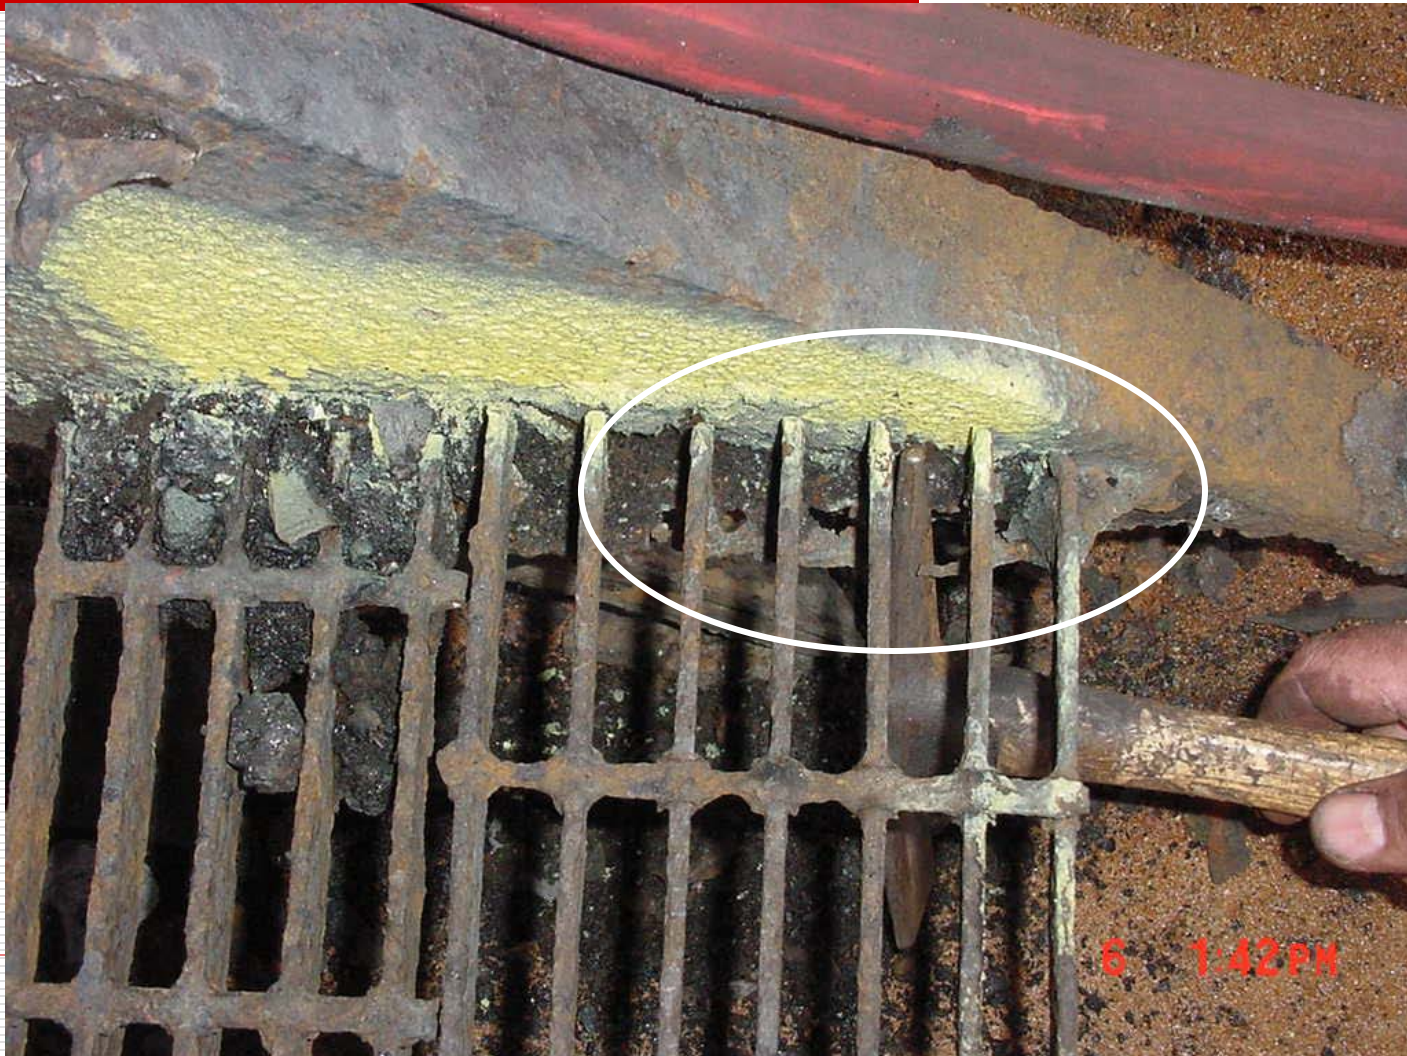
Corroded angle supporting stair tread

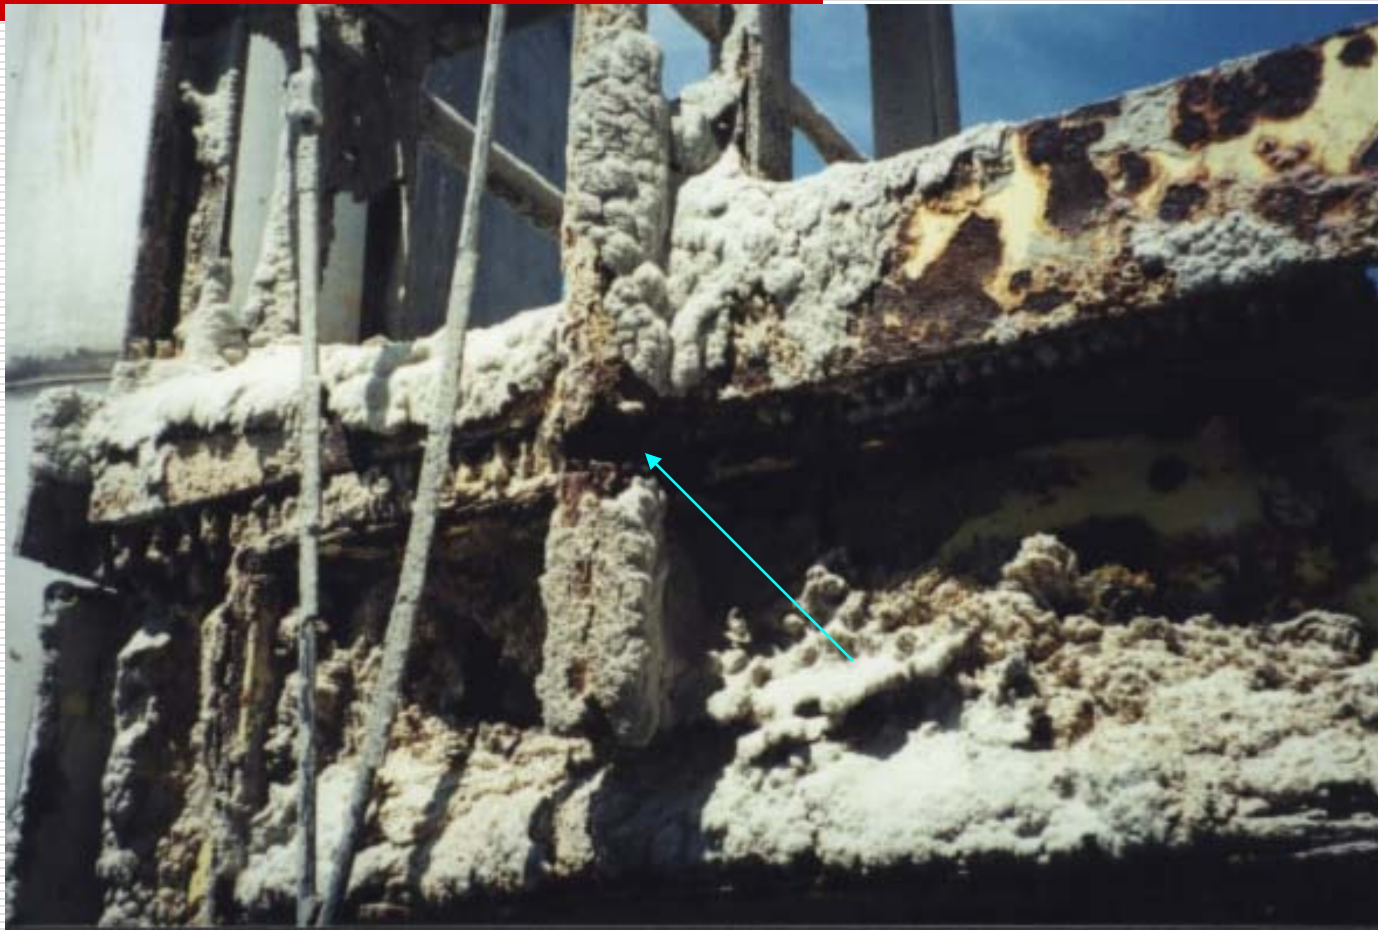
Corrosion holes in handrail support post

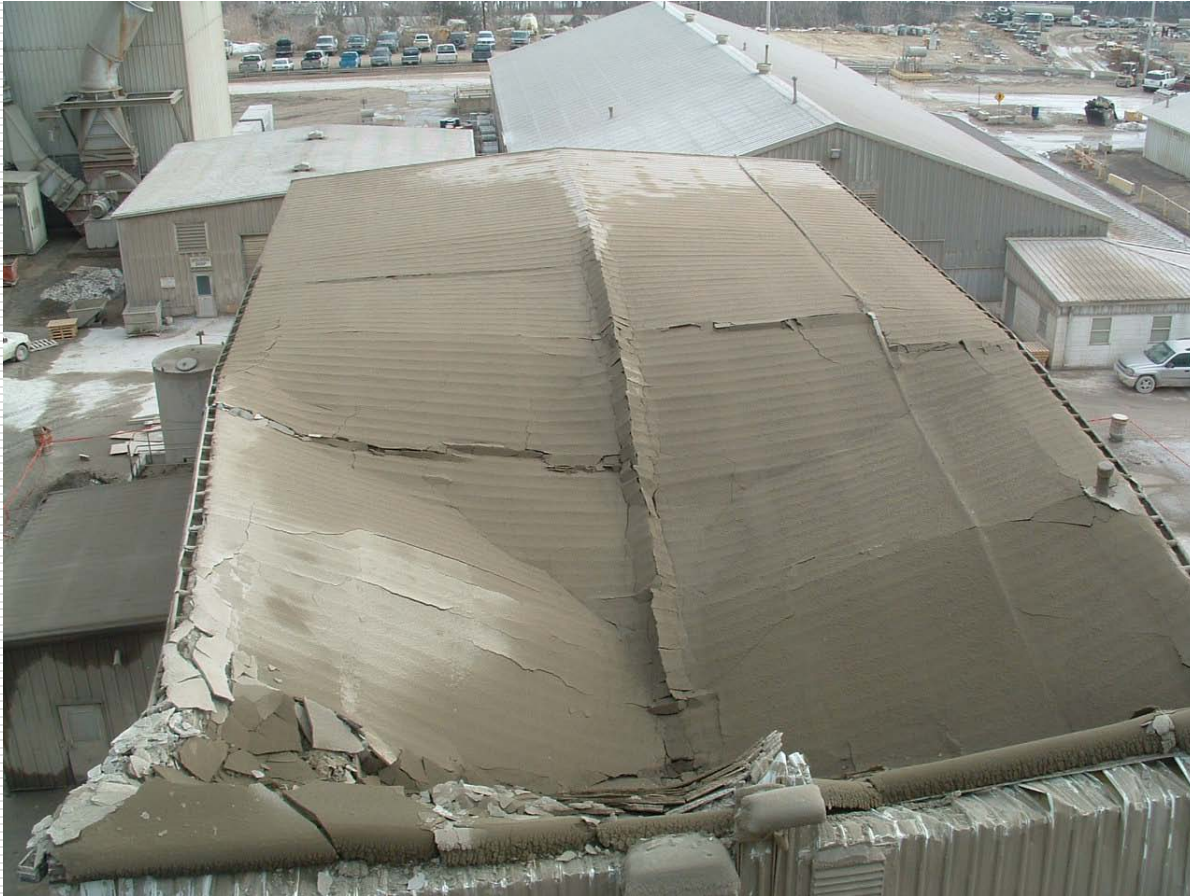
Roof Collapse Due to Clinker Buildup and Snow Load

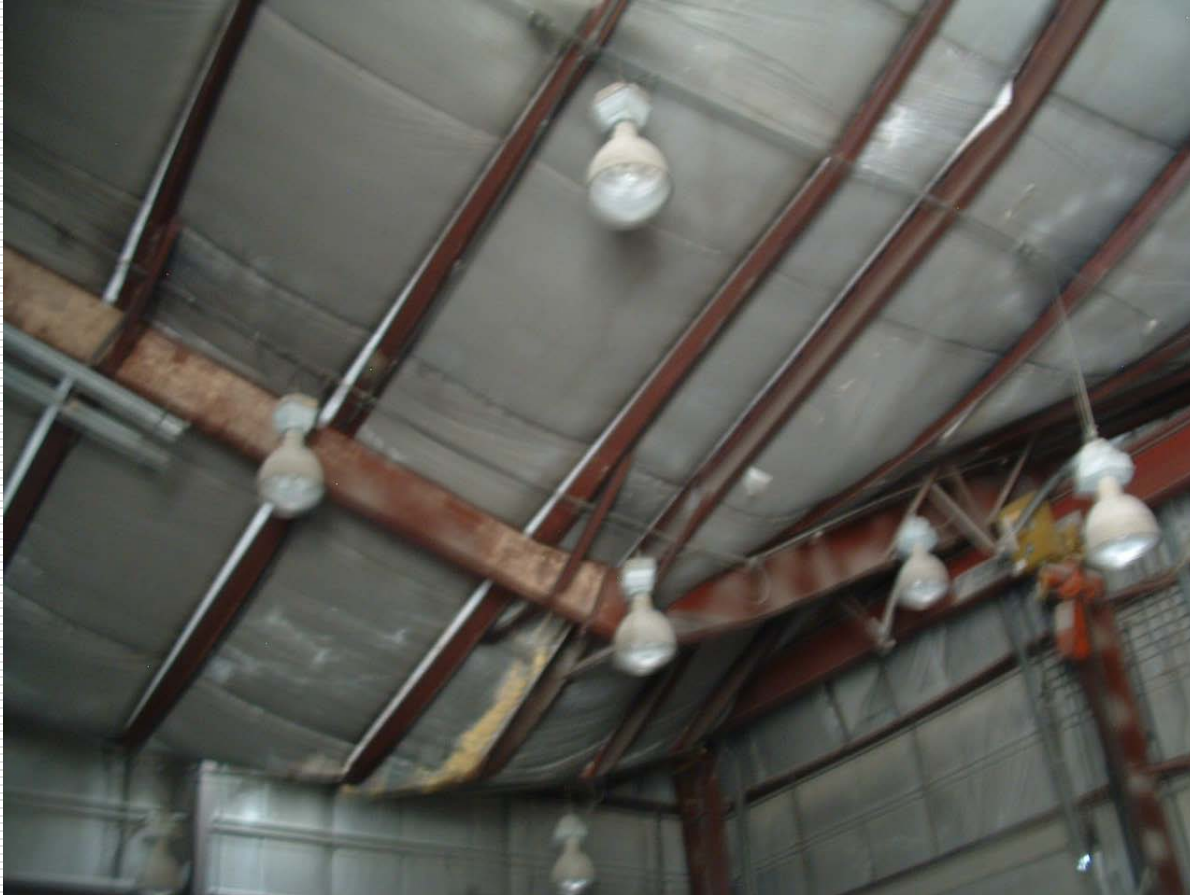
Inside of Failed Structure
