Structural Inspection of Processing Plants

PowerPoint prepared by Terry Taylor, P.E.,
Senior Civil Engineer, PSHTC

Inspection of Processing Plants

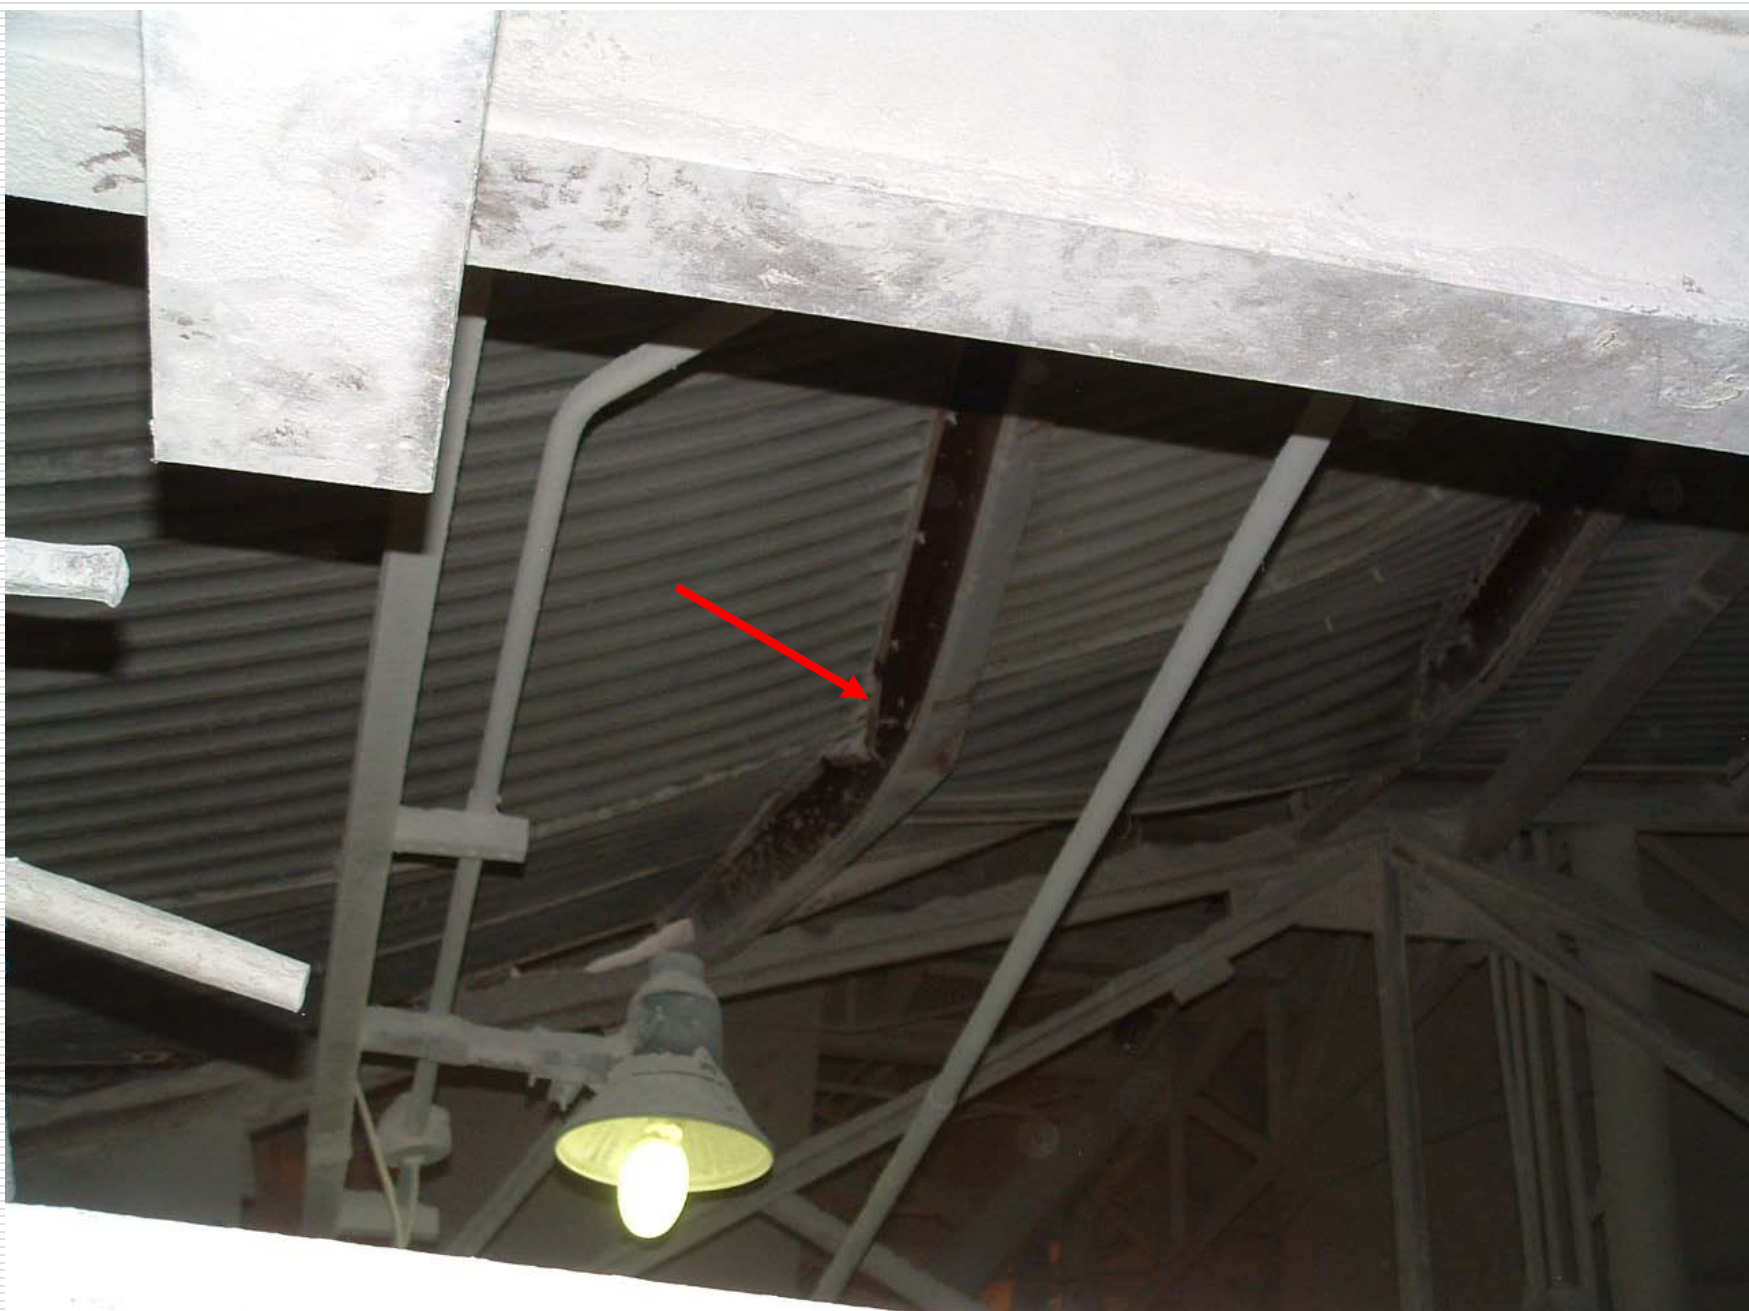
Collapsing Roof Support Purlins

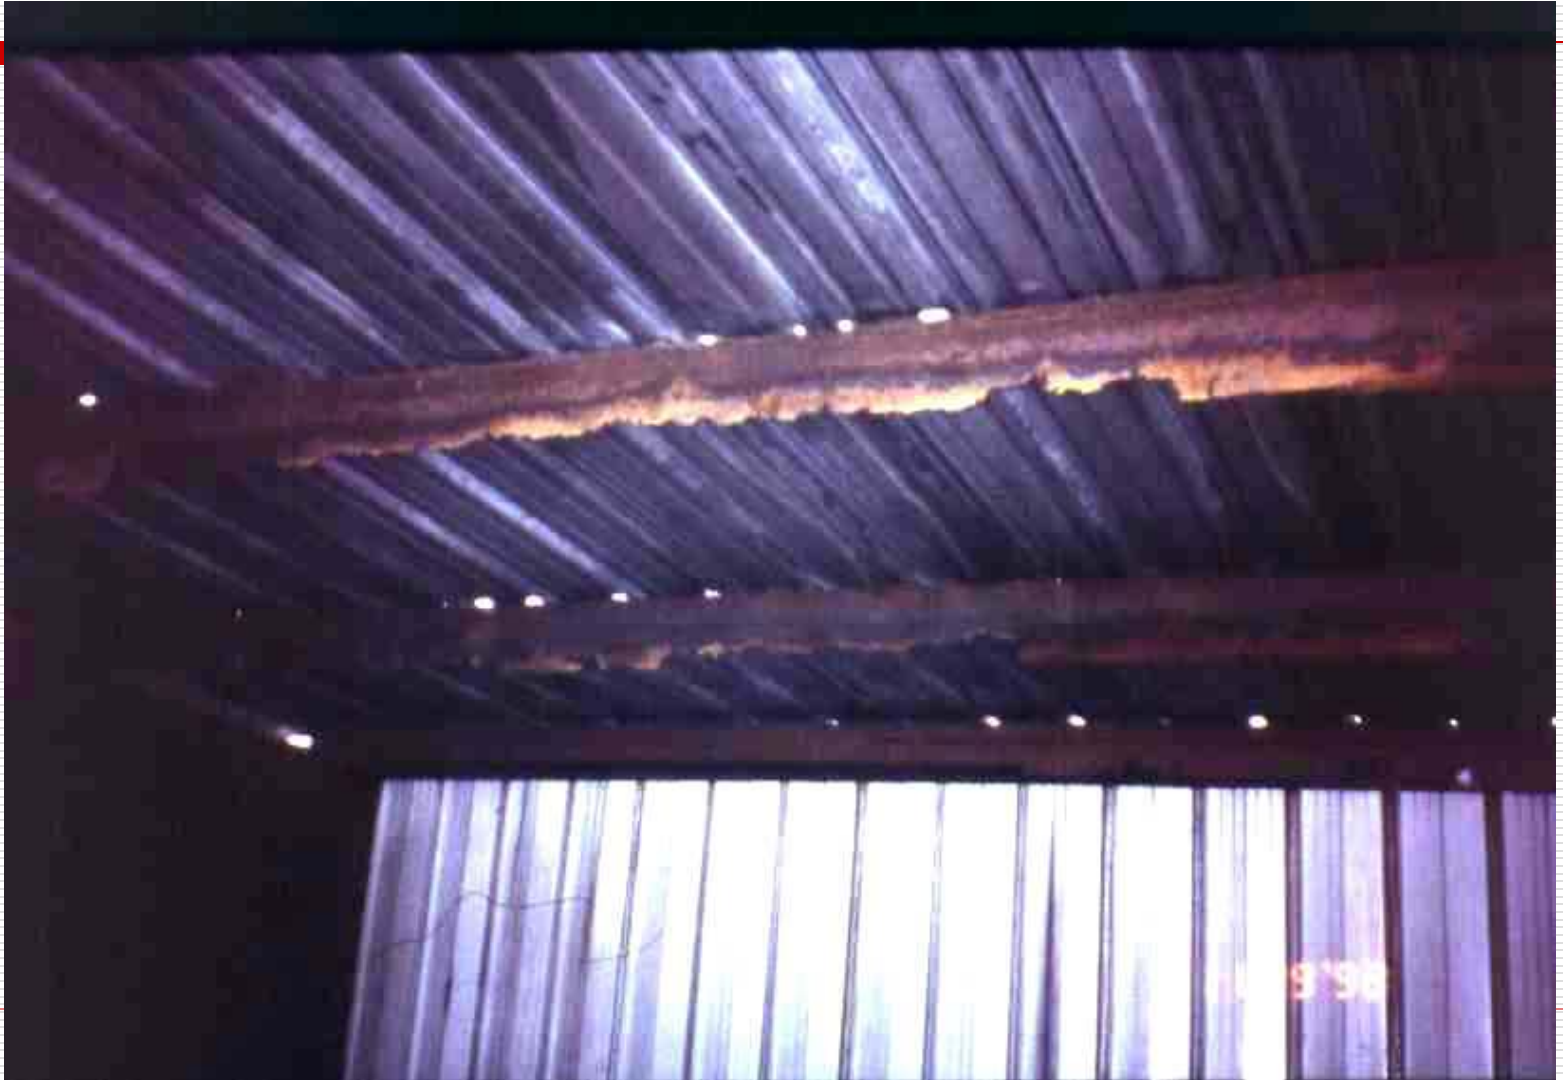
Corrosion of bottom flange of roof support channel

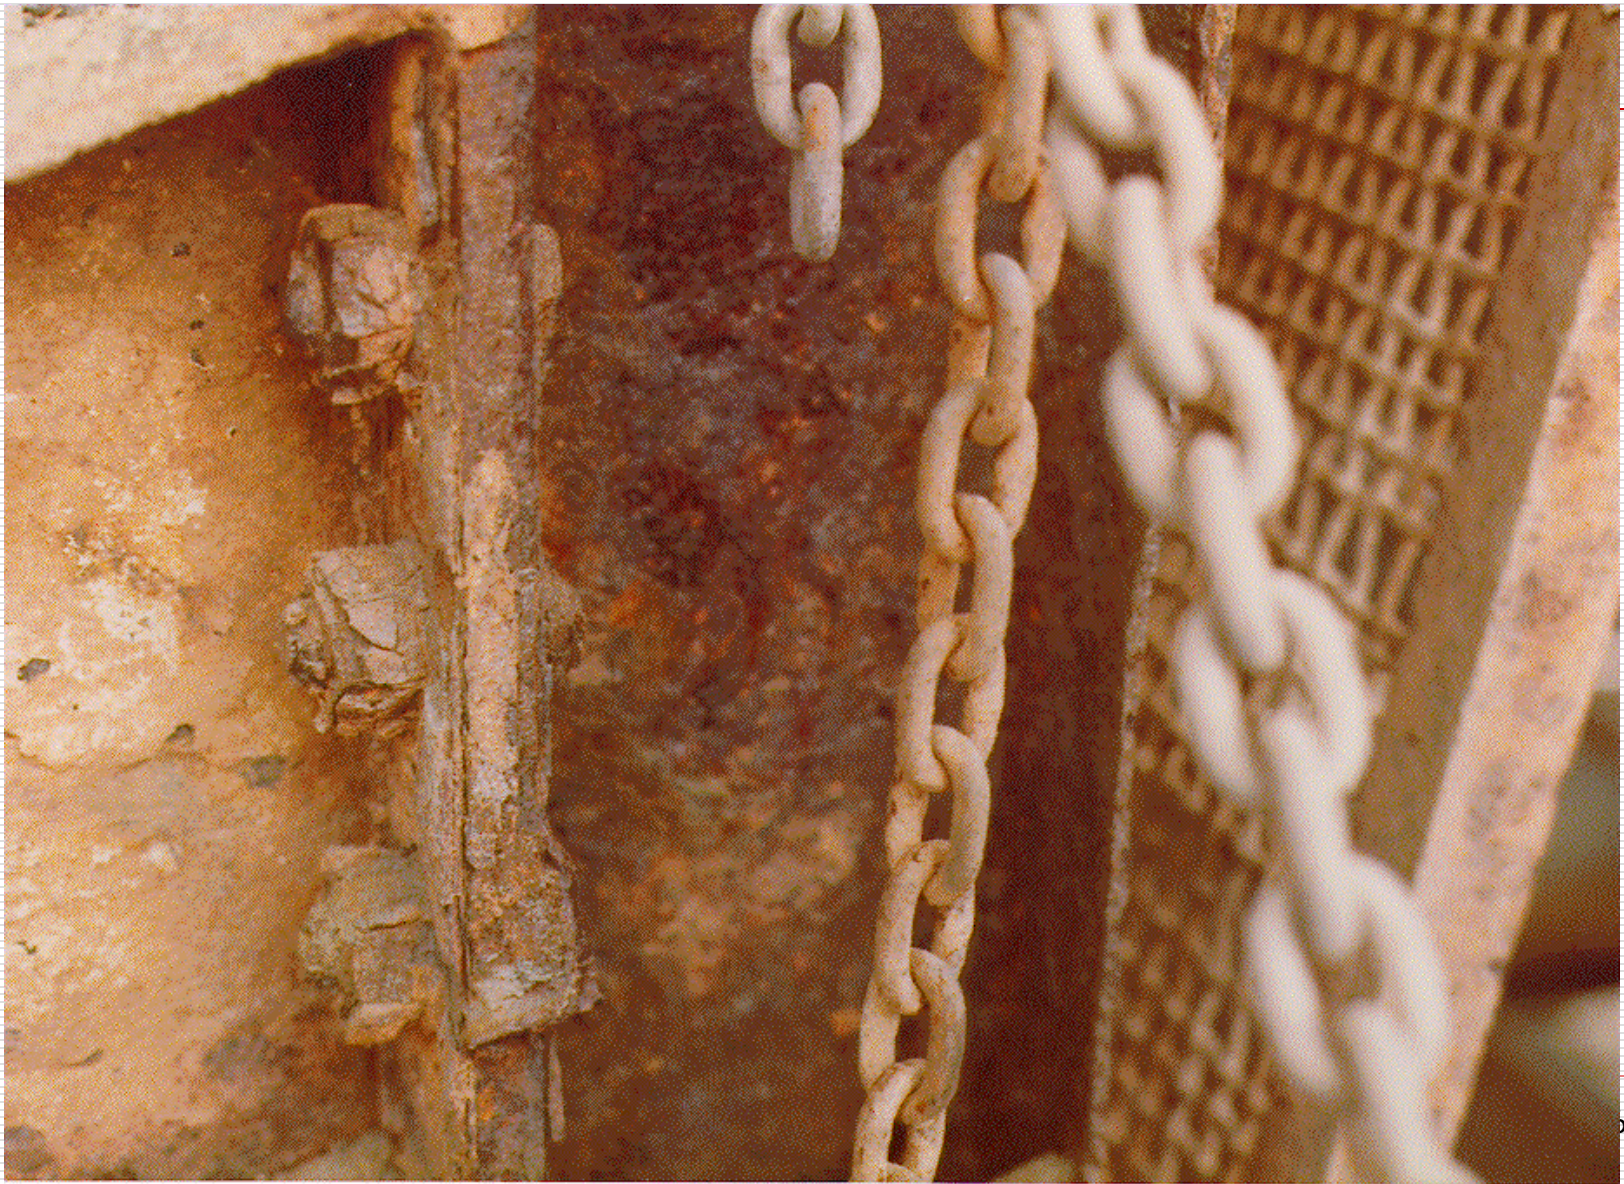
Inspect connections! Corroded bolt heads

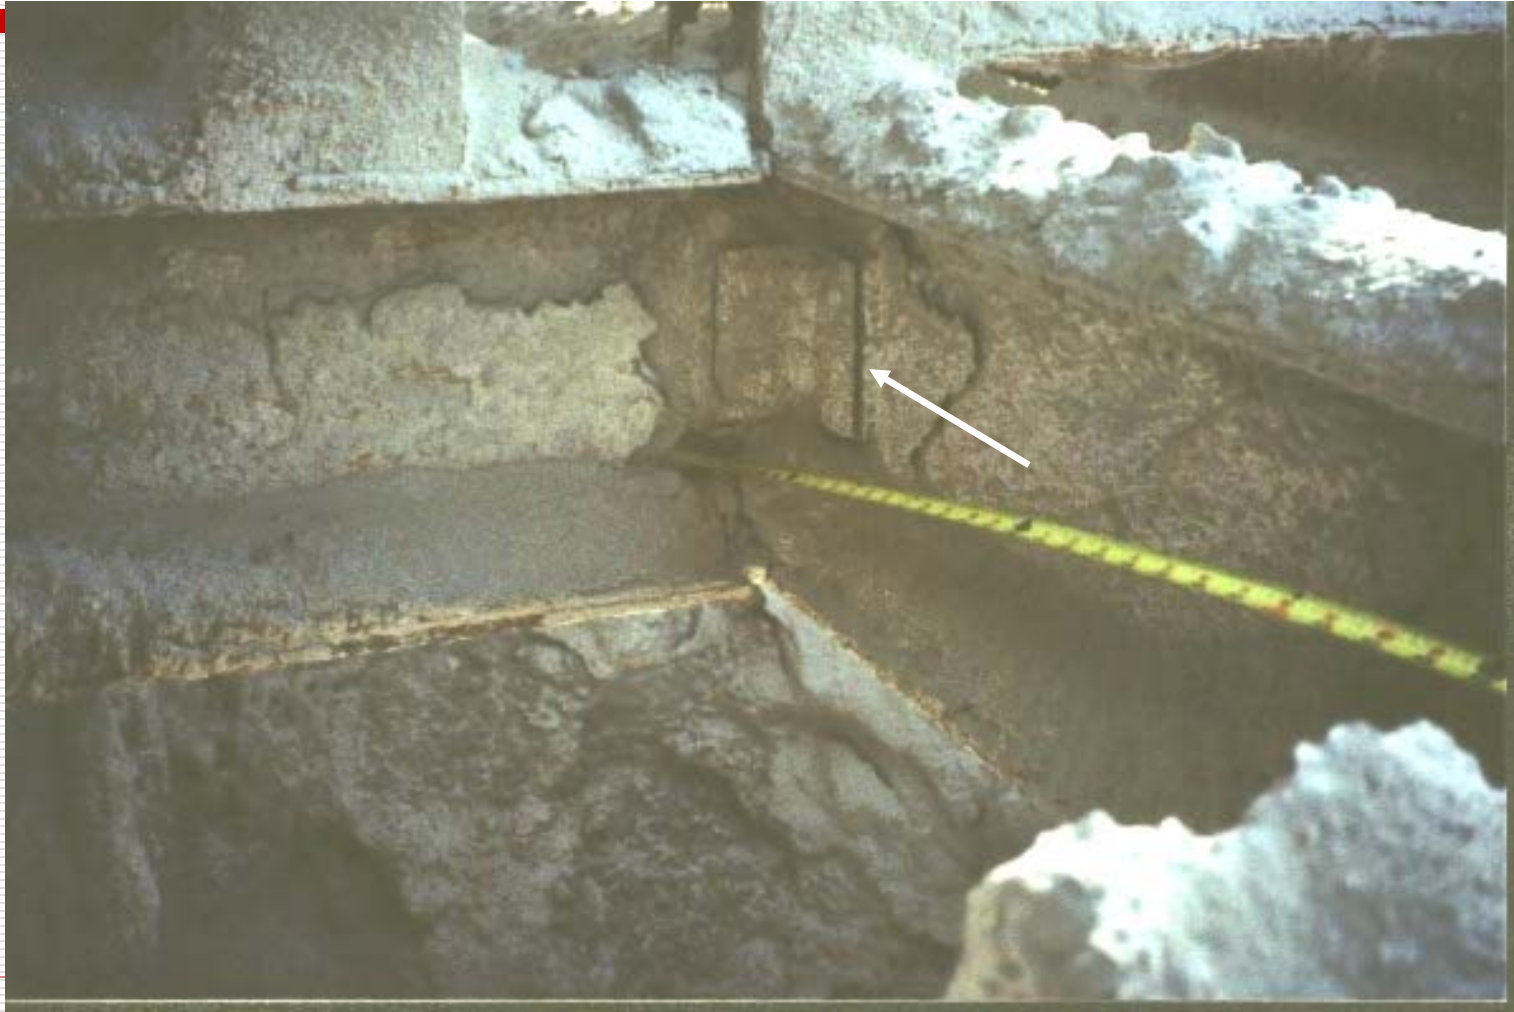
Fractured weld @ connection

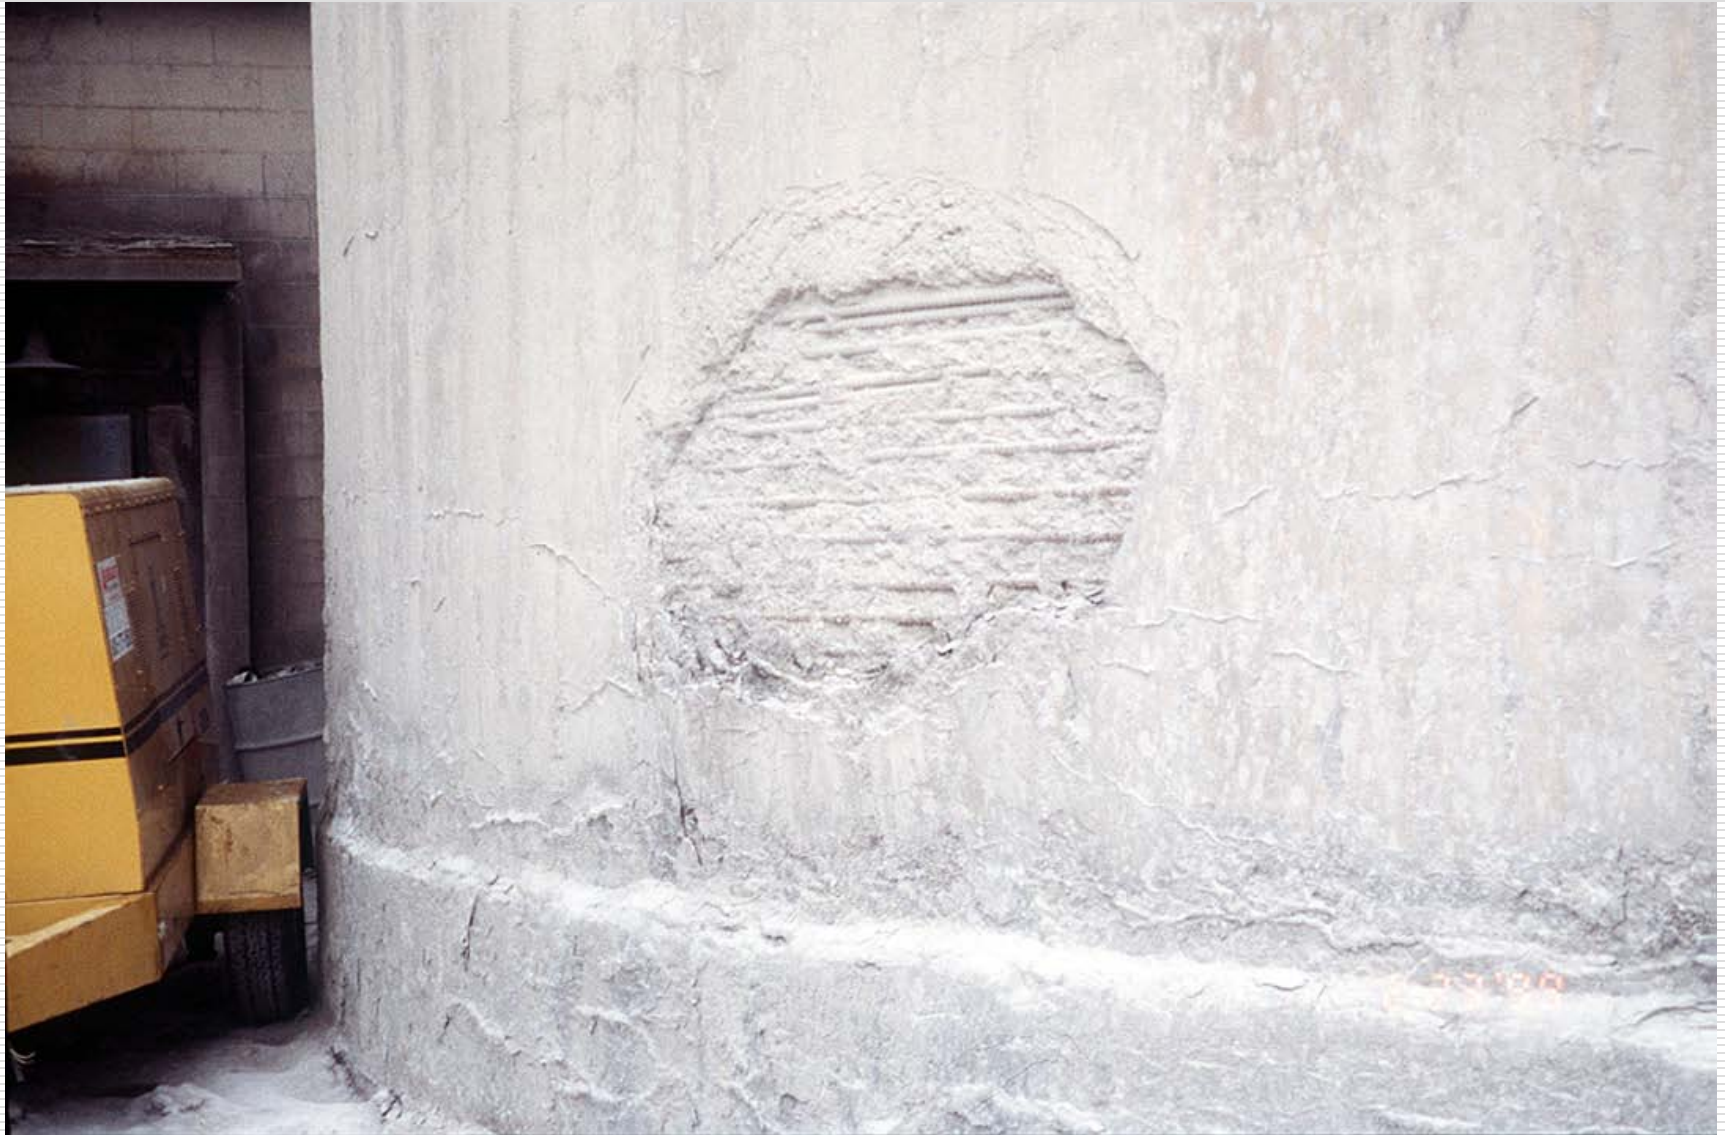
Exposed rebar on the side of a concrete settling tank

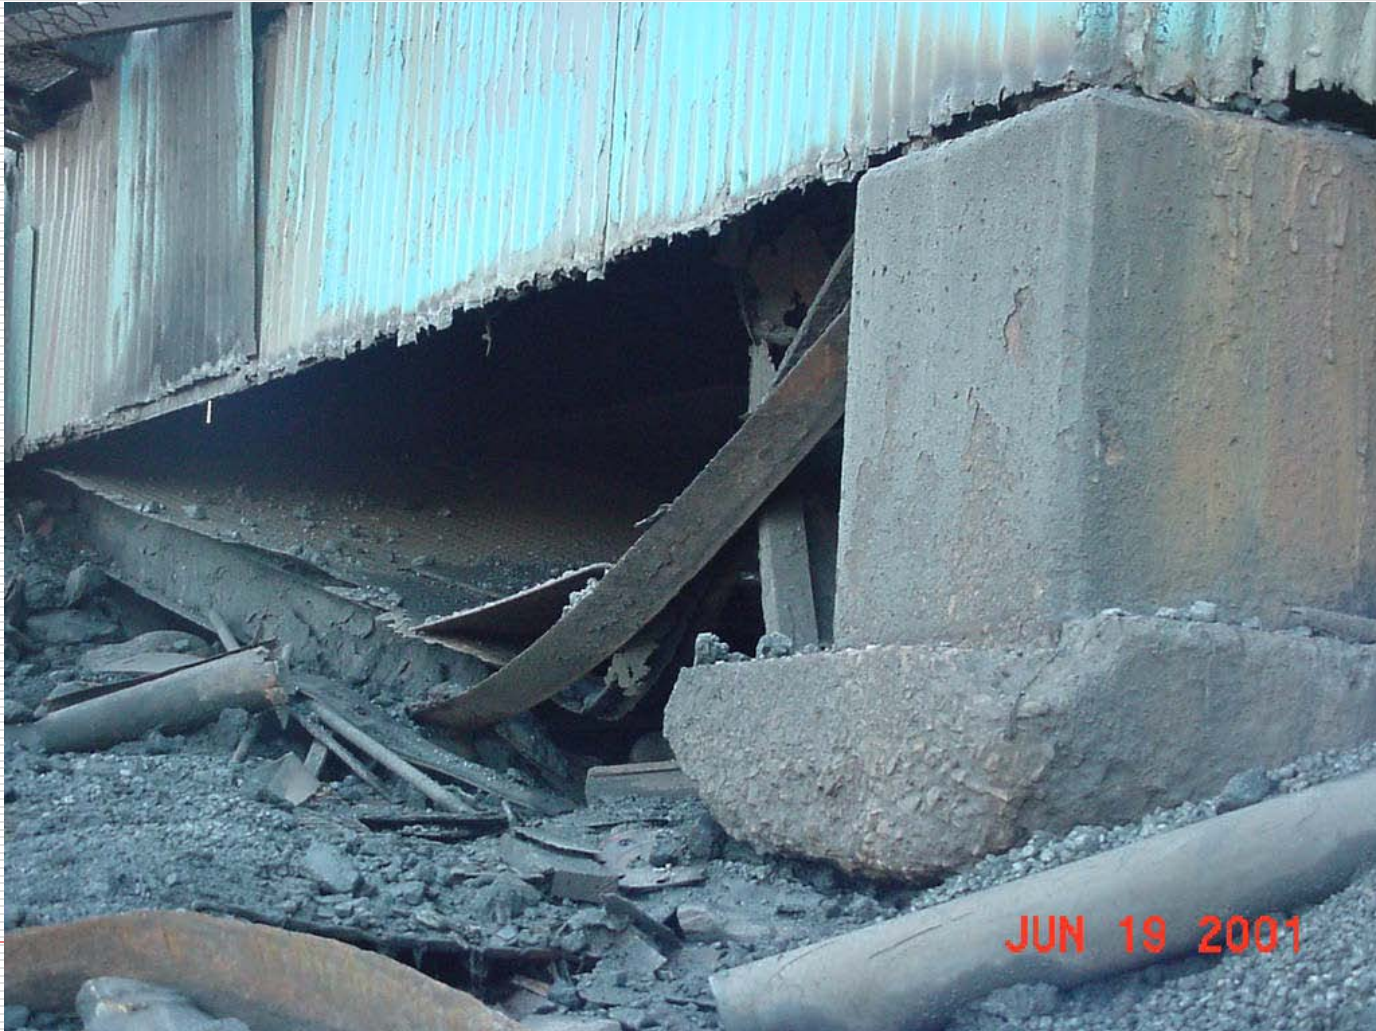
Collapsed floor – Avoid this!
