Hunters Point Shipyard

FINAL HISTORICAL RADIOLOGICAL ASSESSMENT

History of the Use of General Radioactive Materials
1939 – 2003

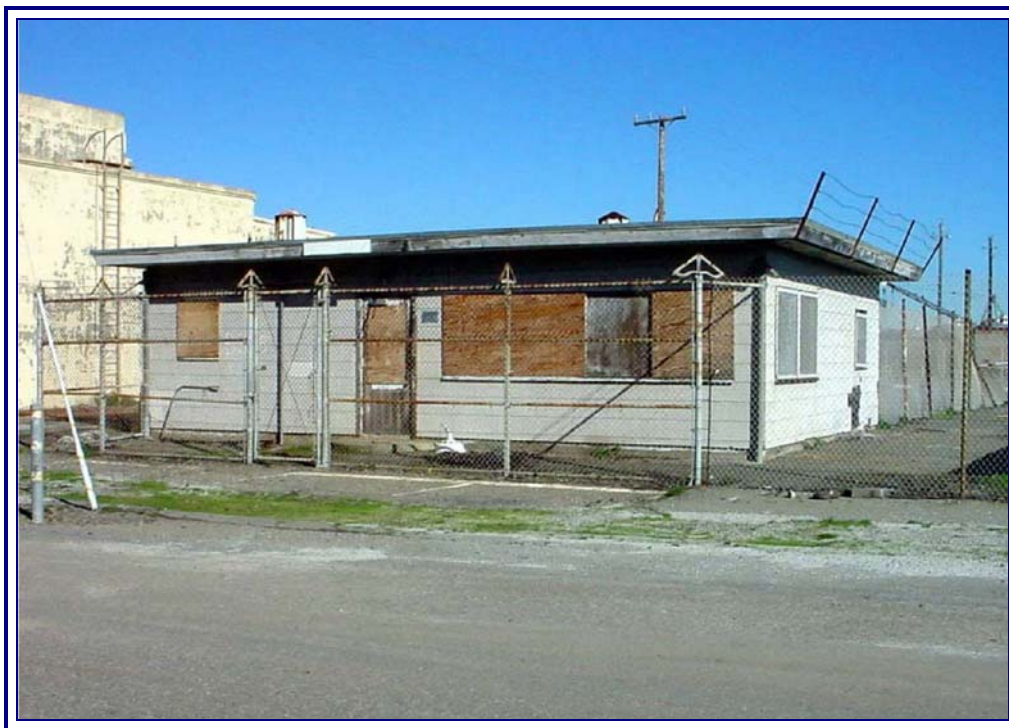
8.3.4.9 *Building 365*

Site Description: Building 365 is a one-story wooden structure with a concrete foundation and measures 30 feet by 40 feet. A building site plan is provided in [Figure 8.3.4.4](#) above.
