THE SLUMGULLION LANDSLIDE, HINSDALE COUNTY, COLORADO

1st North American Landslide Conference
Vail, Colorado, June 9-10, 2007

OVERVIEW

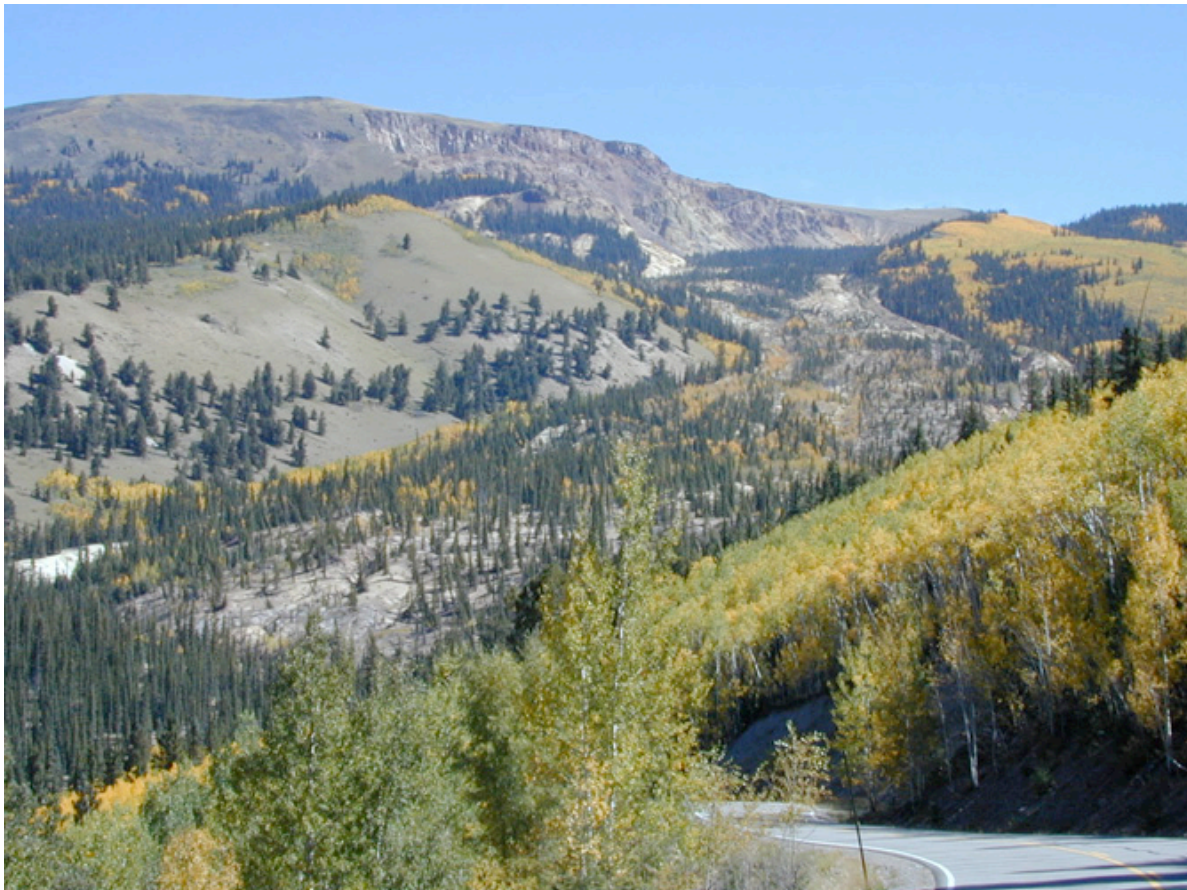
The disrupted surface of the Slumgullion landslide. Photo by J.A. Coe, U.S. Geological Survey

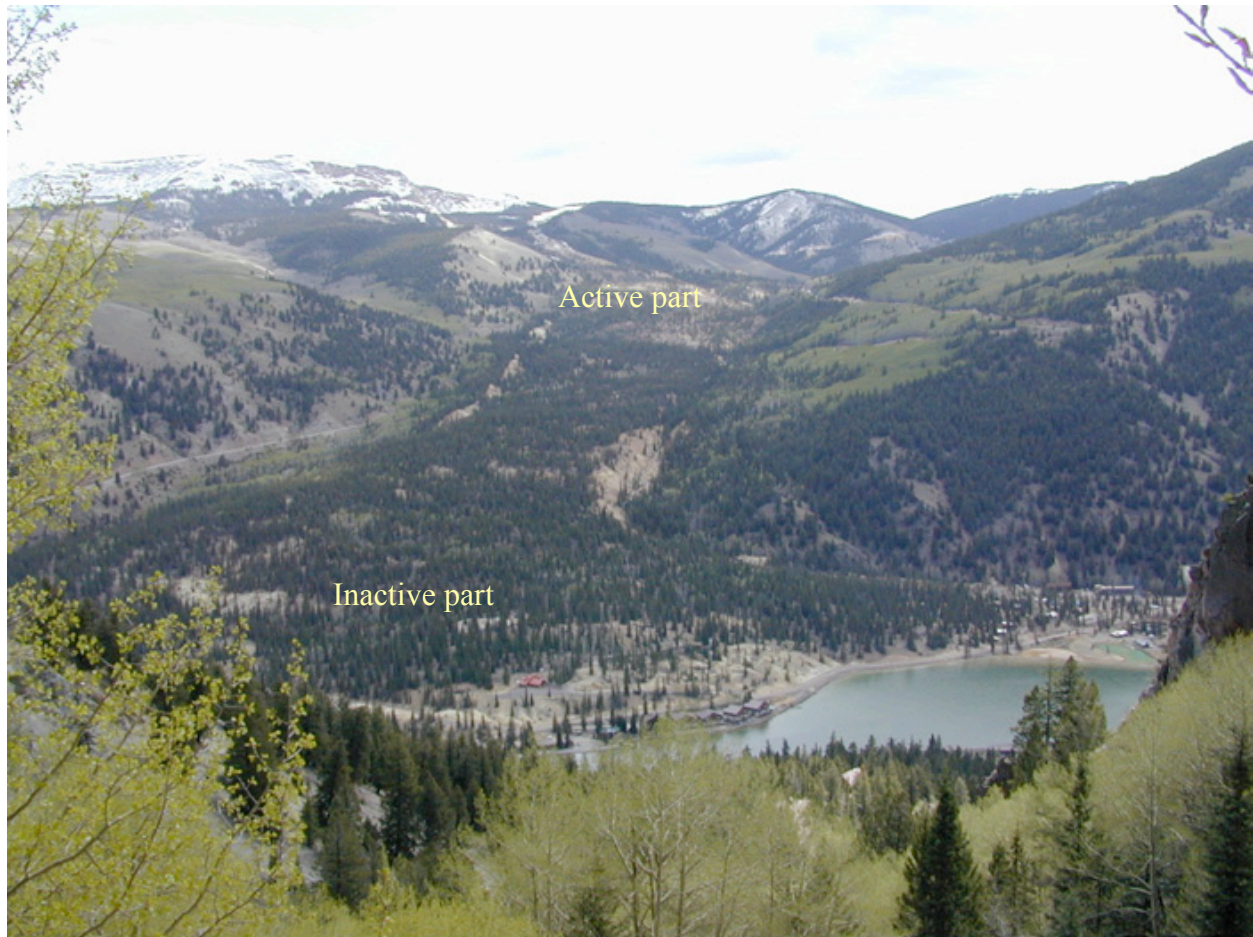
Figure 2. View of the Slumgullion landslide. Photograph by J.A. Coe, U.S. Geological Survey.

The Slumgullion landslide (Figure 2) is a translational debris slide (Cruden and Varnes, 1996) and has been described by numerous investigators (for example, Endlich, 1876; Howe, 1909; Atwood and Mather, 1932; Burbank, 1947; Crandell and Varnes, 1960, 1961; Savage and Fleming, 1996; Fleming and others, 1999; Coe and others, 2003; Schulz and others, 2007). The landslide occurs in Tertiary volcanic rocks and consists of a younger, active, upper part that moves on and over an older, larger, inactive part. The entire landslide is 6.8 km long, averages about 400 m wide, has an estimated depth of up to 120 m, and has an estimated volume of $170 \times 10^6 \text{ m}^3$ (Williams and Pratt, 1996). The active landslide (Figures 1 and 2) is about 3.9 km long, averages about 300 m wide, has an estimated average depth of about 14 m, and has an

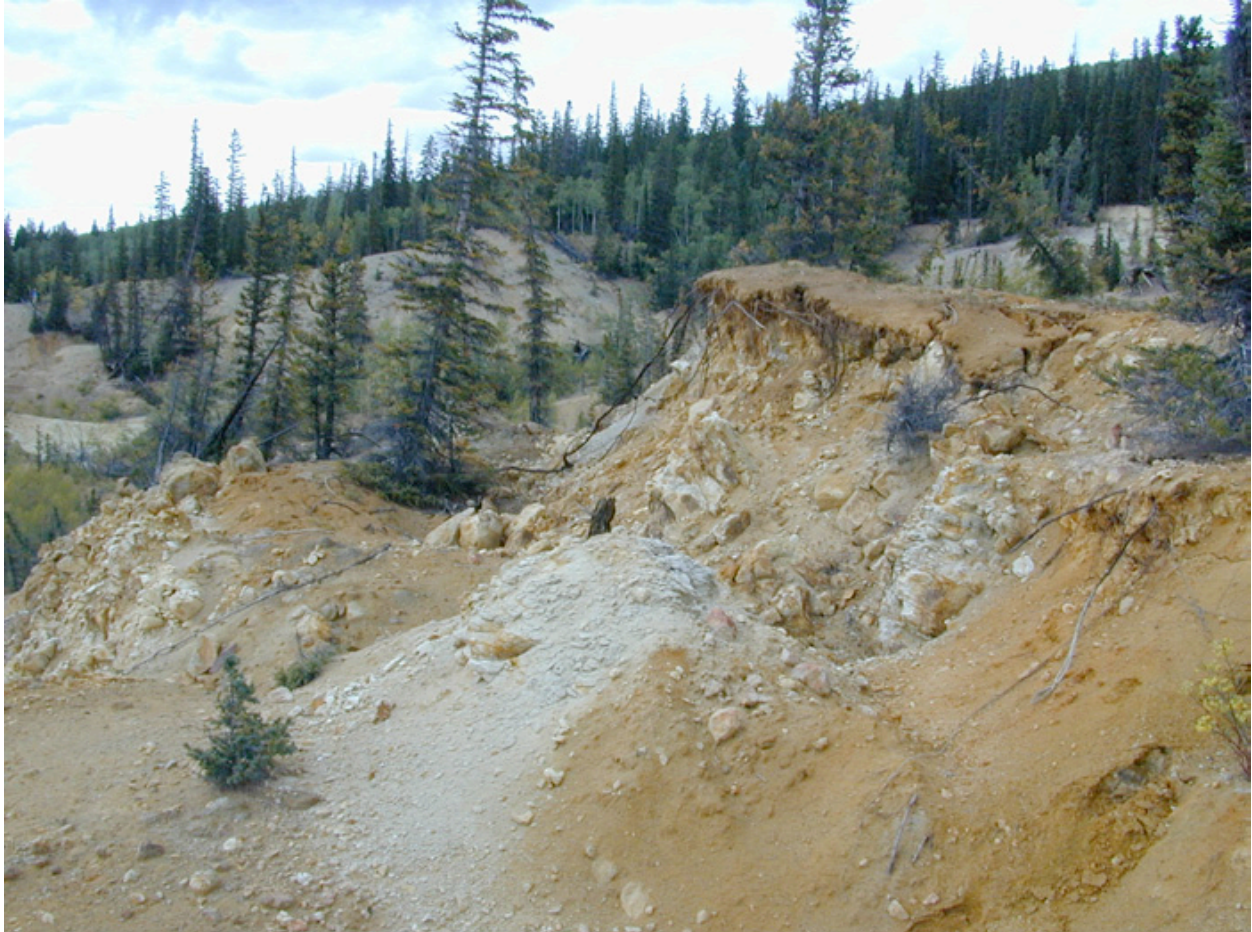
Figure 3. Downhill-facing normal fault scarps in the upper part of the Slumgullion landslide. Photograph by J.A. Coe, U.S. Geological Survey.

In general, the active upper part of the Slumgullion landslide extends, the lower part compresses, and the middle part moves as a plug and has the greatest velocity. This style of movement produces normal faults and tension cracks in the upper part of the landslide (Figure 3) and imbricate thrust faults (Figure 4) and lateral spreading in the lower part of the landslide. The landslide is laterally bounded by strike-slip faults and prominent flank ridges (Figure 5). Low-permeability clay striated by landslide movement is exposed at many locations along these faults. This clay and the continuous movement of the landslide suggest that the landslide may be hydrologically isolated from adjacent areas (Baum and Reid, 2000). Pull-apart basins are common on both sides of the landslide where it widens (Fleming and others, 1996, 1999). At several locations on the lower part of the active landslide, pond sediments are carried downslope

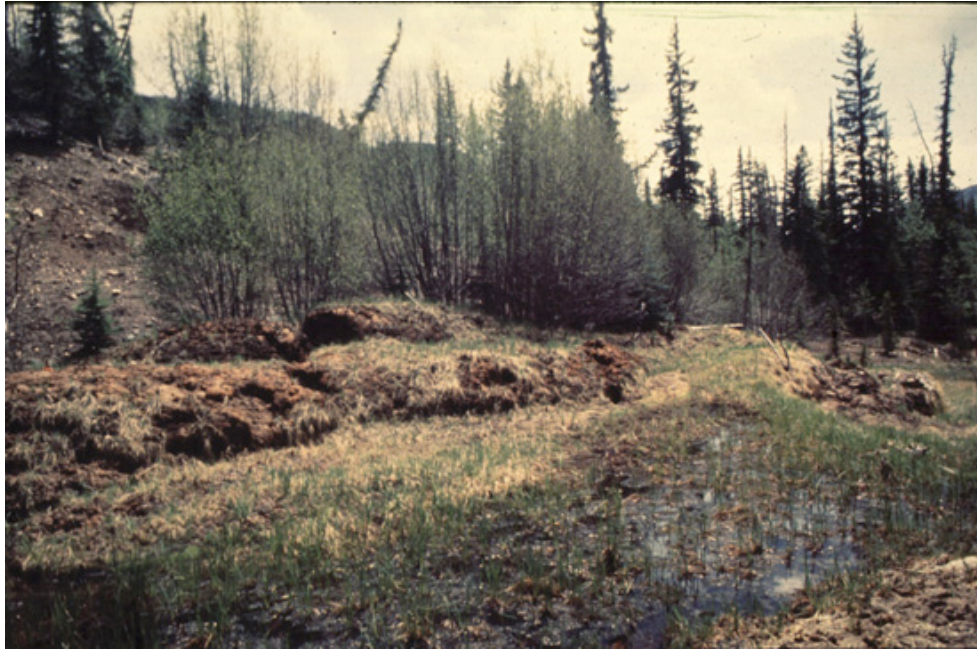
Figure 4. Imbricate thrust faults in the lower part of the Slumgullion landslide. Photograph by W.Z. Savage, U.S. Geological Survey.

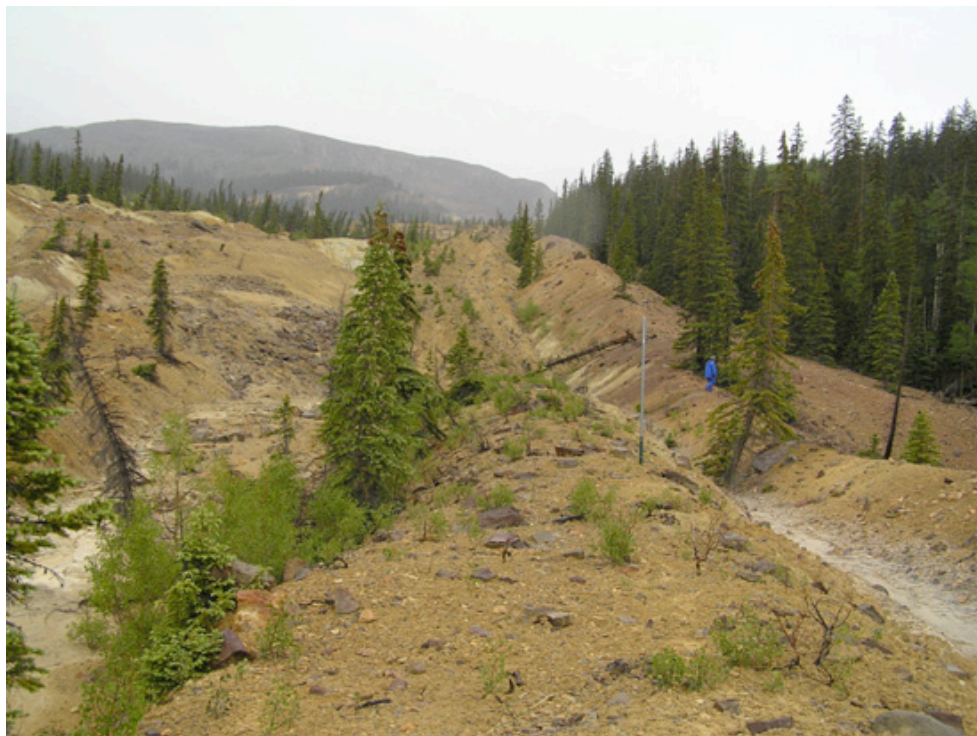
Figure 5. Flank ridges along the southern margin of the Slumgullion landslide (landslide is left of the ridges). Photograph by Giulia Biavati, Università di Bologna, Italy.

We will cross a few flank ridges as we come onto the landslide (Figures 5 and 12). This is one of the few locations where the boundaries of the active and inactive parts of the Slumgullion landslide are nearly coincident. We should be able to locate an active, discrete strike-slip fault or zone of en echelon fractures marking the active landslide margin (Figure 12). Both forms of ground rupture have been observed at this location and along different parts of these flank ridges. Fleming and Johnson (1989) provide an excellent evaluation of flank ridges formed along landslide margins. Mechanisms proposed to explain the development of flank ridges include helical flow of moving landslide debris, dilation within a shear zone, buckle folds, landslide debris spilling over the landslide margin, and upward intrusion of clay within a shear zone. The series of flank ridges here suggests changing conditions during landslide movement, such as narrowing of landslide debris or changing stress conditions.

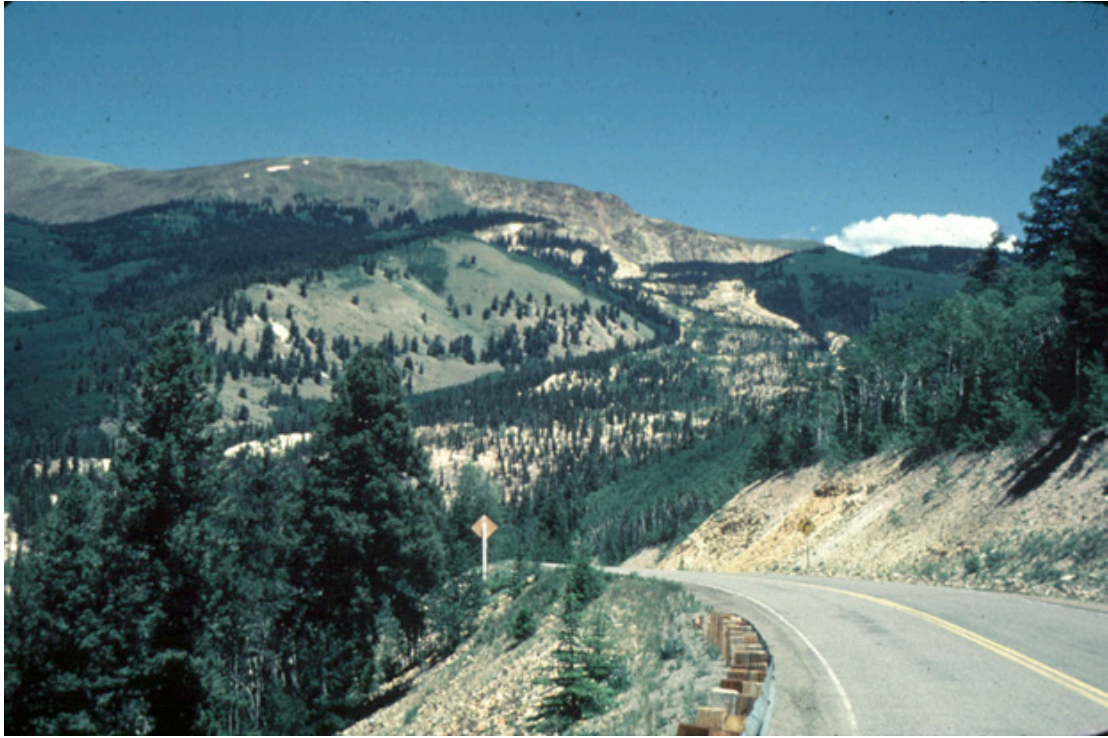
Figure 7. View of the Slumgullion Landslide from Stop 1. Photograph by W.Z. Savage, U.S. Geological Survey.

This stop provides a view of some of the active part of the landslide (Figure 7), some of the toe of the inactive part of the landslide, and Lake San Cristobal (Figure 8). Also visible from this stop is the general setting of the Slumgullion landslide. Directions to the stop are given in Table 3.

The toe of the active part of the Slumgullion landslide is marked by the light-colored soil, disturbed trees, and an abrupt hill upslope from CO-149. The inactive landslide extends downslope to the valley bottom. The toe of the inactive part of the landslide impounds Lake San Cristobal, which is the second largest natural lake in Colorado. The channel of the Lake Fork of the Gunnison River was completely blocked by the landslide and was subsequently re-established where the toe abuts the opposite valley slope. At the toe, landslide deposits extend about 0.5 km upstream and 0.9 km downstream from the projected landslide margins. Failure of the landslide dam is not expected (Schuster, 1996).

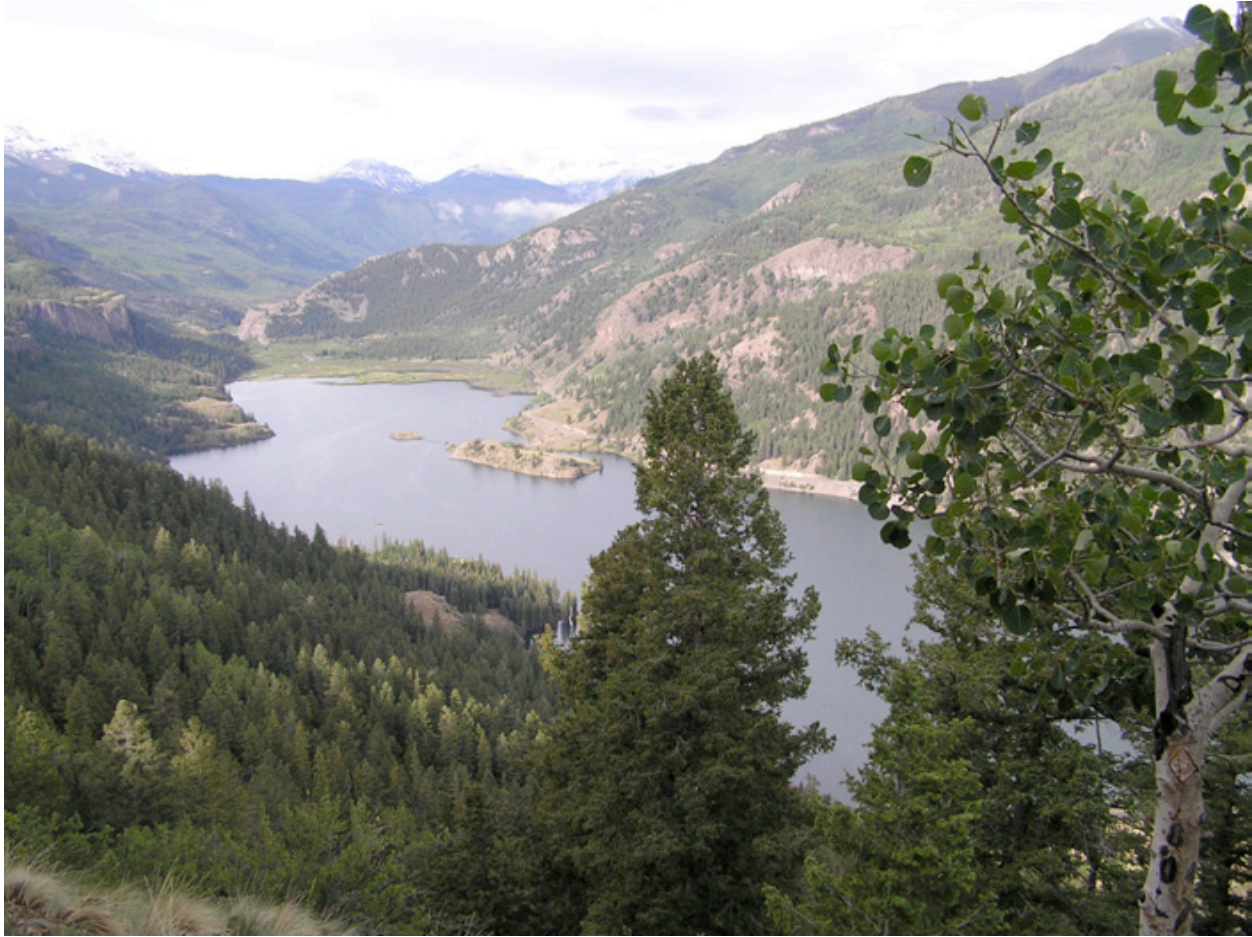
Figure 8. View of Lake San Cristobal from Stop 1. Photograph by Giulia Biavati, Università di Bologna, Italy.

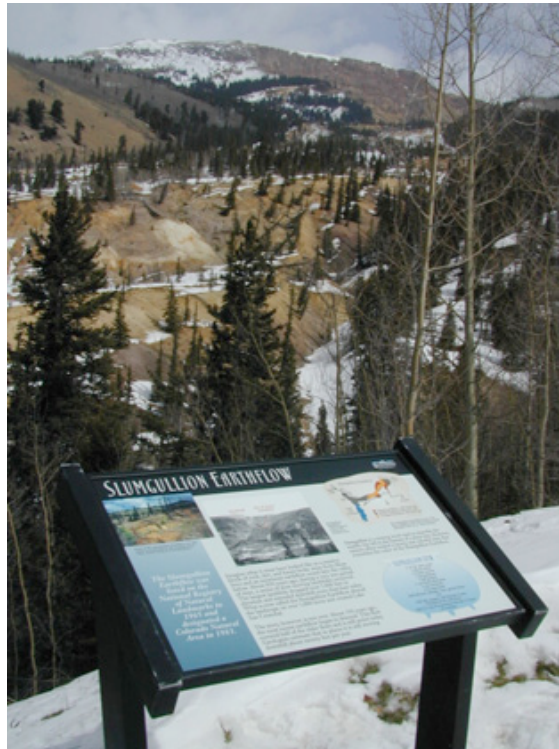
Figure 9. View of part of the Slumgullion landslide from the Slumgullion Landslide Overlook. Photograph by J.A. Coe, U.S. Geological Survey.

This stop (Table 4) provides a closer view of some of the active part of the Slumgullion landslide than did Stop 1. The active nature of the landslide is readily apparent from this location and is indicated by disturbed soil, hummocky topography, freshly exposed rock and soil, and jumbled orientation of trees on the landslide (Figure 9). Also apparent from this location is a series of flank ridges located along the near margin of the landslide. These ridges are also located

along the margins of most of the active landslide. A monitoring station where nearly continuous displacement, groundwater pressure, soil temperature, soil moisture, and climatic conditions have been recorded is visible (but barely discernible) to the northeast and an additional monitoring station is similarly visible to the west. The flatter area located to the west may mark the location where the active part of the landslide emerged from the subsurface and began overriding the ground surface located downslope.

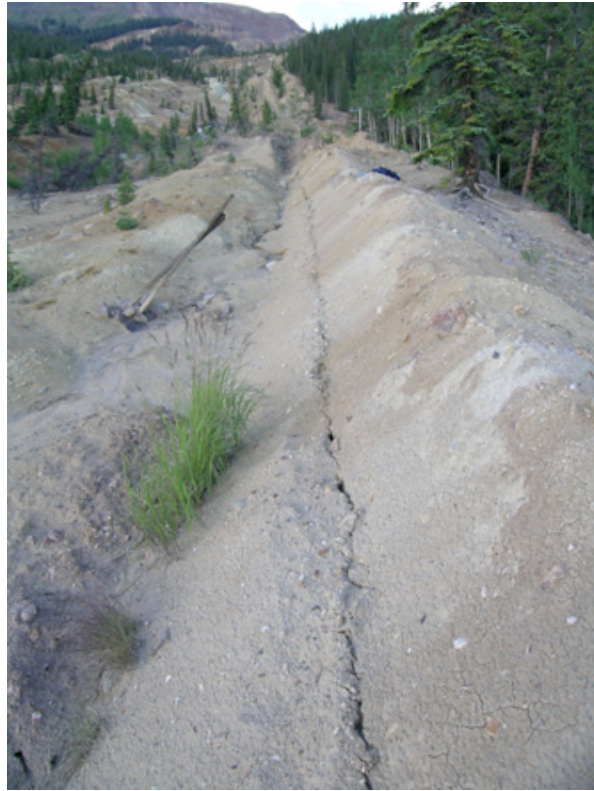
Figure 12. View to northeast of southern lateral margin. Photograph by J.A. Coe, U.S. Geological Survey.

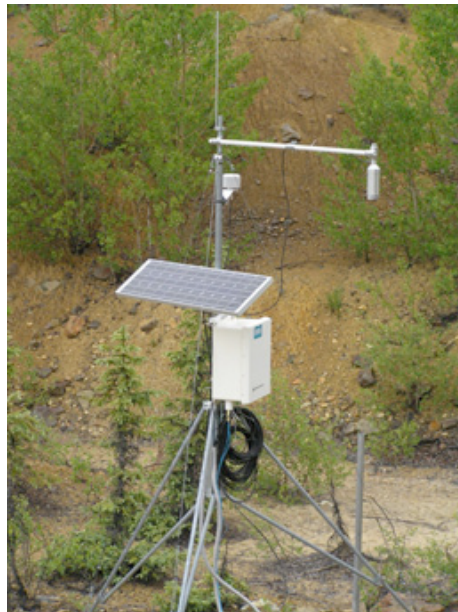
Figure 13. Equipment at the monitoring station. Photograph by Giulia Biavati, Università di Bologna, Italy.

This is the location of much of the monitoring performed by the U.S. Geological Survey (Figure 13). Various pieces and types of equipment have been located here periodically for the past several decades. Currently, we measure landslide displacement, positive and negative ground-water pressures, soil and air temperature, rainfall, soil water content, and snow depth (Coe and others, 2003; Schulz and others, 2007). Measurements are made hourly and results are stored on a datalogger. Previous studies in this area included measurements of hydrogeologic properties of landslide debris (Schulz and others, 2007) and of slidequakes associated with landslide movement (Gomberg and others, 1996). Earlier, nearly continuous monitoring of landslide movement was also performed near here using modified tide gauges (Savage and Fleming, 1996) and episodic monitoring using an automatic camera.

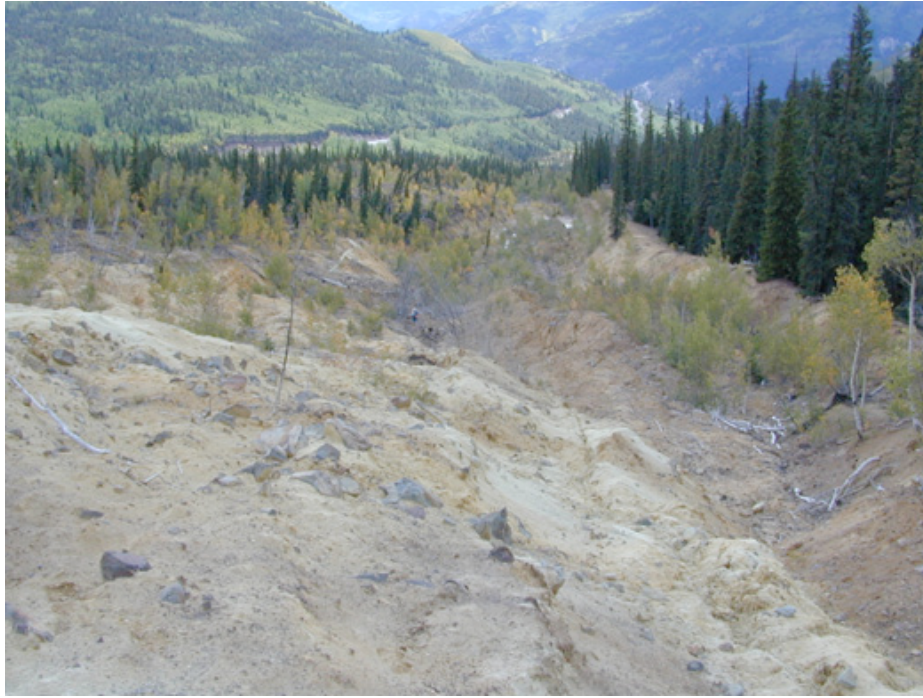
Figure 15. View to southwest of pull-apart basin from its upper end. Photo by J.A. Coe, U.S. Geological Survey.

Pull-apart basins occur in a few places along the flanks of the Slumgullion landslide and are both structural and topographic basins that form to accommodate downhill widening of the landslide (Fleming and others, 1996, 1999). These basins reflect controls on landslide kinematics exerted by lateral boundary conditions. The location of this stop marks probably the most well-developed basin on the landslide (Figures 14-16). It appears that abrupt widening of the landslide here is accommodated by thinning of landslide debris and resultant secondary sliding of adjacent landslide debris that has been oversteepened by the thinning (Fleming and others, 1996, 1999). This conclusion is suggested by the series of crescent-shaped tension cracks and normal faults above the south part of the basin and thrust faults and soft-sediment folding at the bottom of the basin, all of which are subparallel to the overall landslide margin. A pond is generally present at the bottom of the basin and its sediments extend downslope beyond the basin, while basin structural features do not. These features are destroyed at and just beyond the downslope end of the basin during landslide movement. Detailed mapping of this area performed recently and about ten years ago shows that structural features have changed very little in character and location, although the landslide has moved about 40 m through here in the intervening years.

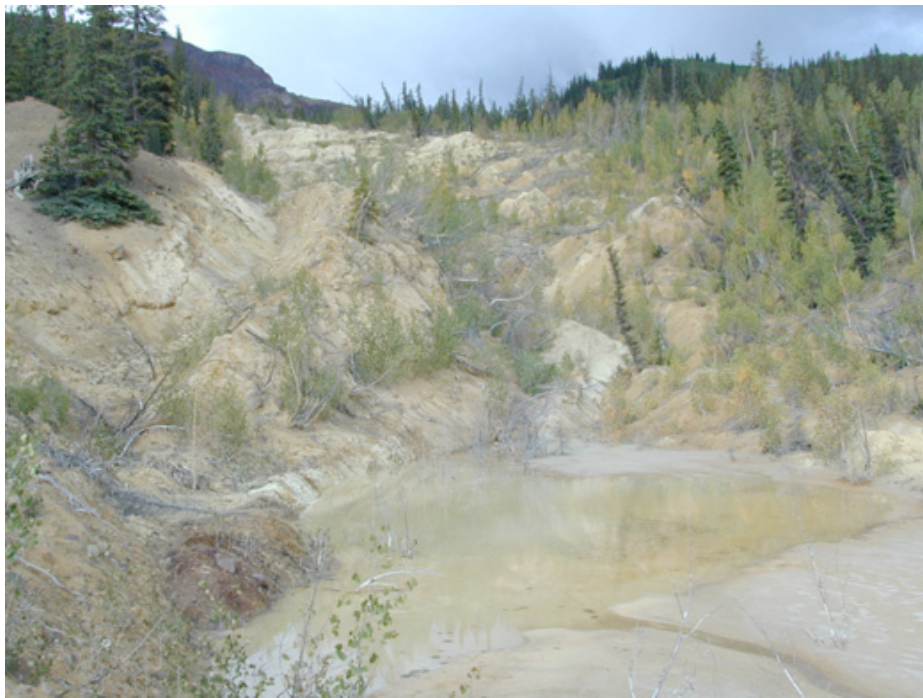
Figure 16. View to northeast of pull-apart basin from its lower end. Photo by J.A. Coe, U.S. Geological Survey.

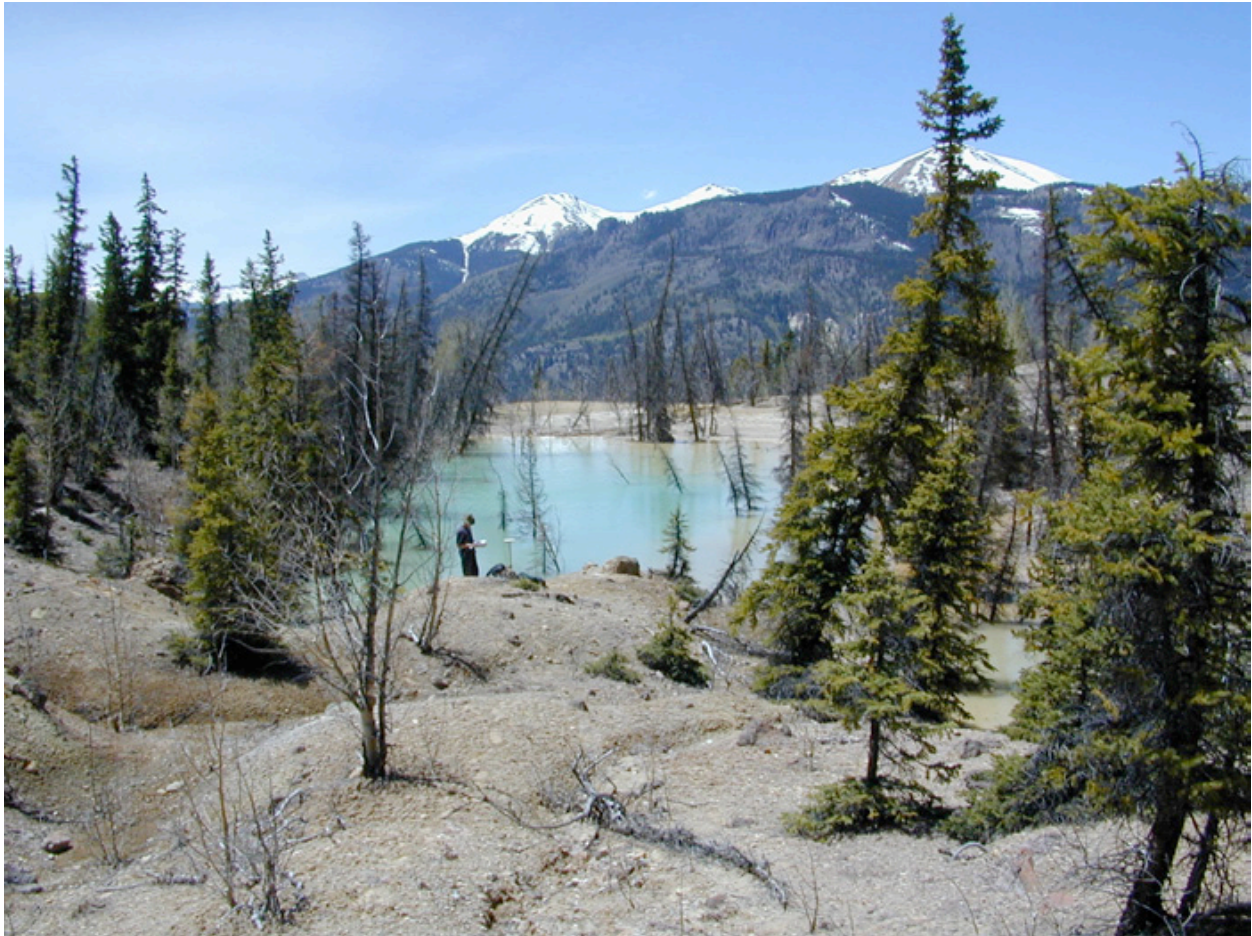
Figure 17. View to the southwest of a pond located on the active Slumgullion landslide. Photograph by J.A. Coe, U.S. Geological Survey.

We saw at the basin how lateral boundary conditions appear to affect landslide structural and geomorphic characteristics. At this location we can see how basal boundary conditions apparently also affect landslide characteristics. Observations of this pond (Figure 17) indicate that it has remained generally the same and at the same location for at least the last few decades. During this time, the landslide has moved about 150 m here, or several times farther than the length of the pond. In addition, thrust faults have been observed just upslope from the pond for many years, as have been normal faults at the slope break located just downslope from the pond. We are near the inferred location of the former surface-water divide between Slumgullion Creek and the unnamed creek just to the north (Fleming and others, 1999). Perhaps the landslide overrides this divide and creates the features we see here.

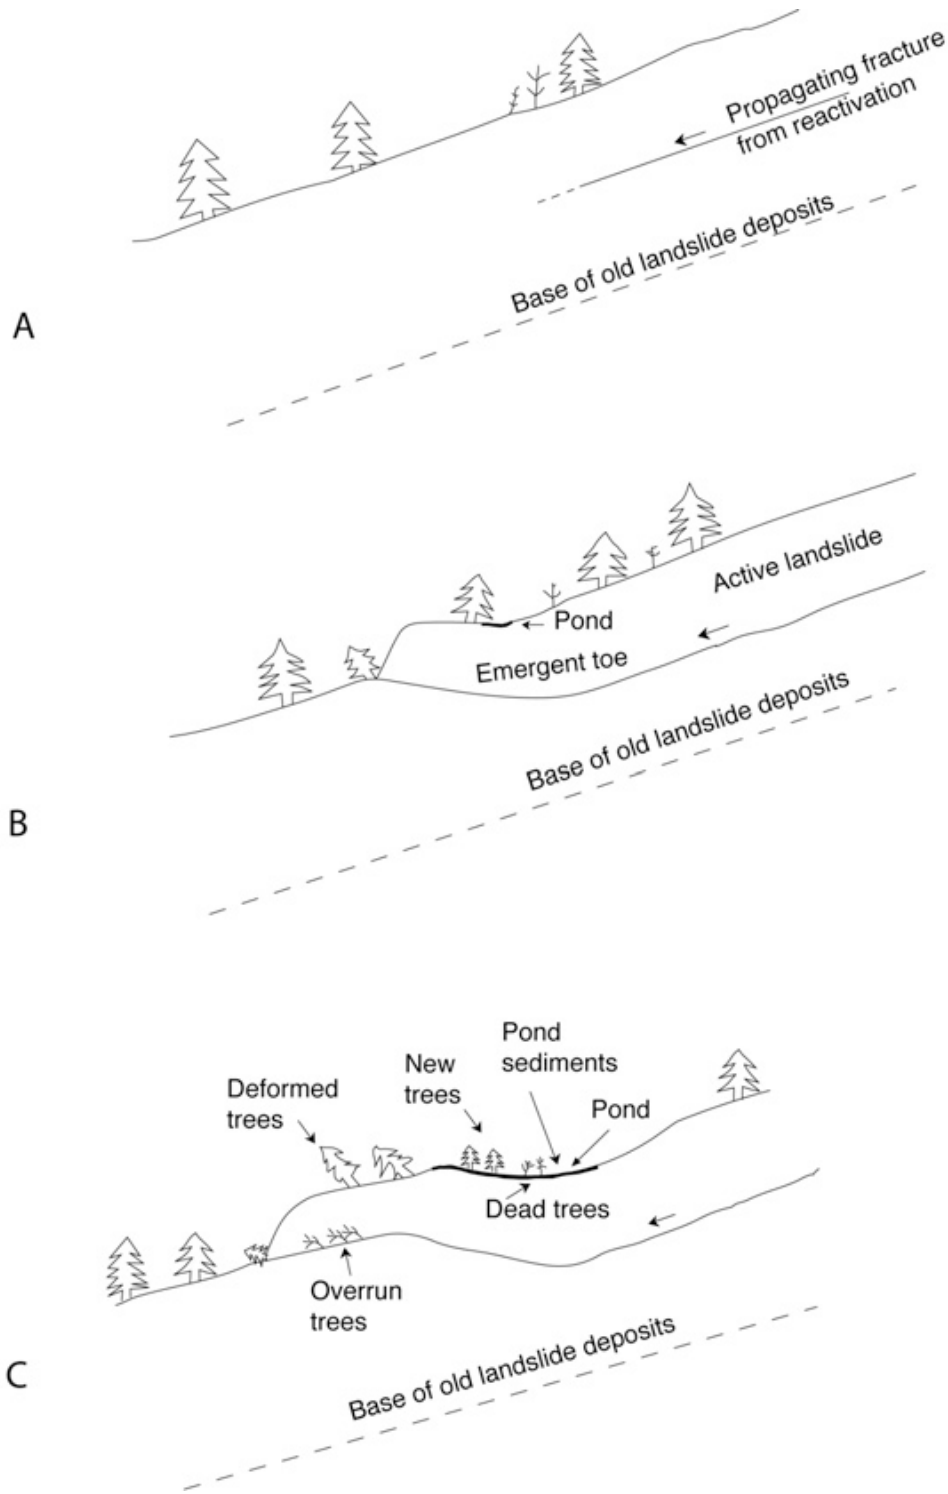
Figure 18. Idealized cross-section showing conceptual sequence of reactivation of the Slumgullion landslide at the location of the emergent toe. From Fleming and others, 1999.

Based on detailed mapping, Fleming and others (1999) concluded that a large area of the landslide headscarp collapsed and resulted in mobilization of the reactivated part of the Slumgullion landslide. This reactivation does not involve the entire length or width of the original landslide, as we have seen, nor does it appear to involve the entire depth. Our stop at the upper pond provided evidence for basal boundary conditions controlling kinematics of the active landslide, and similar conditions appear to occur here. However, rather than overriding a bump in original topography below the landslide, it has been proposed that features here are due to the toe of the reactivated part of the landslide rupturing through the ground surface near here a few hundred years ago. As we'll see when we descend the active toe of the landslide, the landslide is clearly moving along the ground surface at its downslope end. It has been proposed (Parise and Guzzi, 1992) that the location where the landslide originally moved out of the subsurface and onto the ground surface occurred in this area (Figure 18). This change of displacement style is associated with significant changes in the geometry of the base of the landslide. This changing geometry results in the features seen here. Thrust faults occur upslope of the large back-tilted area on which a small pond occurs. Pond sediments extend for at least 250 m downslope from the pond due to displacement of the landslide mass past this location (Fleming and others, 1999). These sediments are well exposed in a gully eroded just downslope (Figure 19). Based on the current rate of landslide movement here, this pond must have persisted for at least the last hundred years (Fleming and others, 1999).

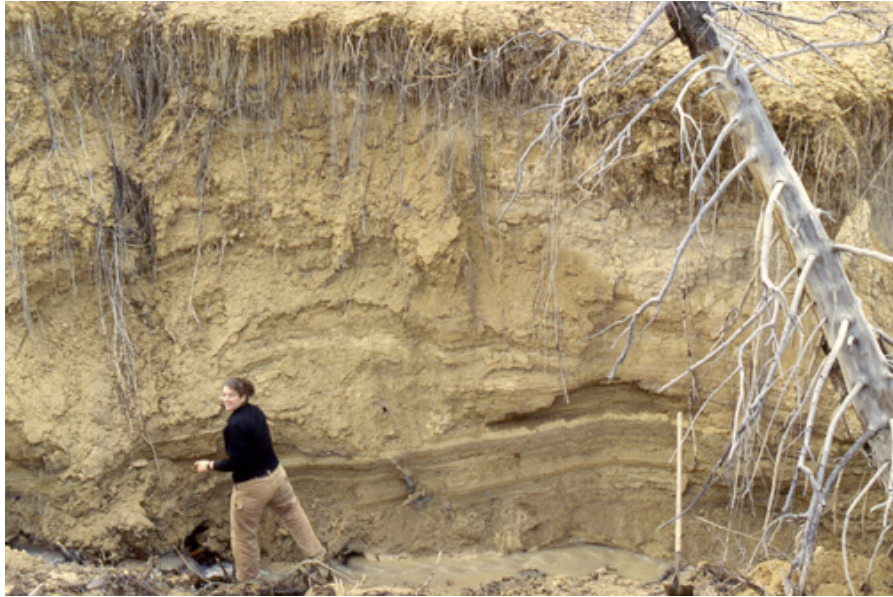
Figure 19. Exposure of pond sediments in the emergent toe area of the active Slumgullion landslide. Photograph by J.A. Coe, U.S. Geological Survey.
