Expert Meeting Report: Interior Insulation Retrofit of Mass Masonry Wall Assemblies

K. Ueno and R. Van Straaten
Building Science Corporation (BSC)

February 2012

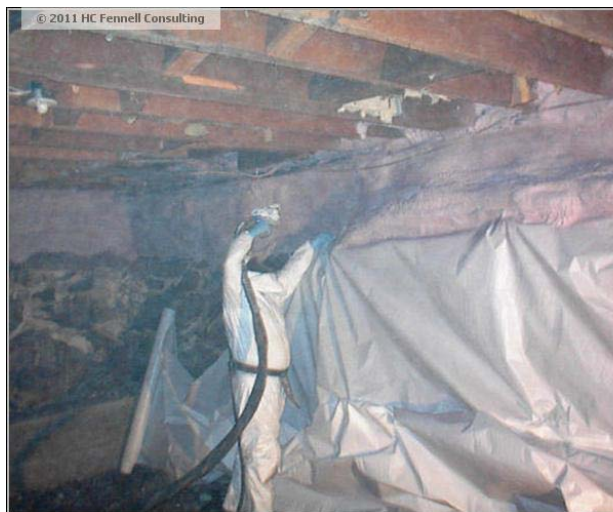
Figure 4. AVID installation and diagram (© 2011 by HC Fennell Consulting; reprinted with permission)

Mr. Fennell opened his presentation by describing the Air, Vapor, Insulation, Drainage (AVID) approach, which is an interior insulation/drainage detail applied to basements and crawl spaces (Figure 4). Interior spray foam was deemed inadequate for management of bulk water alone, without intentional drainage. The recommended AVID approach is shown in Figure 4: it involves draping polyethylene from grade to a perimeter drain, and then applying spray foam. Some specific details of this approach are to treat wood beams buried in the insulation with preservatives, and to include a “drip edge” detail at the bottom of the plastic sheet to drain the water into the gutter (to avoid water intrusion at the basement slab).

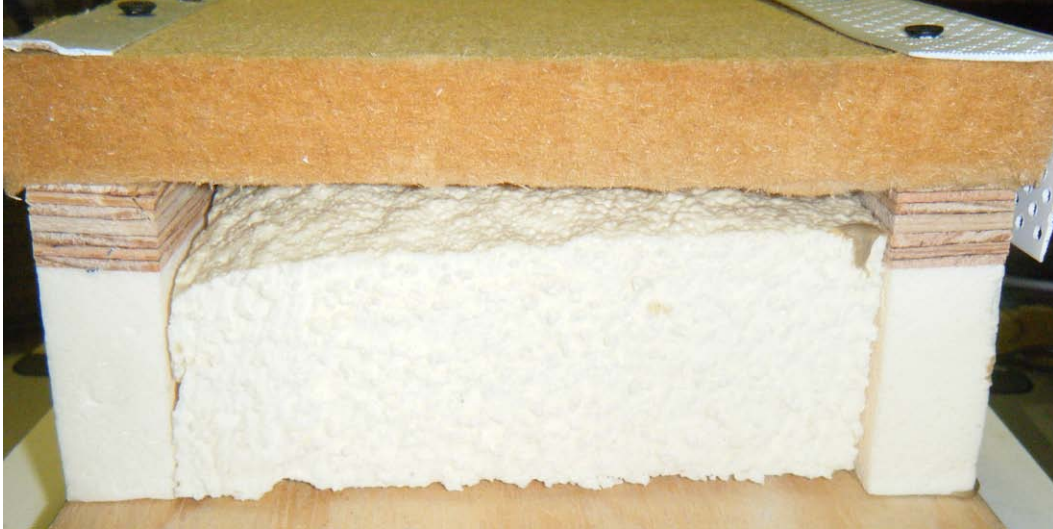
Figure 7. Mock-up of IFT insulation system: two continuous layers of insulation and air gap

Dr. Bomberg prefers this product over calcium silicate. The system consists of spray foam against masonry, a ventilated air gap, a treated wood fiberboard insulation board, and a lime plaster finish (see Figure 7). The recommended spray foam products are between 1.1 pcf and 3.5 pcf. In this application, the limit is 1.5” of closed cell, to allow for drying. Future work includes research on this moisture active thermal insulation layer, including the potential to integrate it with heating, cooling and ventilation, air conditioning systems. View Dr. Bomberg’ [presentation](#).

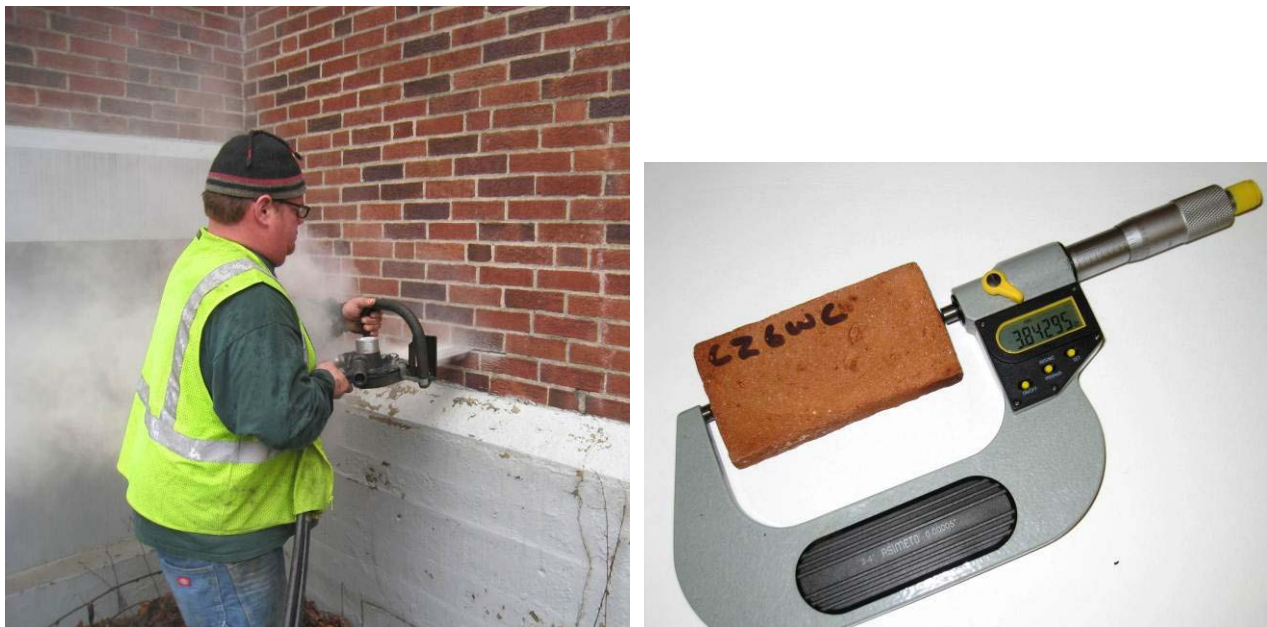
Figure 8. Removal of brick sample, and dilatometry (dimensional change) measurements

The measurement involves removal and preparation of brick samples from the building, freeze-thaw cycling them at various moisture contents, and measuring dimensional changes of the sample (see Figure 8).

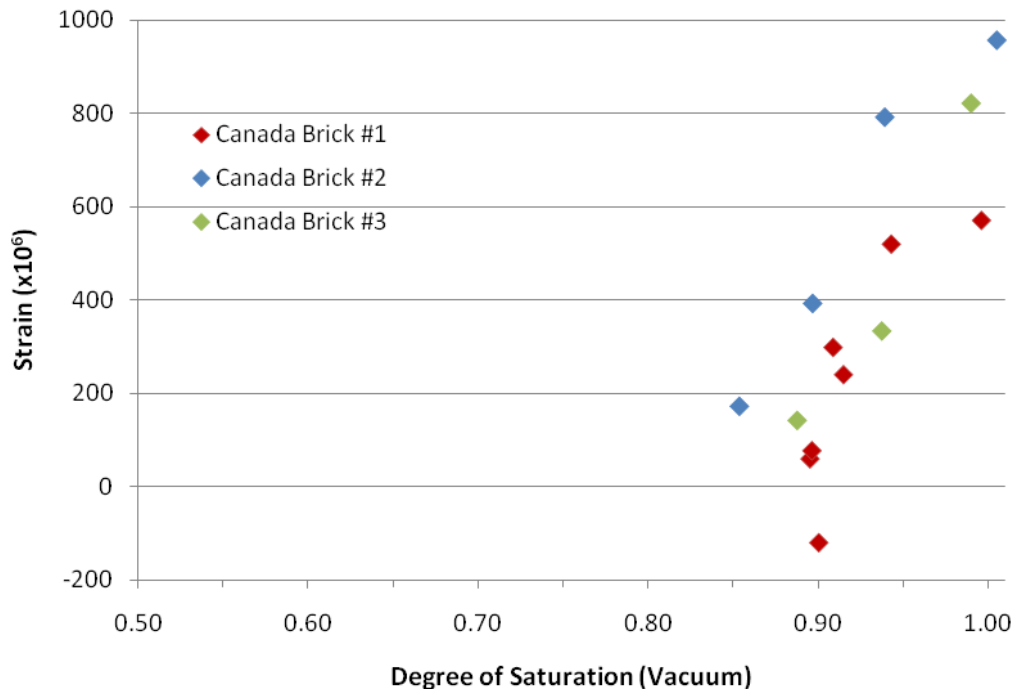
Figure 9. Determination of S_{crit} value plotting degree of saturation against strain (dilation)

S_{crit} level can be determined by plotting sample dimensions before and after thermal cycling, at various moisture contents (Figure 9). If the sample grows, then freeze thaw degradation is occurring and that sample's moisture content is above the S_{crit} threshold. This threshold can subsequently be used as a limit state in evaluating hygrothermal model outputs.

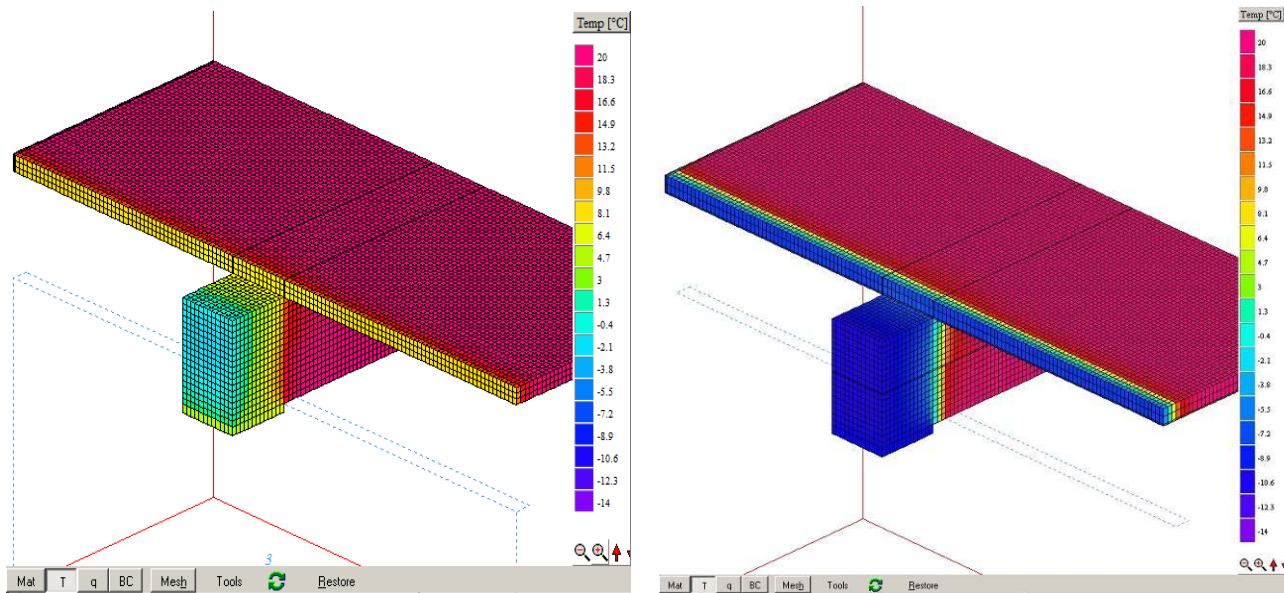
Figure 10. Embedded beam uninsulated case (left) and insulated case (right)

These results applied to both embedded heavy beams and smaller dimension lumber floor joists. The heat transfer analysis showed that the addition of metal plates reduced the heat loss savings (due to insulation) by 9%, and that having an uninsulated band had a 20% “giveback” effect.

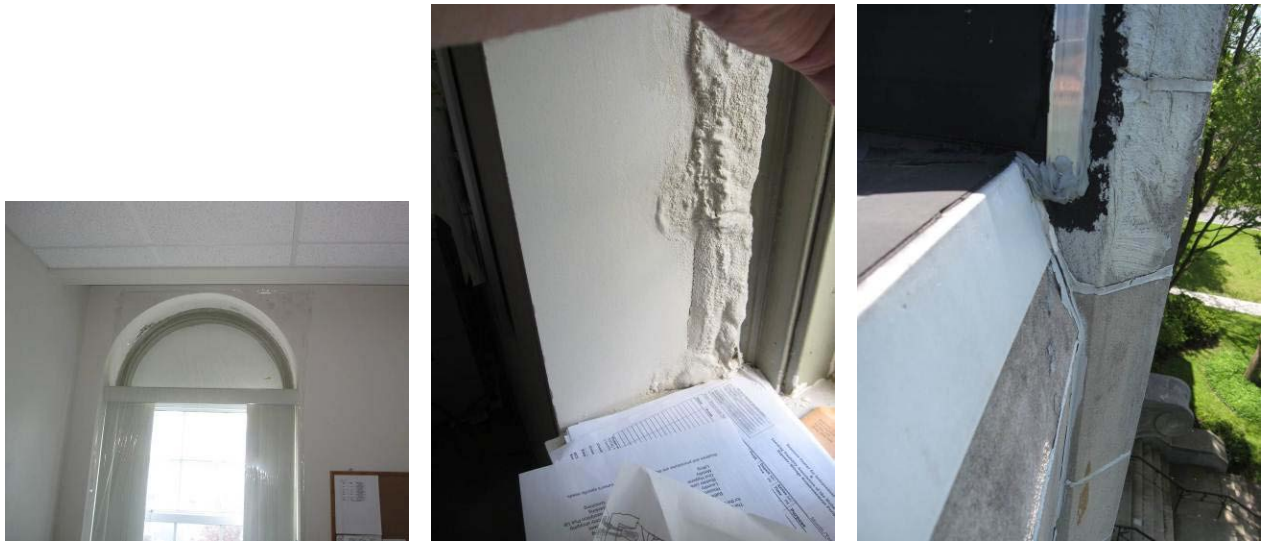
Figure 11. Moisture issues at windows in retrofitted building (Brennan 2011)

The building owner initially reported mold issues around the window penetrations on the top floor of the building (particularly at arch-top windows), on all orientations. It was found that this was not mold, but re-emulsification of gypsum drywall compound due to bulk water penetration

(see Figure 11); the compound was sufficiently wet and plastic that it could be “ribboned” like clay.

A diagnosis of the building exterior revealed a series of details that concentrate exterior rainwater at vulnerable locations, for instance, the window pan coping deposits rainwater onto the existing stonework, where it concentrates at the grout joint (Figure 11). A preferred approach would be a metal water shedding detail that covers the entire sloping stonework, with a drip edge 1” off the face of the stonework, to shed the water from the masonry. Other poor masonry detailing was observed throughout of the building, resulting in the observation that builders did not necessarily make buildings “better in the old days”—instead, only the well-detailed buildings have survived until today.

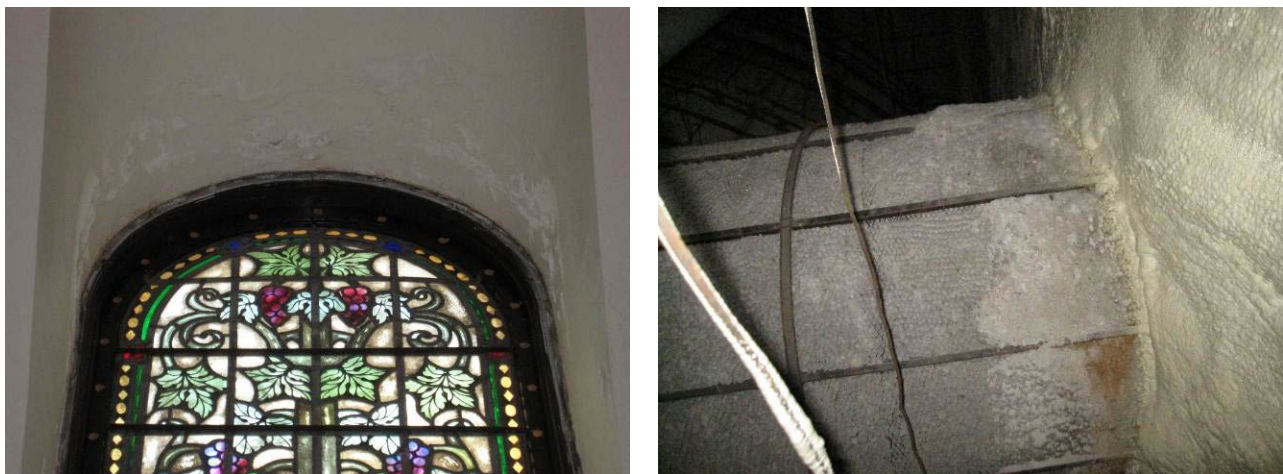
Figure 12. Moisture issues at chapel windows (Brennan 2011)

Brennan also observed newly occurring freeze-thaw damage in the cast stone material. At the chapel section, damage was observed at some of the arch-top windows, with an interior ceiling vault, and spray foam at the exterior wall (Figure 12). Excavation at the damage site showed plaster degradation and rust of the reinforcement mesh and steel framing.

Investigation revealed that the problem windows were surrounded by wet masonry, while the non-problem windows had dry masonry (as confirmed by measurements with a electrical capacitance moisture meter). All windows that showed damage had obvious water management defects in the brickwork above. Site work showed that it is often difficult to get an honest assessment of the building from the occupants and staff.

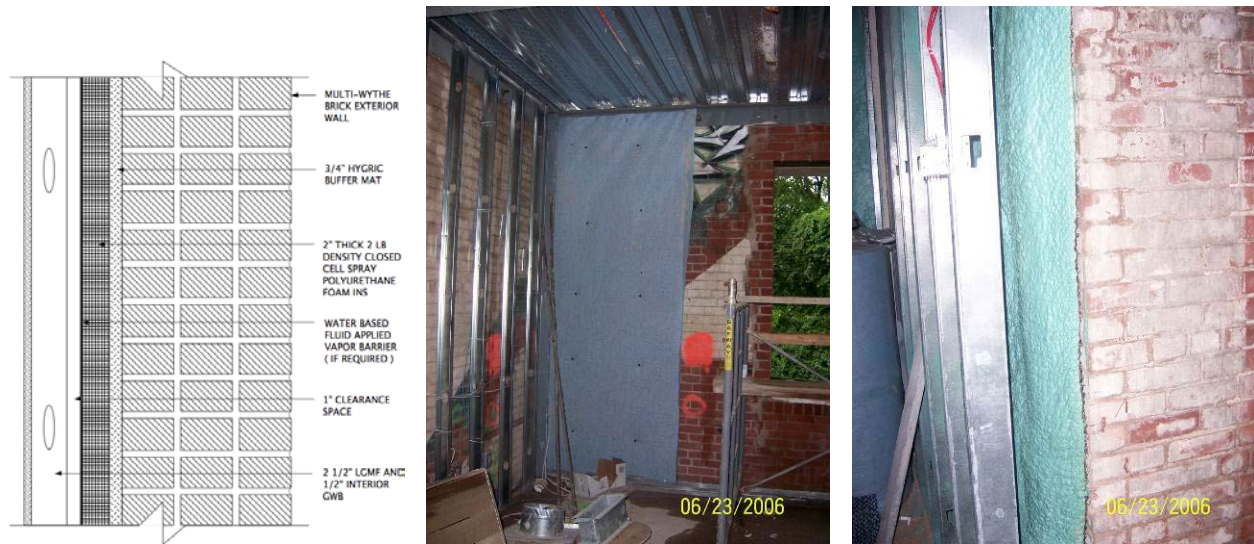
Figure 13. Hygric buffer mat and interior insulation application (Anastasi 2011)

Mr. Anastasi presented his preferred approach to interior insulation retrofits of masonry assemblies. His solution involves attaching a drainage mat covered with a polyolefin film to the interior of the masonry, and applying closed cell spraying foam inboard of that material. The point of the cavity is that bulk water in incidental locations could be drained and/or redistributed without concentrated damage to the immediate area. It allows greater drying to the masonry, compared to direct application of ccSPF to the interior surface. This application has been developed into a commercial product, marketed as a “hygric buffer mat.”

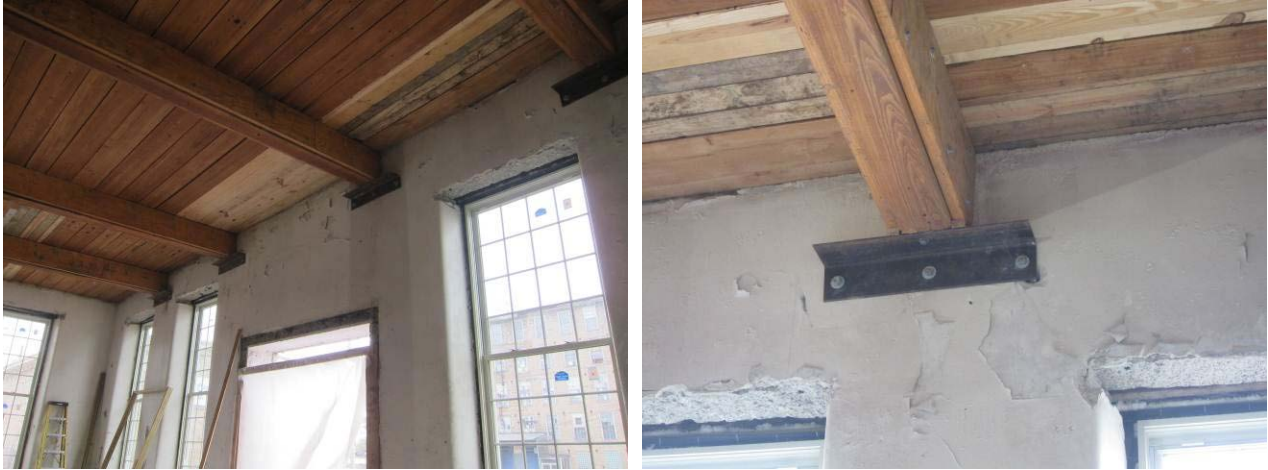
Figure 16. Steel angle bolted to masonry to transfer load out of beam pocket

Q: Could one use a steel shoe (joist hanger) to transfer the load from the beam to the masonry in the case of an embedded wood beam?

A: Yes. Another option is a pressure treated ledger board connected to the masonry and the joists.

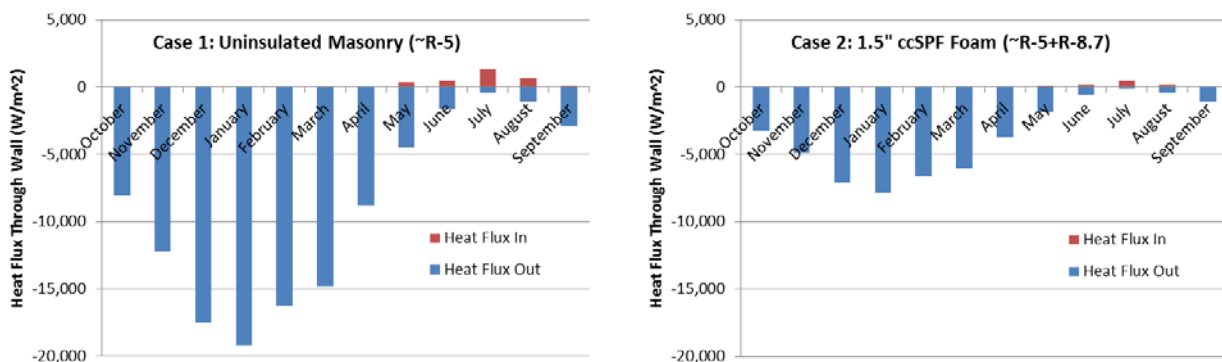
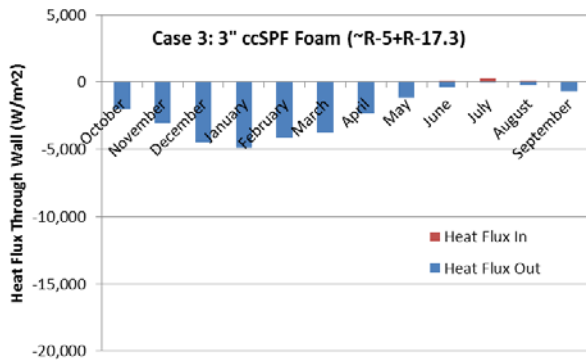
Climate: Burlington, VT

Case 2 ≈ 60% reduction in heat flow through walls

What are the energy savings associated with interior insulation retrofits? Can effective thermal performance be obtained by leaving these buildings uninsulated, and relying on thermal mass effects? Energy models suggest thermal mass is not significant to energy performance for buildings located in heating-dominated climates; it is of greater benefit in locations with high diurnal swings around the interior setpoint (see Figure 19).

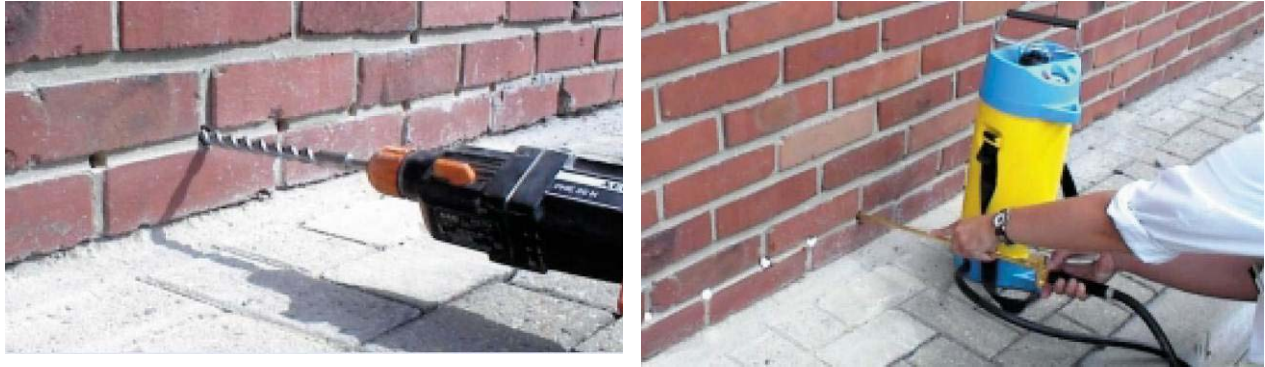
Figure 20. Installation of injectable liquid damp-proofing course (Aida DPC, Remmers Ltd., 2005)

There are “damp proof cremes” available commercially in the United Kingdom, which are injected into horizontal holes in order to create a “damp proofing course” (Figure 20). Are these viable products? They are reported to work only 20%-30% of time in the field (Künzel).

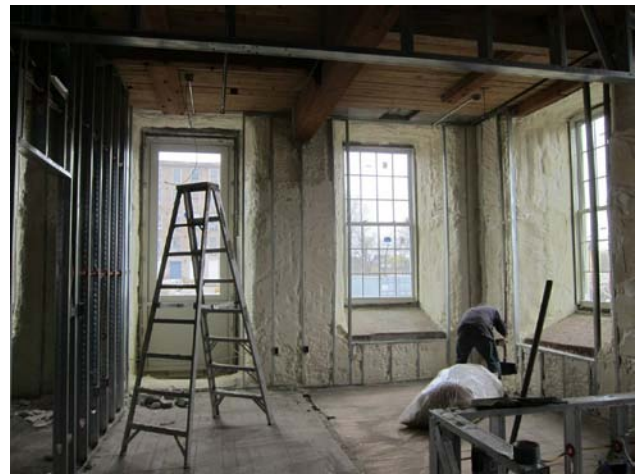
Figure 21. Tapered window opening jamb detail and interior view (sill left uninsulated)

Tapered window opening and exposed window sills limit ability to add insulation. No available solutions were presented. Two- or three-dimensional thermal modeling would provide some insight into this issue.
