RPSEA FINAL REPORT

RPSEA Document Number: 09121-3500-02.FINAL

SRP SHRINK-FIT CONNECTION 09121-3500-02

The Shrink-Fit connection approach to riser fabrication has been successfully designed and developed to enable the manufacture of riser systems from high strength thick walled pipe that are capable of operating with high internal pressures, beyond that which are typically available within the industry today. This technology has already been employed for manufacture of a shallow water drilling riser system in the North Sea.

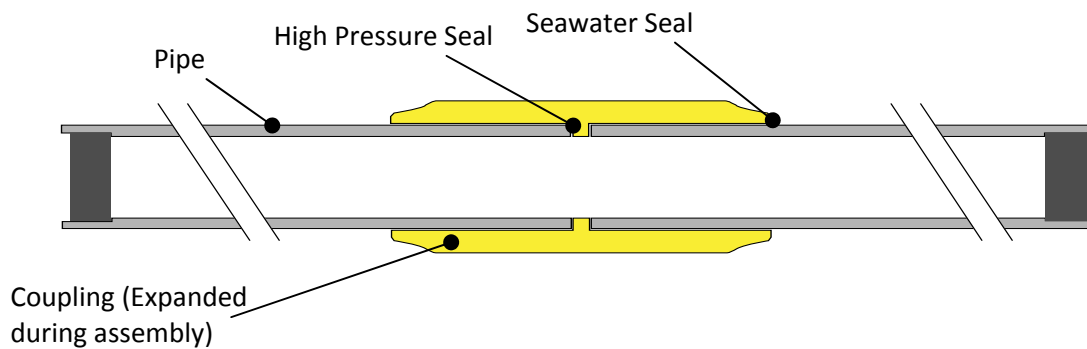
Figure 3.1 – Cross-Sectional Diagram of Shrink-Fit Connection

The couplings, once thermally expanded, swallow the pipe with the pipe butting against a shoulder, as shown in and Figure 3.2. Very high pressure rated seals are created at the pipe ends. Sealing sufficient to retard seawater ingress is located at the extremities of the coupling.

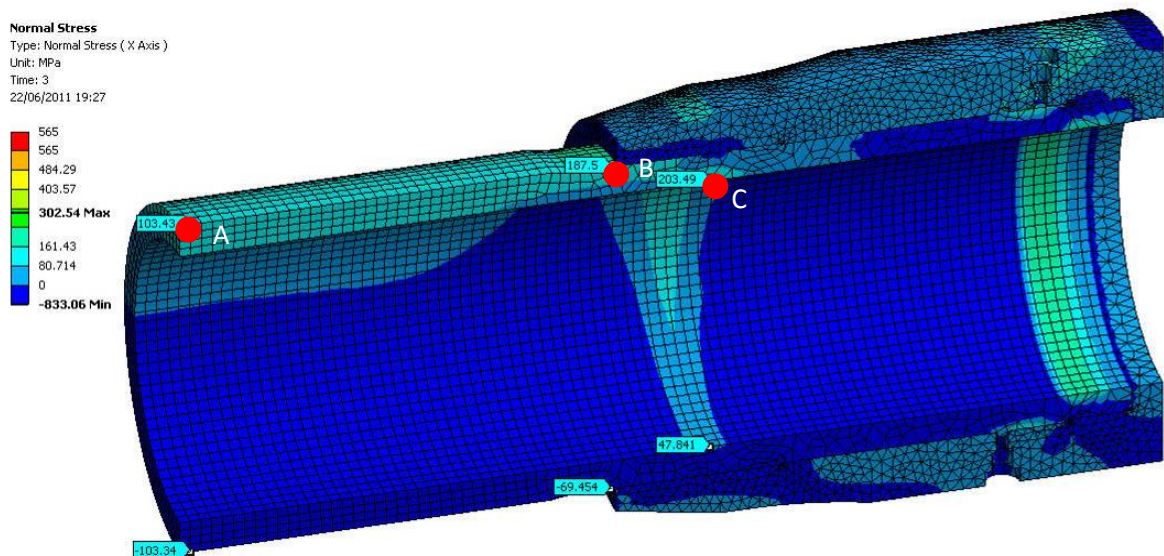
Figure 3.3 – Pipe Stress Range Investigation, Ambient Internal Pressure

The worst fatigue location (at design phase) was hypothesized to be near fatigue location 'B' on the pipe, on the outer diameter (OD) of the pipe as it enters the coupling. At this location slight rubbing 'fretting' between the coupling and pipe could reduce the fatigue life. A detailed discussion of the causes and severity of this effect is beyond the scope of this report.

Internal Pressure	Location	Dir1 (ksi)	Dir2 (ksi)	Basic Stress Range (ksi)	Modified Stress Range* (ksi)	Basic SCF	Modified SCF*
0 ksi	A	15.0	-15.0	30.0	24.0	1.00	0.80
	B	27.2	-10.1	37.3	33.2	1.24	1.11
	C	29.5	6.9	22.6	22.6	0.75	0.75
5 ksi	A	24.7	-5.3	30.0	27.9	1.00	0.93
	B	48.9	11.8	37.2	37.2	1.24	1.24
	C	40.0	20.8	19.3	19.3	0.64	0.64

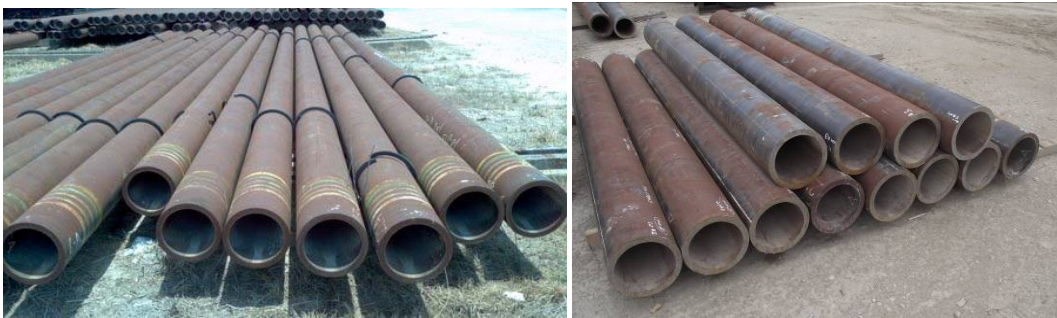
Figure 4.1 – API 5CT SM-C110 Pipe, Before & After Cut to Length

The API 5CT SM-C110 11-3/4 inch pipe with a nominal 1.1 inch wall thickness were provided by BP for the purposes of destructive testing. Initially, the pipe was supplied in 39 foot lengths, which were then cut to size through our machining contractor. The pipe had been 100 percent volumetrically inspected at the pipe mill.

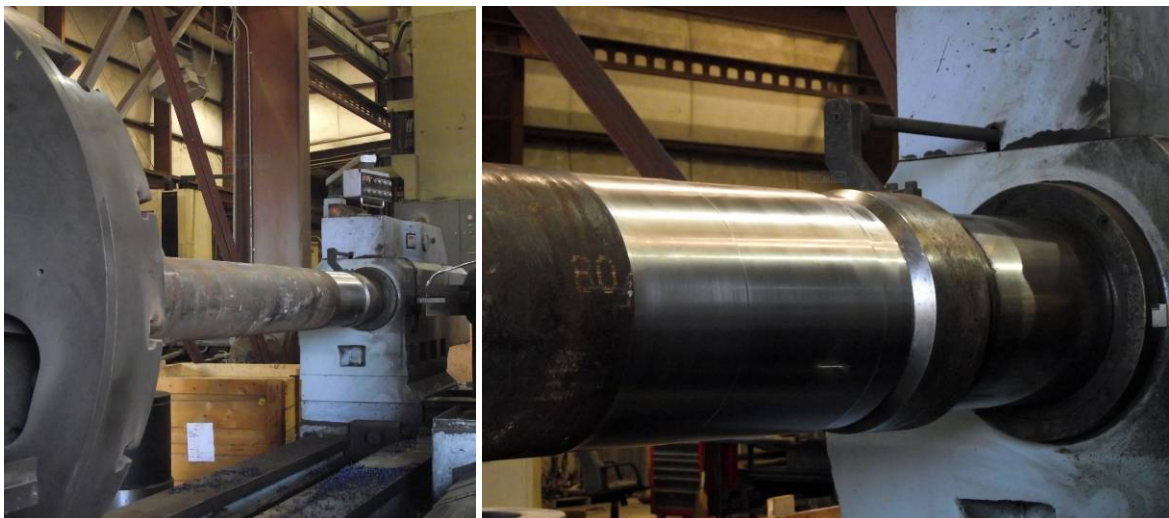
Figure 4.2 – Machining Of Pipe Ends

The detailed machining was carried out on a manual lathe; the internal diameter (ID) of the pipe was left un-machined. Around 0.2 inch was removed from diameter to ensure that the pipe could be made cylindrical, this proved to be unnecessary – and it is proposed that only 0.08 inch would have been required. This means that the thinning of the wall thickness could be reduced to a fraction of what it currently is; reducing the SCF of the connection by 10 percent (i.e., an SCF of 1.46 becomes 1.33).

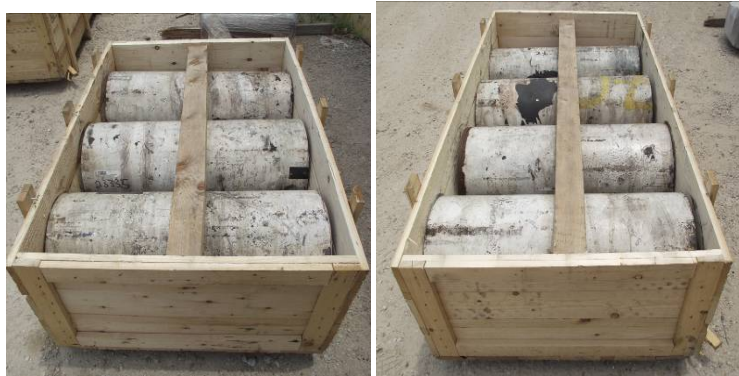
The SRP stress joint forgings were cut to produce the ASTM A182 Grade F22 coupling stock in the UK. There were seven pieces, of which six would be machined into project couplings (the last was for assembly test only). The pieces were crated and shipped to the selected machining contractor in Houston; clearing customs (see Figure 4.3). Further tests were carried out to confirm the material strength.

Figure 4.3 – Crated Coupling Forgings Arrive at Machining Contractor in Houston

The coupling stock was 100 percent ultrasonically inspected to API 6A PSL3/ASTM 388 requirements by a local NDT subcontractor, no relevant indications were found, and so detailed machining could begin.

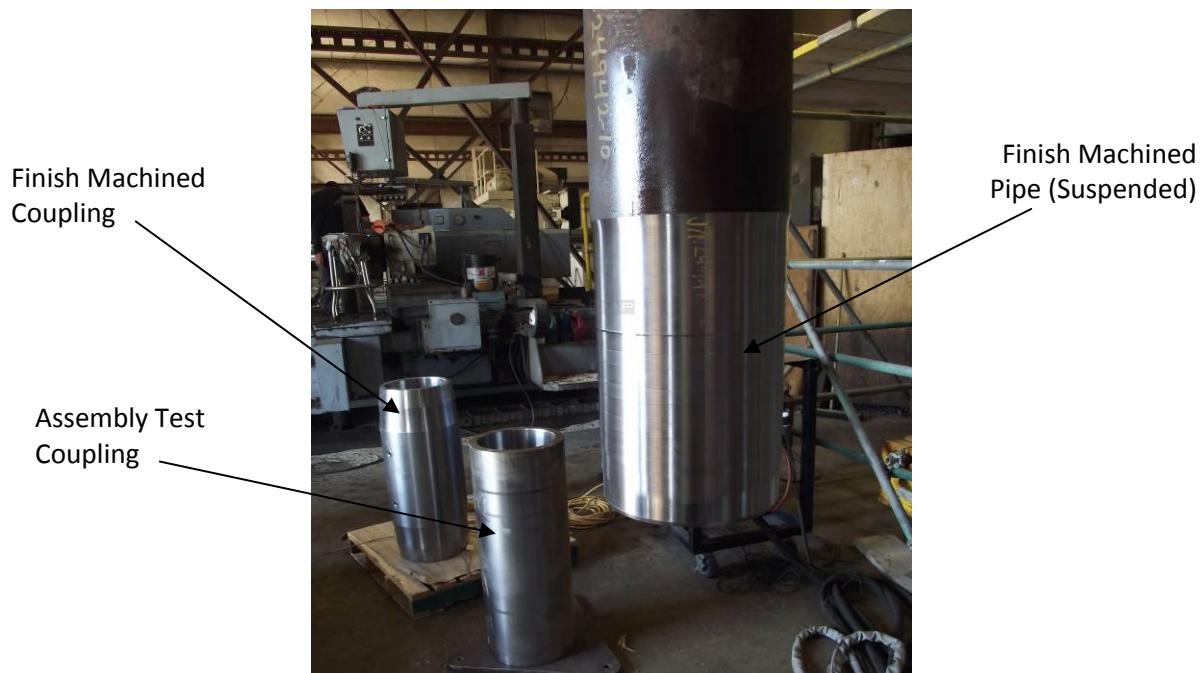
Figure 4.4 – Pre-Assembly Test

The shrink-fit assembly process works by expanding the female coupling or flange through the application of heat, after which the pipe is carefully inserted. The heat is provided in this instance by portable induction heating equipment.

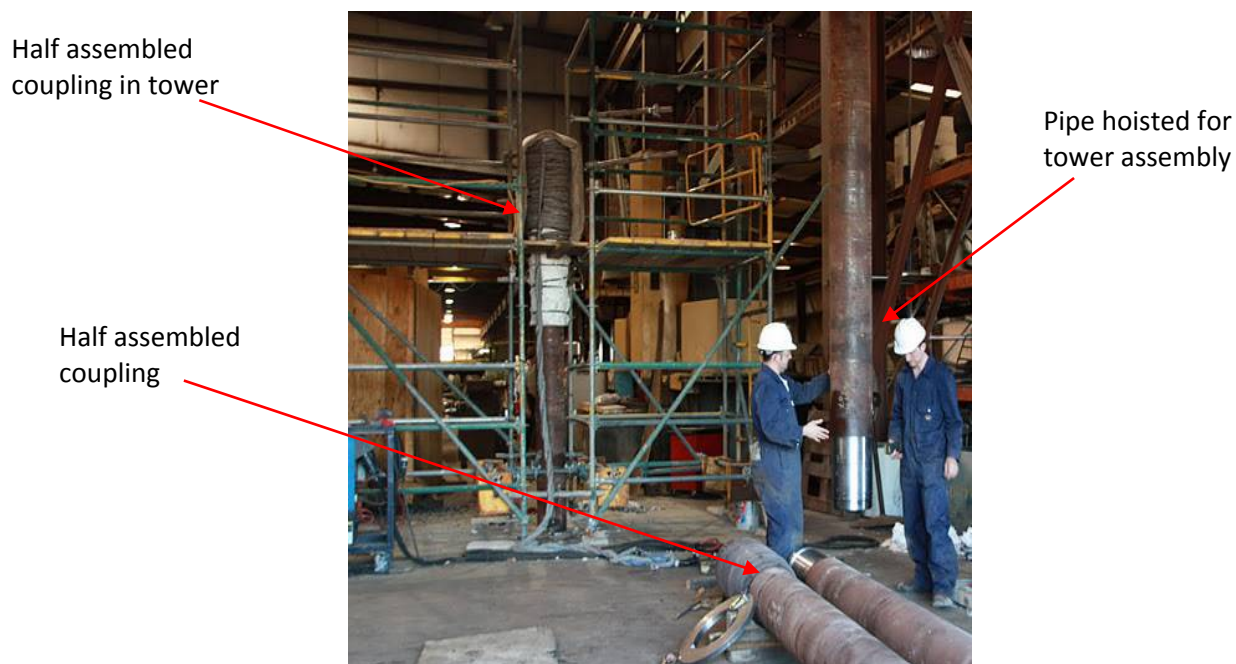
Figure 4.5 – Preparation for Second Shrink-Fit in Assembly Tower

Since the connection is a coupling, the assembly is carried out in two steps. First the pipe is lowered into the coupling which rests on an alignment plate on the ground, and after it cools, the entire connection is up-ended into the assembly tower. Then the second shrink-fit operation is performed and the entire sample is lowered down to cool.

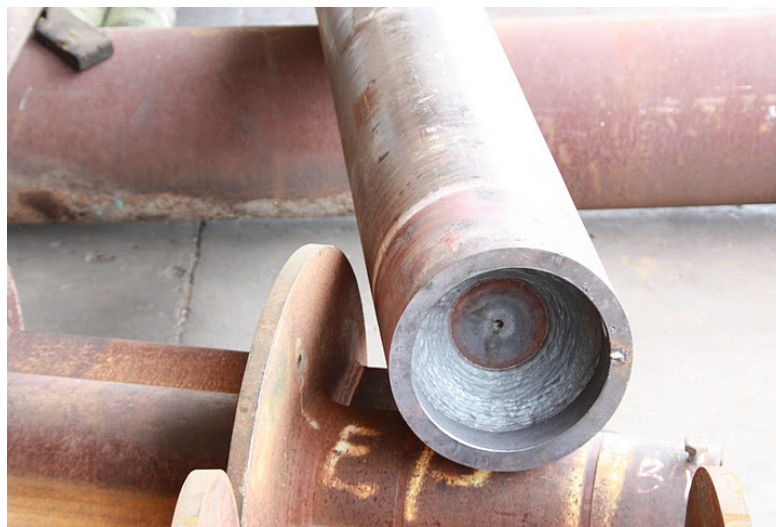
Figure 4.6 – End-Cap Fillet-Weld Into Pipe Bore

Once assembly is complete, end-cap plates were welded inside the ends of the pipe for pressure containment. A large fillet weld was laid down, which was then stress relieved by post weld heat treatment (PWHT). This was carried out at Stress Engineering Services (SES), to SES pre-qualified weld procedures.

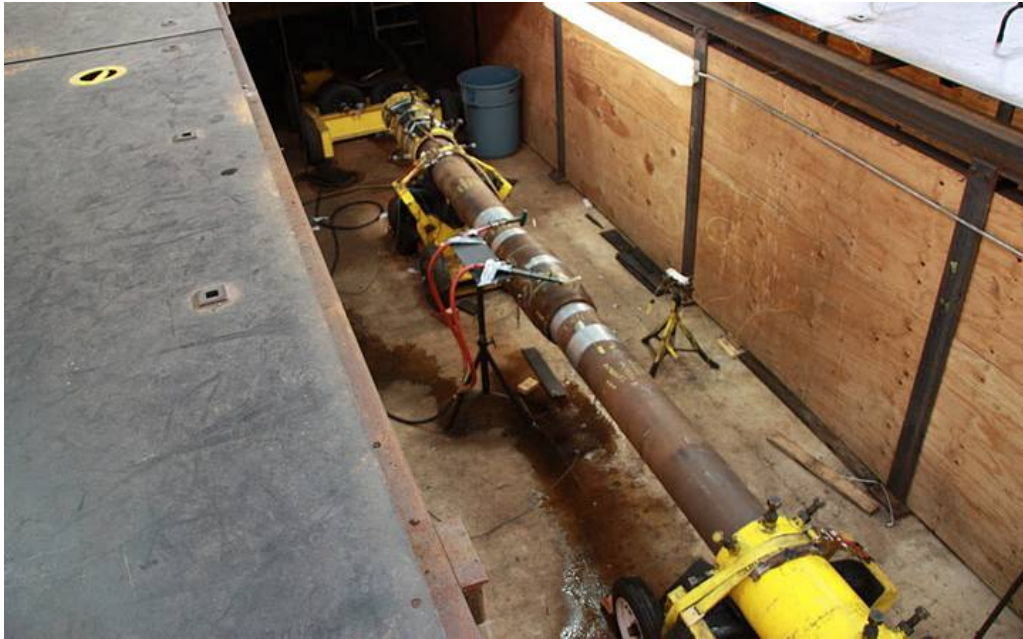
Figure 5.1 – Resonant Bending Fatigue Test Pit, With Sample Installed

A standard SES resonant fatigue machine is used, which consists of two supports, a variable speed electric motor, drive housing, and dead weight housing. The variable speed motor rotates an eccentric mass in the drive housing clamped to one end of the sample and loads the pipe. The rotational velocity of the motor is adjusted to load the sample near its natural frequency. The dead weight housing is clamped to the other end of the sample to balance the assembly (See Figure 5.1).

The stress was measured using 8 off axial strain gauges on the outer diameter of the pipe (4 off each side of the connector, 90-degree spacing). Maximum and minimum strain gauge readings were averaged for one minute intervals and the averages written to a results file. This forms the basis for calculating the stress ranges. Additional data recorded is the mean and standard deviation of the one minute averages, along with the cycle count.

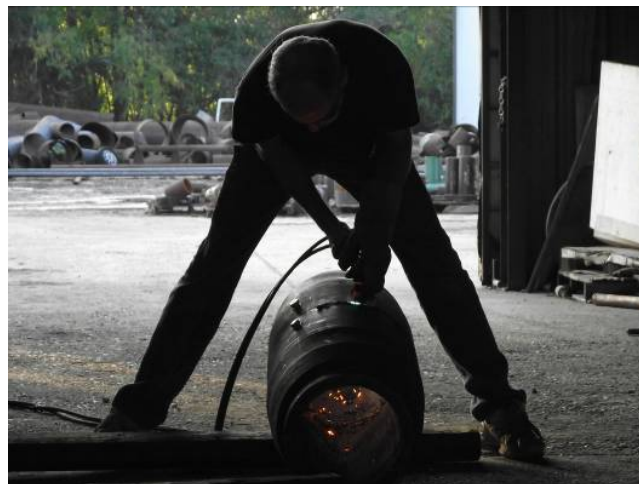
Figure 5.2 – Cutting Samples for Post-Test Examination

After fatigue failures at SES, the mechanical locking chambers were opened and examined to determine whether hydrotest fluid had entered the chambers. All ports were found to be dry on post-failure inspection. This indicates that leakage was not due to failure of the main pressure seal, since it would have to fill the chambers in order to continue to the coupling neck and final leak.

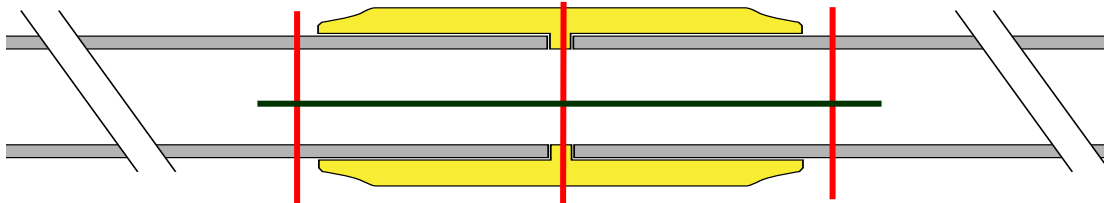
Figure 5.3 – Sample Dissection

The samples were then dissected in order to better ascertain the failure mode and location, and to direct possible design modifications. As shown in Figure 5.3, three girth cuts were made with a gas axe (red lines), and then the samples were split lengthwise (green line).

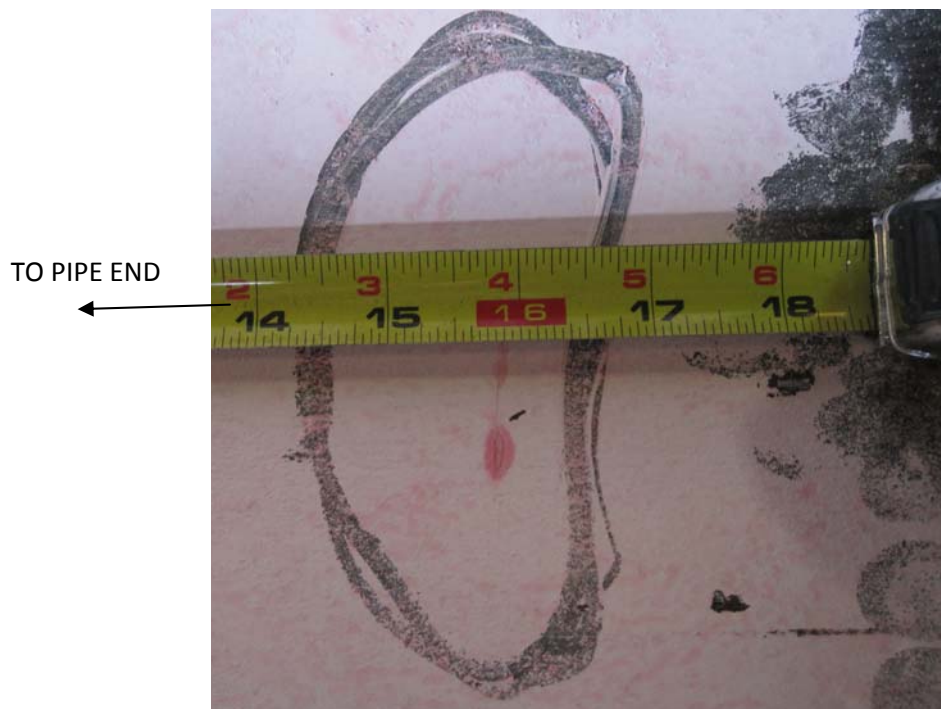
Figure 5.4 – Pipe Bore Cracking, Measurement Taken From Pipe End

The bores and outer diameters of the pipes inside the couplings were examined for fatigue cracks using dye-penetrant inspection techniques. Cracks were found at the entry point of the pipe to the flange. The main seal remained intact, with the pressure escaping through the cracked pipe. A typical example of cracking picked up by dye penetrant testing is shown in Figure 5.4.

A summary of the non-destructive testing carried out on the samples is to be found in Appendix B, five out of the six failure points were identified as circumferential fatigue cracking of the pipe. It is considered that the remaining failure point failed in the same manner, but that the NDT investigation failed to detect it, possibly due to the dissection intersecting the indication.

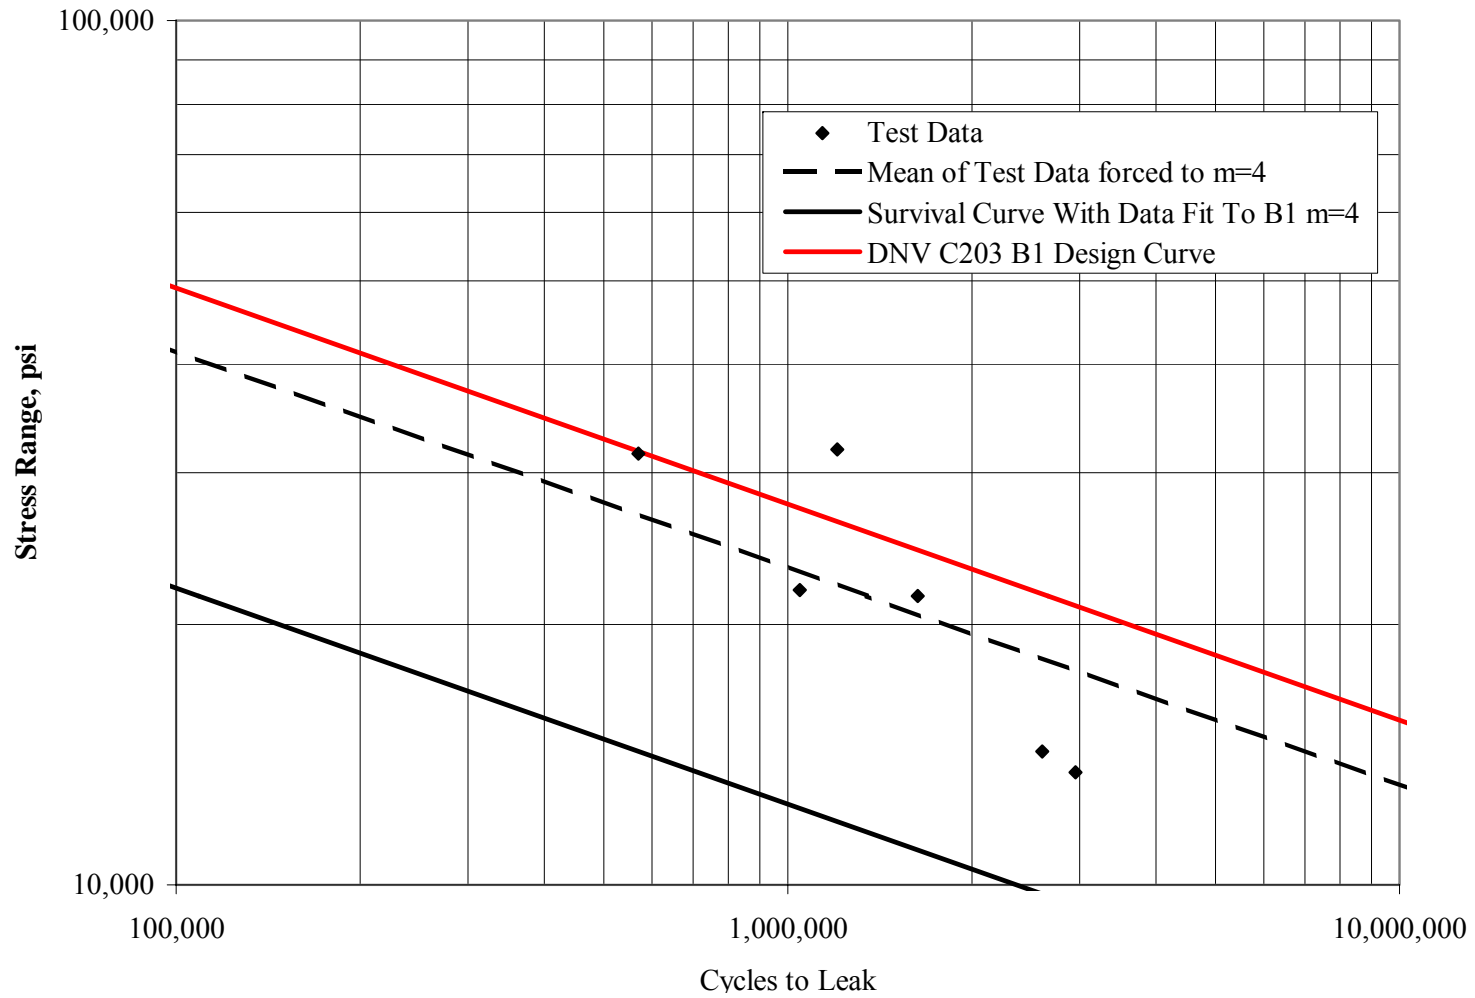
FIGURE 1
11.75" OD x 1.1" WALL SHRINK-FIT CONNECTOR FATIGUE TEST RESULTS
COMPARED TO DNV C203 B1 CURVE

Stress Engineering Service's resonant fatigue test machines were used to fatigue test the samples at a frequency of about 24 Hz. The samples were filled with water and pressured to 3000 psi during the fatigue tests. All of the samples failed by leaking out one end of the coupling. Table 1 and Figures 1 and 2 summarize the fatigue test results.

Although only six samples have been tested, the data indicated that the slope of the data is steeper than either the B1 or C1 curved. That is “m” for the data is lower than 3 and the use of the test stress factors is not recommended for stress ranges below the lowest test stress range of 14,000 psi.

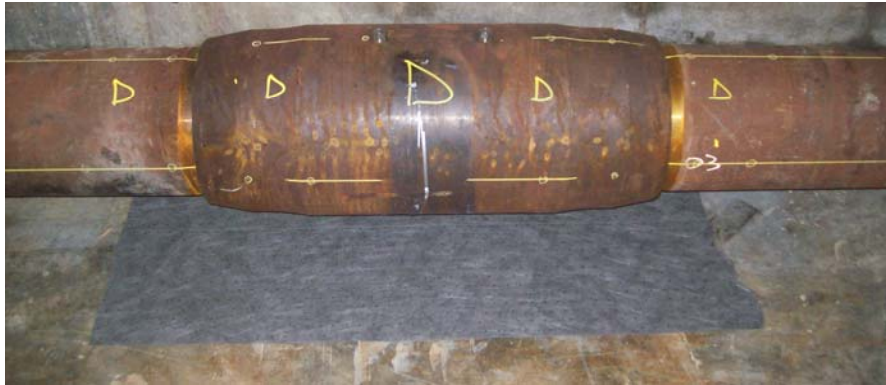
Absorbent Pad Under Coupling To Monitor for Leaks

Absorbent pads were placed under the coupling during the hydro test to detect leaks. If the sample leaked, the water would drop on the pad and discolor it.

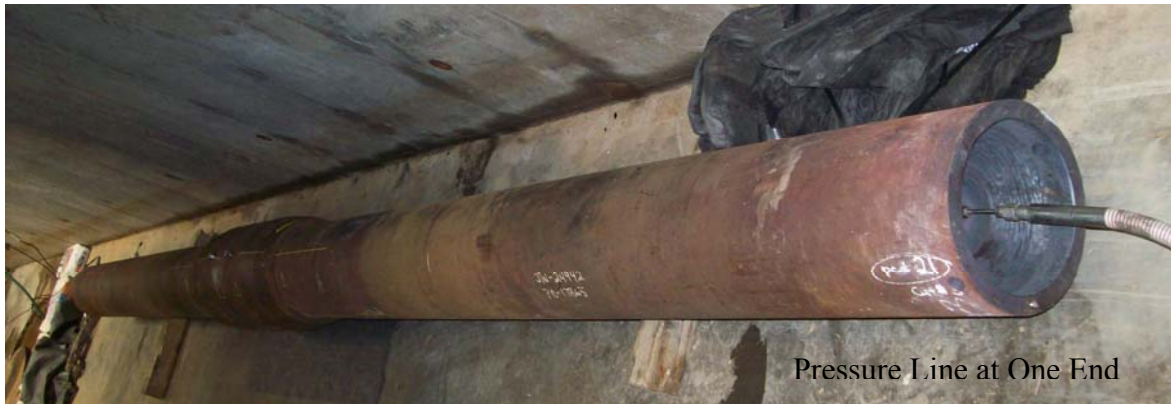
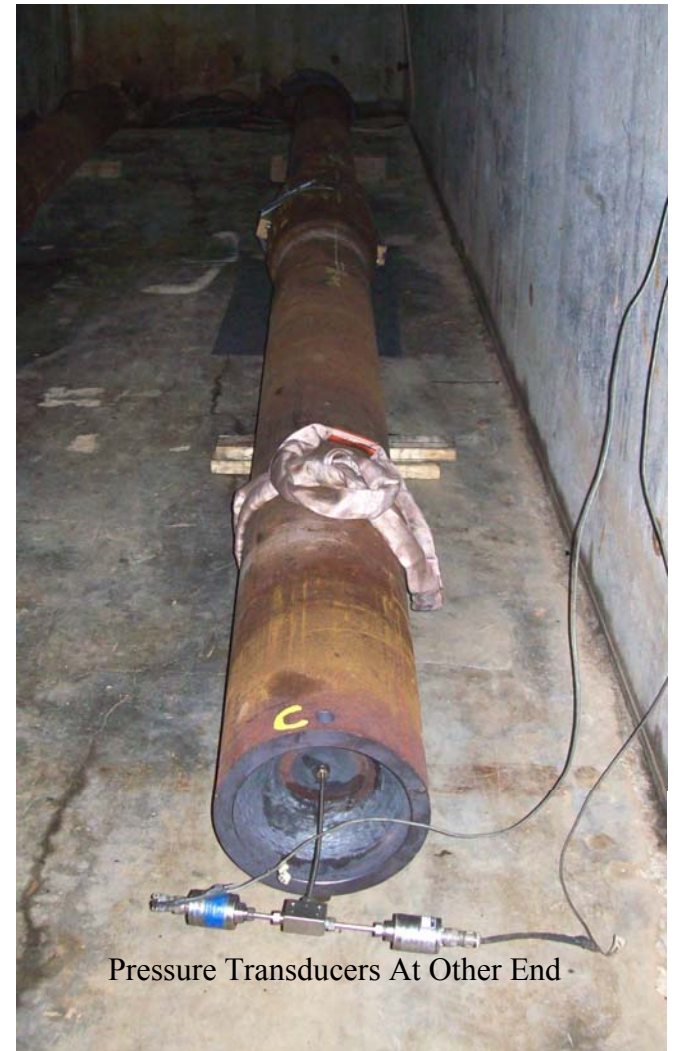
**FIGURE 2.1
HYDRO TEST SAMPLE IN PIT**

Pressure Line at One End

Pressure Transducers At Other End

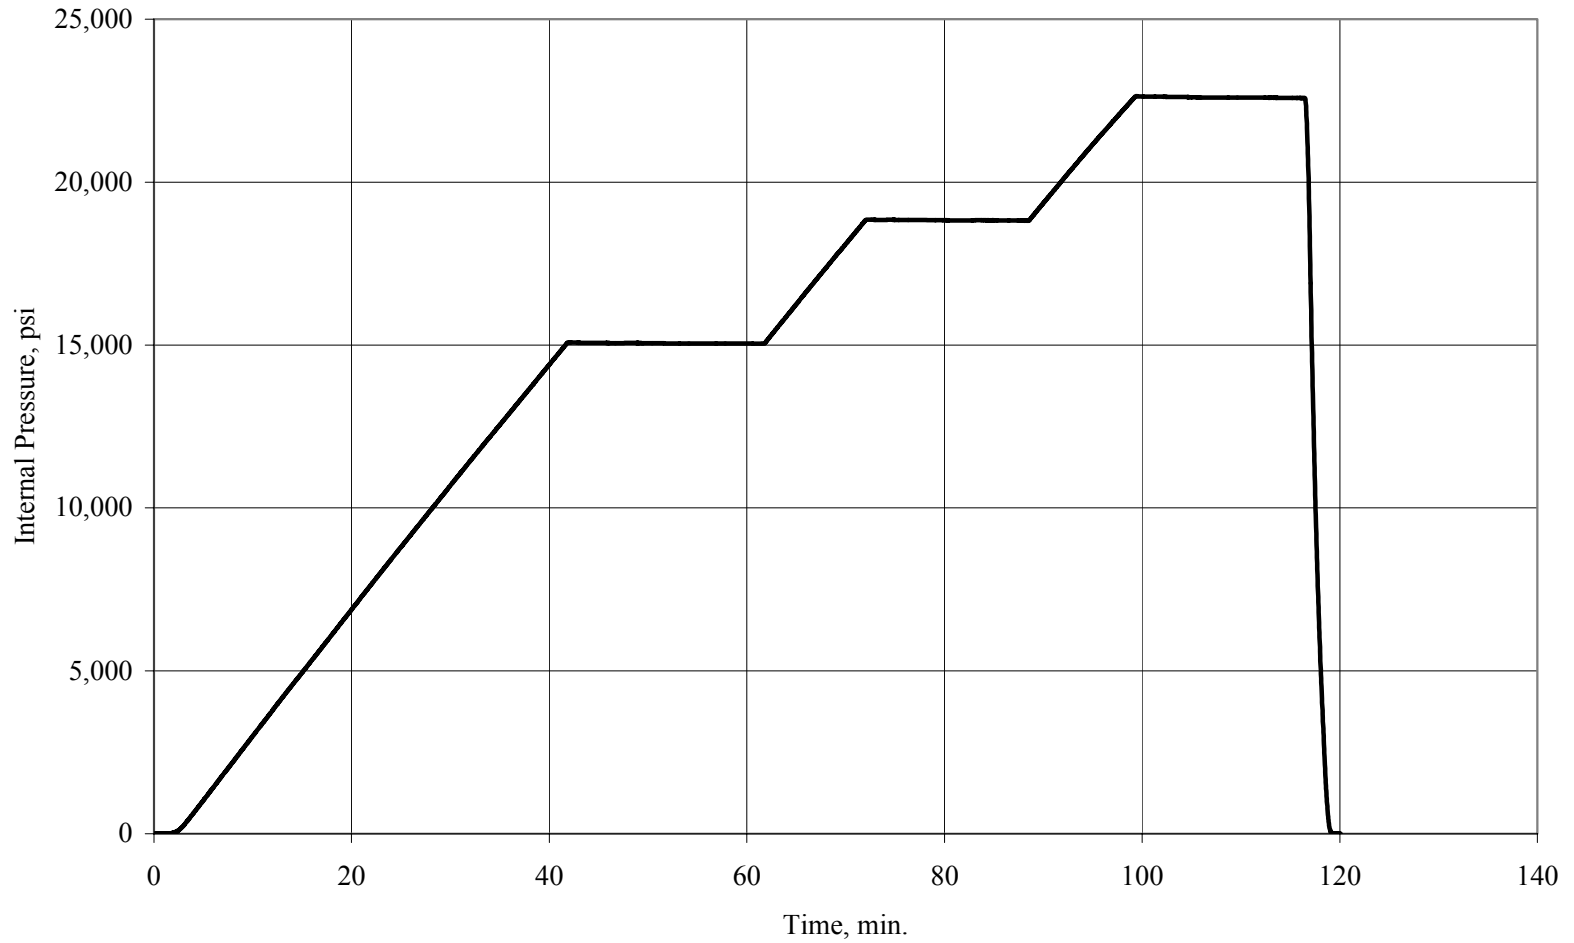
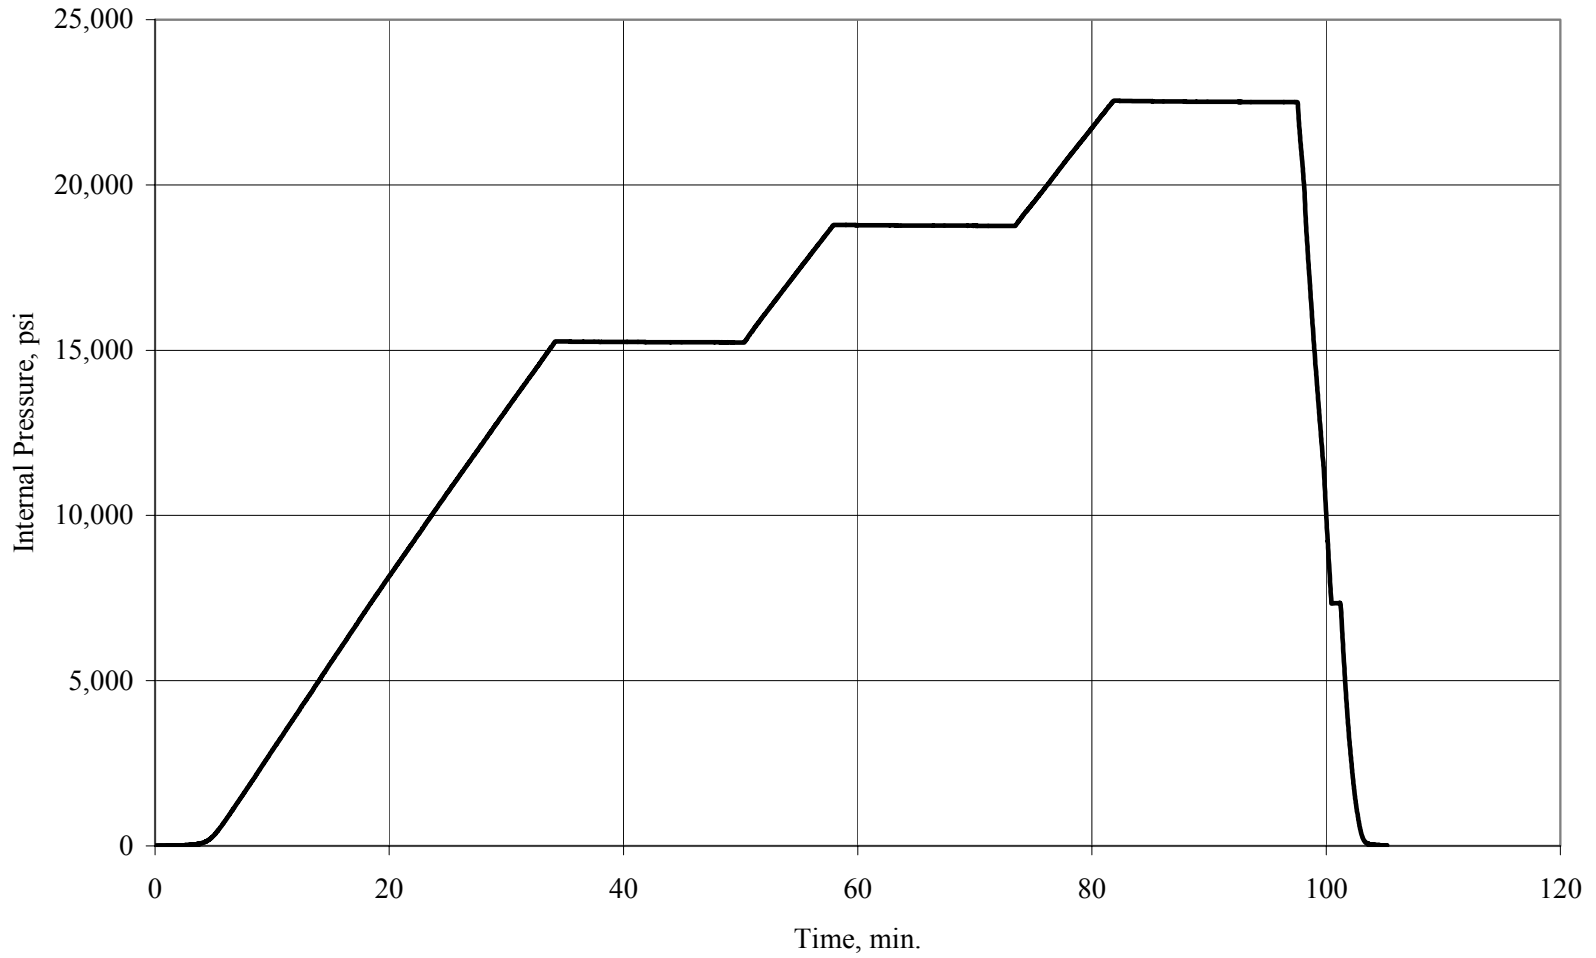
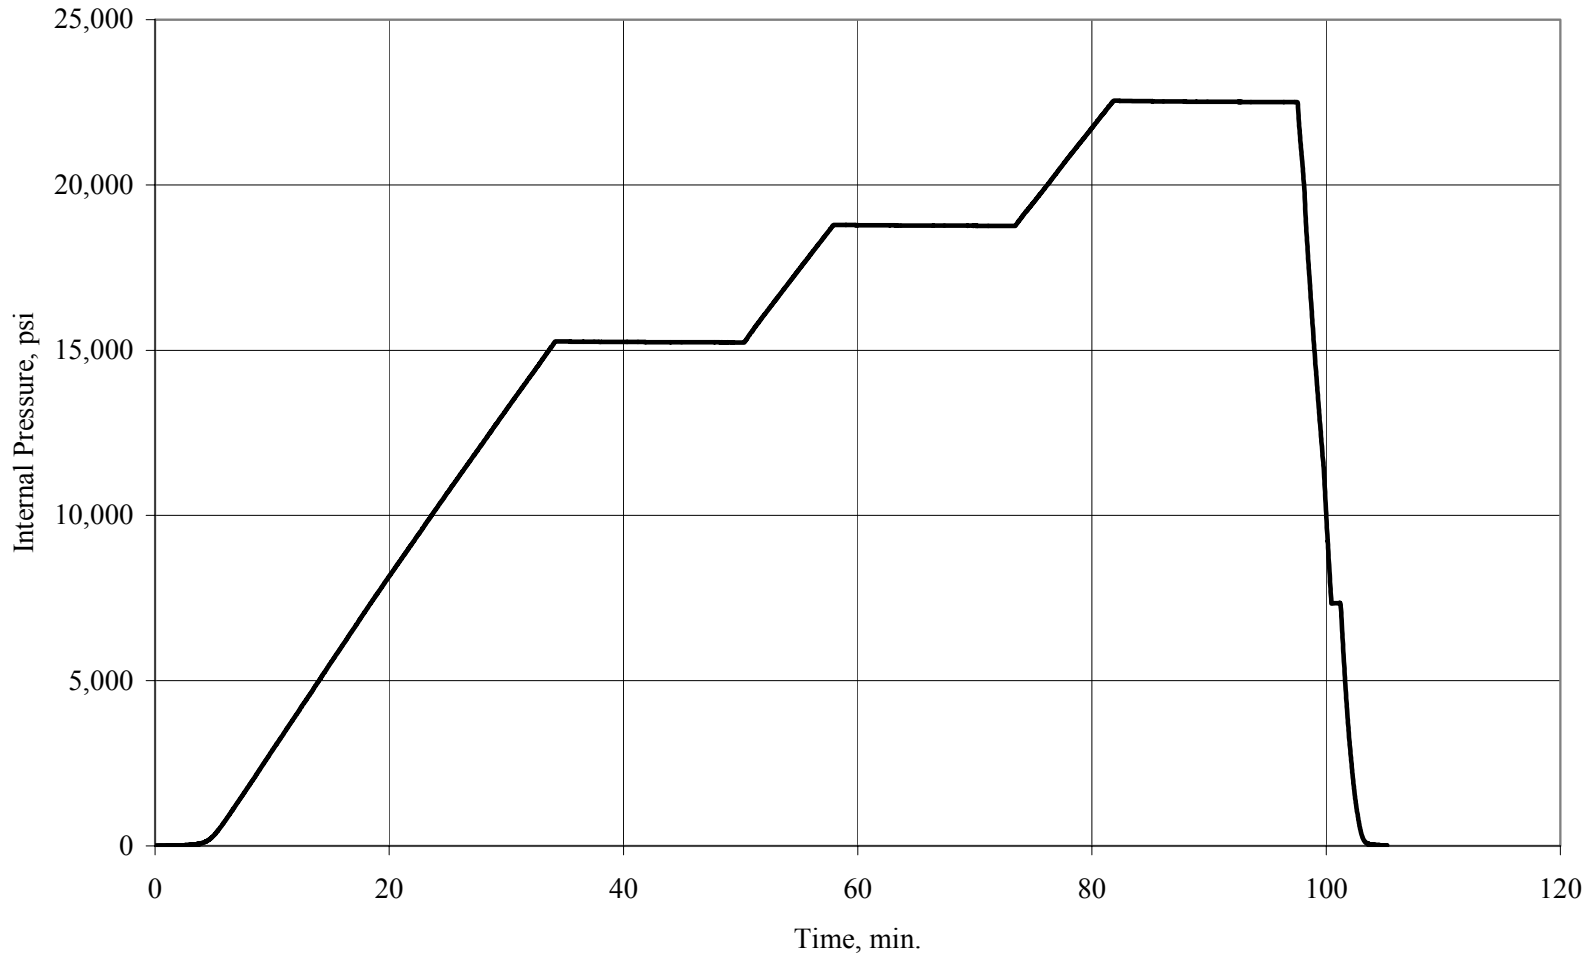
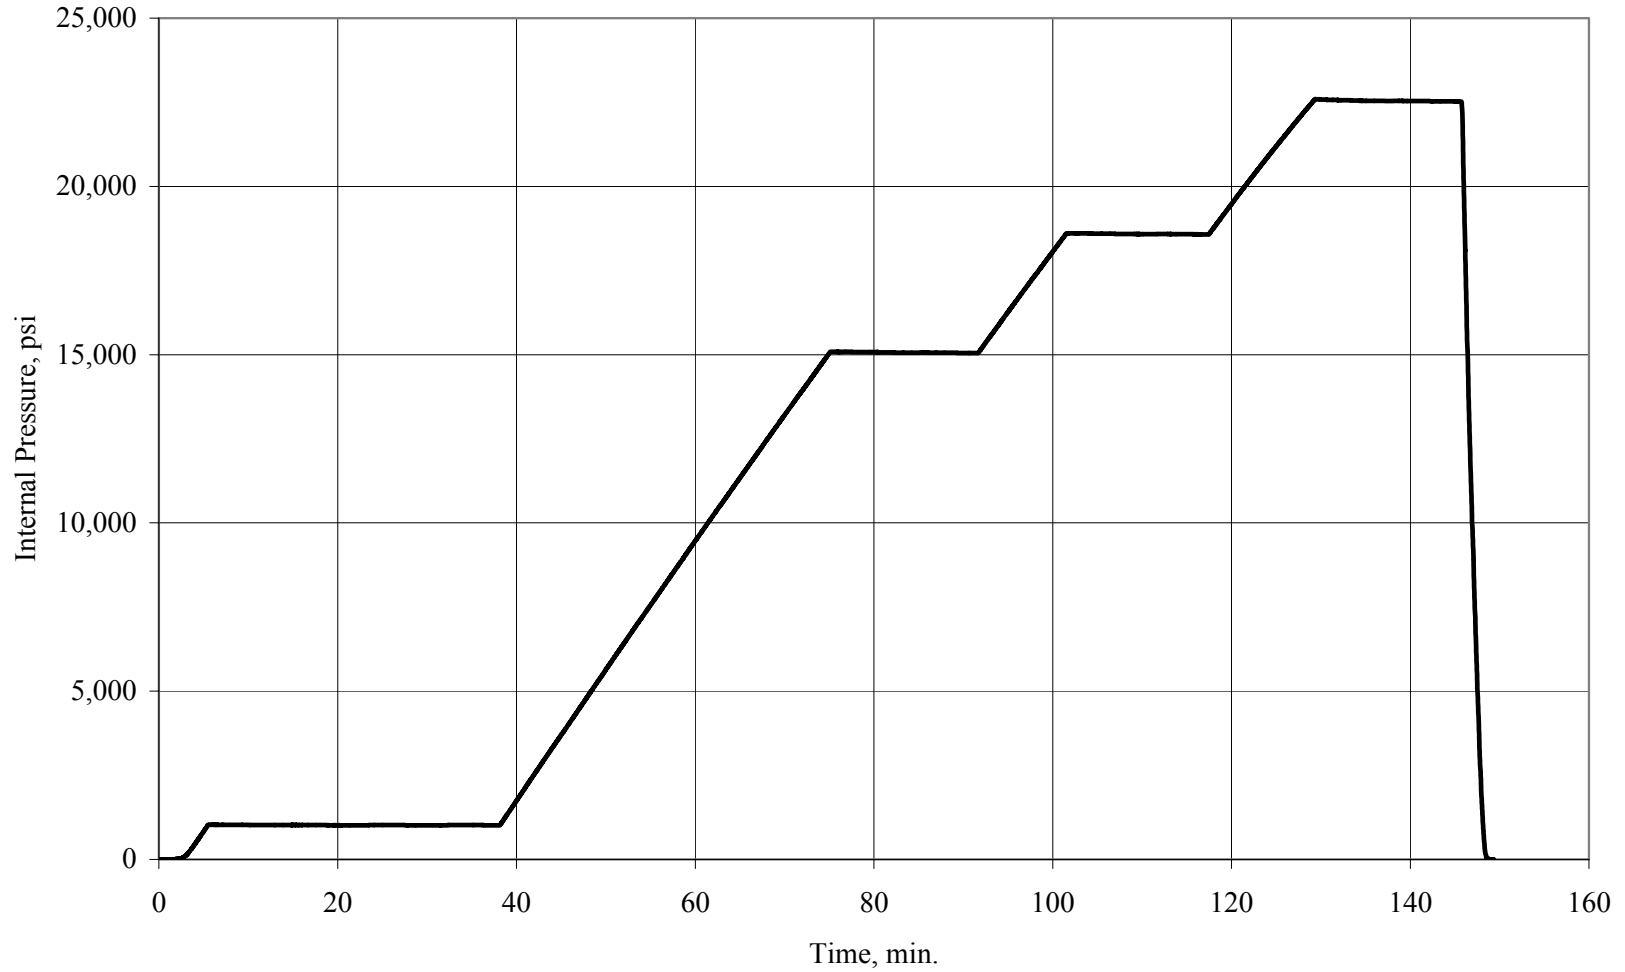
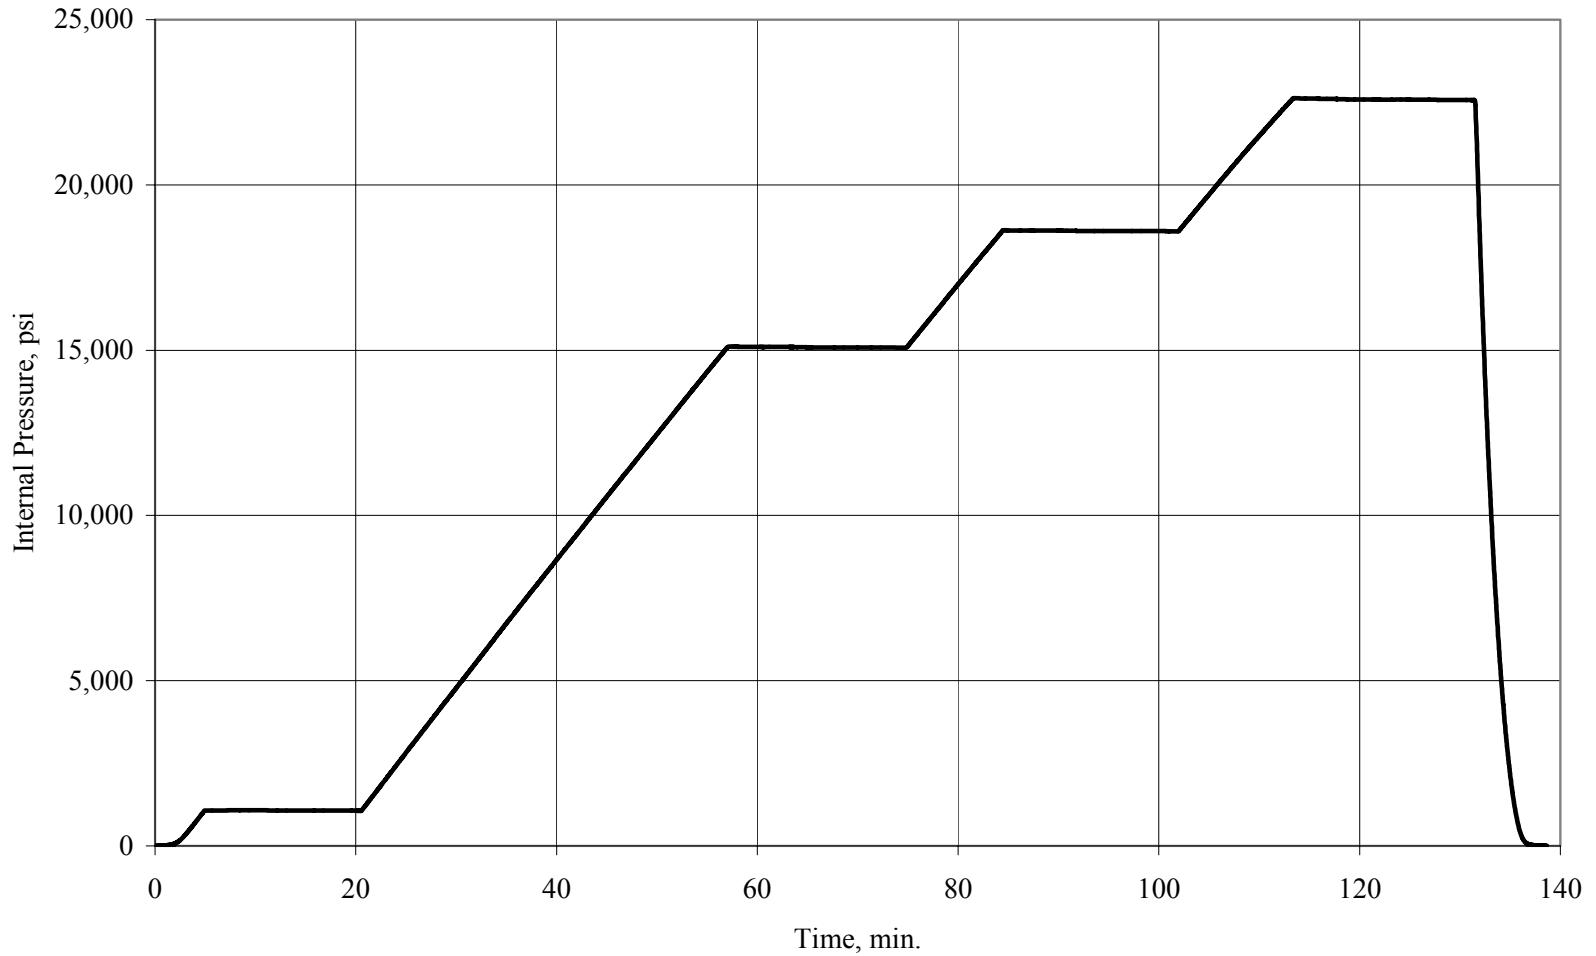
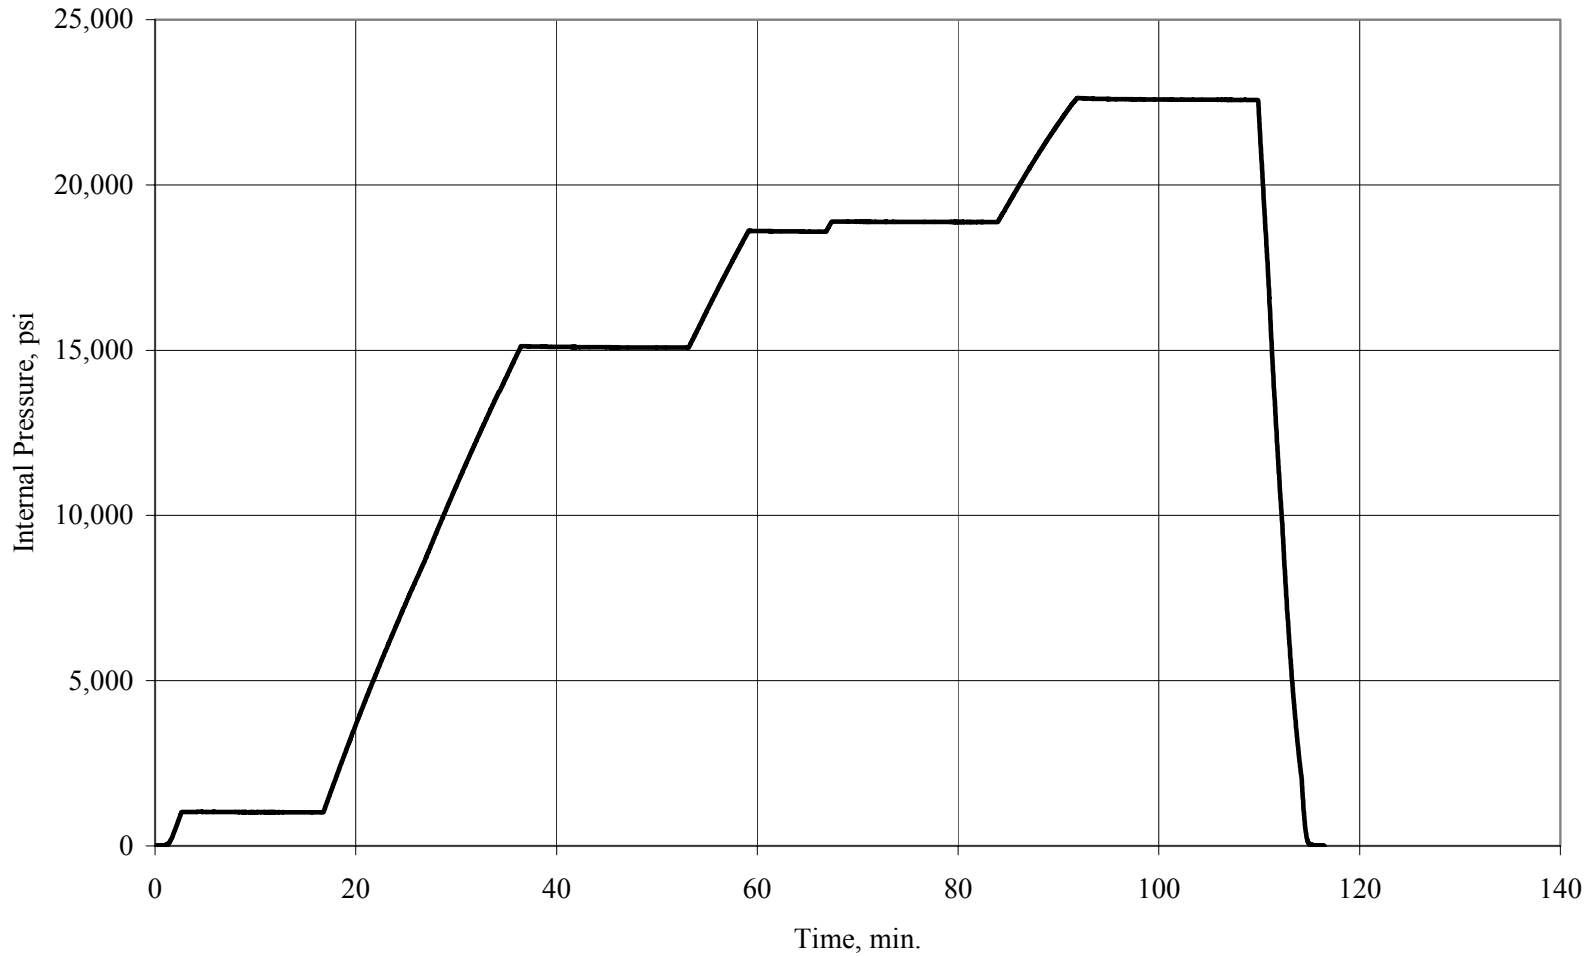
Figures 3.1-3.6 show the pressure history plots for the hydro test samples. Table 3.1 shows the hydro test results. As shown in Table 3.1, the pressure change during each pressure step test was negotiable. No leaks were observed during any of the hydro tests. Table 3.2 summarizes OD readings recorded before and after the hydro tests.

FIGURE 3.1
11.75" OD x 1.1" WALL SHRINK-FIT CONNECTOR SAMPLE A HYDRO TEST HISTORY

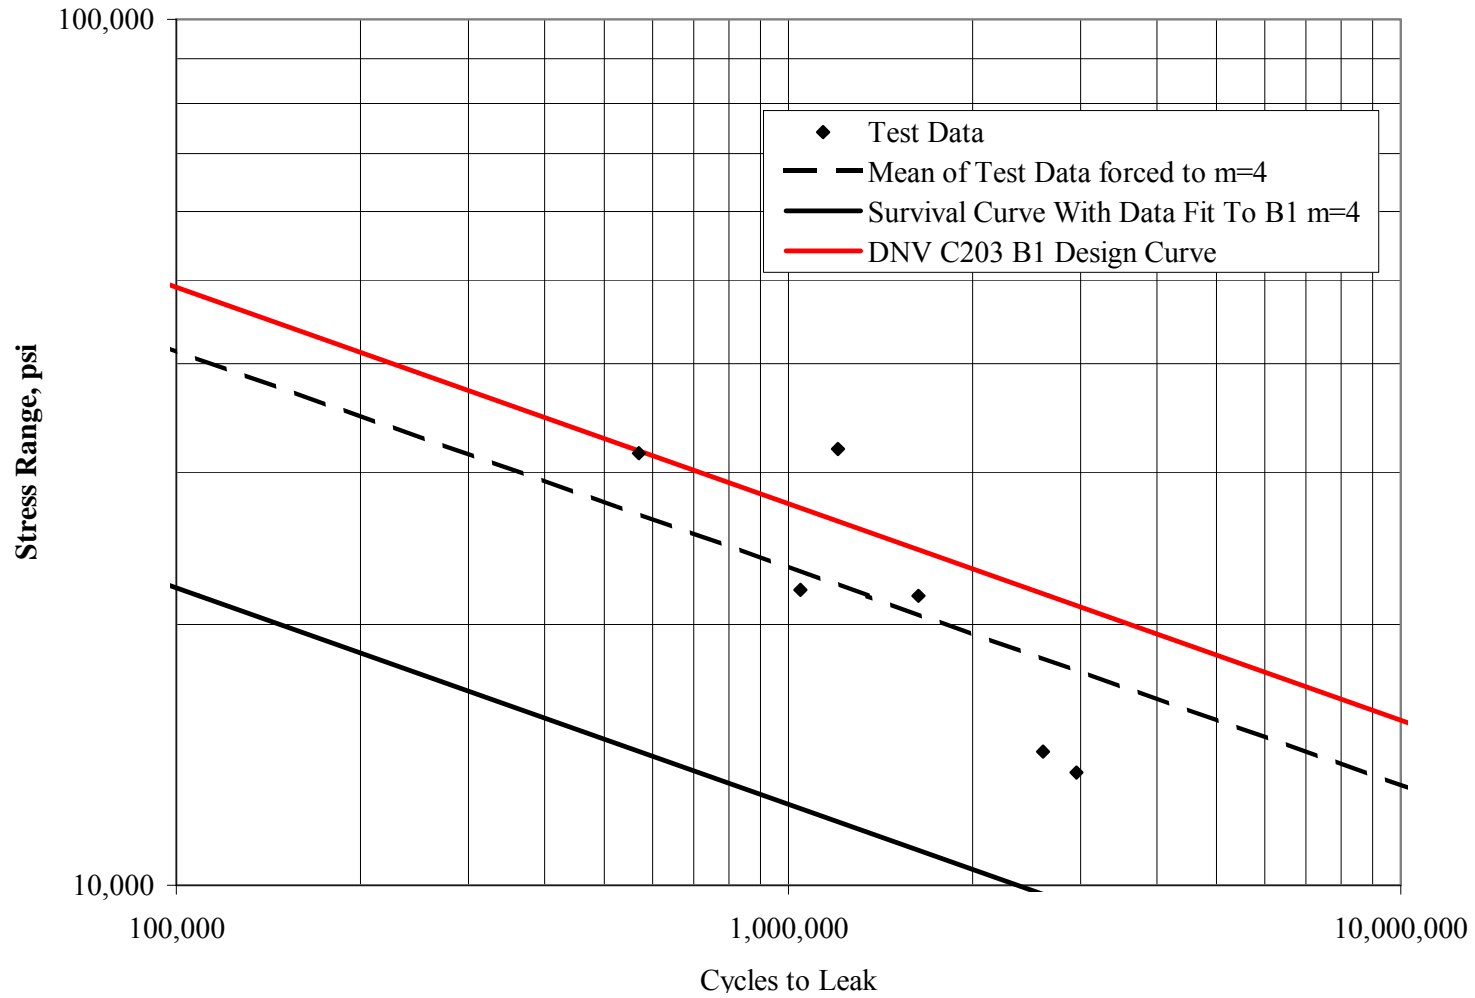
FIGURE 3.7
11.75" OD x 1.1" WALL SHRINK-FIT CONNECTOR FATIGUE TEST RESULTS
COMPARED TO DNV C203 B1 CURVE

All of the samples leaked out one end of the coupling. Table 3.4 along with Figures 3.7 and 3.8 summarize the fatigue test results.

The test stress factor is only valid when the curve used to derive it is used to evaluate the fatigue performance. If another curve is to be used, a new factor must be derived, since the stress factor is dependent on the fatigue curve used. Although only six samples have been tested, the data indicated that the slope of the data is steeper than either the B1 or C1 curved. That is m for the data is lower than 3 and the use of the test stress factors is not recommended for stress ranges below the lowest test stress range of 14,000 psi.
