RPSEA FINAL REPORT

RPSEA Document Number: 09121-3500-02.FINAL

SRP SHRINK-FIT CONNECTION 09121-3500-02

The Shrink-Fit connection approach to riser fabrication has been successfully designed and developed to enable the manufacture of riser systems from high strength thick walled pipe that are capable of operating with high internal pressures, beyond that which are typically available within the industry today. This technology has already been employed for manufacture of a shallow water drilling riser system in the North Sea.

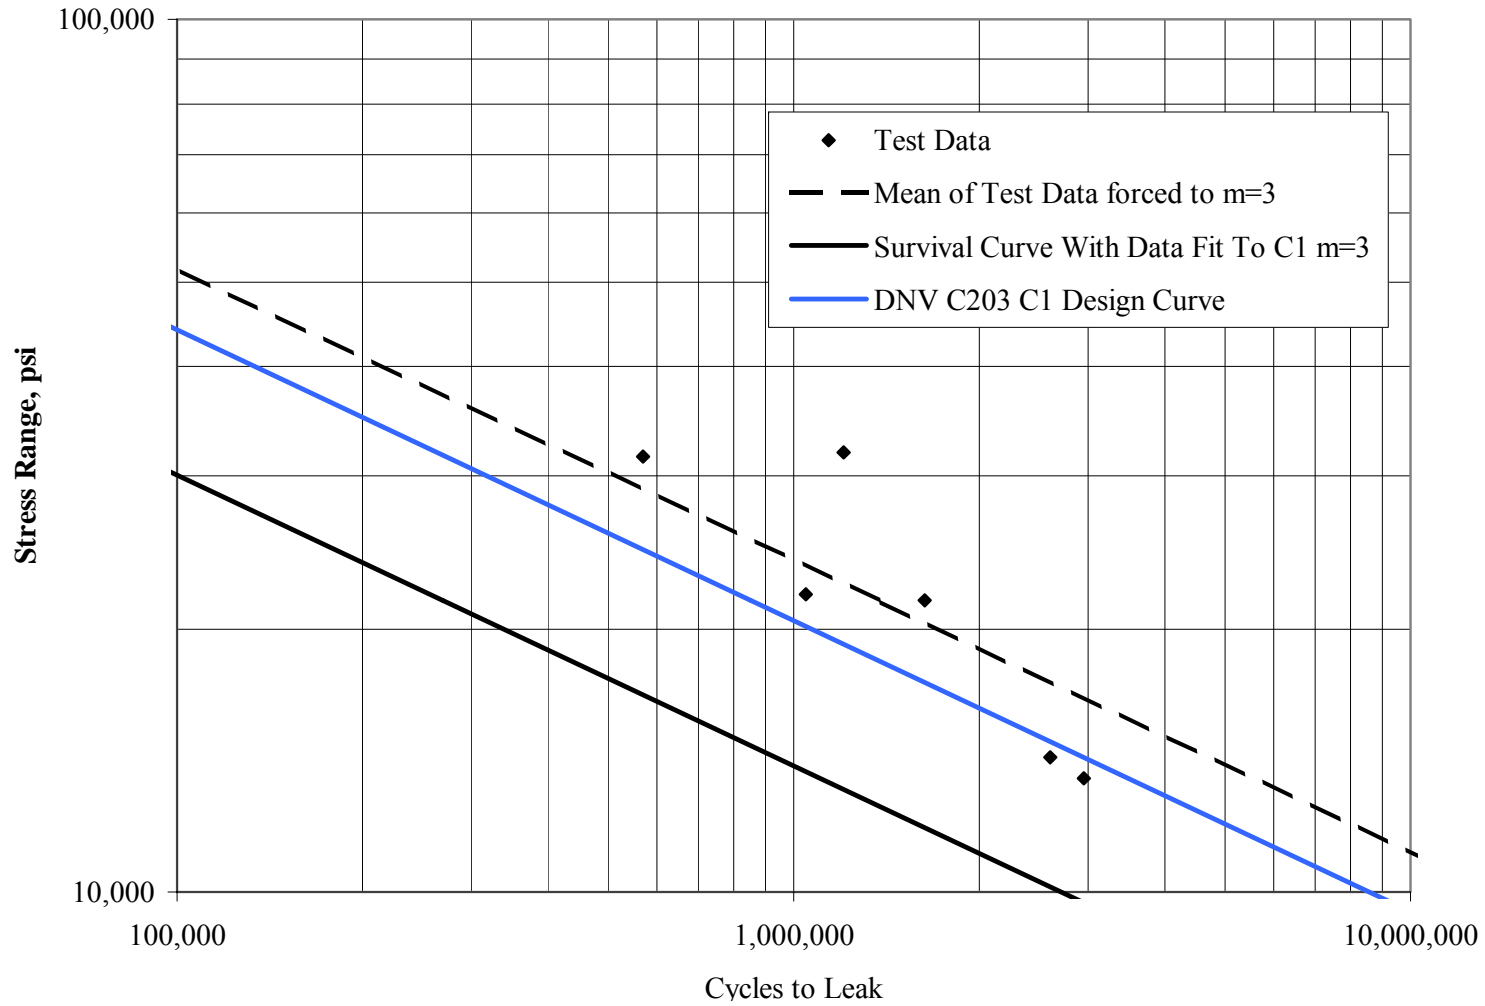
FIGURE 3.8
11.75" OD x 1.1" WALL SHRINK-FIT CONNECTOR FATIGUE TEST RESULTS
COMPARED TO DNV C203 C1 CURVE

All of the samples leaked out one end of the coupling. Table 3.4 along with Figures 3.7 and 3.8 summarize the fatigue test results.

The test stress factor is only valid when the curve used to derive it is used to evaluate the fatigue performance. If another curve is to be used, a new factor must be derived, since the stress factor is dependent on the fatigue curve used. Although only six samples have been tested, the data indicated that the slope of the data is steeper than either the B1 or C1 curved. That is m for the data is lower than 3 and the use of the test stress factors is not recommended for stress ranges below the lowest test stress range of 14,000 psi.
