# Appendix D

## DETAILED AFFECTED ENVIRONMENT DATA

### D.0 INTRODUCTION

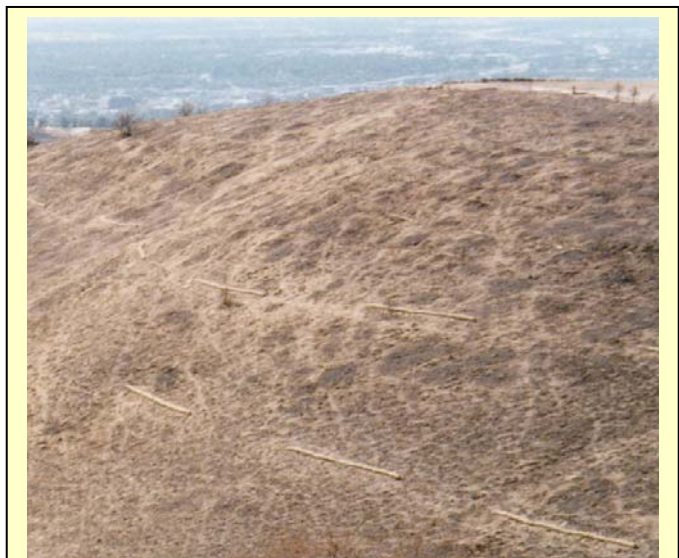
***Fig. D.1-2 Eighth Street Burn area after critical area treatment***

Of principal concern was the Boise Front watershed’s susceptibility to catastrophic erosion and flooding. The combination of steep slopes and highly erodible granitic soils in more than 90 percent of the burn area make the area extremely susceptible to erosion with the loss of vegetative cover resulting from the fire (See Fig. D.1-2). As many as 4,500 residents within the floodplain, as well as the state capitol, medical facilities, utilities, schools, and telecommunications, were at risk from flooding as a result of the fire. The potential loss from a 100-year thunderstorm was estimated at \$144 million (BLM, et al., 1996). The concerns expressed about catastrophic erosion and flooding deemed it appropriate to perform the cumulative impact analysis in the Lower Boise River watershed.

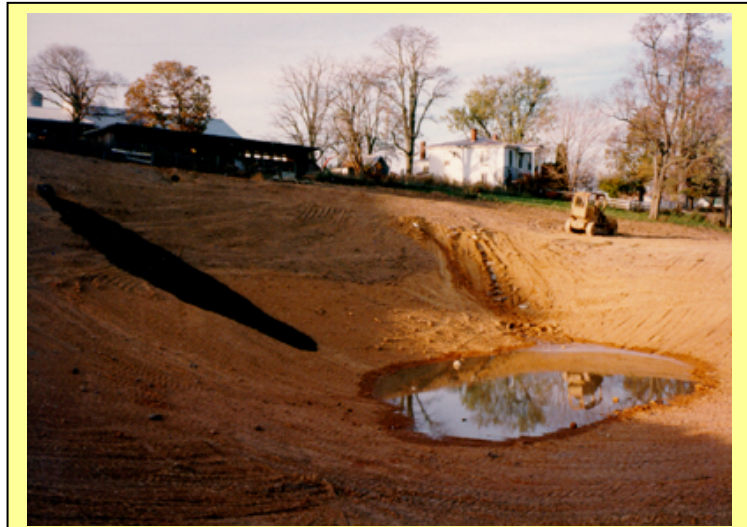
***Fig. D.1-9 Example of a Waste Storage Pond***

The waste storage pond is found on the Martin farm, to the north of the town of Fairfield. The waste from the dairy on-site is collected and dried within the pond before eventually being applied to agricultural fields. There is no outflow from the pond and no stream channels are located nearby, although intermittent portions of Marlbrook Creek are a quarter of a mile away.

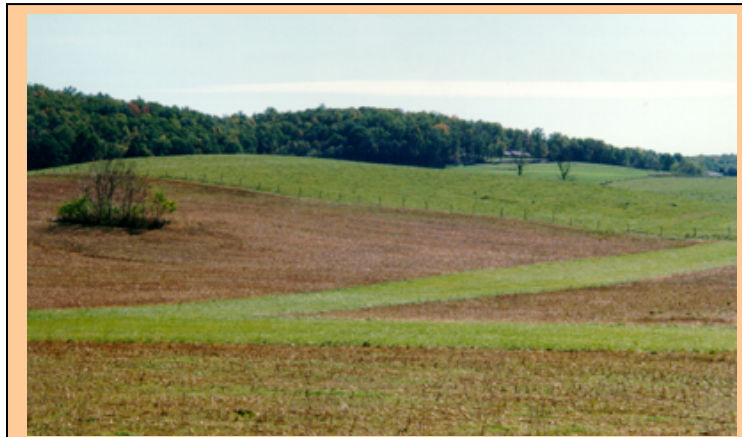
***Fig. D.1-10 Example of a Grassed Waterway***

The grassed waterway site is found on the Moore farm to the southwest of the town of Raphine. The waterway routes runoff waters around agricultural land to prevent erosion. The grassy vegetation, a tall fescue, is used to slow flow velocities and prevent erosion of the waterway. The site drains into an unnamed tributary and eventually into Moore's Creek approximately a half mile downstream.

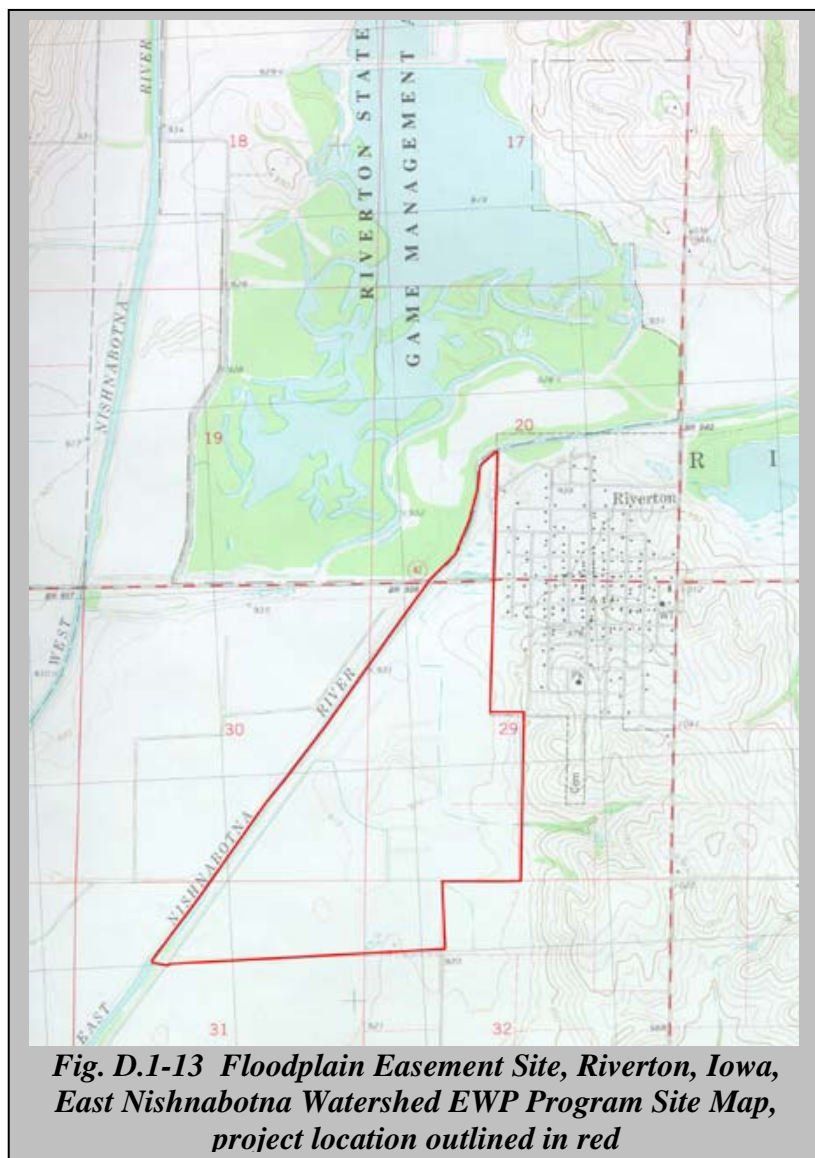
***Fig. D.1-13 Floodplain Easement Site, Riverton, Iowa, East Nishnabotna Watershed EWP Program Site Map, project location outlined in red***

The Riverton floodplain easement site is located just to the east of the town of Riverton, Iowa, along the East Nishnabotna River (Fig. D.1-11). The tract is approximately 655 acres of lowland and subsequently must be protected by levees (Fig. D.1-13). Historically, the land has been exclusively in crops but has faced levee breaches on the order of every three years, causing the landowner to spend more than a quarter of a million dollars in repairs in addition to substantial NRCS expenditures. In 1999, the property was damaged, prompting the landowner to apply for an EWP easement. This part of the East Nishnabotna is a traditionally problematic area for flood damages and was therefore identified as a priority area for easement purchase. There are also 6 other sites awaiting EWP easement purchase along the East Nishnabotna (Hanson 1999).

Due to the repeated damage to the property, the site was a good candidate for the easement program. Since the property is at a lower elevation than the surrounding area, it retains water each spring and will be restored as a wetland. There is an existing forested wetland on the northern portion of the property along the river and runoff from the town of Riverton also contributes to the wet conditions. Water control structures and ditch plugs will be constructed to manage areas of varying water depths to promote wetland revegetation and waterfowl habitat, as well as increasing floodwater retention capability. There will be no planting, as the site is too wet, and the vegetation will be allowed to proceed naturally (Hanson 1999).

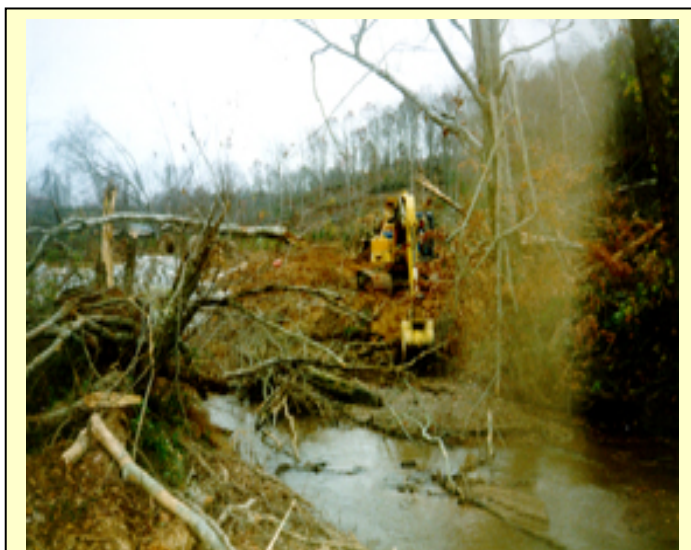
*Fig. D.2-2 Backhoe Removing Woody Debris, Hall County, Georgia*

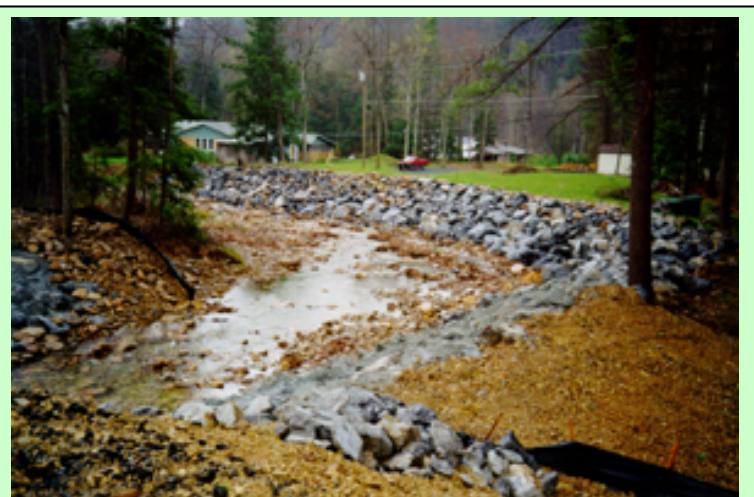
*Fig. D.2-5 Rocky Run Community, Virginia*

Riprap and gabions were placed on streambanks (Fig. D.2-5) to stabilize the channel and to protect life and property from future damage. Yet, in September 1996, heavy rains from Hurricane Fran swelled Rocky Run and the existing practices protecting the

community failed. Rather than following the constructed channel, the stream overflowed its banks and created a new channel directly through the residential areas and emptied into the Dry River. Five homes were flooded, and others endangered, while large volumes of cobble and woody debris were deposited in the floodplain. Approximately 140 feet of gabion and 200 to 300 feet of rock riprap revetments were installed to stabilize the steep slopes of the channel. Gabion mattresses were placed in the streambed at the same location to prevent downcutting.

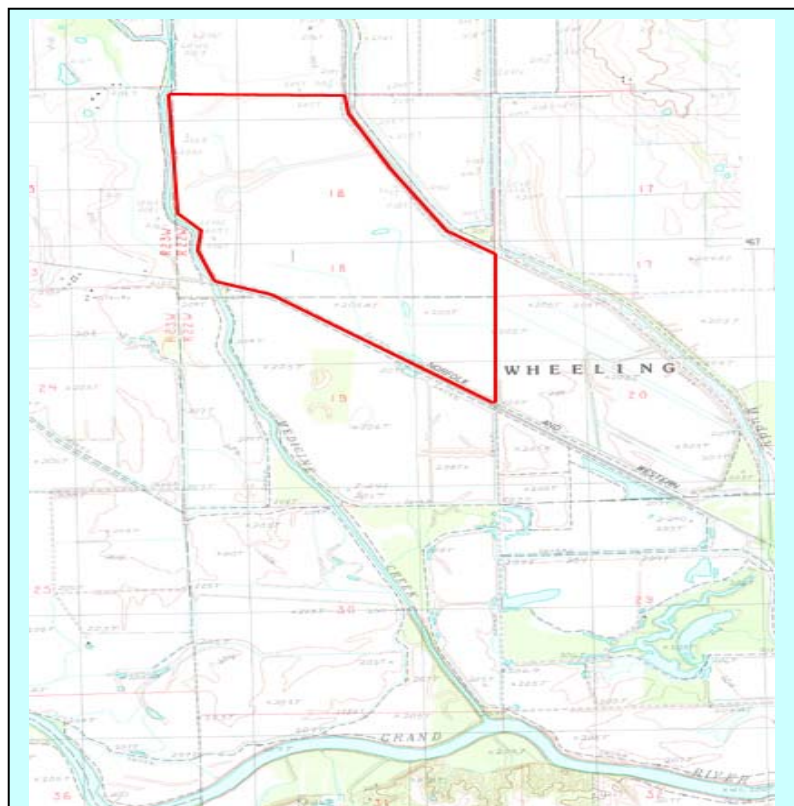
**Fig. D.3-19 Setback Levee Site, Medicine Creek,  
Missouri EWP Program Site Map, project location  
outlined in red**

In 1993 and 1995, the levees protecting the site were breached during flooding and repairs were made. Under the EWP Floodplain Easement Program, the landowner was offered an easement, thus allowing for the construction of a setback levee. Under this proposal, a 300-foot portion of the levee along Medicine Creek (the western boundary of the property, see Fig. D.3-13) would be

removed after the construction of two new levees perpendicular to the stream channel that would protect the croplands both upstream and downstream of the easement site. The newly created floodplain would then be restored as a managed wetland, with water control structures and ditch plugs to maintain wet conditions and a limited amount of vegetative planting. Much of the vegetative restoration is intended to be through natural regenerative processes, with annual site inspections from the designers to ensure that the restoration is proceeding well. Construction is set to begin in early 2000 and restoration costs are estimated to be approximately \$275,000 (Young, 1999).
