Natural Resource Condition Assessment

Whitman Mission National Historic Site

Natural Resource Report NPS/UCBN/NRR-2009/118

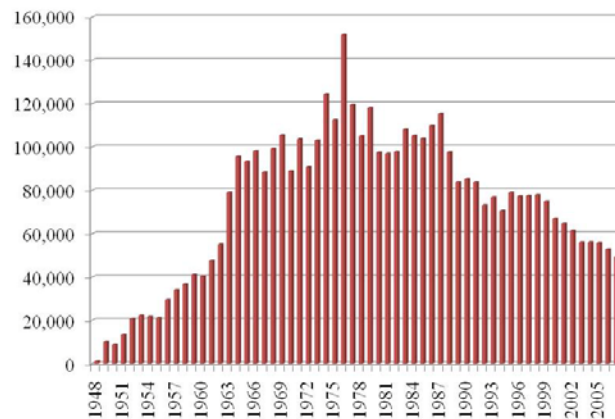
Figure 2. Visitor use days per year at WHMI from 1948-2007.

WHMI visitation at the park reached a high of 151,800 visitor days in 1976 and has slowly been decreasing since to a recent low of 49,337 in 2007 (Figure 2). Visitor days/year has averaged 63,065 over the past 10 years. There is no over-night camping at WHMI so visitor use is limited to day use.

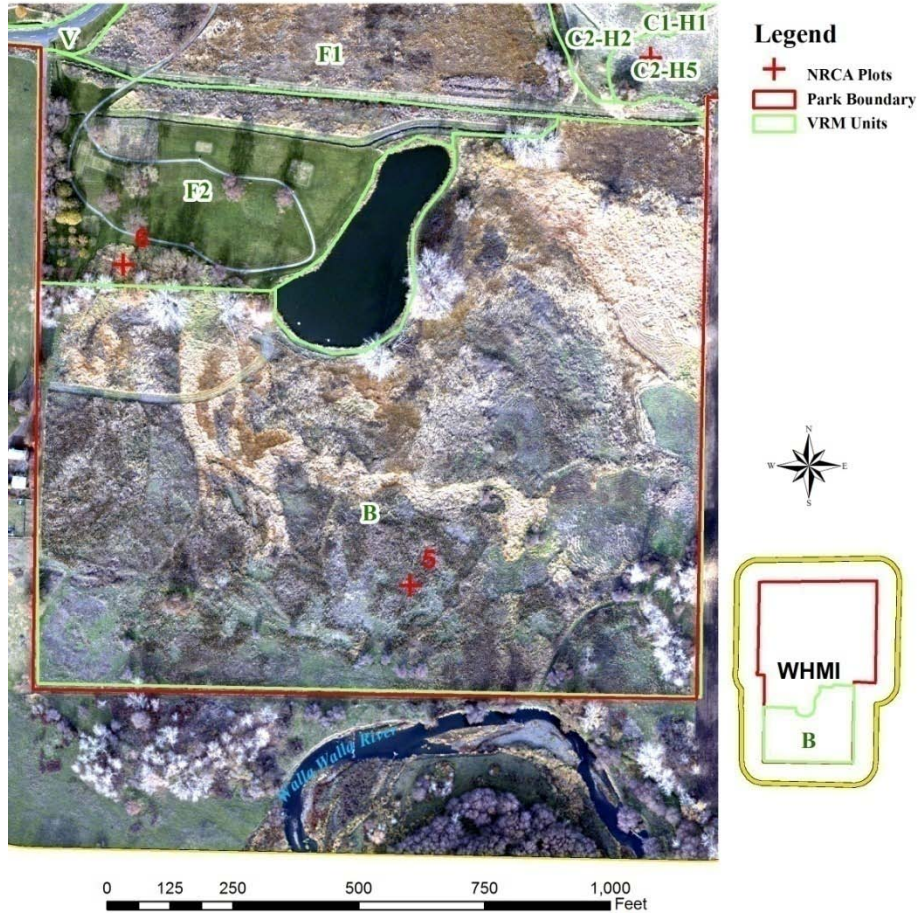
Figure 11. Map of VRM-B and NRCA plot 5 in WHMI.

VRM – B is approximately 27.7 acres (29.32%) located in the south 1/3 of WHMI (Figure 11). The unit has historically been used as pasture for livestock grazing, mainly cattle. Since 1986, grazing has been restricted in this unit to implement a revegetation plan. Garrett and Coyner (2003) documented the extensive work completed to plant, burn, spray, and plant the unit to control weeds and create a historically acceptable landscape. The unit is mainly a Pedigo silt loam soil that is classified as an Alkali Bottom 15+PZ (R009XY401WA) ecological reference site. Based on the ecological reference site, the historical climax plant community is wild rye (*Leymus cinereus*) – bluebunch wheatgrass and falls in the Columbia Basin Palouse Prairie Ecological System (NatureServe 2009).

The unit is in relatively good condition for soil and hydrologic function and not a threat for soil erosion. The biotic function is in better condition than documented in 1984 and 1985 (Gilbert 1984, Romo and Krueger 1985). There is excessive build up of litter that may be due in part to poor functioning of soil microorganisms. Excessive straw buildup is also frequently seen in dryland crop management when converting to a direct seed tillage operation. In these cases, burning is generally not recommended as a method for dealing with excessive straw and litter (STEEP 2008). Research has found that straw decomposes faster when in contact or near the soil. Mowing or rolling in late fall may be the most effective method to facilitate the decomposition of the past years' growth and incorporate it into the soil (STEEP 2008). Over time soil fungi and bacteria levels will increase and improve decomposition rates, which may reduce the need for mowing in the future.

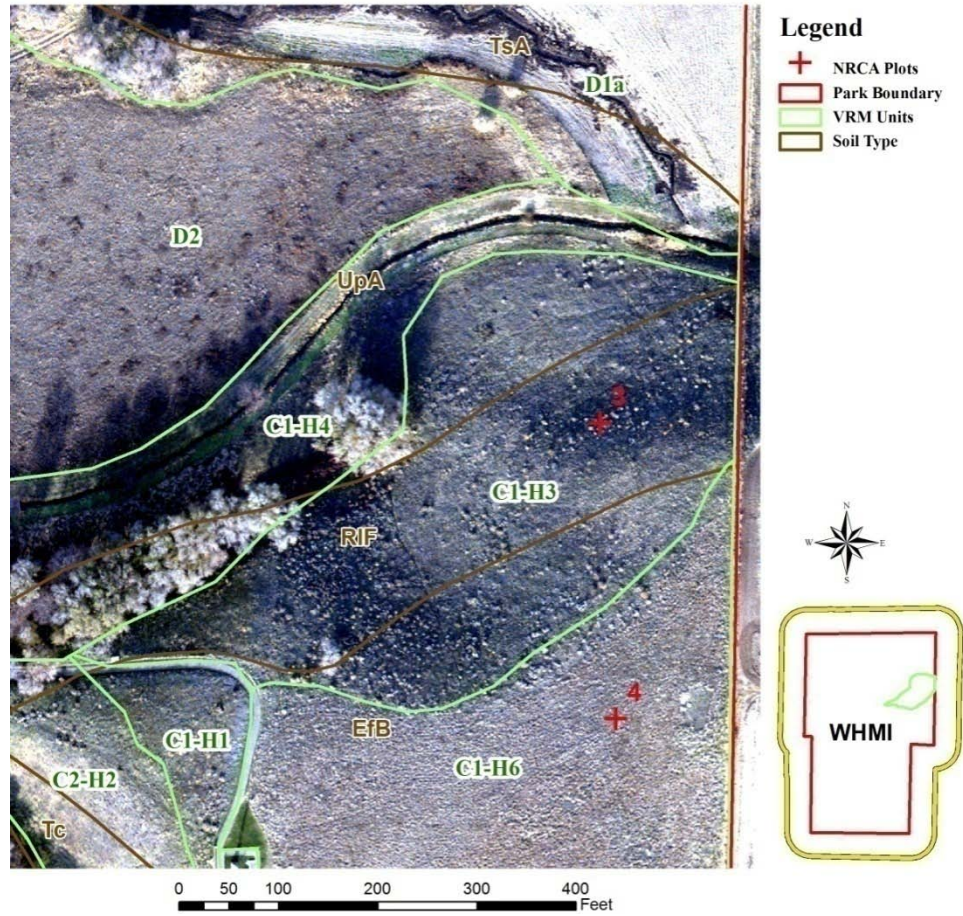
Figure 13. Map of VRM-C1-H3 in WHMI.

VRM – C1-H3 is approximately 3.71 acres (3.93%) of WHMI located on the north side of Memorial Shaft Hill (Figure 13). The unit was historically used as a pasture for livestock grazing, mainly cattle. Records indicate the unit has had no recent grazing and in 1986 a revegetation plan was implemented (Gilbert 1984). Garrett and Coyner (2003) documented the extensive work completed to plant, burn, spray, and plant the unit to control weeds and create a historically acceptable landscape. The unit is mainly a Ritzville silt loam soil that is classified as a Cool Loamy 9-15PZ (R008XY103WA) ecological reference site. Based on the ecological reference site, the historical climax plant community is Idaho fescue (*Festuca idahoensis*) - bluebunch wheatgrass and falls in the Columbia Basin Palouse Prairie Ecological System (NatureServe 2009).

The unit is in relatively good condition for soil and hydrologic function and not a threat for soil erosion. The biotic function is in better condition than documented in 1984 and 1985 (Gilbert 1984, Romo and Krueger 1985). However, there is still a very high dominance of yellow starthistle. Continued treatment with herbicide spot spraying will reduce the vigor and health of the yellow starthistle while improving the ability of native forbs to establish viable populations. The hot dry summers experienced at WHMI reduce the competitiveness of native species over already established non-native and noxious species. WHMI's staff has a record of working with researchers in weed control and revegetation techniques. Recommendations are to continue this cooperation, to find non-native species that can compete with current noxious weeds, and meet the objective of restoring a historically acceptable landscape. WHMI staff should continue to seek noxious weed control techniques that are species specific such as biological control.

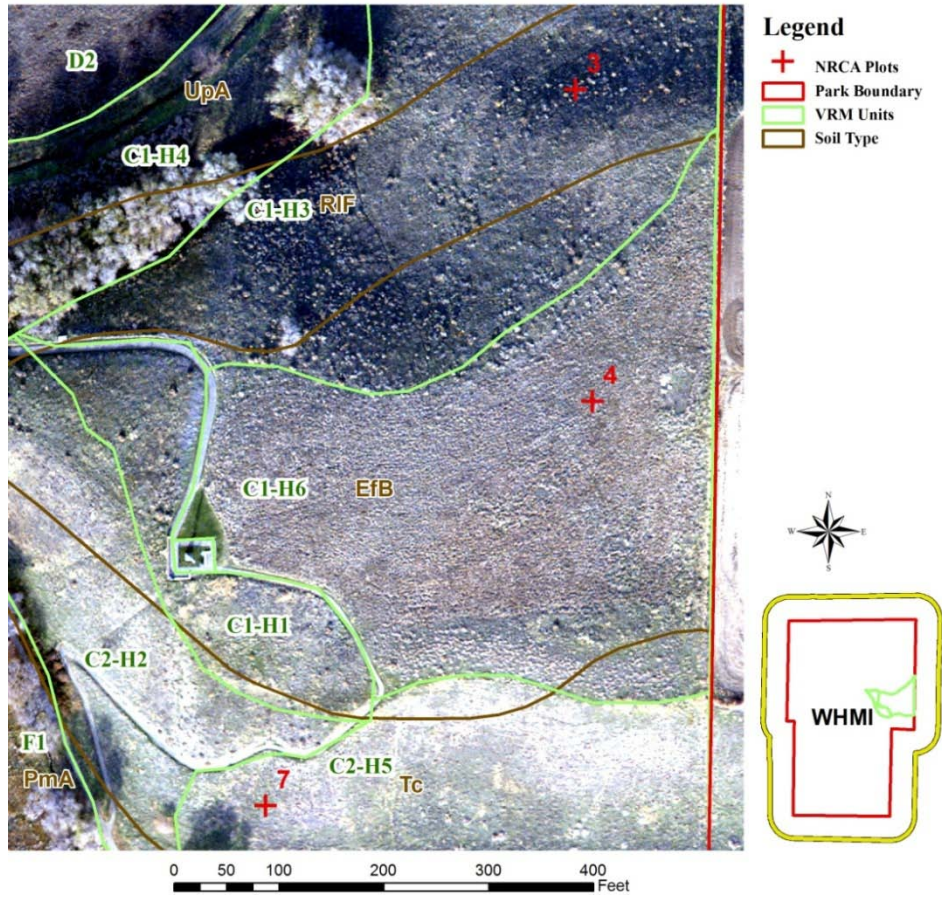
Figure 15. Map of VRM-C1-H6 in WHMI.

VRM – C1-H6 is approximately 3.58 acres (3.79%) of WHMI located on the top of Memorial Shaft Hill and is very similar to VRM – C1-H1, which is 0.89 acres (0.95%) and lies directly to the west (Figure 15). The unit was historically used as a pasture for livestock grazing, mainly cattle, and as a crop field. Records indicate the unit has had no recent grazing or farming and in 1986 a revegetation plan was implemented (Gilbert 1984). Garrett and Coyner (2003) documented the extensive work completed to plant, burn, spray, and plant the unit to control weeds and create a historically acceptable landscape. The unit is mainly an Ellisforde silt loam soil that is classified as a Loamy 9-15PZ (R008XY102WA) ecological reference site. Based on the ecological reference site, the historical climax plant community is bluebunch wheatgrass – Sandberg’s bluegrass and falls in the Columbia Basin Palouse Prairie Ecological System (NatureServe 2009).

The biotic function is in better condition than documented in 1984 and 1985 (Gilbert 1984, Romo and Krueger 1985). WHMI staff have recognized the lack of native forb species and in 2000 changed their noxious weed control program to spot spray with herbicides (Garrett and Coyner 2003). The staff also introduced 2 biological control agents for yellow starthistle stands on the adjacent hillsides to reduce reproduction capabilities. Even with the hot dry summers experienced at WHMI, this unit is proof that under the right conditions a competitive stand of native species can be established and maintained. WHMI’s staff has a record of working with researchers in weed control and revegetation techniques. Recommendations are to continue this cooperation to find noxious weed control techniques that are species specific such as biological control.

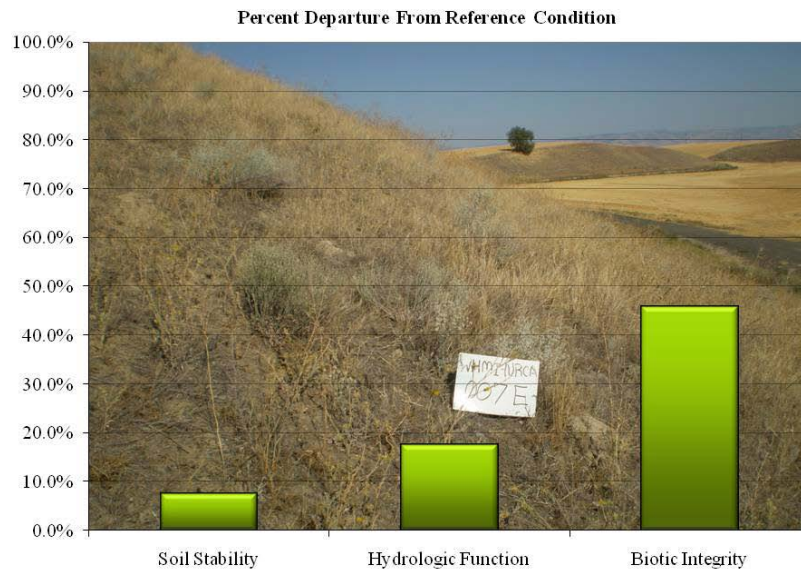
Figure 18. Departure from reference condition of the 3 landscape attributes in the Loamy 9-15PZ ecological site at VRM-C2-H5, WHMI (background is of plot 7).

These units are in relatively good condition for soil and hydrologic function and not a threat for soil erosion even though it has the steepest slopes in WHMI. The biotic function is in similar condition as documented in 1984 and 1985 (Gilbert 1984, Romo and Krueger 1985). Even with the planting effort following Romo and Krueger (1985) after a wildfire in 1998, the species composition has changed little. There is still a dominance of cheatgrass and yellow starthistle in the unit. Continued treatment with herbicide spot spraying will reduce the vigor and health of the yellow starthistle while improving the ability of native forbs to maintain or increase their populations. The hot dry summers experienced at WHMI reduce the competitiveness of native species over many of the already established non-native and noxious species. Solutions to the revegetation effort will require additional efforts following specialist's recommendations. WHMI's staff has a record of working with researchers in weed control and revegetation techniques. Recommendations are to continue this cooperation to find non-native species that can compete with current noxious weeds and meet the historical landscape objective. WHMI staff should continue to use noxious weed control techniques that are species specific such as biological control.

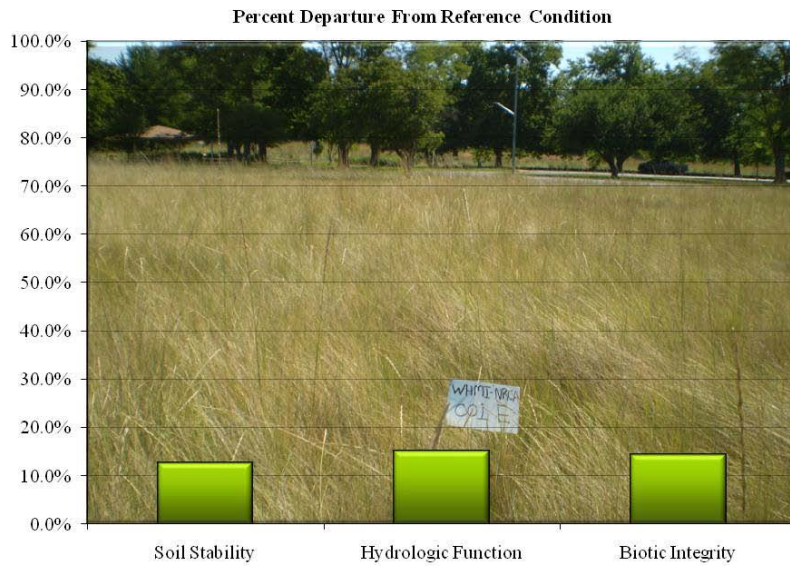
Figure 20. Departure from reference condition of the 3 landscape attributes in the Alkali Bottom 9-15PZ ecological site at VRM-D3, WHMI (background is of plot 1).

All the landscape attribute functions are in better condition than documented in 1984 and 1985 (Gilbert 1984, Romo and Krueger 1985). WHMI staff have recognized the lack of native forb species and use spot spraying in their noxious weed control program (Garrett and Coyner 2003). WHMI staff recognize the problem with litter buildup and have used prescribed fire several times in the past to reinvigorate the stand (Garrett and Coyner 2003). Burning can have a negative impact on soil organic material when repeated too often. The excessive build up of litter may be due in part to the poor functioning of soil microorganisms. Excessive straw buildup is also frequently seen in dryland crop management when converting to a direct seed tillage operation. In these cases, burning is generally not recommended as a method for dealing with excessive straw and litter (STEEP 2008). Research has found that straw decomposes faster when in contact or near the soil. Mowing or rolling in late fall may be the most effective method to facilitate the decomposition of the past years growth and incorporate it into the soil (STEEP 2008). Over time soil fungi and bacteria levels will increase and improve decomposition rates, which may reduce the need for mowing in the future.

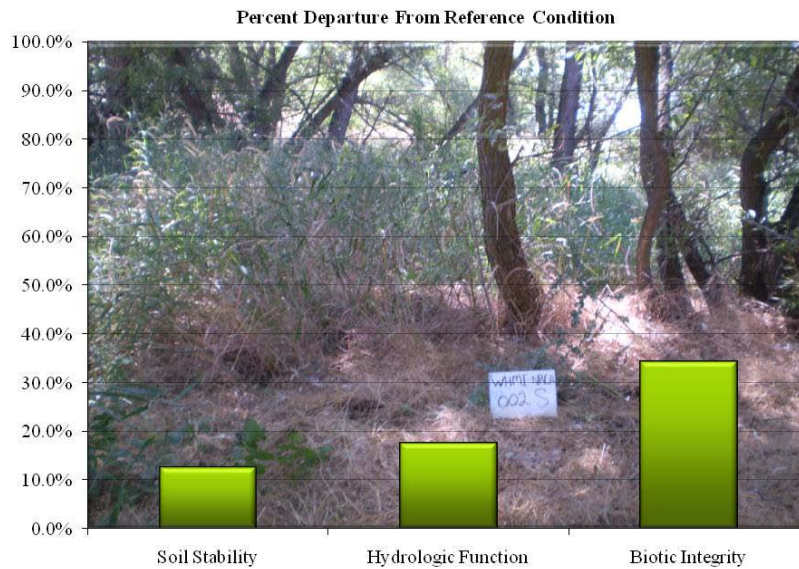
Figure 22. Departure from reference condition of the 3 landscape attributes in the Wet Meadow 9-15PZ ecological site at VRM-D4c, WHMI (background is of plot 2).

The unit is in relatively good condition for soil and hydrologic function and not a threat for soil erosion. The biotic function is in a similar condition to that documented in 1984 and 1985 (Gilbert 1984, Romo and Krueger 1985). There is still a variety of noxious weeds in the unit but herbicide spot spraying has reduced their cover and vigor. This unit is a lower priority for management being located in a little traveled portion of the park. The tree dominated cover meets the historical landscape objective. Recommendations are to continue current noxious weed management strategies and research potential native or non-native species that could be planted to compete with the noxious weeds.

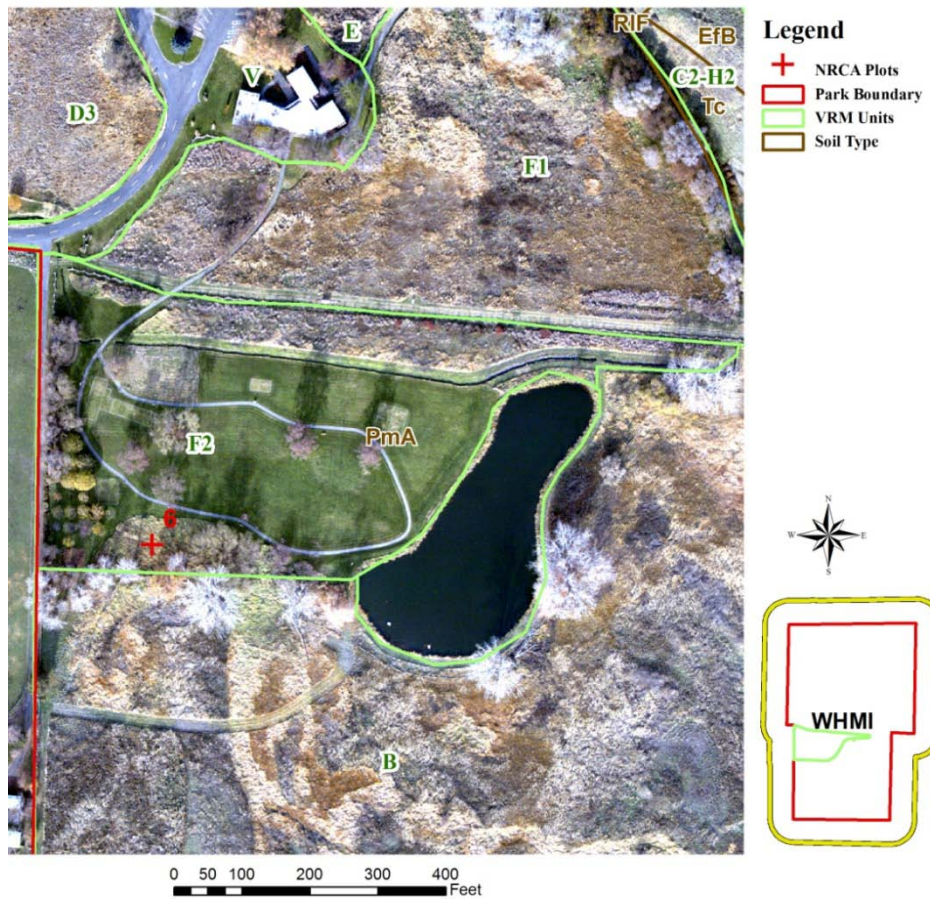
Figure 23. Map of VRM – F2 in WHMI.

VRM – F2 is approximately 6.38 acres (6.76%) of WHMI located on the center west portion of the park and includes the core of the historical sites in the park (Figure 23). The site sampled is actually in the oxbow of the Walla Walla River and represents a semi-riparian community. The unit may have been historically used as pasture for livestock but has received very little use for several decades. The 1986 revegetation plan treated the oxbow areas in unit B but not the area in unit F2 (Gilbert 1984). Garrett and Coyner (2003) did not document work being completed in this portion of the unit. The unit is mapped as a Pedigo silt loam soil and is classified as an Alkali Bottom 15+PZ (R009XY401WA) ecological reference site. Based on the ecological reference site, the historical climax plant community is basin wildrye/bluebunch wheatgrass and falls in the Columbia Basin Palouse Prairie Ecological System (NatureServe 2009).

The unit is in relatively good condition for all landscape attribute functions. The biotic function is in a similar condition to that documented in 1984 and 1985 (Gilbert 1984, Romo and Krueger 1985). There are a few of noxious weeds, except for reed canarygrass, in the unit but they are reduced in cover and vigor due to treatment with spot spraying, and shading from tree cover. This unit is a high priority for management and currently is meeting the historical landscape objective. Recommendations are to continue current noxious weeds management strategies and research methods for replacing reed canarygrass with a less aggressive species that meets the historical landscape criteria for the unit.

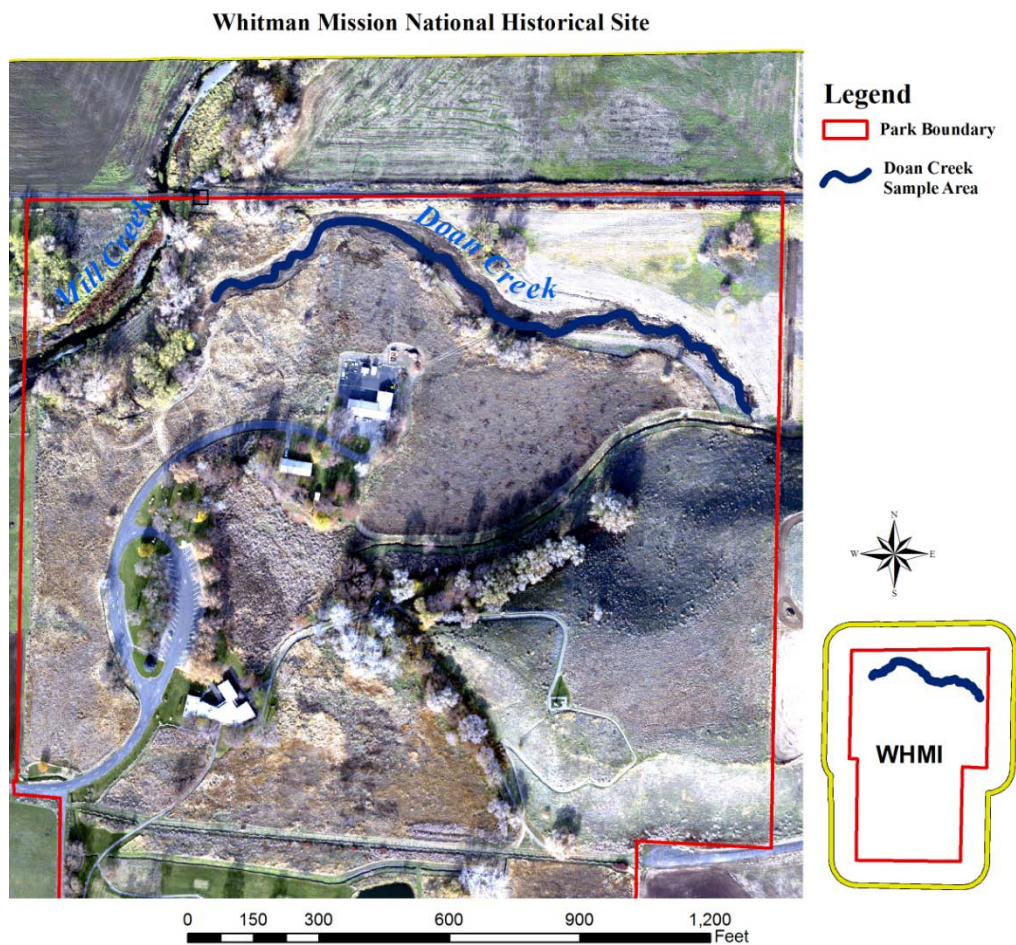
Figure 25. Map of the Doan Creek assessment reach in WHMI.

Doan Creek is a left bank, spring-fed tributary of Mill Creek located on WHMI (Figure 25). The Doan Creek irrigation ditch runs through WHMI and supplies water to the park and to two downstream irrigators. Overflow from the irrigation ditch supplies water to the Doan Creek channel that was relocated to its approximate historic channel location in the mid-1980s. Washington Department of Fish and Wildlife (WDFW) has documented that Doan Creek provides habitat for rainbow/steelhead trout (*Oncorhynchus mykiss*), speckled dace (*Rhinichthys osculus*), redbelt shiner (*Richardsonius balteatus*), 3 species of sculpins (*Cottus* spp.), and common carp (*Cyprinus carpio*) (NPS 2003). WDFW also anticipates that the restored habitat on the WHMI property can support Chinook salmon (*Oncorhynchus tshawytscha*) and coho salmon (*Oncorhynchus kisutch*).

Restoration efforts of the original Doan Creek channel began in 2004 and restored Doan Creek to roughly its original water course between the park's eastern water diversion box and Mill Creek (NPS 2003). The stream channel now flows across the northwest border of the park and enters Mill Creek 300 feet south of the park's northwest border. The entire restored waterway contains natural meanderings in order to provide habitat suitable for the reintroduction of fish species to

the creek. The total length of the restored stream with meanderings is approximately 2500 feet. Stabilizing structures engineered with rock and wood materials have been installed at points where the slope of the channel exceeds -1% to slow the flow of water and dissipate energy. The WDFW habitat biologist helped design this restoration alternative as the optimal choice for fish habitat within WHMI and concluded there is a high chance that hatchery-reared or native fish would enter, survive, and spawn in Doan Creek as a result of the restoration activities (NPS 2003).

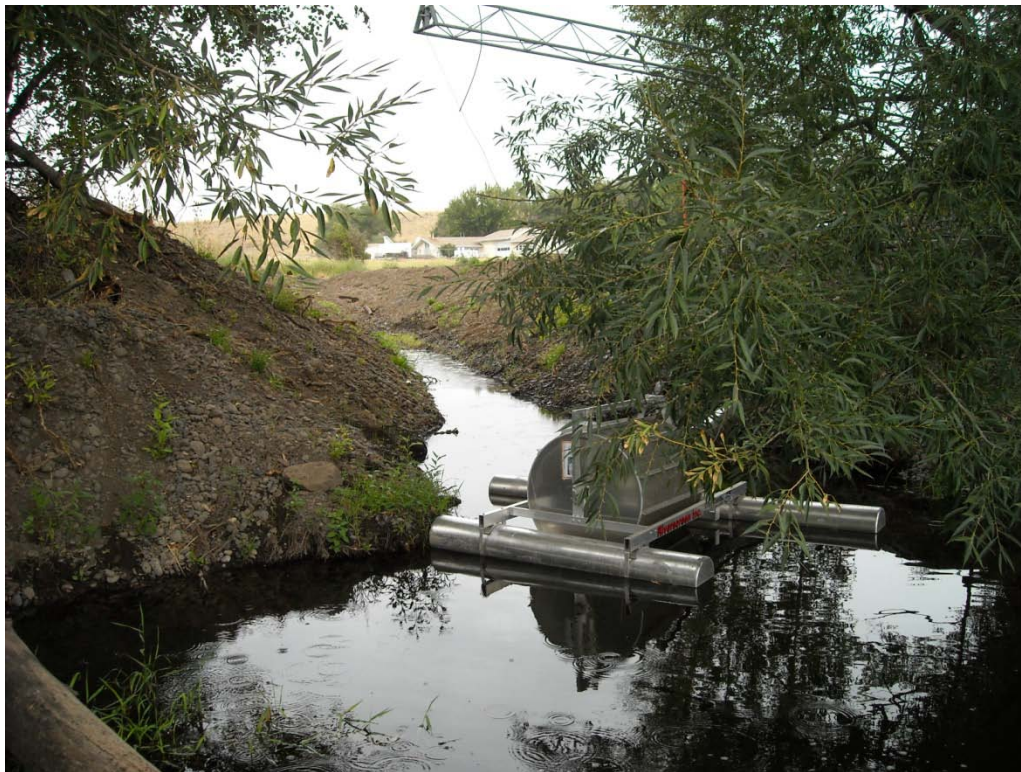
Figure 26. Photograph of the water diversion pump near the mouth of Doan Creek at WHMI.

During the May 2008 field assessment, Doan Creek did not have water flow due to irrigation withdrawals upstream of the restored reach. However, in the late summer of 2008, a new irrigation pump was installed at the downstream end of the restored Doan Creek channel, which allows stream flows to persist in the restored channel rather than being diverted upstream (Figure 26). The goal is to maintain some streamflow in the active restored reach throughout the year and to re-establish potential fish passage from Mill Creek to Doan Creek.

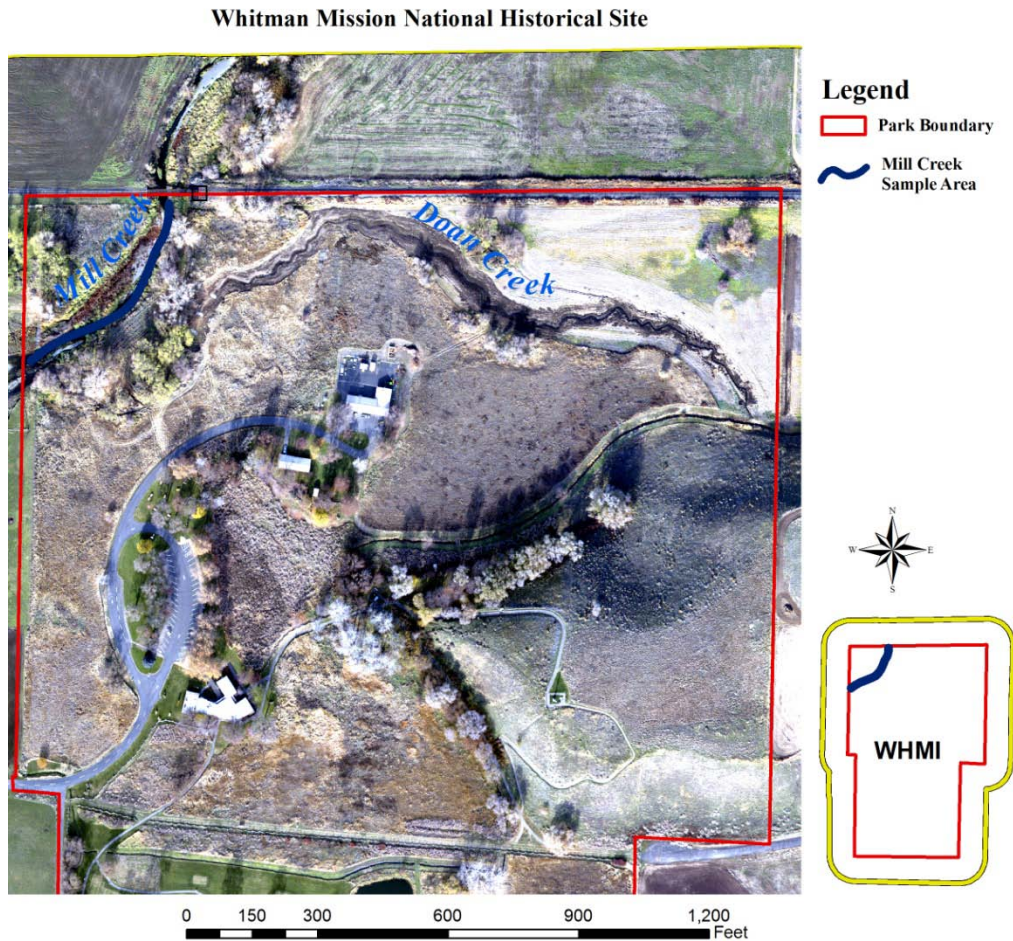
Figure 27. Map of the Mill Creek assessment reach at WHMI.

Mill Creek, a tributary to the Walla Walla River, originates on the western slopes of the Blue Mountains in southeastern Washington at an elevation of 5,500 feet (USACE 1995). It flows for 15 miles in a relatively deep and narrow canyon through mountainous terrain, before entering an alluvial fan a few miles east of the City of Walla Walla. Mill Creek enters the Walla Walla River about 6 miles west of the city at River Mile (RM) 33.6. Just upstream of Mill Creek’s confluence with the Walla Walla River, it flows through the northern corner of the WHMI where it collects streamflow from Doan Creek (Figure 27). At this location and throughout the alluvial fan described above, Mill Creek flows through irrigated agriculture land and provides a large source of irrigation water to local farm fields. To accommodate farming, Mill Creek has been channelized or confined through the use of levees and/or rip rap. This channel confinement results in limited floodplain interaction, which prevents typical energy dissipation expected in a

natural stream system. Levees and rip rap banks have also limited lateral movement of the channel and have minimized the potential extent of the Mill Creek riparian area.

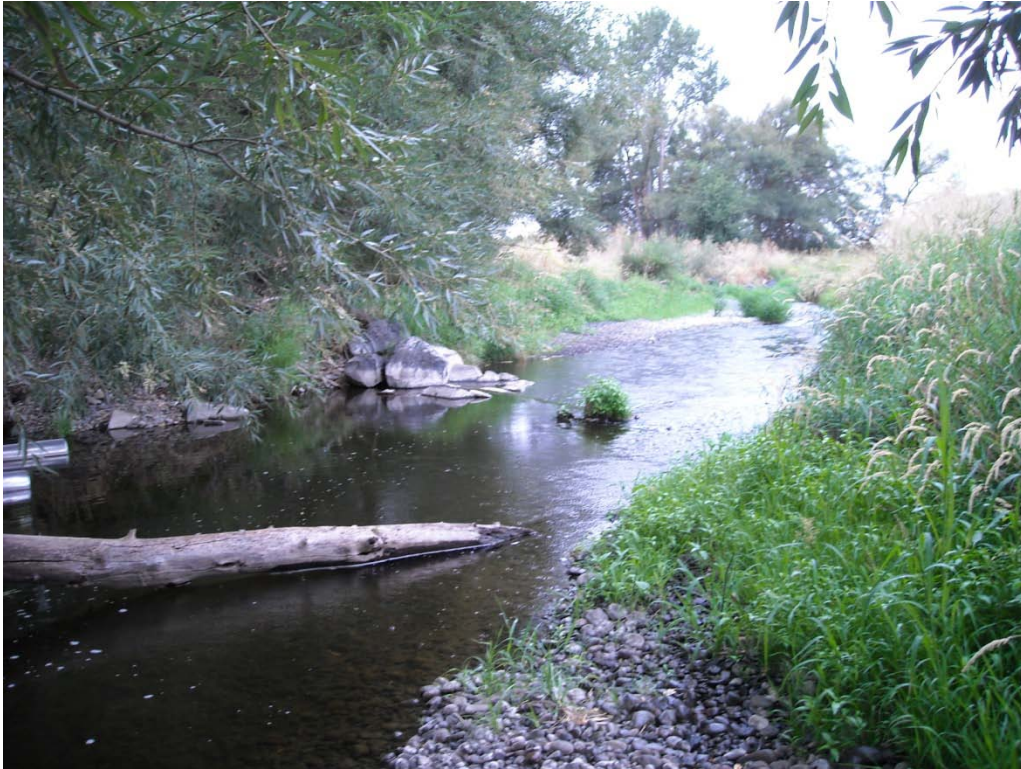
Figure 28. Photograph of Mill Creek assessment site at WHMI.

Onsite riparian vegetation consists of a narrow strip of both young and mature willow and cottonwood trees as well as dense coverage of invasive species, including reed canarygrass, which is preventing native understory colonization (Figure 28). The existing riparian vegetation lacks the diversity of native species and age classes necessary to maintain a healthy stream system onsite. The riparian vegetation that is present is vigorous and contains root masses capable of withstanding high streamflow events and protecting the stream banks from erosion, however, vegetative ground cover is inadequate to dissipate energy during high flows or provide sufficient large woody debris to the stream channel.

The large woody debris present in the onsite Mill Creek stream channel and associated riparian floodplain is inadequate to dissipate stream energy in a stream of this size. The lack of access to the floodplain also inhibits Mill Creek's ability to dissipate stream energy during high flows. Mill Creek contains a few small meanders but is limited in its movement due to the confining rip-rap stream banks and levees. Because stream energy cannot dissipate laterally, Mill Creek is vertically unstable and attempts to dissipate energy through down cutting on stream banks. Erosion is most likely due to farming. The railroad grade and trestle upstream do not seem to be a significant cause of erosion.

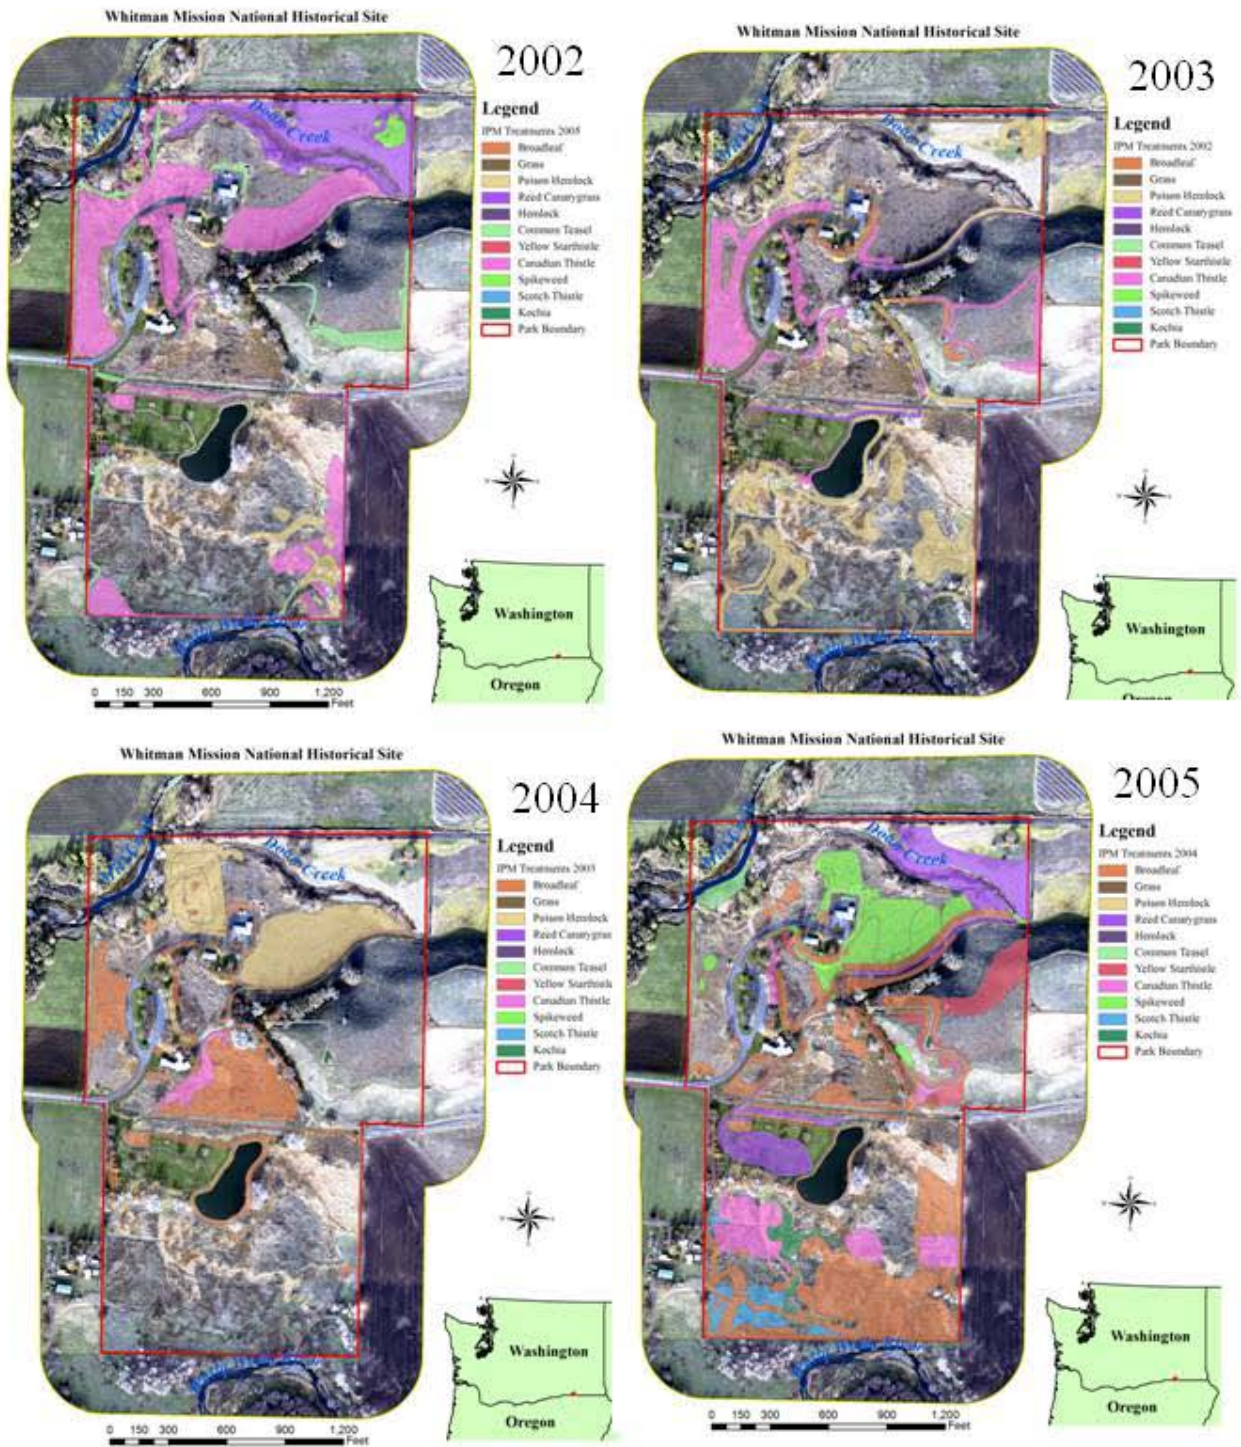
Figure 30. Maps of IPM treatments for weeds by year at WHMI from 2002-2005.

In 2002, the UCBN created a database management system for tracking noxious weed control efforts at WHMI called the Integrated Pest Management Geodatabase (IPMG). The IPMG used ArcGIS software to map and managed data collected by WHMI staff. The data was maintained from 2002 to 2005. The dataset was summarized by year to provide an estimate of the level of effort being exerted by WHMI staff to control noxious weeds on the 98.15 acres of the park. Figure 29 is a graph of the number of acres treated by species and year from 2002 to 2005. Total acres treated by year was 34.33 acres (2002), 26.88 acres (2003), 74.37 acres (2004), and 49.79 acres (2005). The areas treated are displayed in Figure 30.
