CHAPTER 6

Supply Contracts

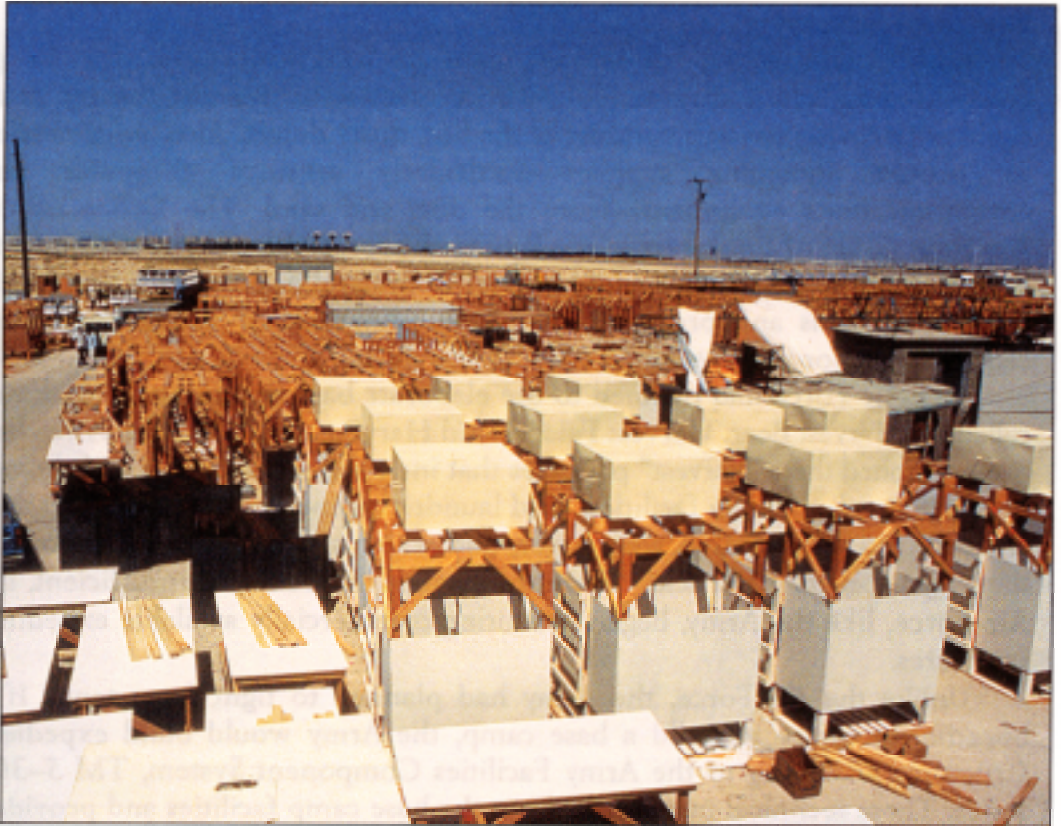
Contractors assemble latrine, shower, and washstand units for U.S. soldiers.

Later that month, the Dhahran office staff held what they called a "build off" to acquire contractors' ideas for assembling collapsible units. The staff could only ship 8 to 12 assembled units on a tractor trailer, and trucks were scarce. Each contractor constructed one latrine unit, one shower unit, and one washstand in the parking lot outside the Dhahran Area Office. The "build off" was a success because the Corps acquired the designs it needed for rapid construction. Although the Dhahran Area Office took great care in designing the units, it never had enough inspectors to ensure that contractors followed the design specifications.

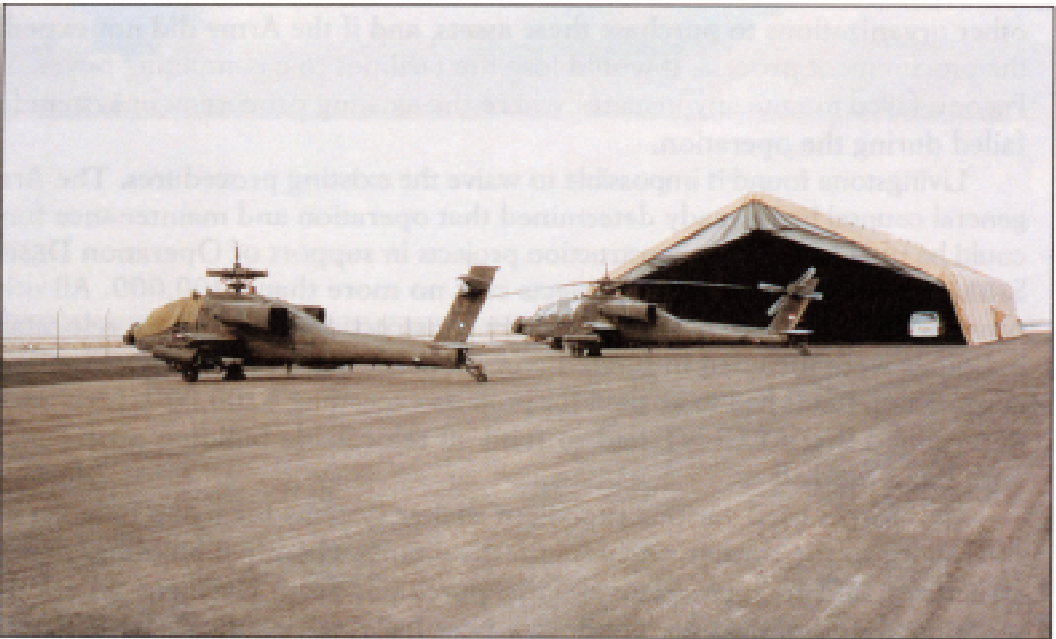
Clamshell buildings, manufactured in Santa Barbara, California, were used for aviation maintenance. Here, two AH-64 helicopters await maintenance outside a clamshell structure at KingFahd International Airport. Sand has eroded the blades from the Apache in the foreground costing \$180,000 in repairs.

Unlike the Air Force, the Army had planned to fight from tents. If it became necessary to build a base camp, the Army would build expedient structures according to the Army Facilities Component System, TM 5-300 series. These technical manuals laid out the base camp facilities and provided detailed construction plans for individual structures. The Army had not placed the same emphasis on facilities as the Air Force. As a result, it did not have enough tents to meet its needs. Some soldiers slept in their vehicles. It deployed highly complex and costly equipment without providing adequate protection from the harsh climate. The need for facilities quickly became apparent. The Aviation Support Command, for example, hurriedly procured clamshell buildings—prefabricated, aluminum framed, tension structures shaped like clamshells—to support its aviation maintenance activities.¹⁰

No one type of expedient structure met all requirements. Many systems were suitable depending on the requirements. Colonel Braden observed that clamshell buildings seemed best suited for the desert environment followed by sprung structures. Most troops preferred clamshell buildings because they were the easiest to erect. Assembly required no engineer skills or equipment and could be completed in one or two days. The K-Span structures were also easy to construct and versatile. Braden later recommended that this system be adopted as a joint service engineer building system. The problems encountered with K-Spans were sand in the equipment, heat buildup, and their immobility

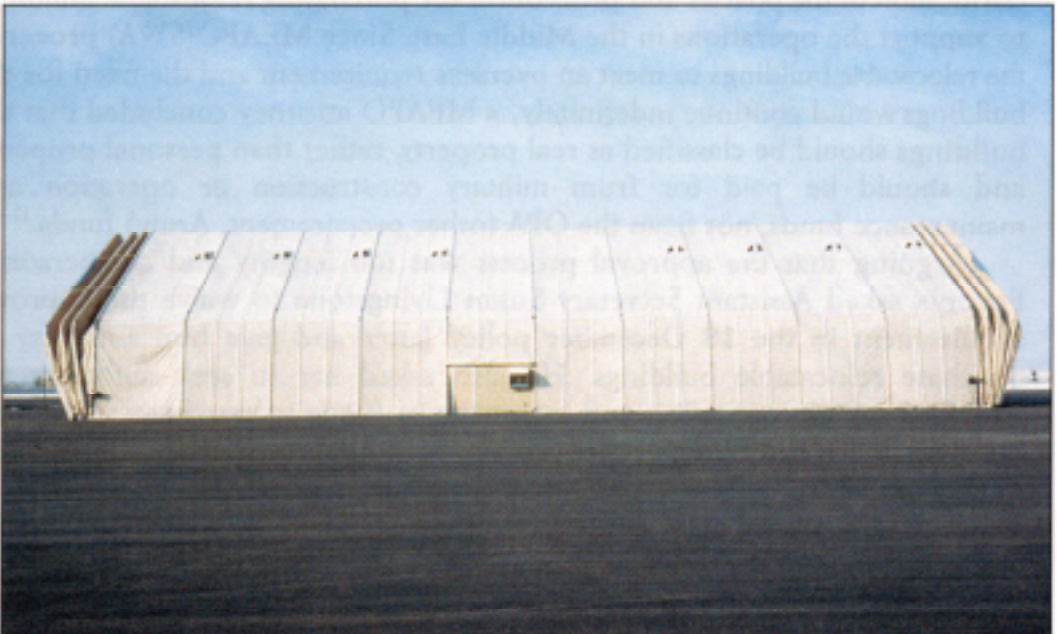
Side view of a clamshell building at King Fahd International Airport. The ends of the clamshell are opened and closed by either a band-cranked or a generator-driven winch.
