# VOID DETECTION DEMONSTRATION PROJECT STATUS REPORT

Underground Mine Mapping Benchmarking Workshop  
Interstate Mining Compact Commission (IMCC) / Office of Surface Mining  
(OSM)

George H. Gardner, PE  
Senior Civil Engineer, Mine Waste and Geotechnical Engineering Division

Pittsburgh Technical Support Center

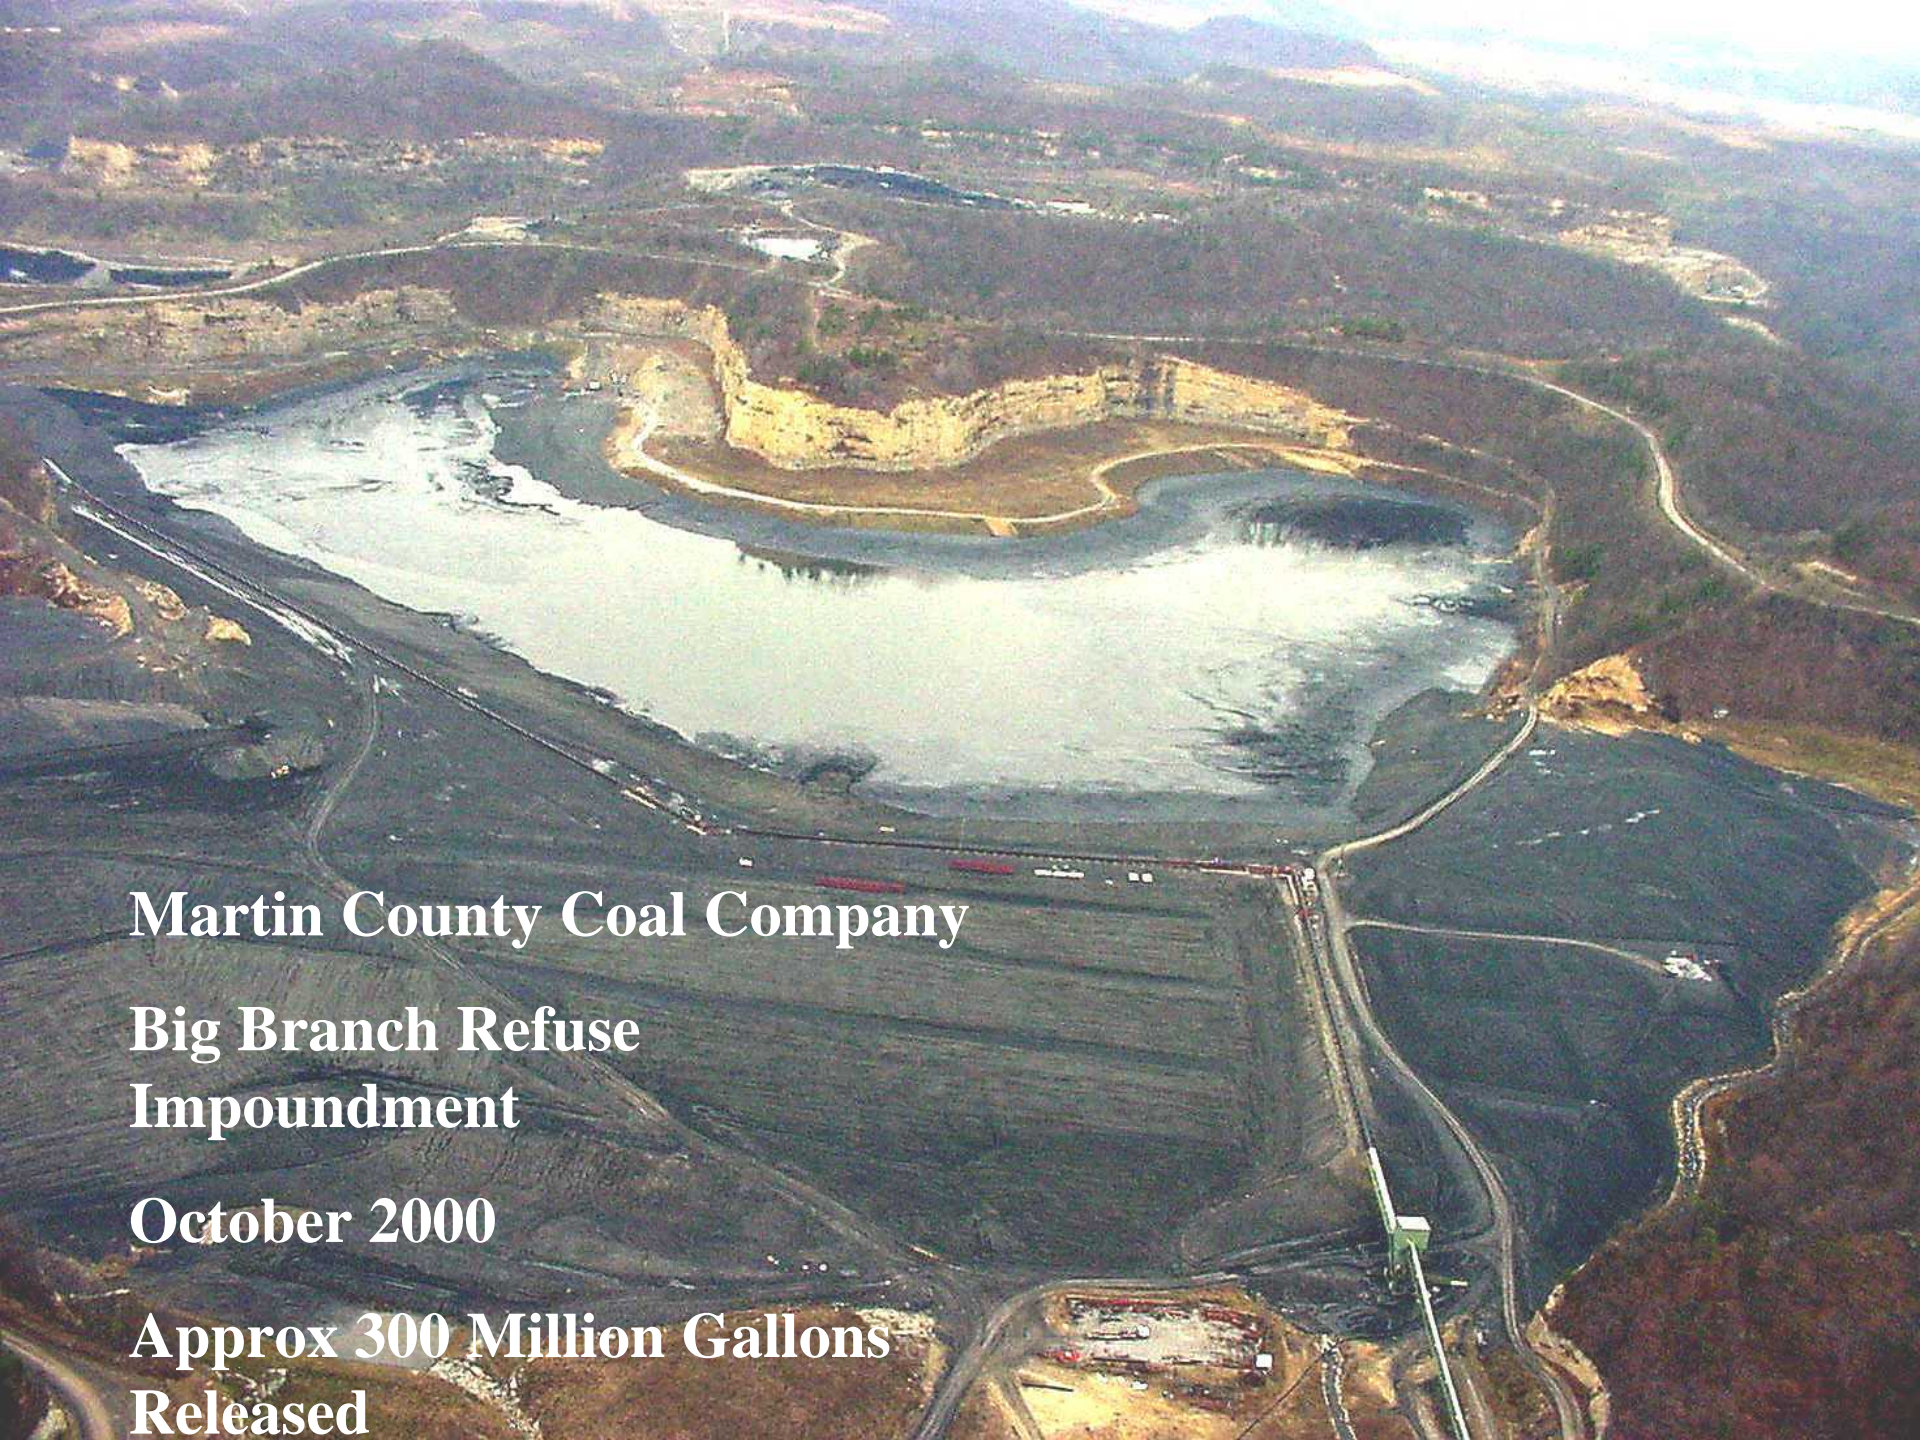
**Big Branch Refuse  
Impoundment**

**Approx 300 Million Gallons  
Released**

**Discharge Exited Mine  
at No. 2 North Portals**

**Approx. limit of  
inundation in  
North Mains**

**Breakthrough  
Location**

**Discharge Exited  
Mine at South  
Mains Portal**

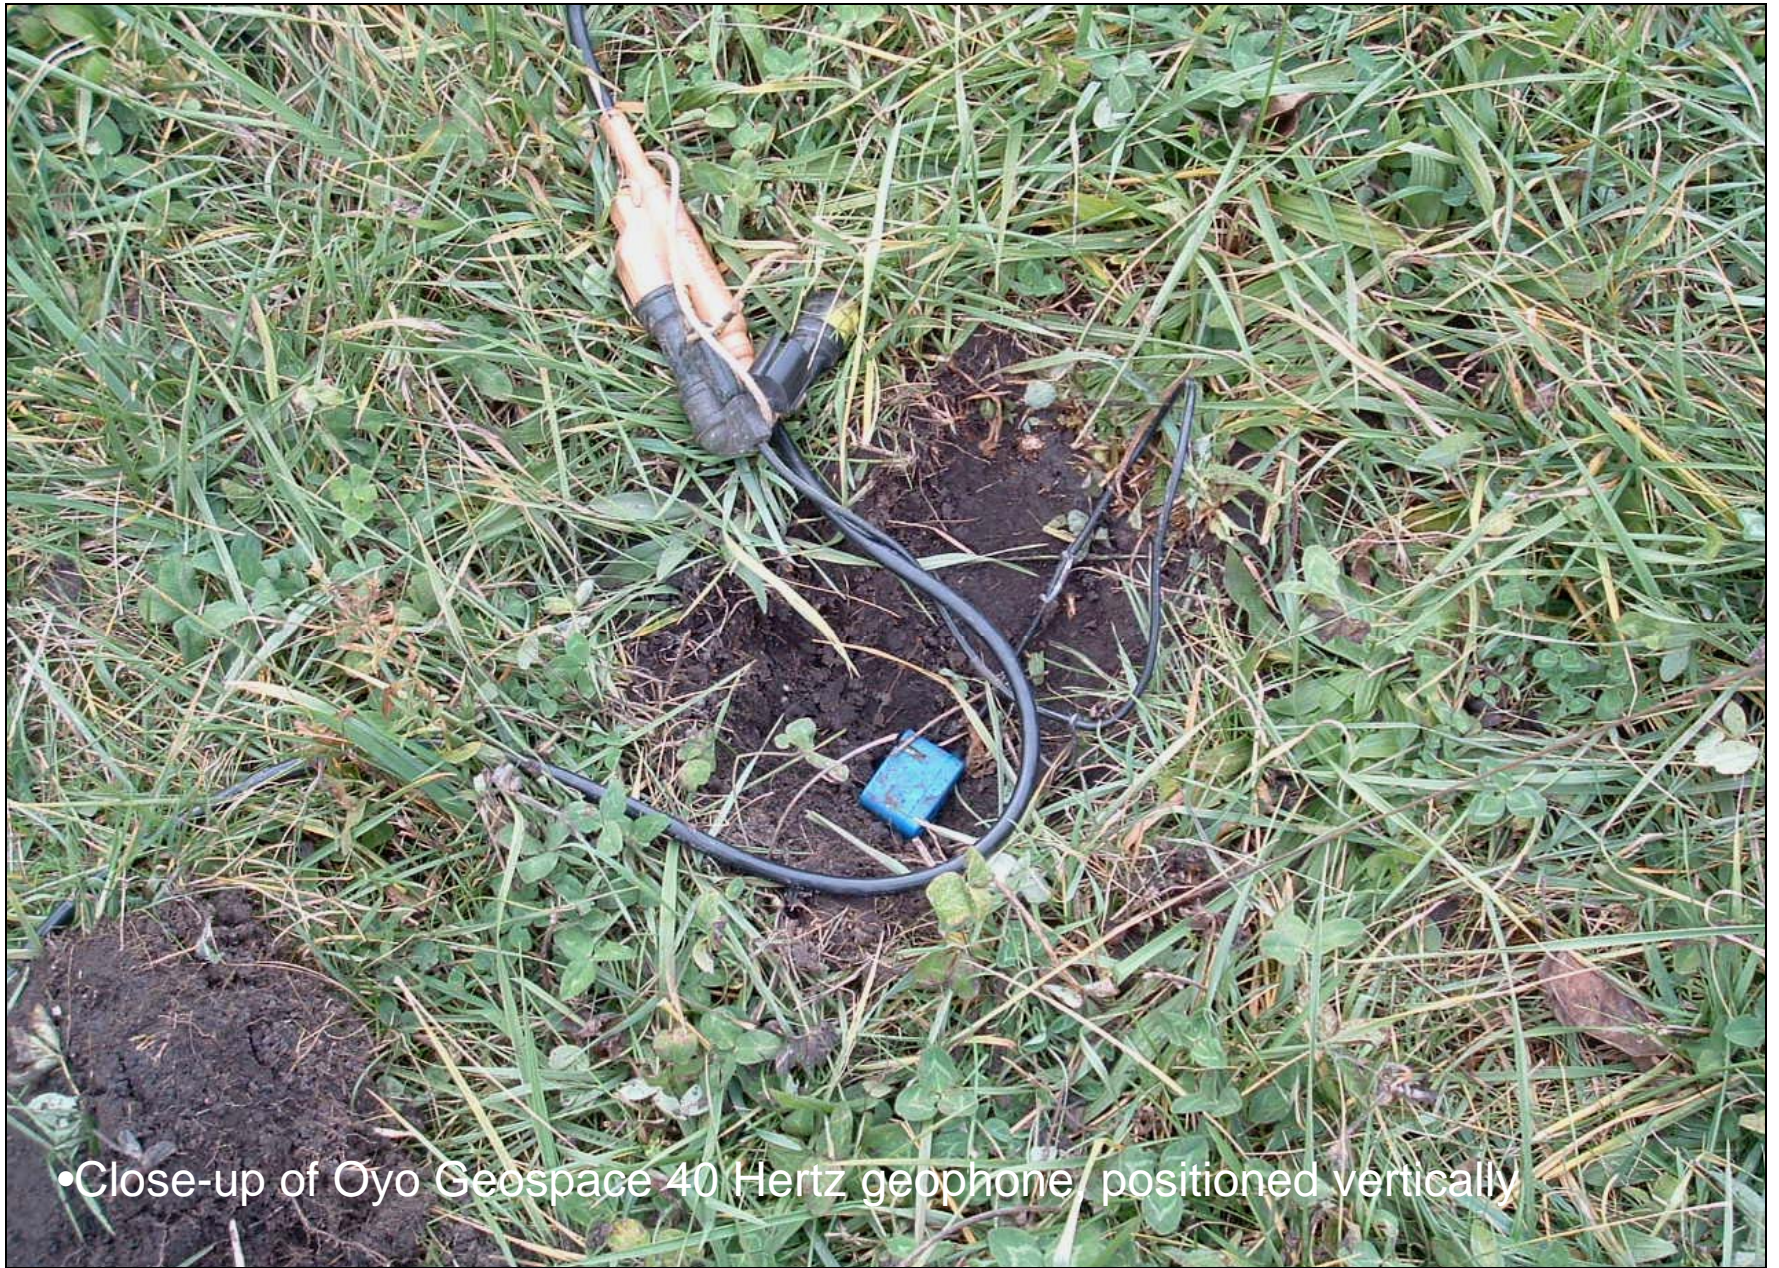
•Close-up of Oyo Geospace 40 Hertz geophone, positioned vertically

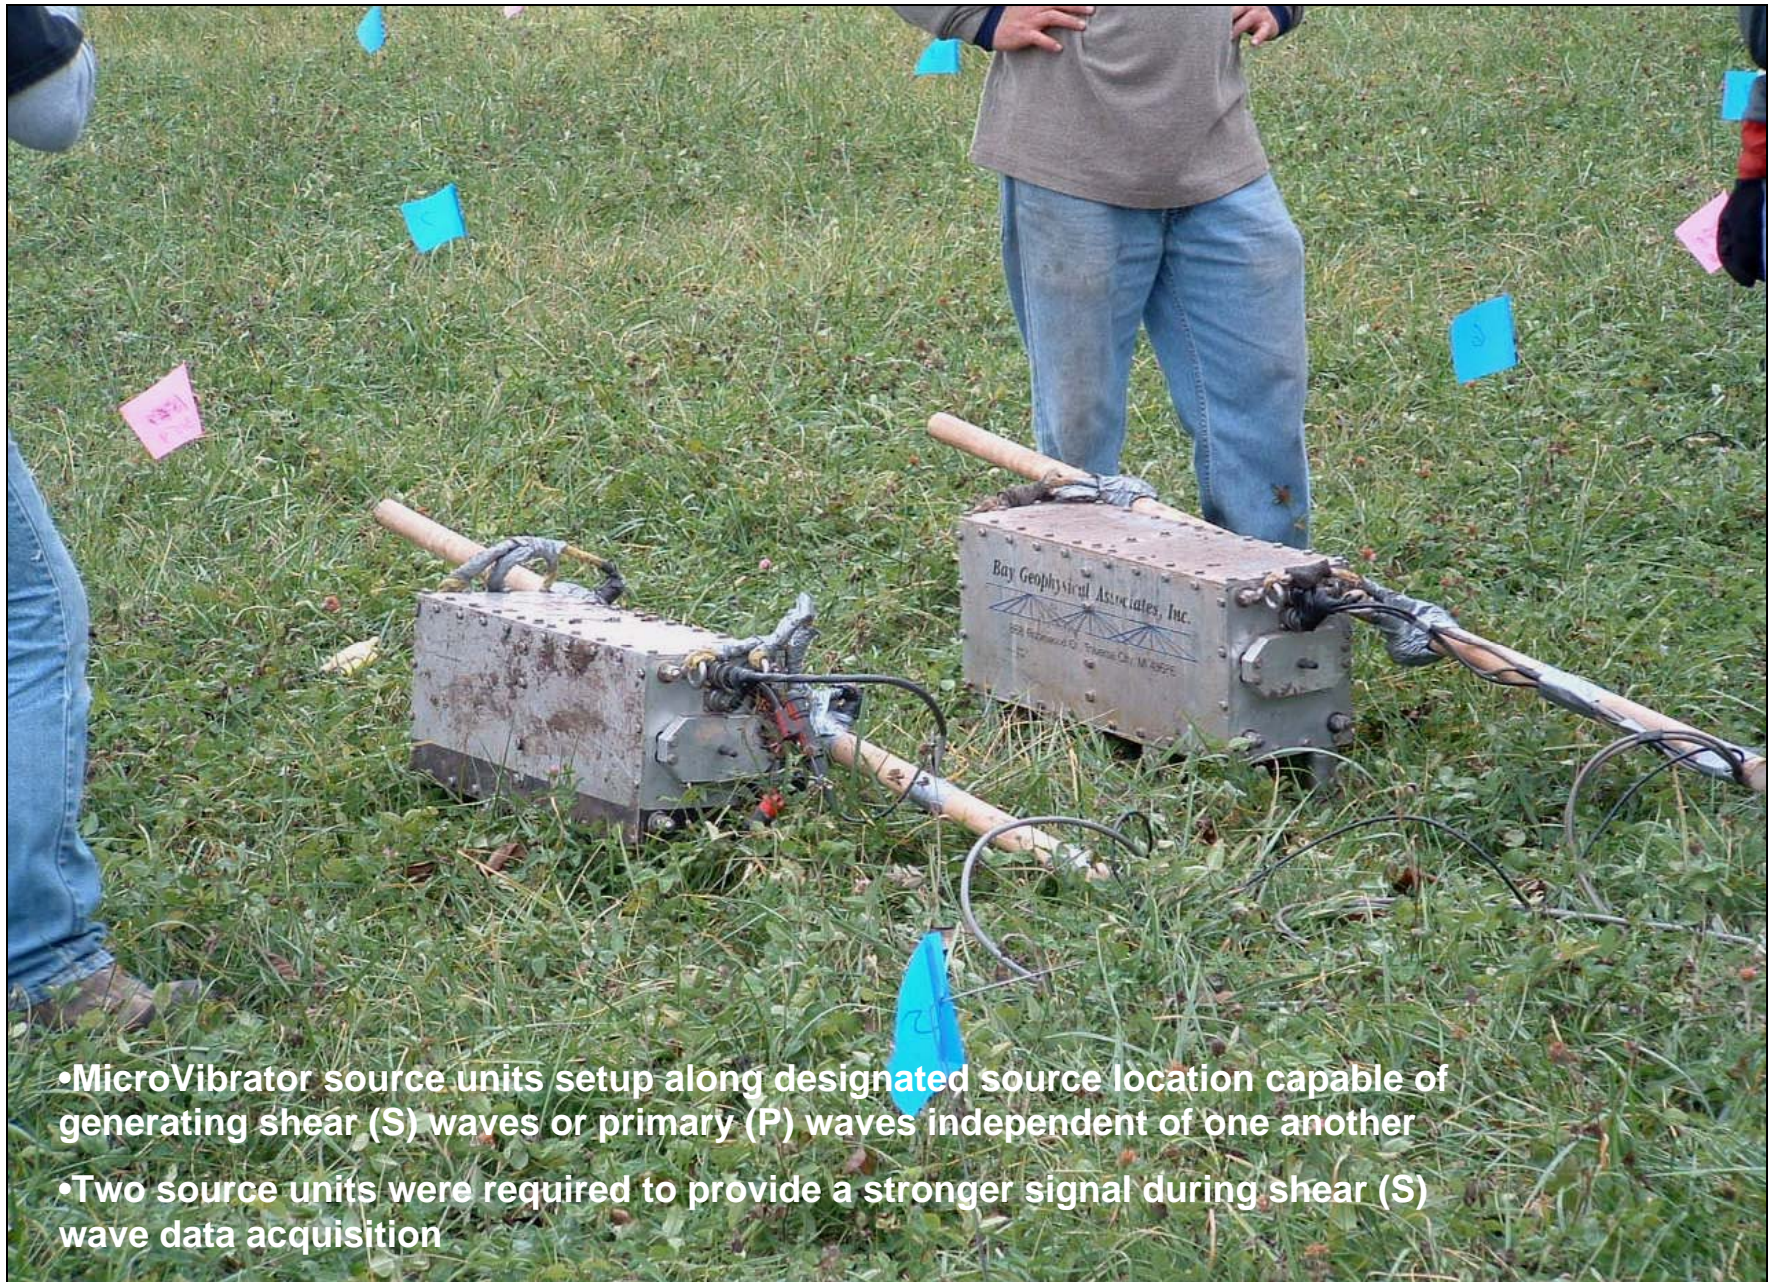
- MicroVibrator source units setup along designated source location capable of generating shear (S) waves or primary (P) waves independent of one another
- Two source units were required to provide a stronger signal during shear (S) wave data acquisition

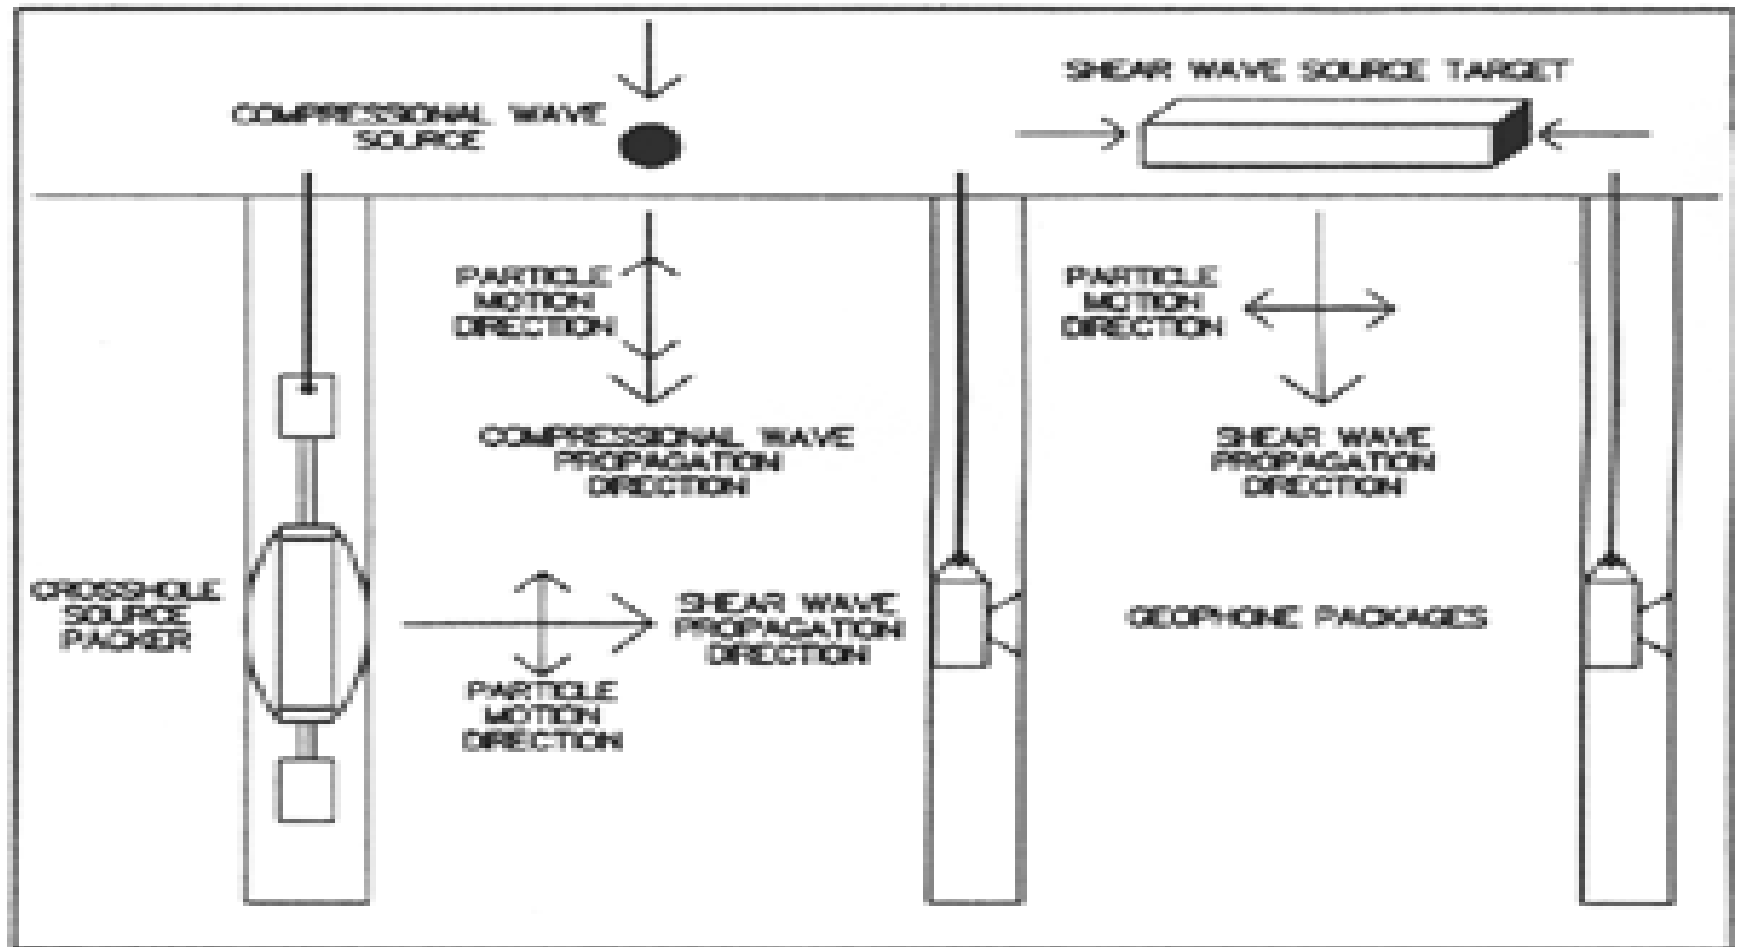
- Borehole XHT-NS#3
- 6-inch-diameter steel casing

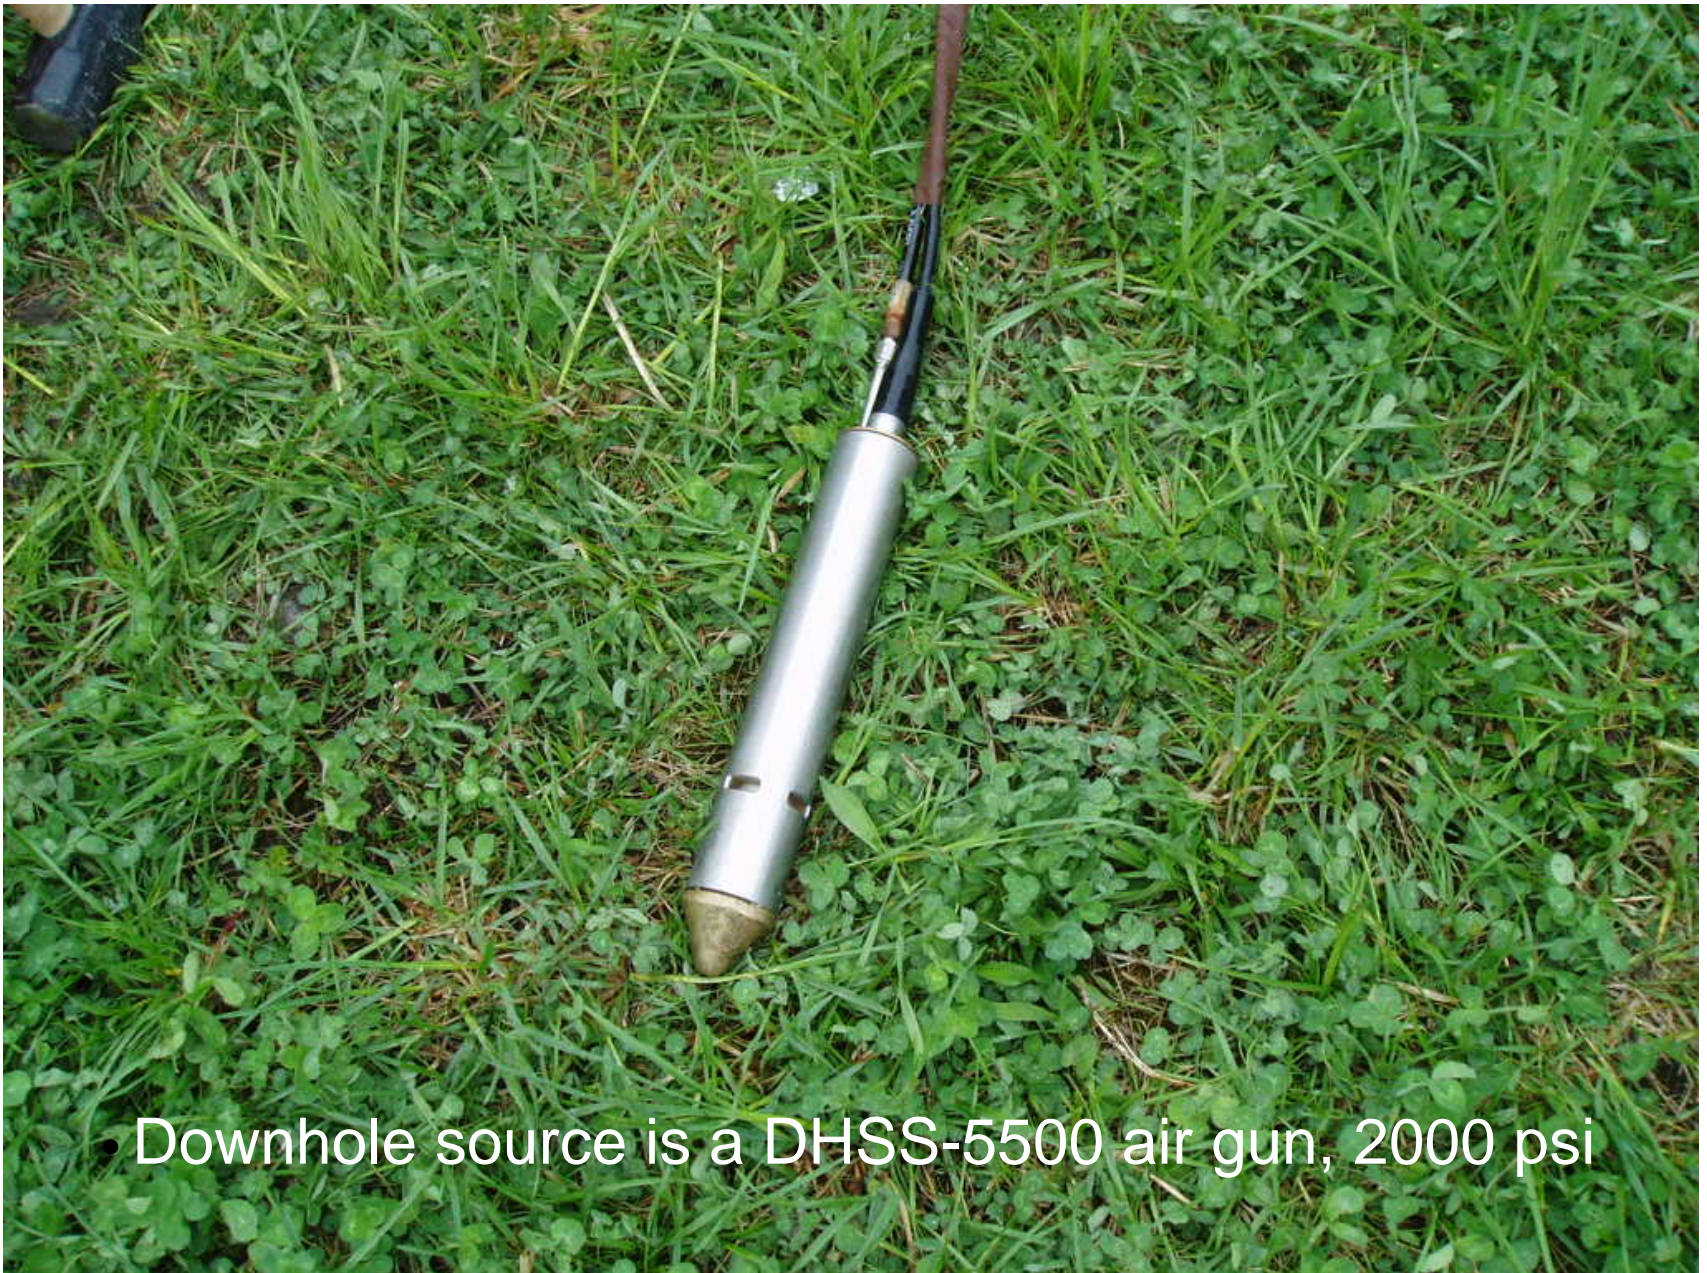
• Downhole source is a DHSS-5500 air gun, 2000 psi

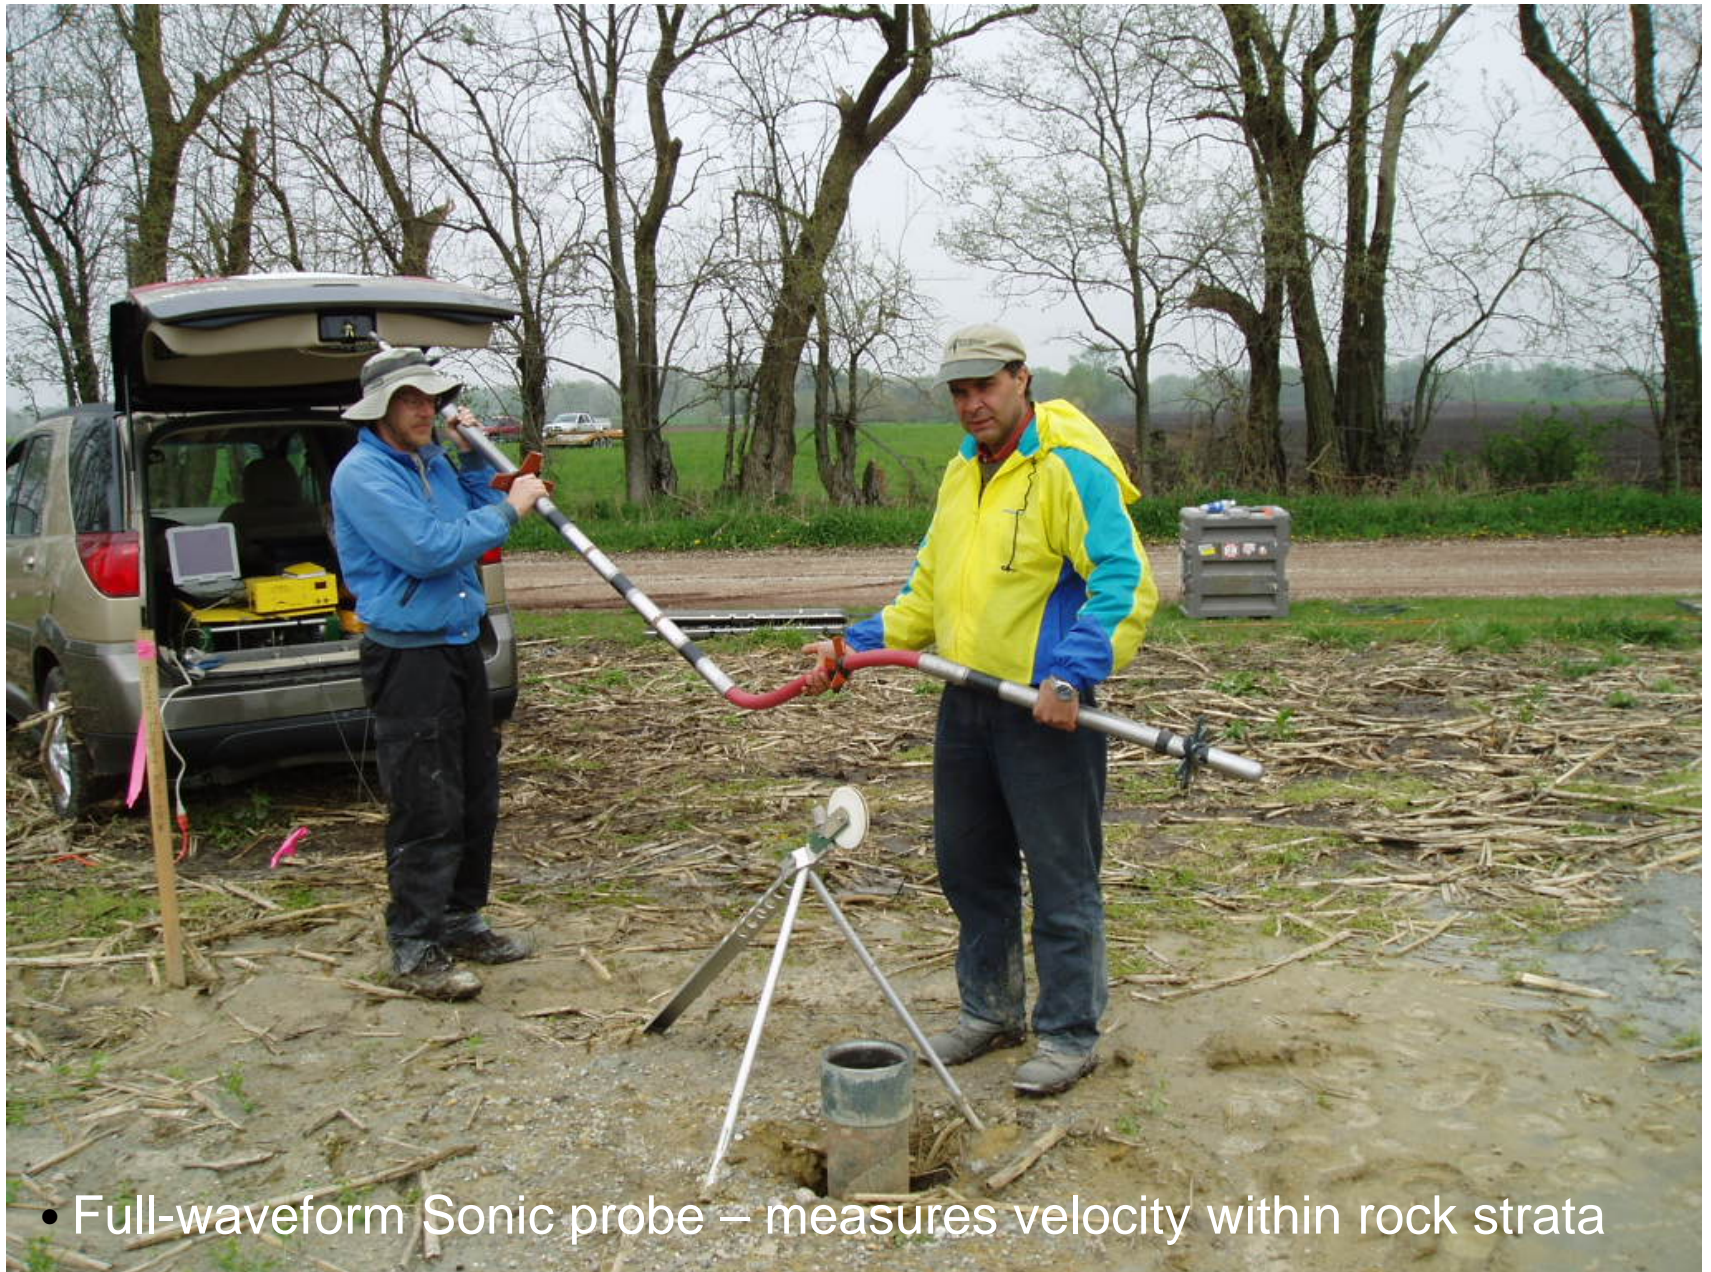
- Full-waveform Sonic probe – measures velocity within rock strata

- Crosshole Seismic recording system

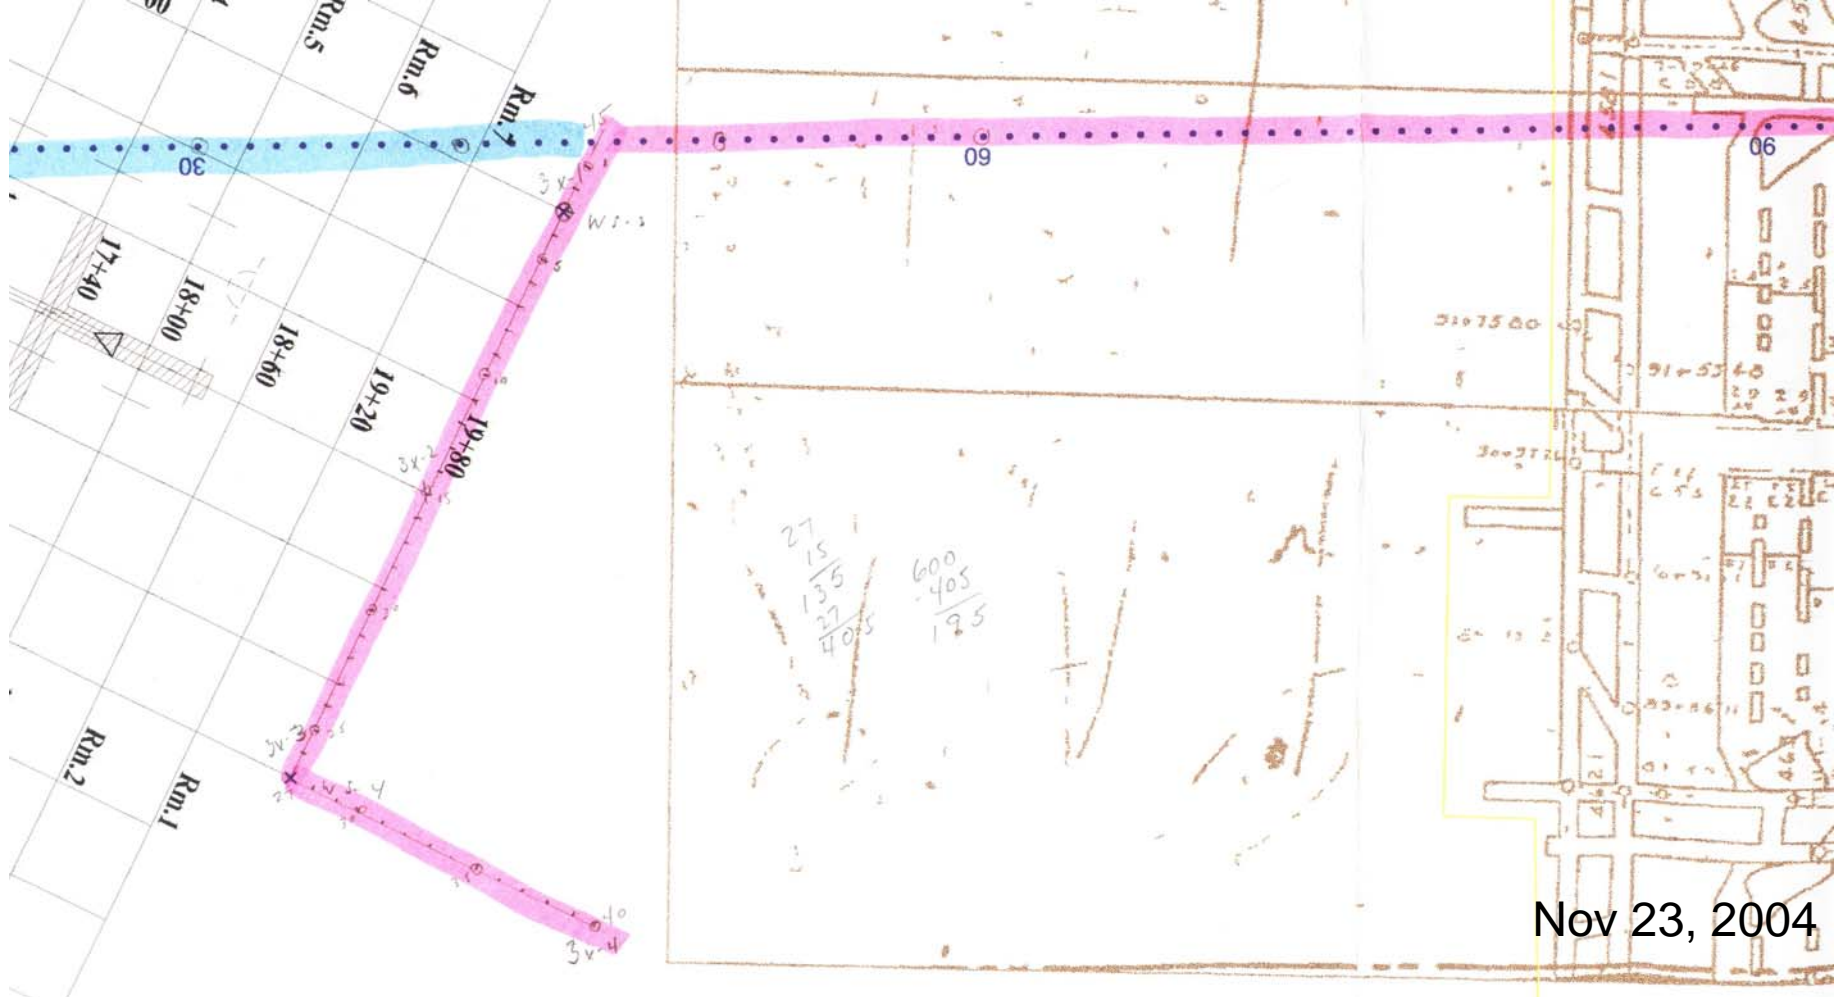
# Plan View of Test Site

- 1) Pink line represents the data acquisition points for preliminary readings.
- 2) 60 vertically mounted geophones were placed along the end of the current production panel and the 160 feet to lower left.
- 3) 120 phones, in 2 parallel lines 60 phones per line were placed perpendicular to panel. Crossing barrier pillar to abandoned Bunsen mine. (60 vertical, 42 horizontal, 6 individual 3 component settings)

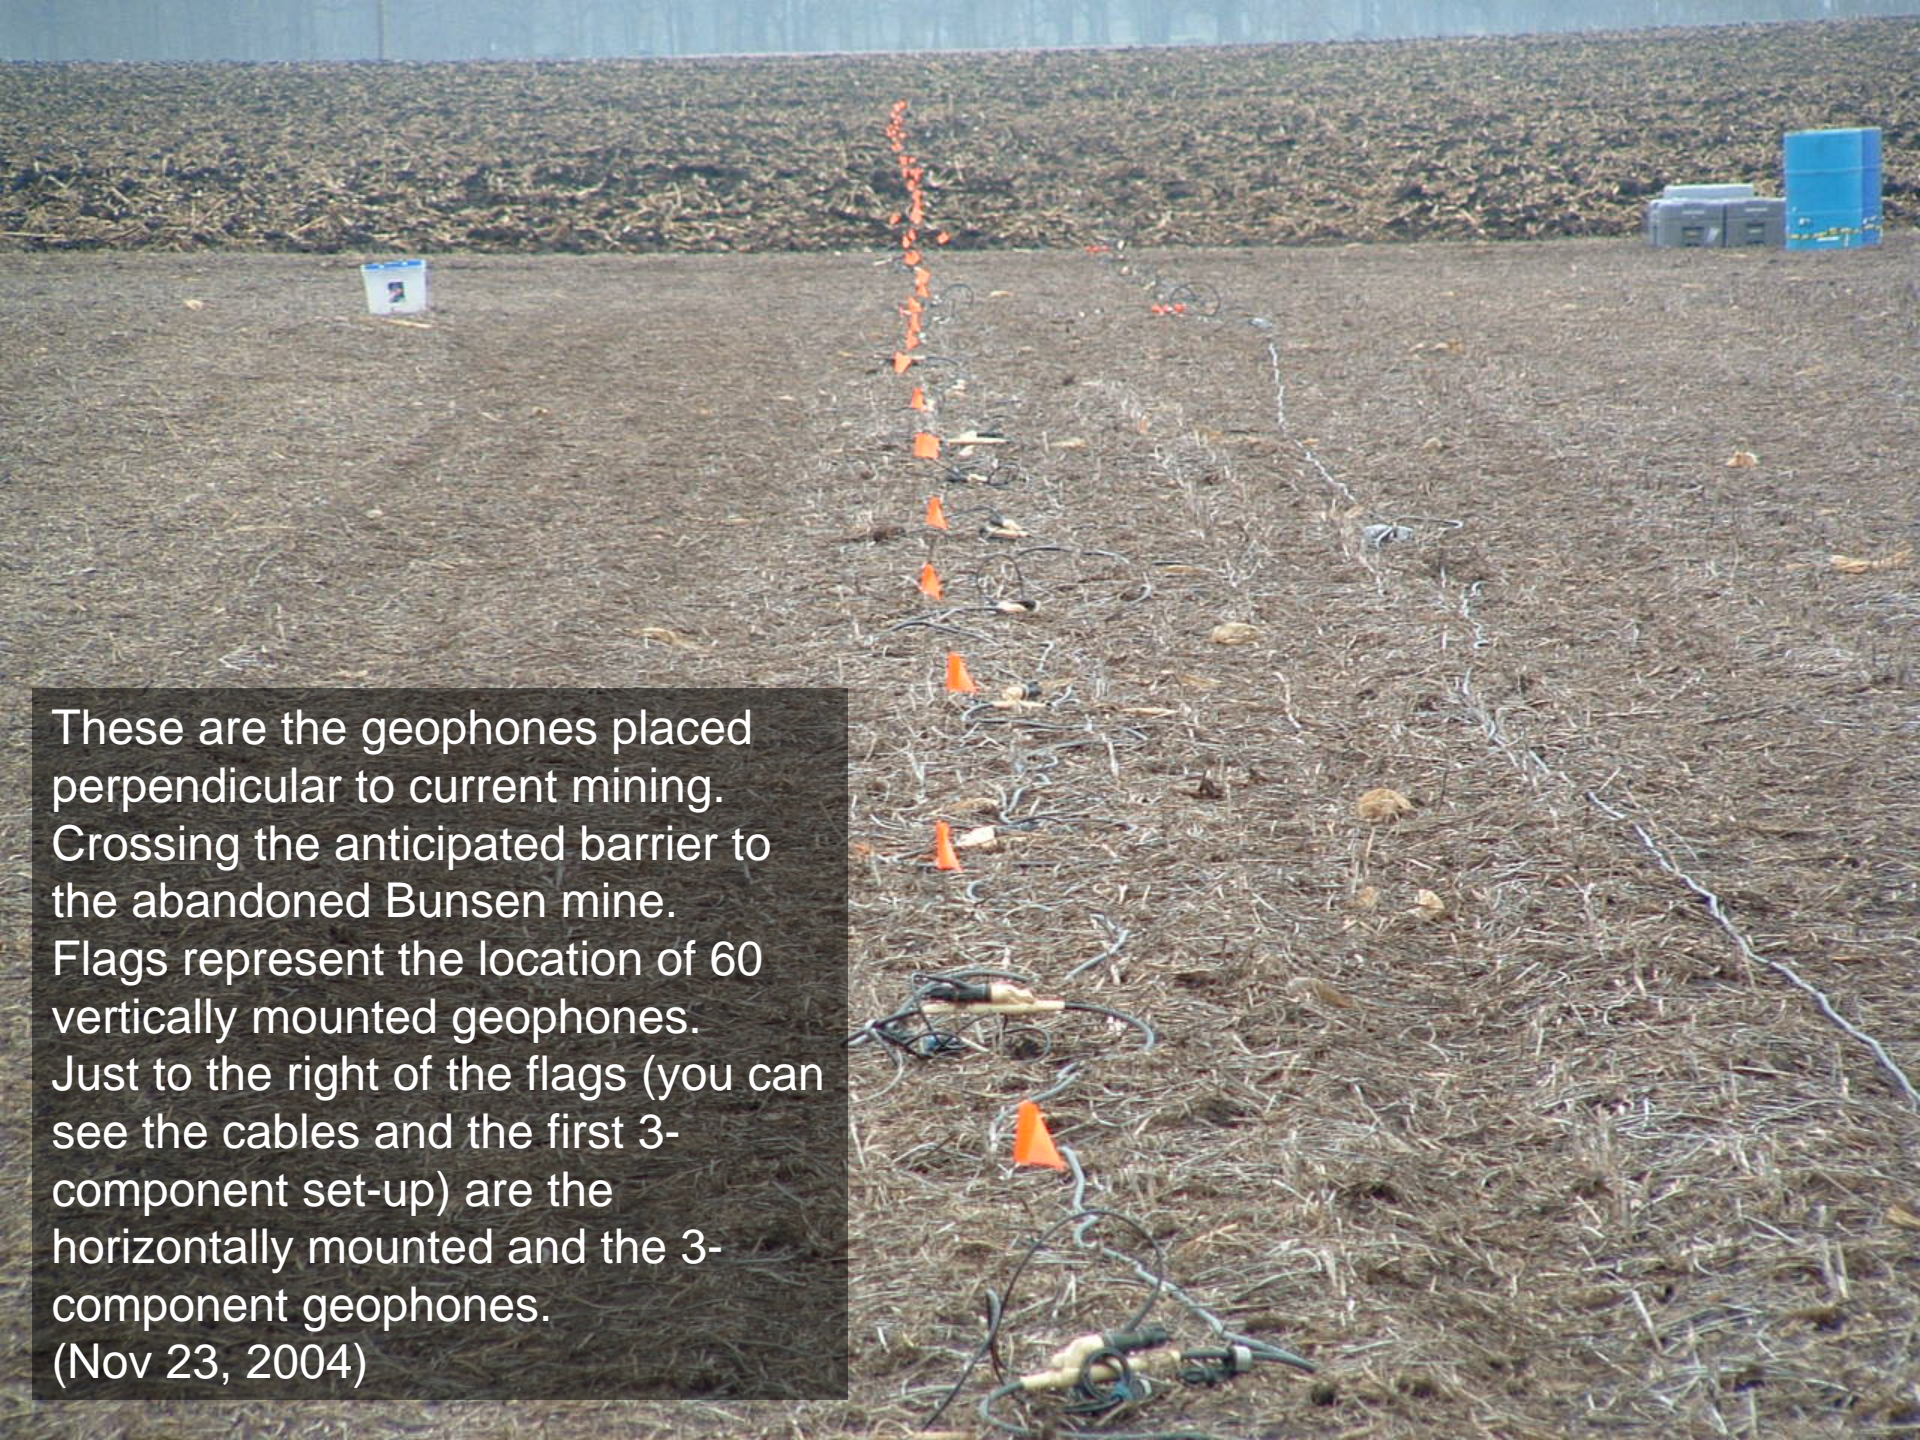
These are the geophones placed perpendicular to current mining. Crossing the anticipated barrier to the abandoned Bunsen mine. Flags represent the location of 60 vertically mounted geophones. Just to the right of the flags (you can see the cables and the first 3-component set-up) are the horizontally mounted and the 3-component geophones. (Nov 23, 2004)

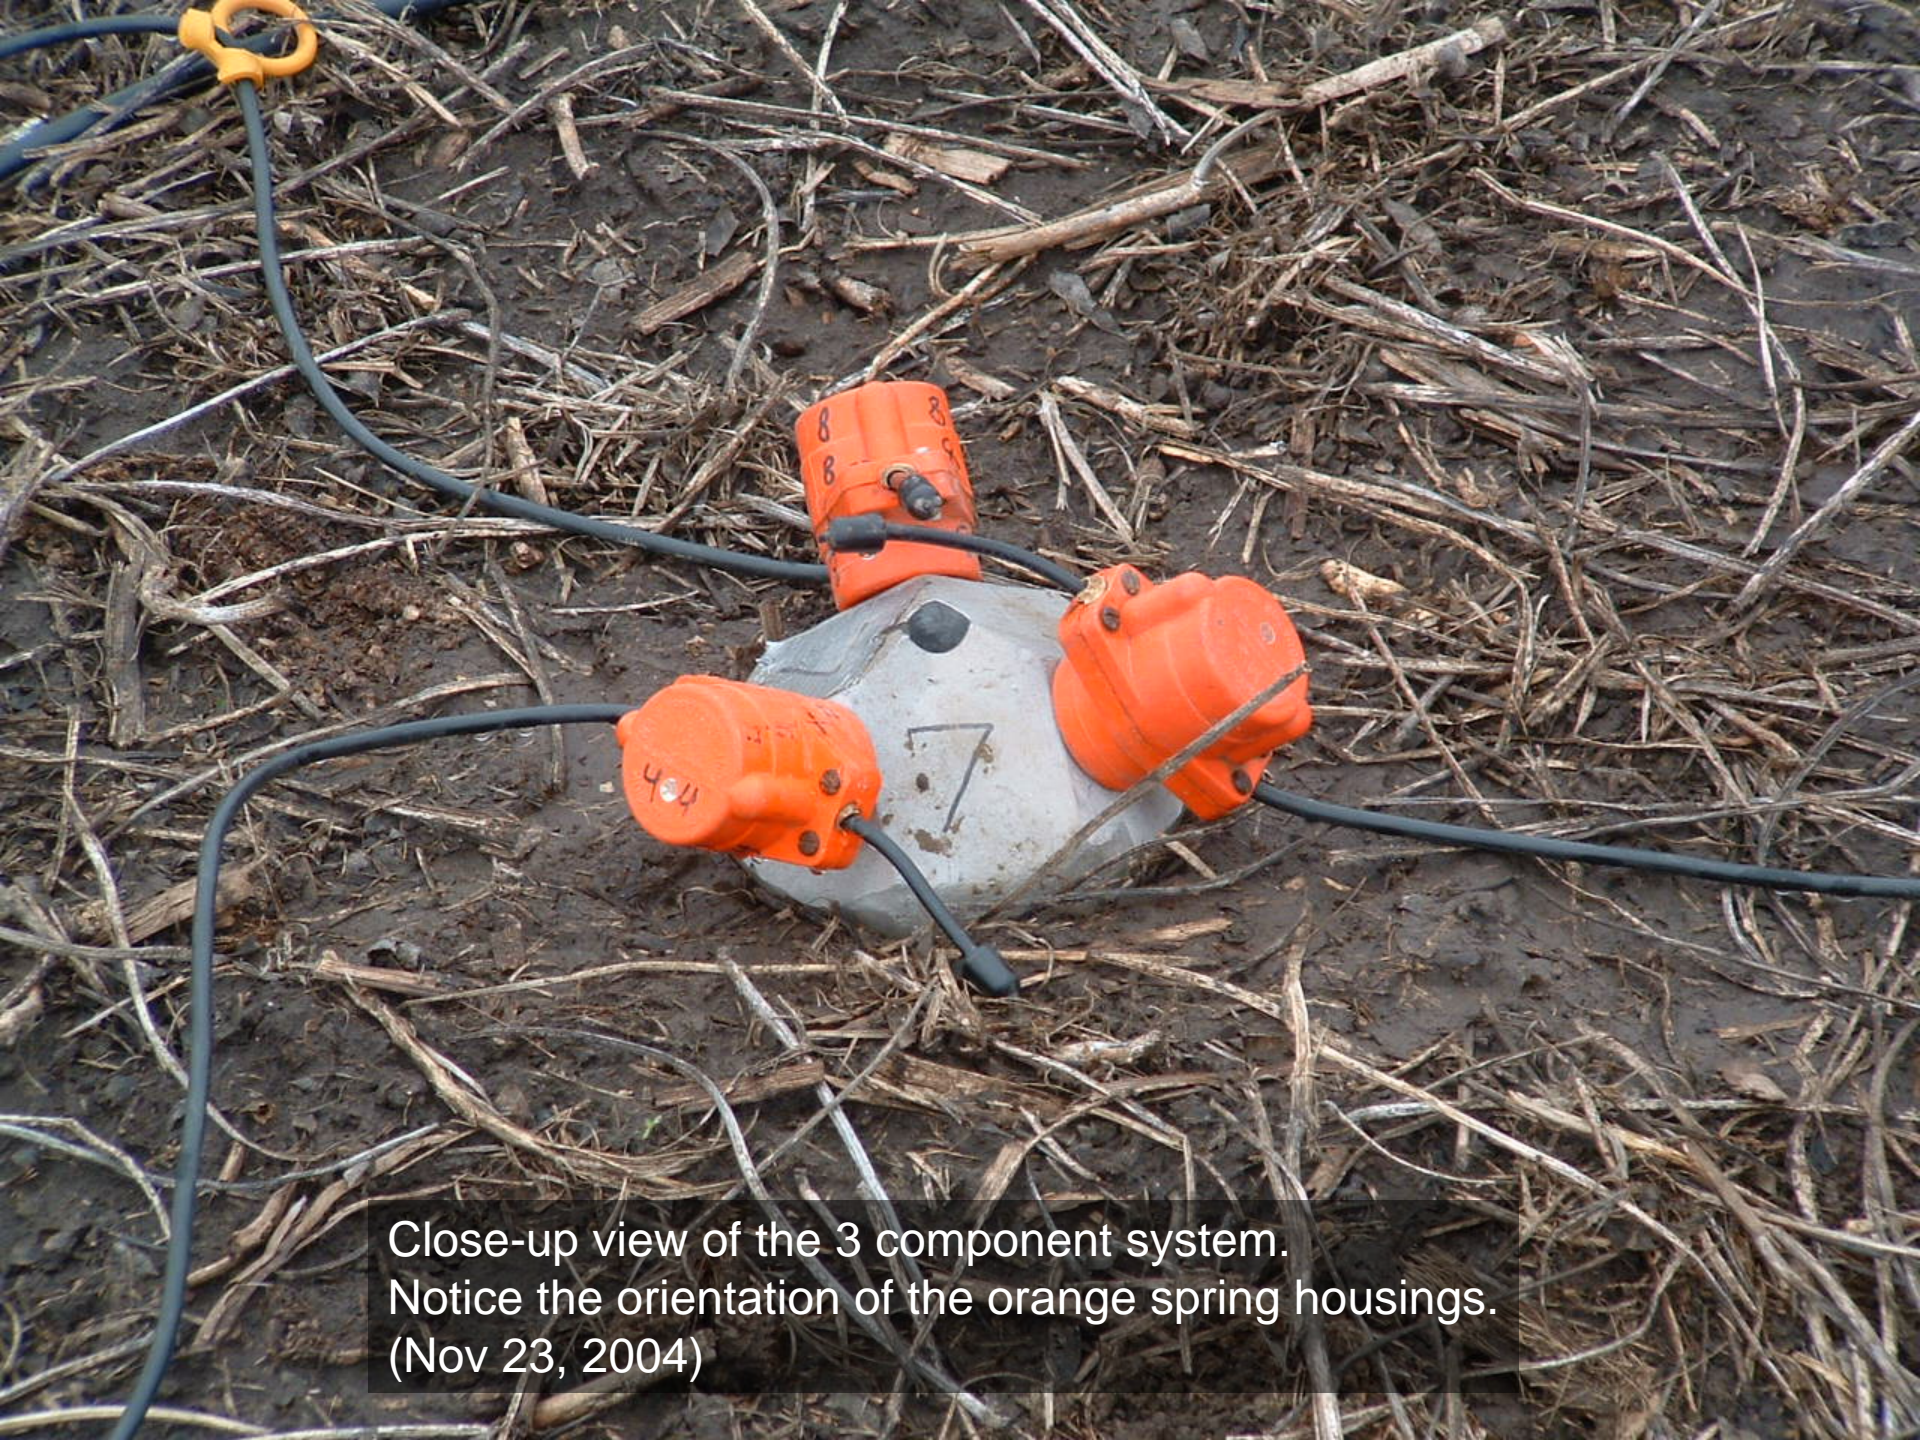
Close-up view of the 3 component system.  
Notice the orientation of the orange spring housings.  
(Nov 23, 2004)

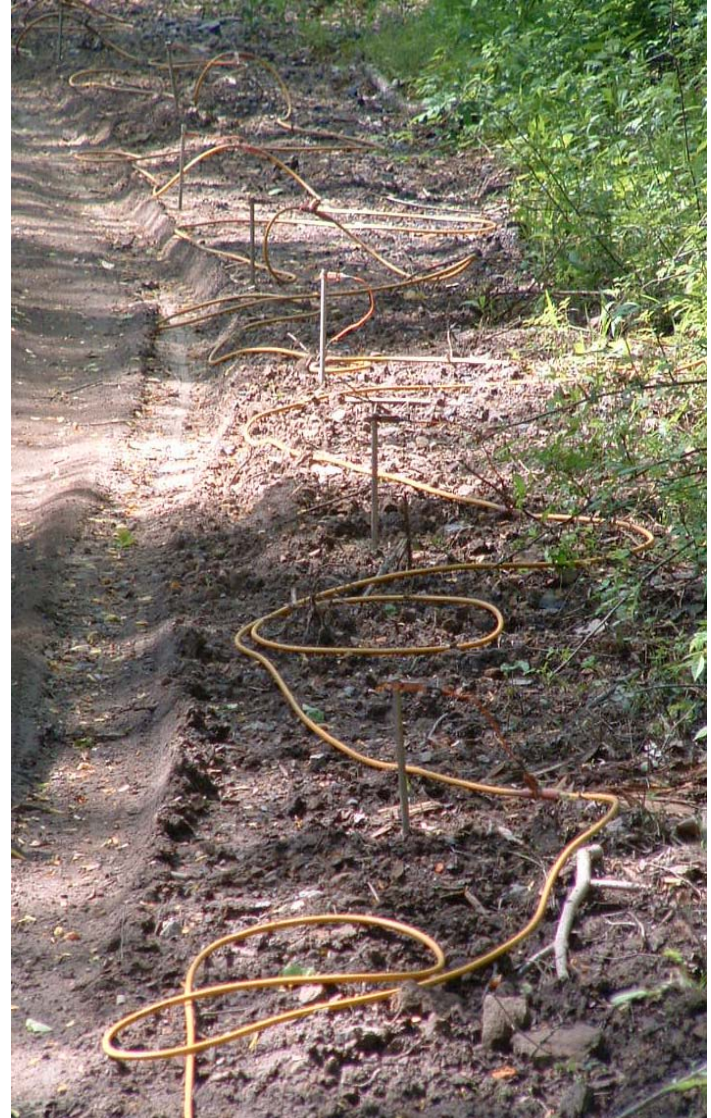
- An electrical current is injected into the ground through two current electrodes and the resulting voltage measured at two potential electrodes.
- The difference between the current and voltage values provide the resistivity of the subsurface material.
- Since resistivity is an intrinsic physical property, the subsurface material is identified by comparing its resistivity to that of known materials.
- The process is repeated along survey lines laid out in parallel or in series to obtain a subsurface profile.
- This technique is generally effective to depths of 50 to 100 feet.

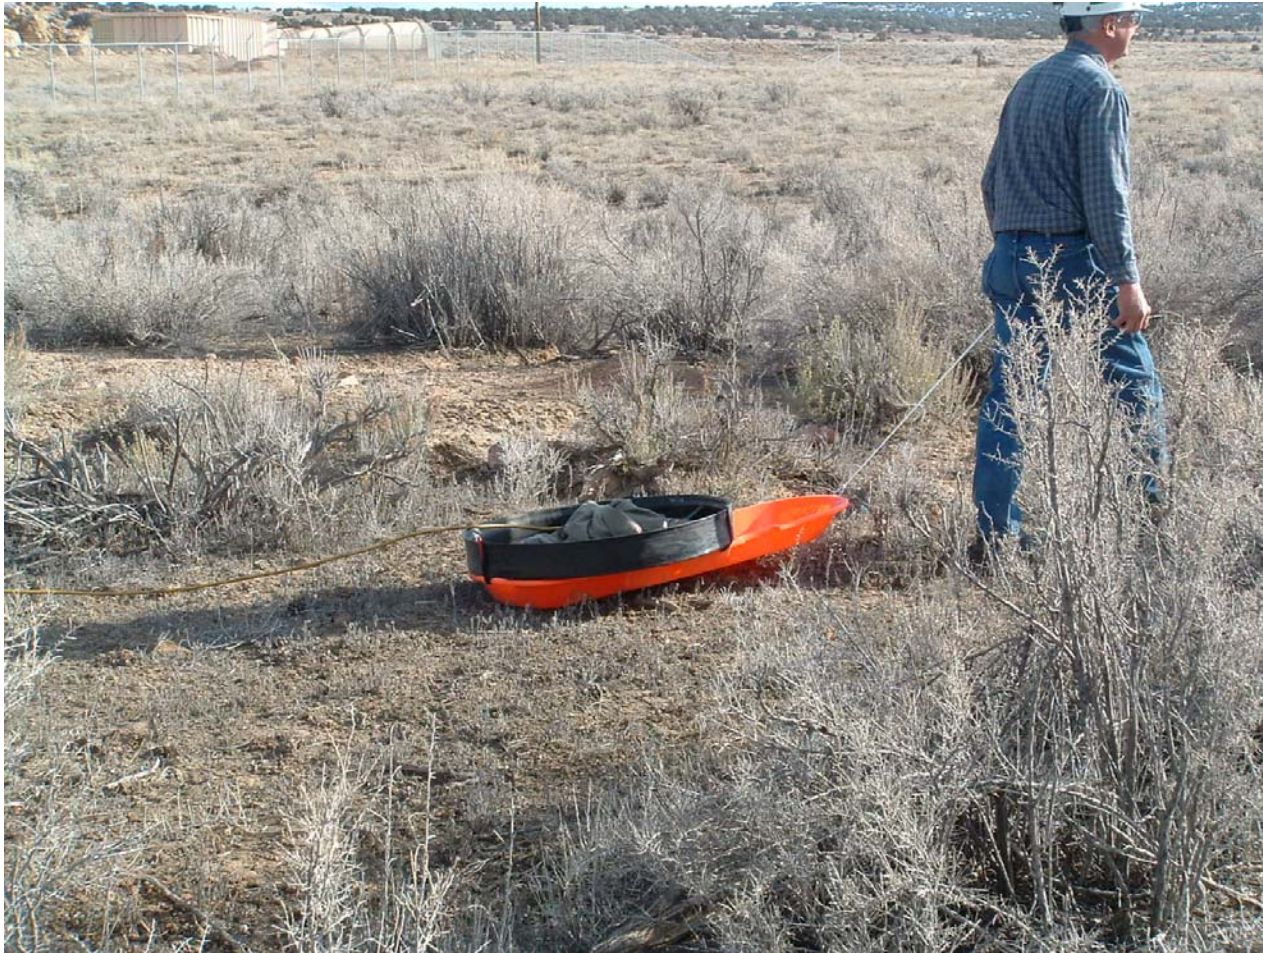
Pulling the mobile transmitter parallel to the receiver survey line.
